Ex-SHADWELL / Ex-State of Maine Salvage Report

August 2007

Ex-SHADWELL / Ex-State of Maine Salvage Report Table of Contents

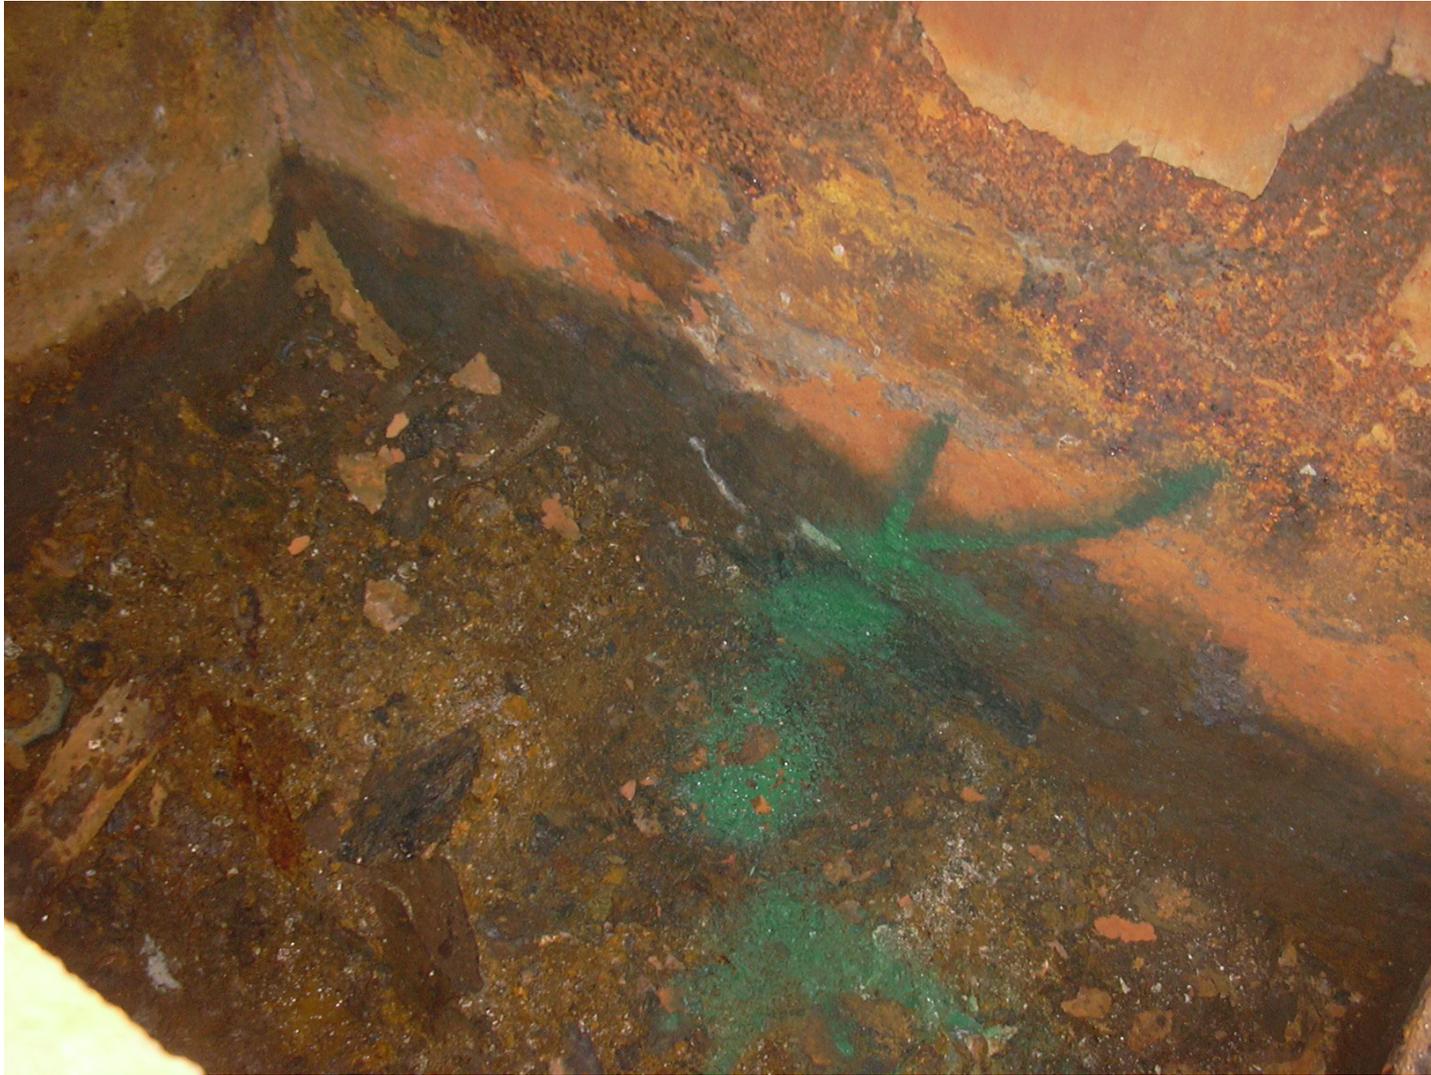
Figure 4. Flat of Keel plate at CL-BHD and Frame 69.

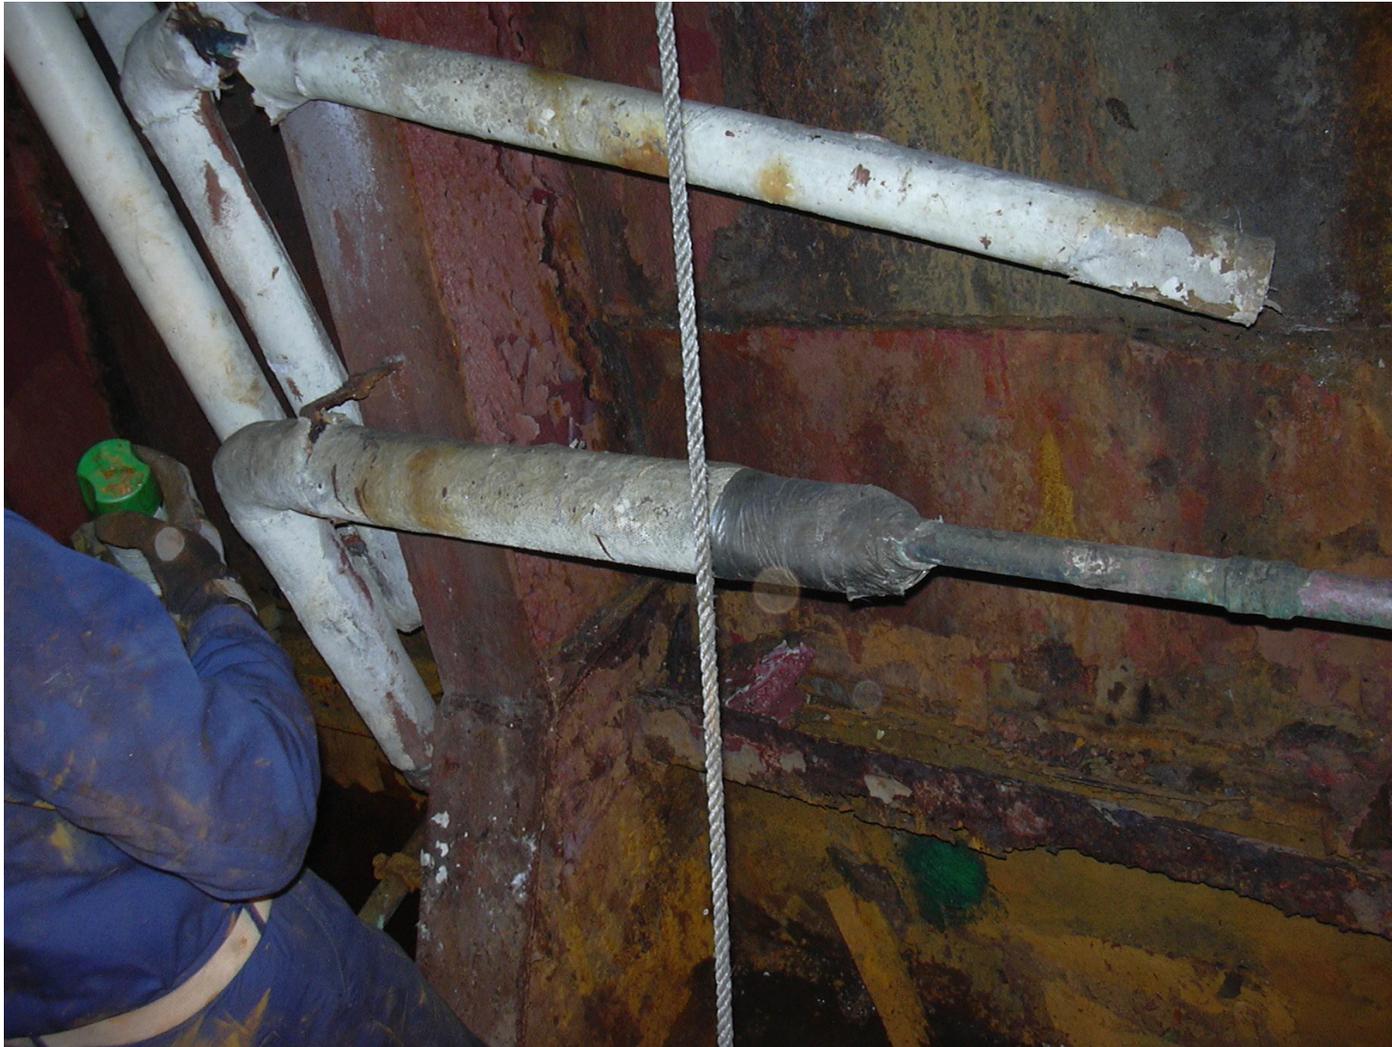
Figure 5. L-8 wasted in stbd. engine room.

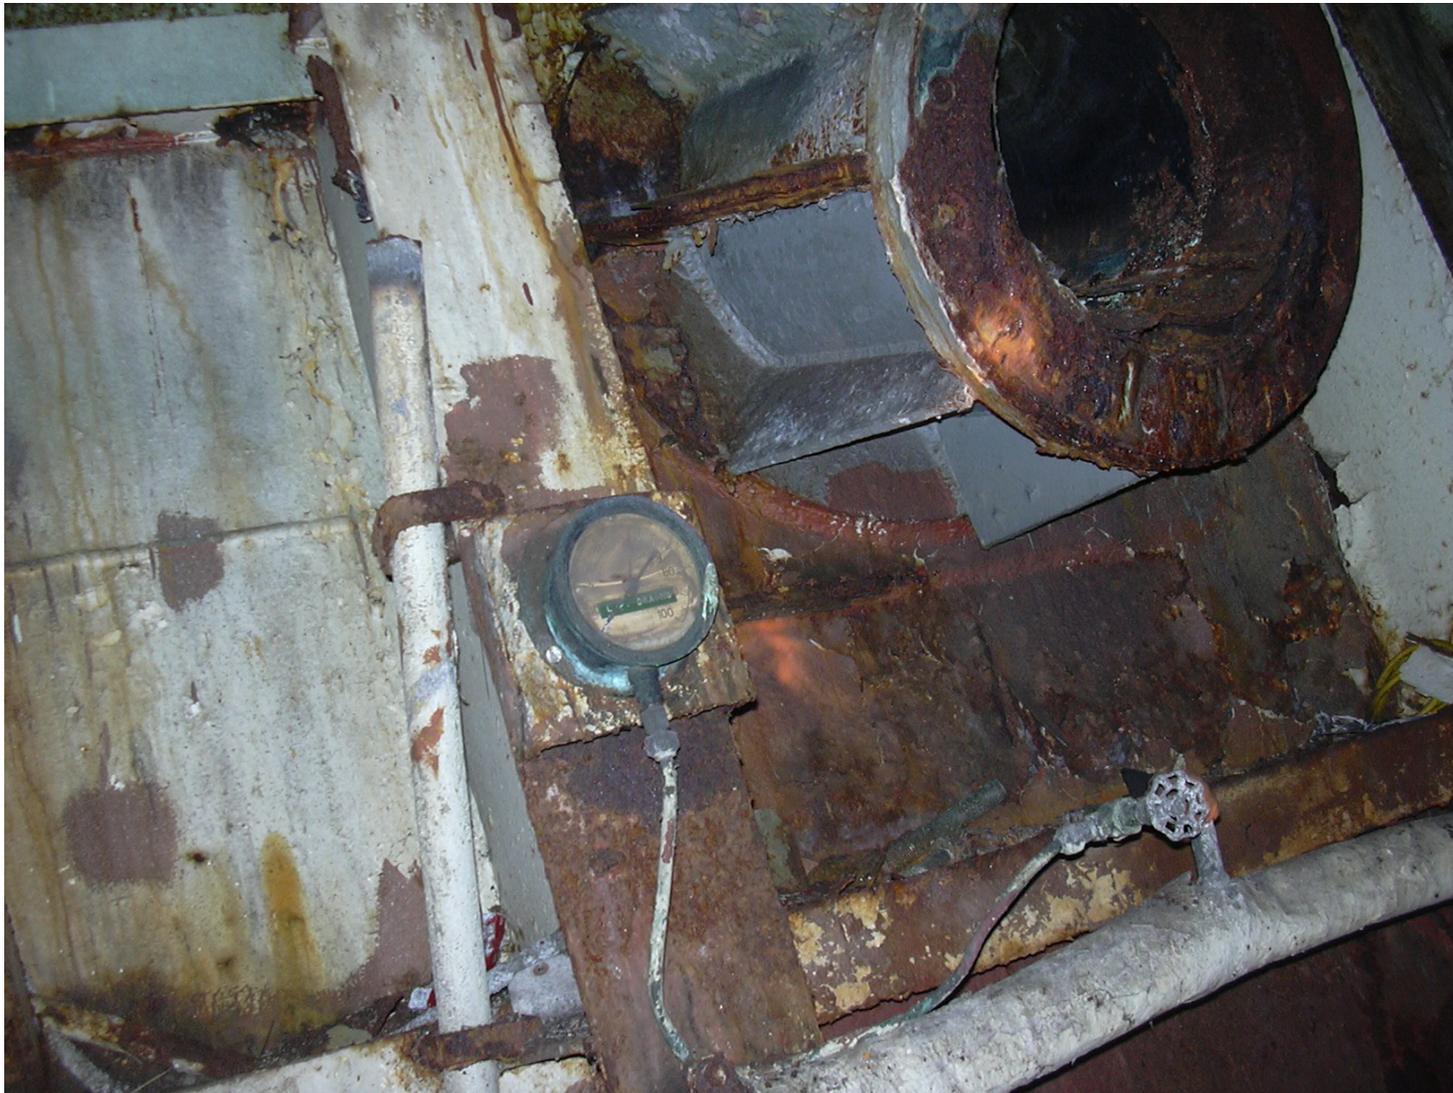
Figure 6. Wasted 6X4 longitudinal above turn of bilge in stbd. engine room.

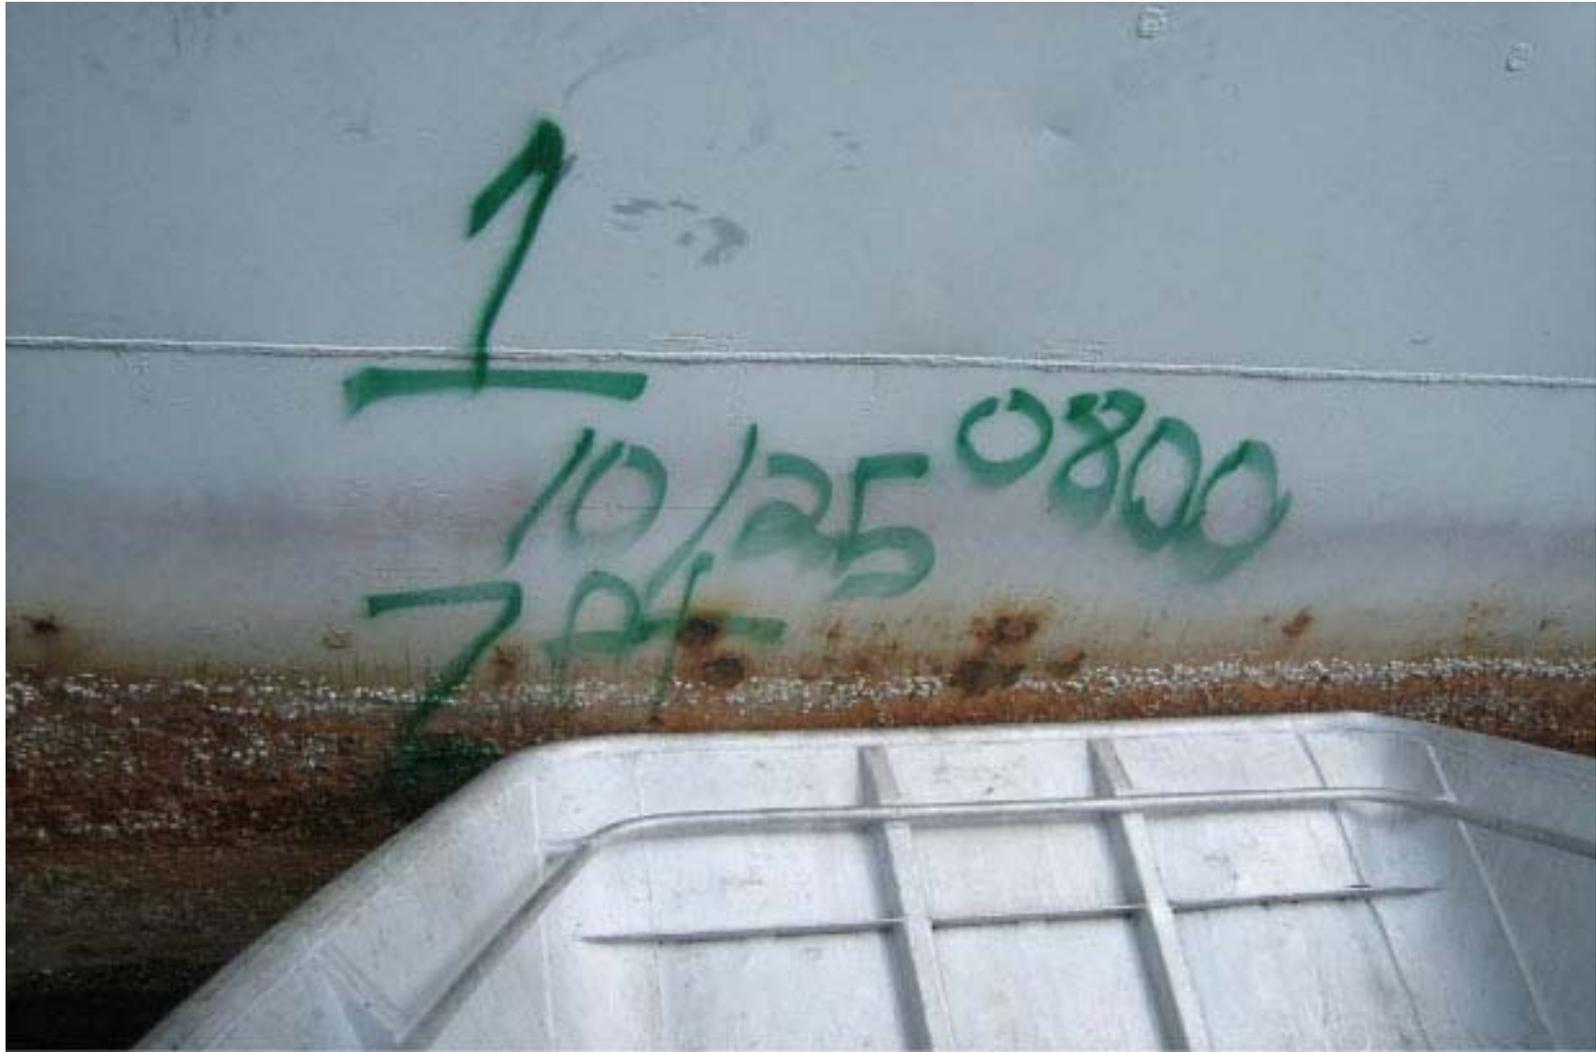
Figure 7. Location 1 Outboard Shell Plate. Readings were taken both above and below the rust/scale line.

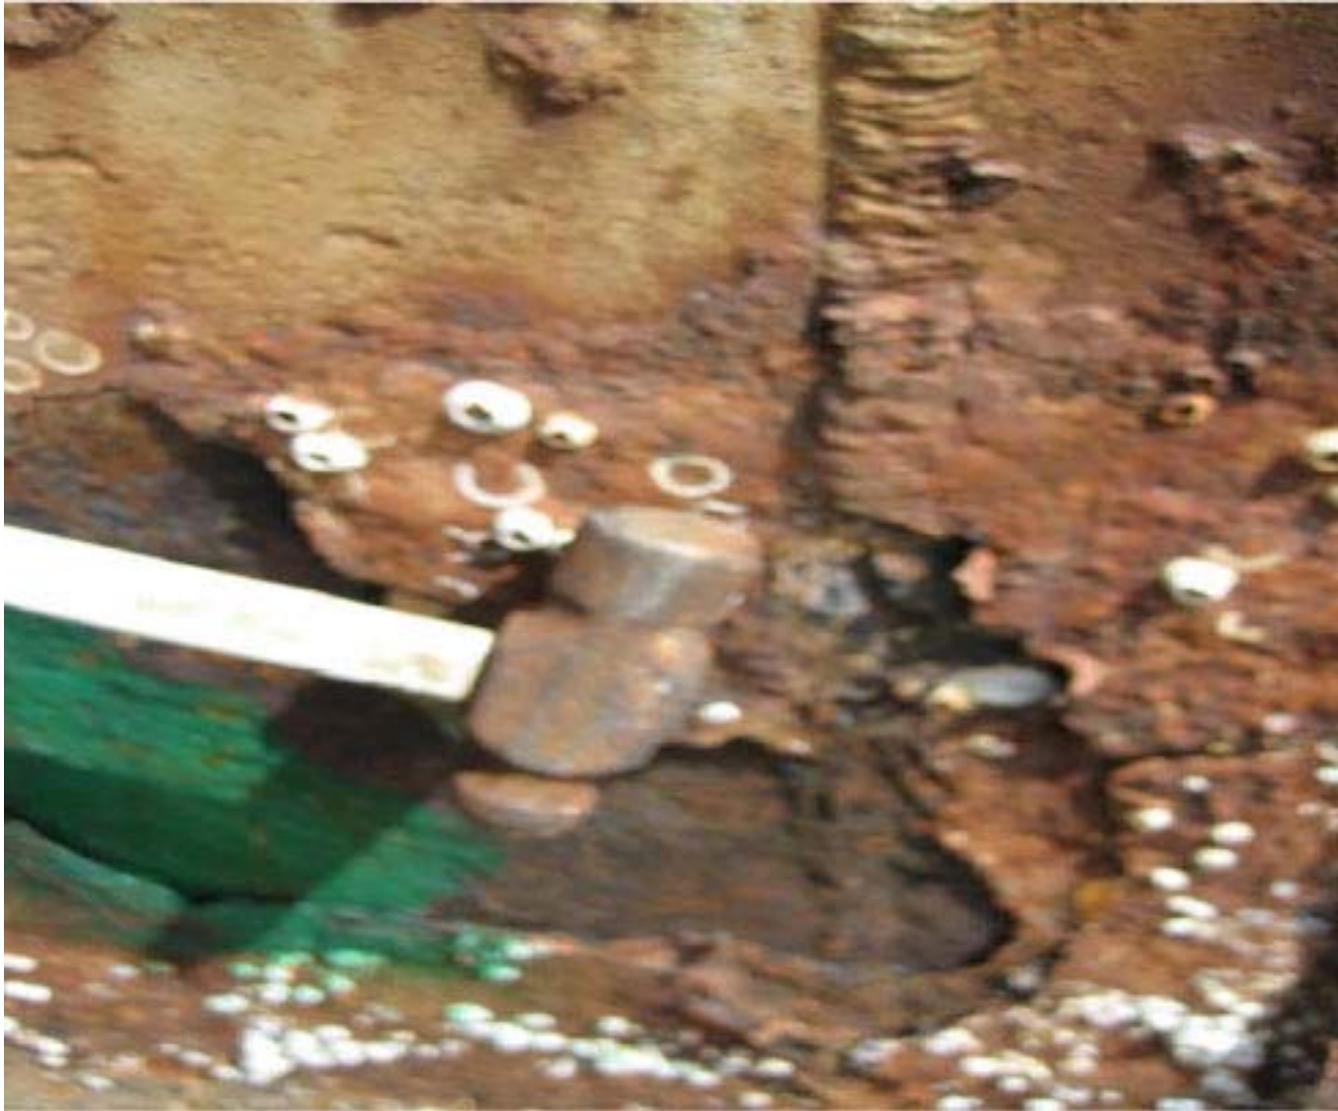
Figure 8. Area showing green location mark at Location 1, and area of chipped off scale.

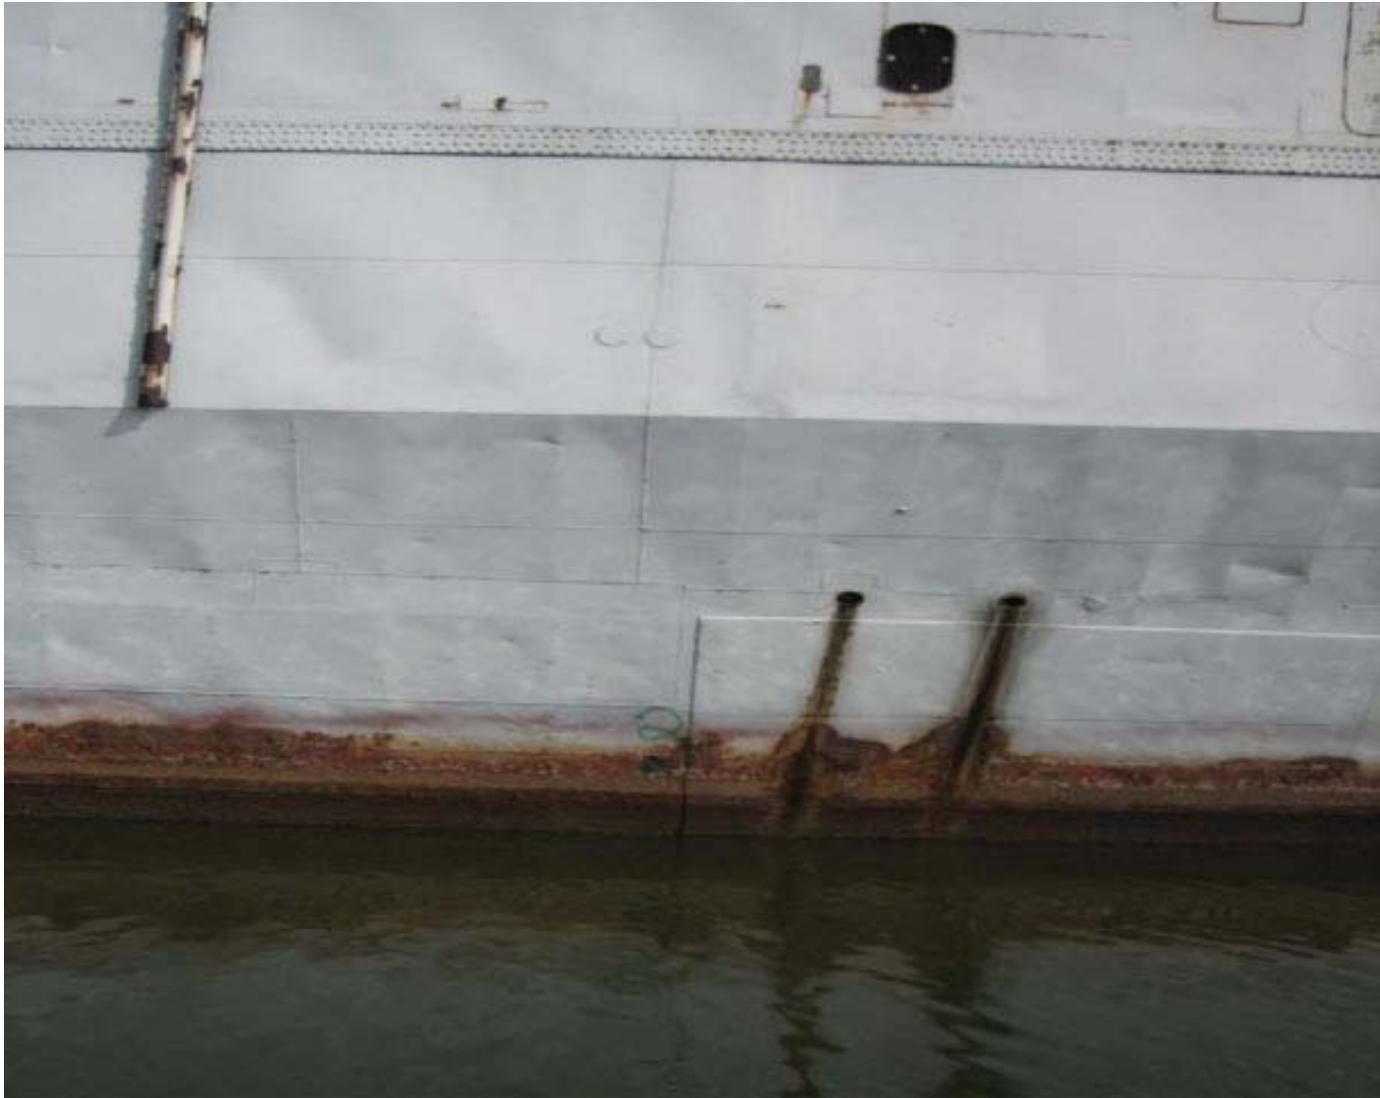
Figure 9. Location 2, Frame 36. Readings were taken aft of the doubler plate in areas both above and below the scale line.

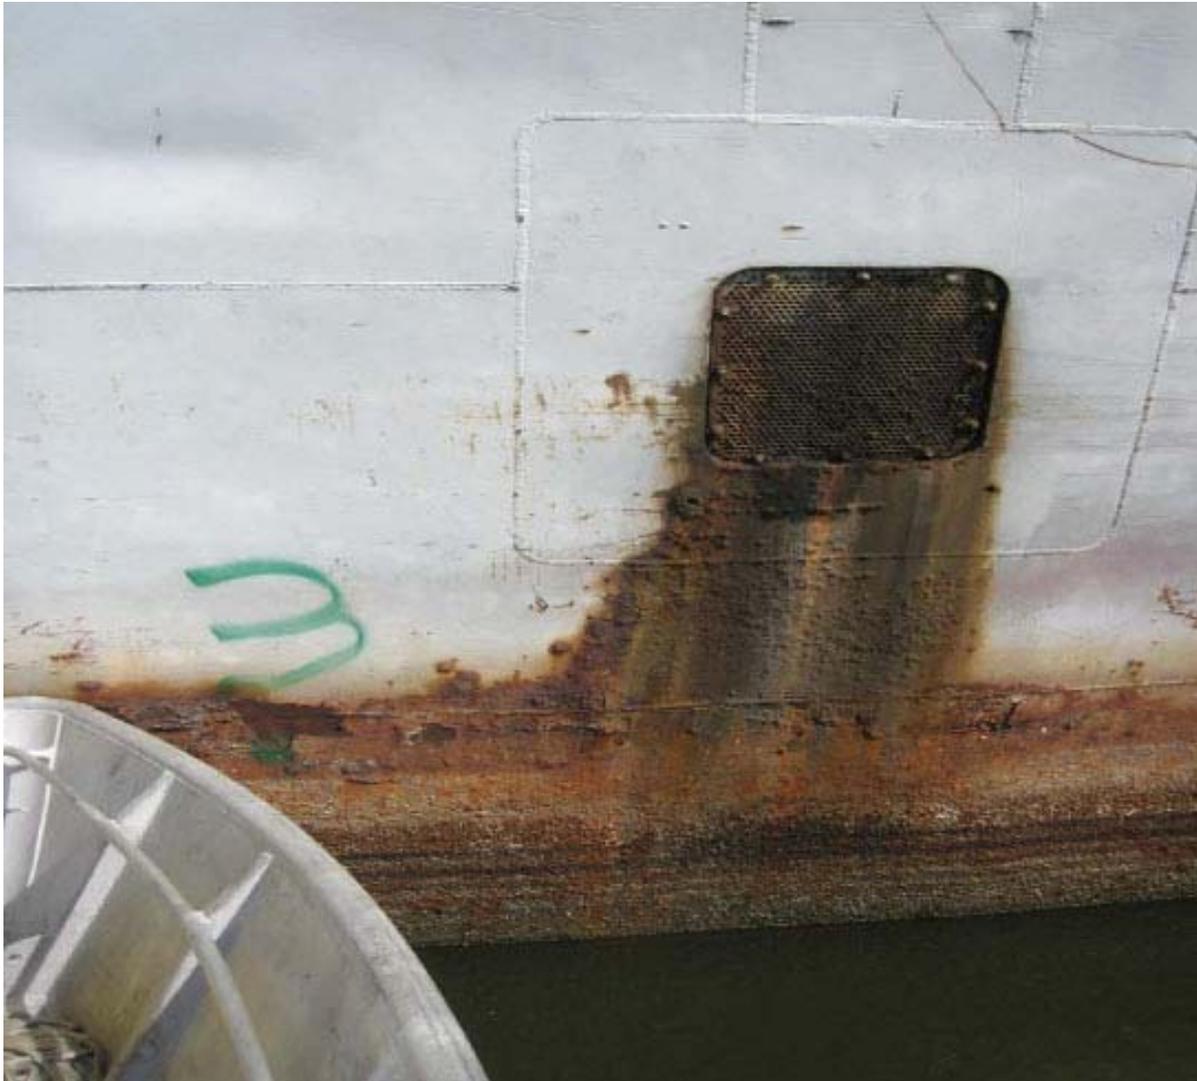
Figure 10. Location 3, Frame 49 in way of seachest for clean ballast.

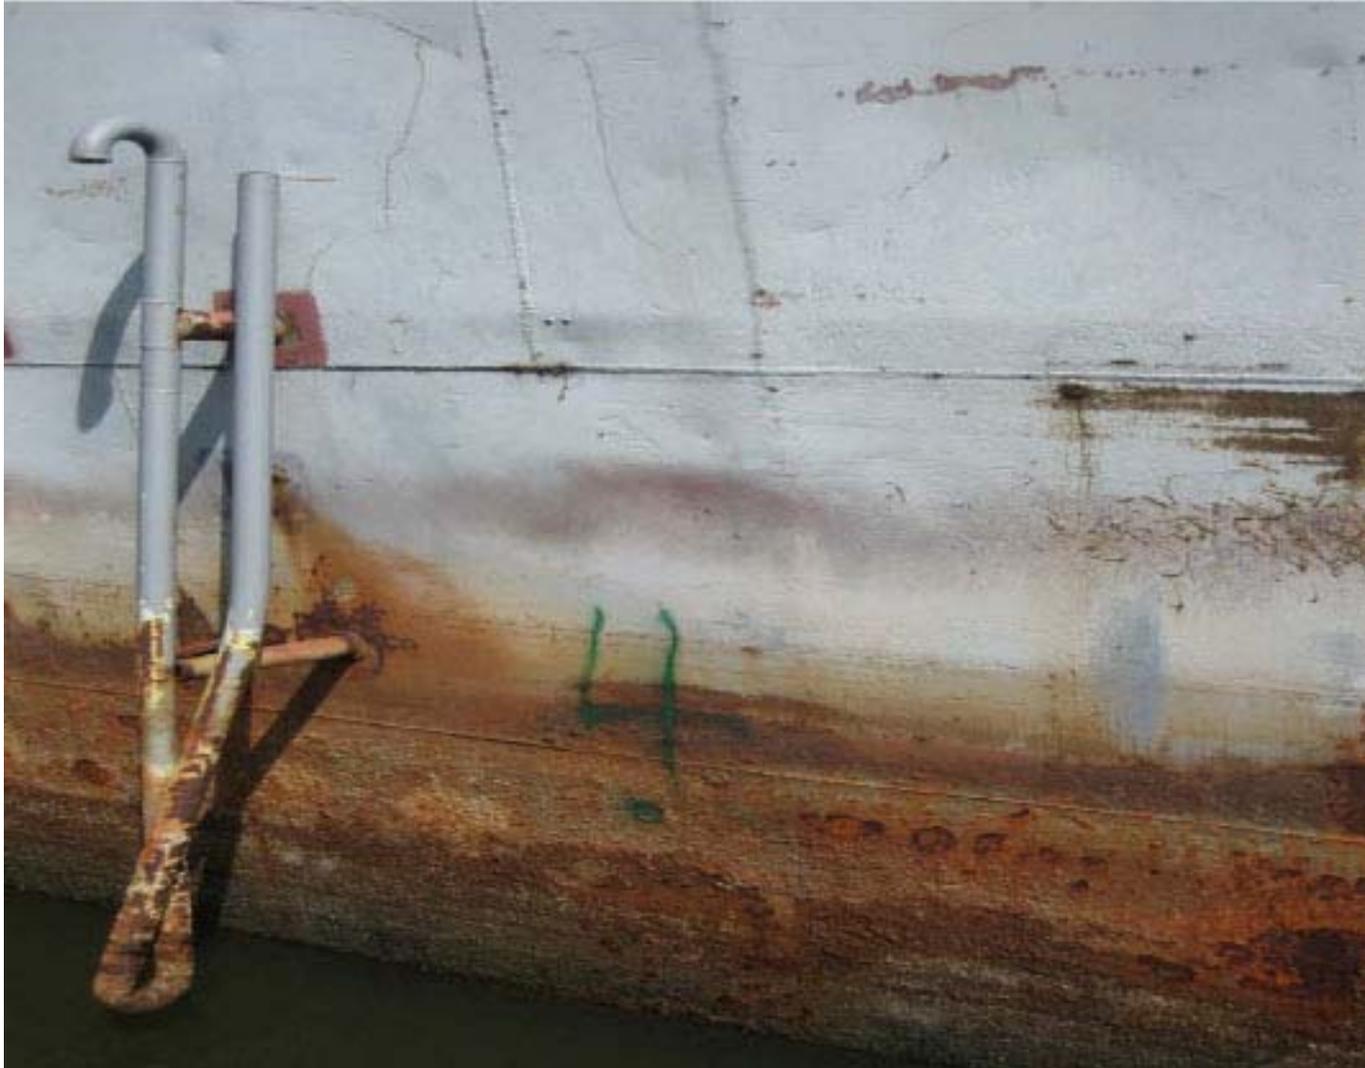
Figure 11. Location 4, Frame 64. Readings were taken both above and below the weld seam to the right of the location number. Note hollowed shell plating between frames

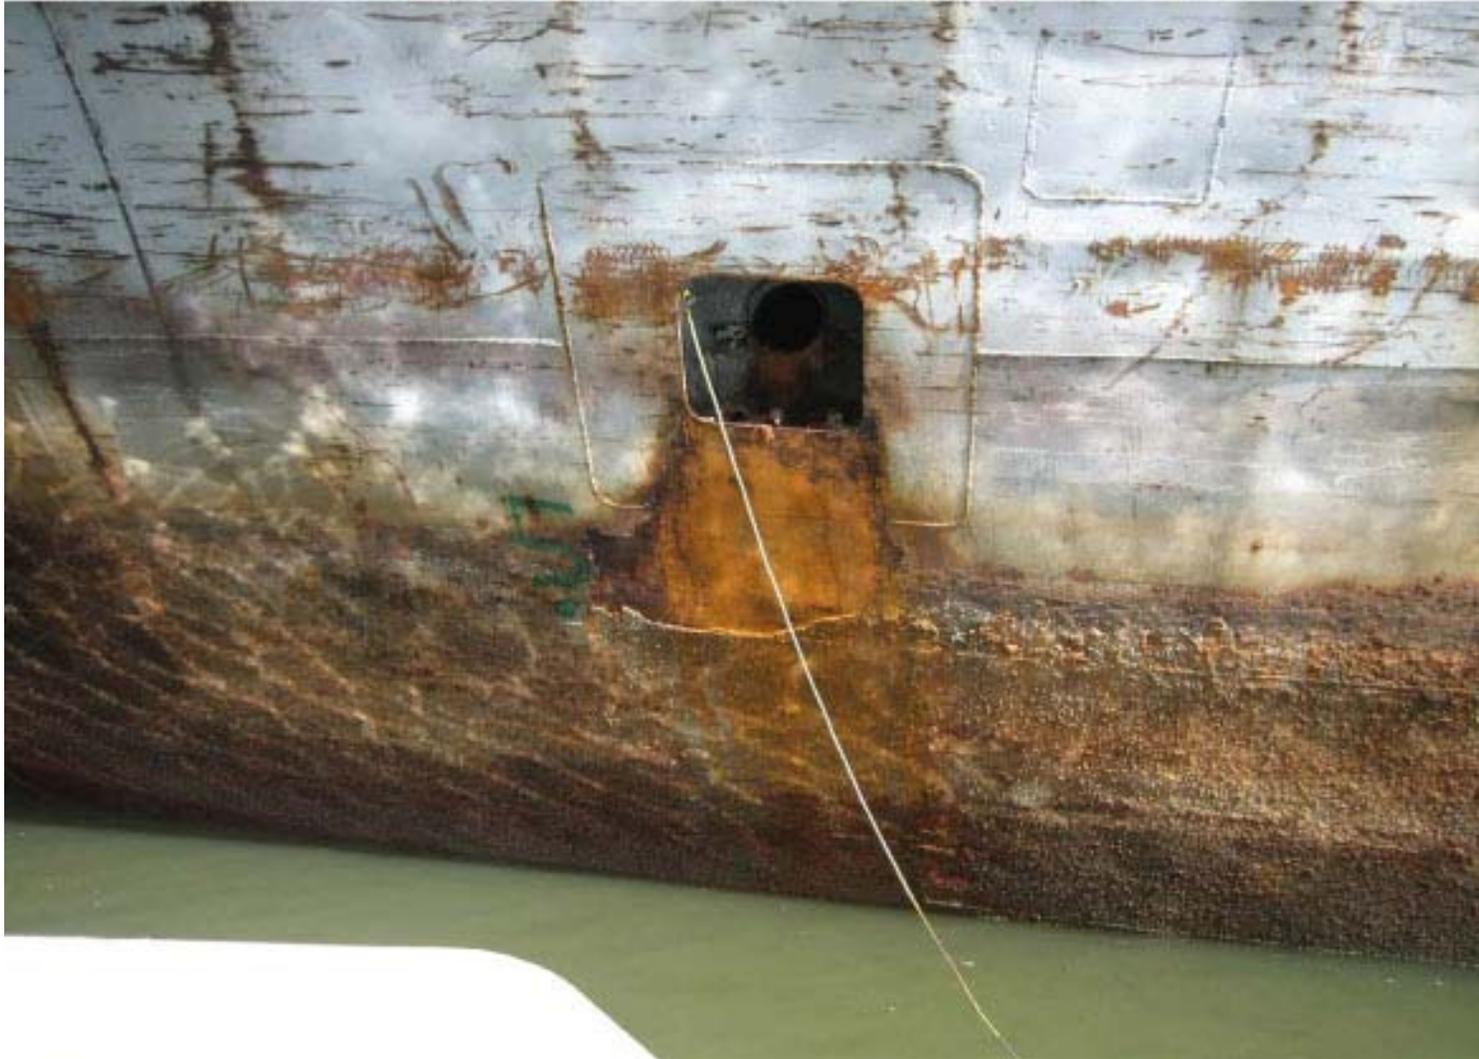
Figure 12. Location 5, Frame 79. In way of seachest for clean ballast.

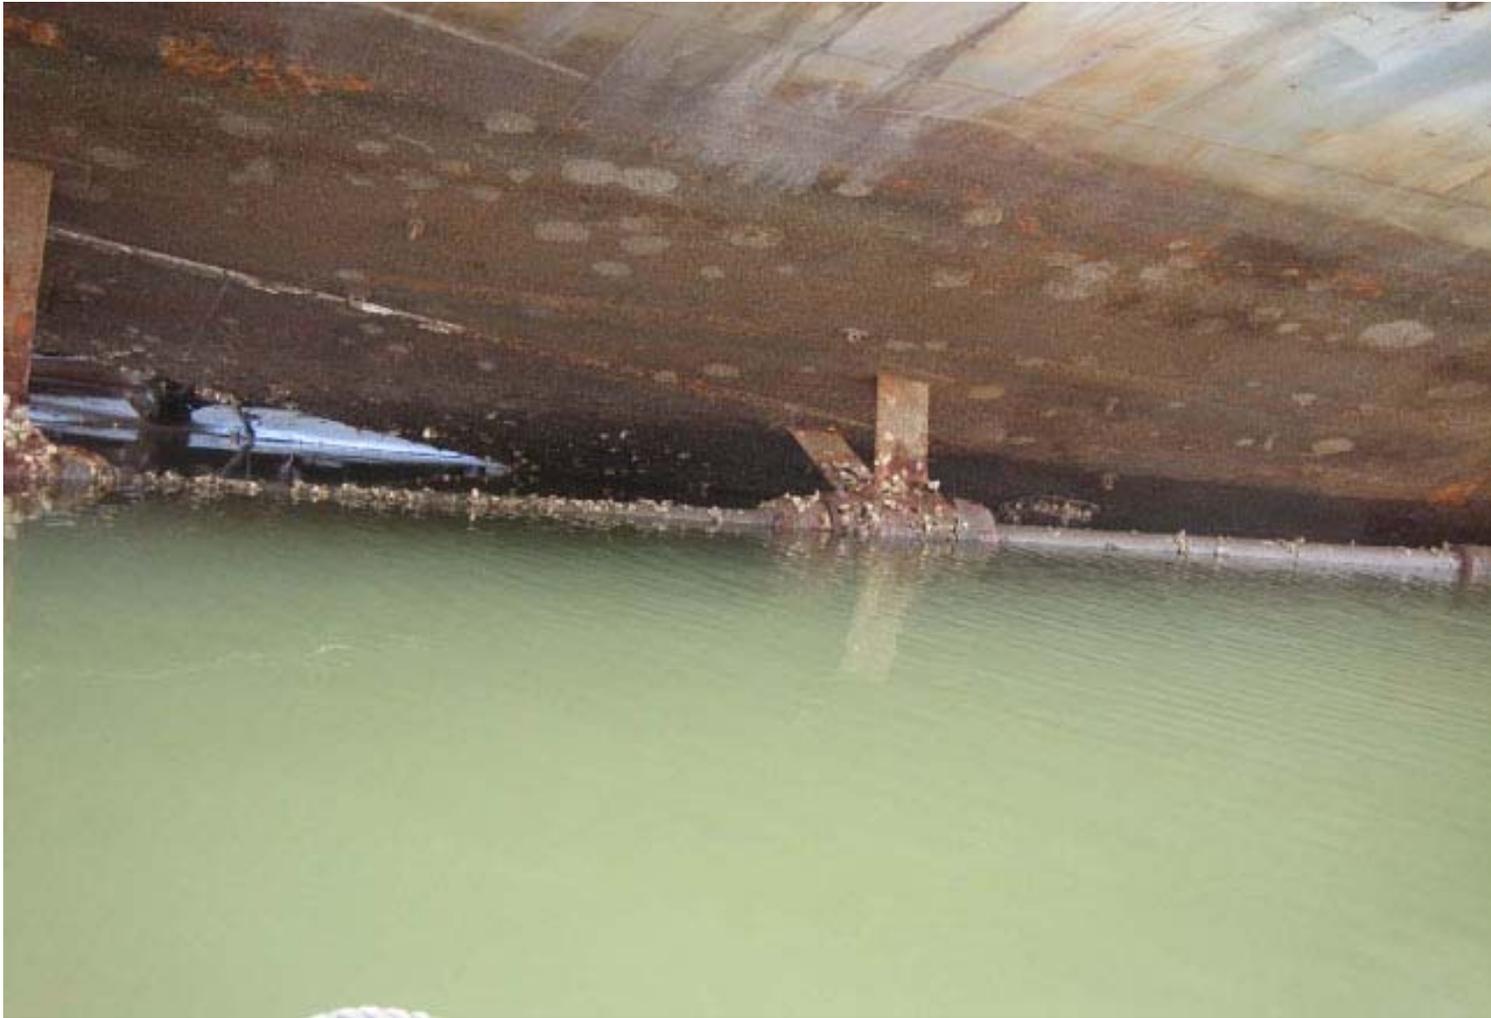
Figure 13. Location 6 and 7 would forward of this picture to the right side. Location 8 is just outboard of the center strut bearing hull attachment and location 9 is midway between the strut bearing and the prop near the upper left padeye left in this picture. Note – shaft angle is known so this photo provides good evidence of the vessel's trim.

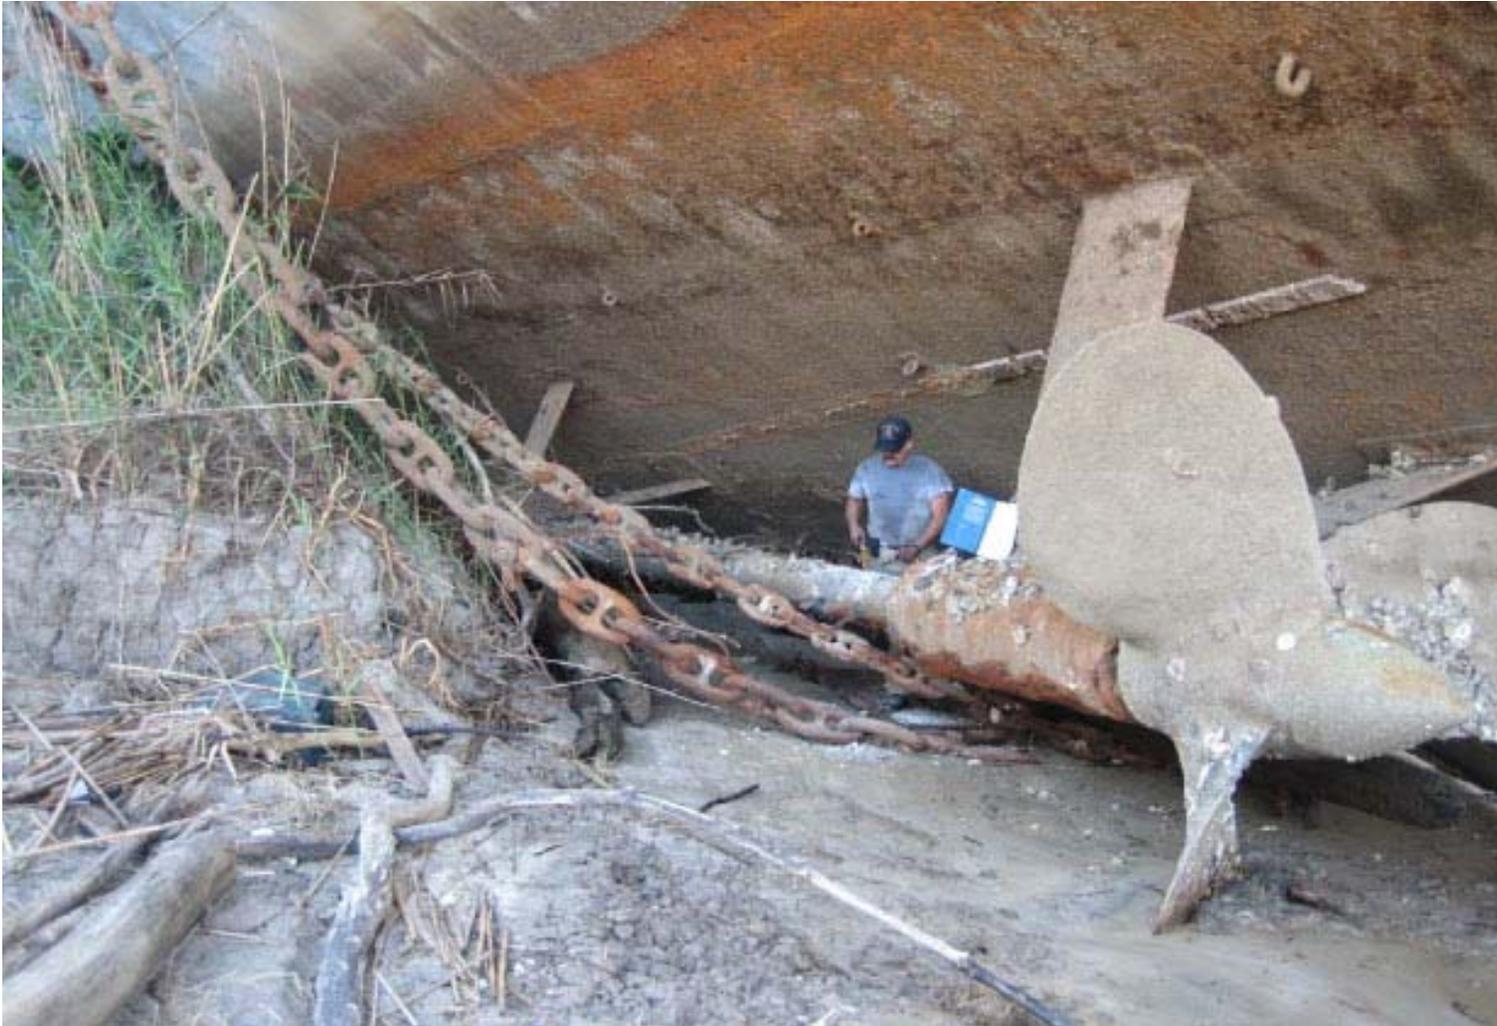
Figure 14. Hull UT readings 10 and 11 were taken on the port stern. Number 10 was located to the right of the shaft next to where the worker is shown in this photo. Number 10 is also where the hole was created in the weld seam. Location 11 is further forward near the strut bearing.

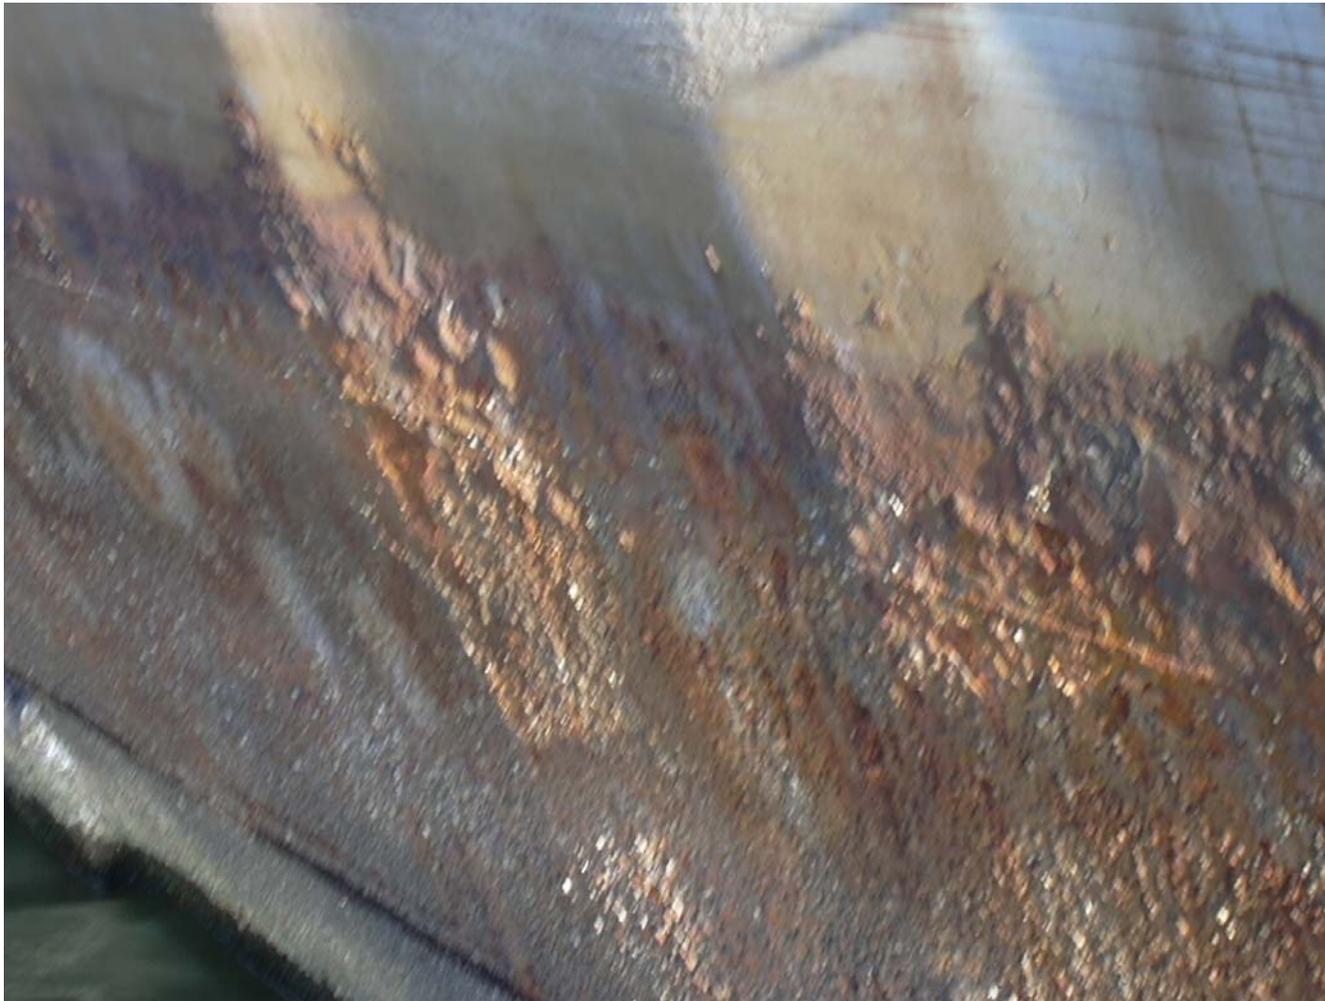
Figure 15. Washboard Plating.

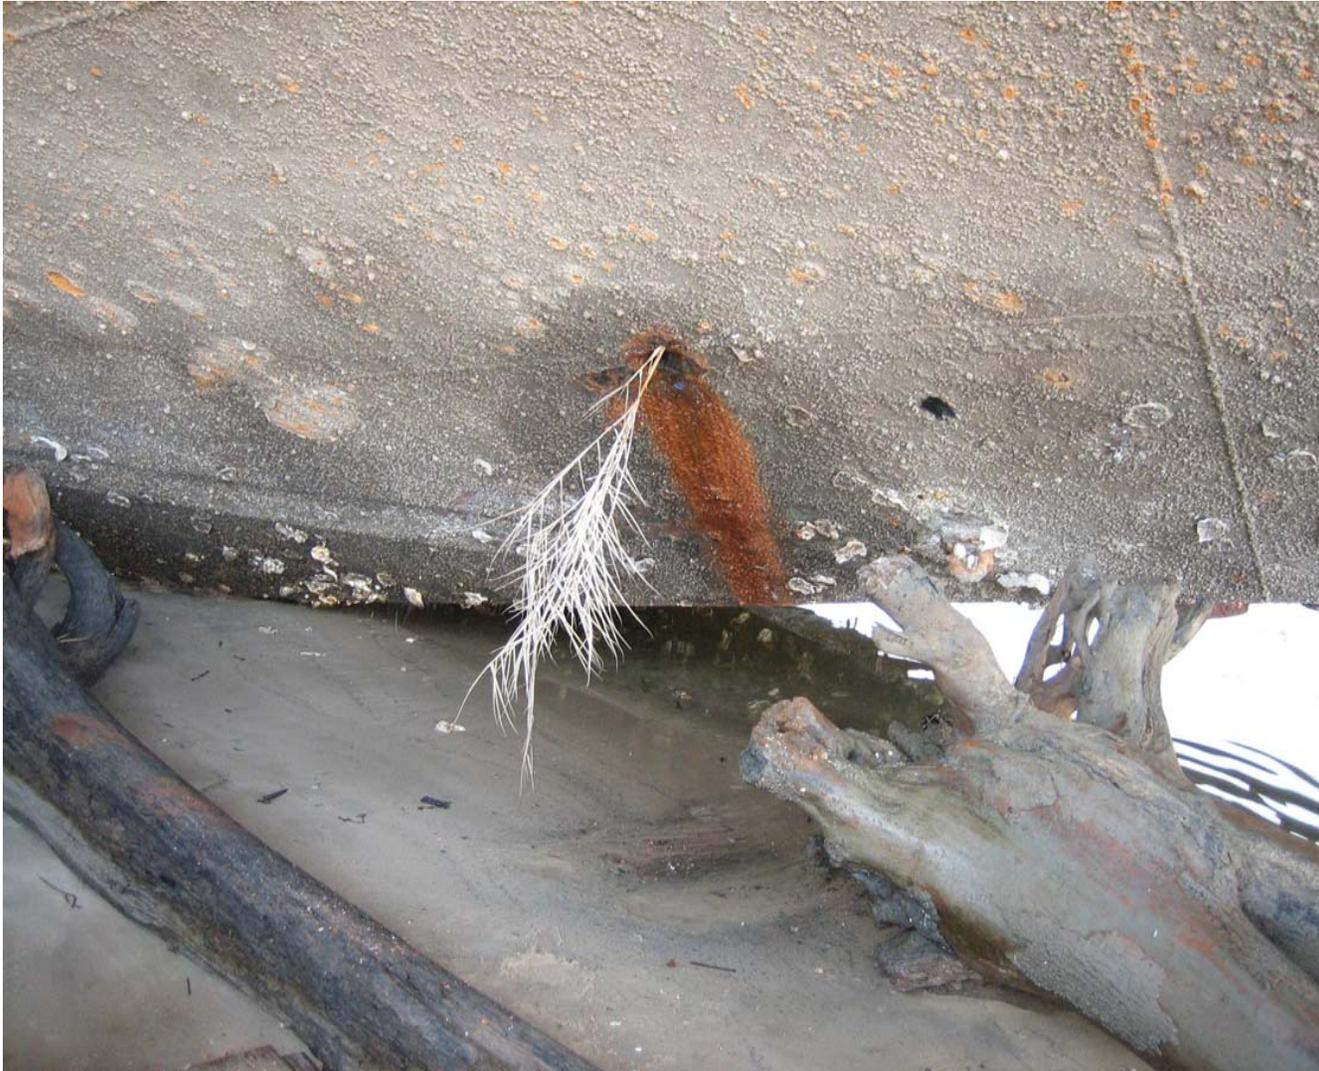
Figure 16. Disintegrated weld in seam near FR 100 port.

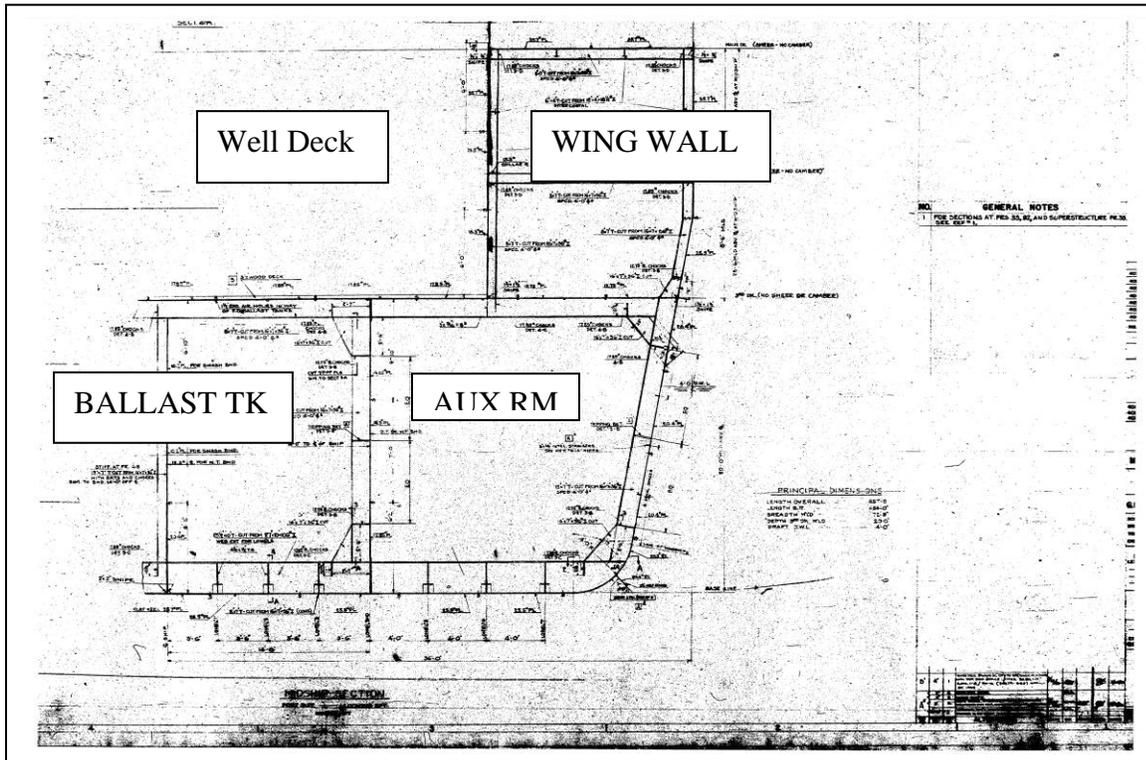
- Horizontal Axis Inertia (Ixx) 3,153 Ft⁴.
- Top Extreme Fiber Distance (yt) 18.57 Ft
- Section Modulus – Top 170 Ft³
- Bottom Extreme Fiber Distance (yb) 18.59 Ft
- Section Modulus – Bottom 170 Ft³
- Shear Area 8.0 Ft²

Figure 1
MIDSHIP SECTION

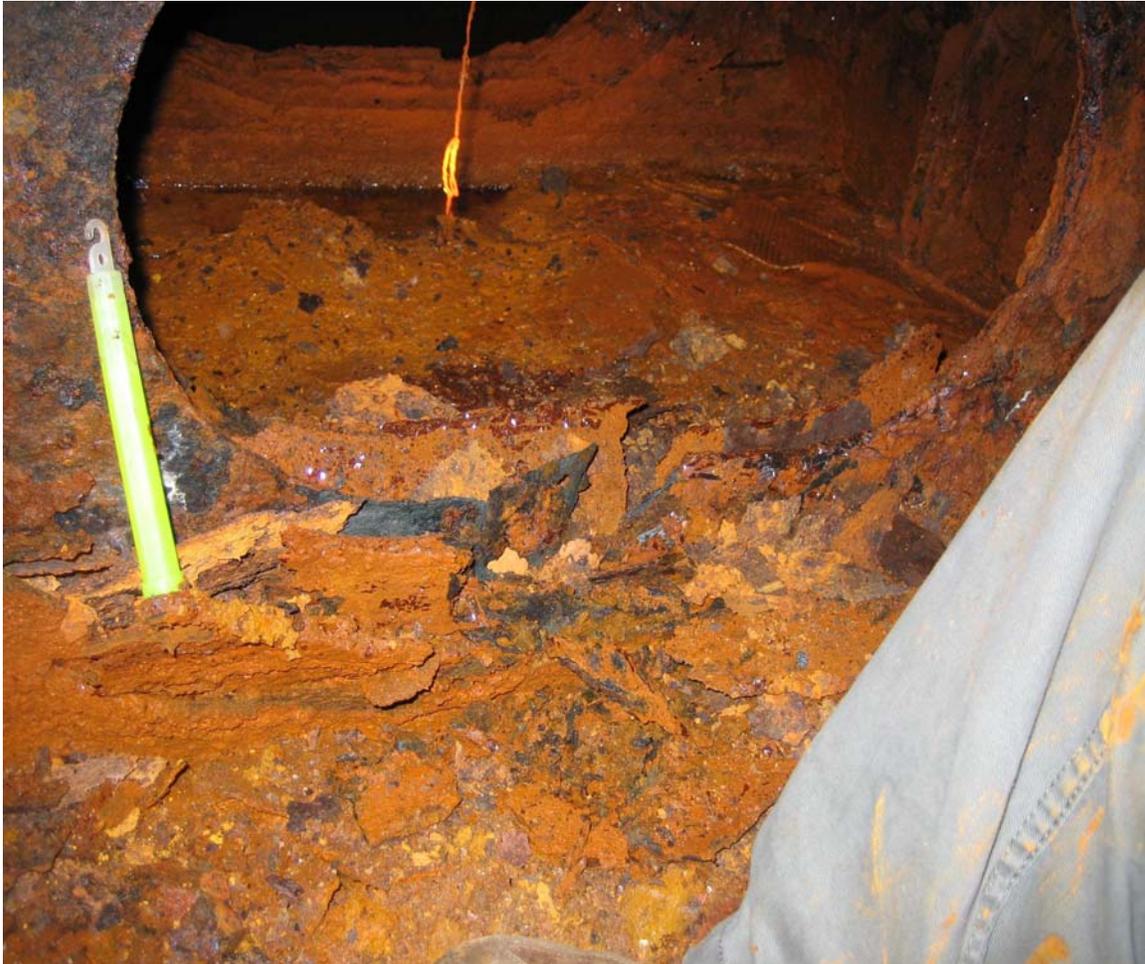
**PHOTO – 1
WASTED LONGITUDINAL GIRDER
ER STBD**

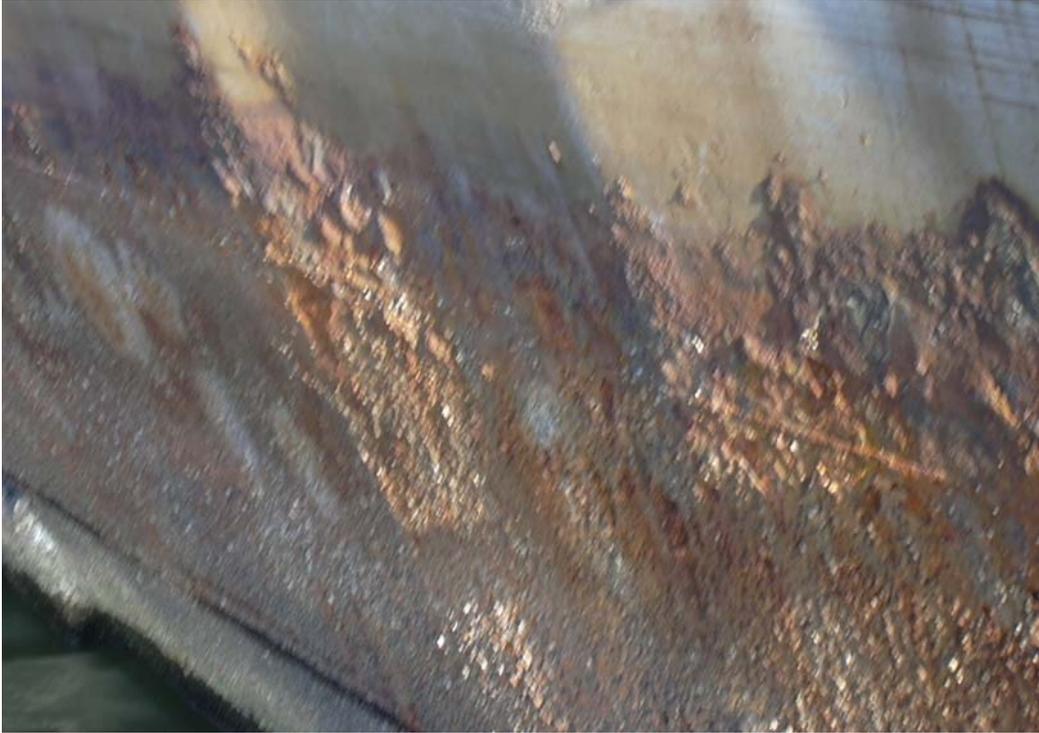
PHOTO-2 - WASHBOARD PLATING
