Ex-SHADWELL / Ex-State of Maine Salvage Report

August 2007

Ex-SHADWELL / Ex-State of Maine Salvage Report Table of Contents

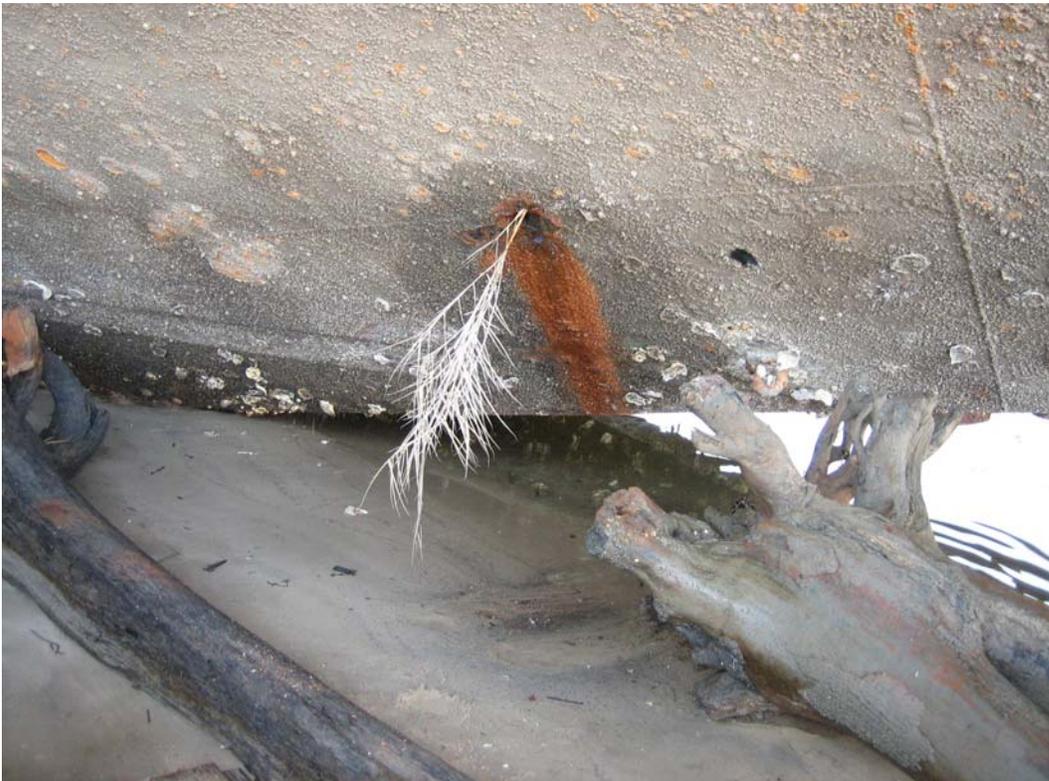
The UT survey revealed another point of concern: plate seam weld integrity. Photo-3, attached shows a hole created in a weld seam by striking the seam with a ball peen hammer. The shell plating surrounding the corroded and disintegrated weld showed virtually no corrosion. In planning the refloat operation, the salvage team may be required to magnetic particle test critical weld seams and create crack arrestors and/or install splicer plates to bridge critical welds.

PHOTO - 3 - DISINTEGRATED WELD IN SEAM - FR 100 PORT

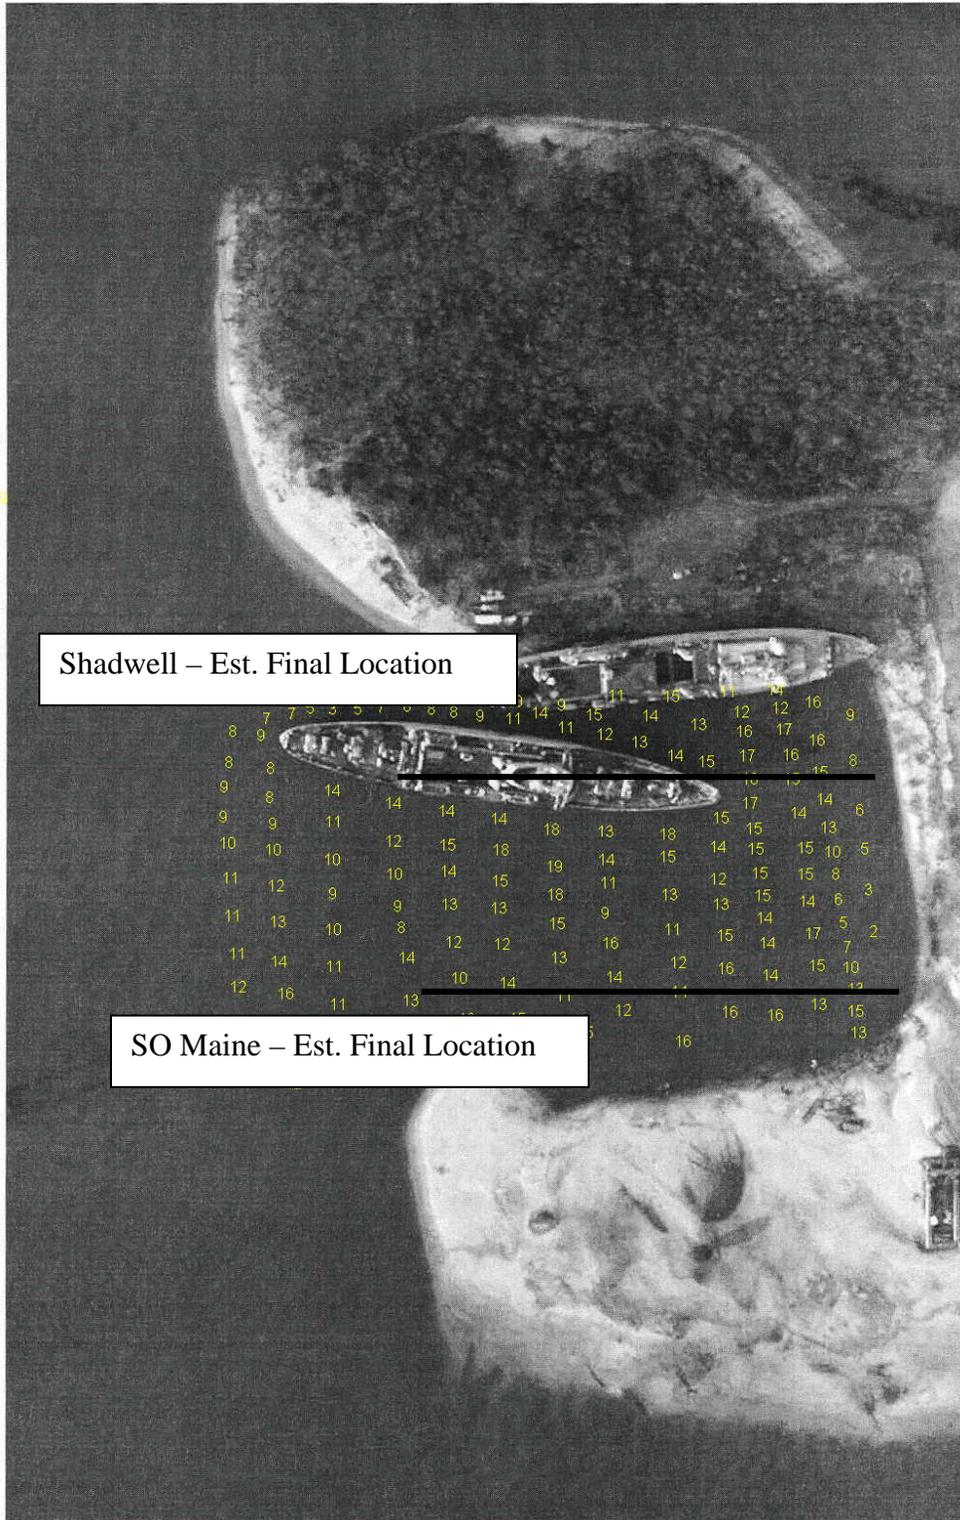
Figure 1
Post Katrina and Post Salvage Mooring Locations

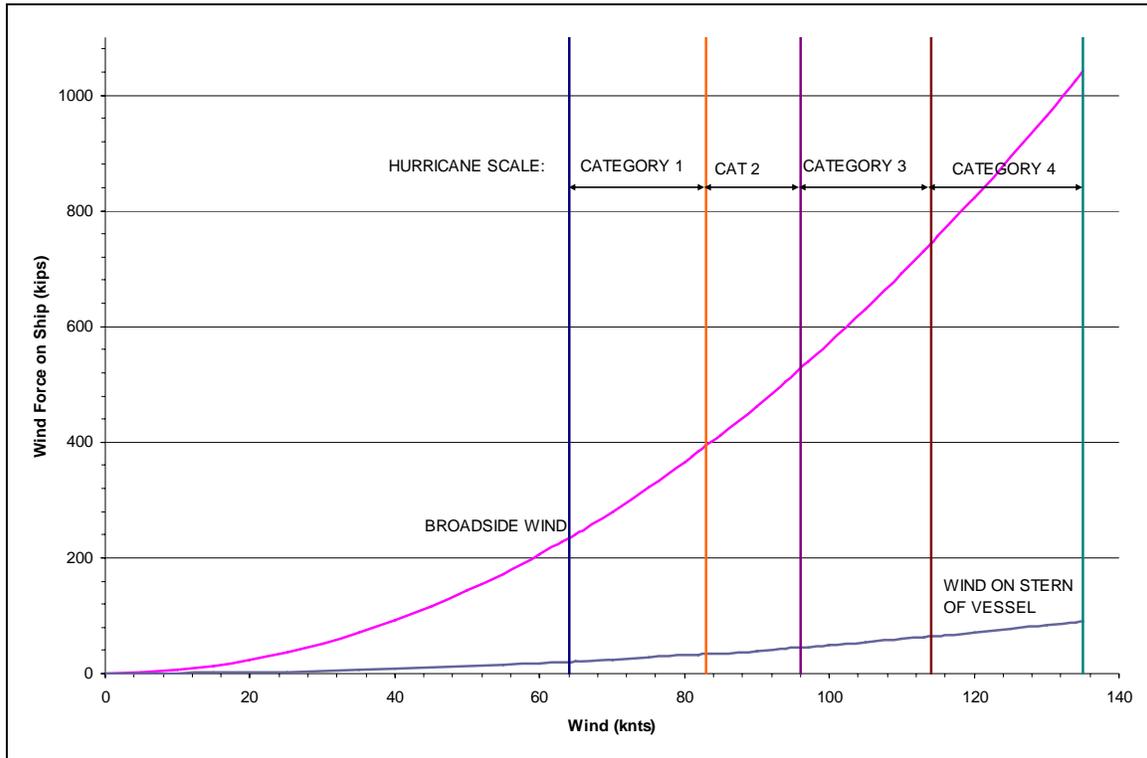
The wind loads on the hull of the Shadwell were determined from the exposed hull and areas above the main deck. The total fore/aft windage area of the hull was calculated as 3,410 square feet. The side windage area is 18,618 square feet. The wind force on the ship increases with the square of the wind speed as shown in Figure 1 for both broadside winds and for winds on the stern. Because of the multi-point mooring, Shadwell can not weathervane to reduce the exposed windage. Therefore, the vessel may be exposed to full broadside winds at some time. Figure 1 shows that minimal hurricane Category 1 winds of 64 knots will produce a lateral force of 234-kips on the ship that must be restrained by the multi-leg mooring. The same wind on the bow or stern would produce a force of only 20-kips, or one-tenth of the broadside wind force.

Figure 1. Ex-Shadwell Wind Force vs Wind Speed

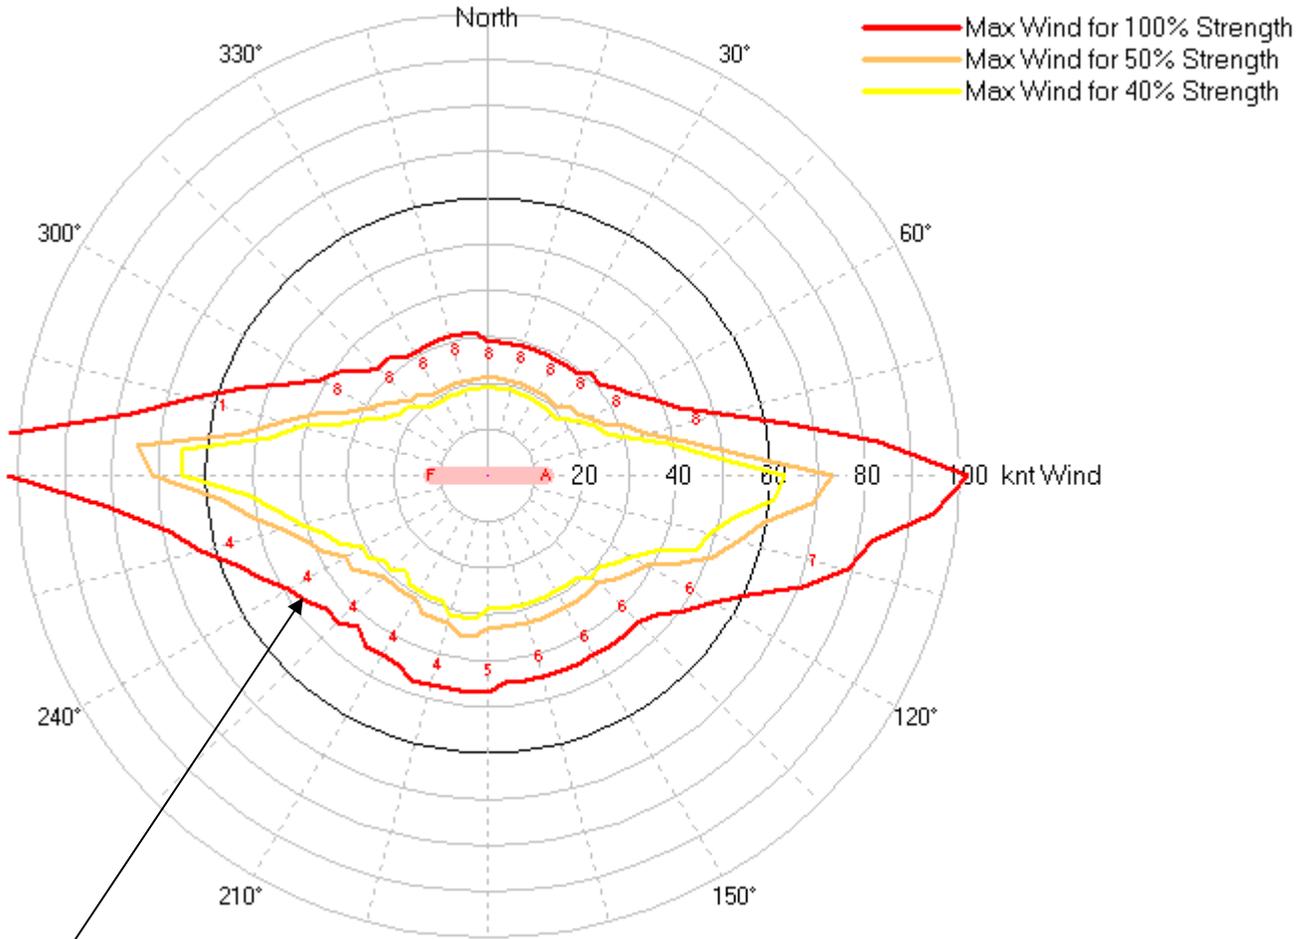
Analysis for Time: 1400 Aug 29 2006
 Ref: 1233 Aug 29 2006
 Remarks: Berth layout from R. Thiel 11Aug06.
 Water Level: 0.00 above datum
 Draft: 14.0
 Trim: 0.0
 Deck Level: 23.0 above Datum (at Target)

Note: The numbers 1, 4, 5, 6, 7, and 8 on the wind rose refer to the mooring line anchor taking the highest load due to wind from that particular direction.

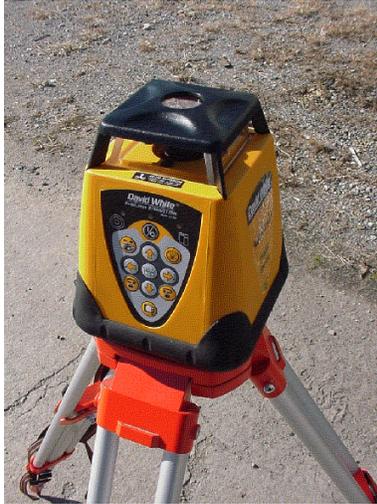
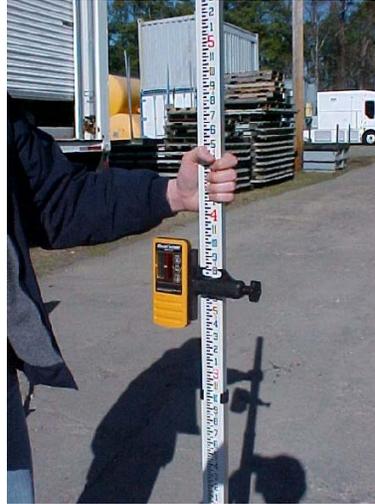
Hull Girder Deflection Laser Monitoring System

Concern for the potential of local failure through plate buckling resulted in the development of a system to monitor very small deflections of *Ex-SHADWELL*'s hull. This system, the Hull Girder Laser Monitoring System, used a surveyor's laser level and

a laser sensing target to measure changes in the hull at multiple pre-defined points, which were then be used to calculate stress in the hull. *Ex-SHADWELL*'s well deck was open and large enough to set the system up. The rotating laser was fixed in the center of the well deck and sixteen measurement points were established. The measurement points established hull deflection conditions at frames 22, 36, 74, 88, 101 and 111. Measurements could be collected in less than 30 minutes and the system proved accurate to within 1/16-inch over the length of the well deck. Figure 11 contains a photo of the rotating laser level and one of the measurement points. Appendix F. contains several spreadsheets depicting hull deflection readings from *Ex-SHADWELL*.

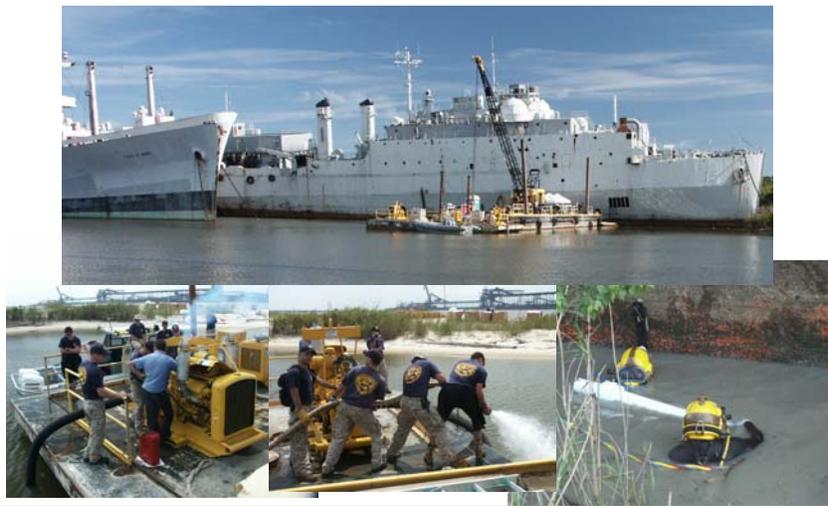
EX-SHADWELL JETTING

Because of *Ex-SHADWELL*'s degraded longitudinal stringers and the potential for the hull plates to buckle under additional stress, the salvors carefully planned her extraction to maintain tension on her hull girder system. Flooding alarms were installed (components from the ESSM Towing System) on 10 April and the Laser Hull Girder Monitoring System was set up on 12 April to track changes in hull stress.
