# THE SQUAW

Technical Report  
on  
Submerged Submarine Hull Target

Department of the Navy  
Naval Ship Systems Command  
Washington, D.C.

This report was created and produced by  
**POTOMAC RESEARCH, INCORPORATED**

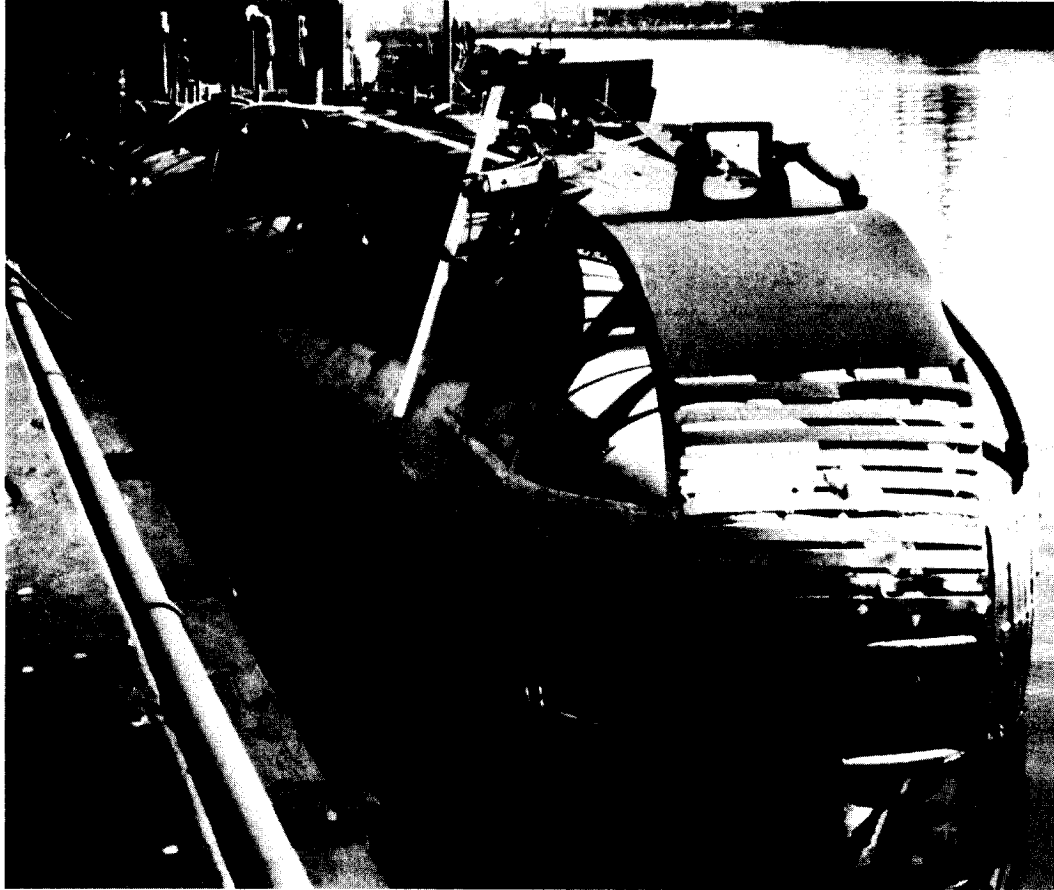
*Frontispiece. SQUAW, the model experimental submarine hull, being readied for mooring operations at the Naval Ship Yard, Long Beach, California.*

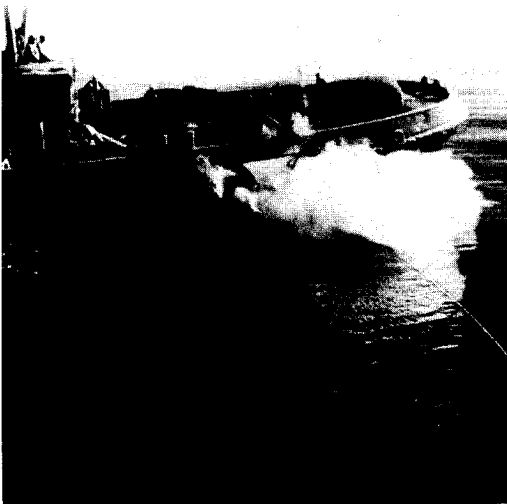
*Photo # 6*  
*Surge Buoys Being Launched*

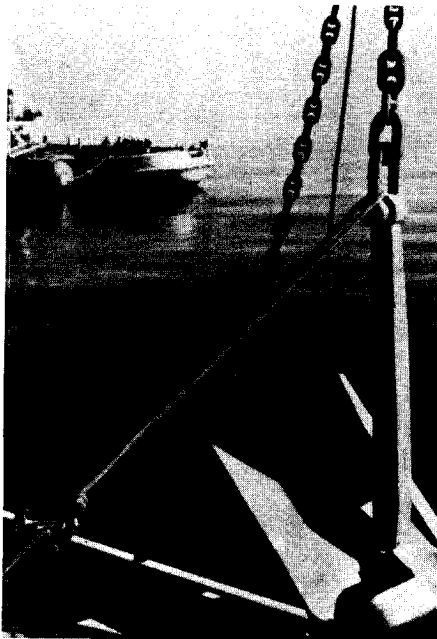
*Photo # 9*  
*CHOWANOC Lowering Anchor over Side*

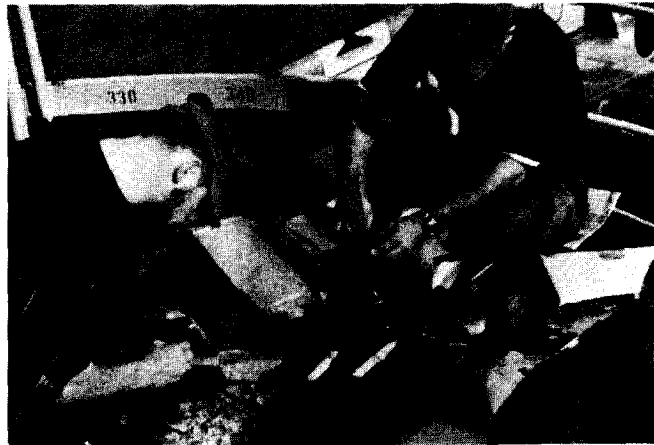
*Photo # 12*  
*UDT Readying Wire Cutters*

- (N) CHOWANOC station kept and payed out 5,700 feet of wire and KALMIA payed out 4,000 feet of crown wire (both wires payed out to their full length). (Photo #11)
- (O) KALMIA put boat in water and secured nylon line to #1 surge buoy.
- (P) UDT personnel readied wire cutters. (Photo #12)

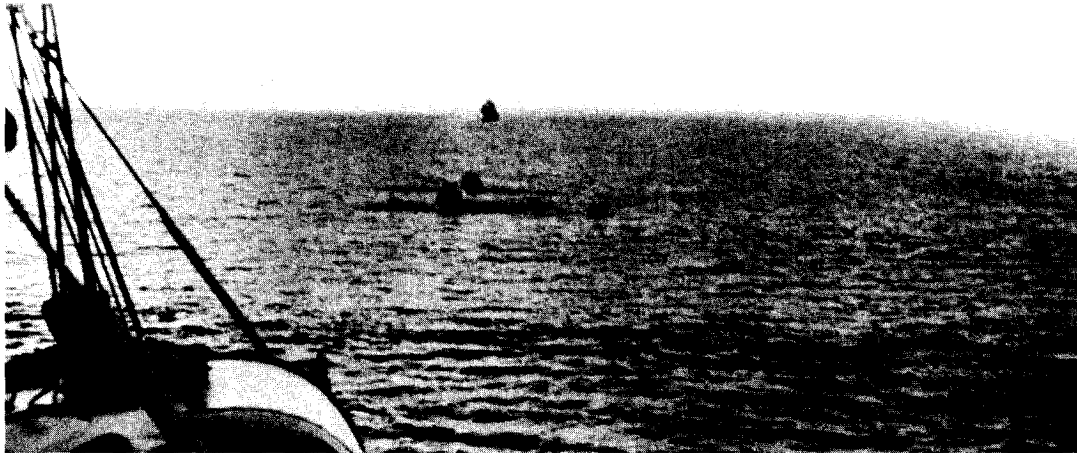
*Photo # 13  
UDT Placing Cutters*

- (Q) KALMIA took station 4,000 feet upwind from CHOWANOC.
- (R) UDT placed cutters and fired. (Photo #13) Anchor leg settled to bottom and KALMIA retrieved both surge buoys, brought buoys alongside, and stretched out anchor and clump.

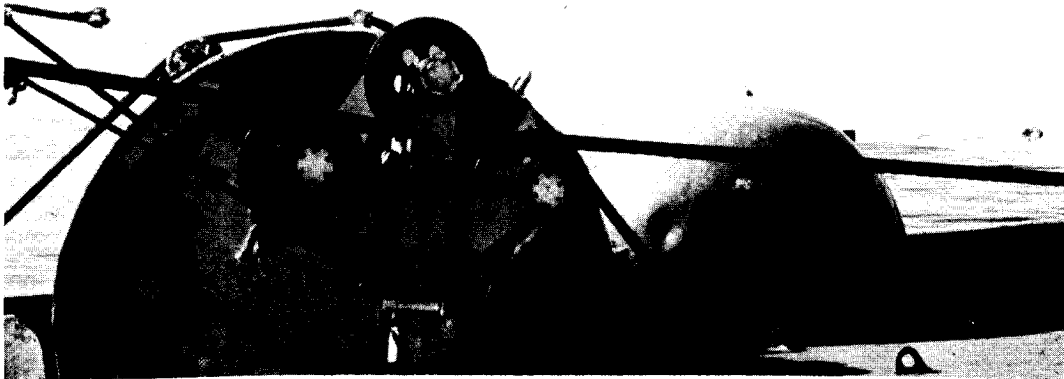
*Photo # 16  
Tensiometers Being Installed on Legs*

(D) CHOWANOC and MOLALA installed tensiometers in legs.  
(Photo #16)

(F) CHOWANOC observed tensiometer readings until leg A-2 was on bottom.

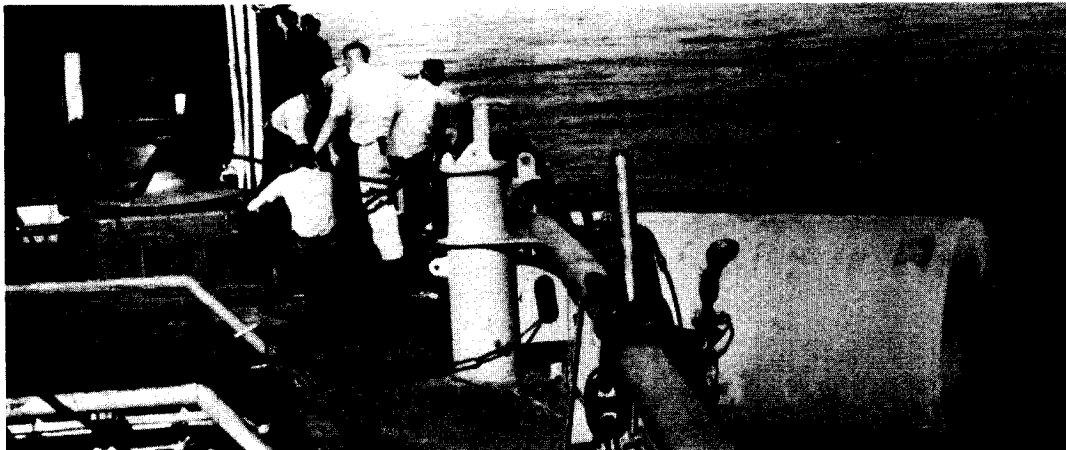
*Photo # 17*

*MOLALA Attaching 60-foot Pendant to Surge Buoy*

1. CHOWANOC and MOLALA lowered leg B-1.
2. Operations proceeded as follows:
  - (A) MOLALA attached 60-foot pendant to surge buoy.  
(Photo #17)
