FACEPLATE

FALL 1981

VOLUME 12, NO. 3

. . . the official magazine for the divers and salvors of the United States Navy

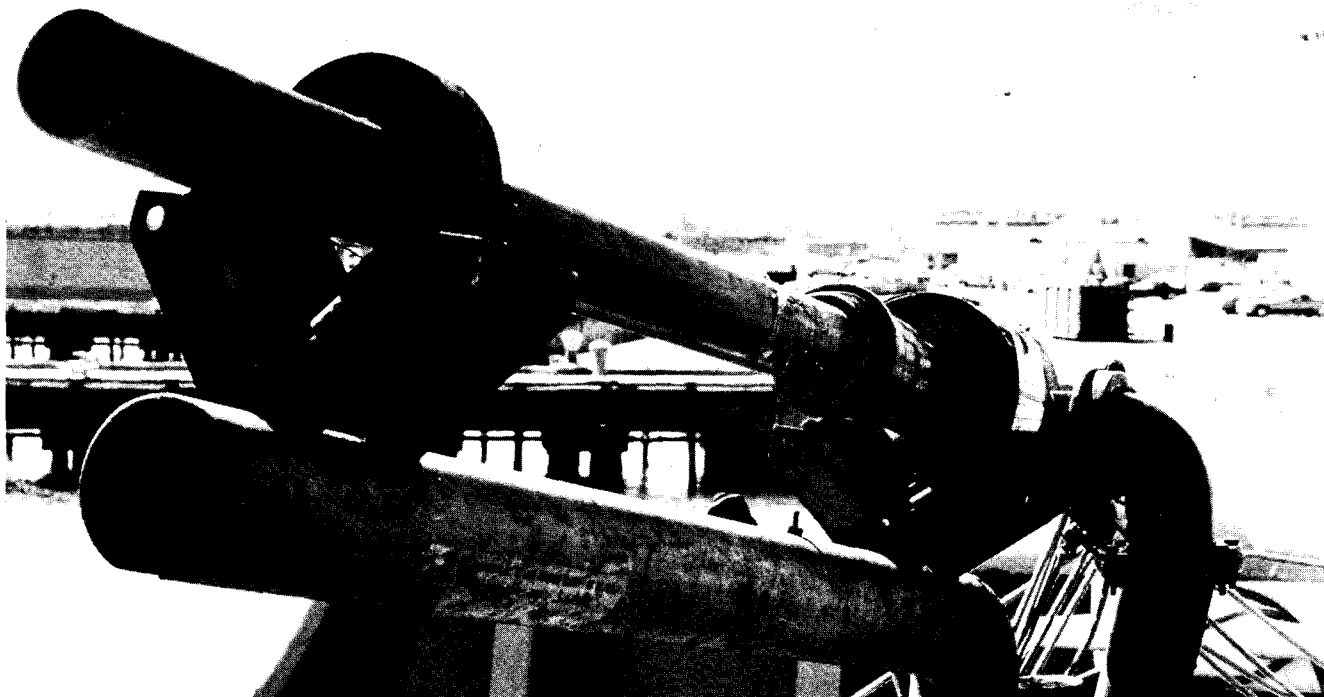
MK 131 launcher hung on OPPORTUNE's bow fire monitor.

The rocket launch tube MK 131 is a 4-foot-long steel tube, slotted on one side, with an "elbow" at one end to serve as a blast deflector. The rocket is loaded nozzle-end first, with the wire harness protruding from the slot. The rocket is held in place before firing by a spring-loaded detent assembly. Two V-shaped clamp assemblies are attached to the launch tube, permitting the launcher to be hung below a 3-inch gun barrel or fire monitor.

Since present salvage ships don't have 3-inch guns, the fire monitors are used. On *OPPORTUNE*, the monitor on the bow was not long enough to allow both clamp bands to

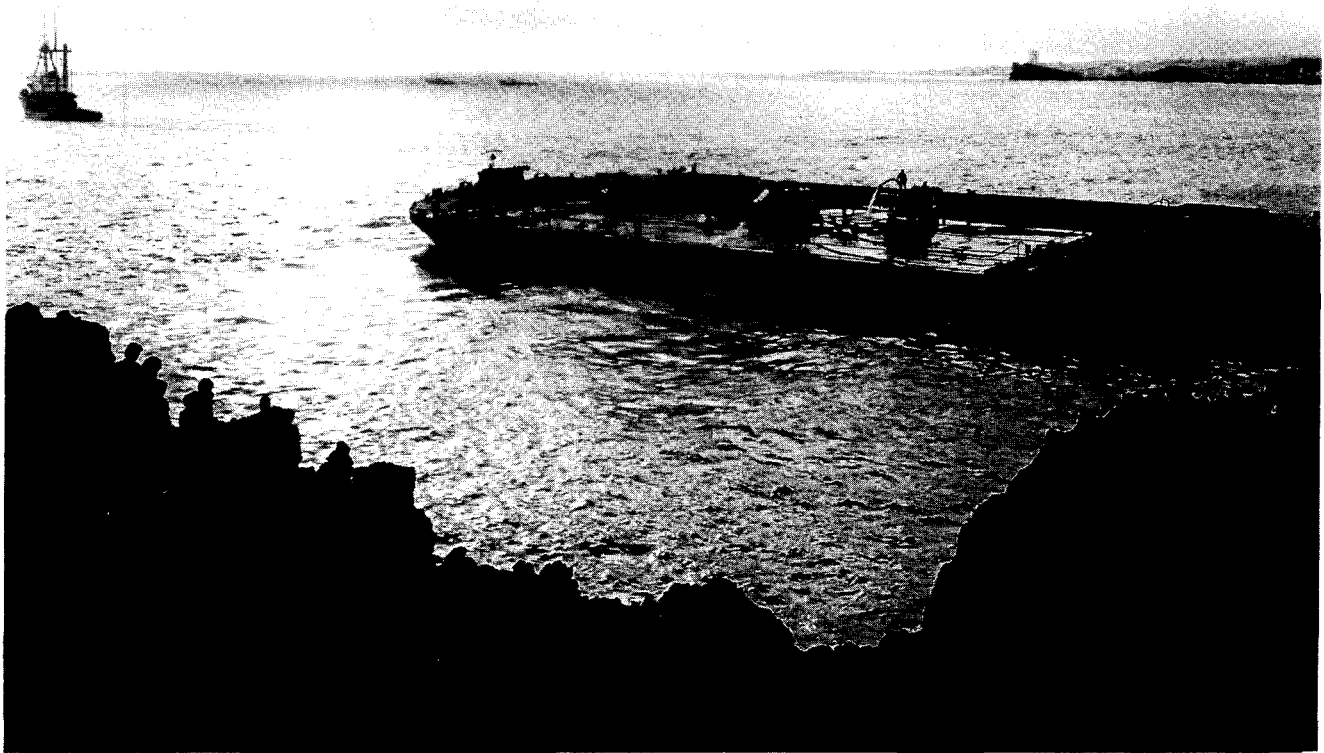
M/V SIMSON moving in to "harness" GOLF pontoon.

Although there was minimal holing in the side hull plating, the bottoms of each pontoon were irreparably breached. Pumping was therefore not a viable option to restore buoyancy. The salvage plan adopted for each pontoon was straightforward: Blow and go! Each ballast tank would have to be fitted with a blow pipe and valve, and air-tight integrity would have to be achieved by sealing the main deck and sides. Compressed air would be used to drive water out of the holes in the bottom and regain initial buoyancy. Once the draft had been reduced as much as possible, SIMSON would be harnessed to perform the retraction.

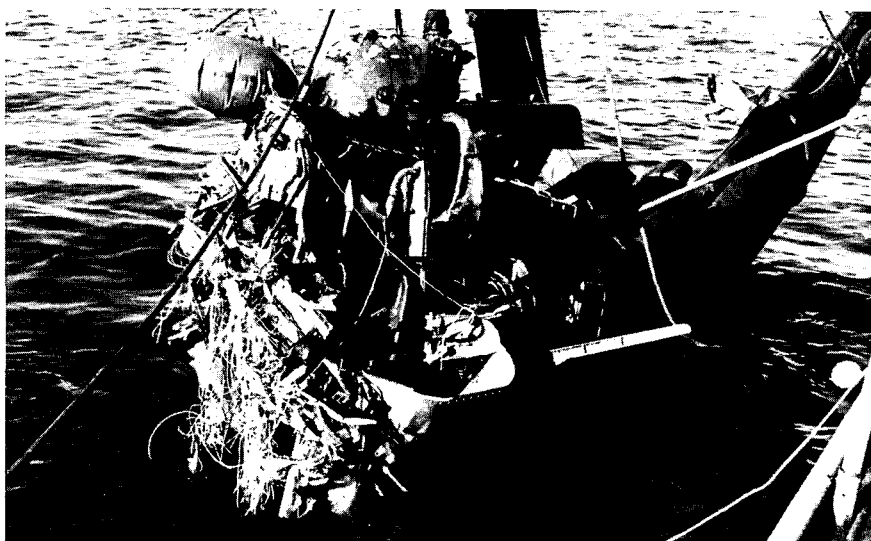
Wreckage being hoisted aboard the YSD-53.

On the second "bight" the aircraft was lifted clear of the water in slow increments to allow for drainage then swung onto the deck. This first phase brought up approximately 75 percent of the wreckage.
