## **SUPSALV Teams with Commercial Diving and Equipment Contractors to Provide an Immediate Rudder Nut Inspection for USS NICHOLAS (FFG 47)**

10 September 2013

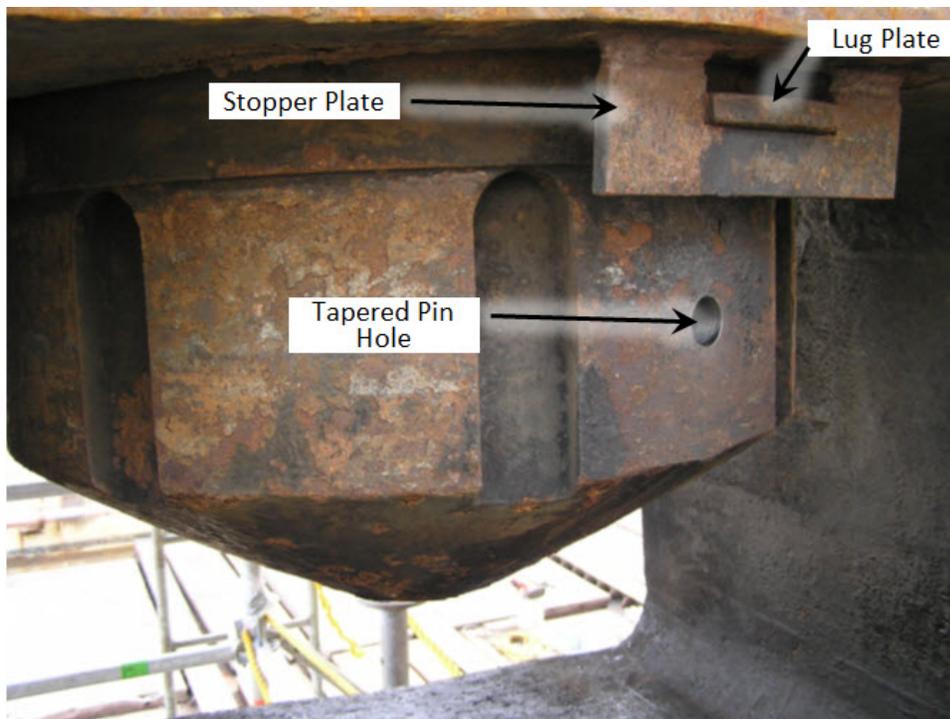
The MN-30 miniature video camera attached to a long rod was manipulated around the rudder nut void by the diver and produced a clear image of the nut, stopper plate and lug for NAVSEA OOC operations manager to monitor pier side. Video from Phoenix was interfaced via live web feed by Seaward to Washington, DC, where NAVSEA program manager could assess the current condition. Below pictures, provided justification that the rudder nut was not backing off nor was rudder dropping.

*Typical configuration of rudder nut stopper plate and lug*
