S0300-BE-MAN-010

**CASE STUDIES
OF SELECTED HARBOR
CLEARANCE OPERATIONS**

PUBLISHED BY DIRECTION OF COMMANDER, NAVAL SEA SYSTEMS COMMAND

1 JUNE 1989

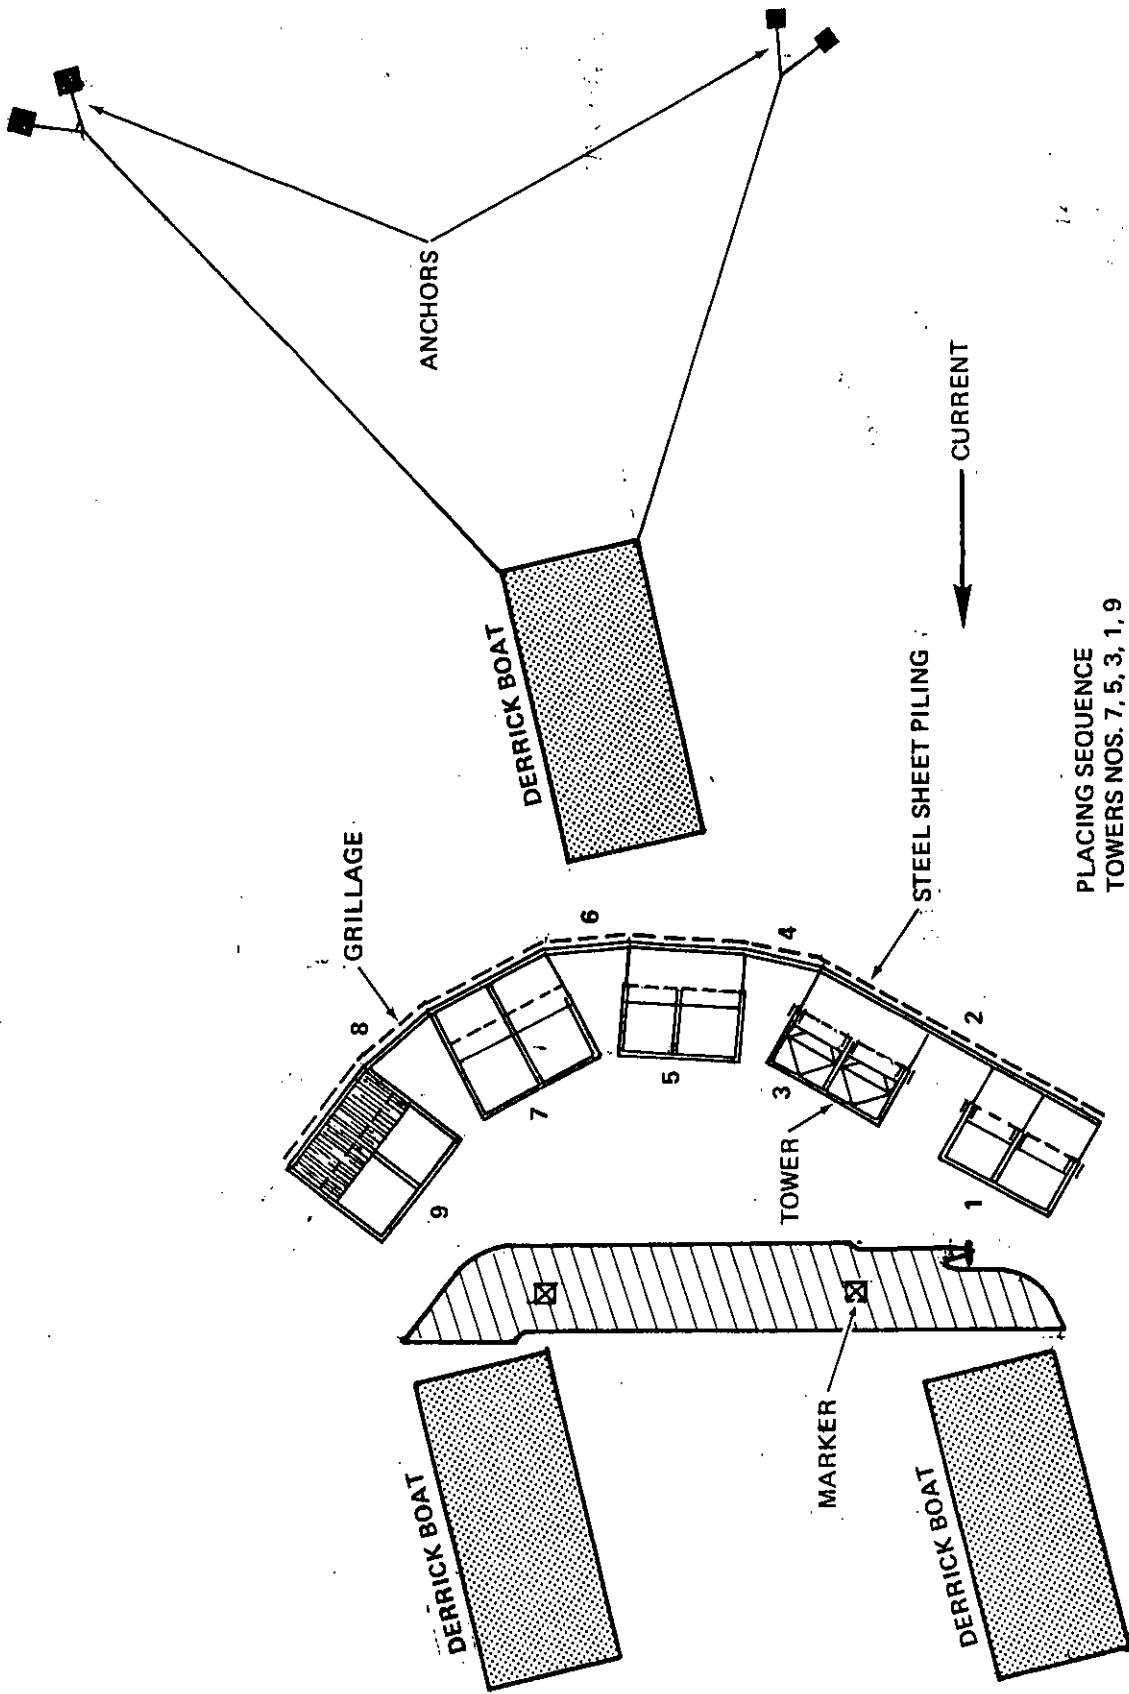
CURRENT DEFLECTOR IN POSITION.
FIG. 6 NO. 5

Precautionary tests proved invaluable as several important discoveries were made. Had the deflector been of solid construction, the area of the wreck would have been swept by back-eddies having a velocity greater than the original current. The model revealed where to leave gaps in the wall to achieve the best results and indicated a need for an increase in design loads allowed for the deflector. Pressures were at a maximum at the center of the deflector and gradually decreased as they approached the ends.

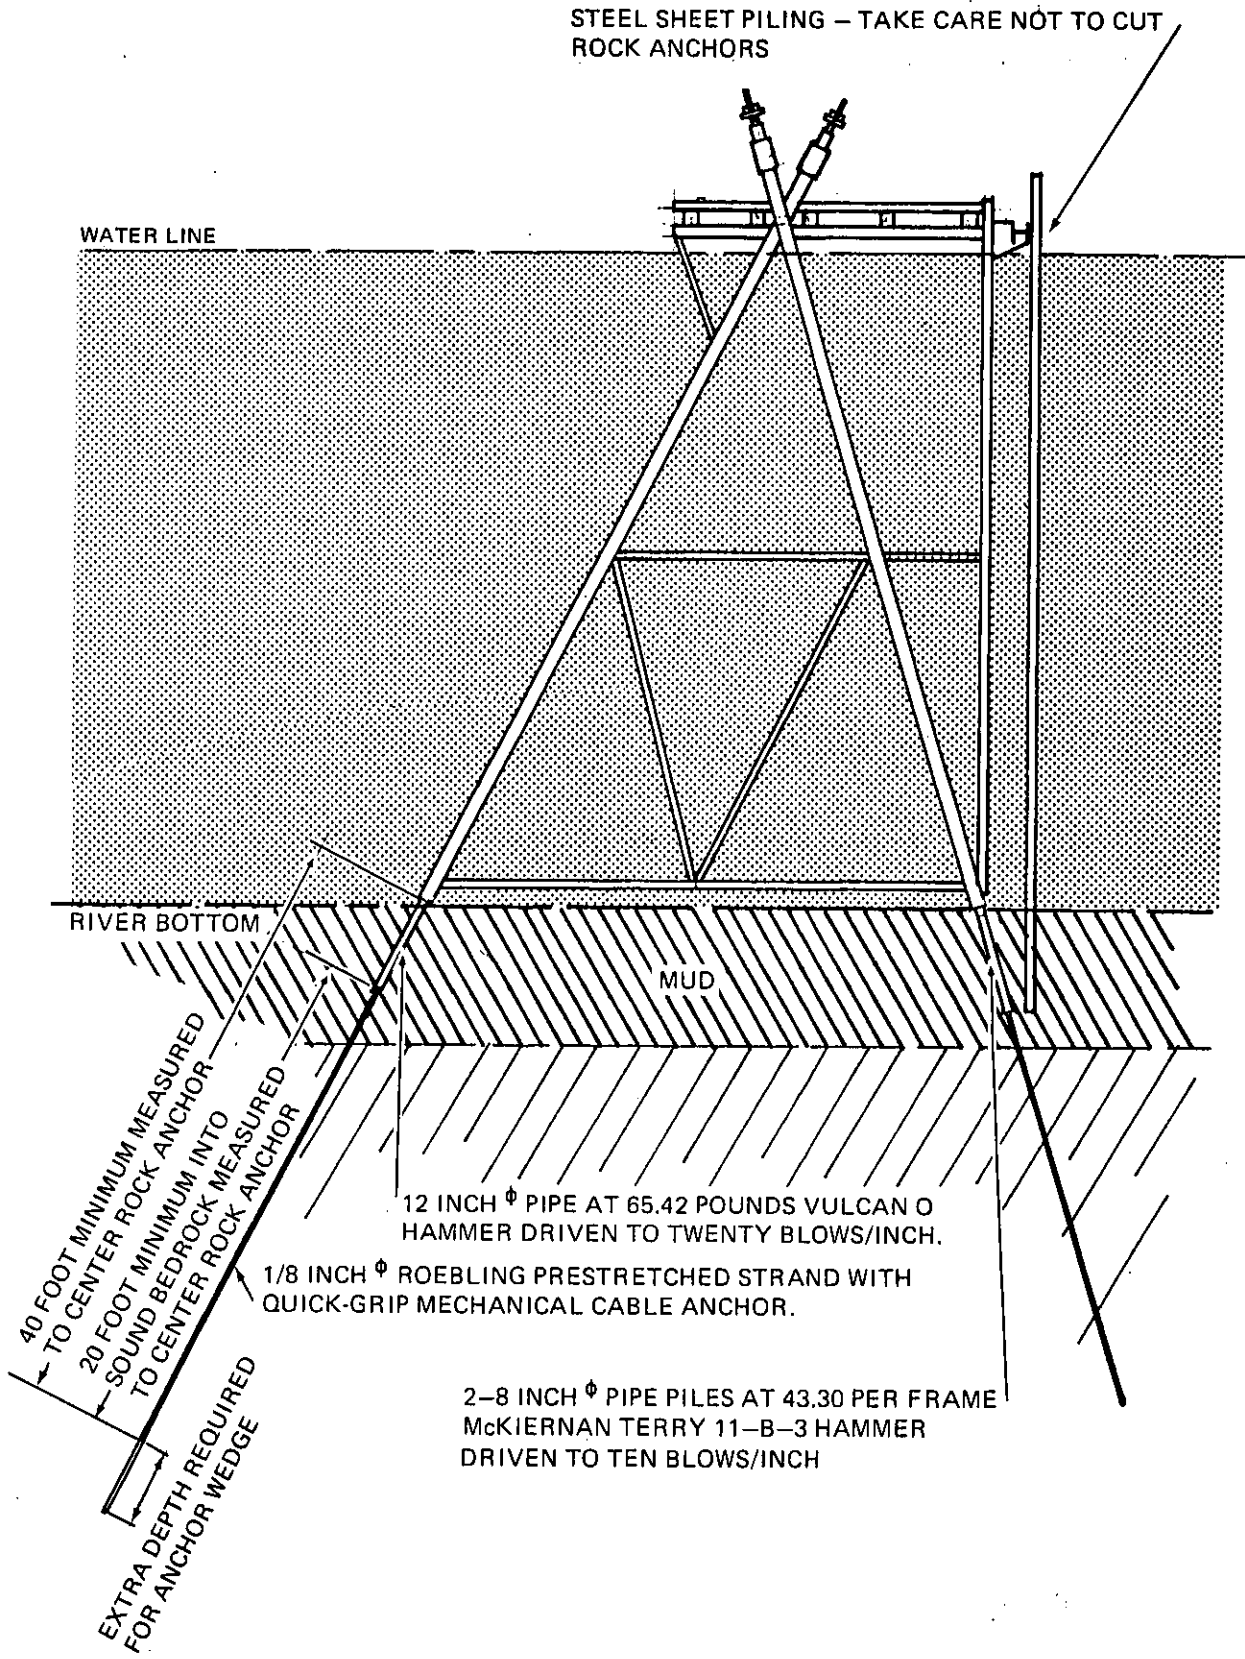
DEFLECTOR TOWER IN ANCHORED POSITION. FIG. 6 NO. 6

A special technique had to be developed to anchor the steel deflector. The deflector wall had to be 50 feet high in the water, about 300 feet long across the river current, and capable of withstanding a total force from the waves and currents of some 1500 tons. Conventional marine anchors and cables could not deal with such loads without impairing the already reduced channel traffic. An anchorage method previously used for the strengthening of dams was eventually adopted. The five towers were anchored to the river bed shale rock by steel cables. To place these cables a hole was diamond-drilled at least 40 feet into the river bed through each pipe pile, and underreamed at the bottom. A bridge strand wire rope cable, 1½ inches in diameter, was attached to a patented expanding rock anchor, and lowered through the pipe pile to the underreamed portion of the hole. There the anchor was expanded by using a tiny explosive charge to cut a retaining pin inside the anchor. In this way some of the anchors were placed up to 130 feet below the water surface. (See Fig. 6, No. 6)

When the anchor and cable were in position, each upstream cable was stressed against its pile to a load of 50 tons, and secured. Each downstream cable was stressed to 38 tons; thus each tower was held down by a prestressed force of 414 tons. The deflector towers themselves, essentially large cubes of space framework, were about 55 feet high, 50 feet long and weighed 45 tons each. After the core towers were placed and anchored, sheet piling was driven five feet into the river bed along the upstream side of the towers to form the deflectors. (See Fig. 6, No. 5 and No. 7.) The deflector was completed and full scale diving operations were commenced on 1 August 1960.

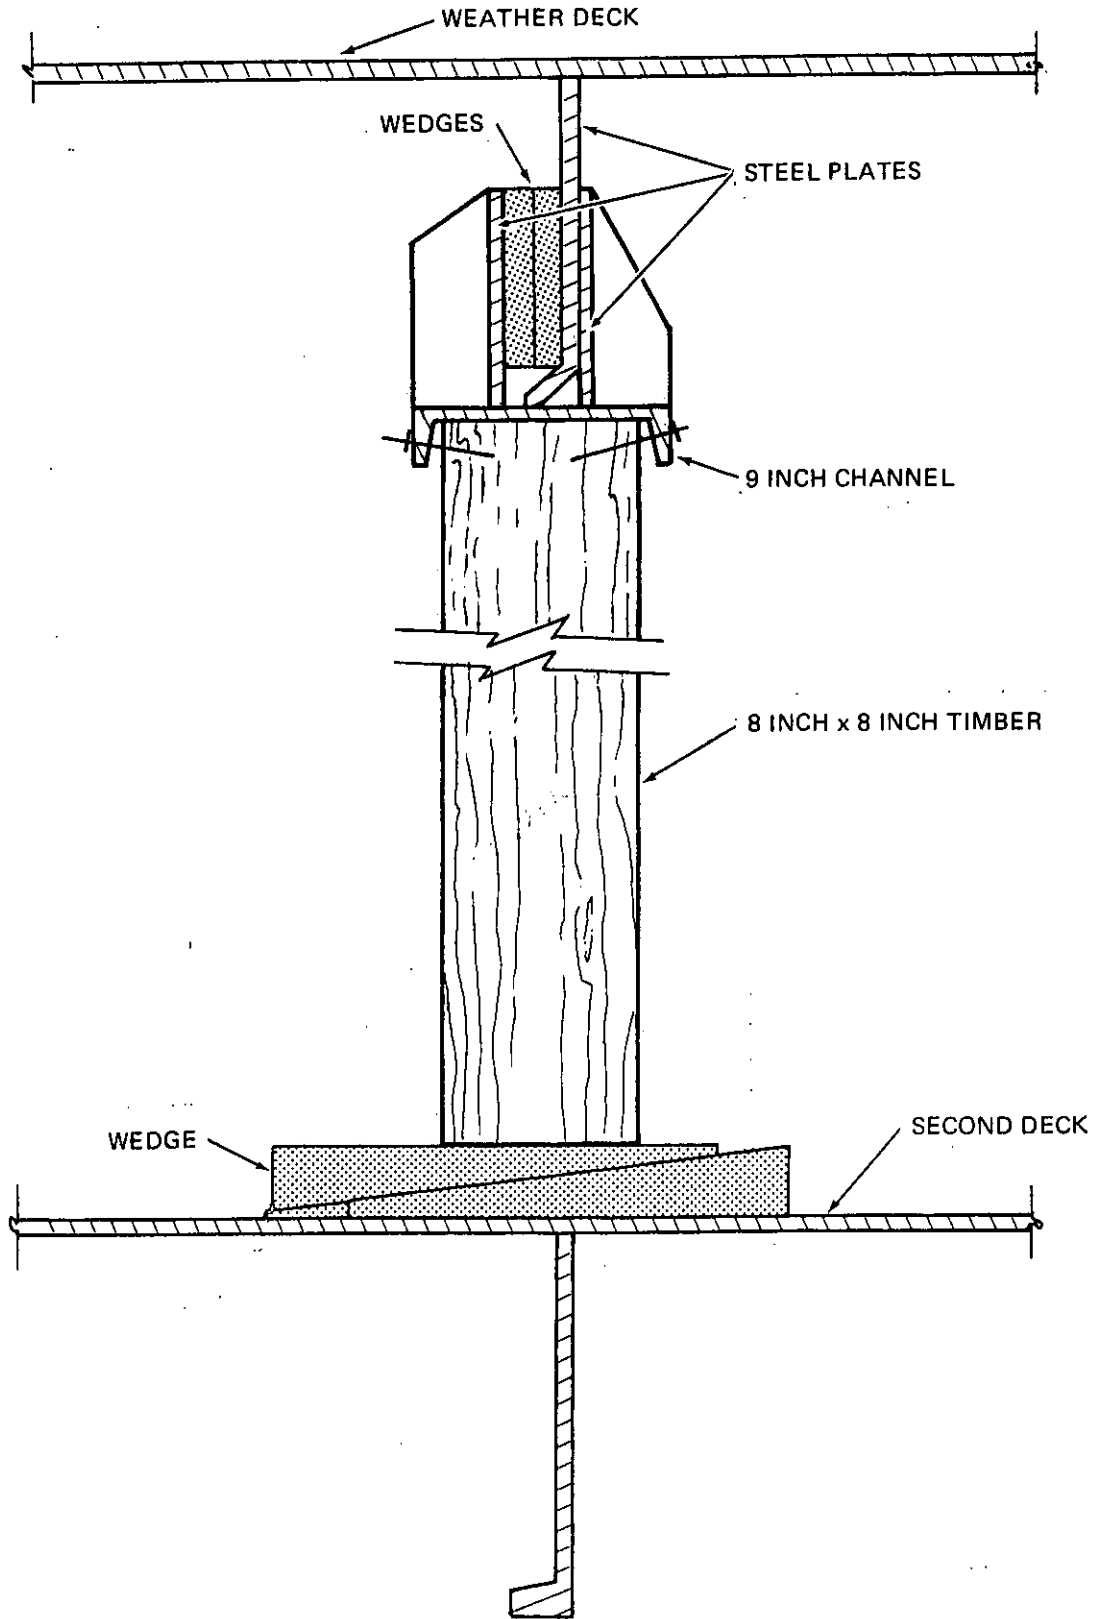
WEATHER DECK SHORING DETAIL.
FIG. 7 NO. 5

Typical framing of the weather deck consisted of steel plates welded to deck plates. Sixty-eight timber shores, fitted with channel caps were used. The channel caps were designed to be slipped over the bulb, with lateral wedges driven against the side of the bulb plate. The shores were then set in a preloaded condition by driving home the base wedges. (Fig. 7, No. 5)

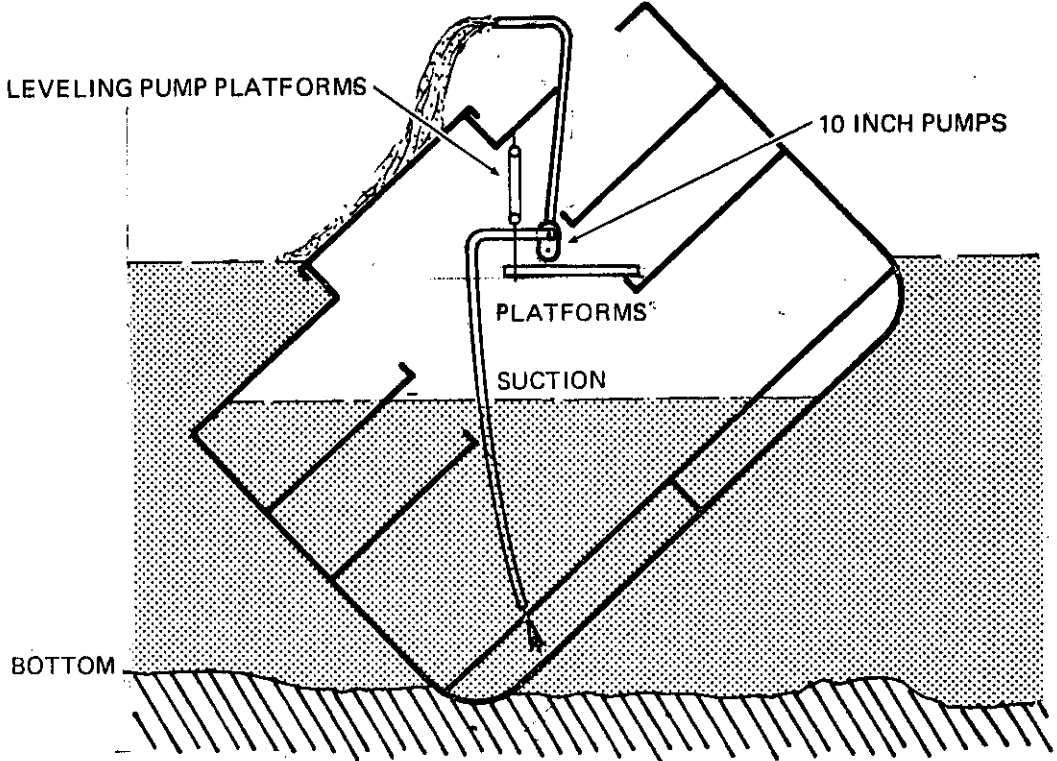
RIGGING OF PUMPING PLATFORMS.
FIG. 7 NO. 8

One ten-inch pump was rigged in each of the five holds, and an extra six inch pump was rigged in hold No. 1 where the most serious leakage occurred. The pumps were gasoline engine driven, self-primed, high delivery, low discharge-head type. The capacity of the ten-inch pumps was 840 tons per hour, at a 15 foot static suction lift. They were mounted on platforms opposite holes cut through the high side of the deck. The platforms were adjustable, enabling them to be leveled during the ship's righting. As the holds were dewatered and the ship righted considerably, the pumps and platforms were reinstalled inside at a lower level to reduce suction lift. (Fig. 7, No. 8)

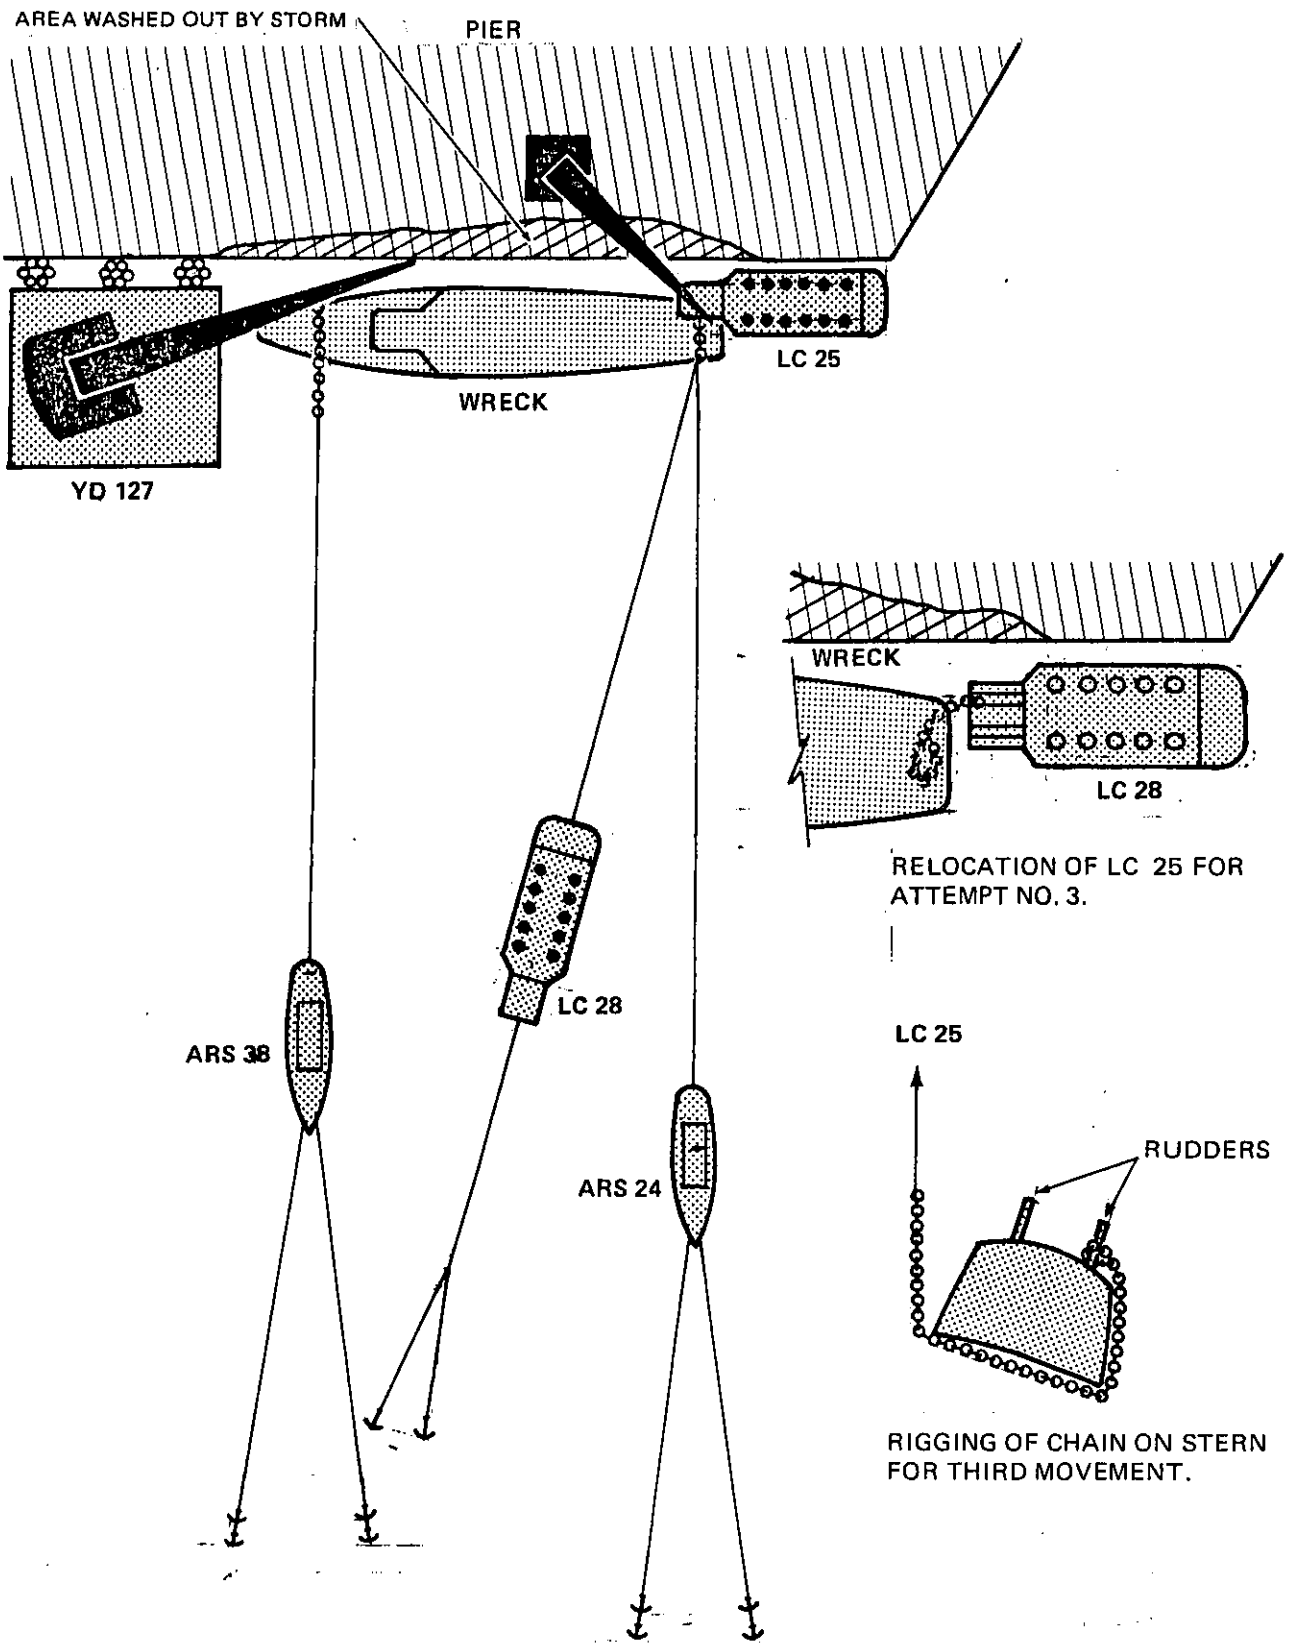
ARRANGEMENT OF FORCES FOR PARBUCKLING ATTEMPTS NUMBERS 2 & 3.
FIG. 8 NO. 3

at a different attitude; the bow had been pulled seaward, and was out of the trench, and the stern was still in the original hole. The new calculations indicated the need for a rearrangement of forces as shown in Fig. 8, No. 3. With this new plan one LC would be used to lift the wreck's stern, taking the place of the 60-ton shore crane which had not been effective. The other LC was to be used as a salvage vessel, pulling on the beach gear from a position between the two ARSs. The LC was capable of a 200 ton lift or pull over the bow using two heavy deck purchases.

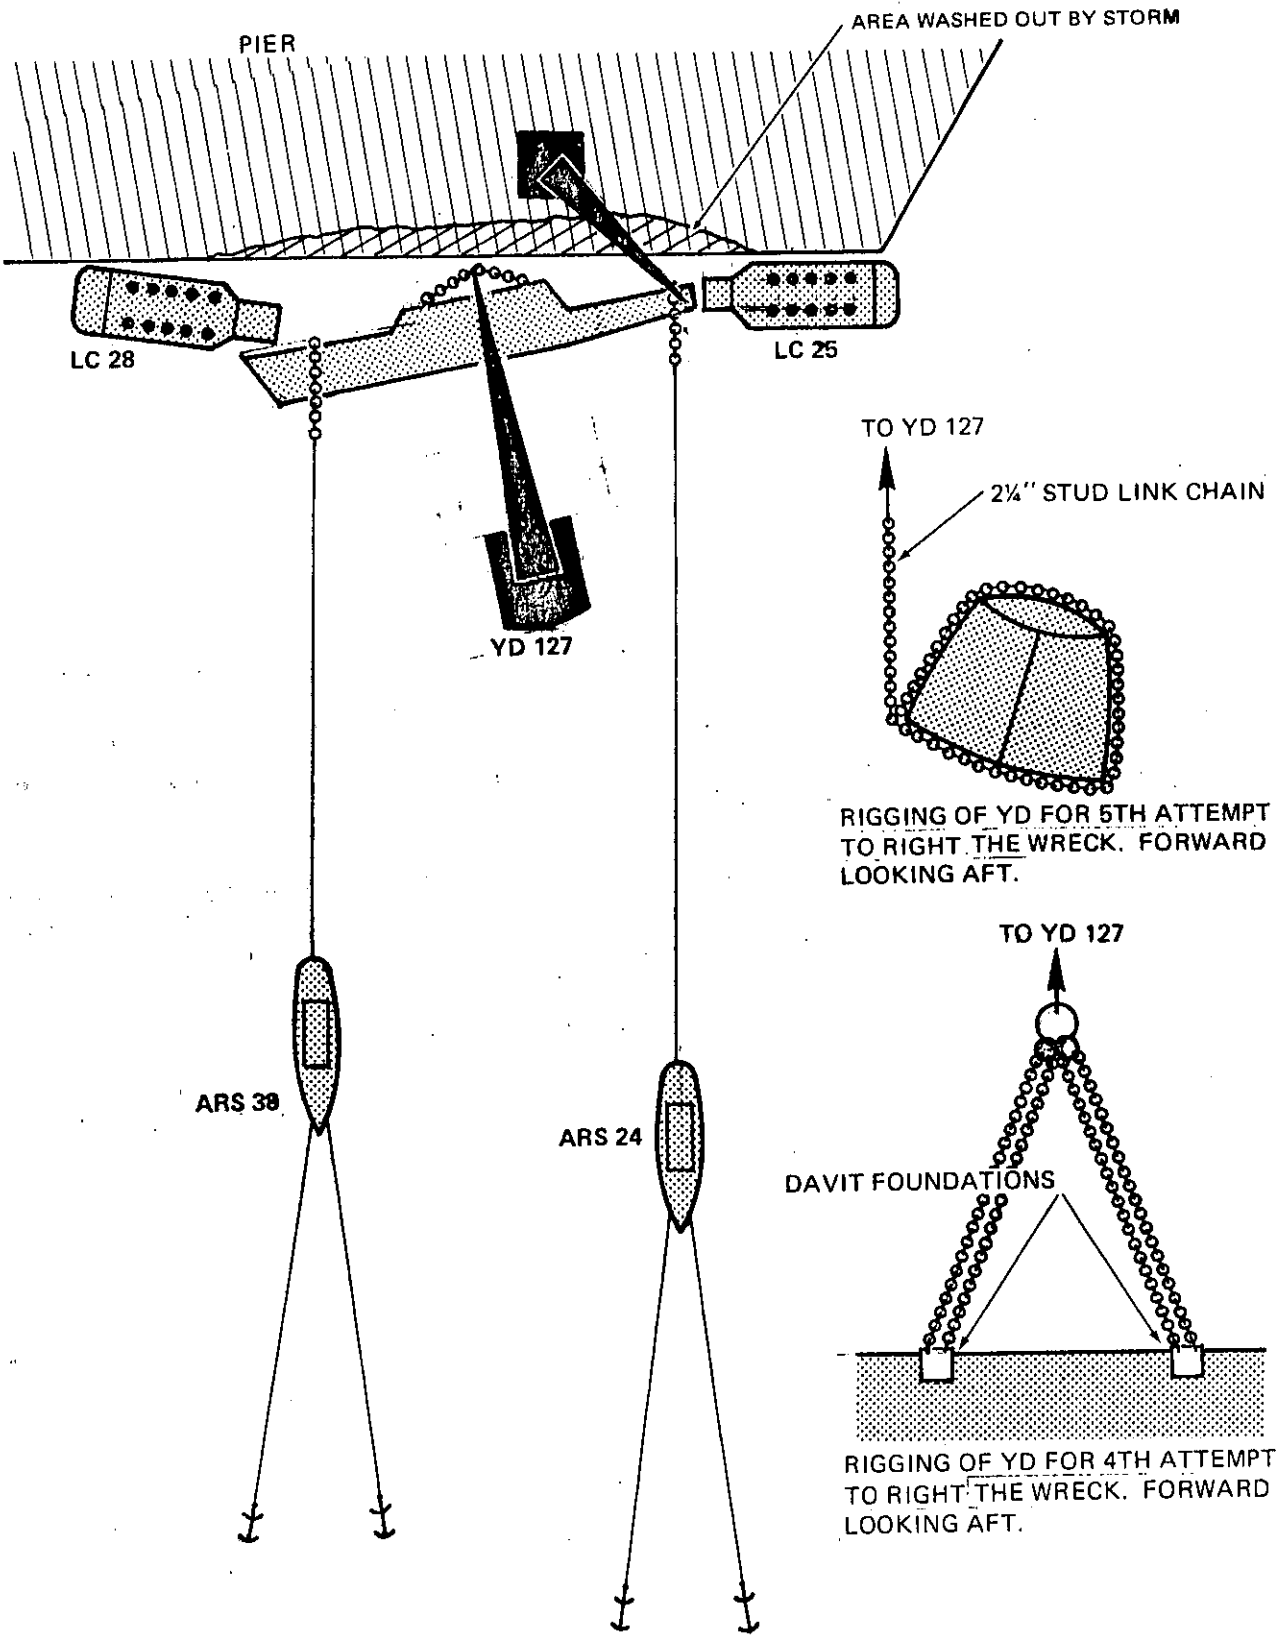
ARRANGEMENT OF FORCES FOR PARBUCKLING ATTEMPTS NUMBERS 4 & 5.
FIG. 8 NO. 8

On 1 February the concensus was that had LC-28's chain not parted the wreck would have rolled on the last attempt. An old crack was discovered in the link where the chain parted.

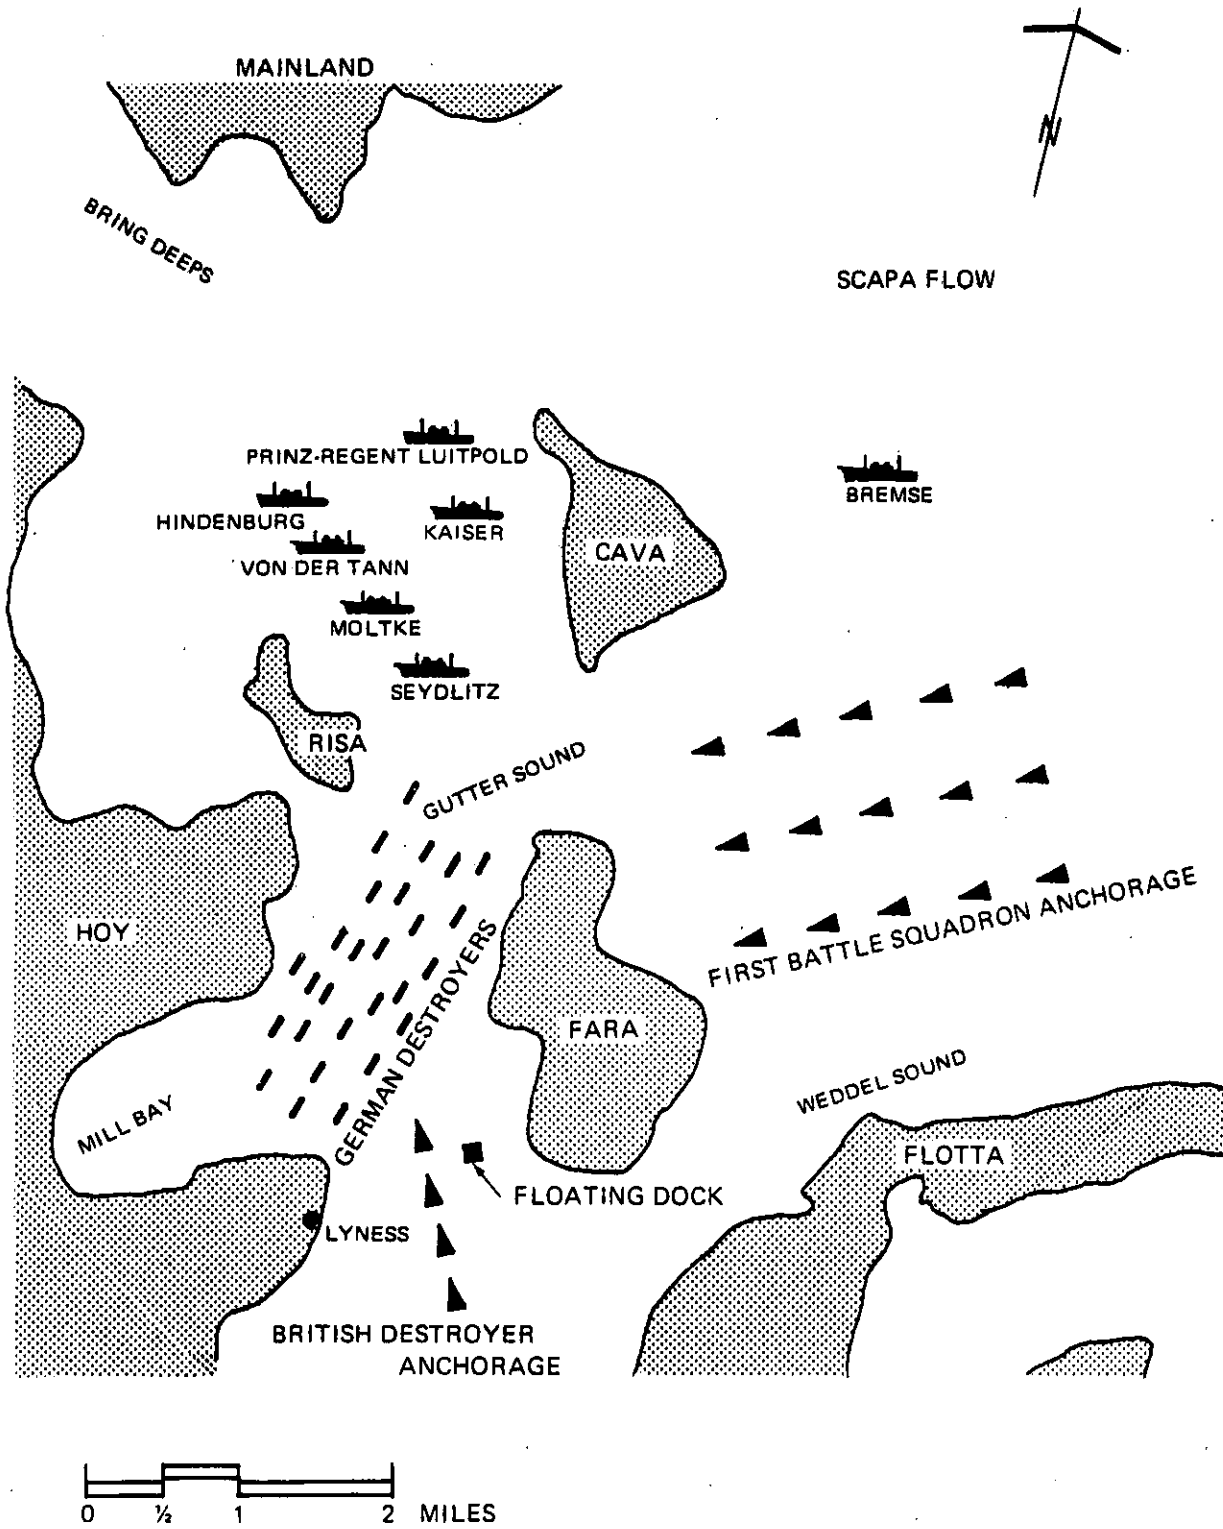
THE GERMAN WAR FLEET AT SCAPA FLOW IN JUNE 1919.
FIG. 10 NO. 1

On 21 June 1919 the fleet of 78 ships was sabotaged and in a very short time went to the bottom of Scapa Flow despite British efforts to save the ships. Military engineers upon surveying the scene shortly thereafter, concluded the fleet was unsalvageable except for a few of the smaller ships. The expense of raising the ships, as compared to their value for scrap, did not warrant salvaging these smaller ships. As the sunken fleet did not constitute a threat to any major navigable waterway, they were left as they lay. (See Fig. 10, No. 1).

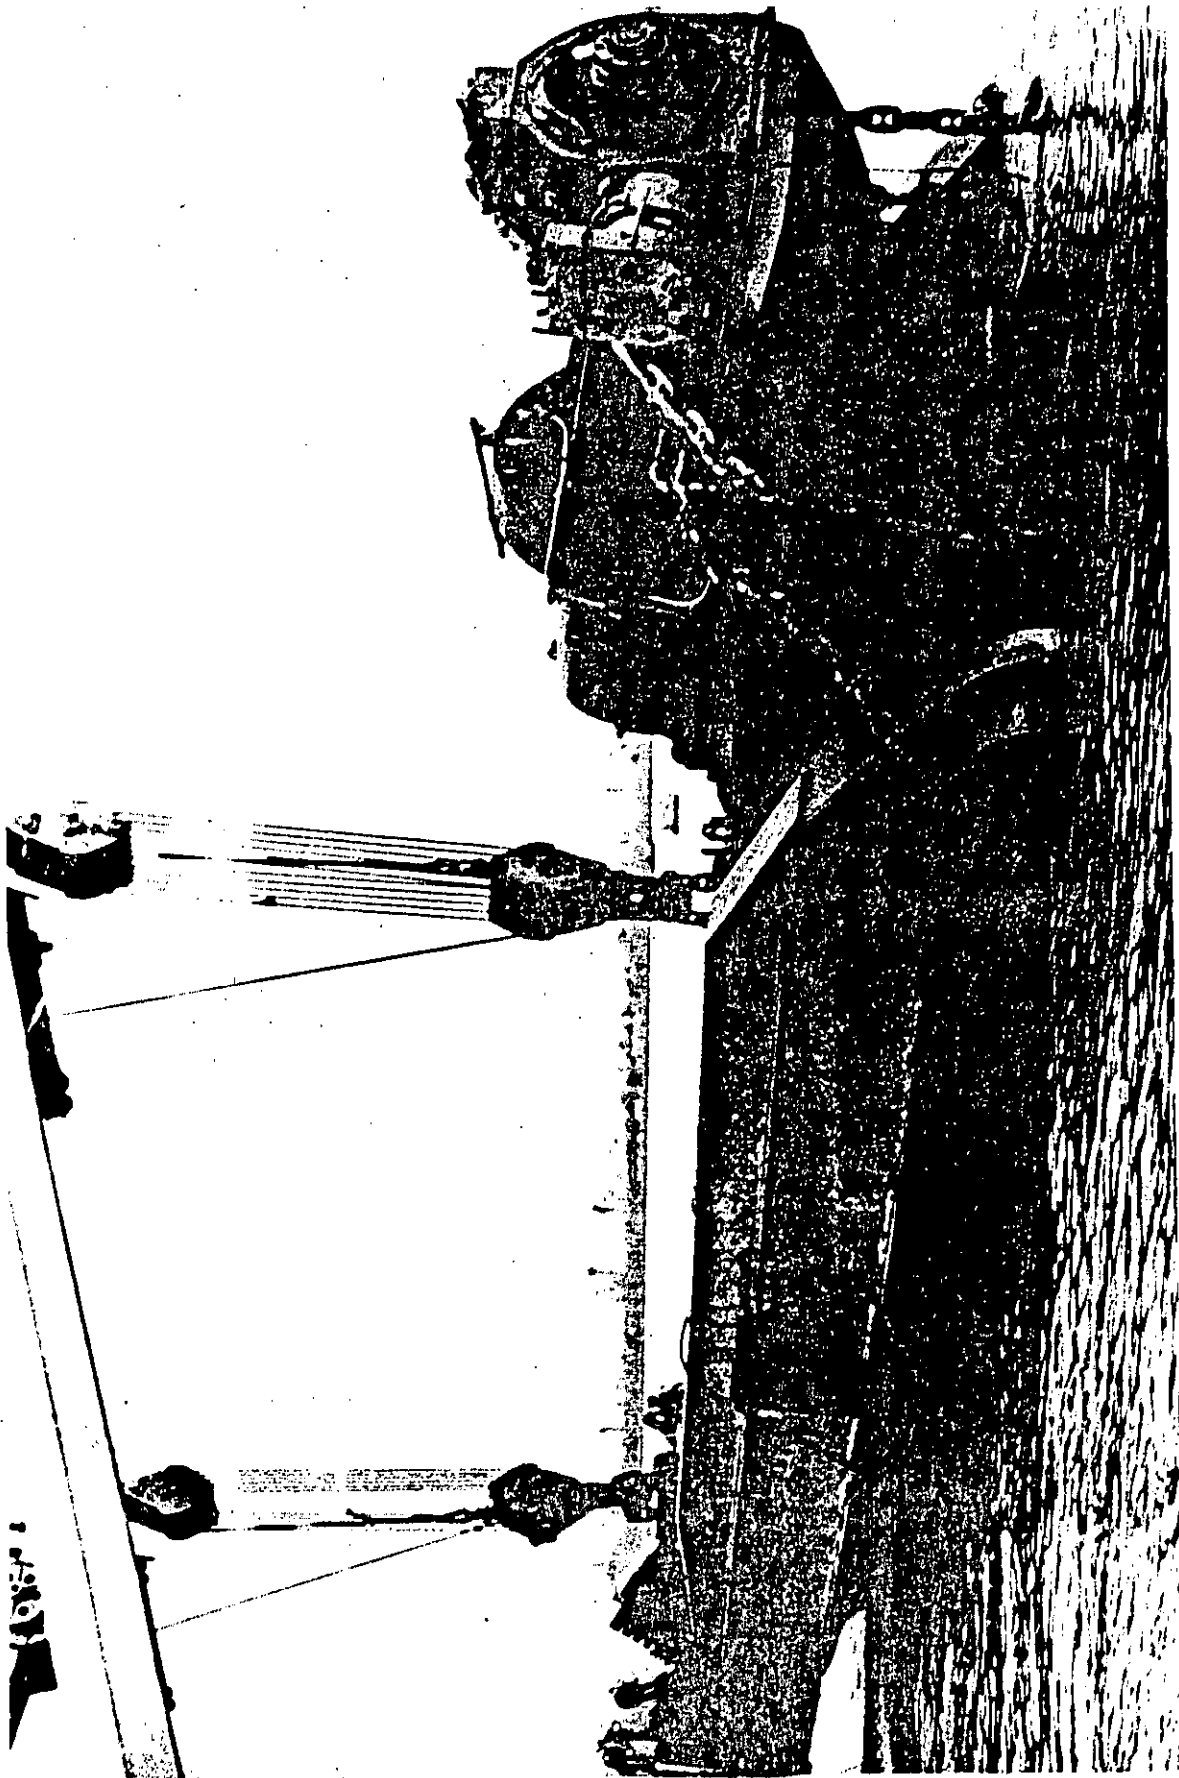
LIFTING SANDPUMPER'S LADDER.
FIG. 14 NO. 13

Phase II commenced on 15 October, and proved to be a major flaw in the salvage plan. The initial attempts to lift the ladder with *CRILLEY*'s stern gantries failed, and the ladder had to be dragged clear of the dredge by *CRANDALL*. A week was lost in this effort. The ladder also cost another week's time when the dredge became fouled with the ladder during the first lift. After the dredge had been successfully moved to shallow water, *CRILLEY* lifted the ladder with her gantries and placed it on a barge for removal.

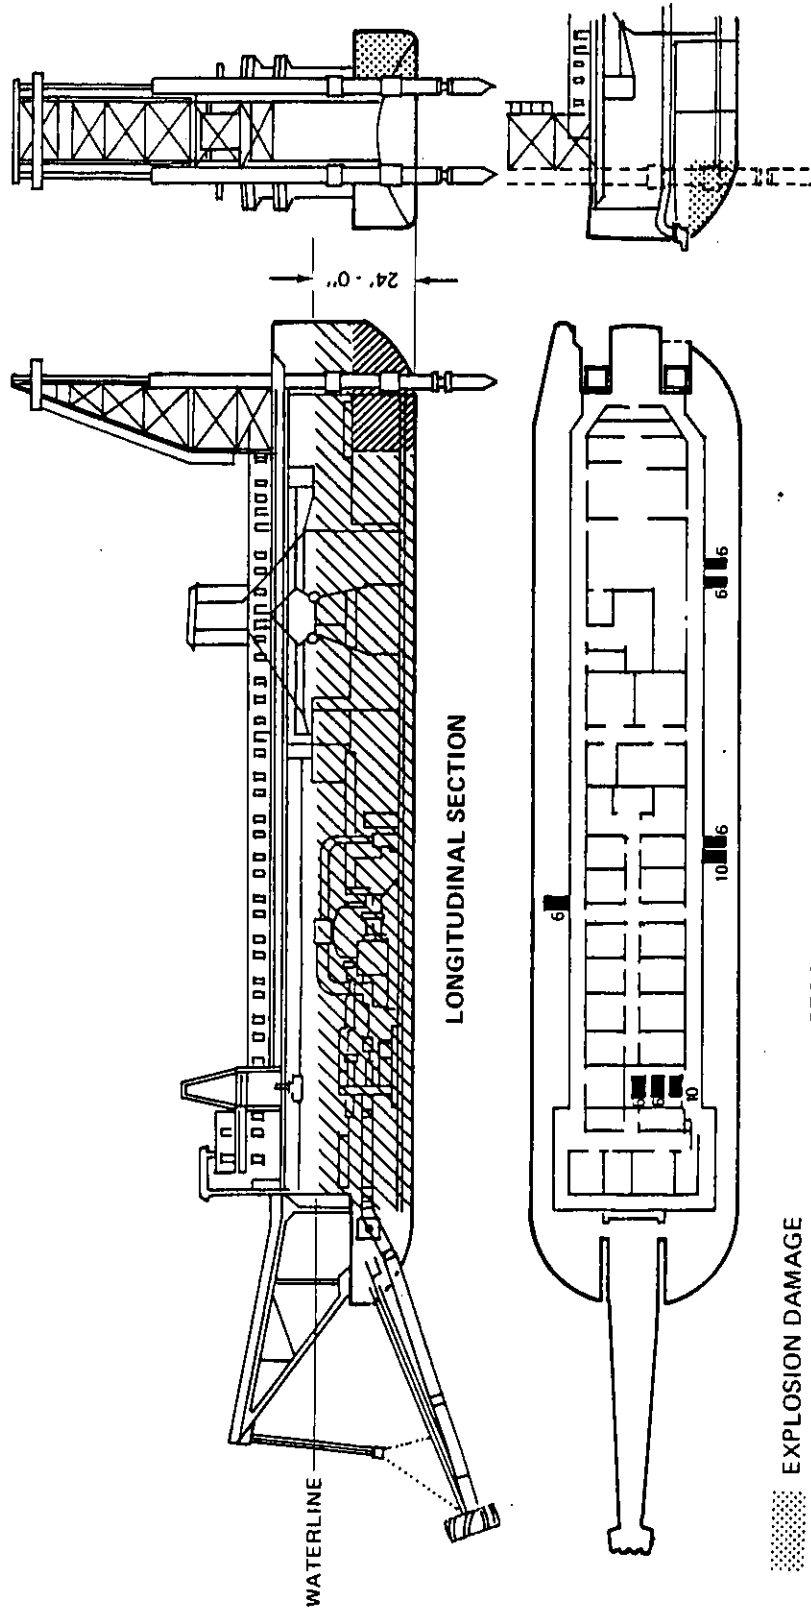
- EXPLOSION DAMAGE
- INITIAL FLOODING
- PROGRESSIVE FLOODING

FLOODING PLAN OF THE DREDGE "NEW JERSEY"
FIG. 14 NO. 19

6" OR 10" FINAL MAJOR PUMP LOCATION

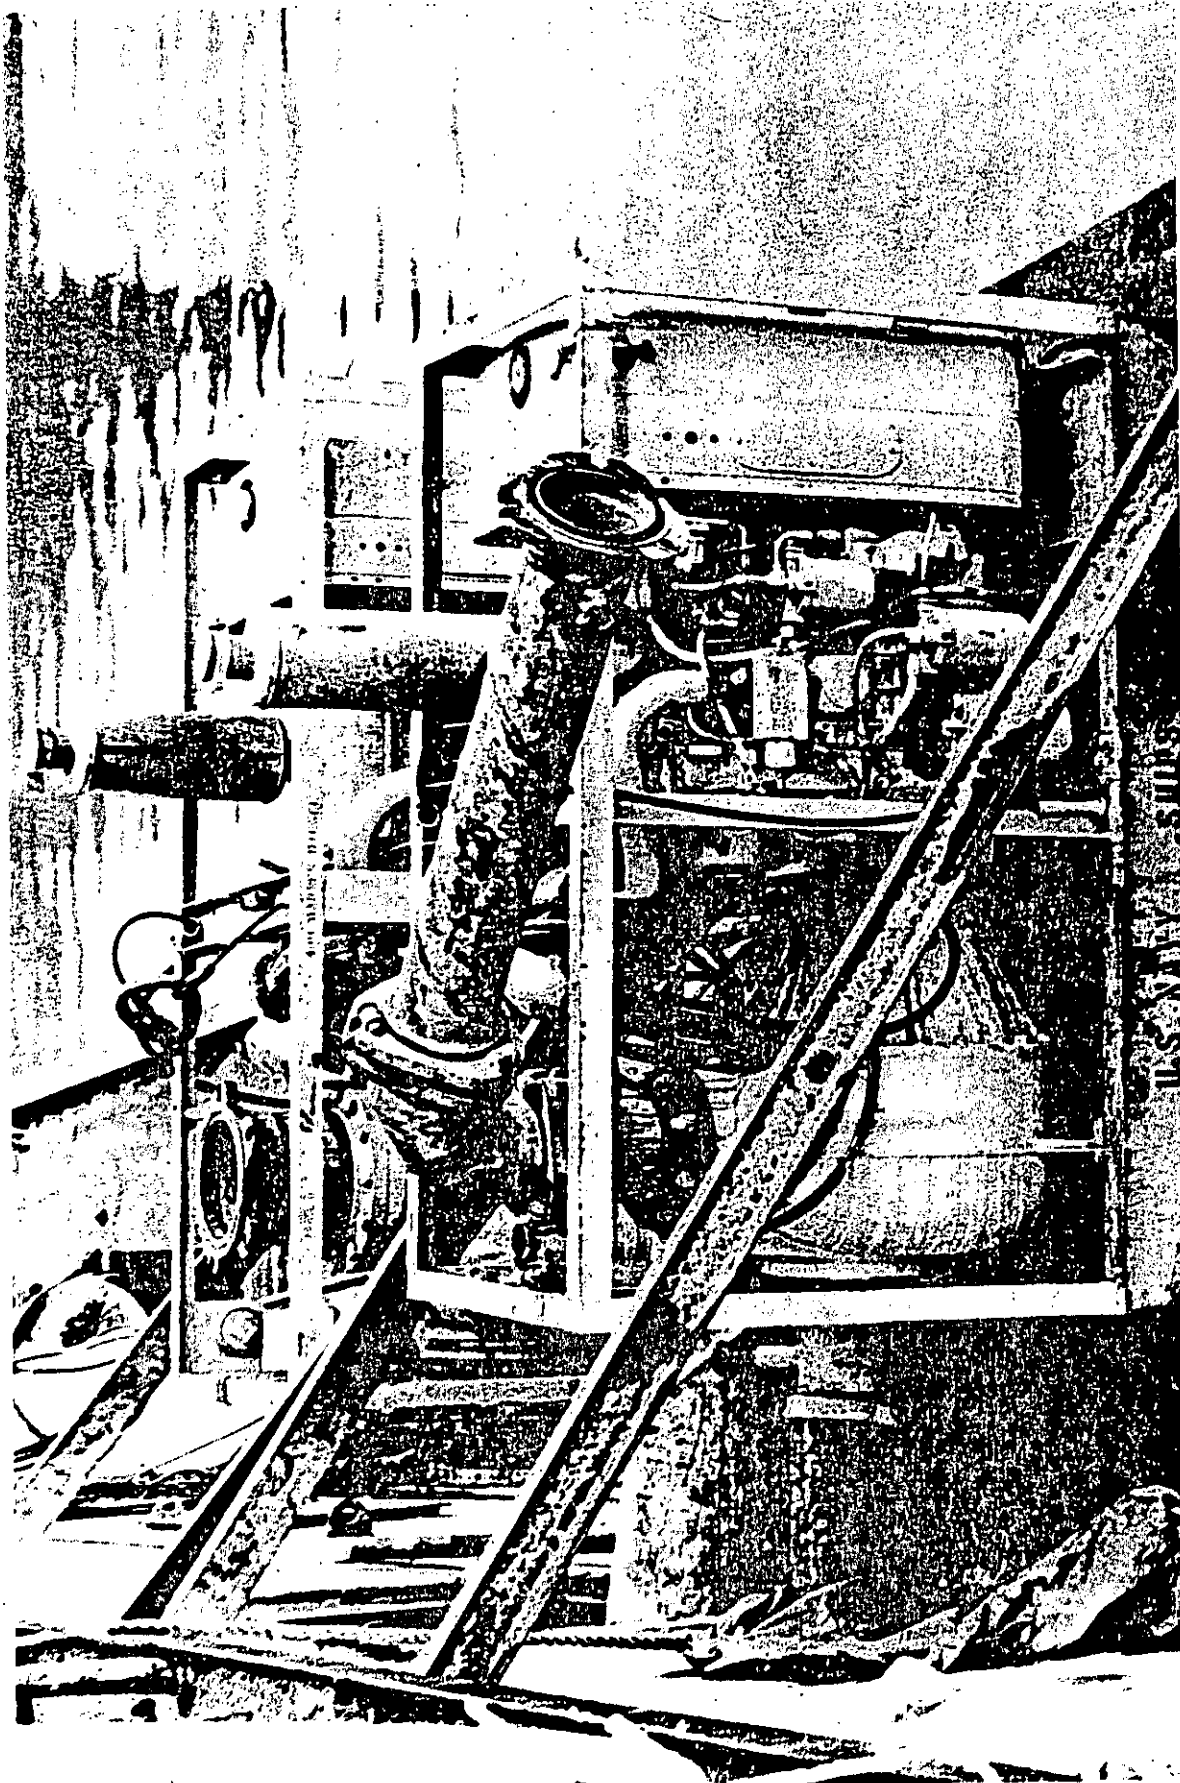
TEN AND SIX INCH PUMPS ON THE PORT
SIDE, NEW JERSEY.
FIG. 14 NO. 22

much as possible. HCU-One forces, with material and assistance from RMK-BRJ, prepared *NEW JERSEY* for the first dewatering attempt on 27 November. This first attempt, using three six-inch pumps and one ten-inch pump, was essentially a trial effort to determine leakage location. On 2 December, after three additional trials, and with the eventual addition of one more ten-inch pump, four more six-inch pumps and two three-inch pumps, *NEW JERSEY* was refloated. When successful refloating became apparent, most of HCU-One forces were brought on the scene. With personnel working around the clock, the *NEW JERSEY* was prepared for movement and was towed to a grounding site on 4 December. Preparations for the tow to a shipyard were then commenced, and on 13 December *NEW JERSEY* departed Dong Tam for Vung Tau on the first leg of her tow to a repair facility at Singapore.

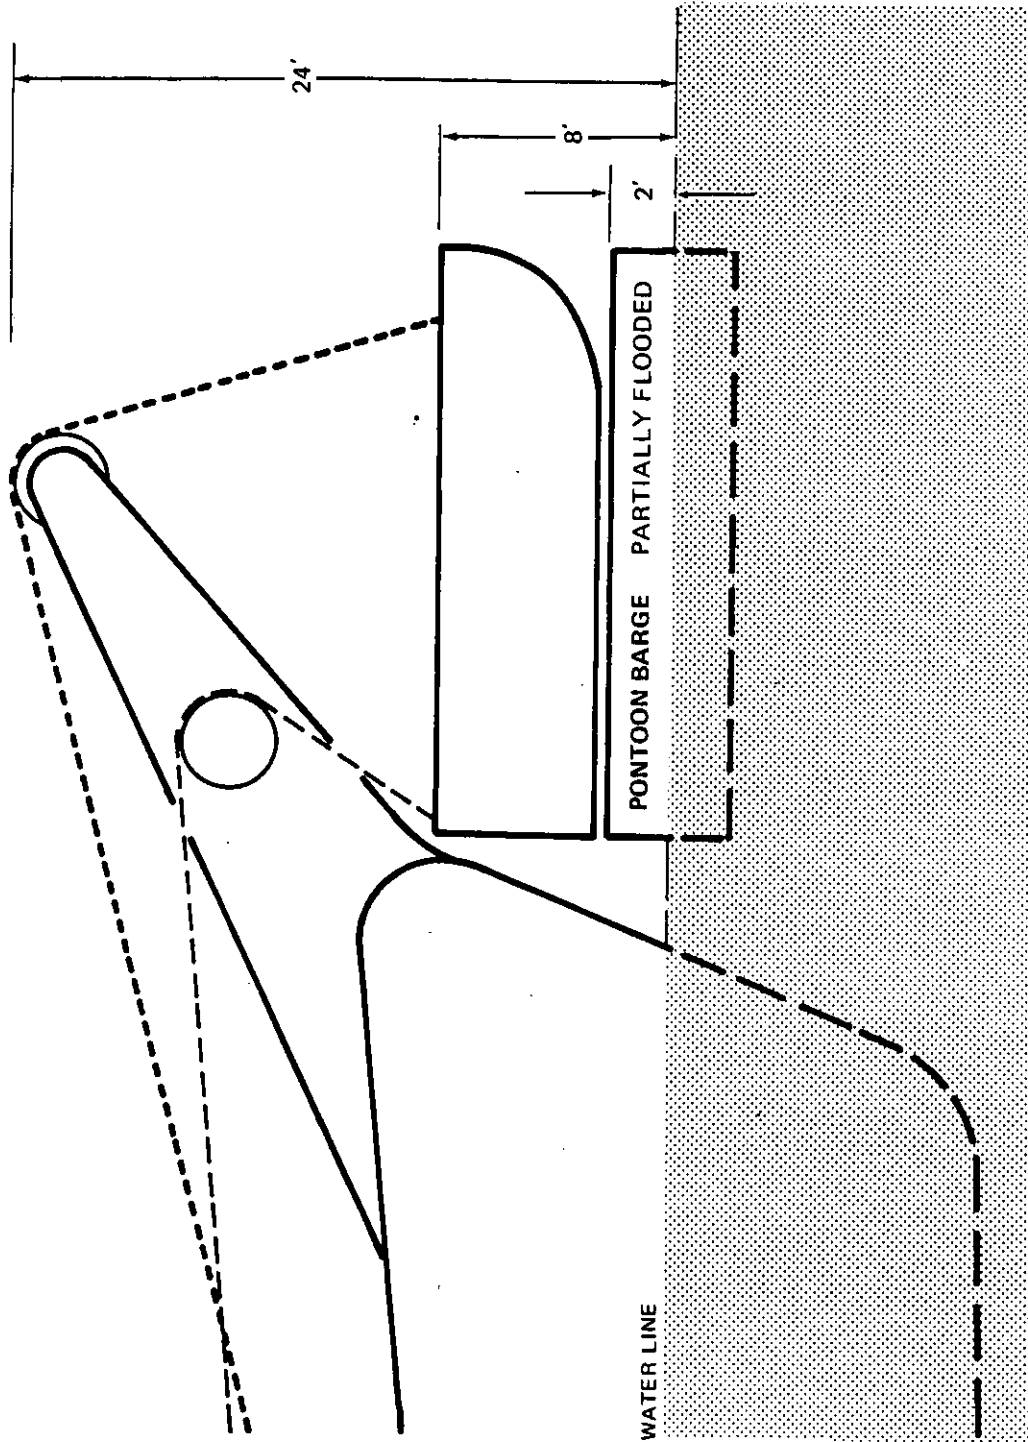
SETTING THE TAILGATE ON A PONTOON BARGE.
FIG. 15.1 NO. 6

Using this alternating procedure, the tailgate was slowly lifted out of the water to a point about five feet above the surface. A 72-section pontoon barge was floated beneath the hoisted tailgate (Fig. 15.1., No. 6). The gate was then landed on the barge and repaired, after which it was reshipped on the ARD.
