S0300-BE-MAN-010

**CASE STUDIES
OF SELECTED HARBOR
CLEARANCE OPERATIONS**

PUBLISHED BY DIRECTION OF COMMANDER, NAVAL SEA SYSTEMS COMMAND

1 JUNE 1989

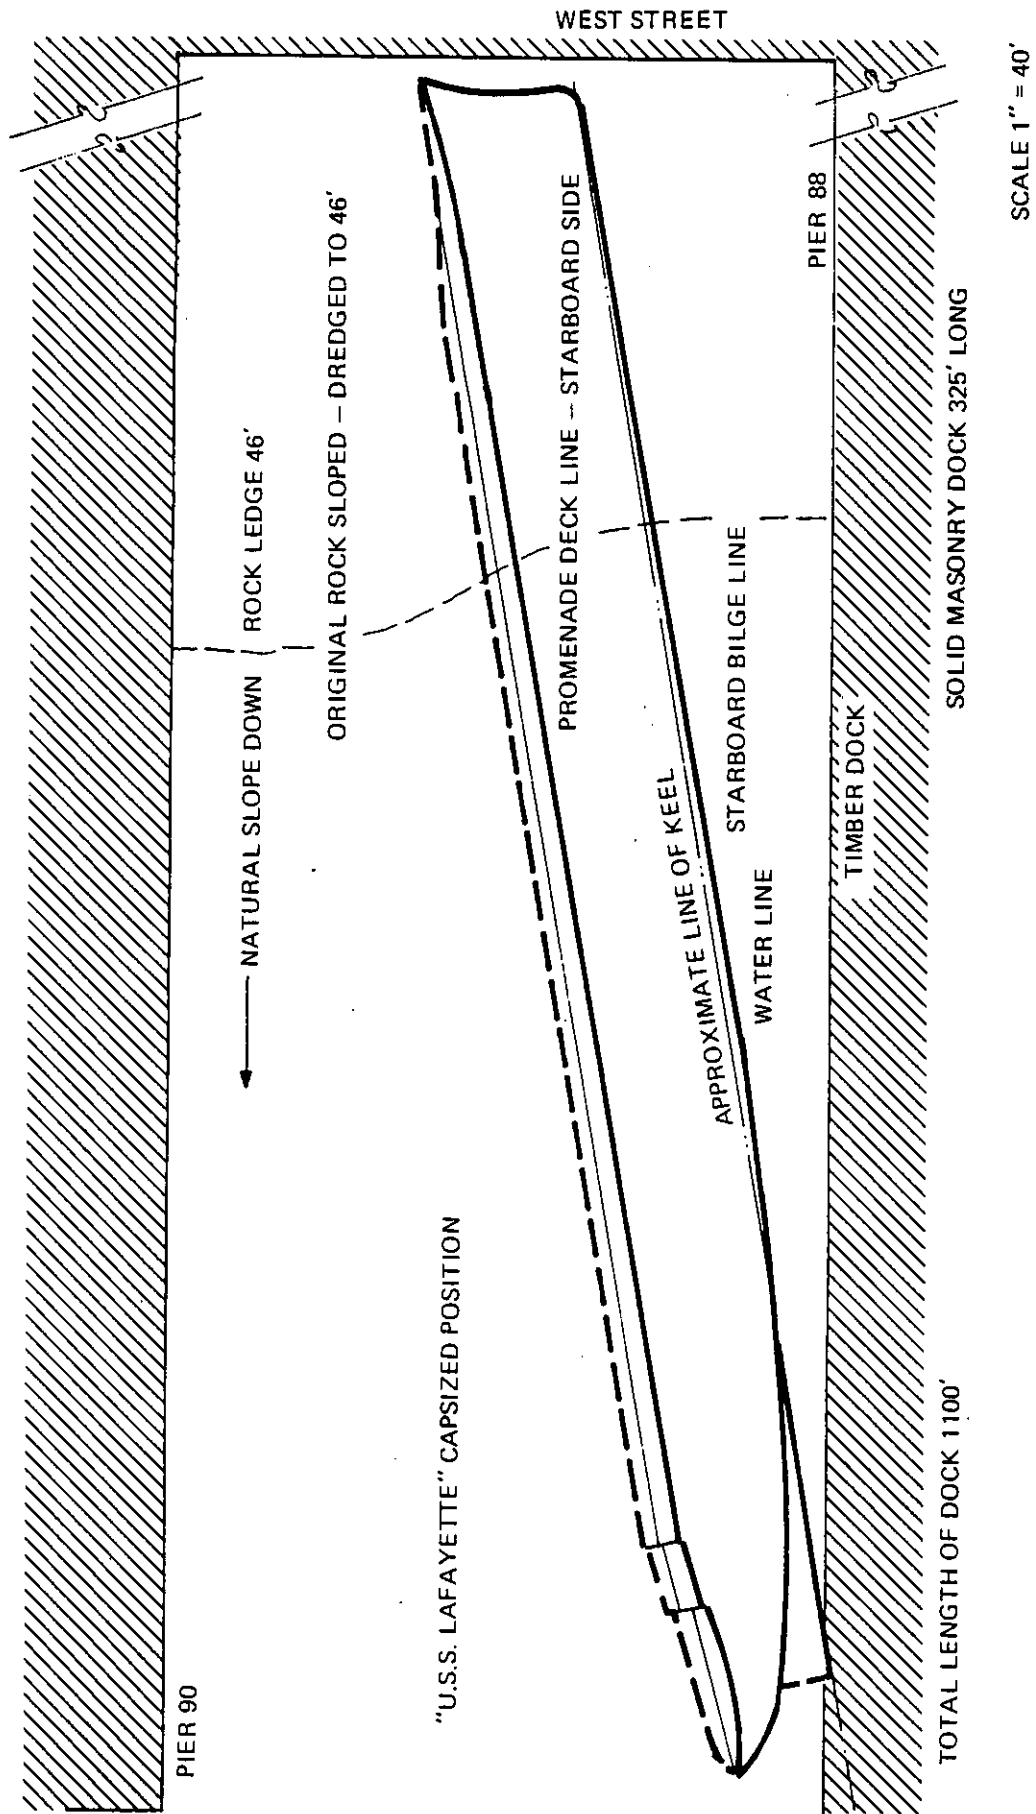
U.S.S. LAFAYETTE IN CAPSIZED POSITION
BETWEEN PIER 88 AND PIER 90.
FIG. 15.2 NO. 1

The *USS LAFAYETTE (ex-SS NORMANDIE)* undergoing final stages of conversion into a troop carrier at Pier 88 in New York Harbor, caught fire, capsized and sank on 10 February 1942 as a result of the enormous amounts of water used to fight the fire. The ship came to rest on her port side, diagonally in the slip, at an angle of less than 80 degrees, and was flooded throughout up to the outside waterline (Fig. 15.2., No. 1). On 11 June, acting upon recommendations of a special investigation committee appointed by the Secretary of the Navy, salvage operations commenced on the *LAFAYETTE*. She was successfully righted and refloated by extensive patching, shoring and pumping operations.

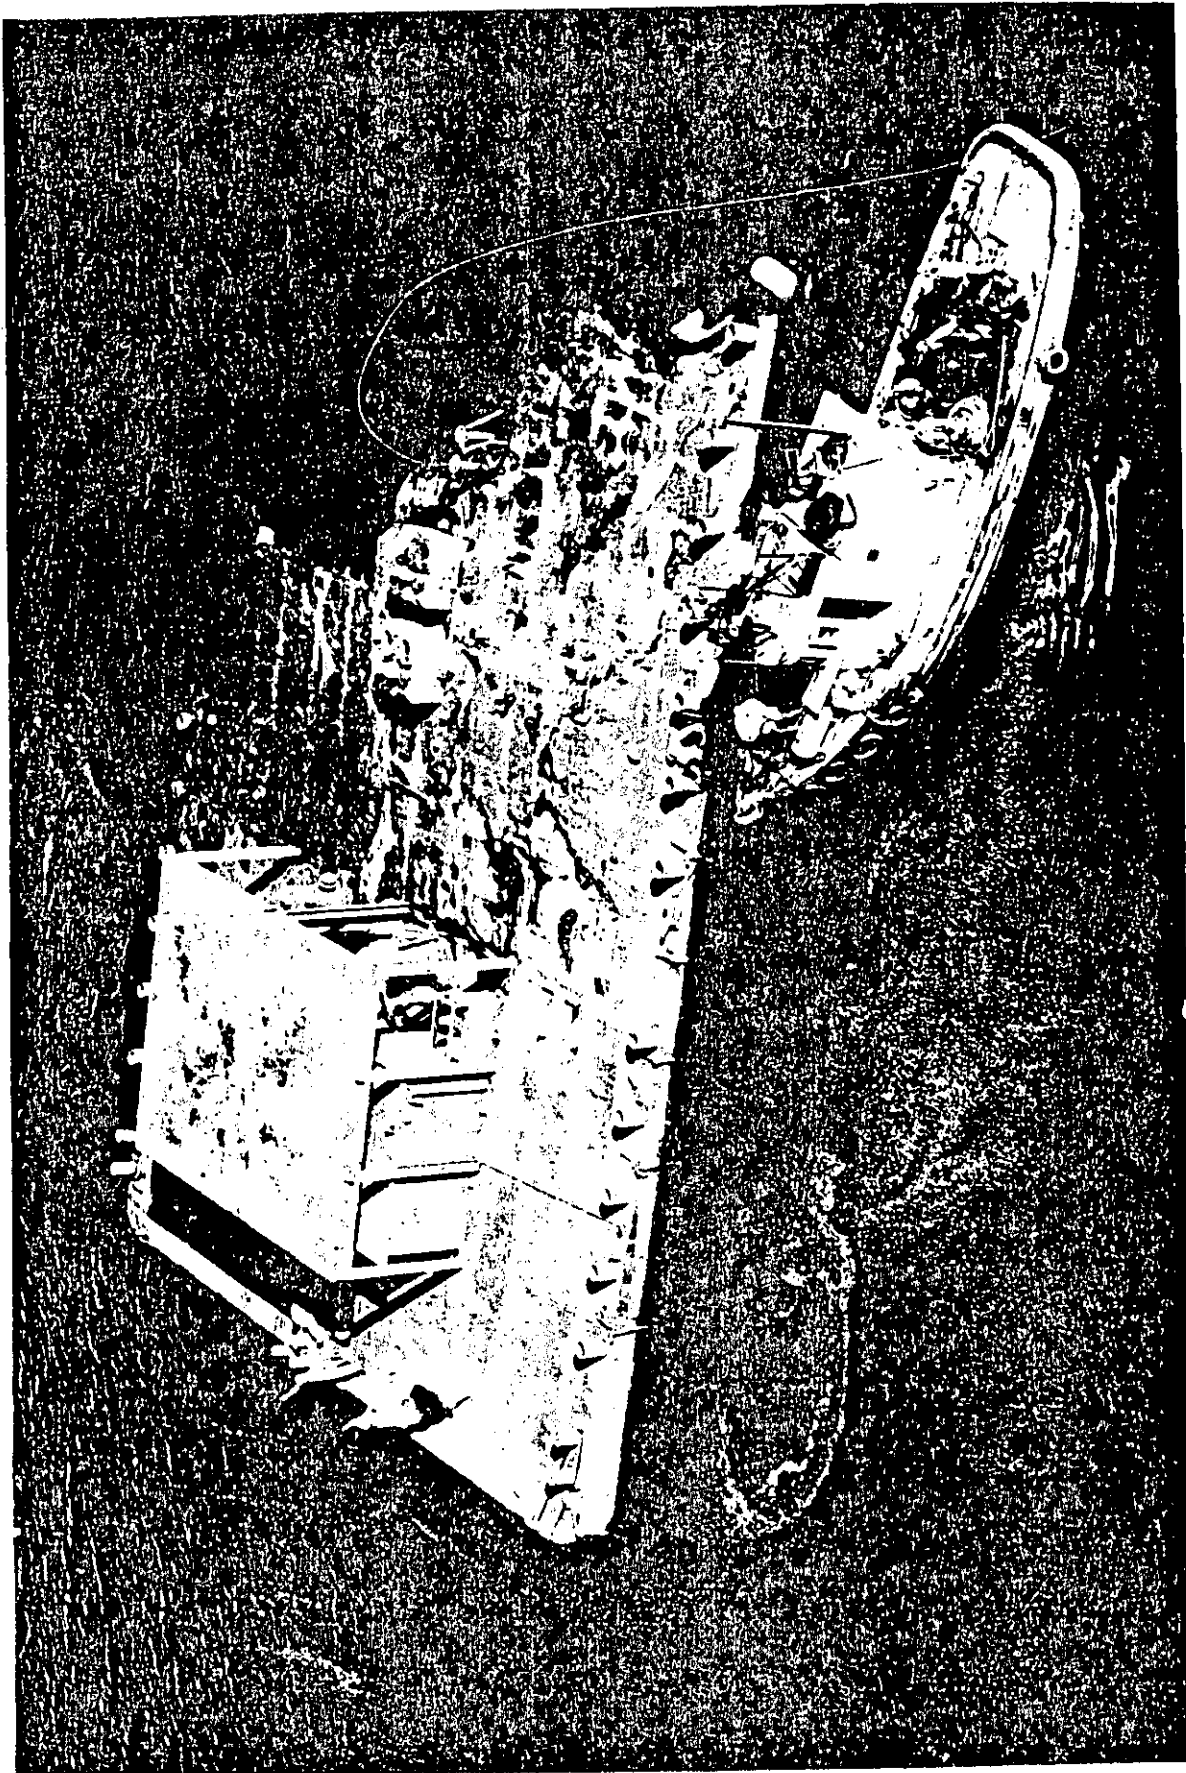
On 31 October one corner of the hull broke the surface as a result of buoyant forces from the foam cast-in-place. The hull appeared impaled and towing by a USCG Cutter failed to free the hulk. On 1 November, the 1500 hp, three-screw tug *QUENETT* was able to tow *LUMBERJACK* to a suitable grounding site where she was cut up and disposed as scrap.

STERN SECTION OF THE "LUMBERJACK"
AFLOAT ON FOAM.
FIG. 15.4 NO. 2

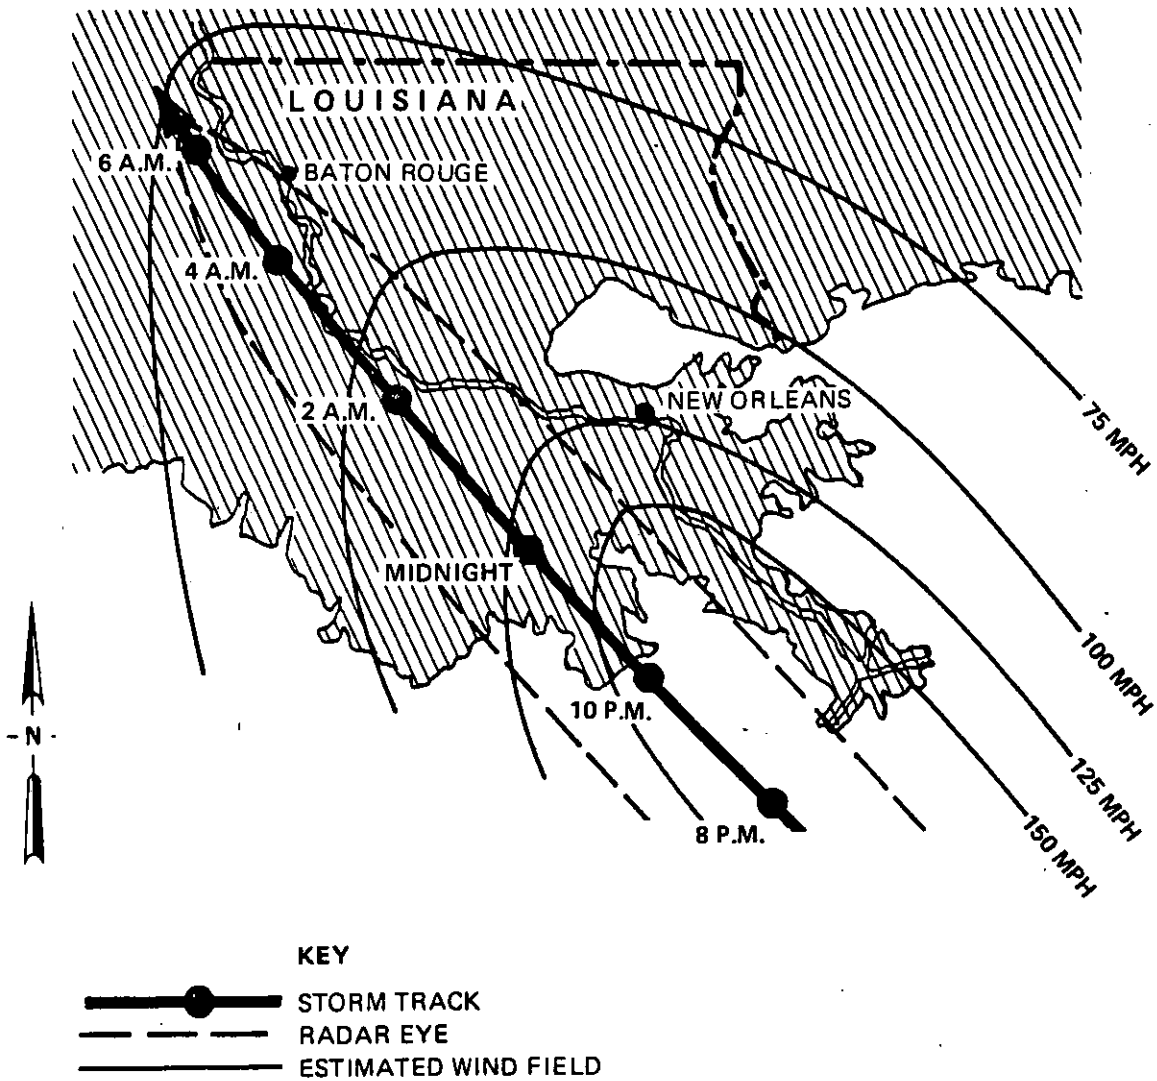
HURRICANE TRACK
ON 9-10 SEPTEMBER 1965
FIG. 15.5 NO. 1

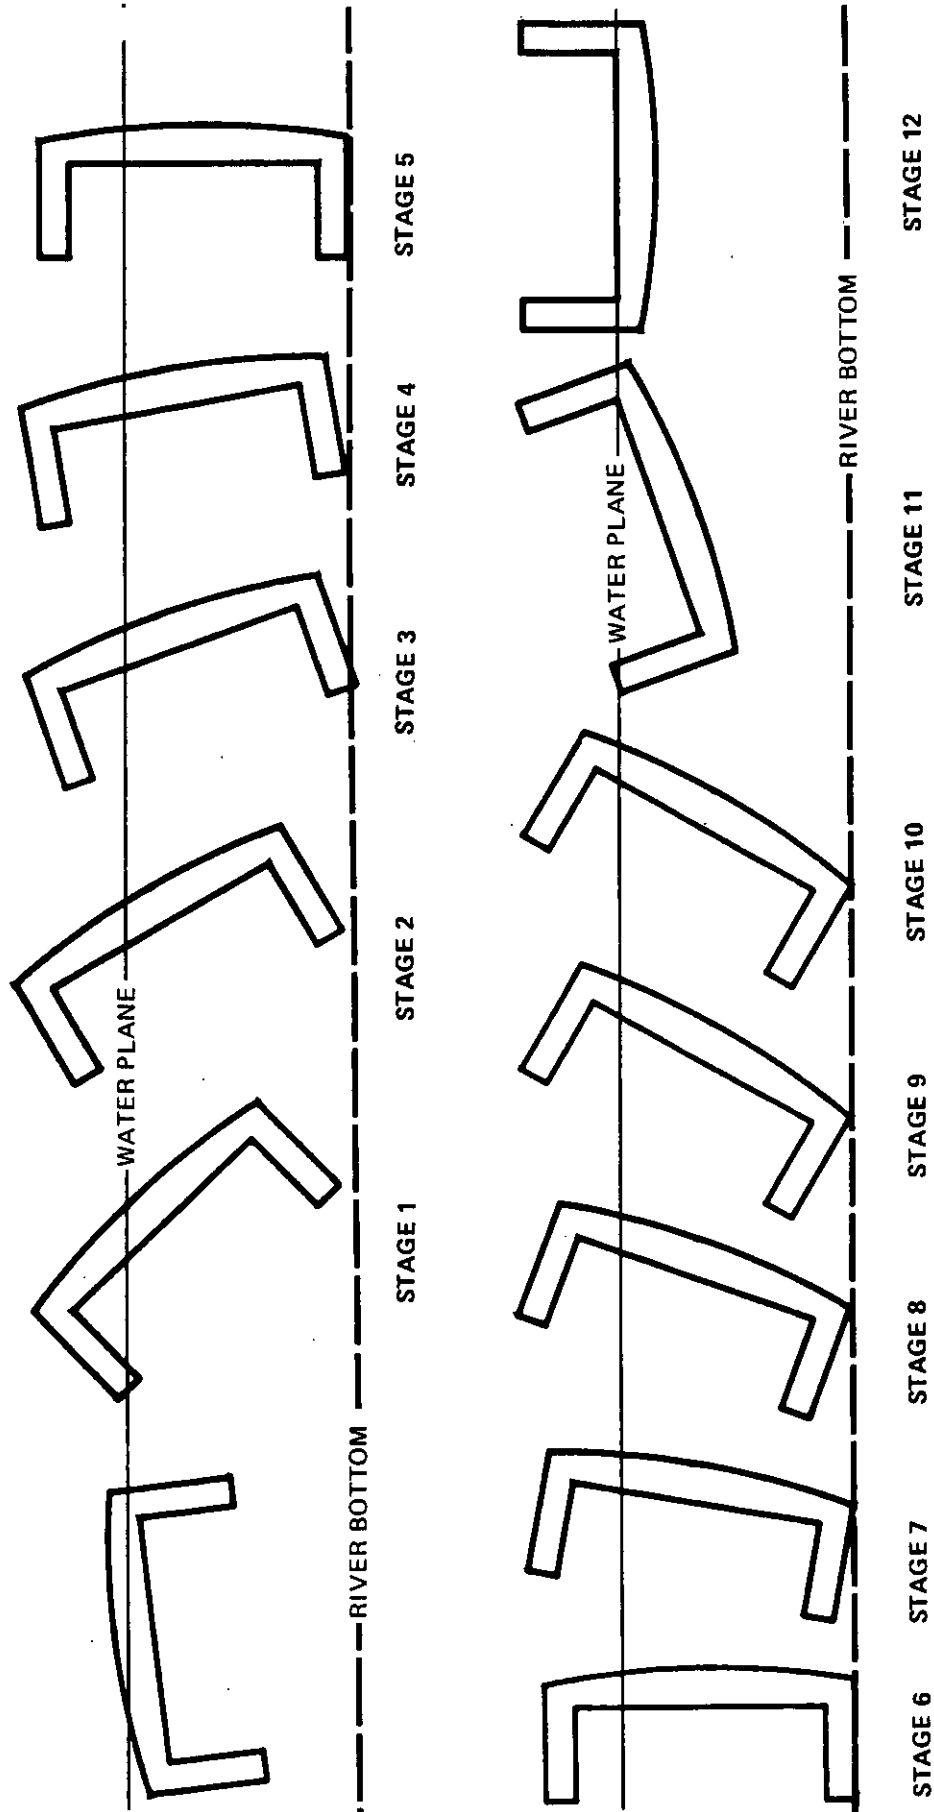
FIG. 15.5 NO. 2

The final approved plan for righting the dock called for snugging the capsized dock against the river bottom and righting by parbuckling it up and over 180 degrees toward the levee. The parbuckling operation was to be accomplished in twelve stages employing a combination of land-based beach gear, inflatable rubber pontoons for external buoyancy, and the judicious use of water ballast and compressed air. This was the first time all of these techniques were used in one carefully determined effort.

CAPSIZED DRYDOCK TURNS RIGHTSIDE UP IN A 12-STAGE SALVAGE OPERATION
AT NEW ORLEANS, LOUISIANA

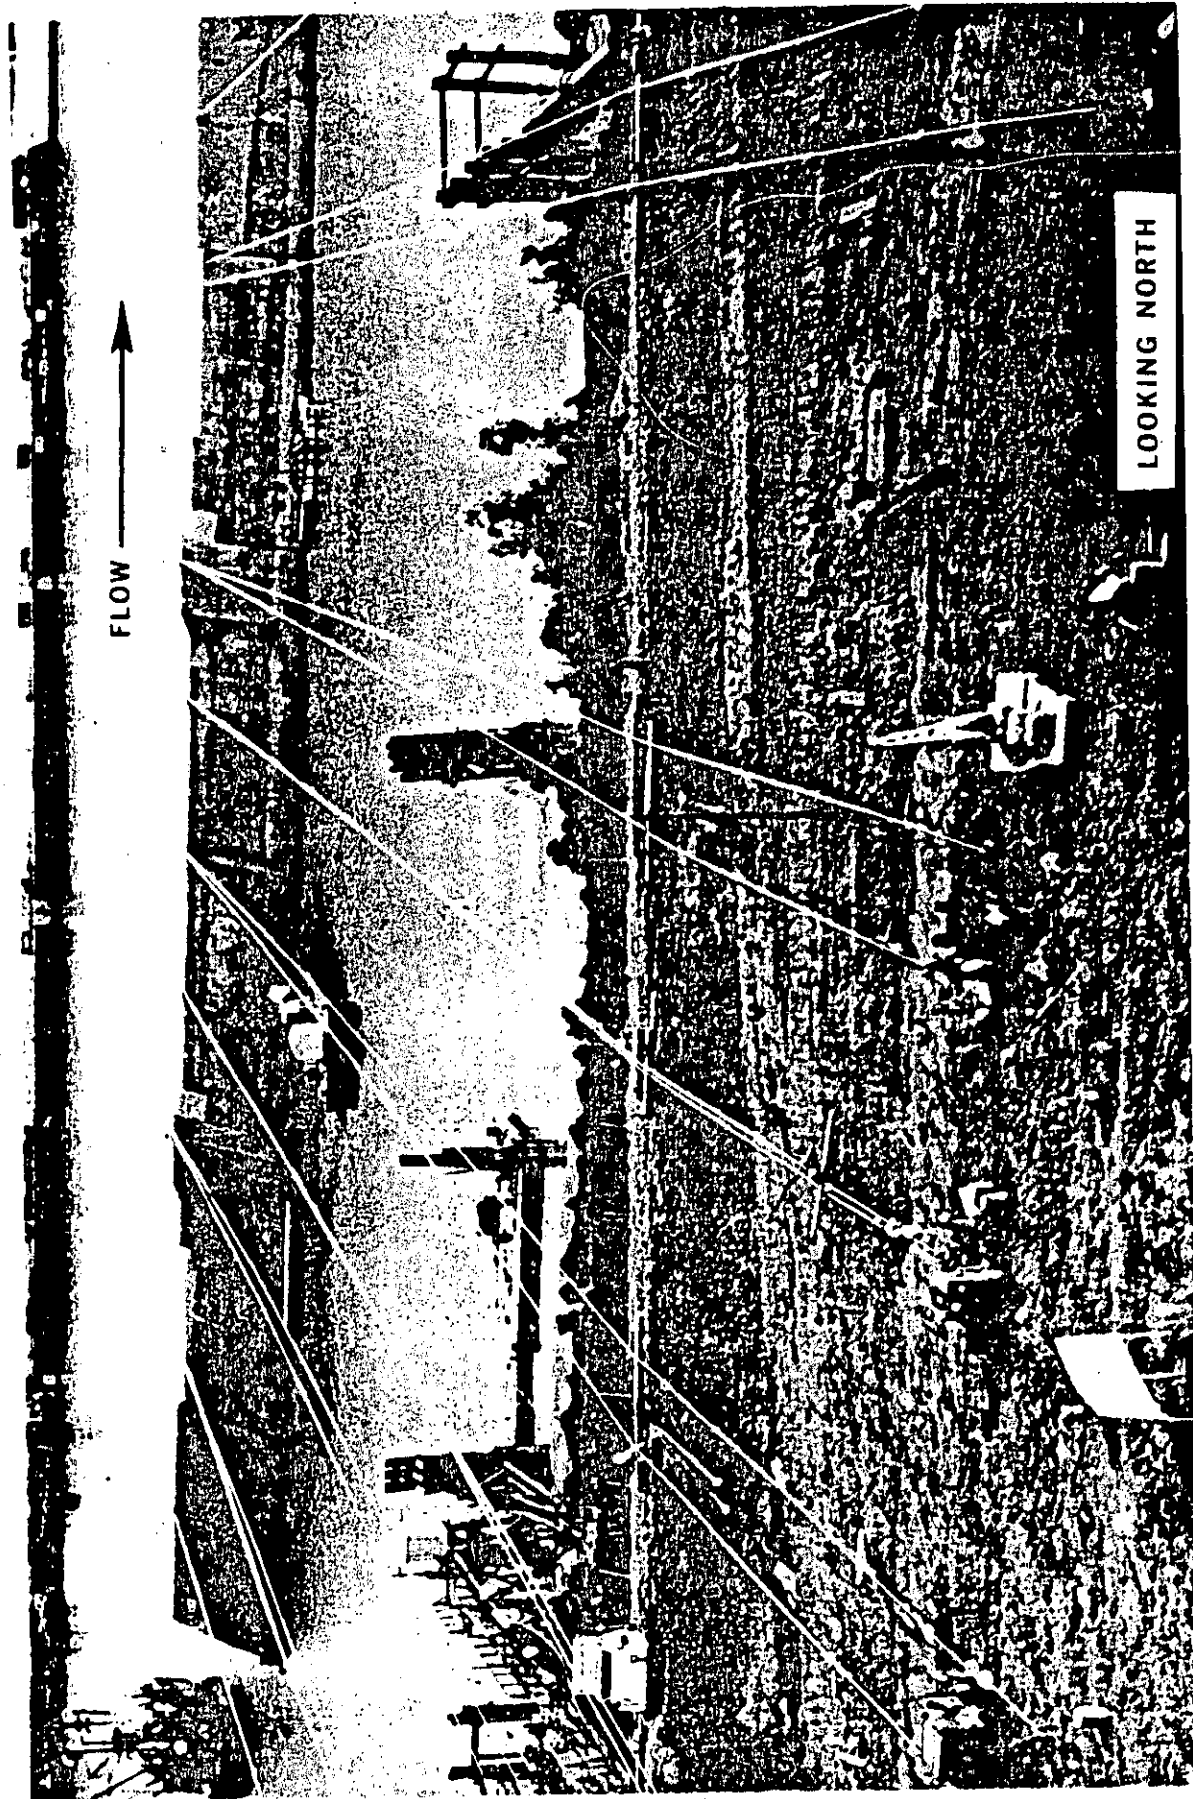
BEACH GEAR RIGGED ASHORE FOR PARBUCKLING
THE AFDM-2.
FIG. 15.5 NO. 4

The preparatory work was two-fold; the repairs to the hull and wingwalls that would be underwater during the righting operation had to be made, and the vents, valves, padeyes, and other fittings that would be used during the operation had to be installed. During this time the dock was jarred loose from her moorings by high water and a surge of debris, and had to be moved across the river again back to the west bank. While the work was being carried out on the dock, another crew was installing beach gear in the area behind the levee, and the salvage site was selected. A suitable site, meeting the requirements needed for the parbuckling operation was found only 1,500 feet downstream.

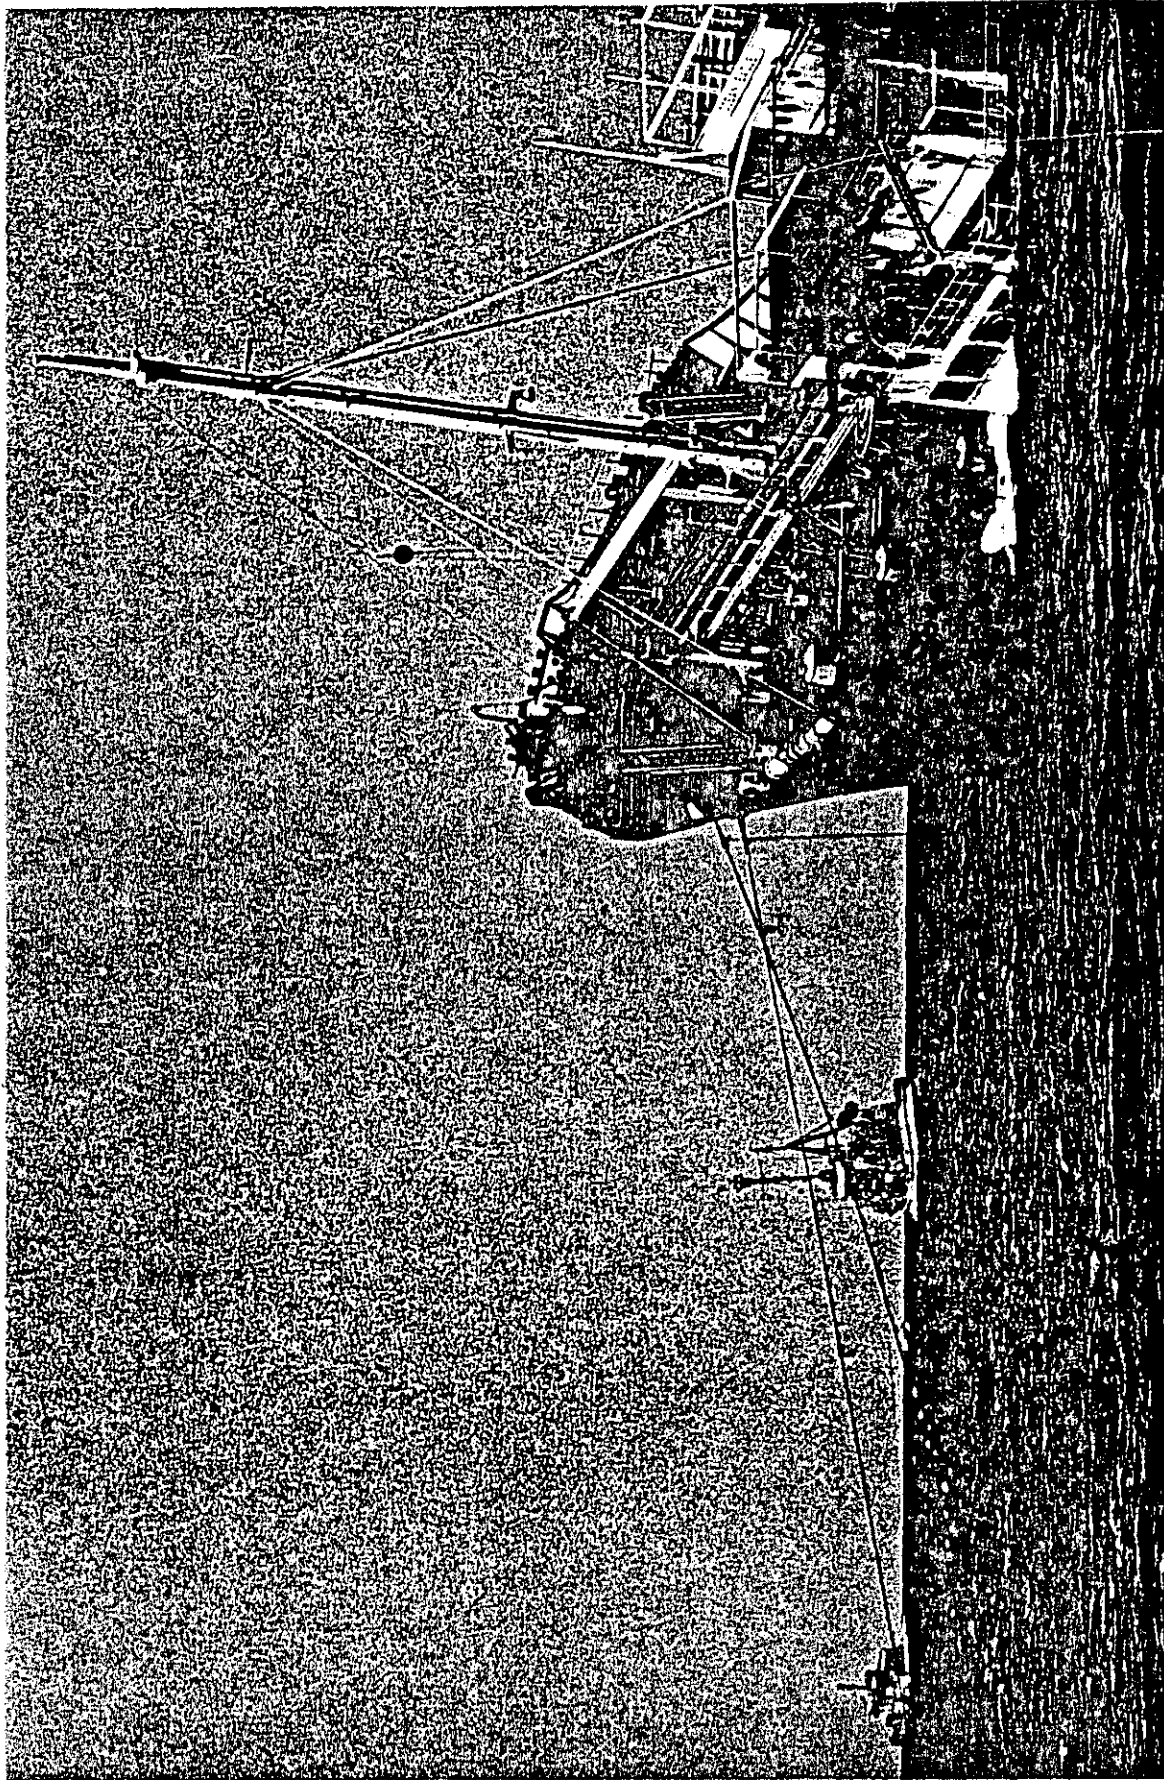
During the period from 5 to 9 March, the *USS PRESERVER (ARS-8)*, *USS UTINA (ATF-163)* and the *USS PAIUTE (ATF-159)* attempted to tow the bow section to sea. On 9 March operations were suspended because heavy swells caused a major change in the condition of the bow. This necessitated the change to a long range salvage program of cargo removal and refloating for eventual disposal of the hulk. From 11 to 21 March essentially all remaining cargo oil was removed – 1,192,487 gallons. On 4 April, after several delays because of rough seas, the hulk was refloated and towed to sea where it was scuttled in 600 fathoms of water approximately eight miles north of San Juan.

S/T OCEAN EAGLE BOW SECTION UNDER
TOW TO DISPOSAL SITE FOR SINKING.
FIG. 15.6 NO. 2

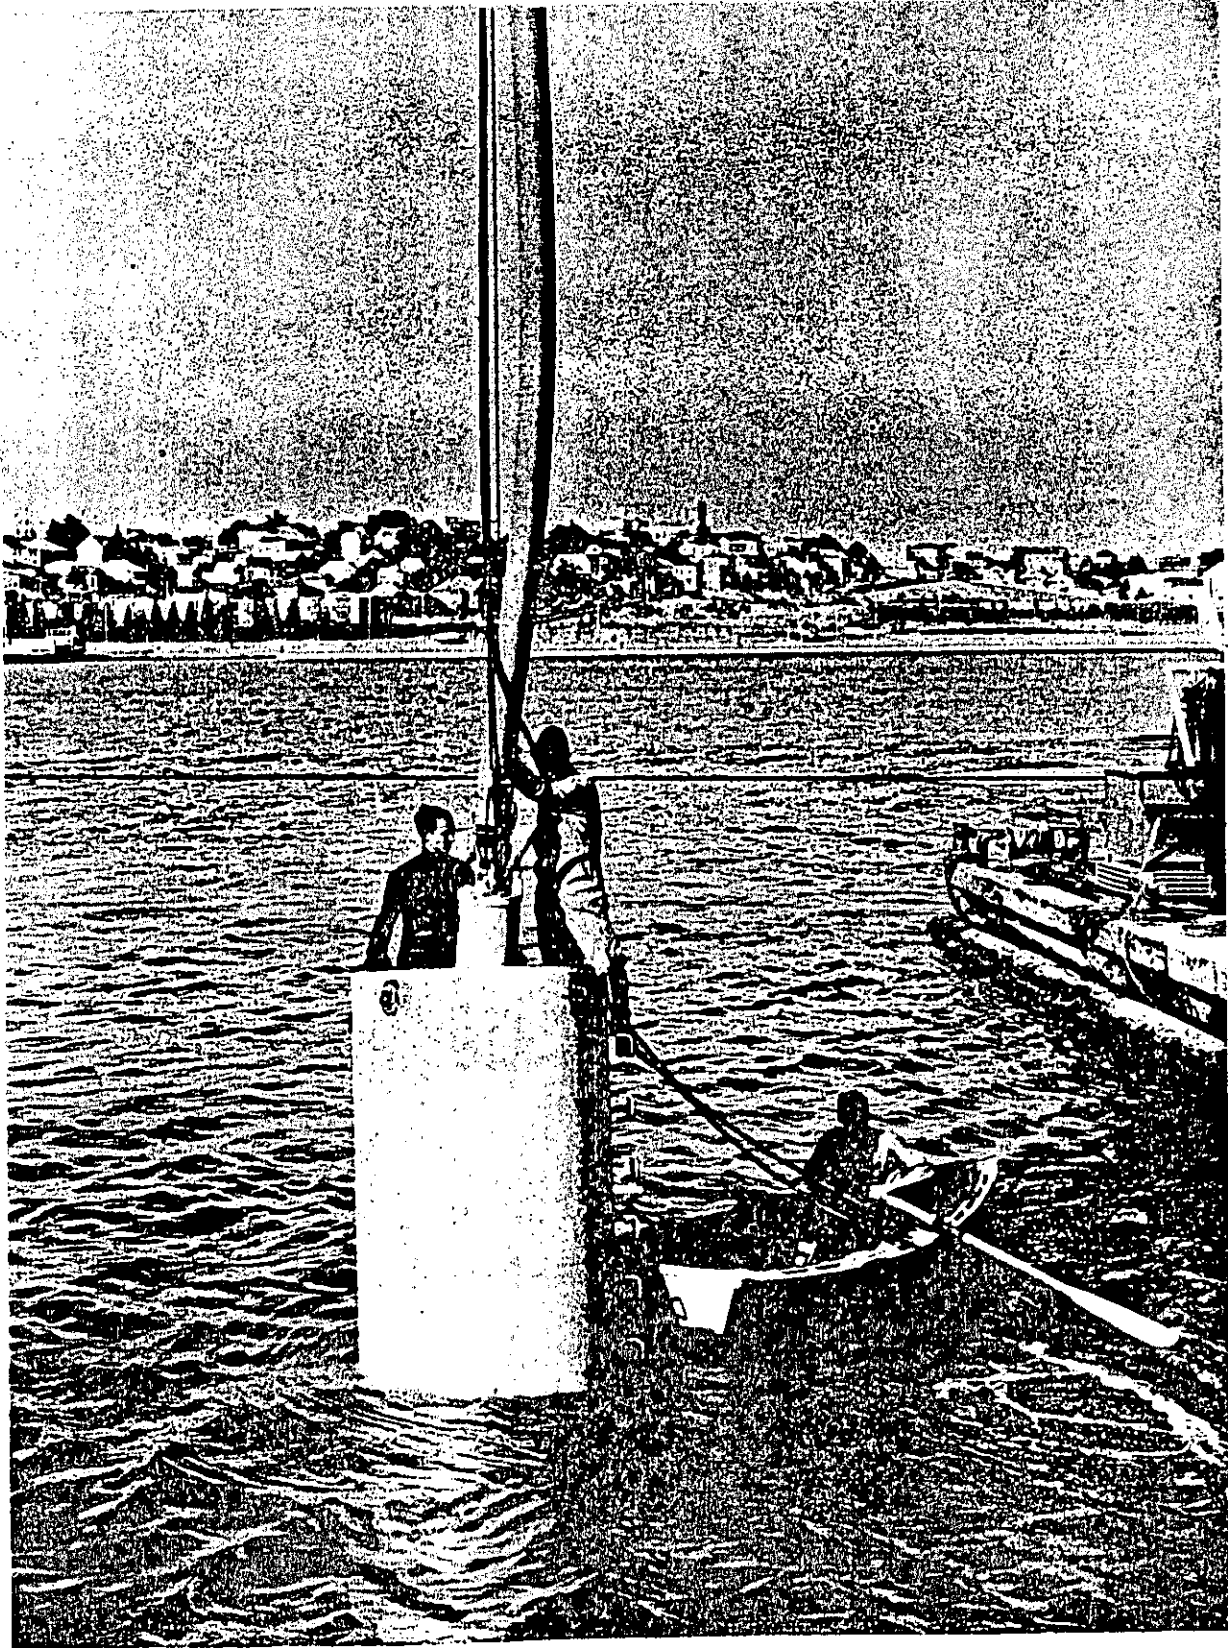
ELECTRIC PUMP BEING LOWERED INTO COFFERDAM
ON THE "GUITARRO".
FIG. 15.7 NO. 3

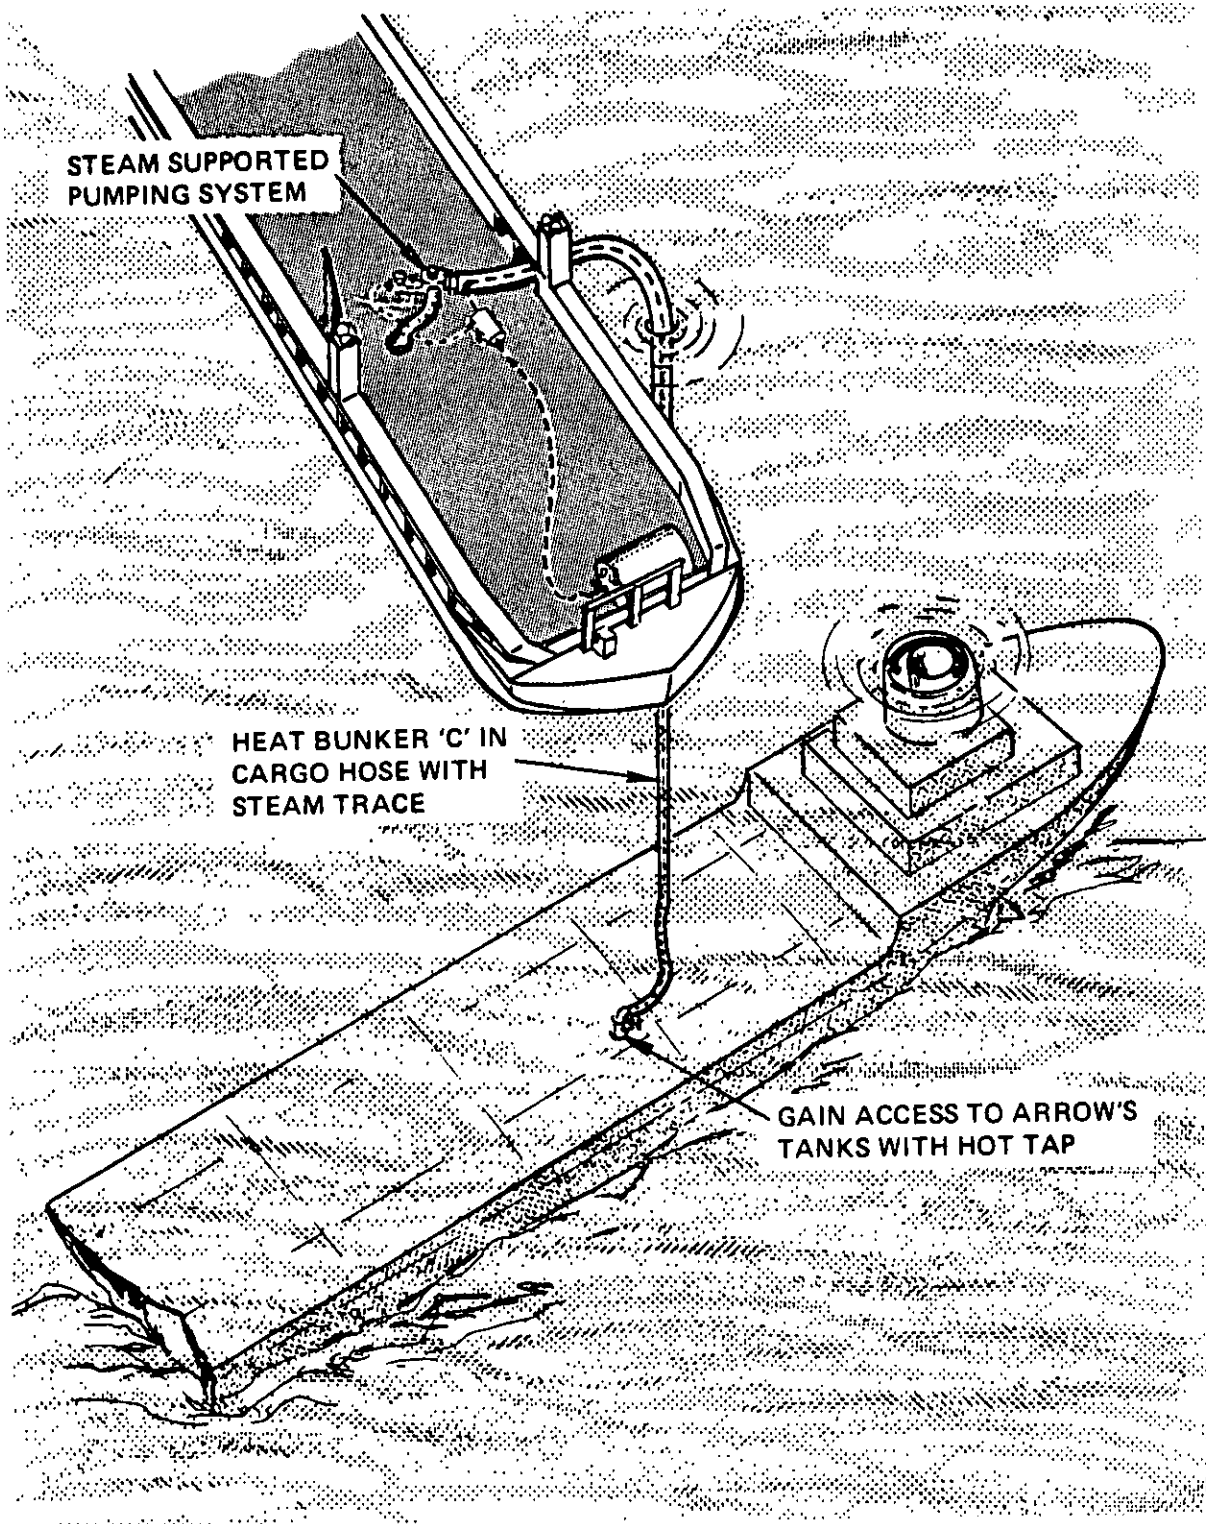
PRIMARY METHOD FOR HEATING AND LIFTING THE BUNKER "C". S.S. ARROW SALVAGE OPERATIONS. 1970. FIG. 15.8 NO. 1

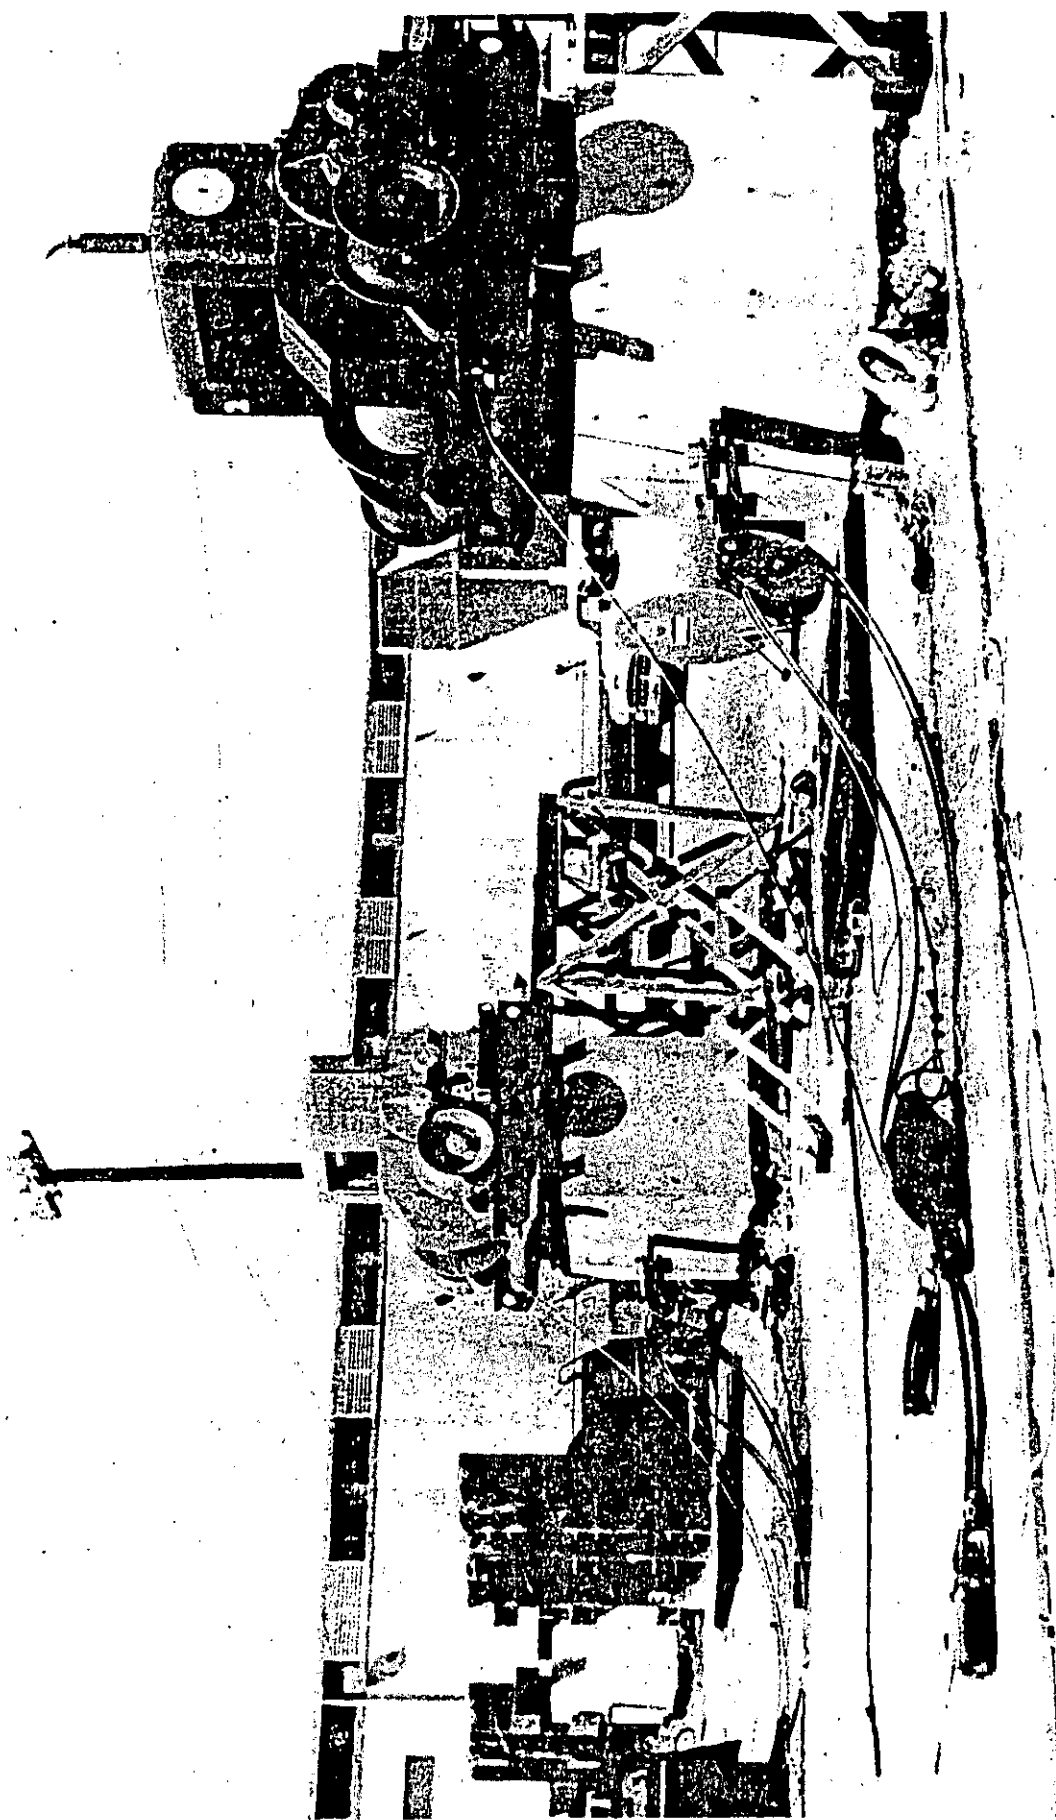
ANCHOR POINTS FOR PARBUCKLING STATIONS.
NOTE PURCHASE GEAR AND WINCHES IN POSITION
FIG. 15.10 NO. 3

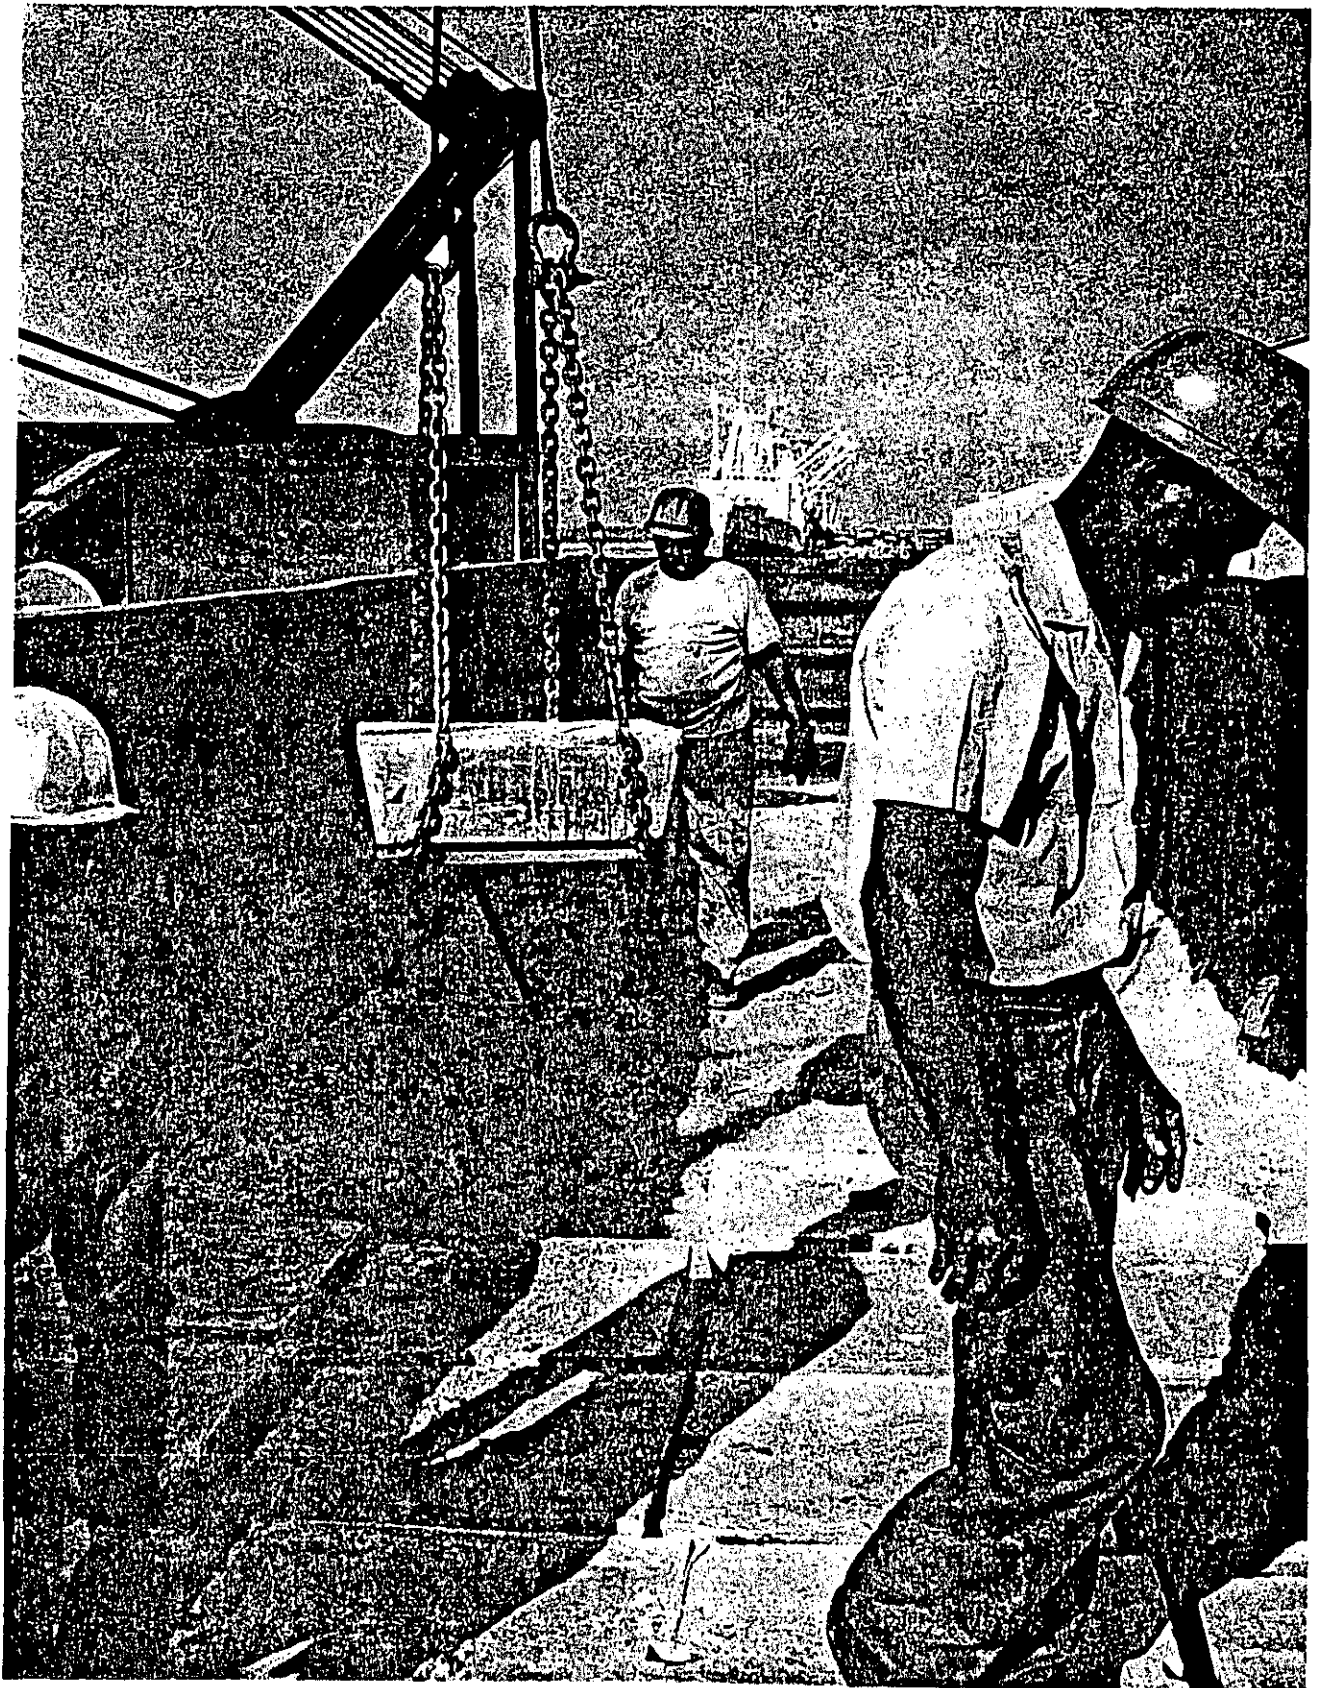
LONGSHOREMEN LOADING ONE TON LEAD BALLAST PIGS FROM RAILROAD CAR.
FIG. 15.10 NO. 4

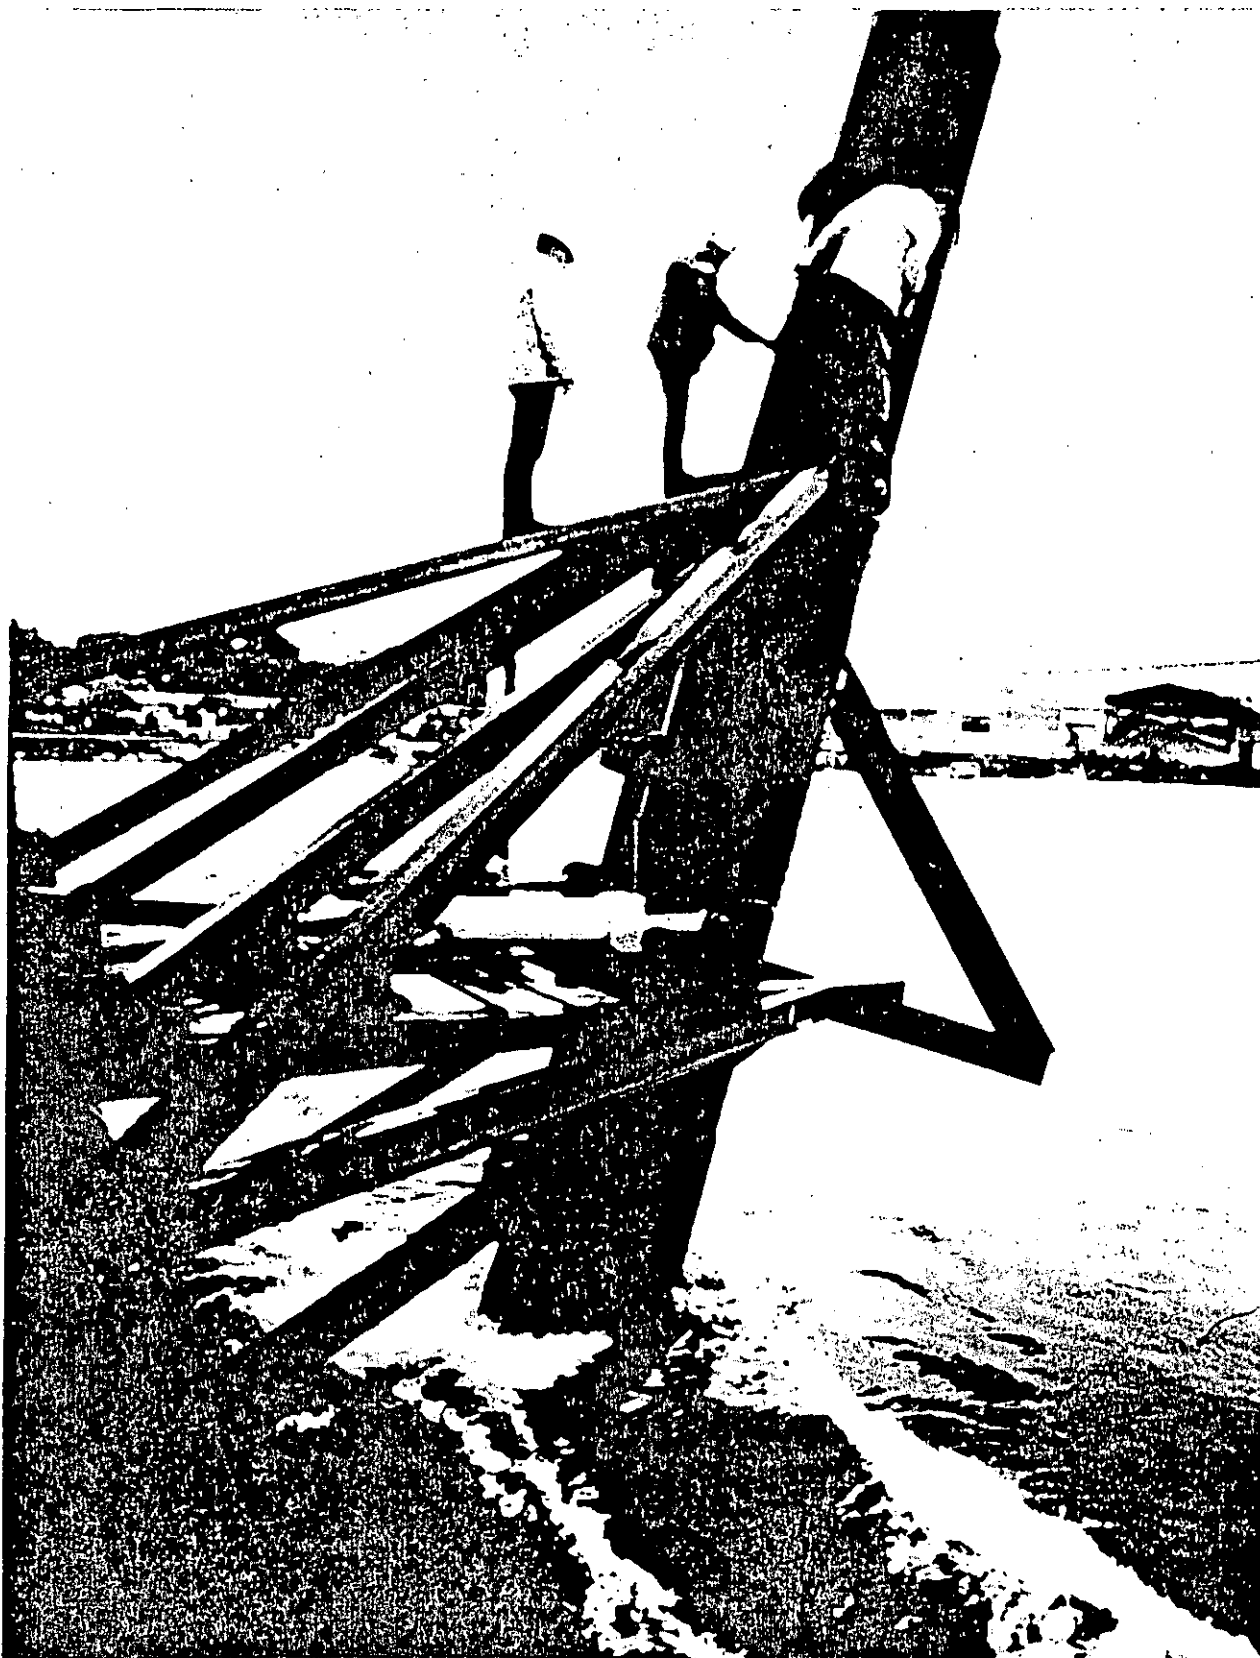
LOCATING MECHANISM POSITIONING DIVERS
ACCESS COFFERDAM.
FIG. 15.11 NO. 2
