NAVSHIPS 0900-004-8000  
(FORMERLY NAVSHIPS 250-694-3)

**REFLOATING**  
OF THE  
**U. S. S. MISSOURI**  
**(BB-63)**

NAVY DEPARTMENT  
BUREAU OF SHIPS  
WASHINGTON, D. C.

1 JUNE 1950.

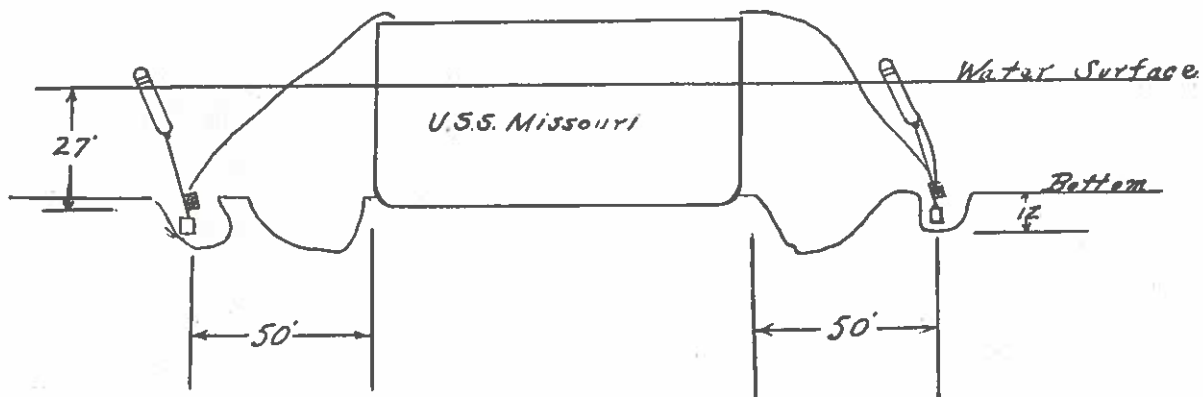
FIGURE 4.—Explosive shots.

One scheme involved the use of small charges (i. e., less than 20 pounds of TNT) on the sand underneath the overhang of the stern; the other involved burying of two moderate charges (50 pounds of HBX-1) in the sand, one on each side, about 50 feet outboard of the after turret. The latter was chosen as most nearly meeting the basic requirements and promising the best results, and is shown in figure 4. Holes for placing the charges in the sand were blown by divers with high pressure tunneling nozzles.

It was observed that each shot caused the stern of the *Missouri* to settle one-fourth inch. This confirmed previous beliefs that such a process would be slow and require more time than could be readily spared. Moreover, it is quite likely that succeeding shots would have resulted in successively smaller amounts of settling.

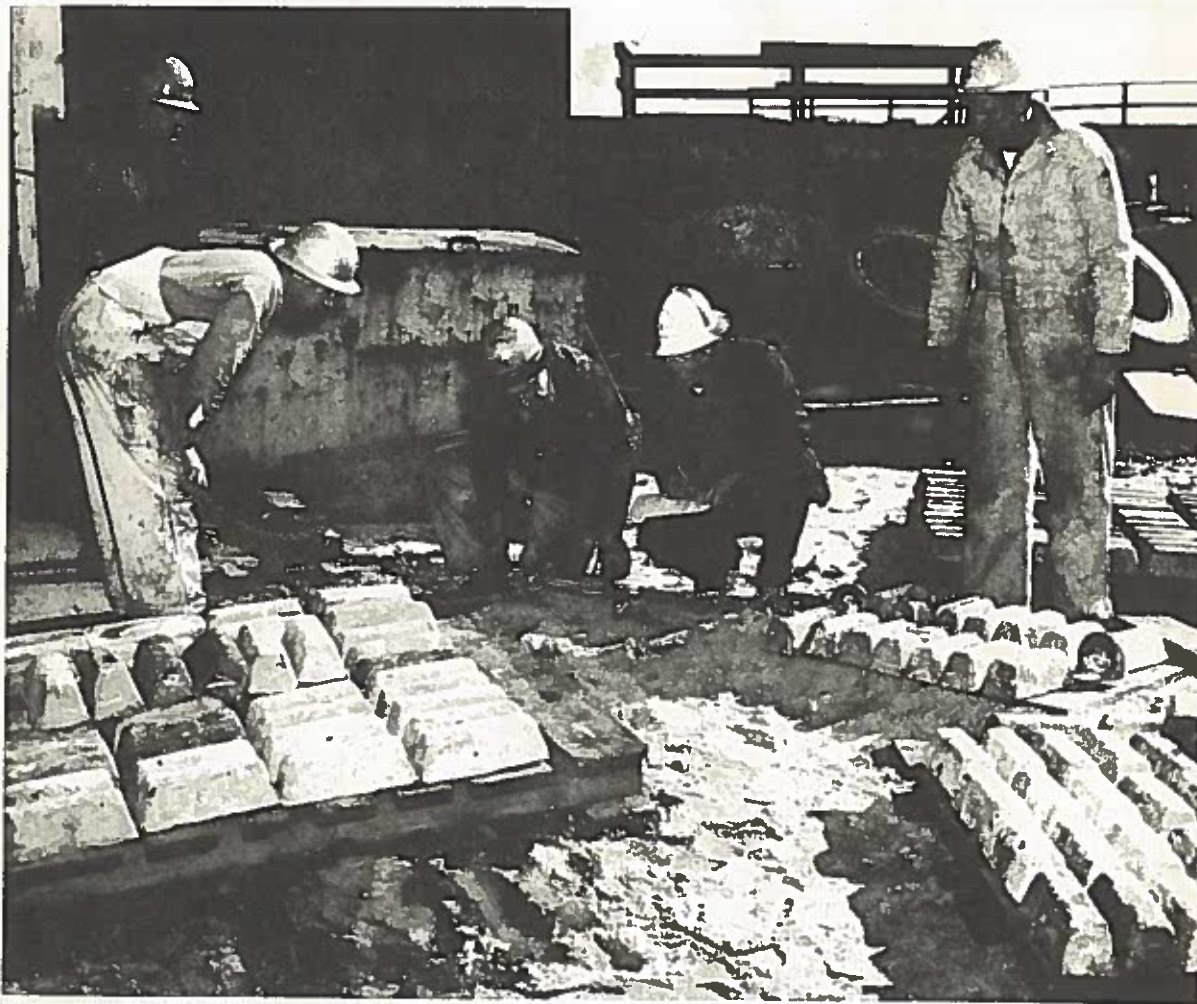
FIGURE 6.—Arrangements for testing to determine coefficient of friction.

The testing procedure varied slightly in the manner in which the loads were applied, but in general the test apparatus and testing method remained the same. A 2- by 3-foot, 40.8-pound, STS plate was chosen as the test vehicle and was pulled in the direction of its longest length over a sand bed about 8 inches deep. Ground loads were simulated by using cast lead pigs weighing approximately 38 pounds apiece, and these were added in small increments in the first procedure, and in total loads in the second. All pull loads were applied with a chain fall. Figure 5 indicates the dynamometer calibration. Pull measurements were made with a bungee rubber shock cord dynamometer for the first light load tests and with a calibrated Dillon 10,000-pound capacity dynamometer for all the higher ground load tests. Figure 6 shows arrangements for testing to determine coefficient of friction.

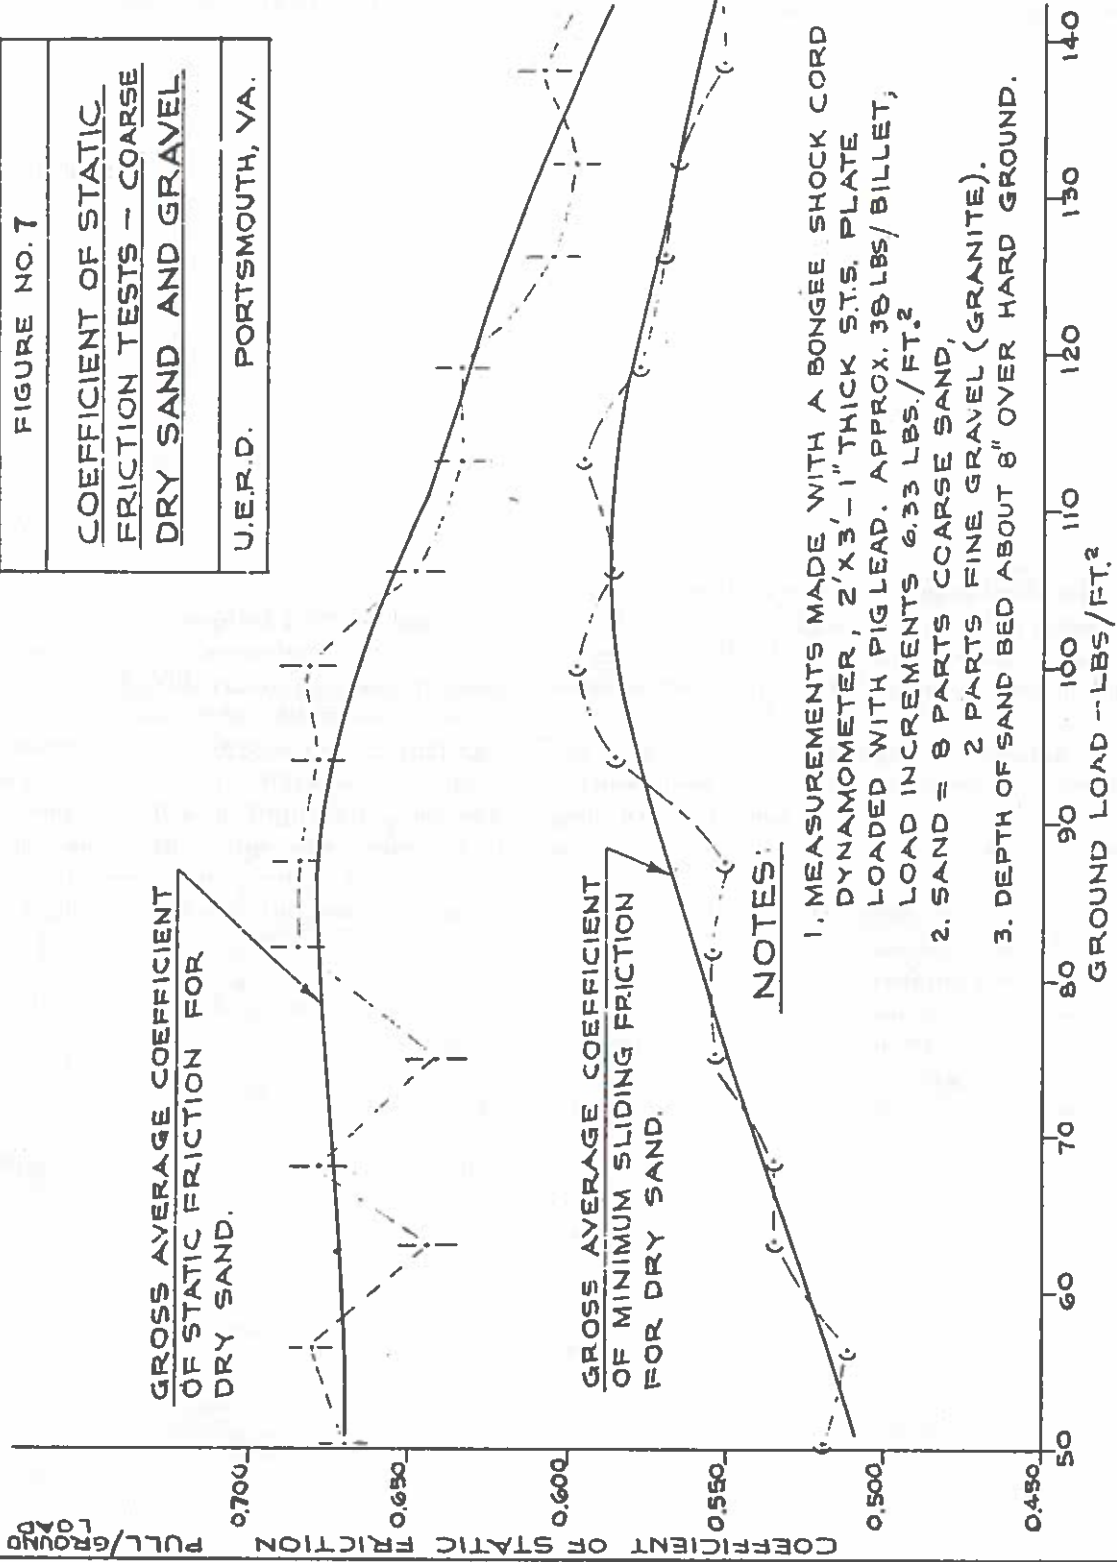
FIGURE NO. 7

Tests were first made at light ground loads (below 150 pounds per square foot) on both dry and wet coarse sand and gravel with results as indicated in figures 7 and 8. The reduction in static coefficient with increasing loads initially appeared inconsistent with expected behavior and accordingly additional tests were conducted for varying ground loads up to 1,400 pounds per square foot on several different mixtures. Wet clay was included only for academic reasons. The results of the tests for the various mixtures are indicated in the following figures:

COEFFICIENT OF STATIC FRICTION TESTS - COARSE DRY SAND AND GRAVEL

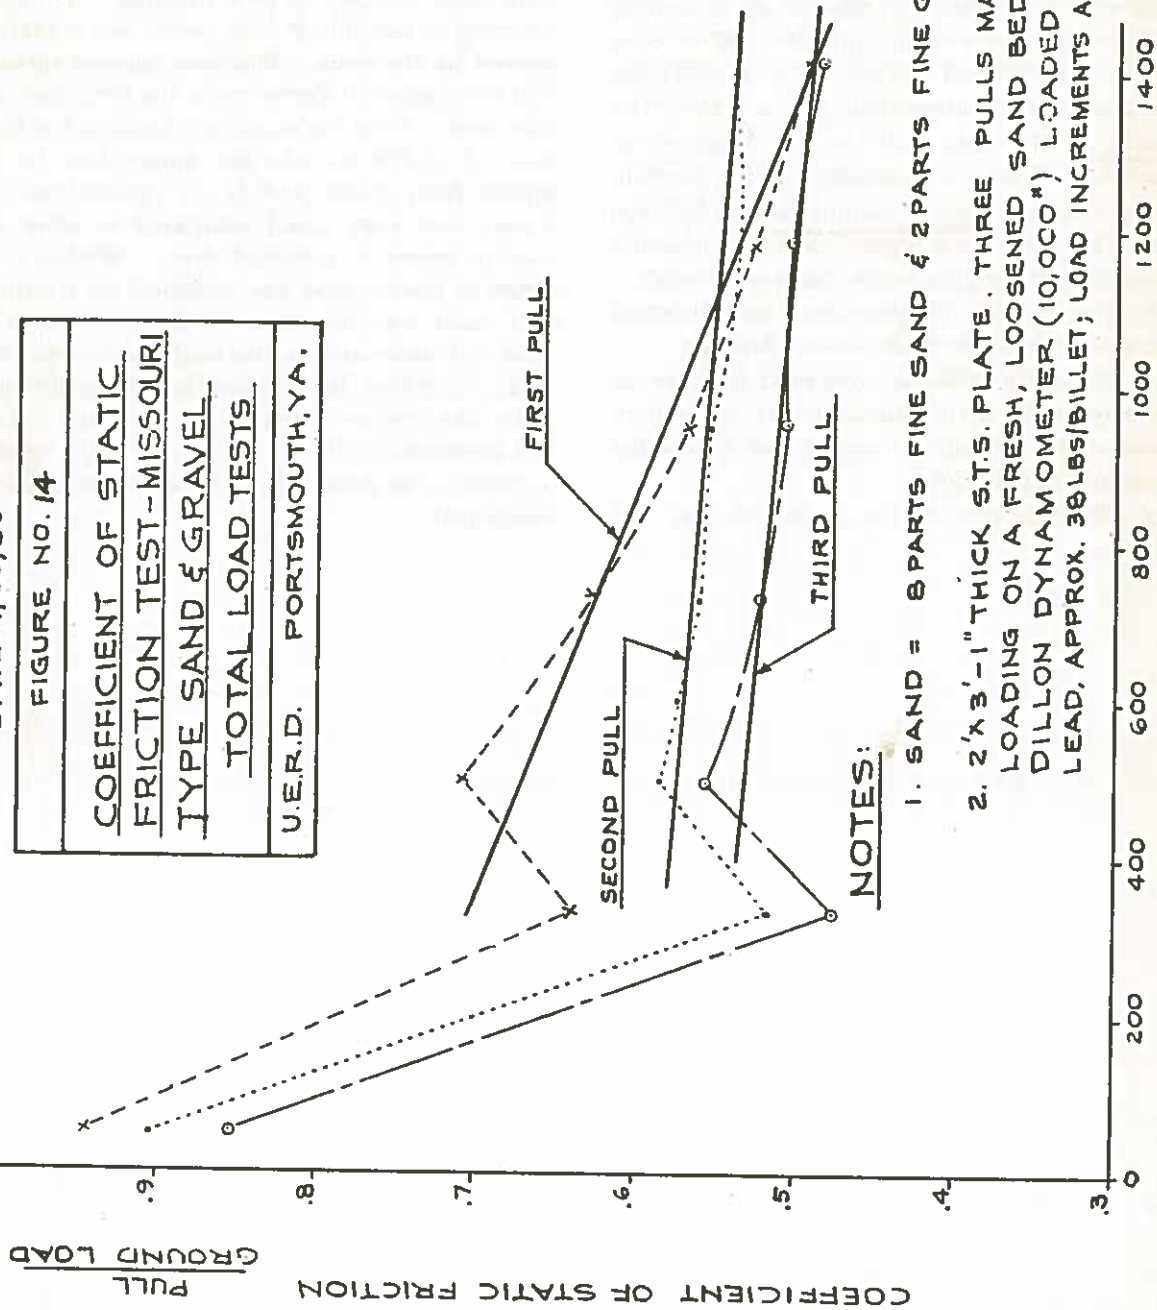
FIGURE NO. 14

It will be noted that, except for clay, the curves show a decrease in static coefficient as the load is increased. This is also true in Figure 14 which represents tests in which an effort was made to reduce the possible influence of the method of loading on the results (i. e., adding load increments to an already loaded plate), by using fresh sand for each particular ground loading measurement series.

COEFFICIENT OF STATIC  
FRICTION TEST - MISSOURI  
TYPE SAND & GRAVEL  
TOTAL LOAD TESTS

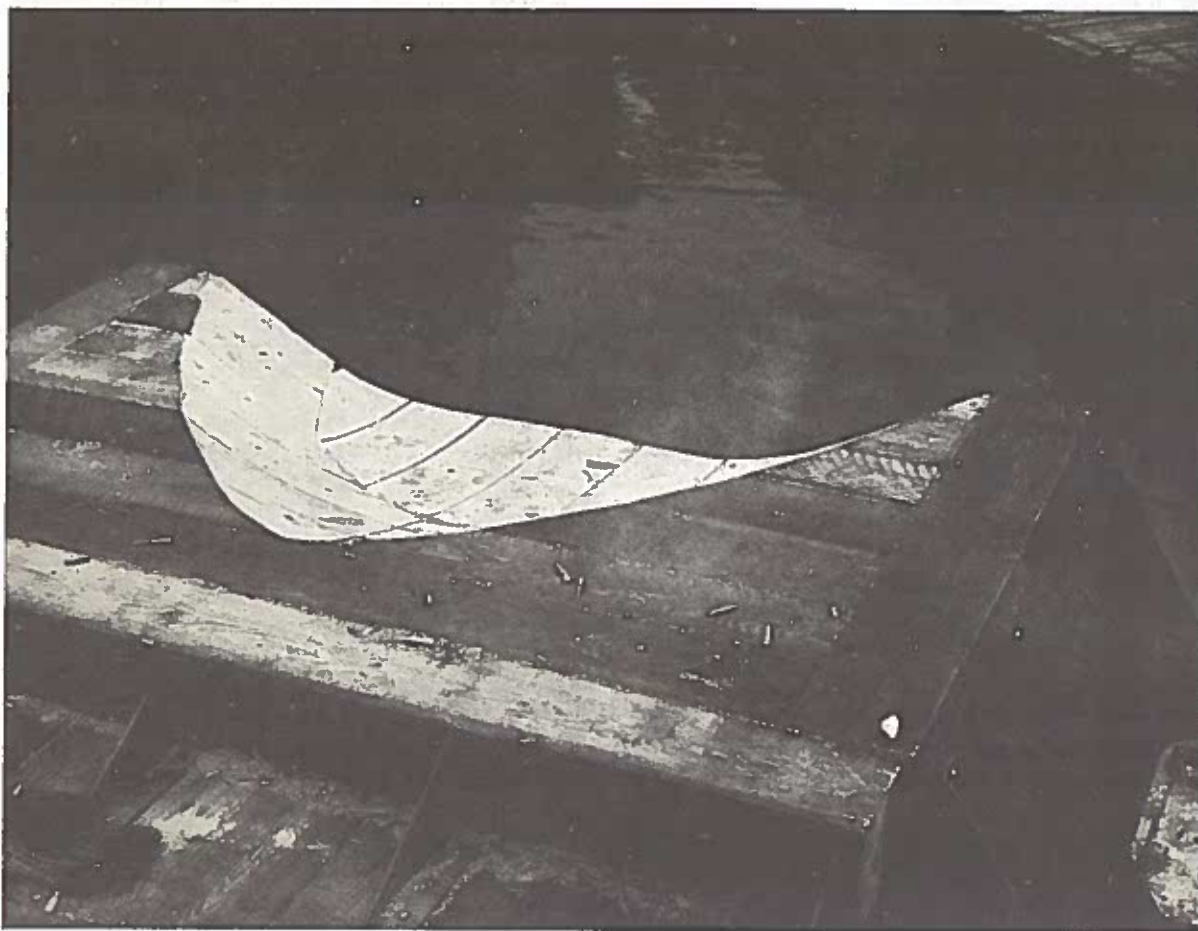
FIGURE 16.—Wood cribbing on barge formed to fit curved hull of U. S. S. *Missouri*.

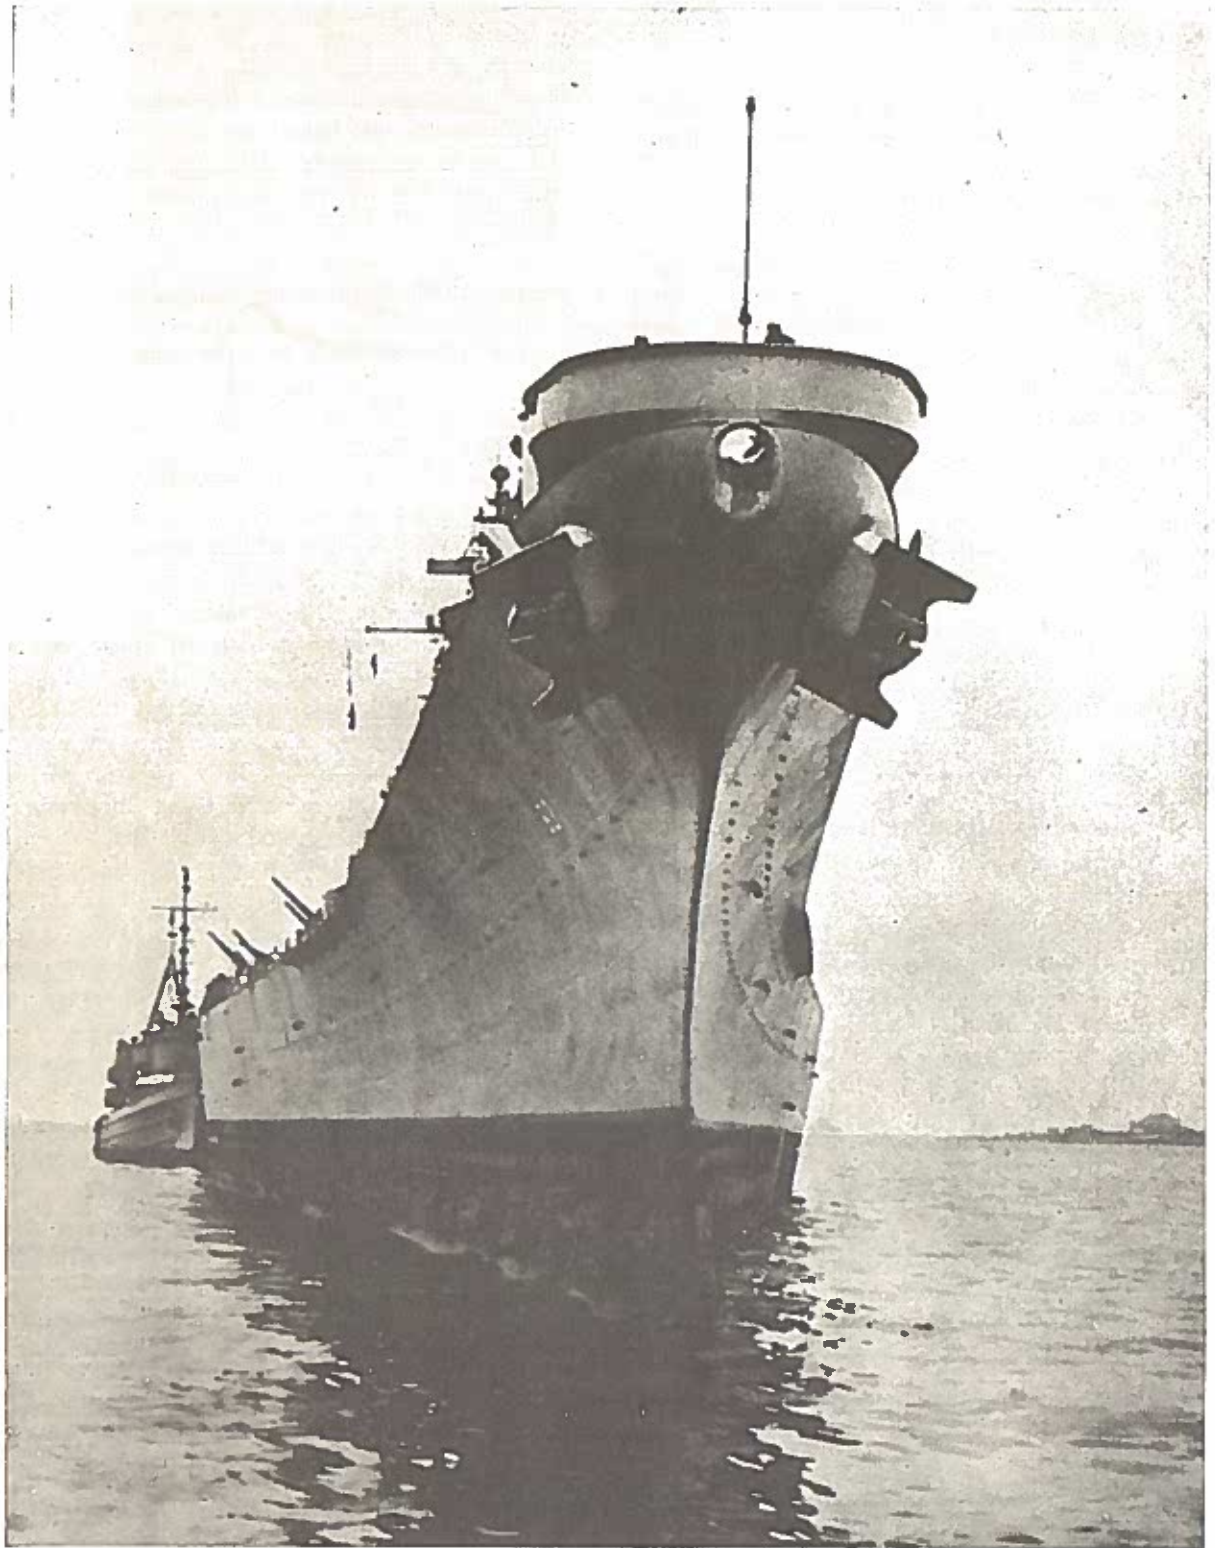
The *Missouri* soon after grounding.

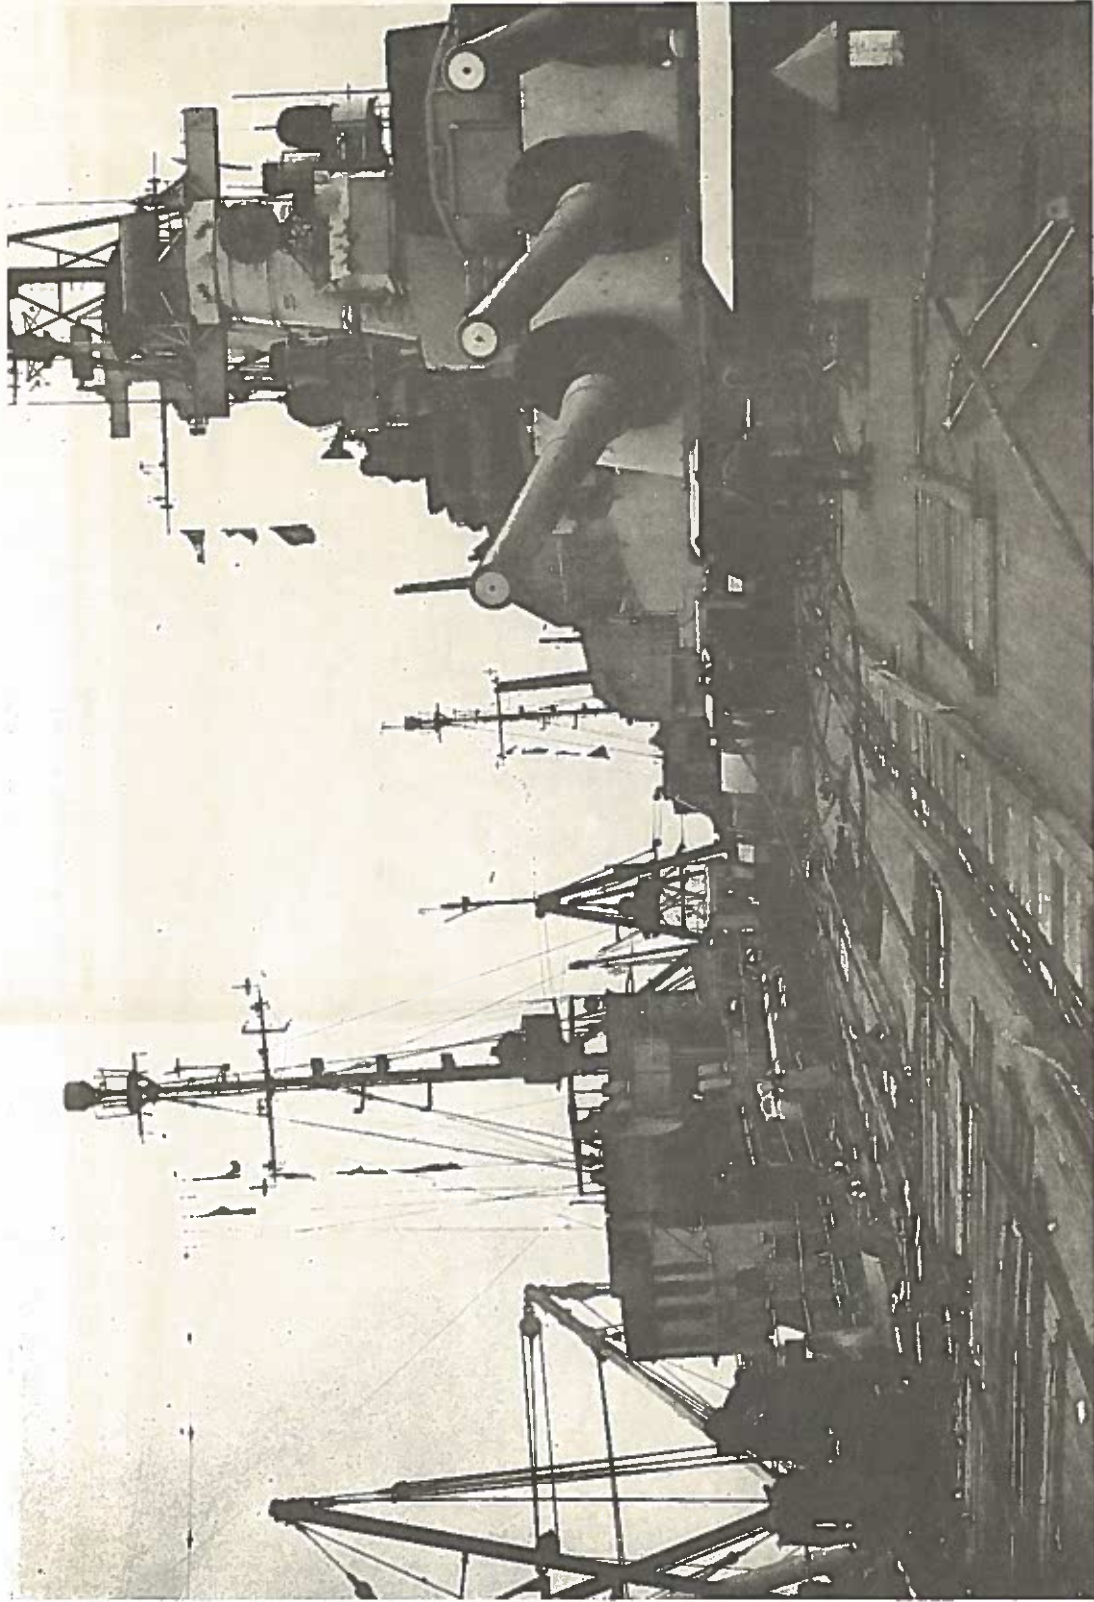
Three sets of bench gear being rigged on port side aft. Note two portable gasoline-driven salvage winches and ship's electric winch. Wood troughs are to protect the wood deck from being damaged by the running block of the bench gear falls. A similar three sets of bench gear were rigged on the starboard side, and one amidships aft, in addition to two sets leading to the bow capstans.
