SALVOPS 73

A review of significant salvage operations
conducted by U.S. Navy salvage forces
and other salvage activities during 1973.

NAVSEA 0994-LP-012-6050

FOREWORD

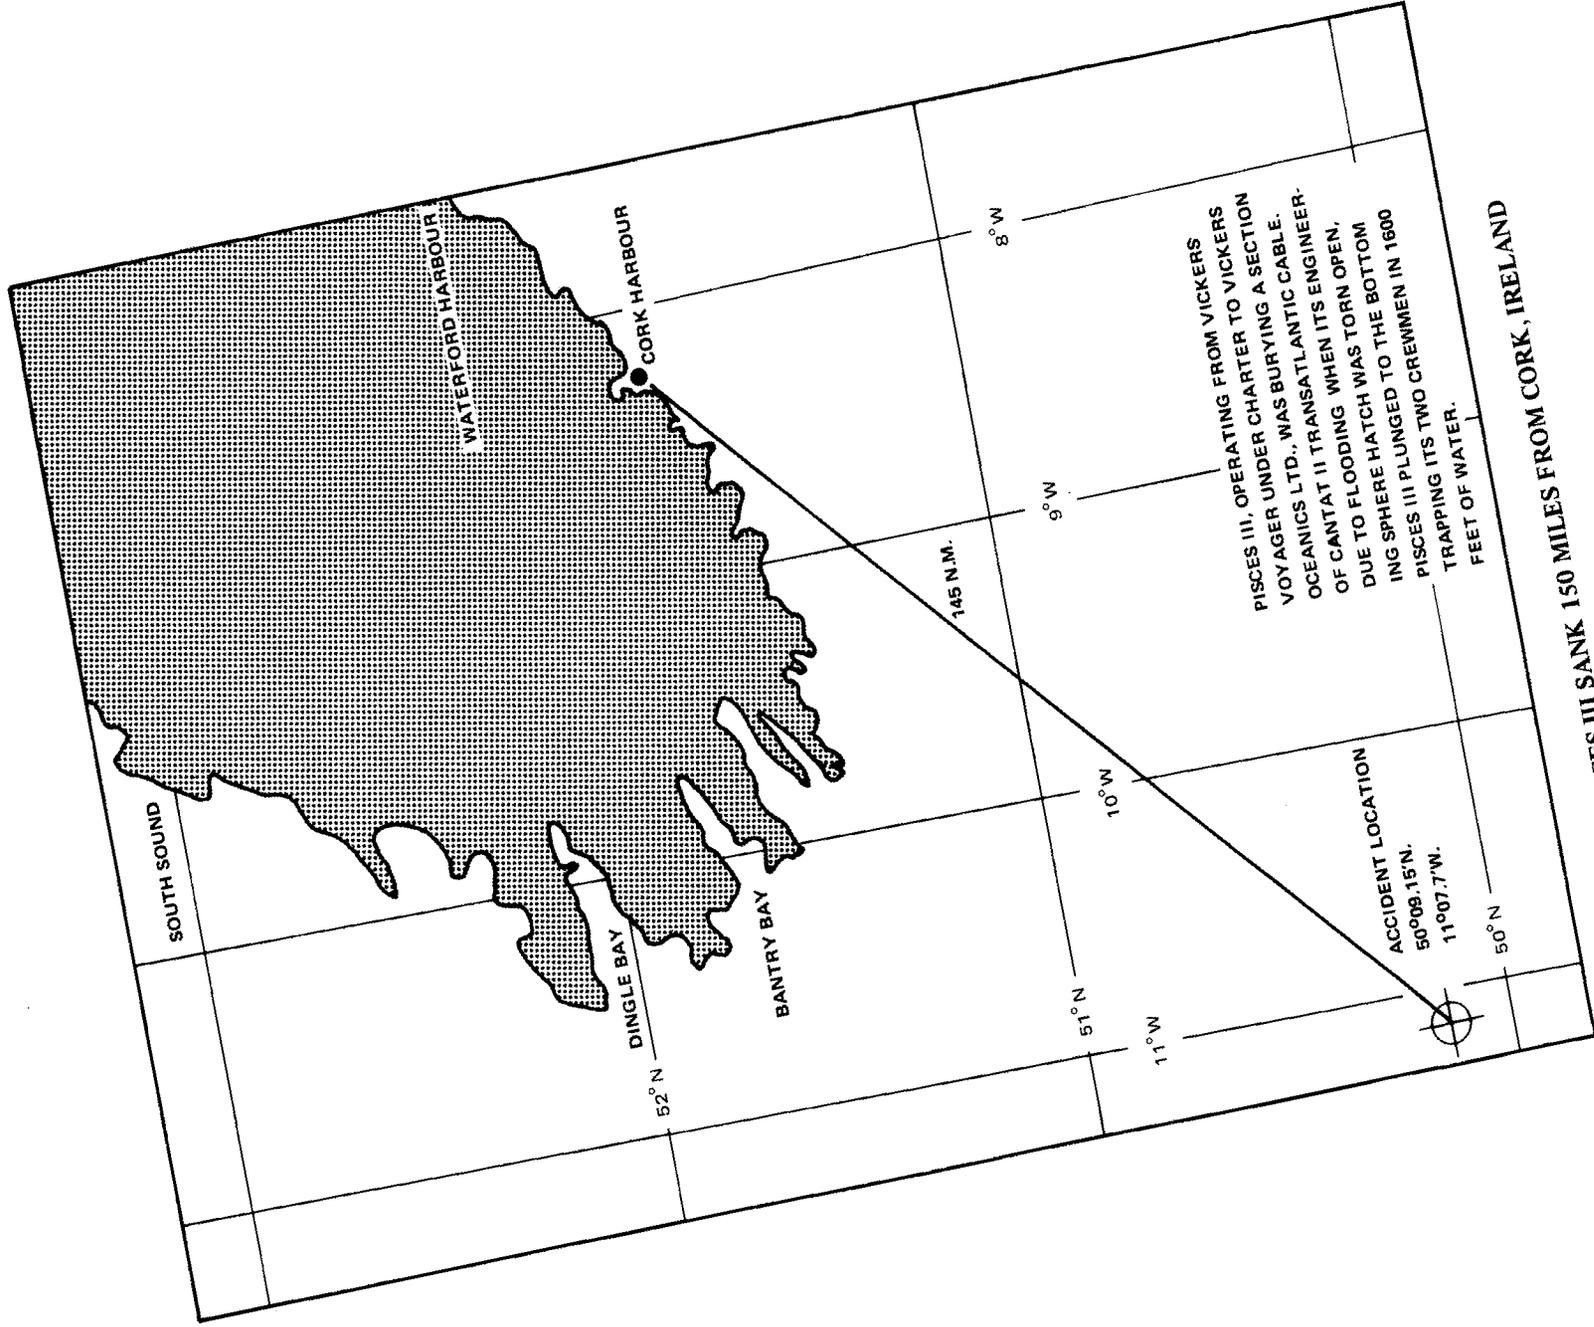
RECOVERY POSITION FOR PISCES III

PISCES III was being hauled in, stern first, to VOYAGER's after-mounted A-frame recovery-lift, when its engineering sphere hatch was torn open.

PISCES III was still some distance from the recovery position, as shown above, when a surge in the sea painter caused a bight to foul the handle of the after hatch and pull it open, causing flooding of the after sphere.

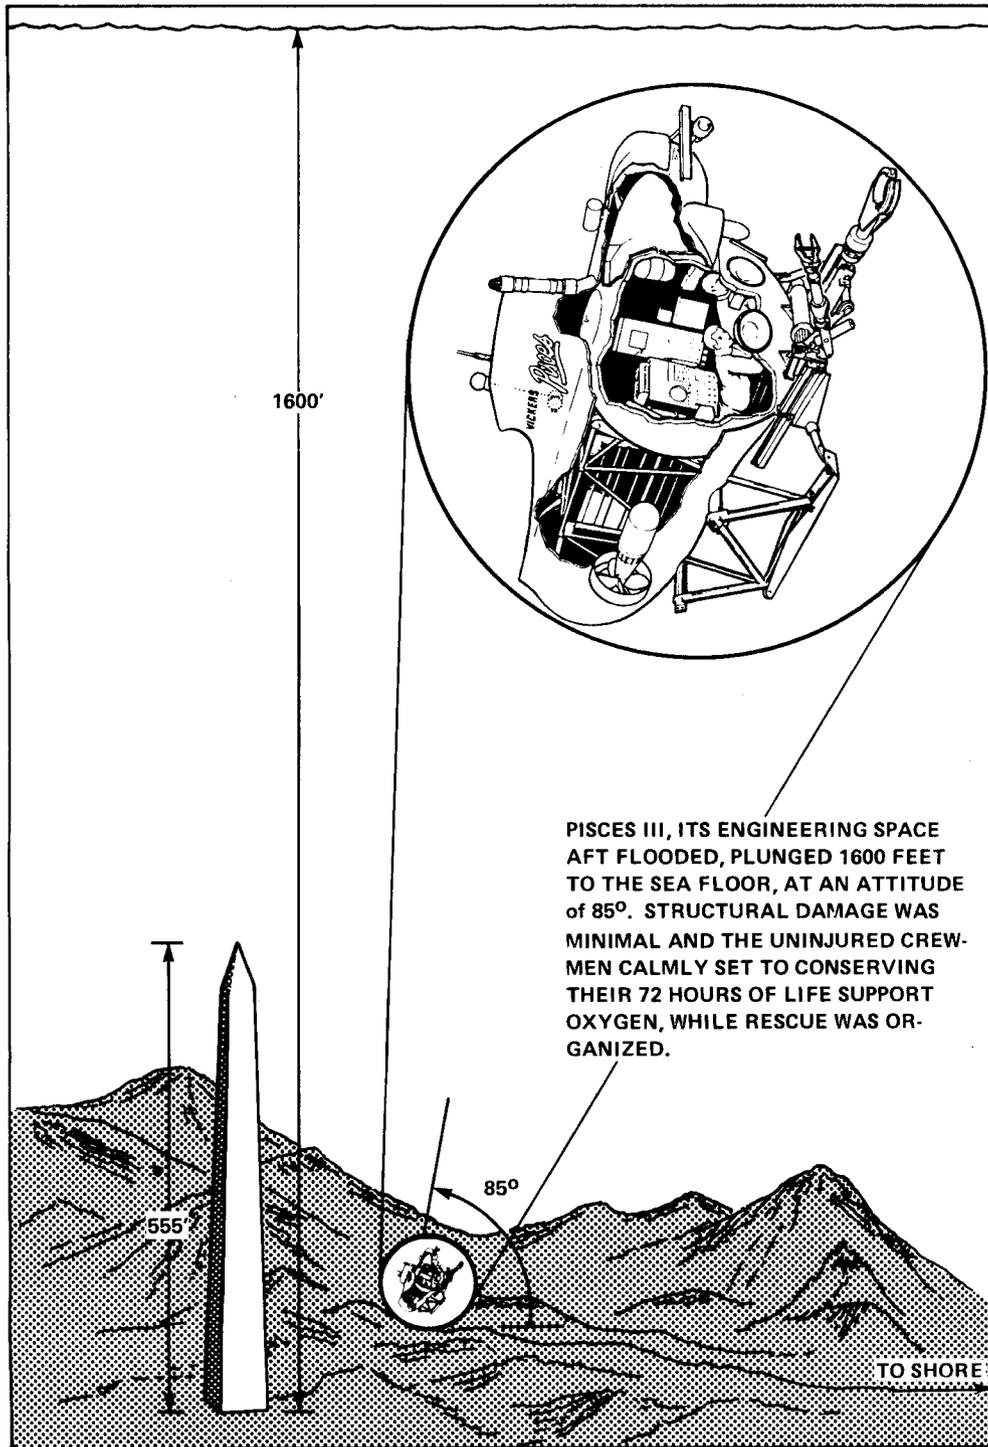
BOTTOMED SITUATION OF PISCES III

Although the craft struck stern first in hard sand at about 17 knots, the impact caused little damage to the 20-foot craft's batteries, life support, or structure. The two-man crew

reported themselves in good physical condition, with adequate water and a little food, but with only 72 hours of life support. Vickers, Barrow, was notified and went into action to conduct rescue. PISCES III was stuck in an 85°, bow-up position, some 150 miles southwest of Cork. VICKERS VOYAGER remained in voice and sonar contact with PISCES III, and two marker buoys were put out. The accident occurred about 1000 Wednesday morning, 29 August. Life support was computed to last until late Saturday morning or early afternoon. PISCES III crew were ordered to remain as inactive as possible to conserve life support.

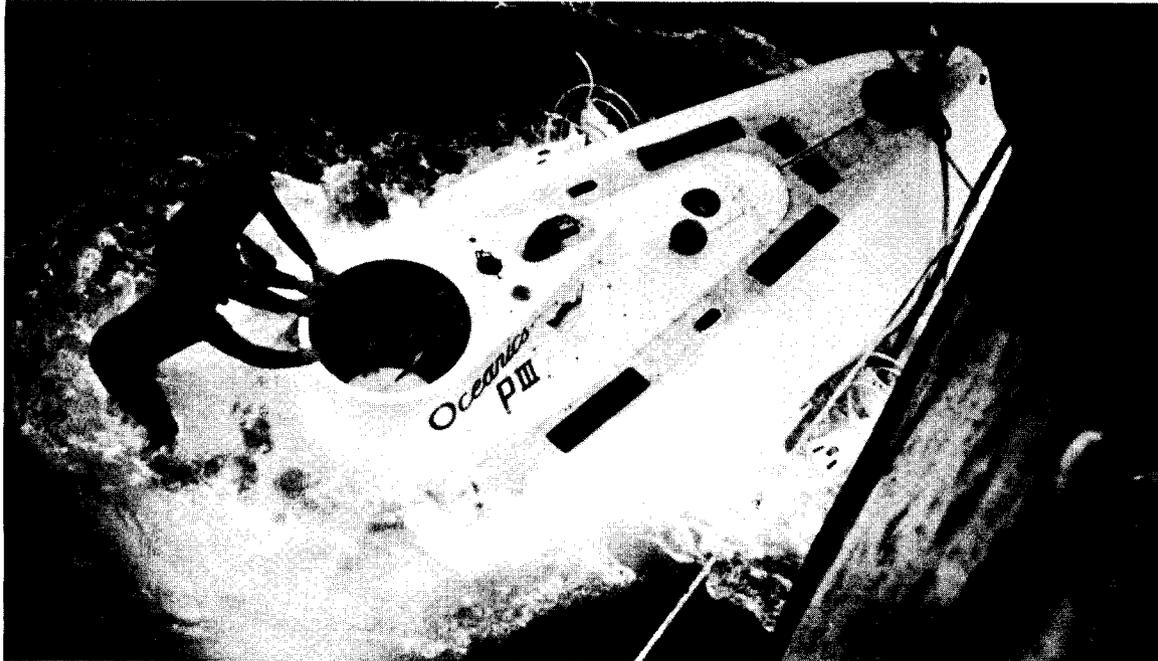
PISCES III breaks surface alongside CABOT. Note toggles and two lines lifting at after hatch. Divers are already aboard to assist crew out of the submersible.

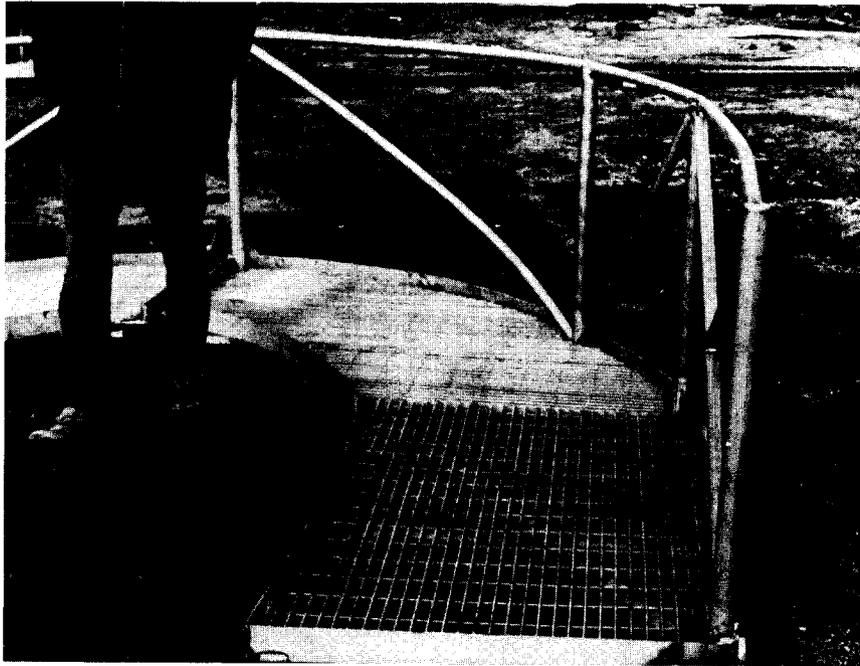
UNDERWATER WORK STAGE

Aluminum work stage fabricated and mounted on the leading edge of ROOSEVELT's rudder to provide a working base for divers repairing the rudder.

Using oxy-arc cutting equipment, the divers then removed the horizontal plate atop the rudder where welds had failed. With the top plate removed, a thorough inspection of the inside and outside of the rudder was performed. Inspection revealed that the upper two feet of the transverse bulkhead, inside the rudder, had fractured and separated. The rudder was large enough to accommodate divers to work inside it to install a new section of bulkhead.

From inside the rudder, divers drilled and tapped holes on the inside of the rudder shell, to receive bolts that would secure the new bulkhead section. After the bulkhead was installed and repair engineers had inspected the installation, using UDATS operated by the divers, preparation was made for installing the 1,050-pound cap plate between the skeg and the rudder. The cap plate was installed using chain falls and wire, run beneath the ship between the rudder and the propellers. There was no way of attaching buoyancy to the cap plate to lighten it for handling by the divers, because of close quarters in the installation – the clearance between the top of the rudder and the rudder skeg above it was only 2 inches. The first attempt at installation revealed that the cap plate would have to be brought back to the surface for some changes. When installed the second time, a near perfect fit was achieved, with no more than .125 of an inch clearance at any one point.

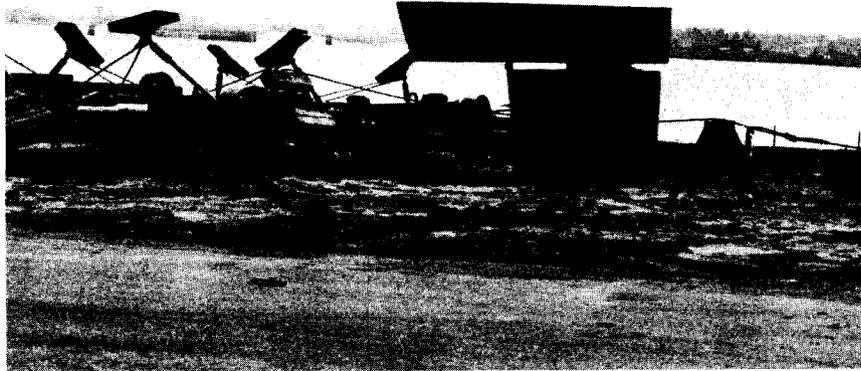
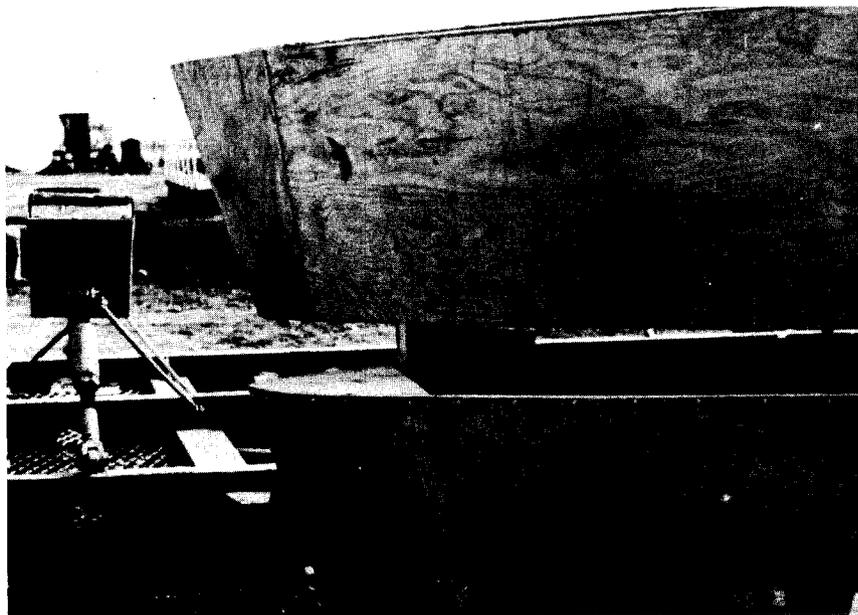
WOODEN MOCKUP OF ROOSEVELT'S RUDDER

An accurate plywood mockup of ROOSEVELT's rudder was made to familiarize divers with their underwater job and to facilitate understanding between them and repair technicians.

When ultrasonic testing revealed that there were no cracks in the main casting, the decision was made to proceed with the repair work with the ship in the water.

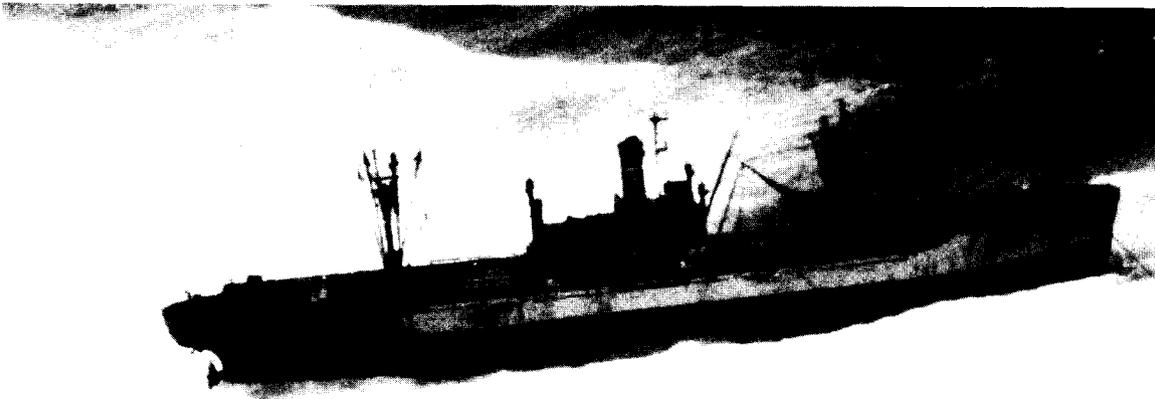
TYPHOON BATTERS PENDLETON

Before adequate salvage resources could be brought to bear, typhoons NORA, OPAL, PATSY and RUTH, in quick succession, broached PENDLETON 70 yards onto the reef.

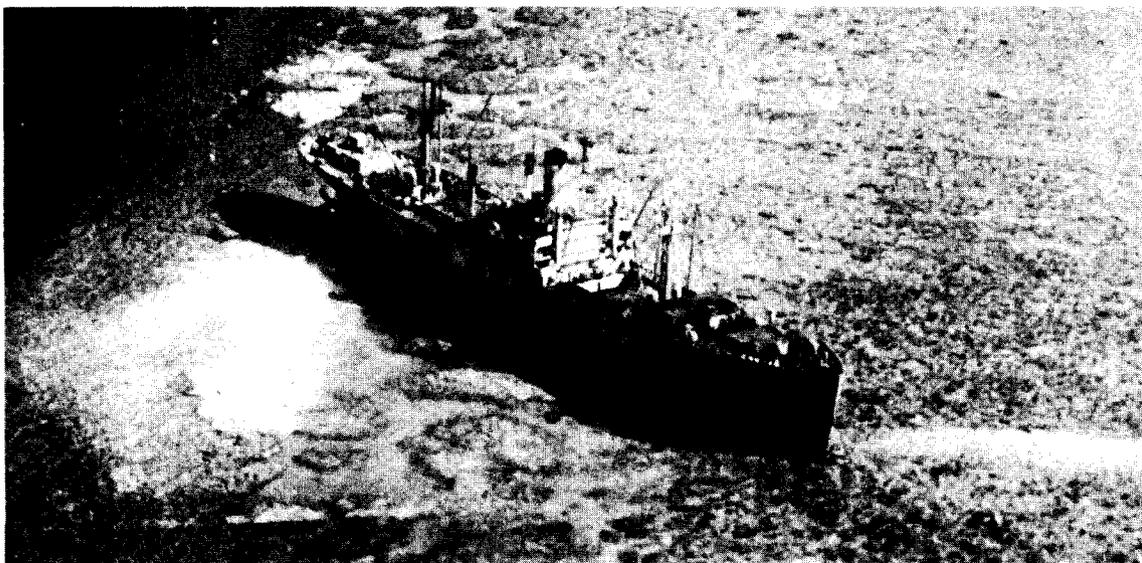
PENDLETON DECLARED A LOSS

After the typhoons, salvage was limited to unloading cargo, stripping ship of all valuable gear, and transferring fuel oil to prevent marine pollution.

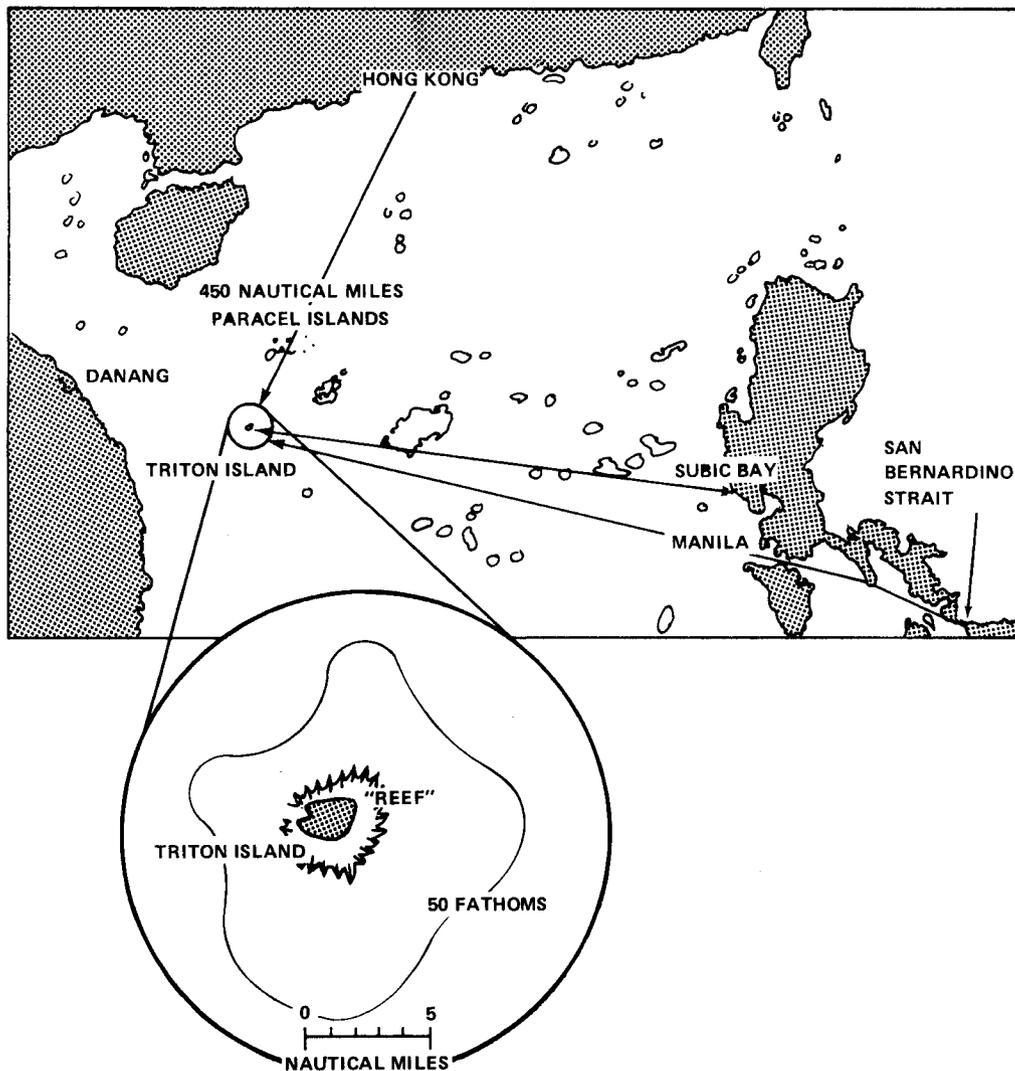
PENDLETON GROUNDED ON TRITON ISLAND IN THE SOUTH CHINA SEA

suspended due to the imminence of typhoons. During the following two-week period from 5 to 20 October, four typhoons passed through the area, during which *PENDLETON* was broached-to and driven 70 yards further onto the reef. Inspection of the vessel then revealed her to be wrecked beyond economical salvage, and the decision had to be made to remove all cargo and valuables and abandon the wreck. All efforts, including removal of oil, were completed by 6 November.

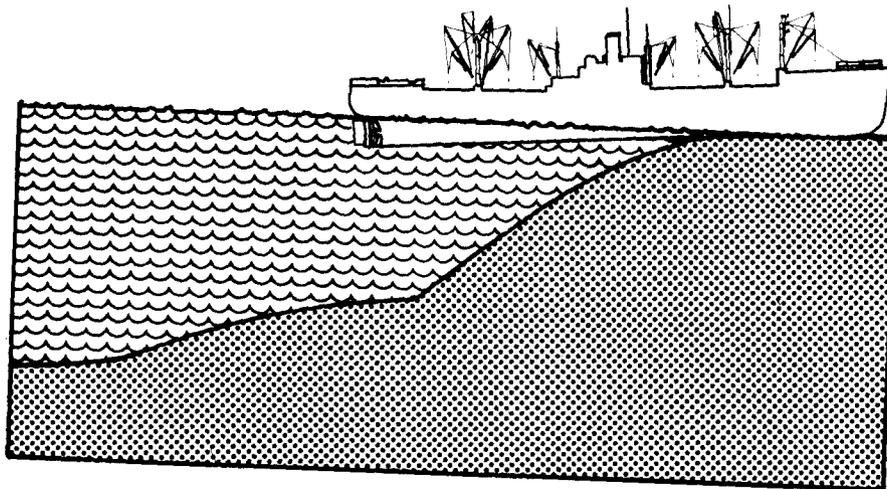
DIAGRAM OF PENDLETON'S GROUNDED SITUATION

PENDLETON was aground, in contact between Frames 40 and 50, approximately 110 feet abaft the bow. With fuel transfer aft and deballasting, she trimmed with a 32-foot draft astern and the bow 4 feet out of water.

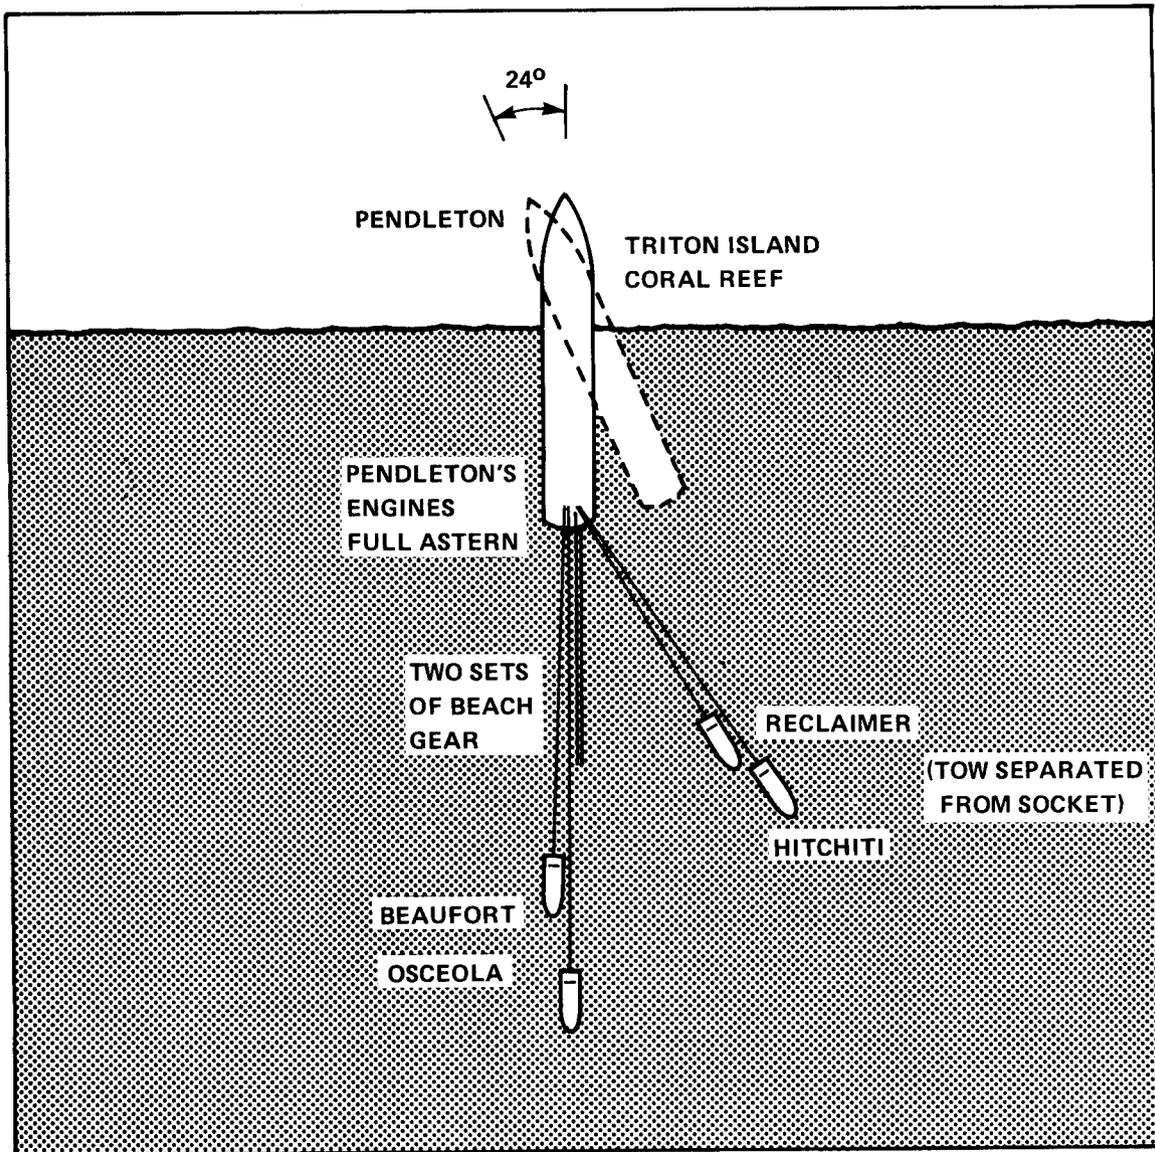
PULL SCHEME FOR FINAL ATTEMPT TO RETRACT PENDLETON

Pendleton was swinging easily through 24° about a point 95 feet abaft the bow. It was concluded that the structurally solid bulkhead at this point was restricted by a high spot in the reef, retarding any retraction.

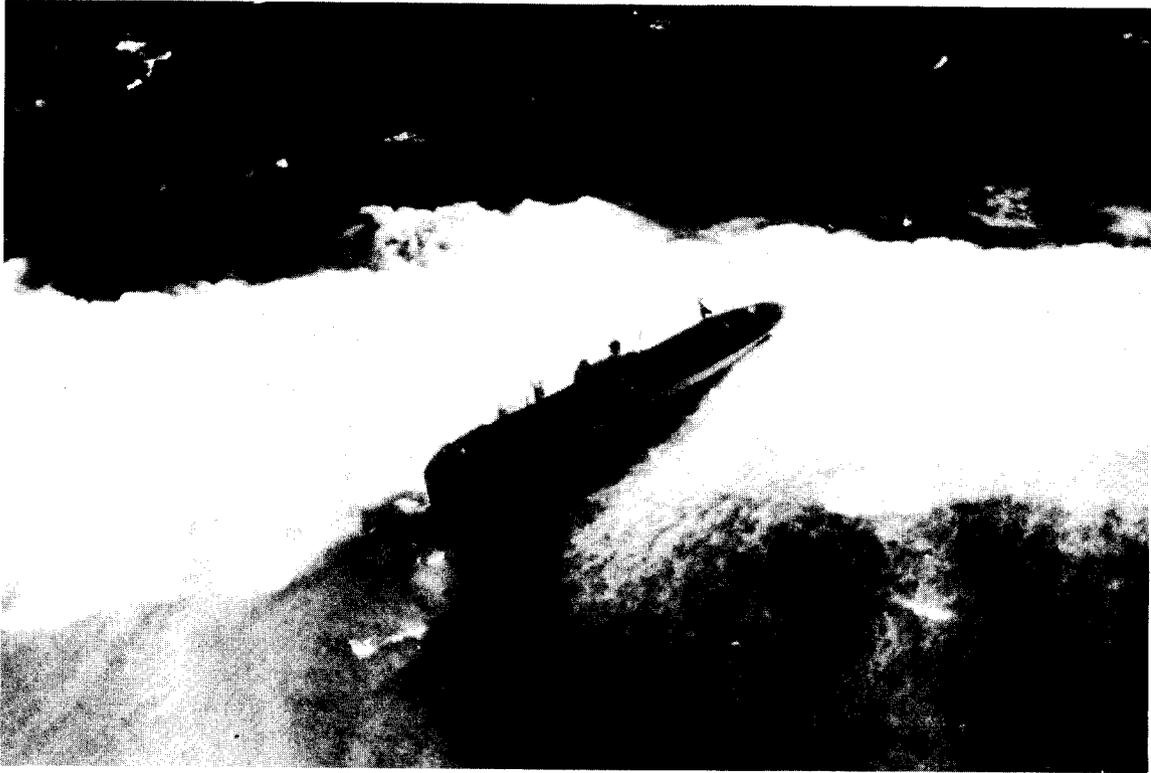
PENDLETON BROACHING ONTO REEF DURING TYPHOON RUTH

key salvage personnel found her broached-to, port side inboard of the reef, still intact but severely damaged. On the 10th, a small survey party boarded the ship to make a salvage assessment. The PENDLETON was hard aground on the fringe of the reef, with surf continuously pounding into the starboard side. One set of beach gear from her fantail had parted, the other was under heavy strain, and the port bow anchor had parted.

The ship itself had suffered extensive destruction. The port side was severely damaged along the turn of the bilge, with numerous double bottom tanks open to the sea. Cargo holds 2 and 3 were filled with oil and water, in free communication with the sea. The ship was buckled amidships, her superstructure evidenced gross distortion, and a lifeboat had been carried away.

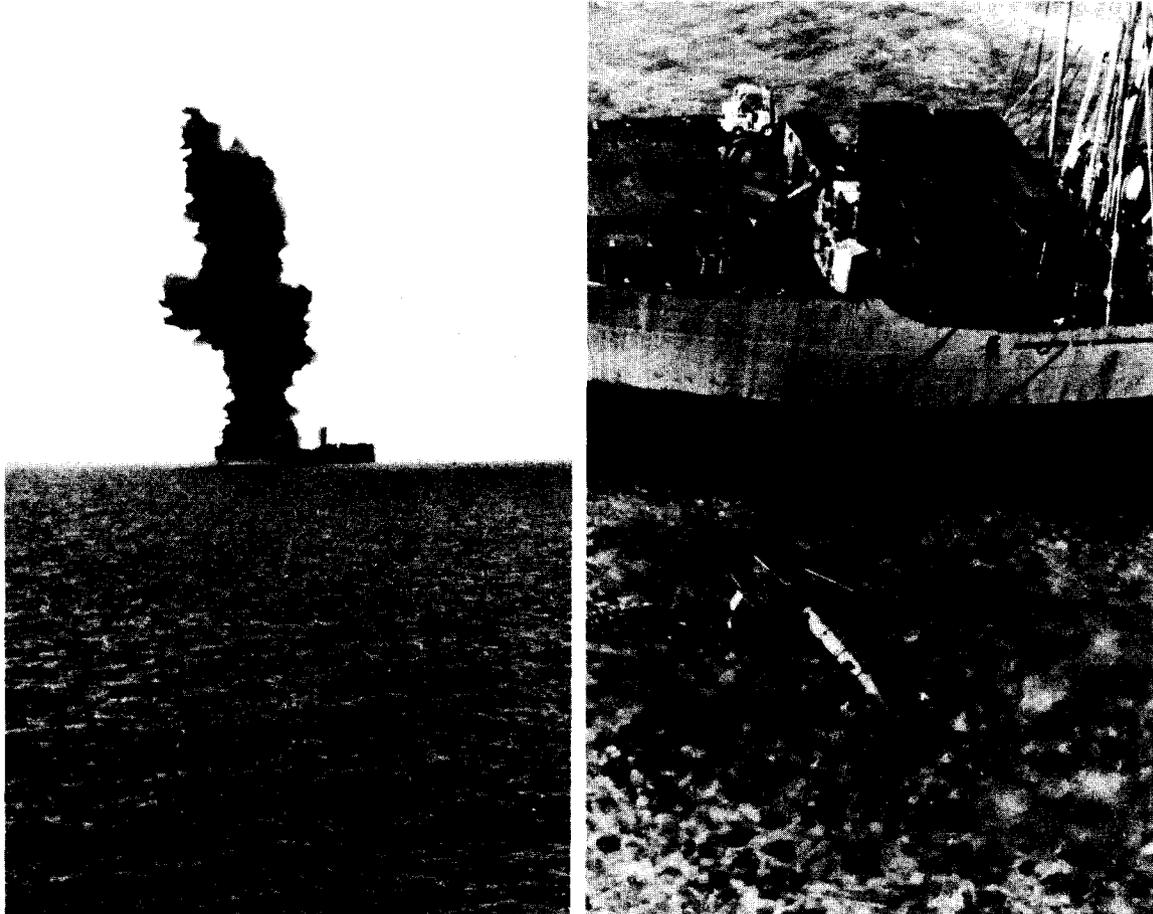
**FOR HELICOPTER OFFLOADING, PENDLETON'S FOREMAST
HAD TO BE REMOVED**

During this period, two helo offloading stations were established. This required the removal of several projecting structures for helo safety. The after station provided no problems and was easily cleared; however, the forward station required explosive removal of the forward mast. This mast was 6 feet in diameter and made from 1-inch-thick steel. To remove the mast, shipfitters first skip-cut around it on a diagonal, oriented downward to

port, in the direction desired for the mast to fall. Ten haversacks of C-4 explosives were then used. Four haversacks were placed to port, at deck level, below the skip-cut. Four haversacks were also placed to starboard, just below the crossree to starboard, to be used as “kickers” to push the mast to port. The ship was then evacuated, and using a fifteen minute delay fuse, the detonation took place as planned. Removal was entirely successful. The mast was pushed 40 feet to port, clearing the side, causing no fires and only minimal damage.

Shipfitters made a preliminary skip-cut on the mast, oriented diagonally downward to port. Four haversacks of C-4 explosives were placed on the mast's port side below the cut. Four haversacks were placed to starboard above the cut, and two more were placed to starboard above the crossree, to act as "kickers." Detonation pushed the mast neatly to port, clearing the side, with minimal damage.

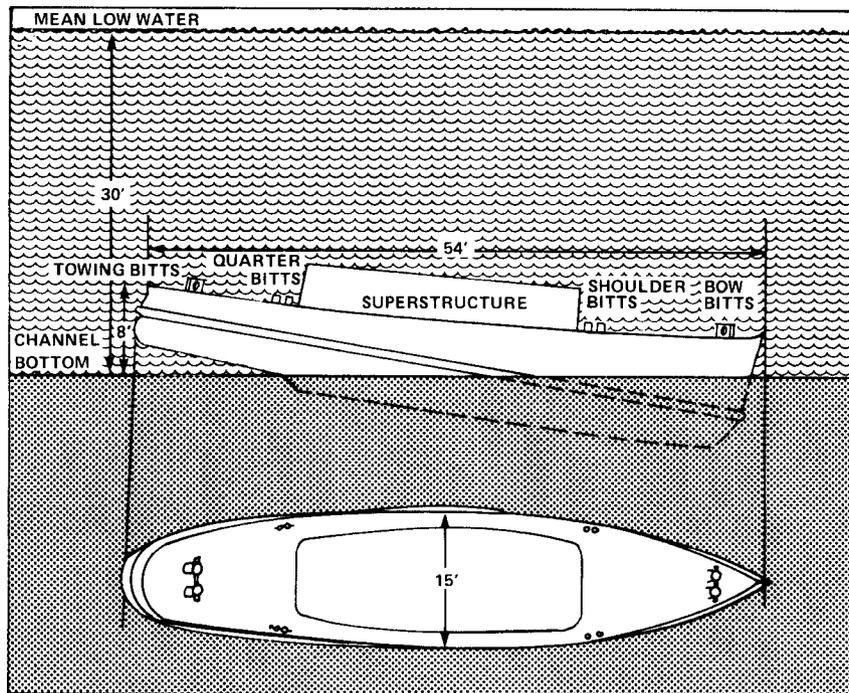
SITUATION OF WRECKED TUG IN CHANNEL BOTTOM

in the bottom mud. The steel hull appeared structurally sound, but covered with marine growth. Although internal survey was not performed, it did not appear at that time that the mud, in which the bow section was embedded, had penetrated the tug's steel hull. Upon completion of the survey, the wreck was marked with buoys, bow and stern, to facilitate OPPORTUNE locating the wreck and mooring for salvage operations.

The steel hull of the H.W. LONG was sunk in the clay-mud bottom, down by the bow, which was half submerged in mud and gravel.

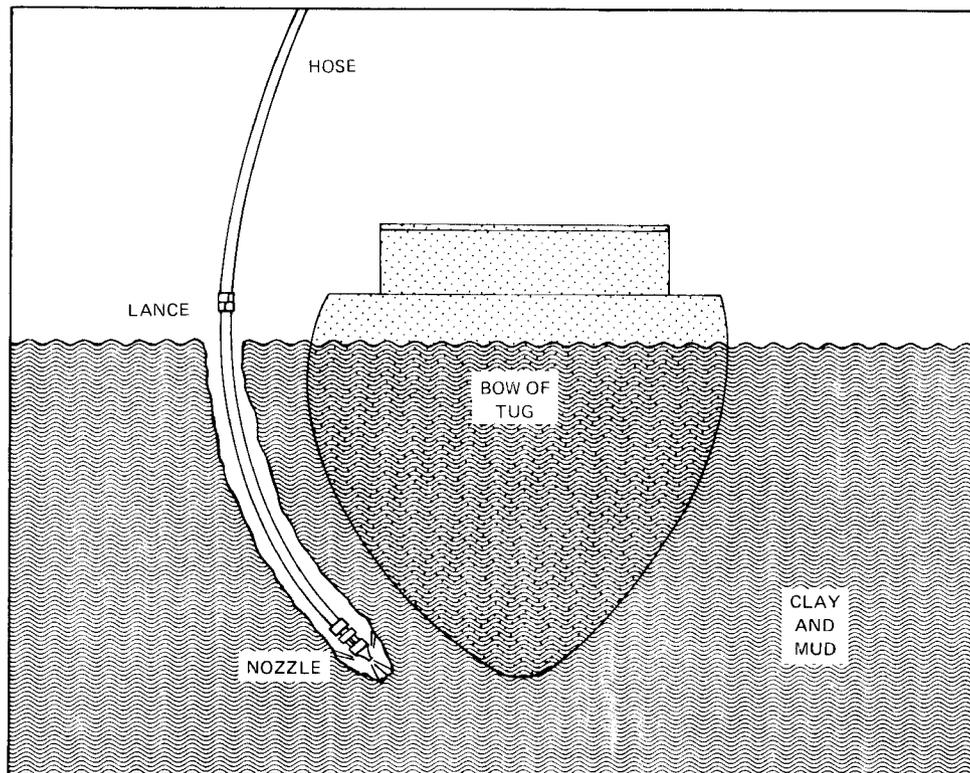
**USING WATER LANCE TO CUT TUNNEL
UNDER BOW FOR CHAIN SLING**

It was anticipated that a tunnel could be quickly cut under the LONG's bow for one of two chain slings. The hard clay of the channel bottom proved difficult for a variety of lance nozzles.

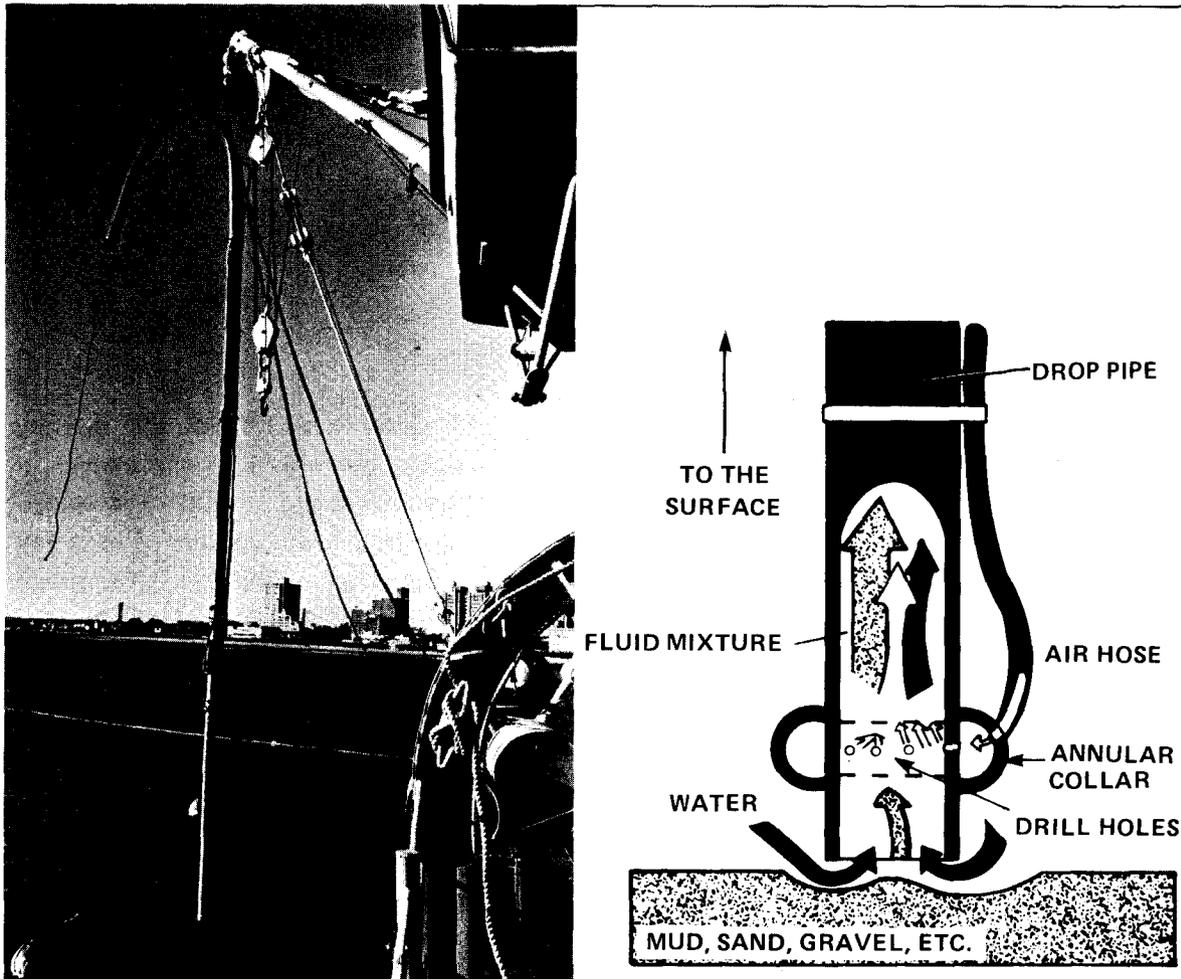
**SIX-INCH AIR LIFT SOLVED THE PROBLEM
OF CLEARING TUNNEL DEBRIS**

Several cutting nozzles were tried for tunneling under the LONG. They were found to be relatively inefficient due to tidal currents refilling the tunnels with sand, gravel, and debris. This problem was solved by employing an air lift, whose action is illustrated in the diagram.

Because of the problem of tunnel refilling, the in-port period on 26 October was used to fabricate a 6-inch air lift, and on 27 October, OPPORTUNE proceeded to NAD, Earle, New Jersey, to load a 600-cubic-foot-per-minute air compressor to drive it. Later in the day, OPPORTUNE arrived back at the salvage site and despite subsiding winds and sea from GILDA, took up the moor and again started work on the bow tunnel. Next day, 28 October, divers in deep sea gear manipulated the air lift to clean the bow tunnel of sand and debris, while others hand passed a 7/8-inch wire messenger. This was used to pass a 1-5/8 inch lift wire and a 2-1/4 inch chain, working with a combination of OPPORTUNE's after boom and a work boat. At this point, wind and seas again began to hinder operations

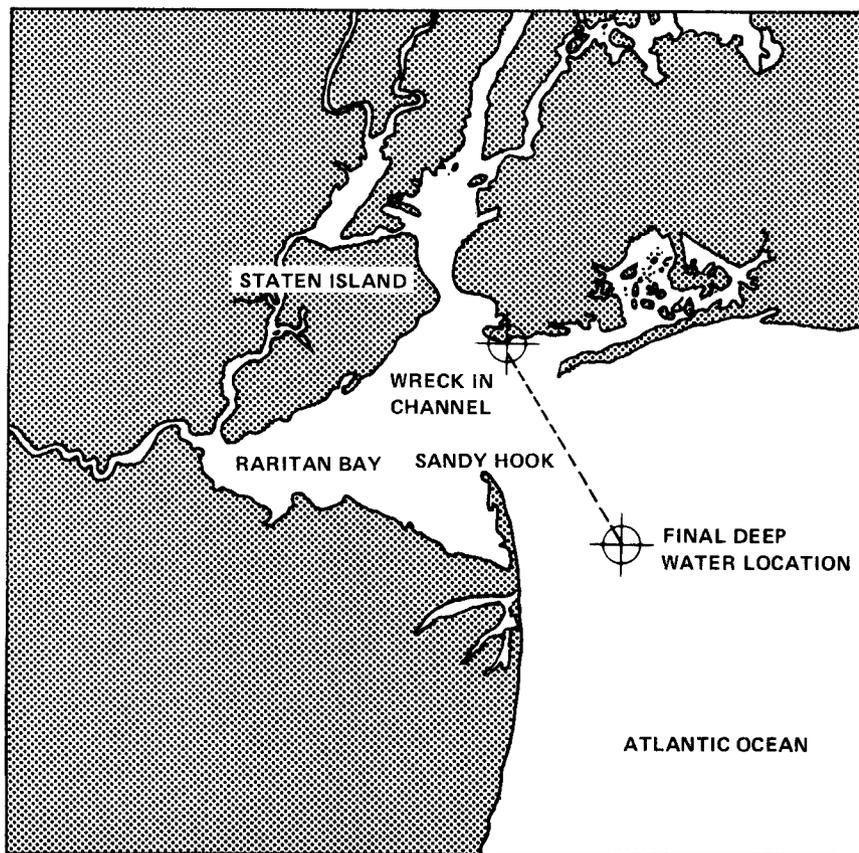
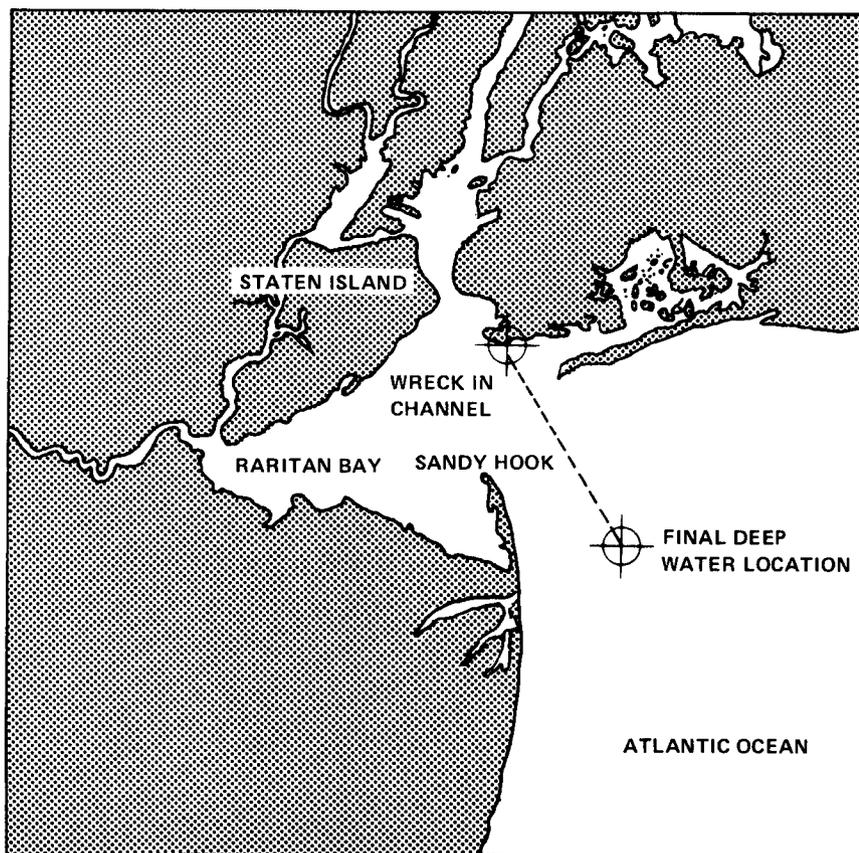
OPPORTUNE MOVED THE LONG'S HULL TO DEEP WATER

While proceeding to the designated deep water disposal site, increasing swells and waves caused the wrecked hull to work in the OPPORTUNE's lifting slings in which it was being carried. Ultimately, the cable of one of the slings parted and the remains of the LONG slipped out of the other sling. Fortunately, this occurred in suitably deep water, if a little short of the designated site.

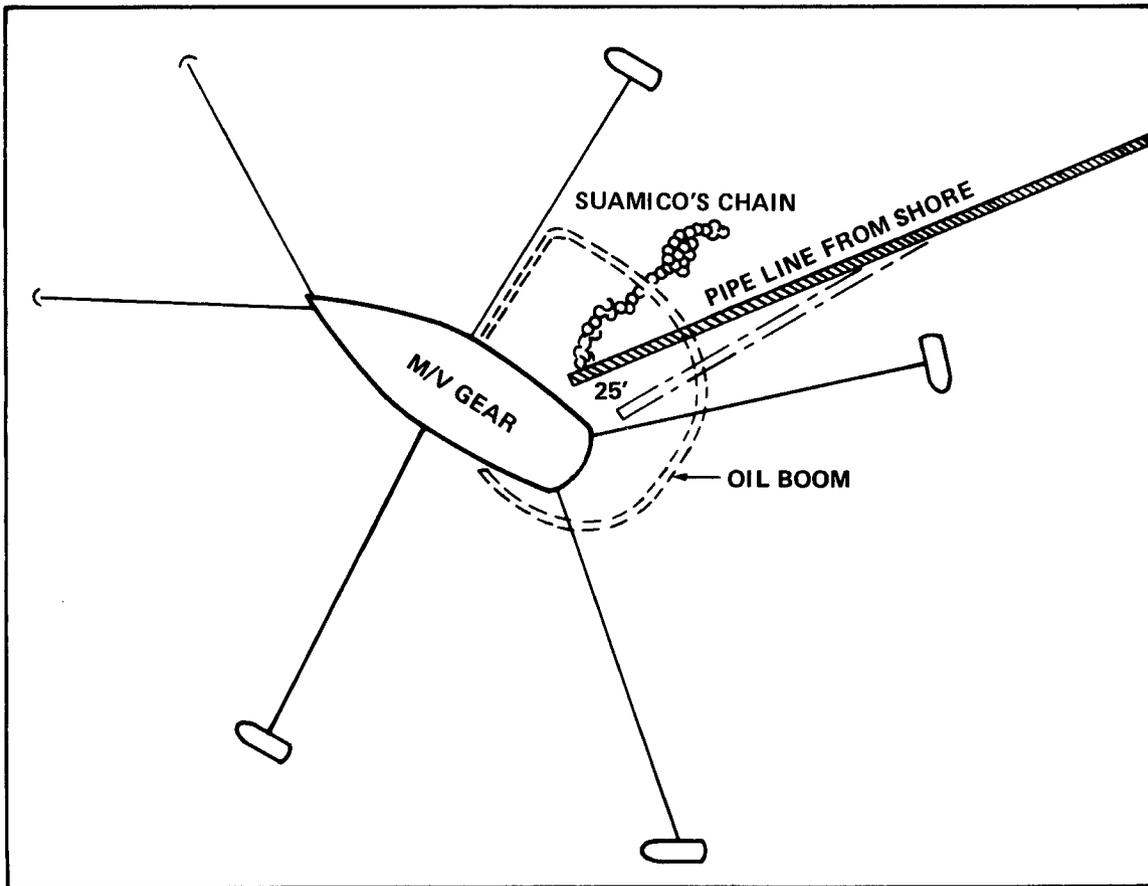
**MOORING OF M/V GEAR WITH
DEPLOYED OIL CONTAINMENT BOOM**

The assigned salvage ship, M/V GEAR, moored at the oil unloading installation to free the SUAMICO's anchor. Oil containment boom was set out against release of JP-5 jet fuel as a consequence of working on the fouled pipeline and hose.

The tug CAYUCOS arrived with another section of oil boom and it was deployed with the assistance of GEAR's work boat. A final section of oil boom was delivered at 1255. The entire boom was secured to the GEAR's mooring line at one end and to SUAMICO's abandoned anchor chain, by means of an 80-foot wire, at the other.

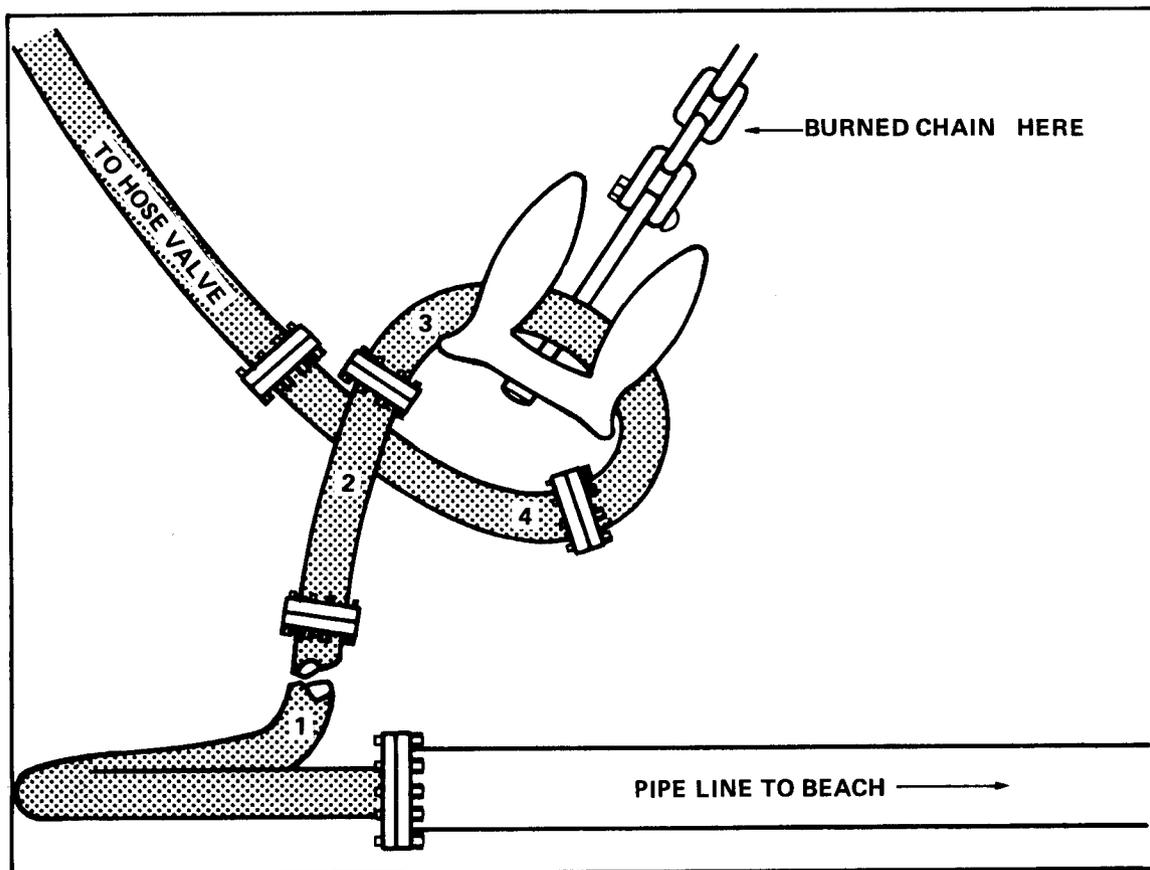
DETAIL OF FOULED ANCHOR AND FUEL HOSE

SUAMICO's anchor was fouled on a twisted bight of the fuel hose. It was necessary to cut the anchor chain to free the anchor before raising it.

The Murphy pollution control team deployed oil containment boom, obtained from the Navy Pollution Response Center, San Francisco, as a preventive measure. Divers from the GEAR burned the SUAMICO's anchor loose from its chain, enabling it to be disentangled from the POL hose and raised to the deck of M/V GEAR. With the POL hose connected to shore tanks, the salvage team then back-flushed 400 barrels of the JP-5 fuel from the hose without loss or spillage. Installation of a new POL hose and recovery of the anchor chain concluded the work successfully. This operation averted an oil pollution incident while concurrently making necessary repairs in an efficient and expeditious manner.

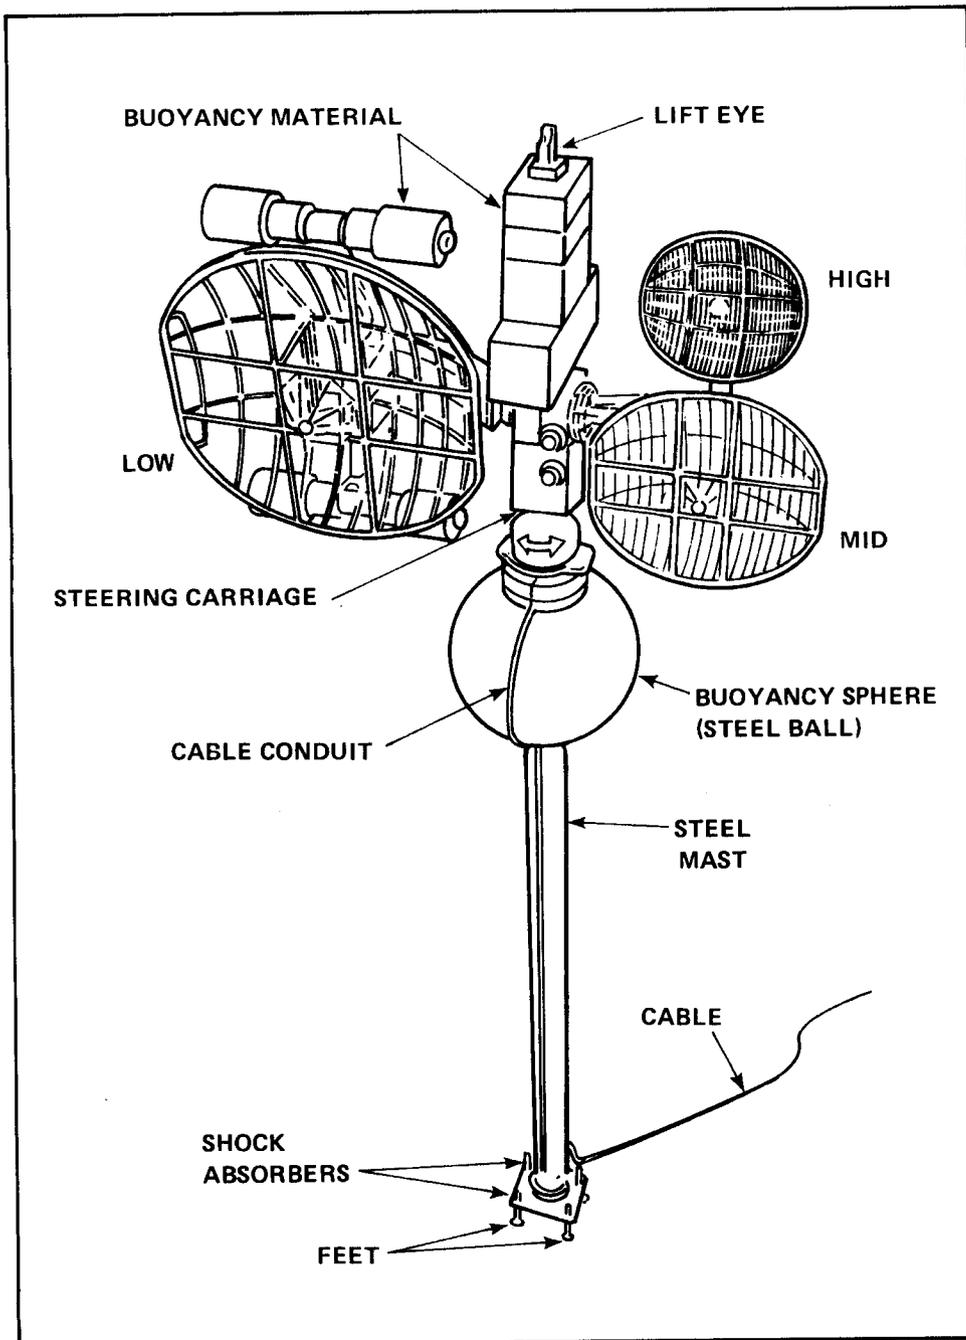
ECHO ACOUSTIC-ARRAY TOWER

ECHO, the easternmost of three 120-foot-high towers, had to be lifted off the sea bottom by means of a lifting eye at its top, and turned approximately 95°, to a new orientation.
