SALVOPS 73

A review of significant salvage operations
conducted by U.S. Navy salvage forces
and other salvage activities during 1973.

NAVSEA 0994-LP-012-6050

FOREWORD

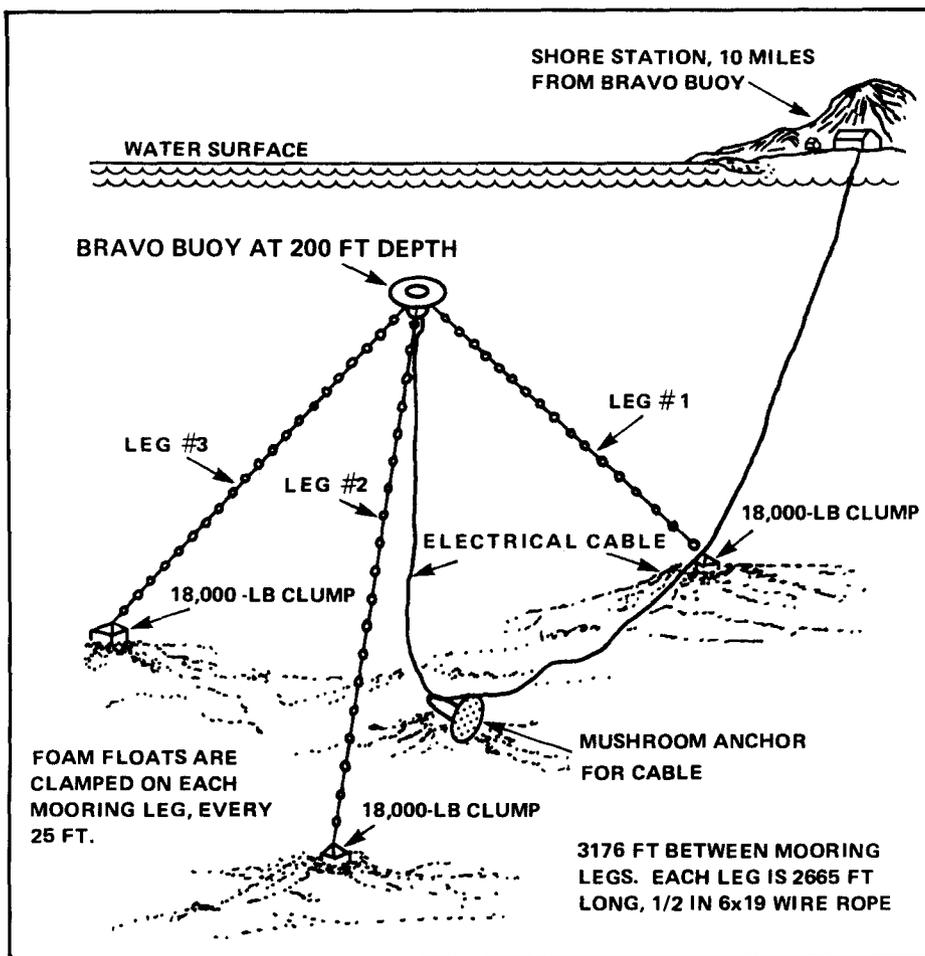
BRAVO BUOY'S UNDERWATER POSITION

BRAVO Buoy, under 12,000 pounds positive buoyancy, is maintained in submerged position, 200 feet below surface, by three mooring legs. Water depth is 2,080 feet.

A second task was to recover Buoy BRAVO, the large subsurface environmental buoy which measures ambient noise and wave height. The buoy system had been inoperative since initial implantment in 1972. Since BRAVO is subsurface moored at a depth of 200 feet, it was required to locate the 18,000 pound clump anchor on one of the three legs, and to lift it clear of the bottom. It would then be moved toward the center of the moor, thus slackening all legs of the moor. This would allow BRAVO to rise to the surface where it could be repaired.

When the buoy was brought to the surface for inspection and repair, inspection revealed that the complete hydrophone assembly and the wave height-measuring transducer both required replacement. However, the electronic package was functioning properly. The ALCOA SEAPROBE stayed positioned alongside the BRAVO Buoy, providing a lee for two Zodiac pneumatic rubber workboats, out of which the diver and electronics teams worked. Various electronic components, transducers, and the hydrophone assembly were replaced. The BRAVO Buoy was then returned to a depth of approximately 184 feet by the ALCOA

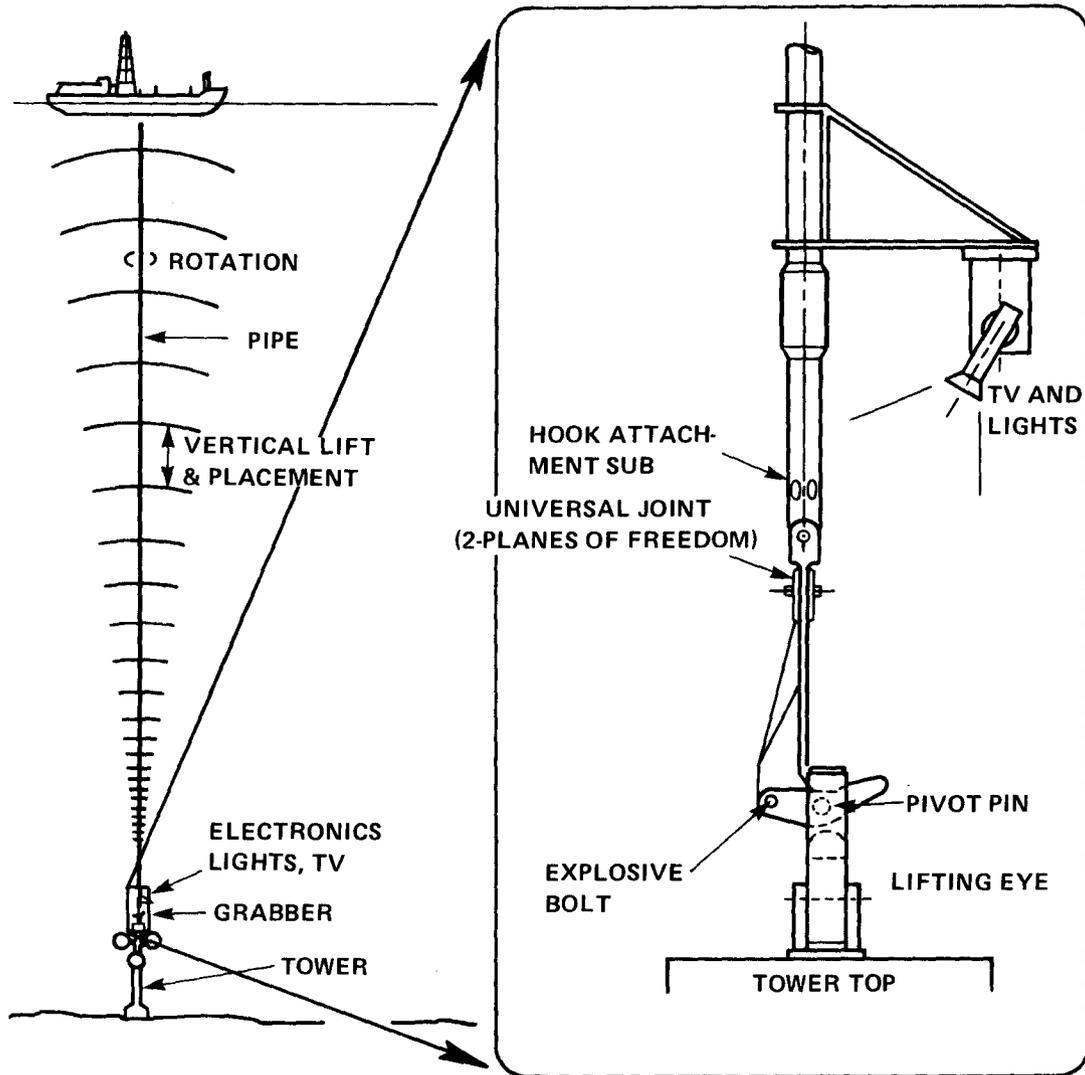
HOOKING NOVEMBER TOWER FOR REORIENTATION

To lift and reorient NOVEMBER Tower, ALCOA SEAPROBE had to thread its hook through a padeye and twist its drill-pipe string 93°. Control of the operation from ALCOA SEAPROBE was greatly facilitated by the closed-circuit TV on the working rig.

The pickup went as scheduled. However, it was found that under the 10- to 14-foot swell conditions, the explosive bolts of the hooking assembly sheared during extremely heavy oscillations, allowing the hook to fall open. The tower then fell back to the ocean floor. It was determined that, if maximum swell conditions alleviated, the hook and release would perform as designed. The tower was picked up six times and relocated back on the ocean floor during this rotation period. Griphoist "come-alongs" were used to rotate the drill-string up at the ship's end. However, it was found that the large shore connection cable attached to the bottom of the tower prevented the tower from freely rotating. The ship, with the tower attached to the drill-string, was maneuvered so the cable was overtwisted and exerted a neutralizing torque in the proper direction, and the tower was properly reoriented. After orientation, a final calibration determined that the tower was within 2 1/2 degrees of its optimum axis.

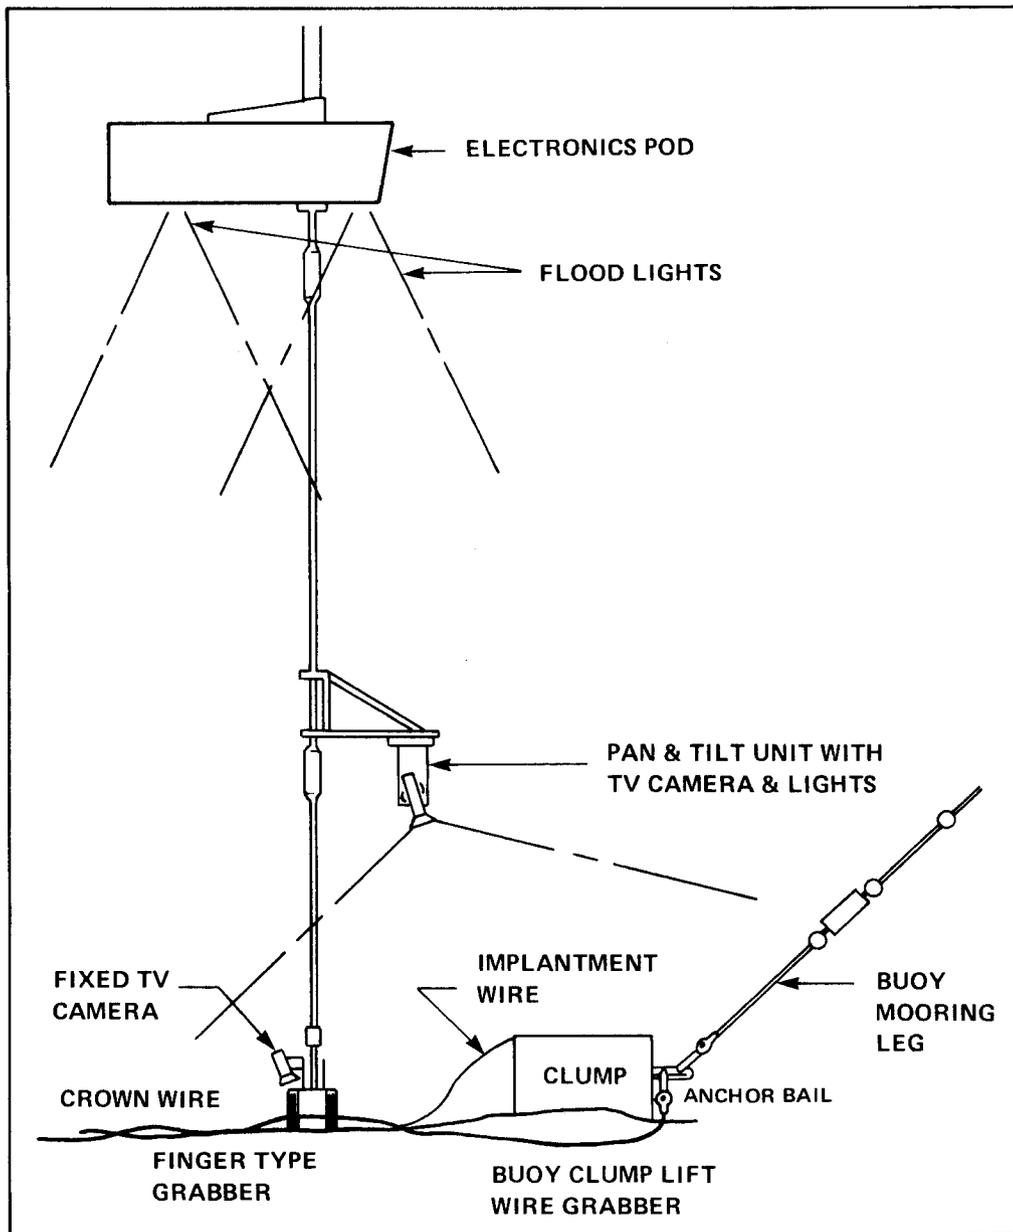
**METHOD OF HOOK CROWN WIRE
TO MOVE BUOY ANCHOR**

The ALCOA SEAPROBE's closed-circuit TV system was used to locate the crown wire of BRAVO Buoy's anchor. This was necessary because the position of the anchor bail prevented direct lifting. The anchor was then moved by means of the crown wire.

SEAPROBE hauling on the crown line to drag the anchor clump out to its leg position. A second 8.4-ton pontoon buoy had been attached to the BRAVO as a surge buoy to indicate its arrival at a depth of 200 feet. The BRAVO Buoy was successfully reimplemented and reported to be functioning properly.

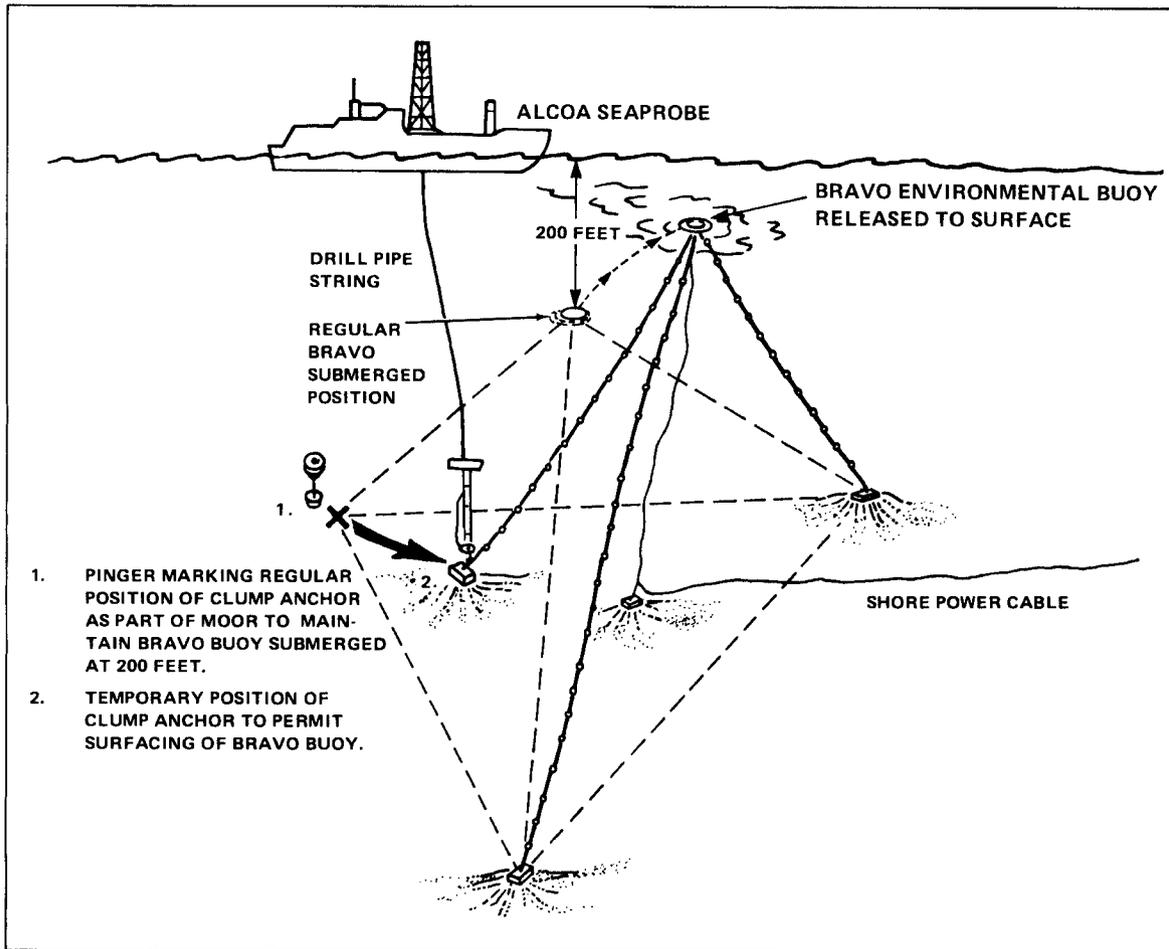
**MOVING AN ANCHOR TO BRING BRAVO BUOY
TO THE SURFACE**

One of the anchors in BRAVO Buoy's moor was moved to a mid-position between the other two legs. Once allowed to assume a vertical direction, the length of the released leg was sufficient to bring BRAVO Buoy to the surface.

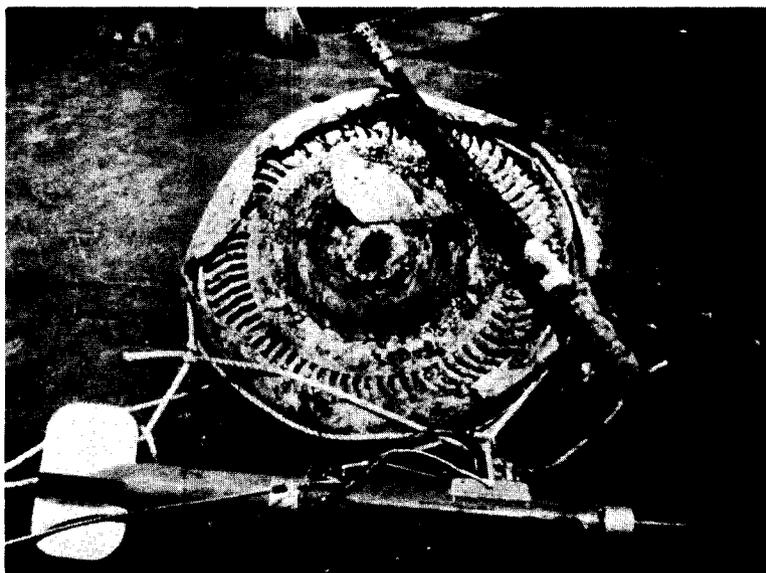
WRECKAGE RECOVERED FROM CONTACT 3

SEA TENDER was moved to that position. In this new position, divers quickly located aircraft wreckage. Only 1 to 2 feet of wreckage was visible, the rest being covered with sand and mud. During two days of salvage operations, enough A-4 aircraft wreckage was recovered for positive identification. Recovered debris included a turbine, engine sections of the fuselage, a machine gun, and a gun actuator. Following an examination and a check of records by the Crash Site Investigator on board the SEA TENDER on 17 July, it could be determined that the A-4 wreckage was not of concern to the JCRC.

A jet-engine rotor and gun barrel were retrieved from Contact 3, an A-4 aircraft. They are shown here together with a side-scan sonar fish.

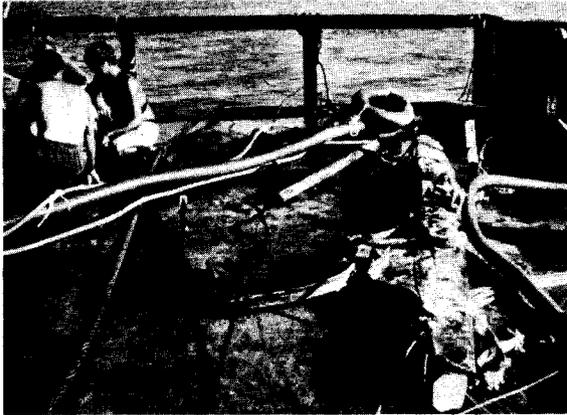
Contact 11 – UH-1 Helicopter rotor on stern of SEA TENDER, with air lift hose, in use for debris recovery.

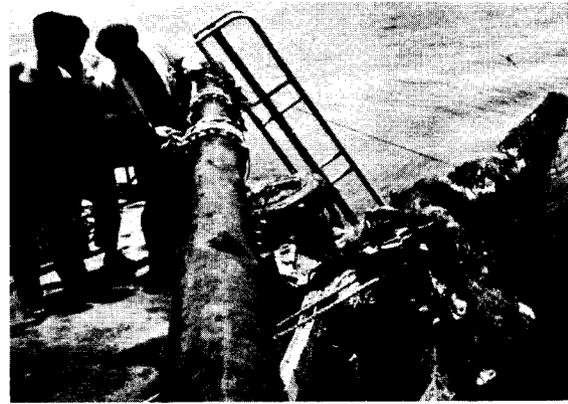
Contact 23 – Nose Wheel of A-7 jet attack bomber hauled to the side of SEA TENDER.

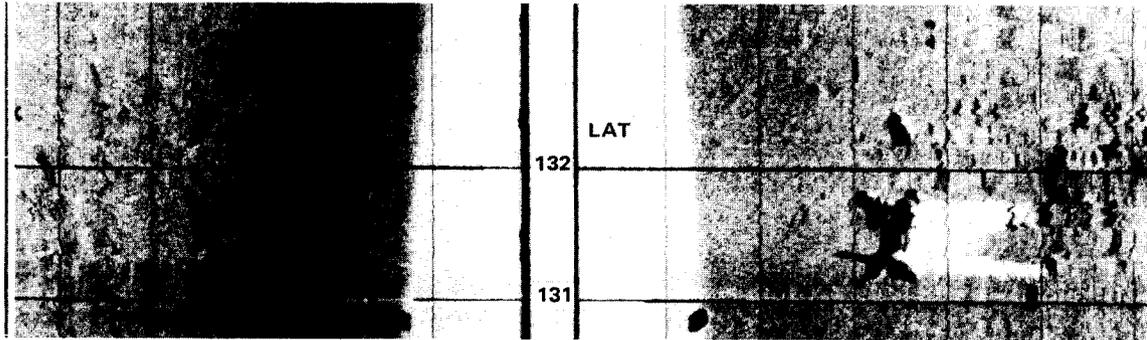
Graphic sonar plot of the ocean bottom area in which P-3B wreck was found. The diagram below identifies various items of wreckage.

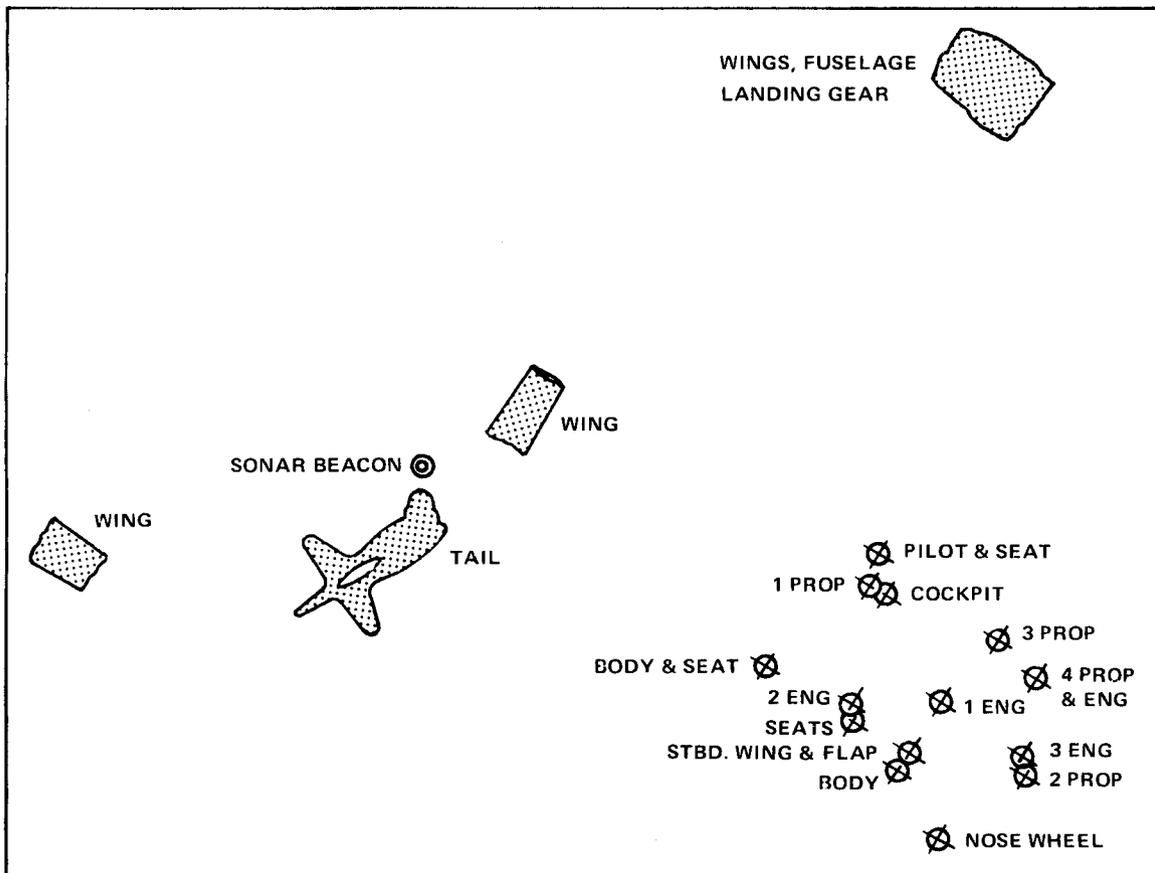
Diagram of the P-3B wreckage found by the search sonar. The items were identified by means of ALCOA SEAPROBE's closed-circuit TV and, for items of aircraft accident analysis importance, by actual recovery.

Contrary to original belief, the aircraft itself was badly broken up from impact. The majority of wreckage was concentrated in an area roughly 400 feet by 400 feet. The largest

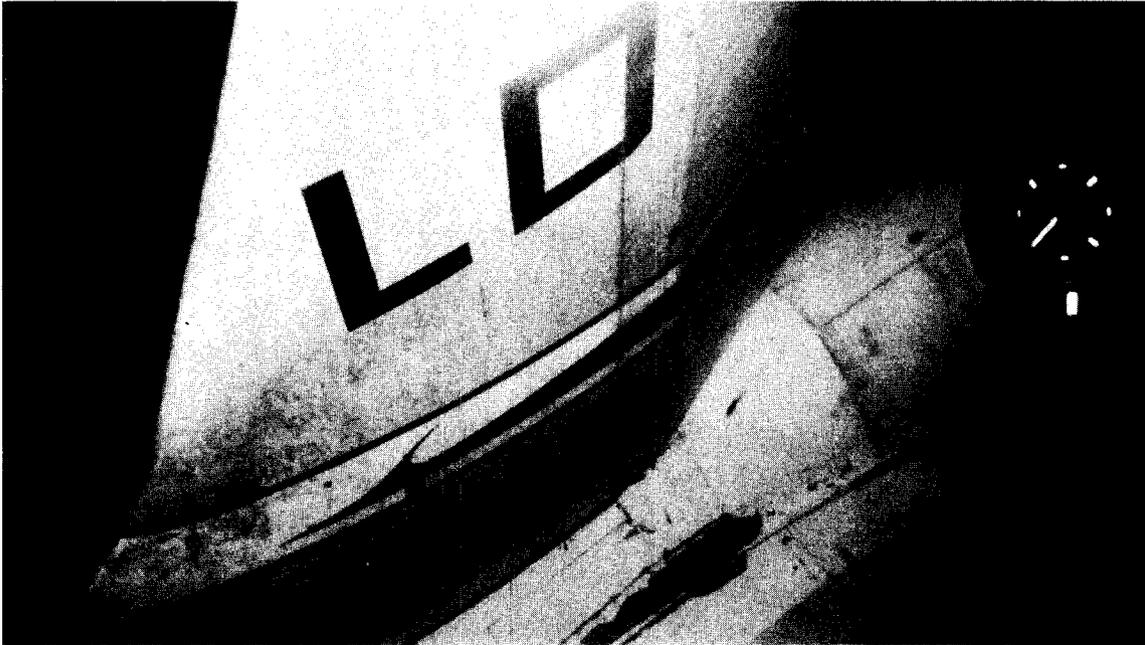
Photo of TV picture of P-3B's tail section. Bureau number of aircraft, 152749, is easily identifiable.

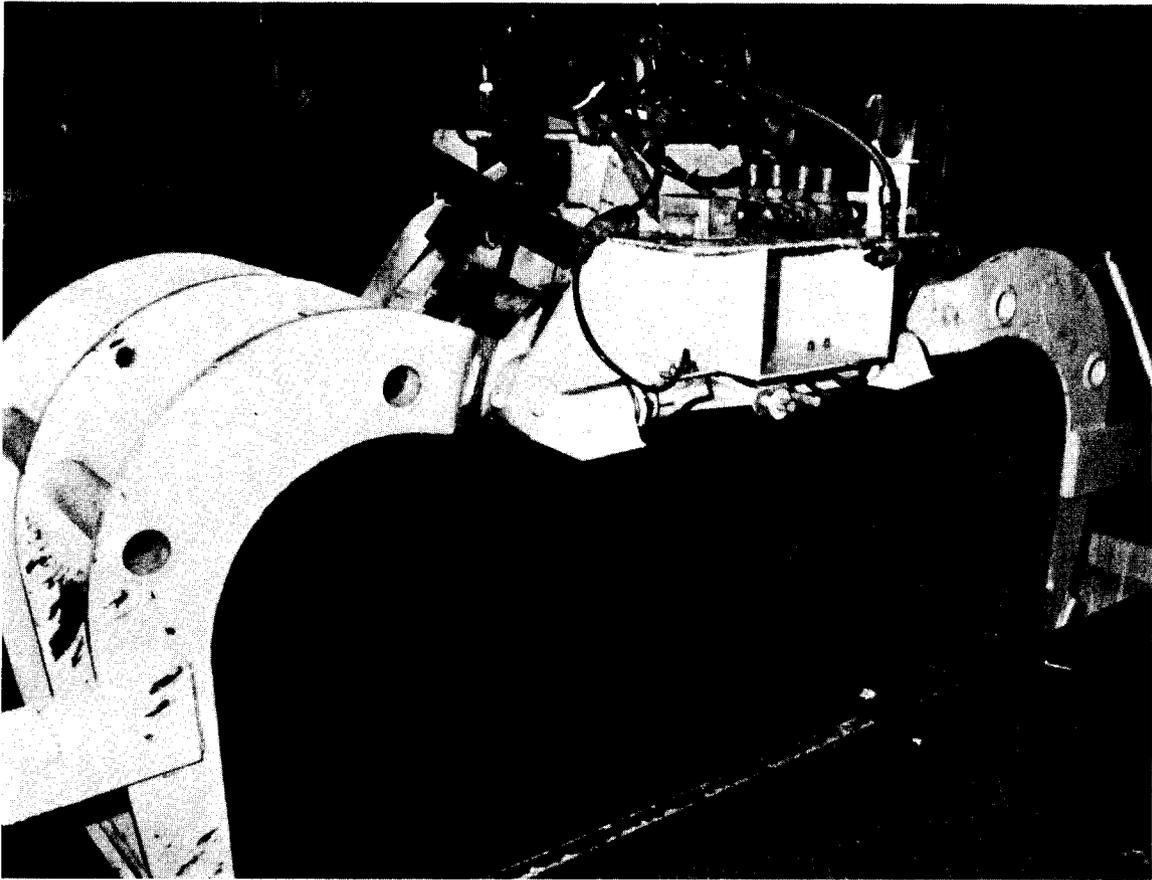
Mechanical grabber element with which ALCOA SEAPROBE's pipe-string was configured for the P-3B wreckage recovery. The grabber is remotely directed from ALCOA SEAPROBE's control center, under TV observation.

The grapnels, then, were exchanged for a mechanical grabber and the recovery of wreckage began. During the initial recovery attempt the grabber failed to open and had to be recovered to replace a ruptured fitter element in the hydraulic system. The grabber was again lowered to the bottom to recover a section of the starboard wing and flap, important because it included the flap screw jack fully extended.

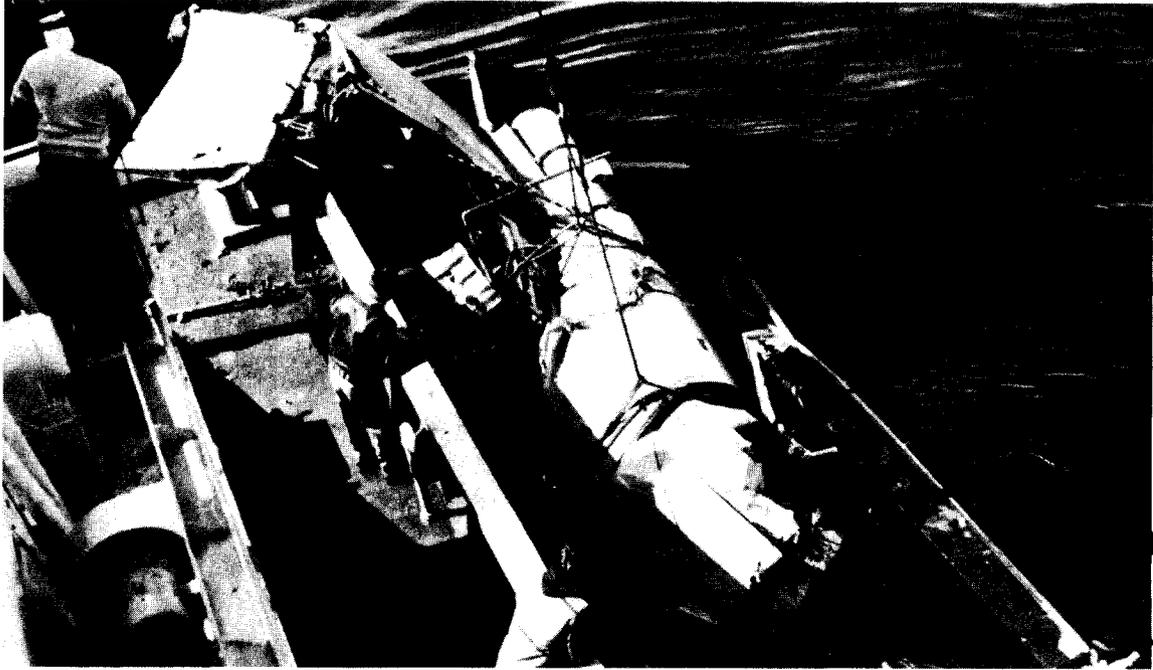
P-3B fuselage section comes aboard EDENTON.

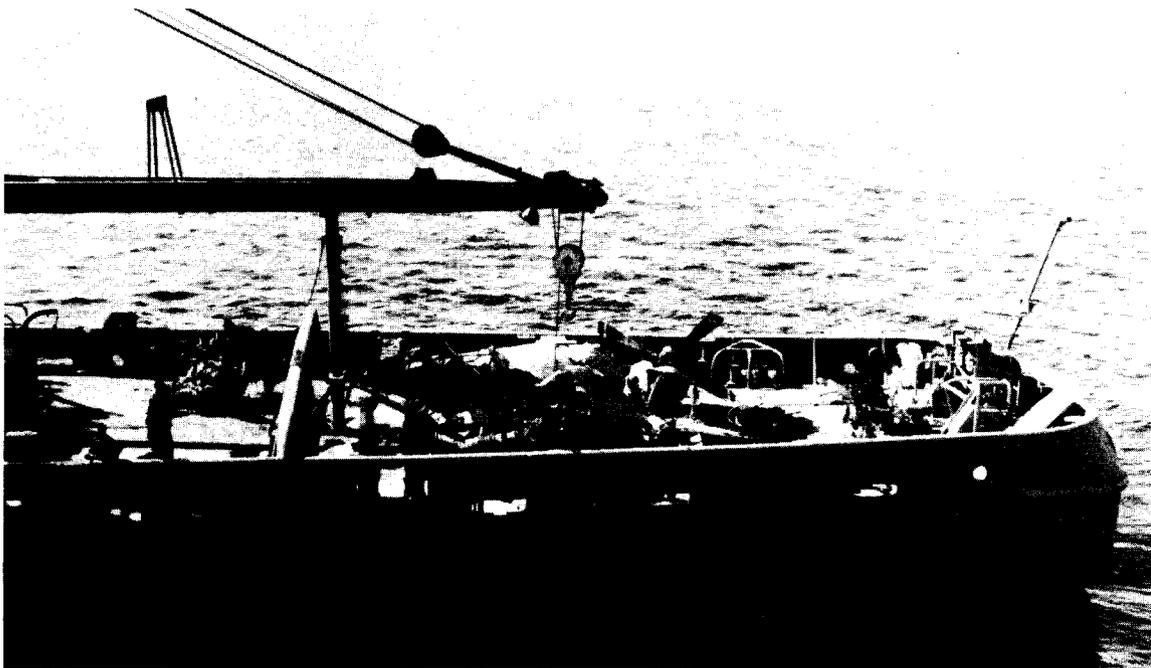
Fantail of EDENTON with recovered P-3B wreckage.
