S.S. SIDNEY E. SMITH, JR. SALVAGE OPERATION

**Removal of the sunken coal freighter, SIDNEY E. SMITH
from the shipping channel of the St. Clair River**

**Port Huron, Michigan
June-November, 1972**

**Department of the Navy
Naval Sea Systems Command
Washington, D.C.**

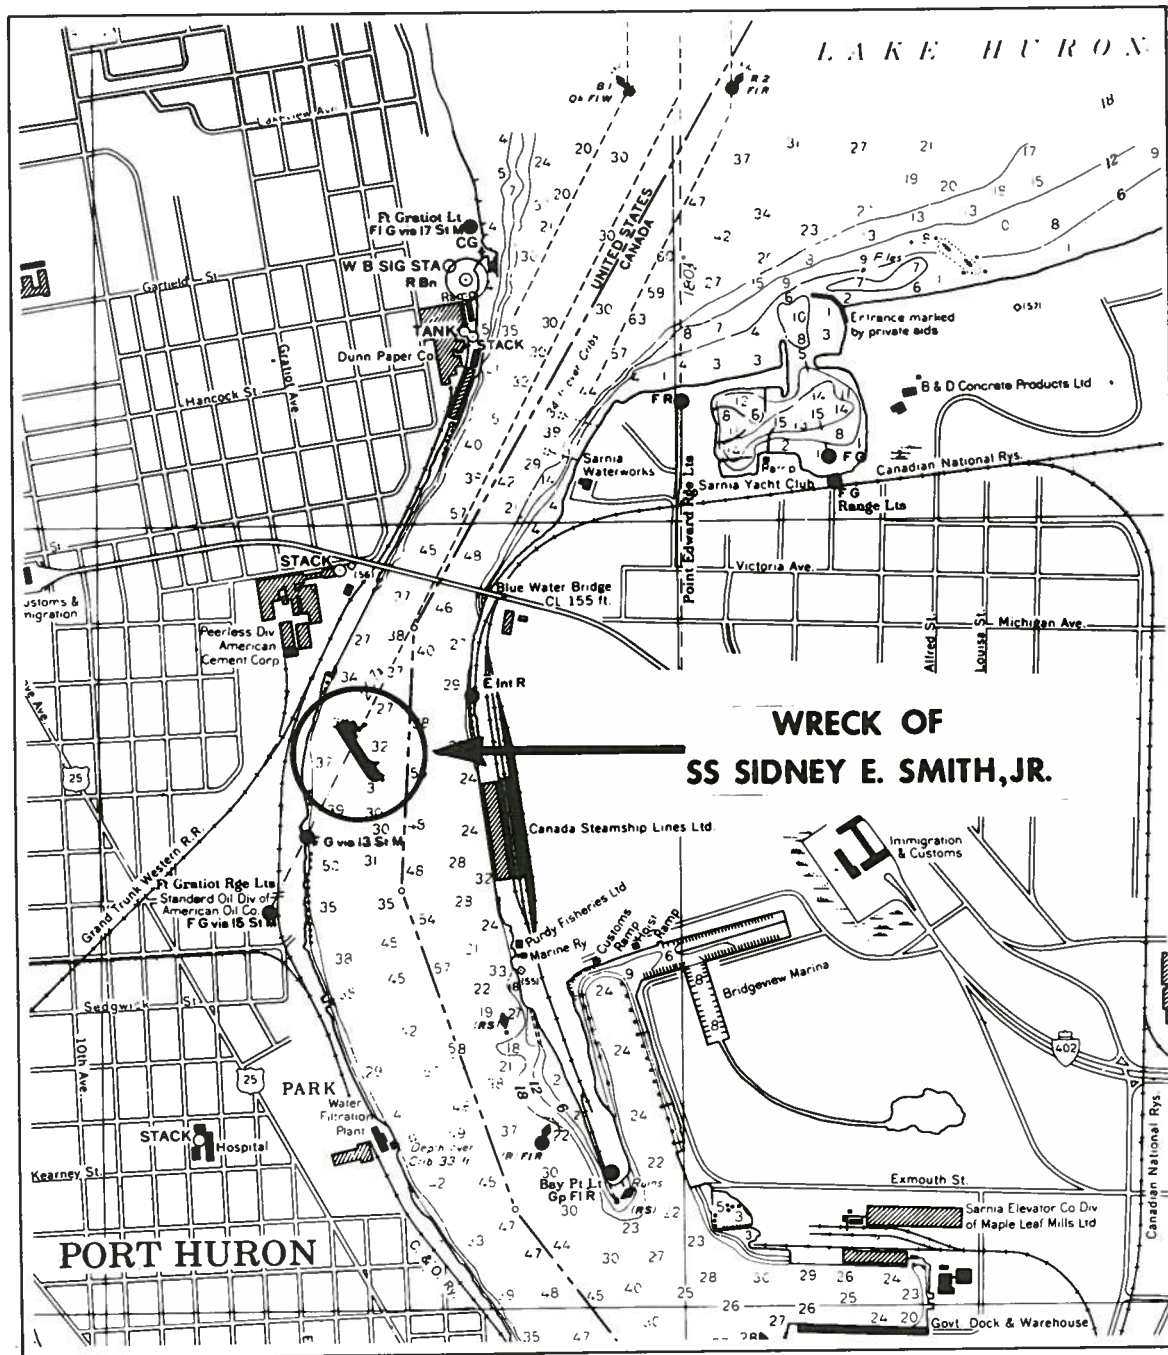
WRECK SITE IN ST CLAIR RIVER CHANNEL AT PORT HURON

Narrows above Blue Water Bridge and bend just below bridge combine with strong current to create dangerous passage. Wreck, blocking downbound lane of channel, increases hazard. Coast Guard imposed one-way traffic controls near wreck area.

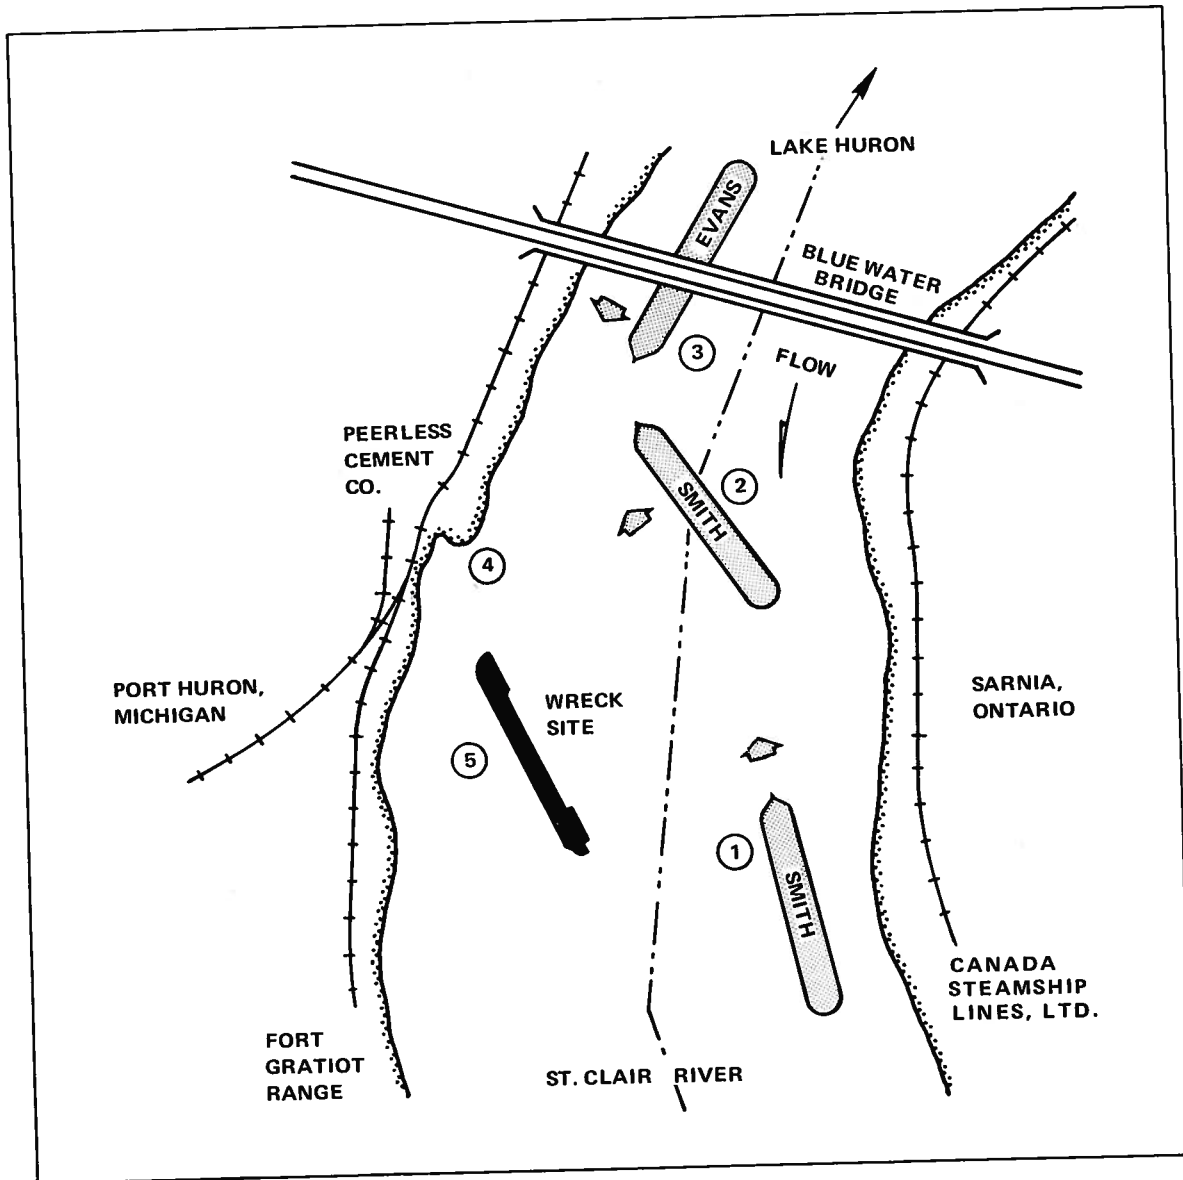
SEQUENCE OF SMITH-EVANS COLLISION

The stem or bow area of the EVANS struck the starboard bow of the SMITH at or slightly aft of the break of the forward deck house and hold #1 (frame 35). The angle of

- ① Close to Canadian shore after negotiating turn, upbound SMITH eased right rudder.
- ② Strong current caught bow, causing ship to veer across mid-channel.
- ③ Downbound EVANS punctured SMITH starboard bow region, causing immediate flooding.
- ④ After collision, SMITH drifted close to Peerless Co. dock, but was unable to tie up.
- ⑤ Strong river current carried SMITH downstream where it soon sank, blocking downbound lane.

impact was approximately 55 degrees relative to the bow of the SMITH. Rebounding from the initial impact, the EVANS' momentum caused her to strike the SMITH a second time 20 to 30 feet aft of the first point of impact. At this time, the EVANS' Master ordered "full ahead" in an attempt to hold the SMITH onto the nearby Peerless Cement Company's dock. The EVANS was unable to hold her position against the SMITH, however, as her stern was set rapidly downriver in the fierce current. At this point, the EVANS dropped her starboard anchor and swinging in on the current, managed to moor at a local asphalt company's dock below the Peerless dock.

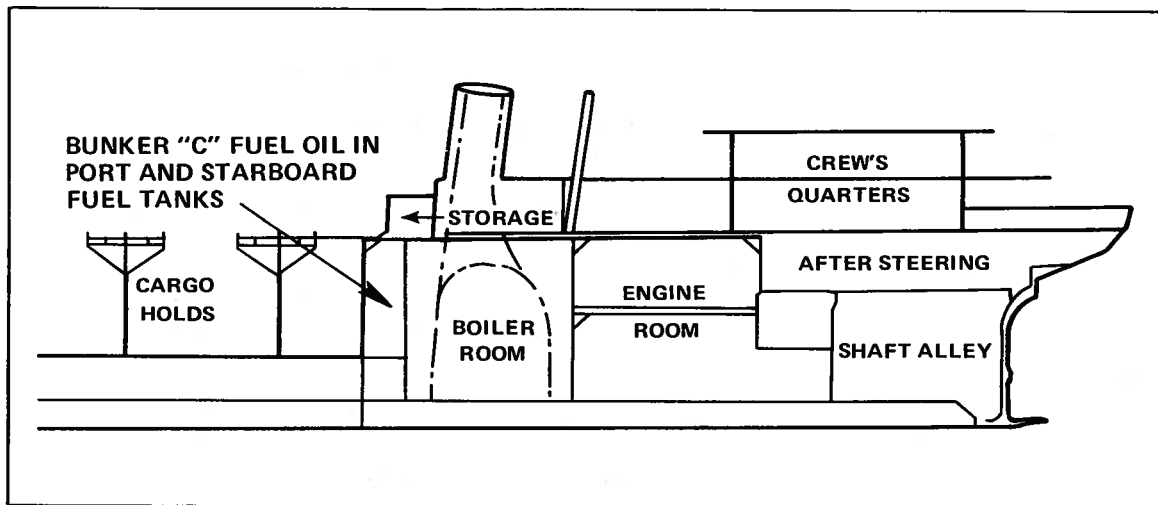
SMITH'S FUEL TANKS – TARGETS FOR OIL RECOVERY OPERATIONS

Loaded fuel tanks in stern section of capsized SMITH presented immediate danger of massive oil spill as hulk began to break up. Coast Guard team concentrated its efforts on defueling these tanks as quickly as possible.

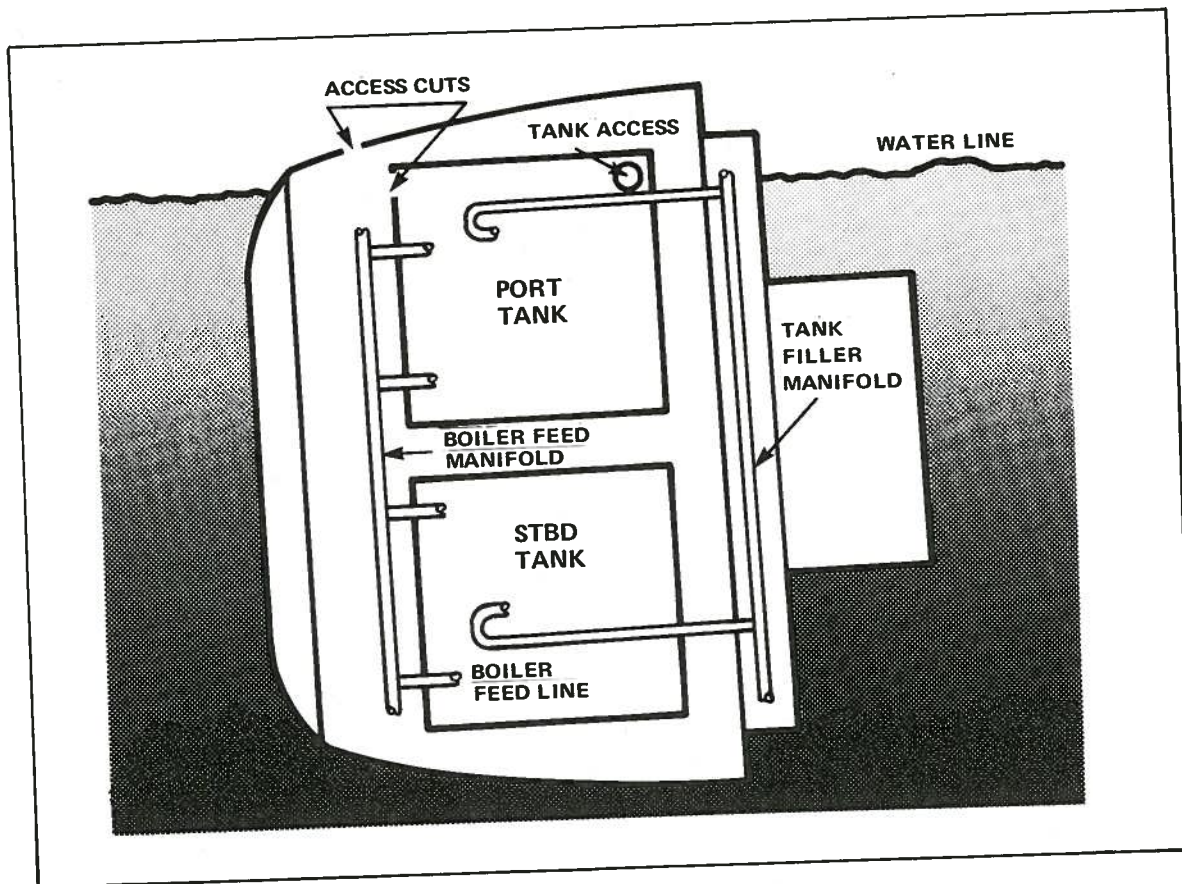
CROSS SECTION OF SMITH'S FUEL TANKS

Coast Guard team pumped port tank first, using tank top and filler manifold. Both filler manifold and boiler feed manifold were then used in pumping starboard tank.

Pumping of the port tank got under way on 7 June. The Coast Guard NSF Team installed an ADAPTS⁽¹⁾ system in the SMITH's port storage compartment. Access to the tank top was difficult because most of it was under water and the compartment was filled with galley stores of linen and foodstuffs. Steel shelving, extending about 15 feet into the compartment, obstructed the limited working space and hampered removal of debris. Part of this shelving had to be cut away to reach the tank top. After clearing the compartment for the ADAPTS equipment, the recovery team removed the manhole cover from the tank and began recovering oil. Operations with the ADAPTS system were soon forced to a halt, however, when the hydraulic system on the pump failed. The recovery team ordered the necessary parts in expectation of resuming operations on the following morning.

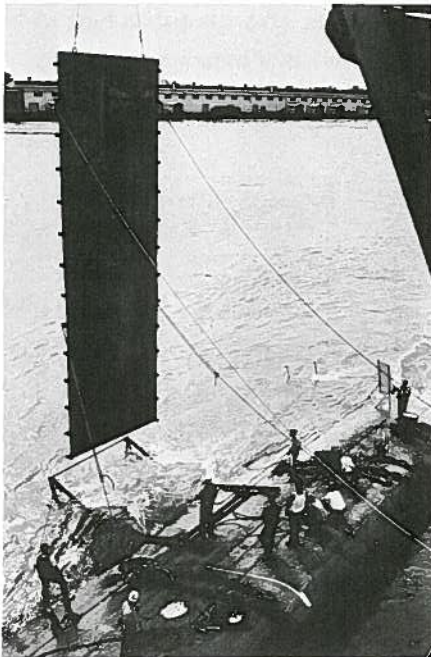
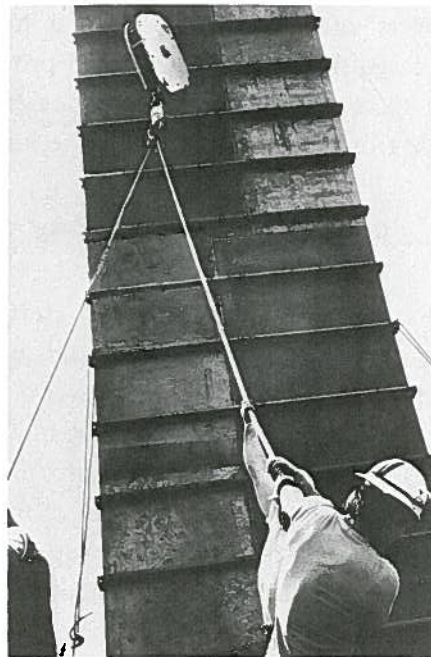
HATCH COVERS – REQUIRED FOR STERN SALVOPS

Hatch covers, 40' by 12', were designed to slide over SMITH's existing hatch coamings to seal cargo holds for foaming. Each cover is 1/4" steel plate, reinforced with transverse stiffeners.

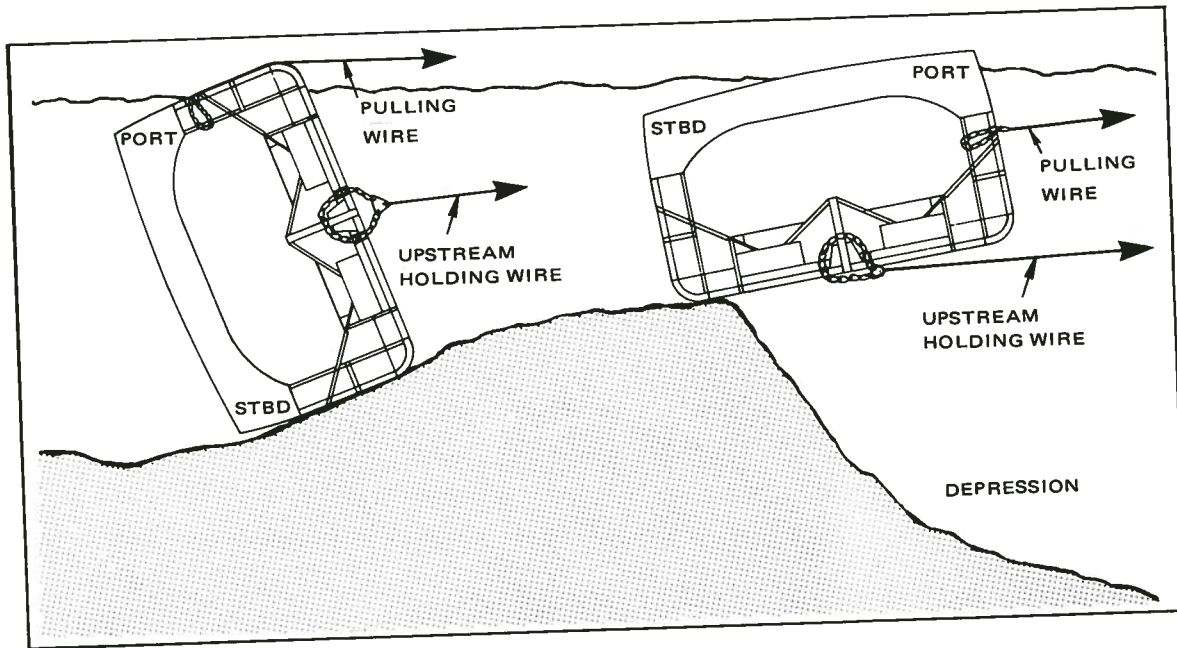
USE OF PARBUCKLING IN STERN RETRIEVAL STRATEGY

Parbuckling was required in order to clear stern section over ridge on river bottom impeding path toward shore. Upright position would also facilitate control of shoreward movement across deep depression.

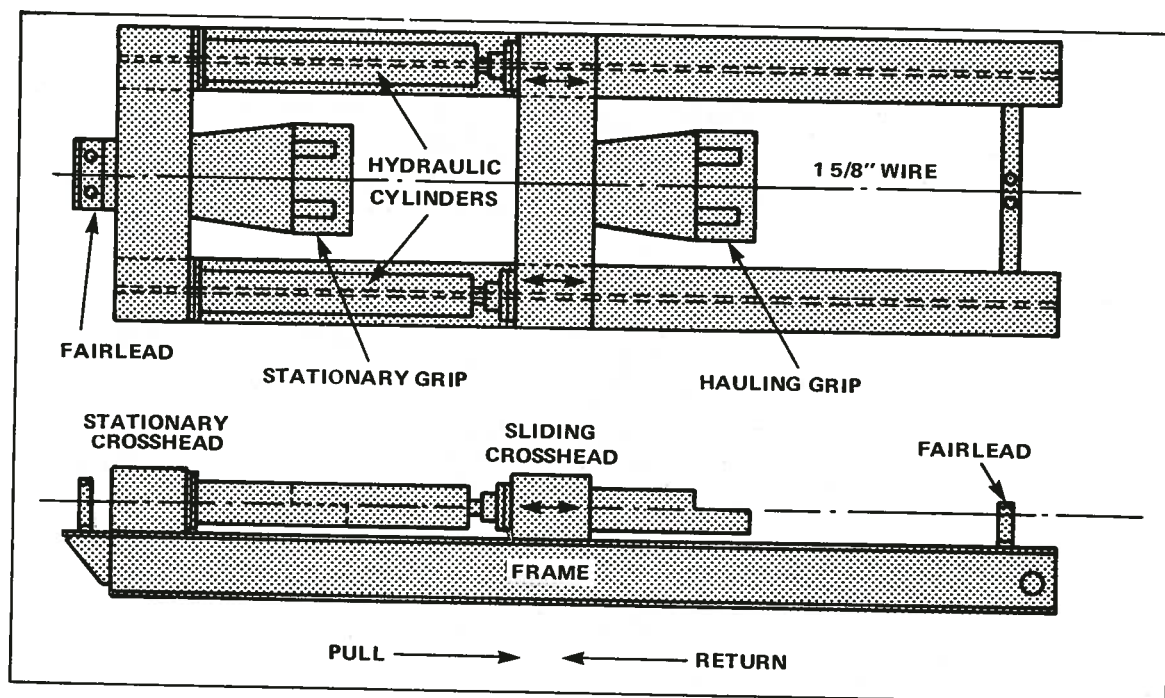
FUNCTIONING OF HYDRAULIC PULLER

Pressure of hydraulic cylinders moves sliding crosshead. Hauling grip moves with crosshead, pulling in length of wire. Stationary grip stops wire as cylinders retract, returning hauling grip to take in another length.

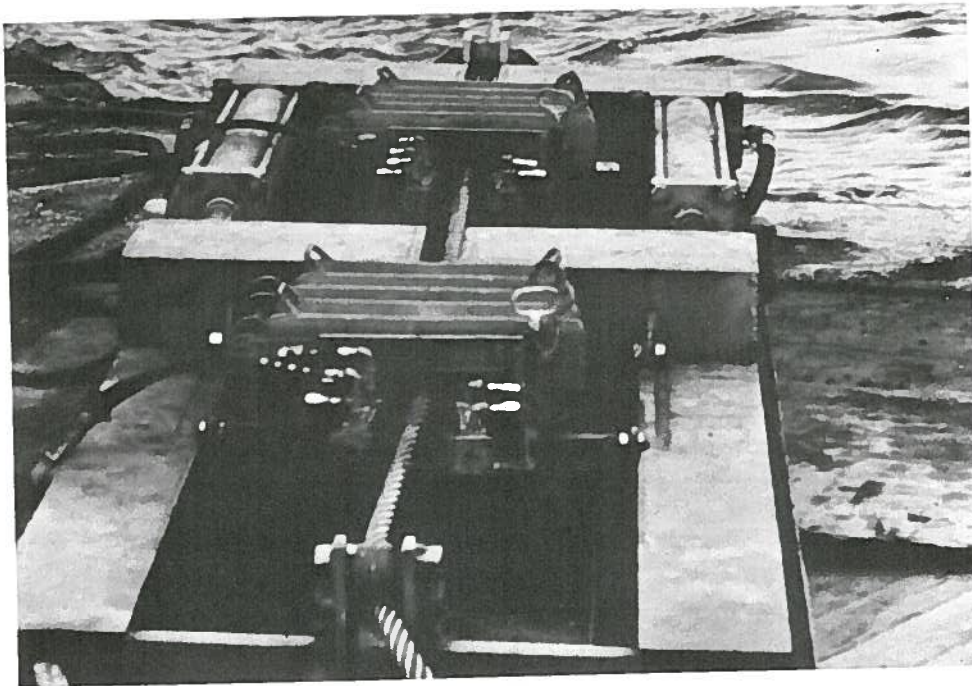
100-TON HYDRAULIC PULLER WITH 2-INCH PULLING WIRE

100-ton puller's hauling grip (foreground) and stationary grip (background) are controlled hydraulically. Note small hose connections on each grip. Larger hoses connect puller's hydraulic cylinders to power unit (not shown).

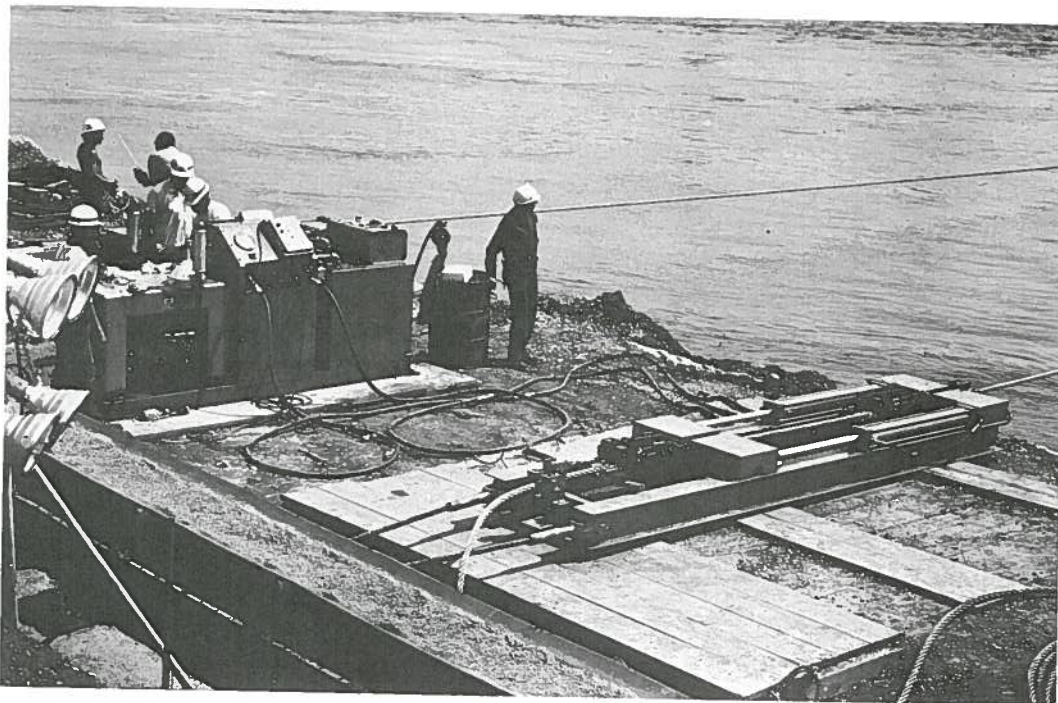
40-TON HYDRAULIC PULLER AT STATION BRAVO

Operator's console, at left with gas-driven hydraulic power unit, is used to control puller operations. Photo shows sliding crosshead extended, almost ready for return movement to grip new length of 1-5/8" wire.

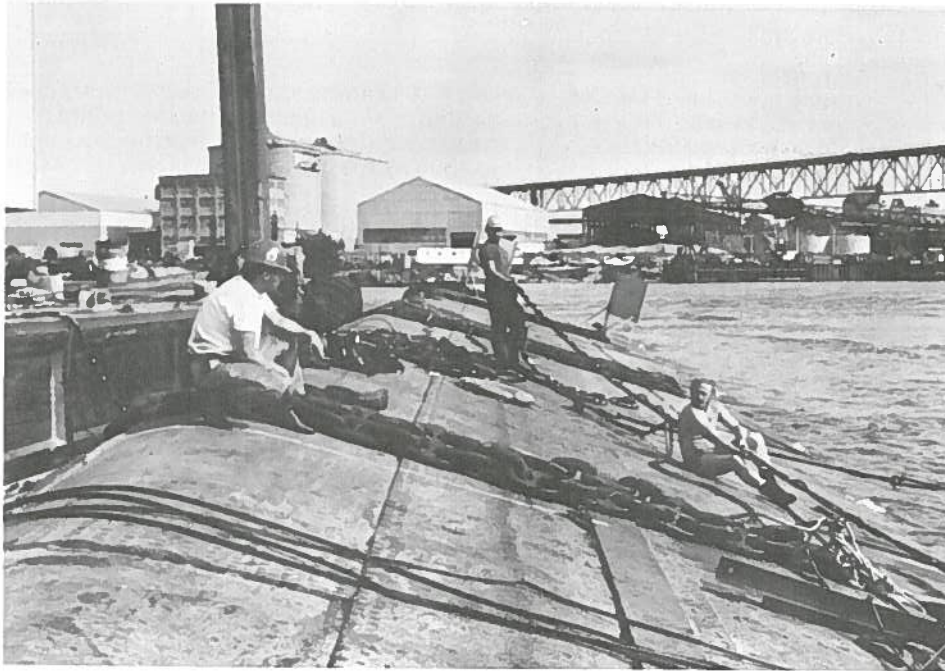
RIGGING PULL POINTS FOR PARBUCKLING

Four pull points, high on stern section's exposed port side, were rigged for parbuckling. Heavy, 2¼" anchor chains were looped around strength members inside hull through holes burned in port skin for attachment to pulling wires.

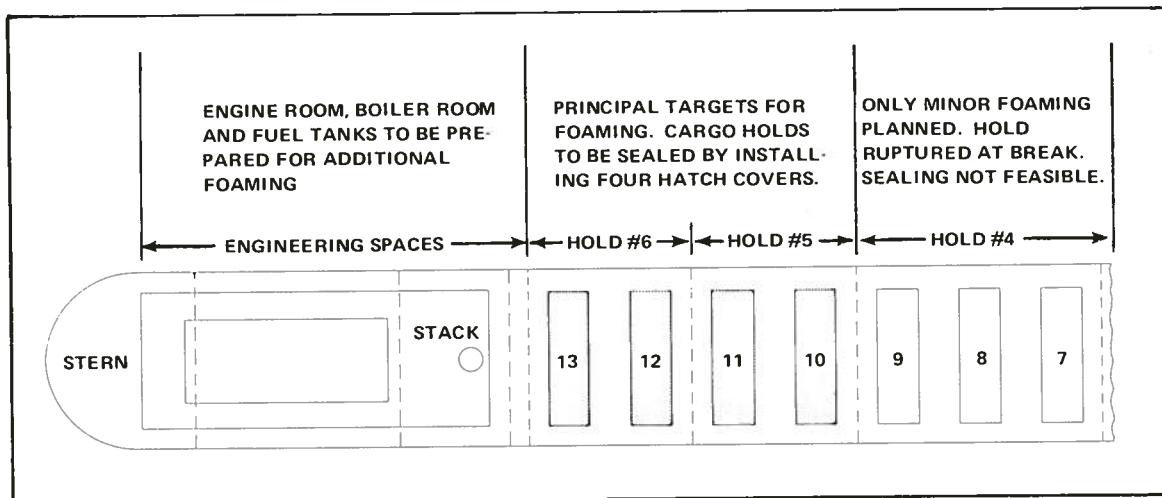
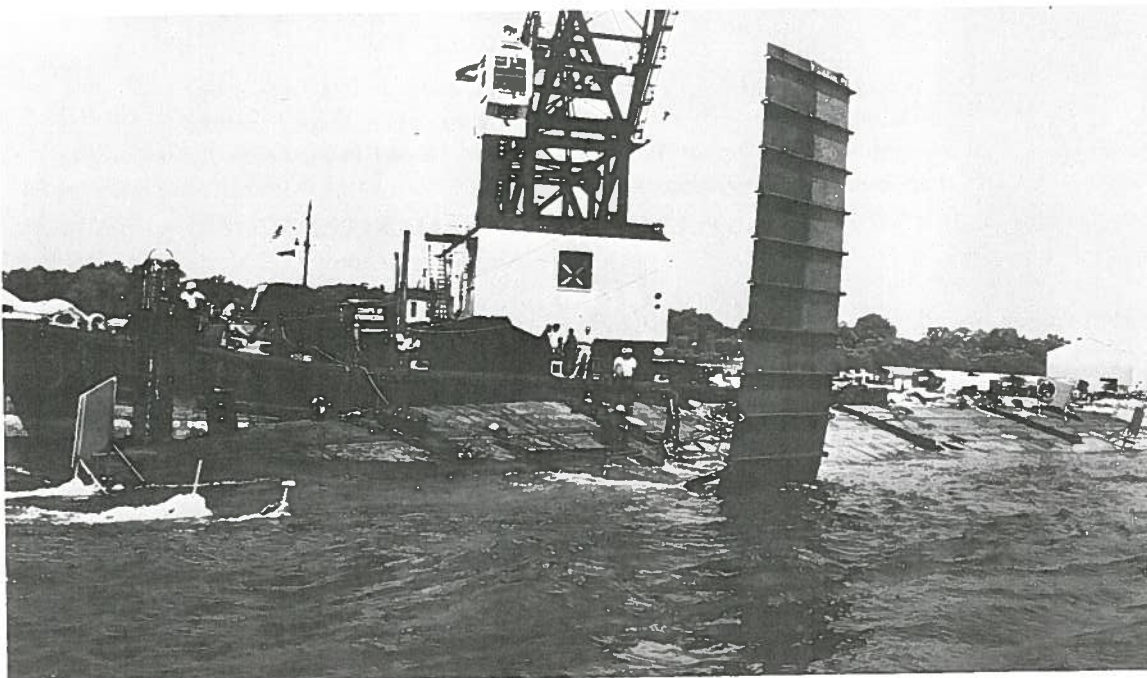
HATCH COVERS SEAL CARGO HOLDS FOR FOAMING

When the installation plans had been formulated originally, several feet of hatch coaming were still visible above the surface and thus accessible for hatch cover installation. By 1 July, however, not only had the hatch coamings disappeared, but also the deck edge and much of the port side of the stern section were underwater. This made it necessary to lower the hatch cover into the water prior to aligning the L-shaped clips under the lip of the hatch coaming. It proved impossible to align the clips properly, primarily because of irregularities in the coaming. The strong current also hampered the work, preventing precise maneuvering of the hatch cover by the divers.

Hatch covers were emplaced in succession over hatches 13, 12, 10 and 11, sealing cargo holds 5 and 6. Installation was accomplished in 3-day period despite difficulties in handling and securing the heavy, cumbersome steel covers.

The first hatch cover was finally installed on 2 July on hatch #13. The other hatch covers had by now been delivered to the site. The hatch cover guide was repositioned over hatch #12 and installation of the second cover was begun. Work proceeded much more quickly with this cover and the two remaining covers on hatches #10 and #11 as the salvors applied the improved installation procedures. All four hatch covers were in place by 4 July, sealing cargo holds #5 and #6, the two principal spaces to be foamed.

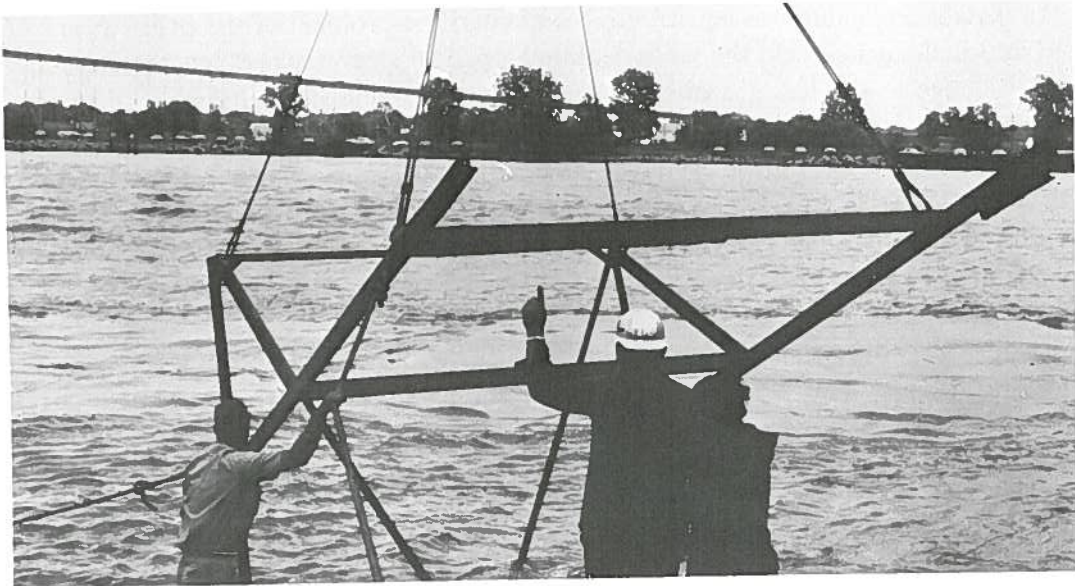
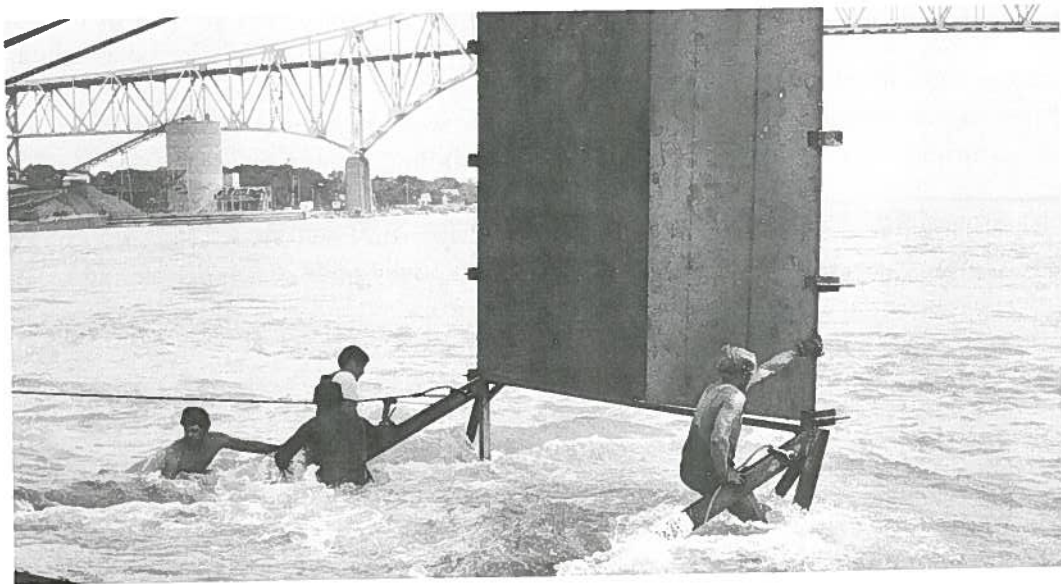
HATCH COVER INSTALLATION GUIDE

Salvors fabricated a steel framework (above) to guide hatch cover during lowering over hatch coaming. Guide functions as standoff against hull (below), enabling salvors to control hatch cover movement in turbulent current.

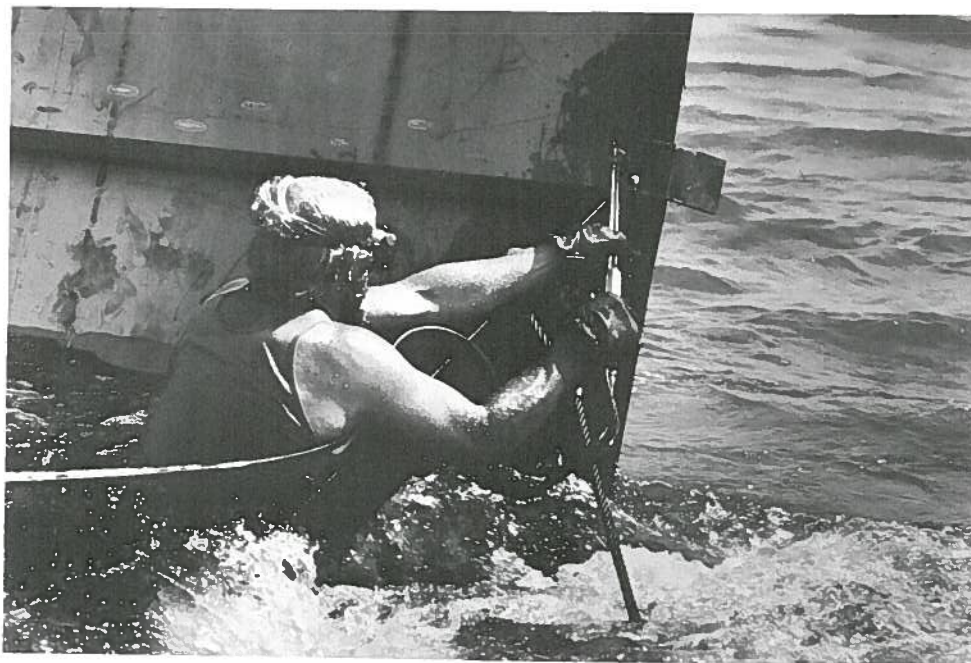
SALVOR MODIFIES CLIP ON HATCH COVER

The salvors also discovered that double plating occurred at the corners of each hatch coaming where the athwartships or transverse coaming lip overlapped the longitudinal lip. Removal of this double plate by burning allowed the hatch cover to slide more easily from the guide to the coaming. Then, as the hatch cover was properly positioned on the hatch coaming, turnbuckles were used to prevent further sliding movement.

L-shaped clips on edges of hatch cover were designed to help hold cover in place over hatch. Some did not fit properly due to irregularities on hatch coaming and had to be modified in order to slide hatch cover into position.

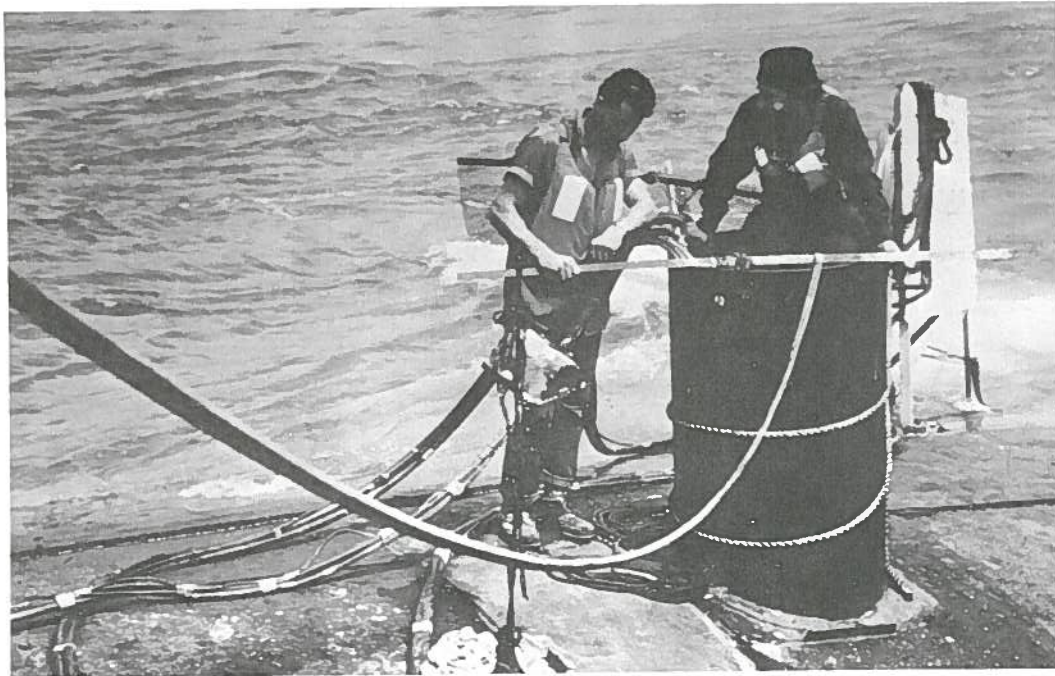
SALVORS TEND DIVER'S FOAM AND AIR HOSES AT TOP OF ACCESS TUBE

Three diver access tubes were inserted into cargo holds 5 and 6 through port side. "Windows" in each 60' cylinder provided exit and entry within holds at three different levels for foaming.

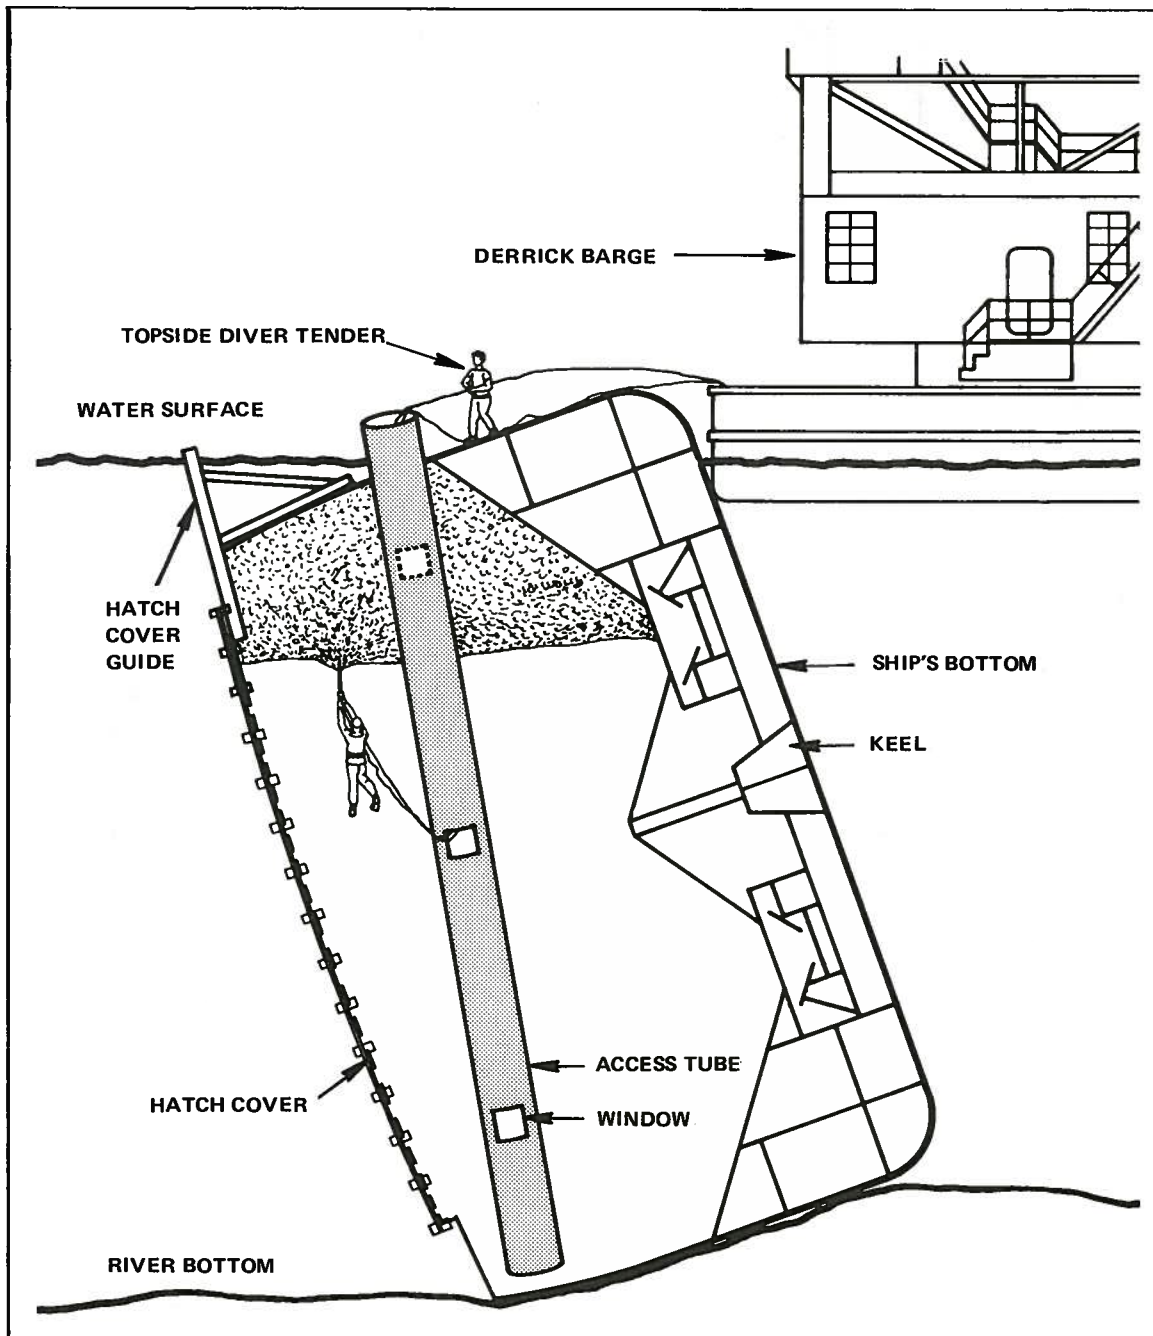
FOAMING IN CARGO HOLD FROM DIVER ACCESS TUBE

Diver foams cargo hold from top down, using each window in succession as foaming progresses to lower levels. Here, diver is tended from topside. Second diver went down to tend foaming diver when working in restricted spaces.

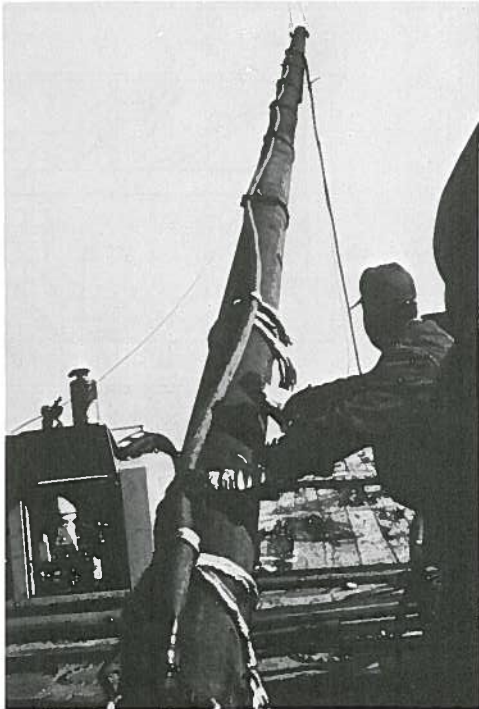
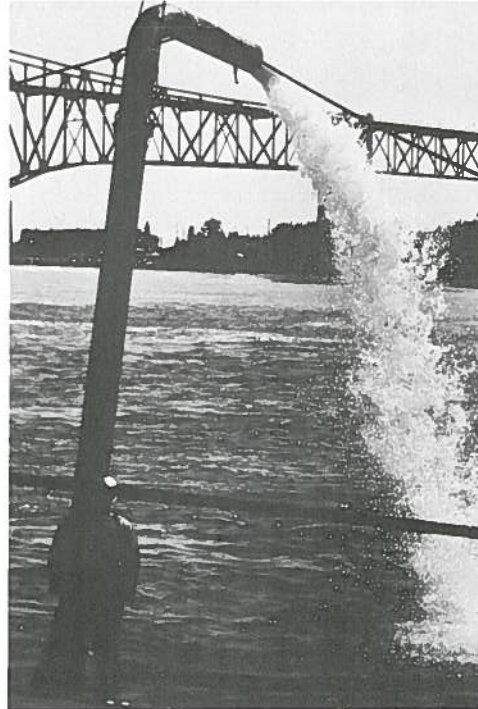
AIRLIFT EXPELS COAL AND DEBRIS FROM CARGO HOLD

Air compressor feeds compressed air through air hose down to base of airlift pipe (left). Presence of air in water column inside airlift pipe creates pressure differential, forcing water, with coal nuggets and sediment, up through pipe for discharge into river (right).

sisted of a fine grade of coal known as stoker coal. However, most of it turned out to be of a much coarser grade, and the 6-inch airlift proved inadequate for removing these relatively large, heavy nuggets. It was replaced with a 10-inch diameter airlift, which proved effective in removing the remaining debris. A second problem was the inability of the coal to gravity feed, or run, to the airlift intake because of its low submerged weight (density). Divers had to rake the coal to the intake, a lengthy and laborious task. Airlifting from hold #5 was completed on 5 July and from hold #6 on 8 July.

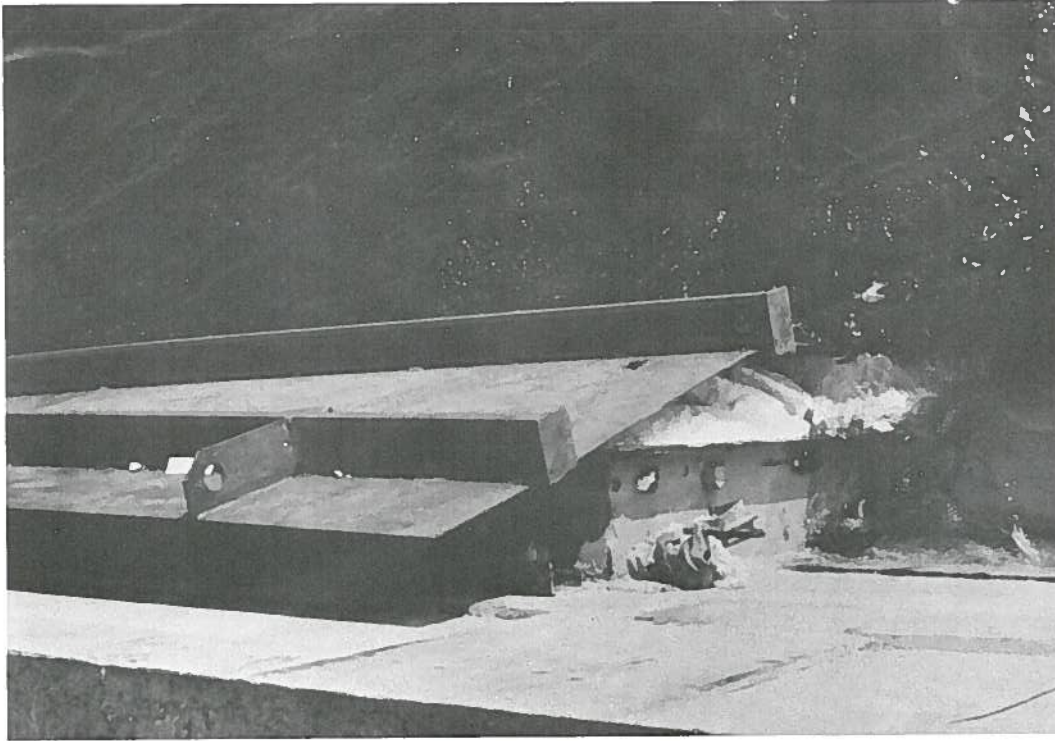
EXPANDING BUOYANT FOAM DISLODGES HATCH COVER

On 13 July, the salvors suffered a minor setback. The pressure of the expanding foam being installed in hold #5 forced the upper end of the hatch cover to break loose from the hatch coaming. A large amount of foam escaped. Some of the escaping foam was captured by the metal screen that had been installed at the downstream end of the wreck for that purpose. Divers immediately began to repair, reposition, and reinforce the hatch cover.

Foam, expanding and hardening in cargo holds, exerted great force against hatch covers. All four hatch covers were reinforced with strongbacks after initial installation in order to contain foam.

Foaming resumed in hold #5 on 14 July, continuing here and in the engine room through 15 July. The port and starboard fuel tanks, near the boiler room, were also foamed during this period, using the probe method. Concurrently, divers installed turnbuckle jigs around the other hatch covers on holds #5 and #6 to snug each cover more securely over the hatch.

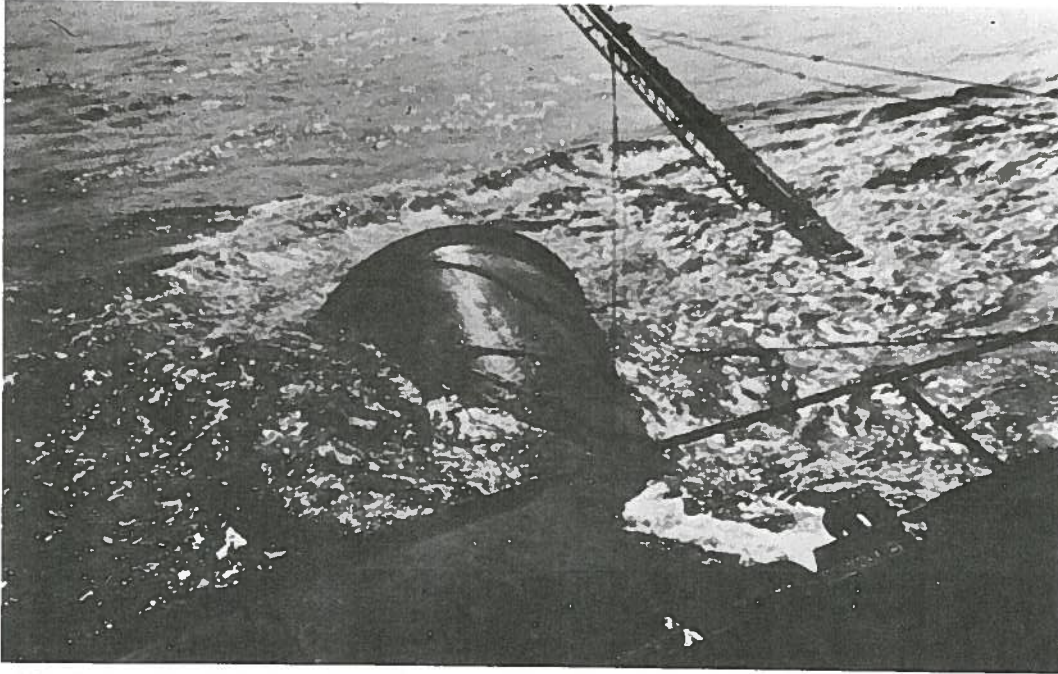
STERN SUPERSTRUCTURE BREAKS SURFACE

The pulling force was maintained through 22 July to allow for a gradual breaking of bottom suction and parting of bow and stern sections. A second inspection dive late in the day confirmed that the two wreck sections were, in fact, connected by part of the starboard skin and several longitudinal strength members. The connection would have to be severed before either section could be beached. Oxy-arc cutting was considered but rejected as being too hazardous for divers because of the torn and mangled metal that would be encountered as the wreck separated. Instead, the salvors decided to implant plastic explosive charges to be detonated simultaneously.

Lateral force of hydraulic pullers and buoyancy of installed foam begin to lift and right the hulk. However, shoreward movement at this stage is minimal because, unknown to salvors, bow and stern sections are still joined.

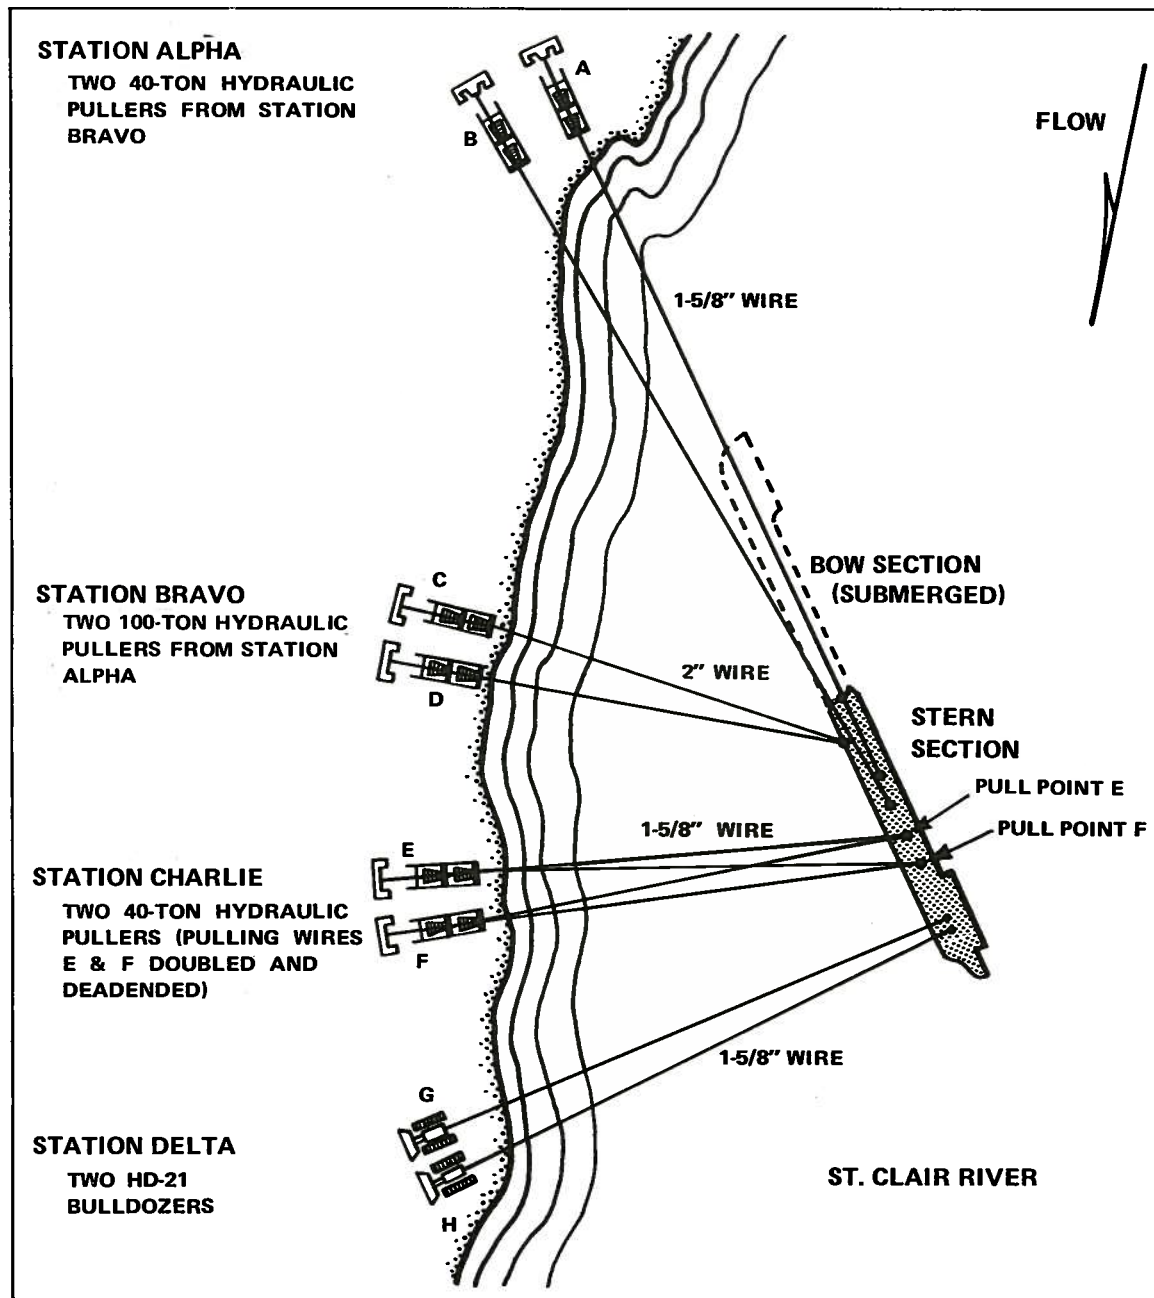
PULLING SYSTEM FOR FINAL STERN REMOVAL EFFORT

Complete rerigging of pulling stations for greater shoreward pulling force resulted in successful removal of stern. Station BRAVO received 100-ton pullers from Station ALPHA; rerigging at Station CHARLIE and on wreck doubled pulling force at pull points E and F; Station DELTA received additional bulldozer.

Another change to the salvage plan affected Pulling Station CHARLIE. Its pulling wires, E and F, were doubled with snatch blocks on the wreck. E wire was then deadended on F pulley and F wire deadended on E pulley. This gave the 40-ton pullers a 2:1 mechanical advantage. Thus, a maximum beaching force of 80 tons could be applied at both pull points E and F aboard the wreck.

In addition, a second HD-21 bulldozer was placed at Pulling Station DELTA to increase pulling power downstream. This additional dozer, designated puller H, was aligned with the first bulldozer, puller G, and connected to a pull point aft on the SMITH's port side with a 1 5/8-inch pulling wire. The addition doubled the 27-ton pulling force originally exerted at Station DELTA by the first dozer.

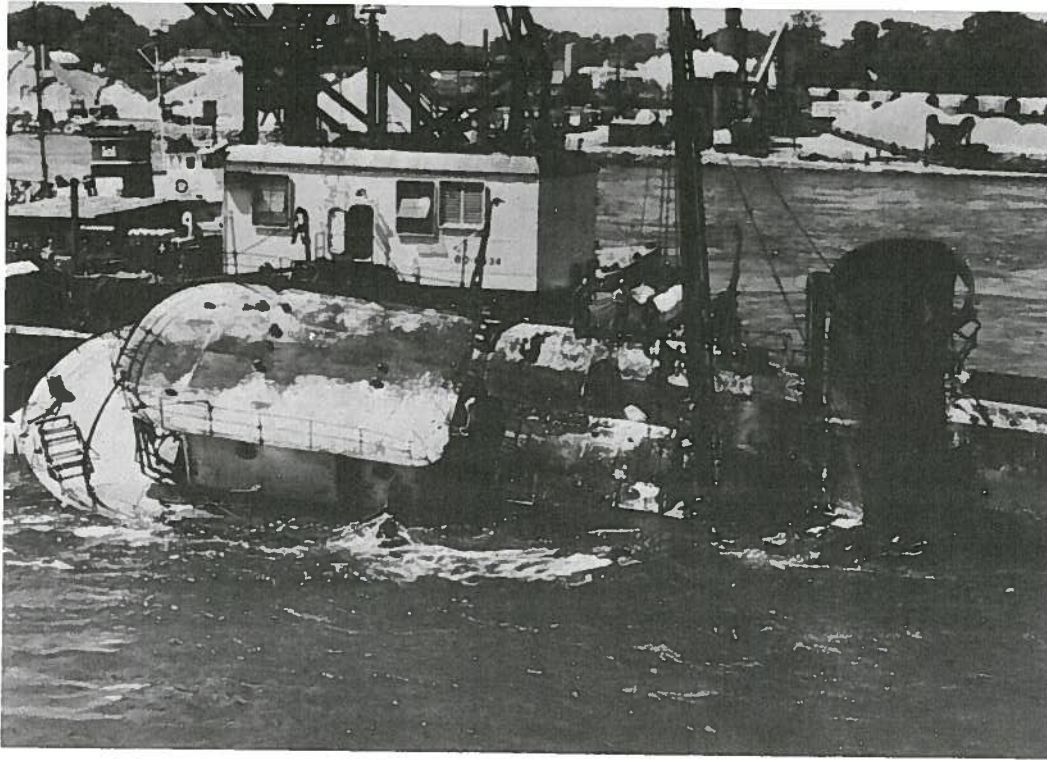
STERN SECTION JUST PRIOR TO FINAL PULL

Foaming operations are nearing completion. Stern is held against shallow underwater ridge initially. River current washed away ridge peak, helping to free the hulk for shoreward pull.
