S.S. SIDNEY E. SMITH, JR. SALVAGE OPERATION

**Removal of the sunken coal freighter, SIDNEY E. SMITH
from the shipping channel of the St. Clair River**

**Port Huron, Michigan
June-November, 1972**

**Department of the Navy
Naval Sea Systems Command
Washington, D.C.**

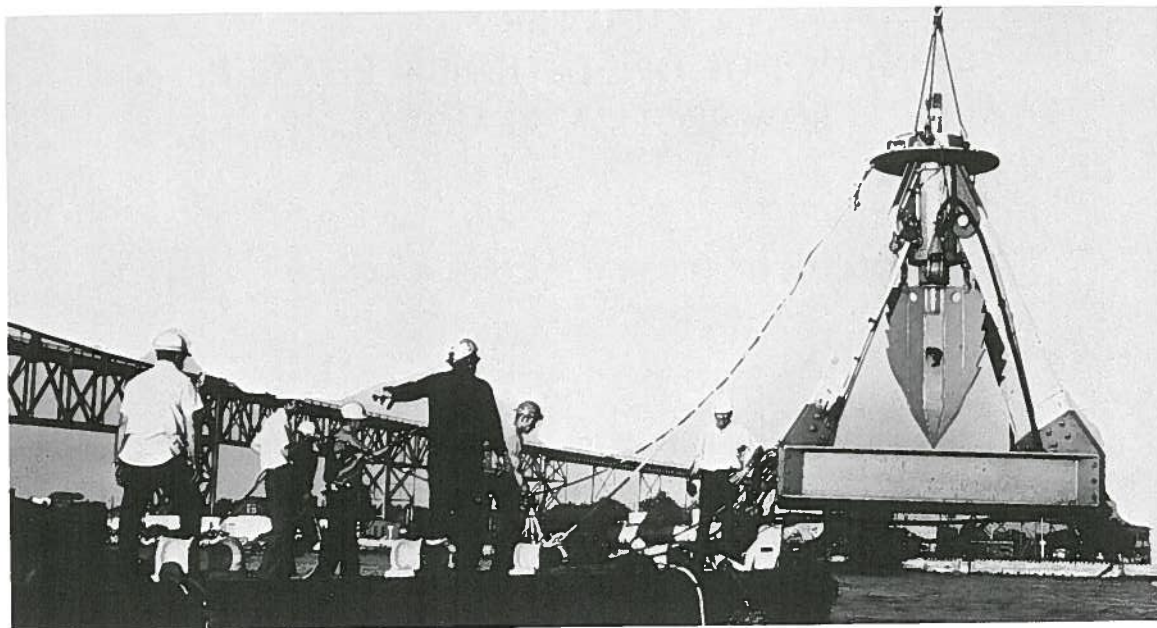
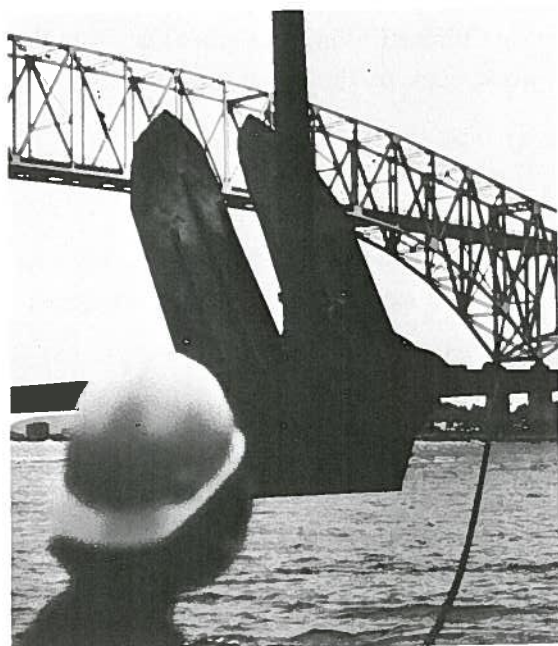
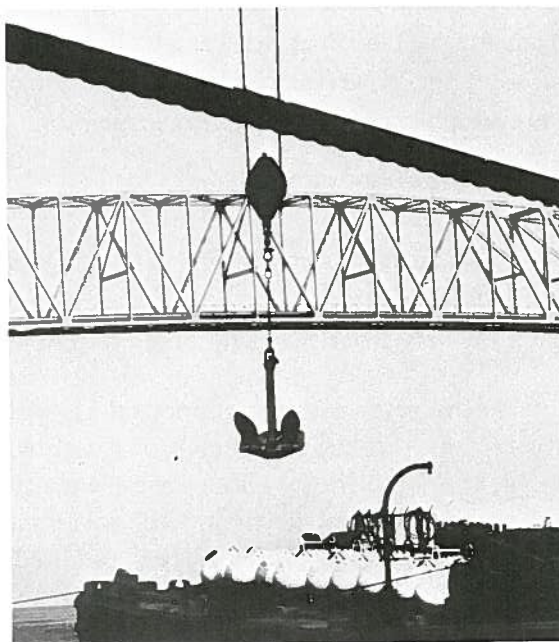
IMPLANTMENT OF ANCHORS FOR MOORING THE DERRICK BARGE

Attempts to implant the embedment anchors failed. Stato anchors were then substituted for the two upstream mooring legs. Stockless anchors were implanted for the other two mid-channel mooring legs as planned.

Failure of Embedment Anchors

On 12 August, mooring legs 1 and 2 were positioned upstream from the submerged bow. The first embedment anchor was lowered into position 240 feet, 130°T, from the southern tip of the Peerless Cement Company dock, and an explosive charge fired. Unfortunately, a shackle pin parted as the anchor penetrated the river bottom and the anchor was lost.

Mooring legs 1 and 2, implanted upstream, had to withstand the heaviest loads. Accordingly, two Navy stato anchors were used for these legs following the failure of the embedment anchors: a 12,000-pound stato anchor for leg 1, the northernmost leg; and a 9,000-pound stato anchor for leg 2, which projected well out into the shipping channel. Mooring legs 3 and 4, implanted downstream, each had a lighter, 6,000-pound stockless anchor.

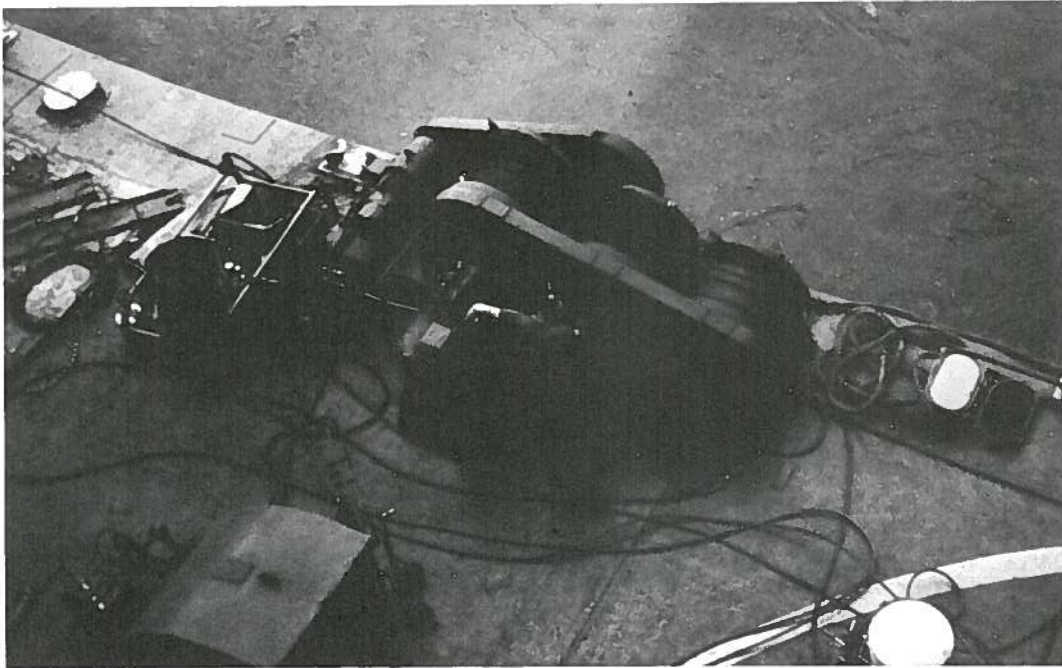
3-DRUM WINCH CONTROLS MOOR OF BARGE OVER SMITH'S BOW

Salvors used the derrick barge's two 3-drum winches to maneuver the moored barge by heaving around and slacking off on mooring wires. Precise maneuvering was crucial during cofferdam installation.

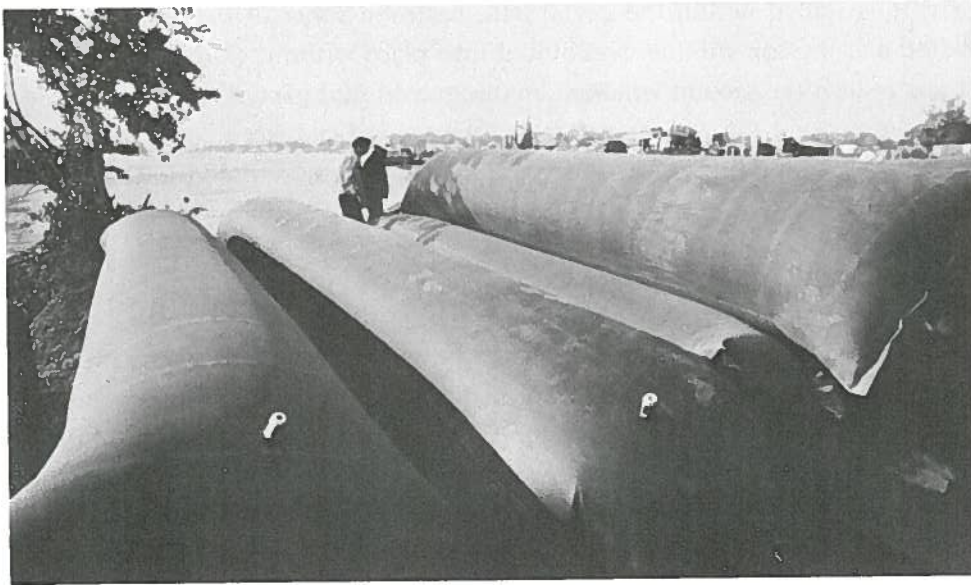
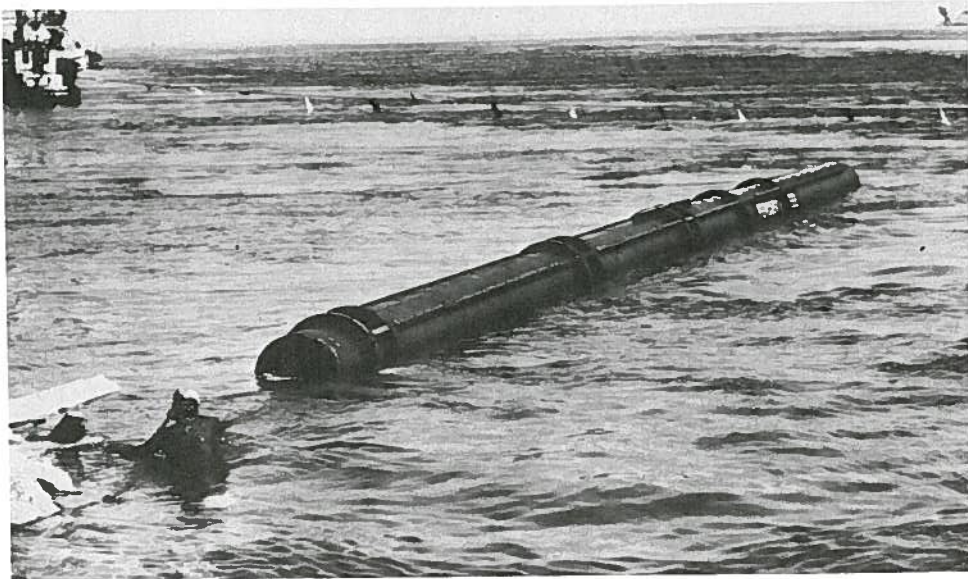
AIR BAGS FLOAT COFFERDAMS TO BARGE

Giant 100' long cofferdams were awkward to handle and move. Salvors solved problem by putting inflated air bags inside cofferdam and floating it out to the barge for installation on bow section. Note cofferdam's newly installed lateral and longitudinal stiffeners.

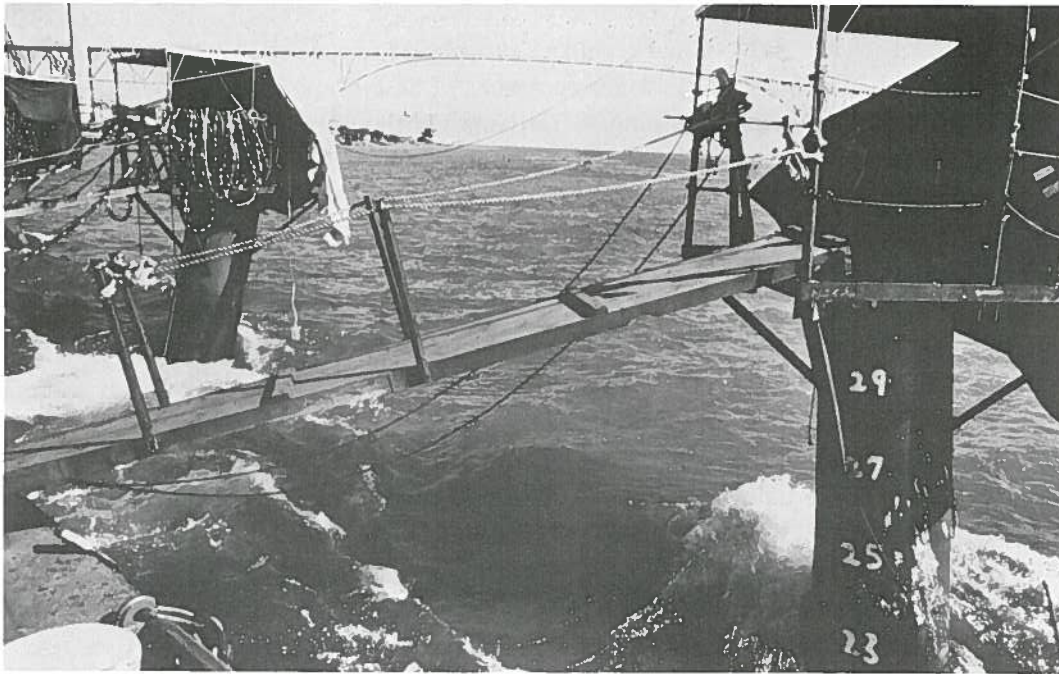
GANGWAY ACCESS FROM BARGE TO PLATFORMS ATOP COFFERDAMS

Bow salvage proceeds with all three cofferdams in place. Numbers on cofferdam mark water depth to port (i.e., top) side of capsized bow section.

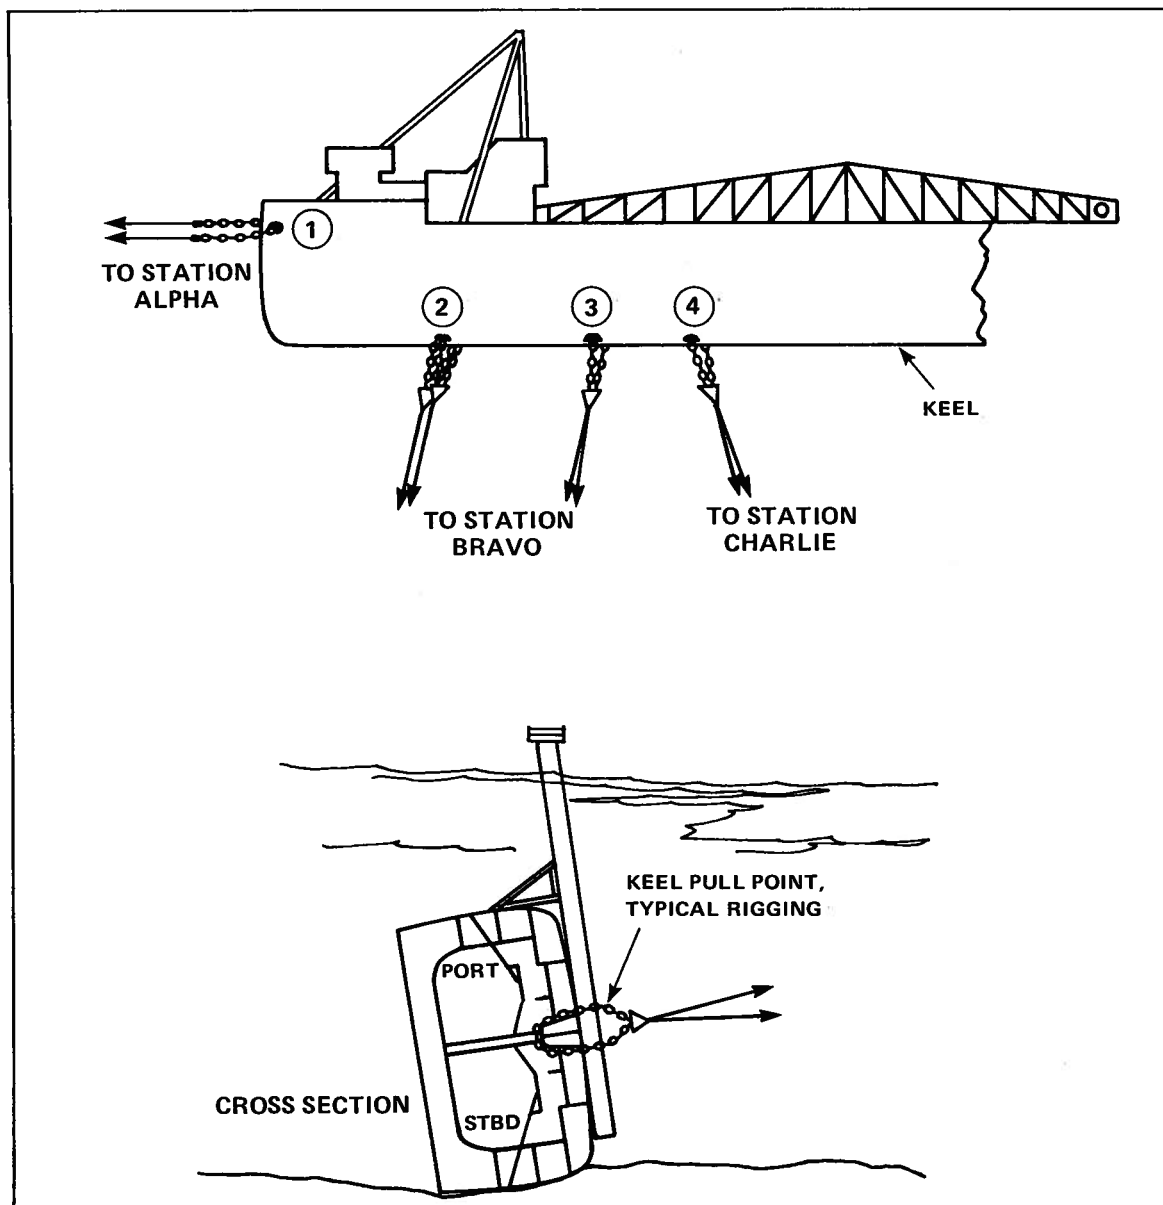
RIGGING OF PULL POINTS ON BOW SECTION

- ① Anchor chain extending from hawse pipes for pulling wires to 40-ton hydraulic pullers.
- ② Double loop of 2" chain around keel at frame 31 for pulling wires to 200-ton Skagit winch.
- ③ Single loop of 2¼" chain around keel at frame 46 for pulling wires to 300-ton Skagit winch.
- ④ Single loop of 2¼" chain around keel at frame 56 for pulling wires to 100-ton hydraulic pullers.

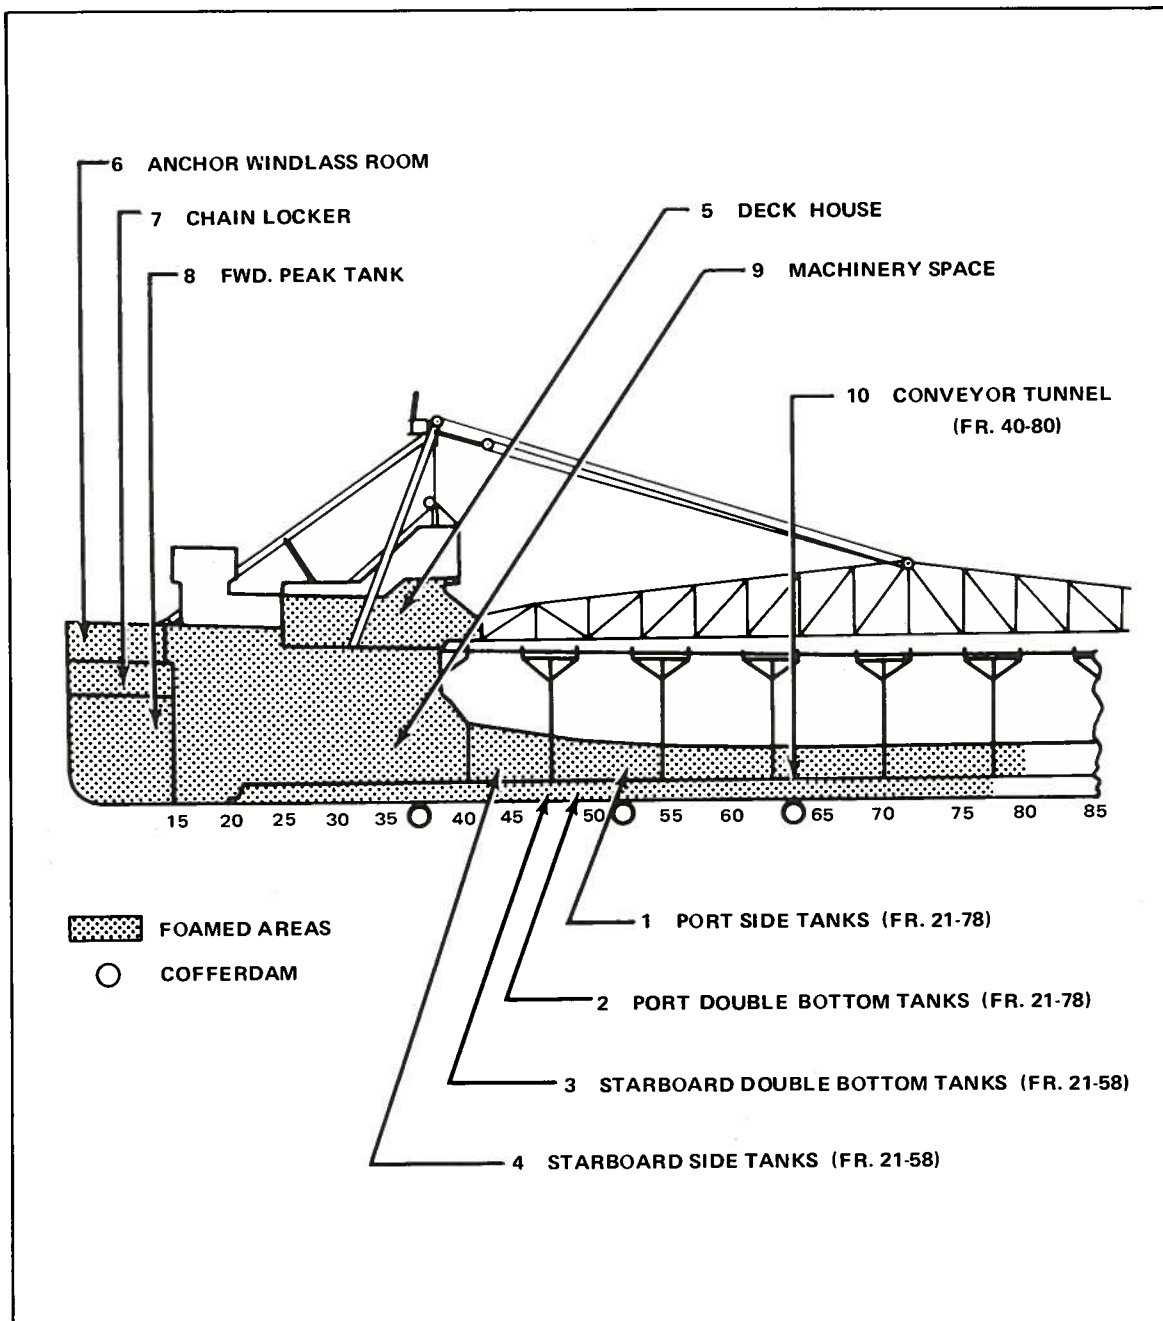
SEQUENCE FOR FOAMING THE BOW SECTION

From 16 to 21 September, divers installed more than 1700 tons of foam buoyancy in bow section's three structurally distinct areas: stem to frame 15; frame 15 to 40; and frame 40 to break. Numbers indicate sequence of tanks and spaces foamed.

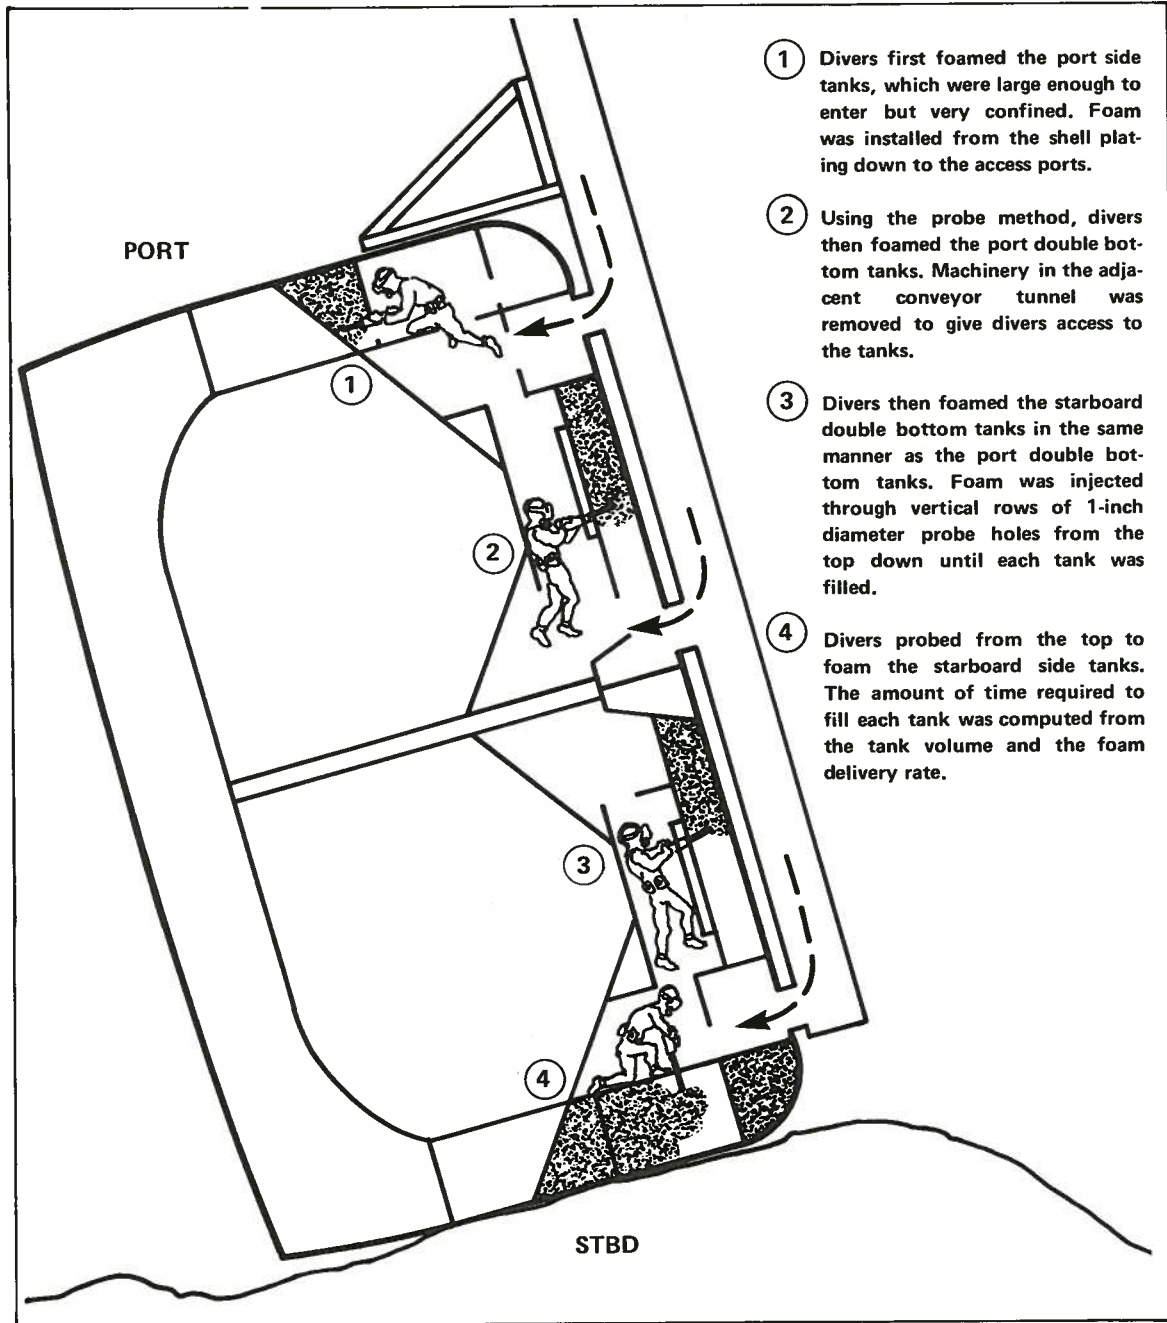
- ① Divers first foamed the port side tanks, which were large enough to enter but very confined. Foam was installed from the shell plating down to the access ports.
- ② Using the probe method, divers then foamed the port double bottom tanks. Machinery in the adjacent conveyor tunnel was removed to give divers access to the tanks.
- ③ Divers then foamed the starboard double bottom tanks in the same manner as the port double bottom tanks. Foam was injected through vertical rows of 1-inch diameter probe holes from the top down until each tank was filled.
- ④ Divers probed from the top to foam the starboard side tanks. The amount of time required to fill each tank was computed from the tank volume and the foam delivery rate.

Divers descended cofferdams to interior of bow section and foamed tanks in sequence shown above. Machinery and obstructions in conveyor tunnel were removed to enable divers to foam double bottom tanks.

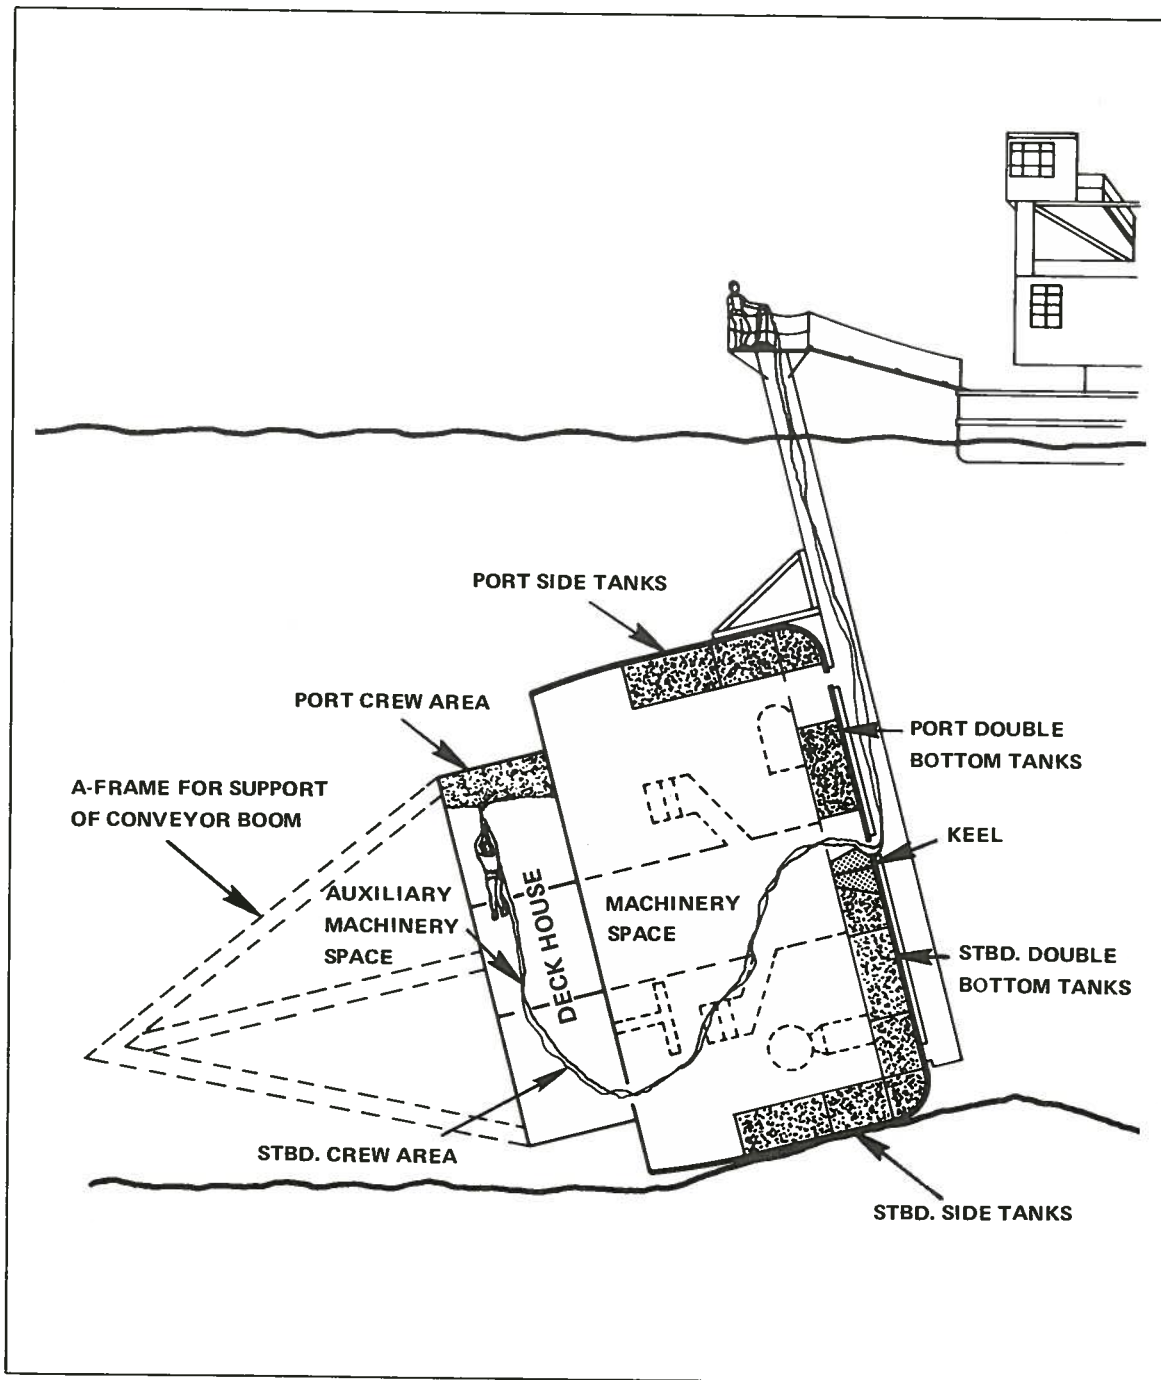
FOAMING THE DECK HOUSE, FRAMES 26 TO 35

Diver foamed deck house after completing side and double bottom tanks. Completion of deck house marked half-way point; forward area, machinery space and conveyor tunnel remained to be foamed.

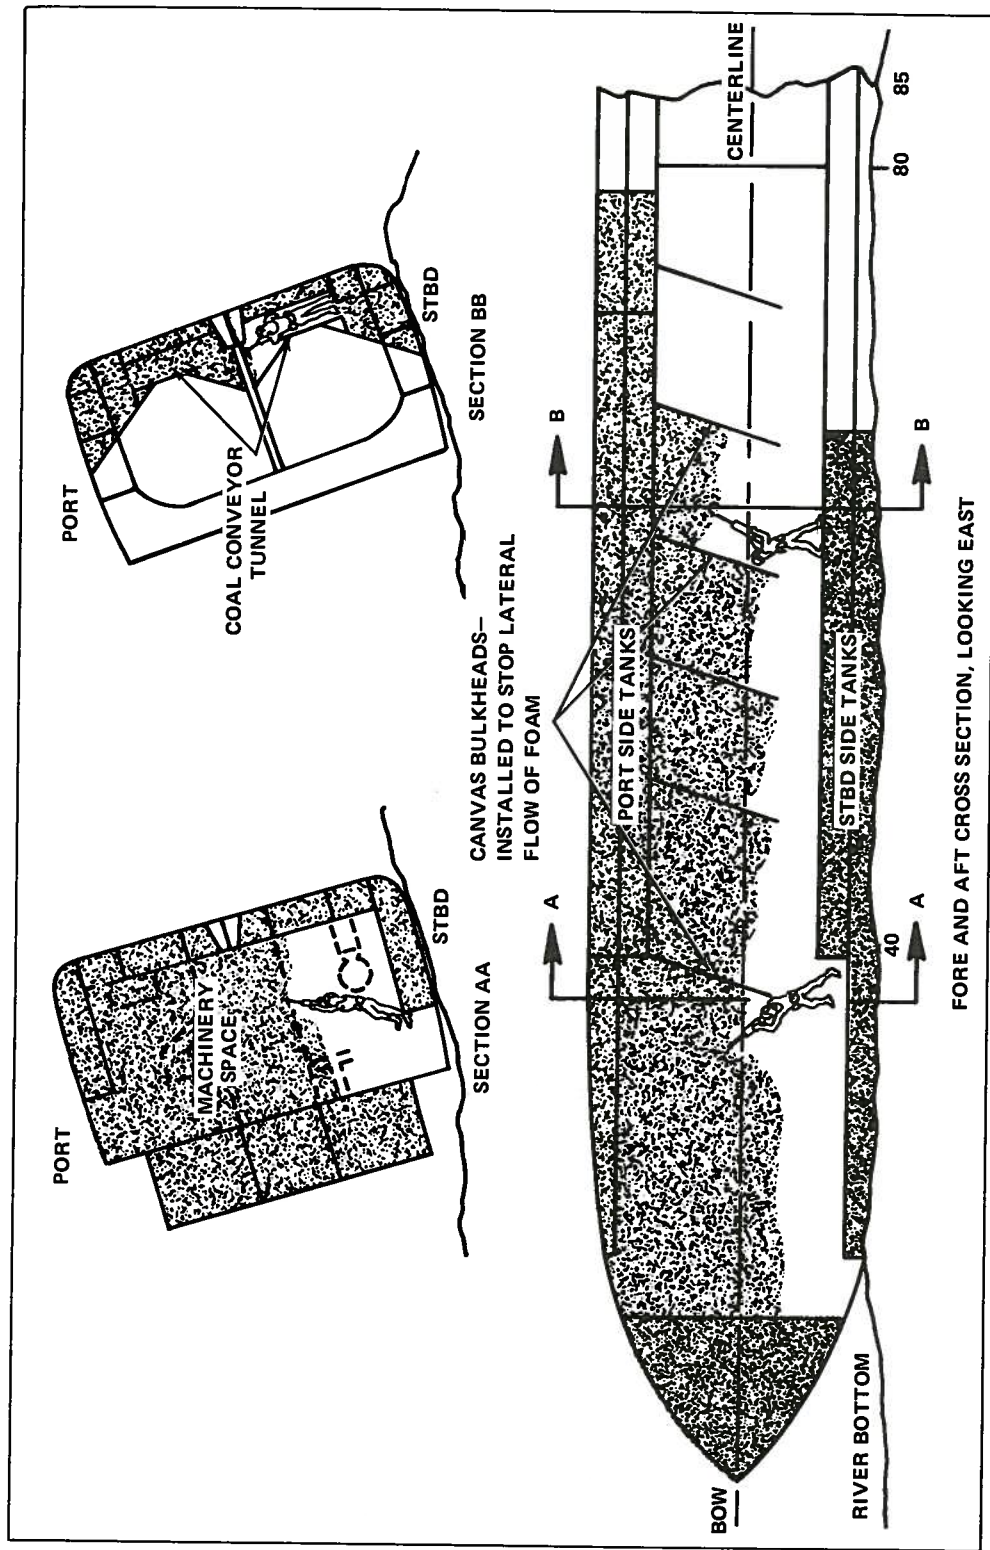
FOAMING THE MACHINERY SPACE AND CONVEYOR TUNNEL

Divers installed canvas bulkhead at frame 40 and foamed machinery space to a level just below ship's centerline. Divers then entered conveyor tunnel, installed additional canvas bulkheads, and foamed toward frame 80 until required 1,700 tons of buoyancy was achieved.

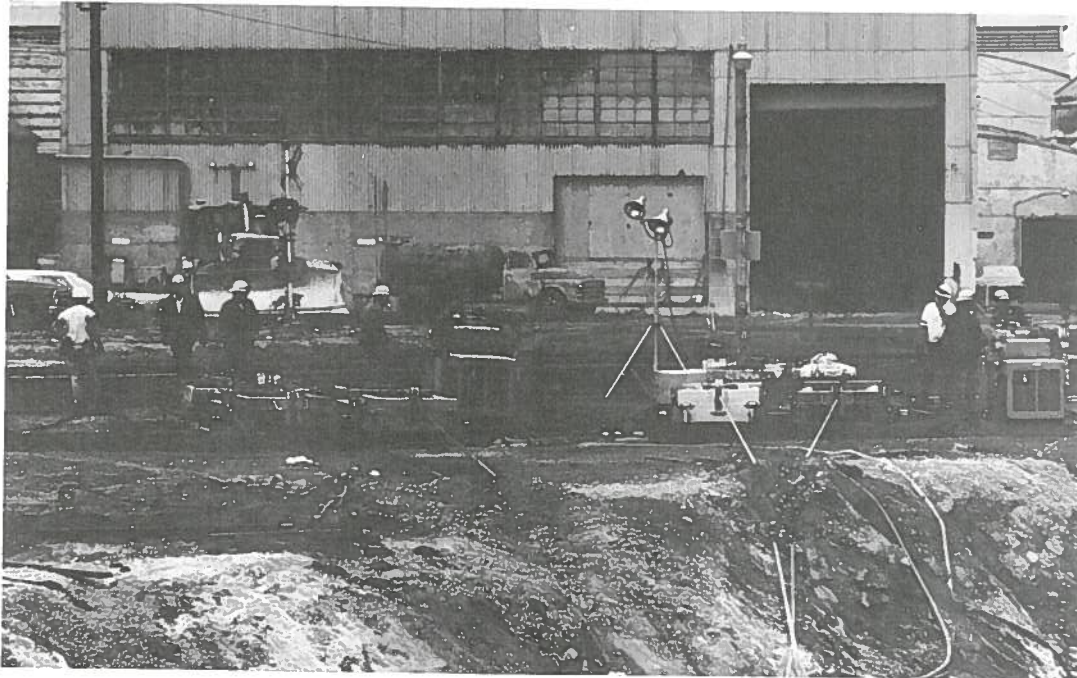
40-TON PULLERS RIGGED IN PAIRS AT STATION ALPHA

Each pair of pullers is rigged to one anchor block using a specially designed spreader bar. Holding wires to SMITH's anchor chains had to be rerigged after initial pulling attempt failed.

moved about 40 feet toward shore but, simultaneously, it also moved downstream farther and faster than anticipated. Tension was placed on the holding wires at Station ALPHA but this effort proved inadequate to control the downstream surge. A chain stopper on the fore-castle of the wreck gave way, releasing the port anchor chain. The pair of holding wires attached to this chain went slack as the anchor chain began paying out. The entire load at Station ALPHA shifted to the other set of pullers. The sudden strain on the two holding wires from these pullers was excessive and one of them soon parted.

As these failures were occurring in rapid succession at Station ALPHA, the wreck grounded, pivoting on its broken after end with the forward end swinging in toward the beach. It was still submerged and still blocking the channel although it had moved about 40 feet closer to shore from its original position. Trouble was not confined to Station ALPHA during this first and unsuccessful pulling effort. At Station BRAVO, a heavy pull by the RB-150 winch damaged the winch's anchor block. The concrete cracked around the block's U-bolt connection to the winch.

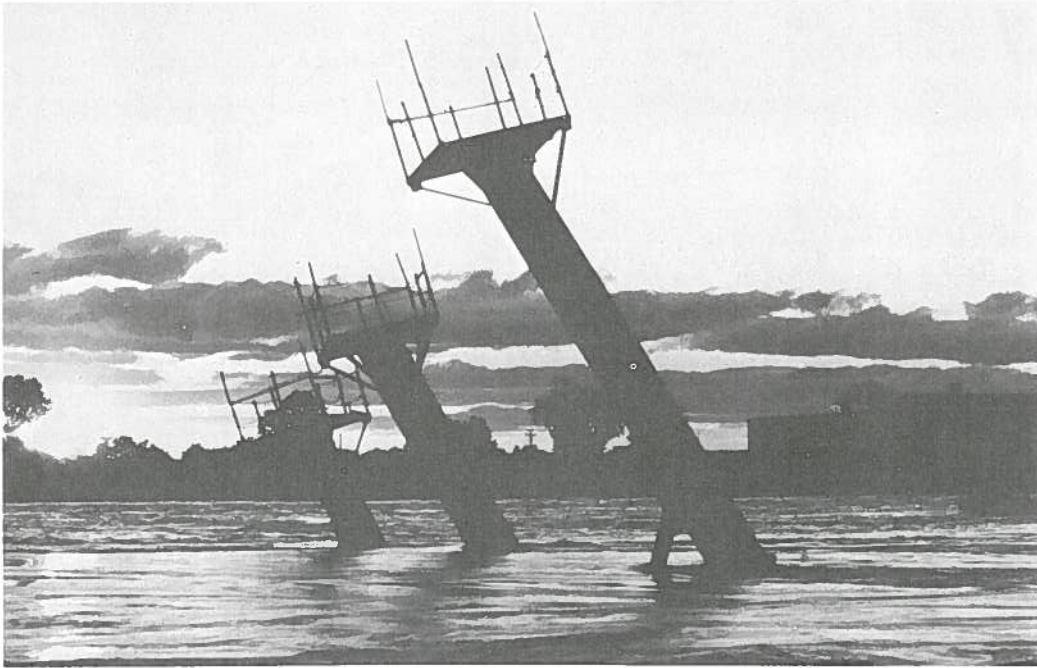
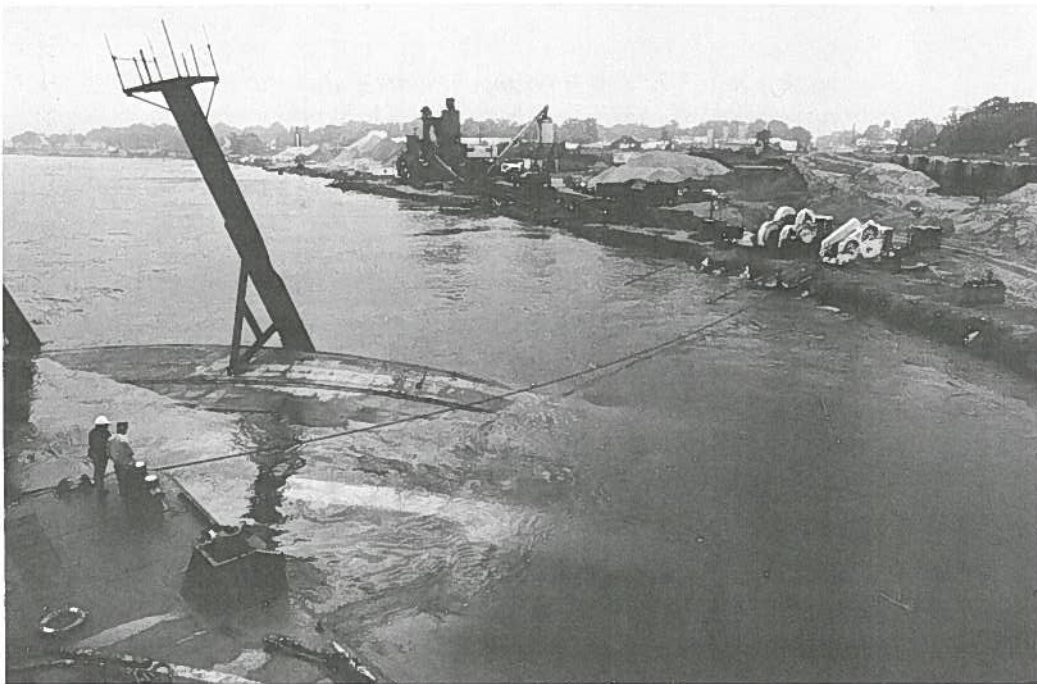
INCREASING HEIGHT OF COFFERDAMS MARKS PROGRESS OF PULL

*Bow broke surface 100 feet from shore near end of all night pull, 21-22
September, after 3½ months on river bottom.*

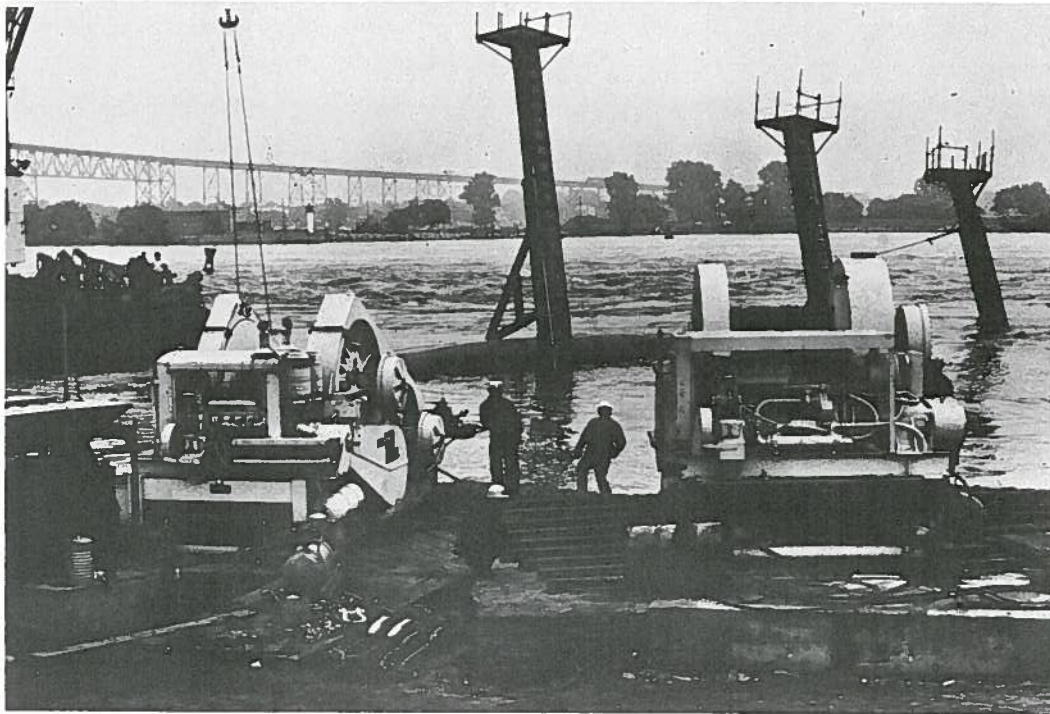
BOW REMOVAL OPERATIONS CONCLUDED

Bow section rested 70 feet from shore morning after successful pull from mid-channel. Salvors moved barge alongside to survey wreck prior to start of Phase III, disposal operations.

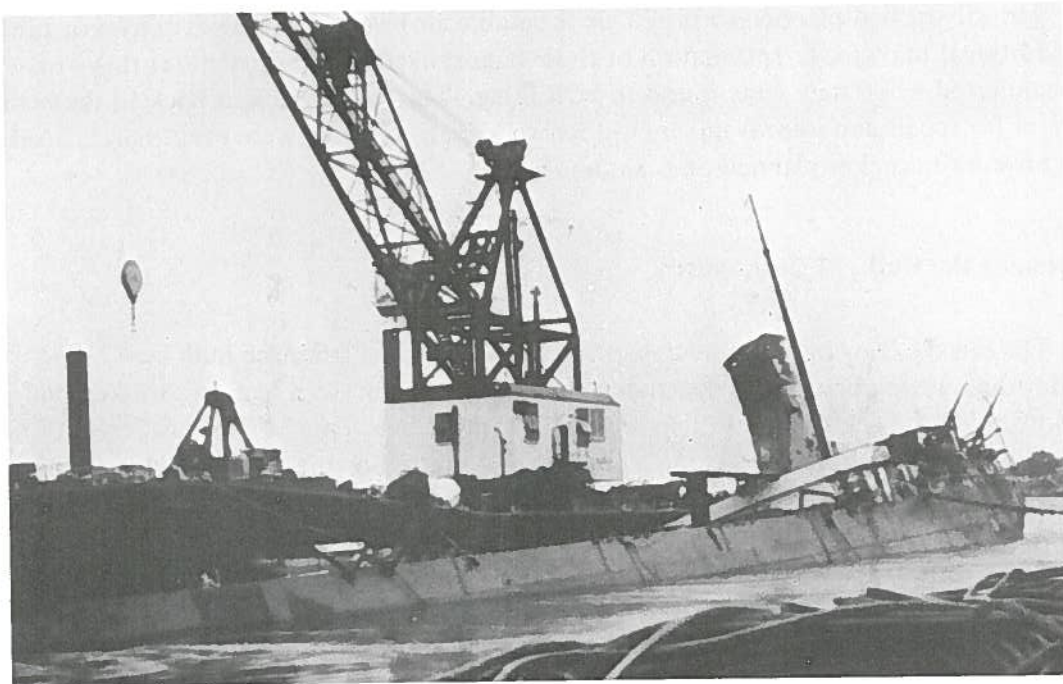
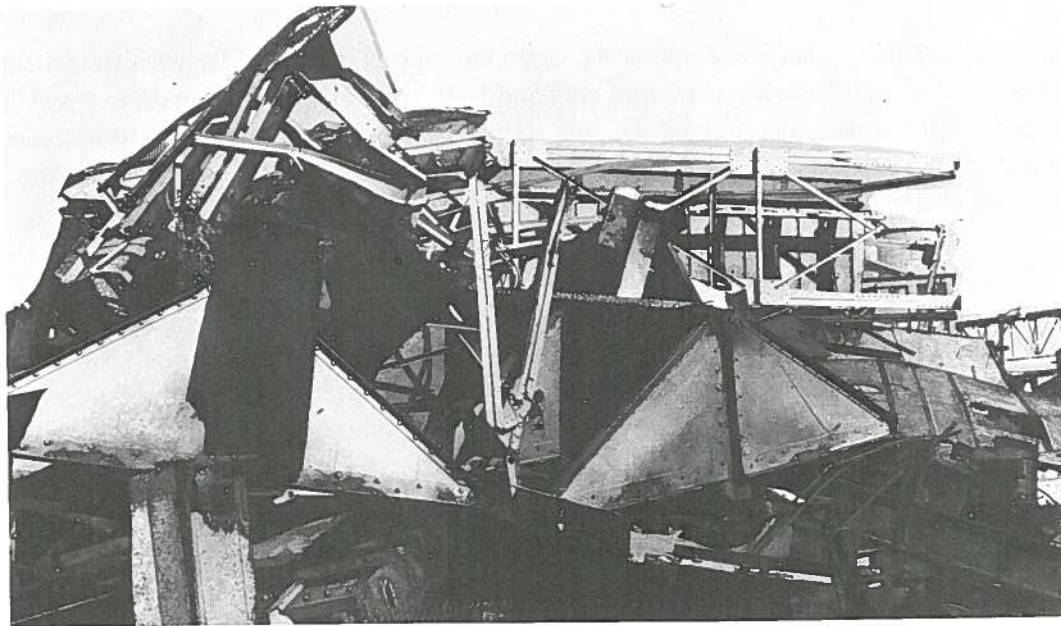
EXCESS WEIGHT REMOVED FROM STERN SECTION

Derrick barge assisted mobile land cranes in stern disposal operations by lifting and placing heavy pieces of scrap ashore. Approximately 350 tons of scrap were temporarily piled near Peerless Co. dock.

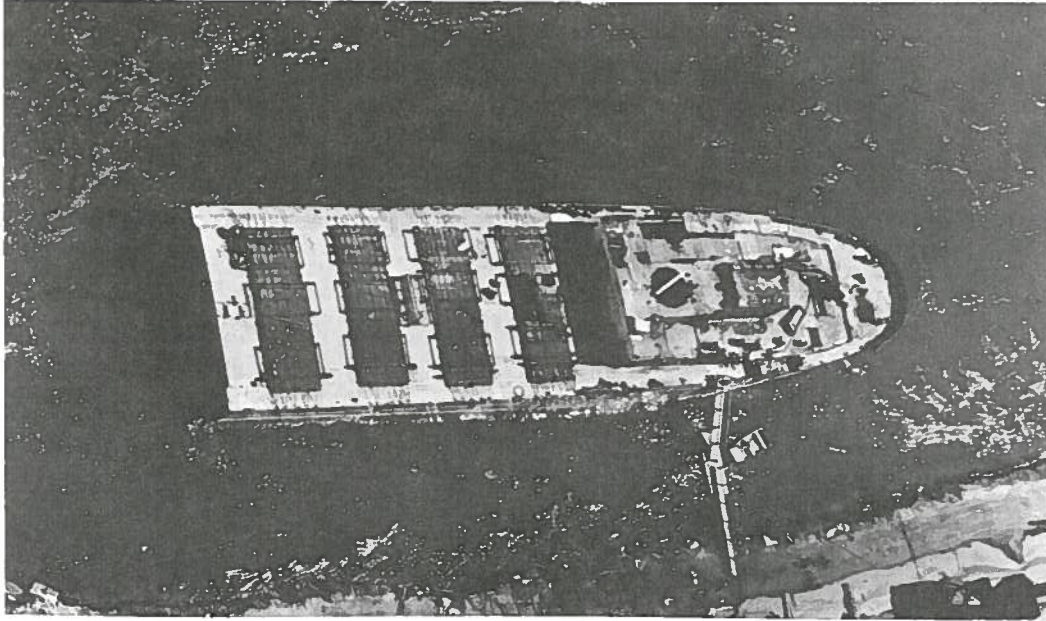
STERN SECTION REFLOATED, AWAITING FINAL DISPOSAL

Hatch covers remain in place over foamed cargo holds 5 and 6. To help refloat wreck, salvors removed 70' long, 200-ton section of cargo hold 4 which was open to river.

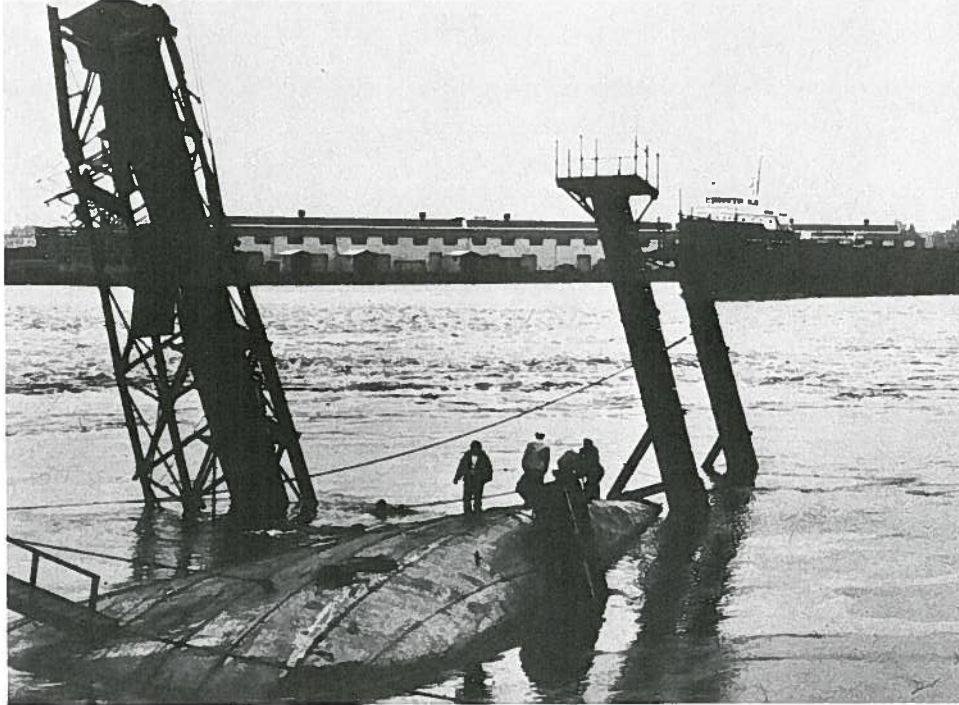
COAL CONVEYOR BOOM LIFTED FROM BOW SECTION

With bow section out of mid-channel, salvors removed cofferdams and SMITH's coal conveyor boom. Wreck was then more manageable for parbuckling.

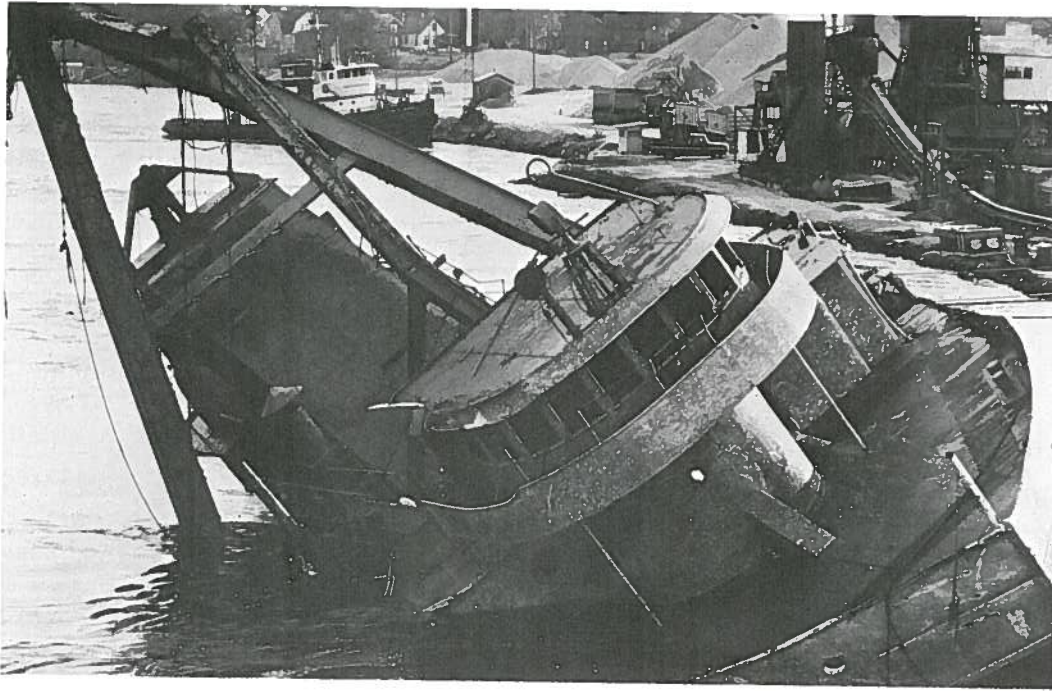
BOW SECTION PARTIALLY RIGHTED

With pull points on wreck rerigged, bow section was brought to within 40 feet of shore and parbuckled to 40° starboard list. Further parbuckling reduced list to 22°, but efforts were hampered by presence of submerged pier pilings beneath wreck.

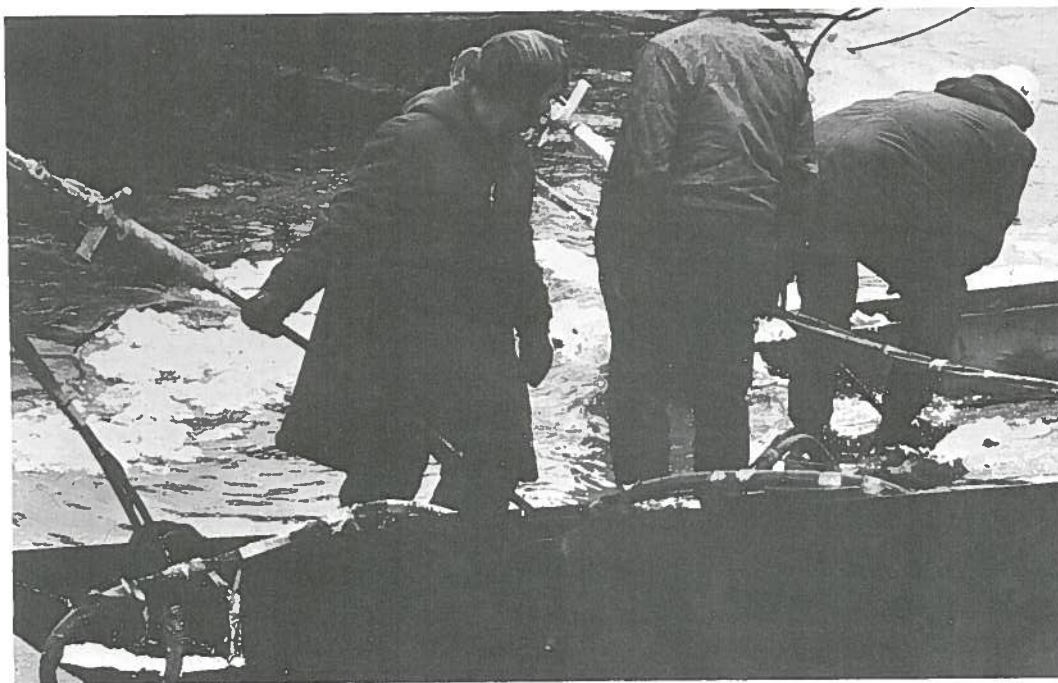
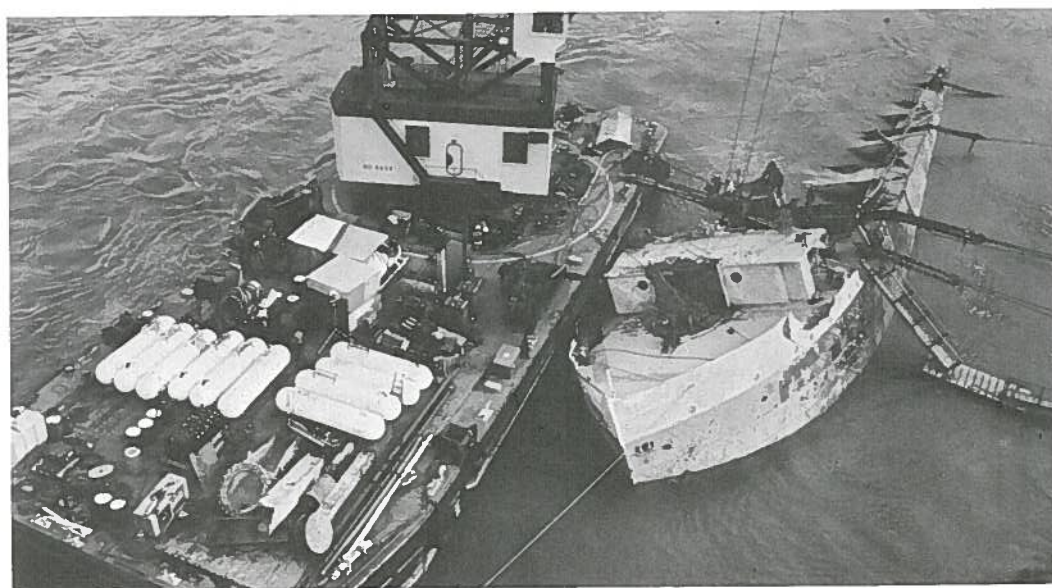
ADDITIONAL FOAM AND PULLING FREES BOW SECTION

Using probe method, salvors installed additional foam in cargo hold 2 and other compartments. Foam, plus rocking motion applied by derrick, finally lifted wreck from pier pilings, allowing it to float freely.

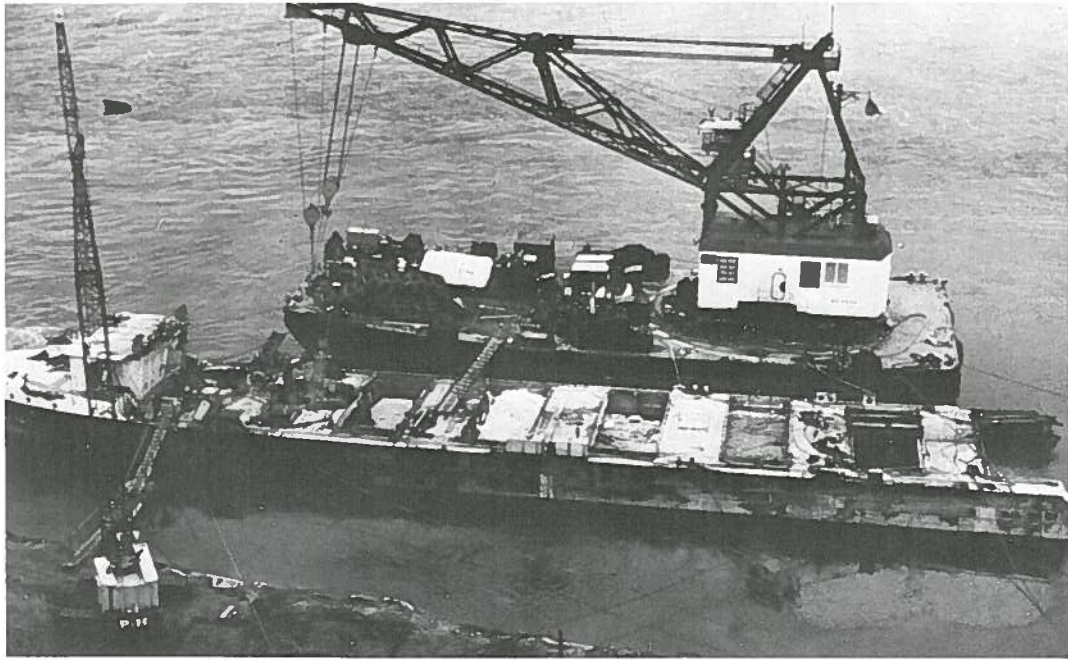
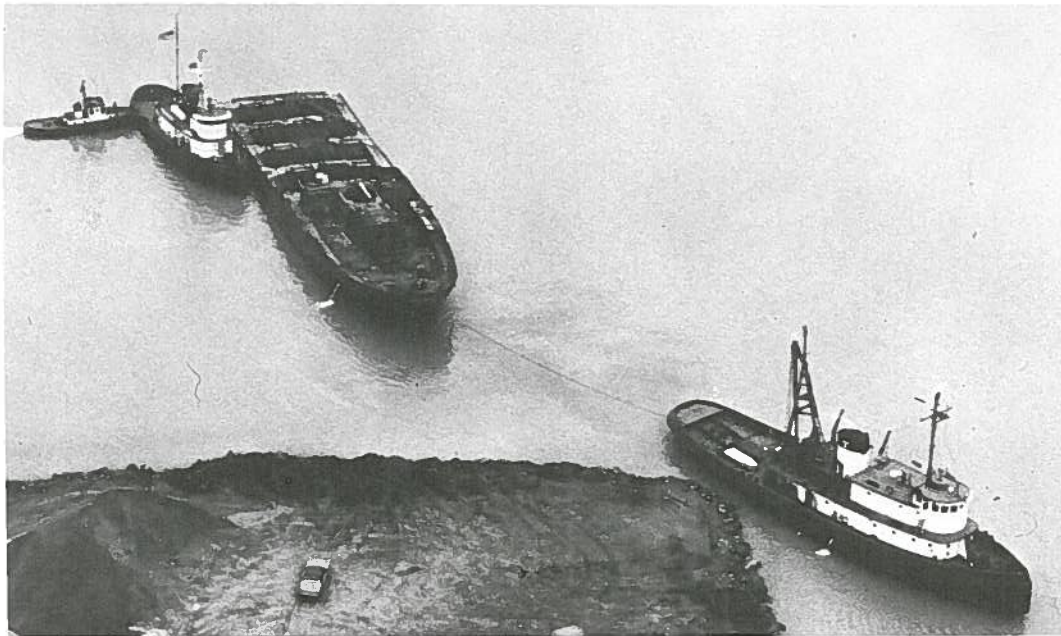
BOW AND STERN SECTIONS PRIOR TO FINAL DISPOSAL

After bow section (top) was floated and stabilized, it followed stern section (bottom) in tow across St. Clair River to Sarnia, Ontario. Both were then sunk in excavations dredged along riverbank.
