S.S. SIDNEY E. SMITH, JR. SALVAGE OPERATION

**Removal of the sunken coal freighter, SIDNEY E. SMITH
from the shipping channel of the St. Clair River**

**Port Huron, Michigan
June-November, 1972**

**Department of the Navy
Naval Sea Systems Command
Washington, D.C.**

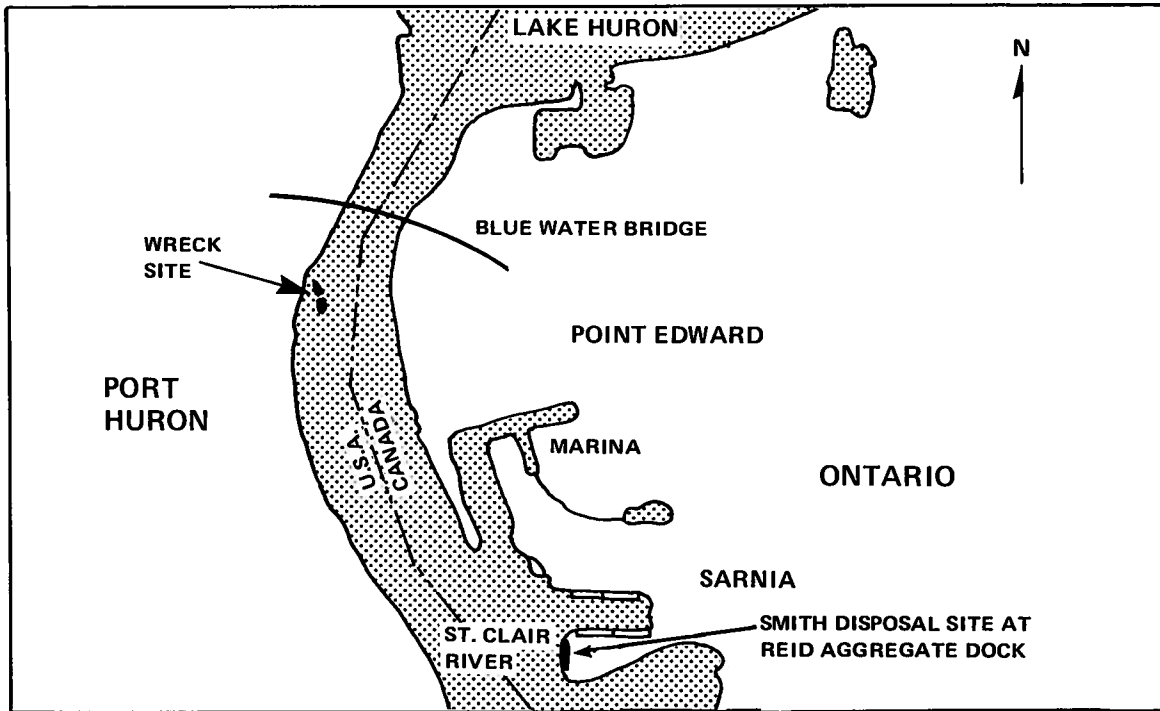
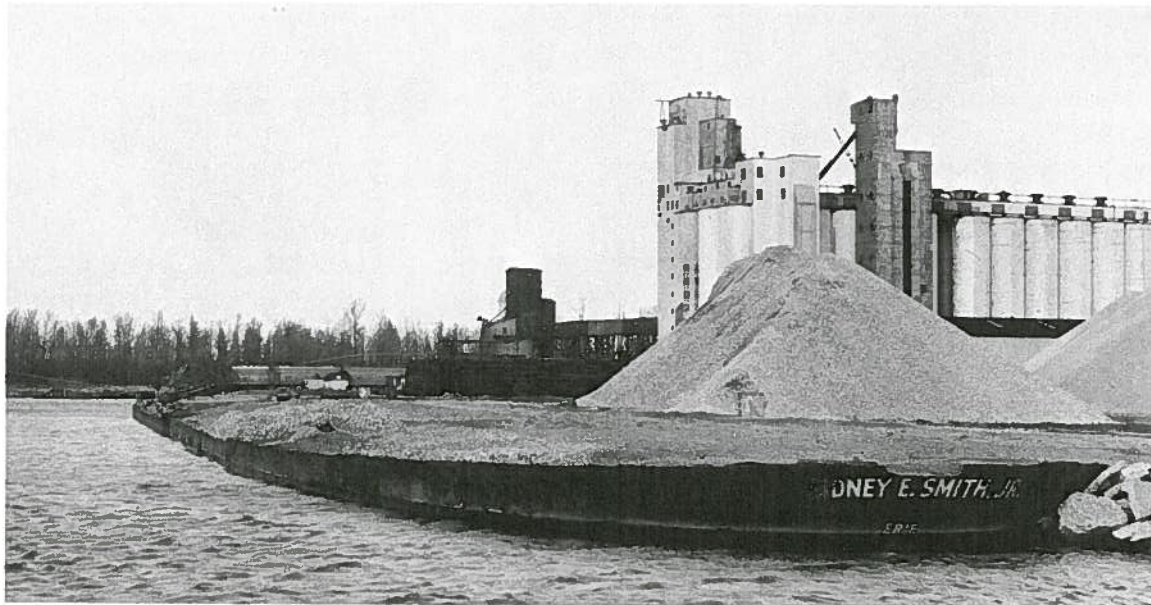
SMITH'S HULK PROTECTS SARNIA SHORELINE

Sailing days over, SMITH still performs useful function in final resting place. City of Sarnia has long range plan to use this waterfront property as site for cultural center.

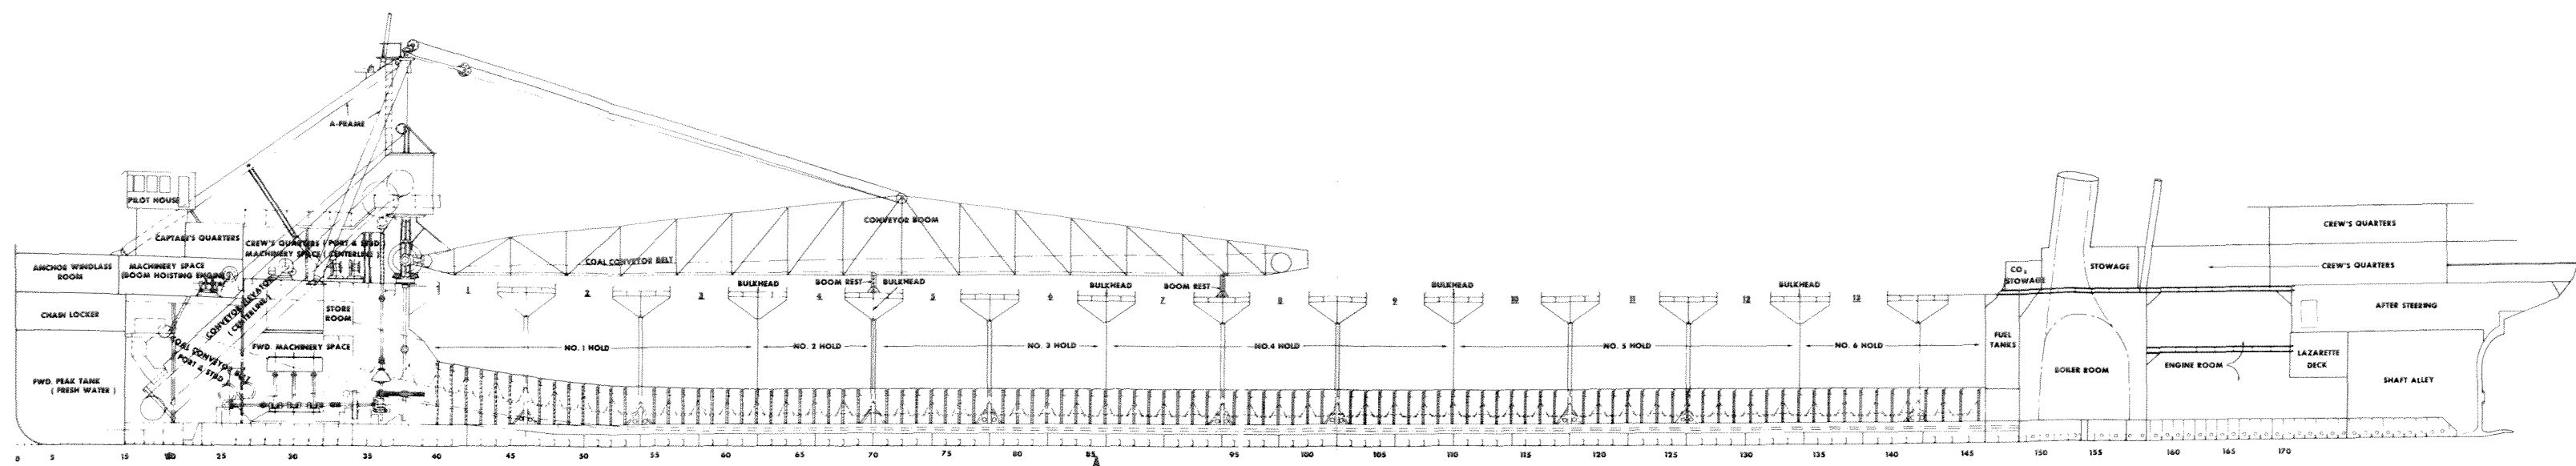
BREAK-UP OCCURRED AT FRAME 85
