ex-USS TORTUGA (LSD 26) SALVAGE REPORT

T9597-AB-RPT-010/SUPSALV

14 SEPTEMBER 1989

**SUPERVISOR OF SALVAGE
U.S. NAVY**

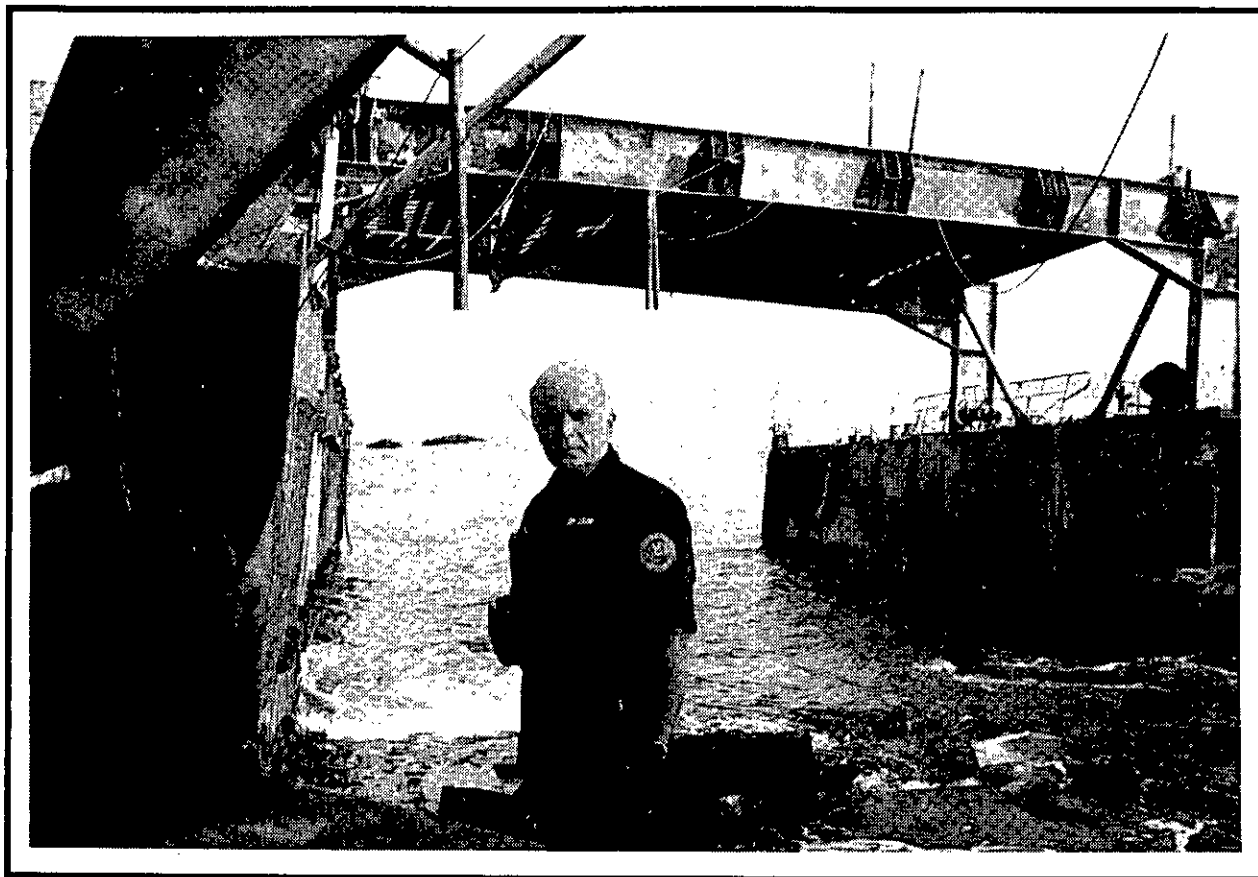
FIGURE 3-1. "Not much to smile about as Jim Bladh surveys TORTUGA."

All fuel and ballast tanks and engineering spaces below the third deck (well deck), with no observed exceptions, were open to the sea. Mechanical systems within these spaces were disrupted. The ship appeared to be impaled by rocks in several locations along the starboard side amidships, and the hull appeared as though it may have sustained a fracture across the bottom at Frame 41. It was estimated that any plan to remove the fore section intact would have to include careful and selective topside weight removal in order to prevent further weakening of the hull girder and possible breaking of the ship at this frame. The detached 100-foot stern section, weighing approximately 400 long tons, appeared to be readily removable by breaking, refloating or a combination of the two.

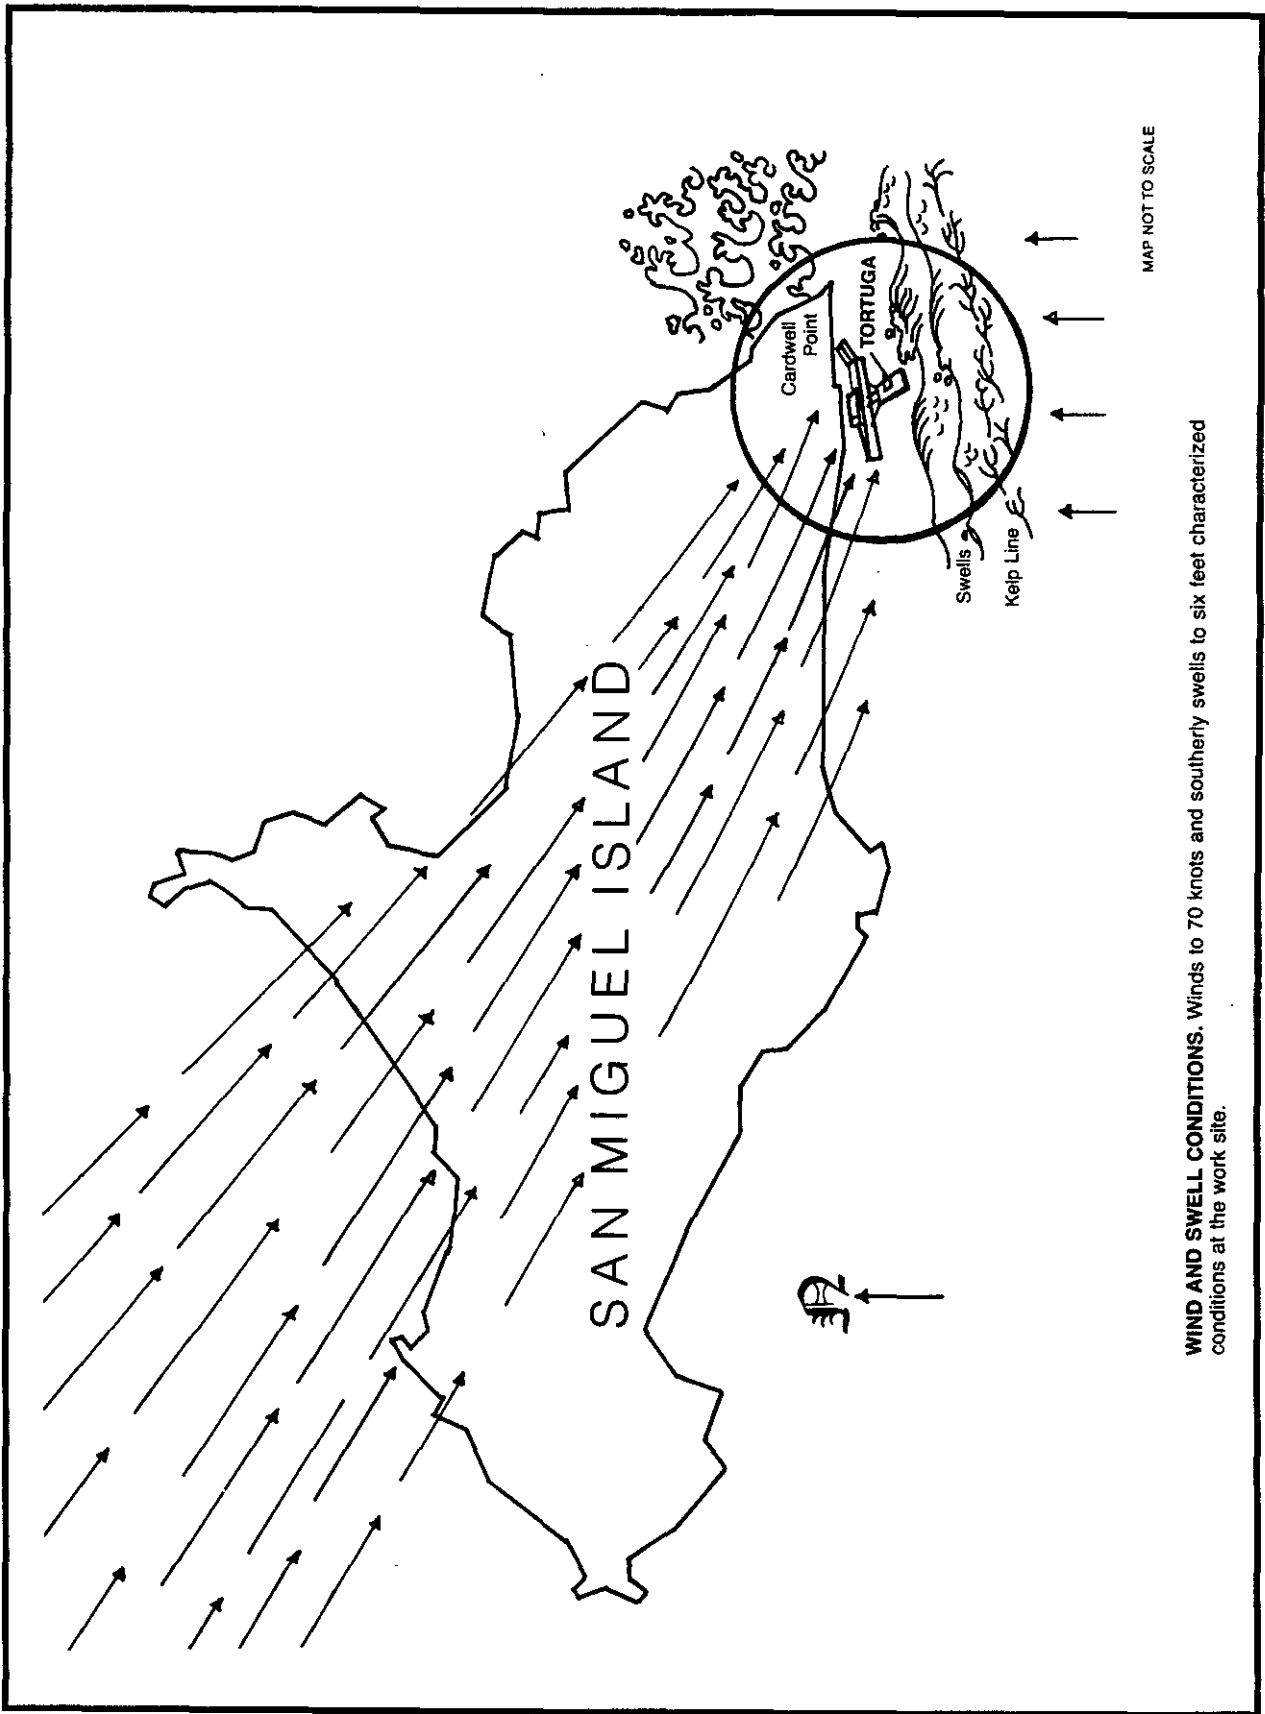
FIGURE 5-6. Wind and Swell Conditions.

WIND AND SWELL CONDITIONS. Winds to 70 knots and southerly swells to six feet characterized conditions at the work site.

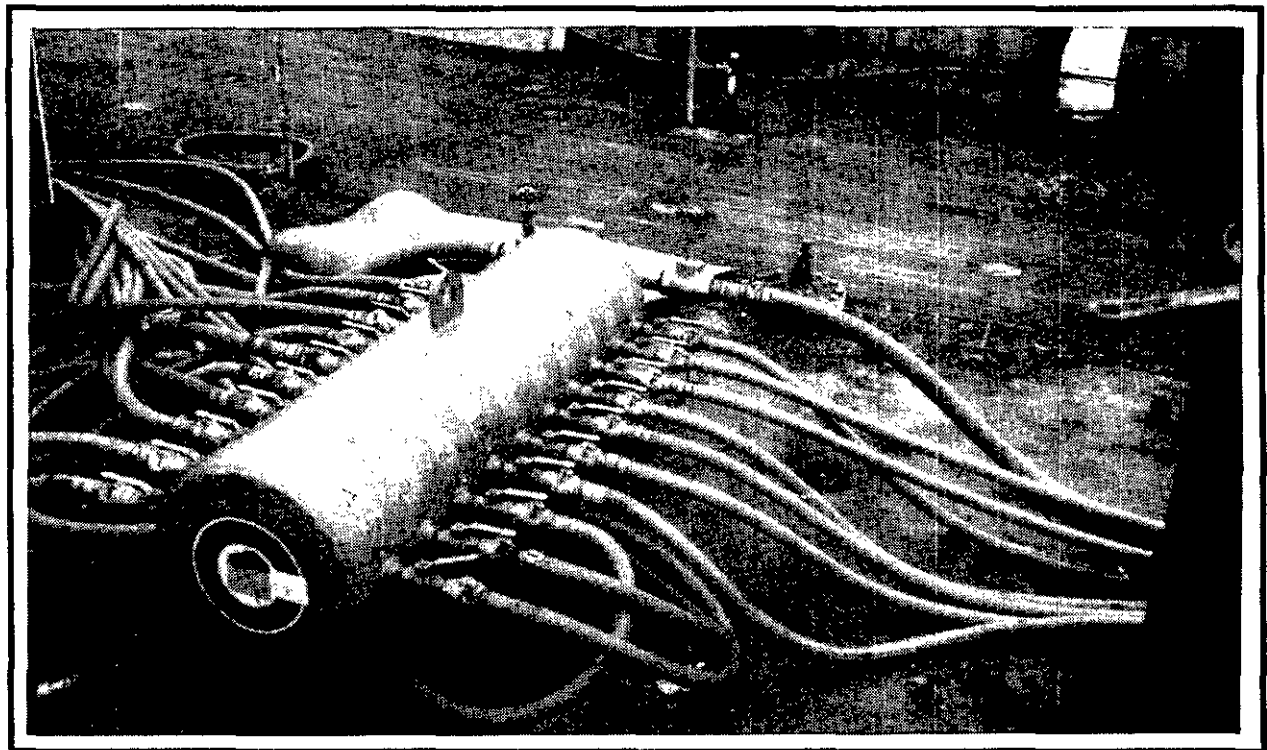
FIGURE 5-19. Primary Manifold to all Tank Tops.

5-3.1 TANK SURVEYS. Every ship tank was surveyed for leaks and to assess the extent of damage. Initial dry surveys were completed by Fleet personnel. Subsequently, the salvage contractor used two of its own salvage divers to perform the remaining underwater surveys and ballast tank repairs. Figures 5-16 through 5-19 depict reviewing of the salvage plan and tank repairs.

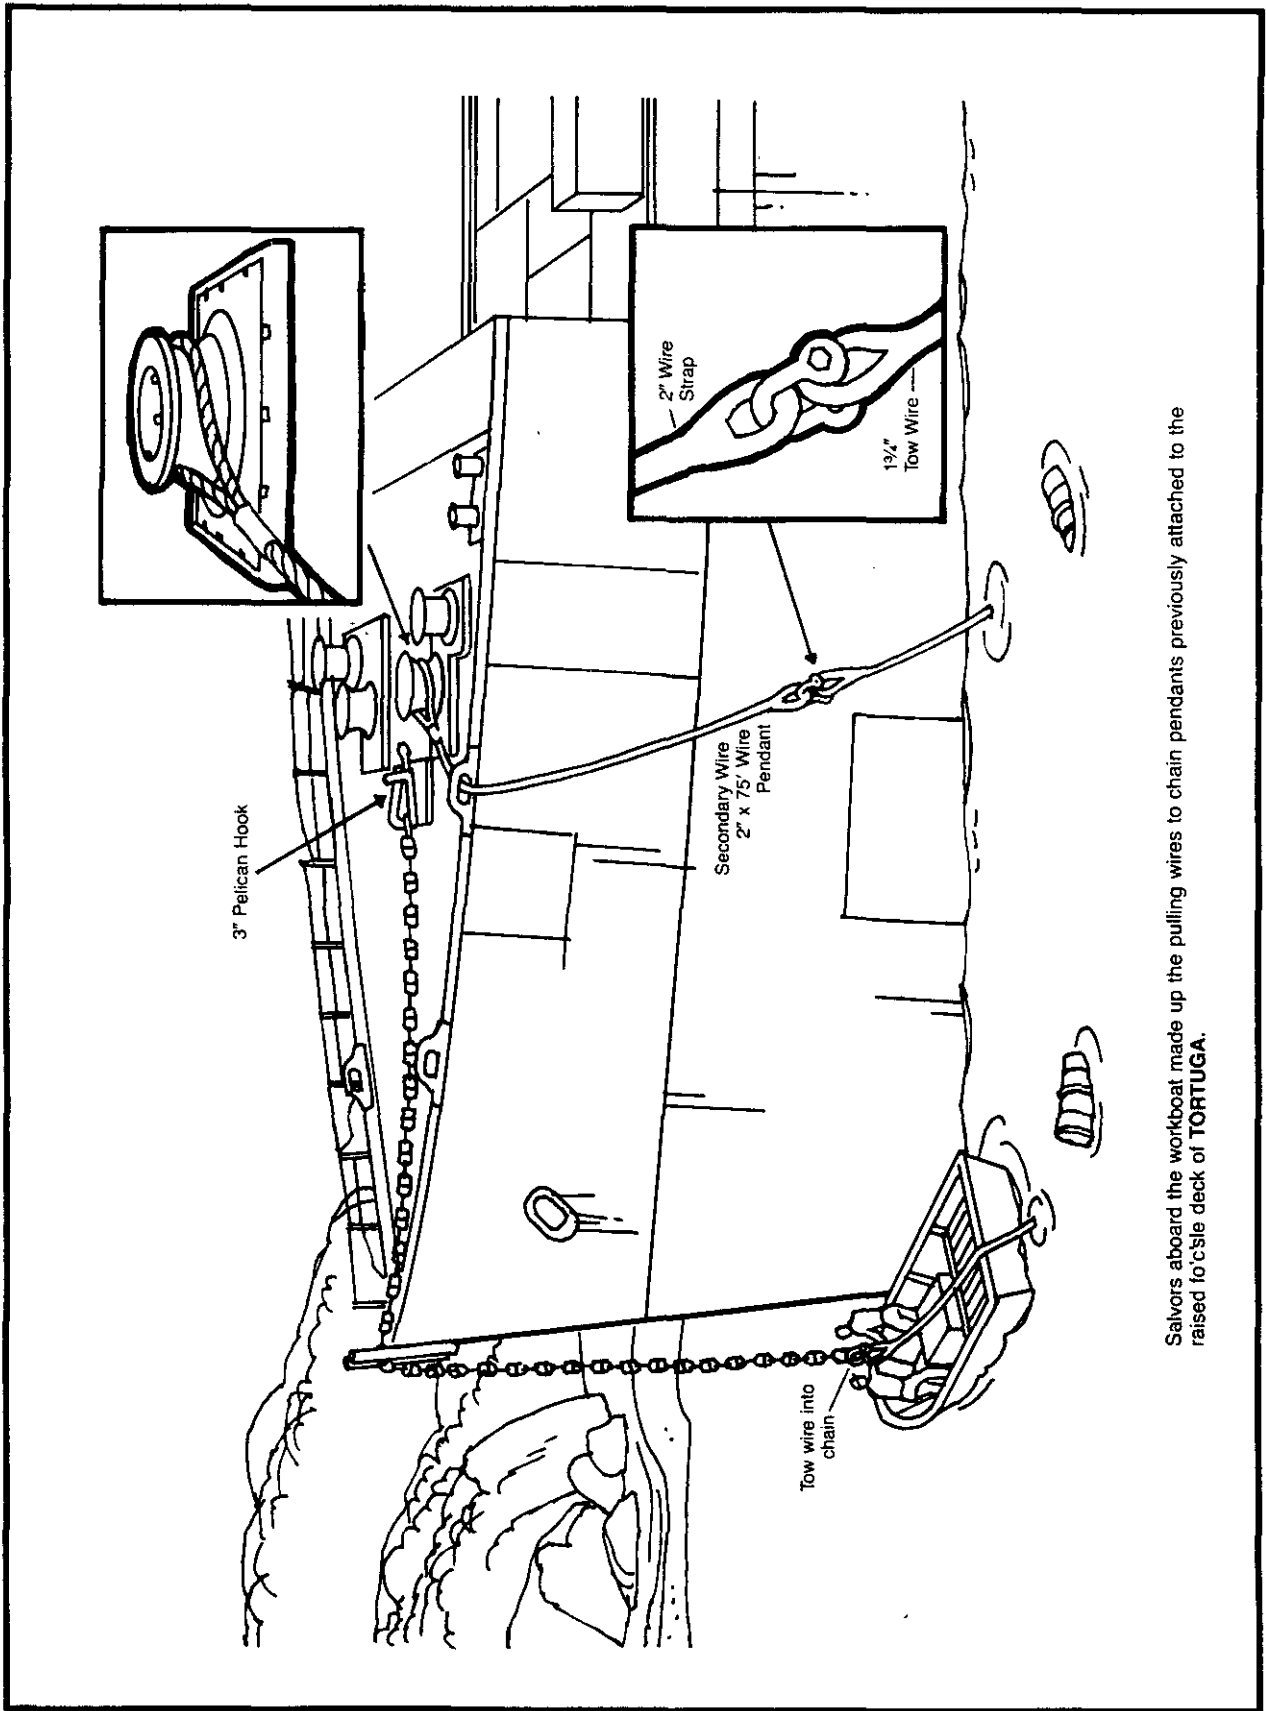
FIGURE 5-21. Rigging for the Pull.

RIGGING FOR THE PULL. The salvage vessel was positioned 2,000 feet from **TORTUGA**, with four 12,000-pound Eells anchors set 2,500 feet forward. Wires from the **ARCTIC SALVOR's** after winches were pulled to the wreck by a small workboat, aided by buoyancy provided by the attachment of barrels at 100-foot intervals.

Salvors aboard the workboat made up the pulling wires to chain pendants previously attached to the raised to c/sle deck of TORTUGA.

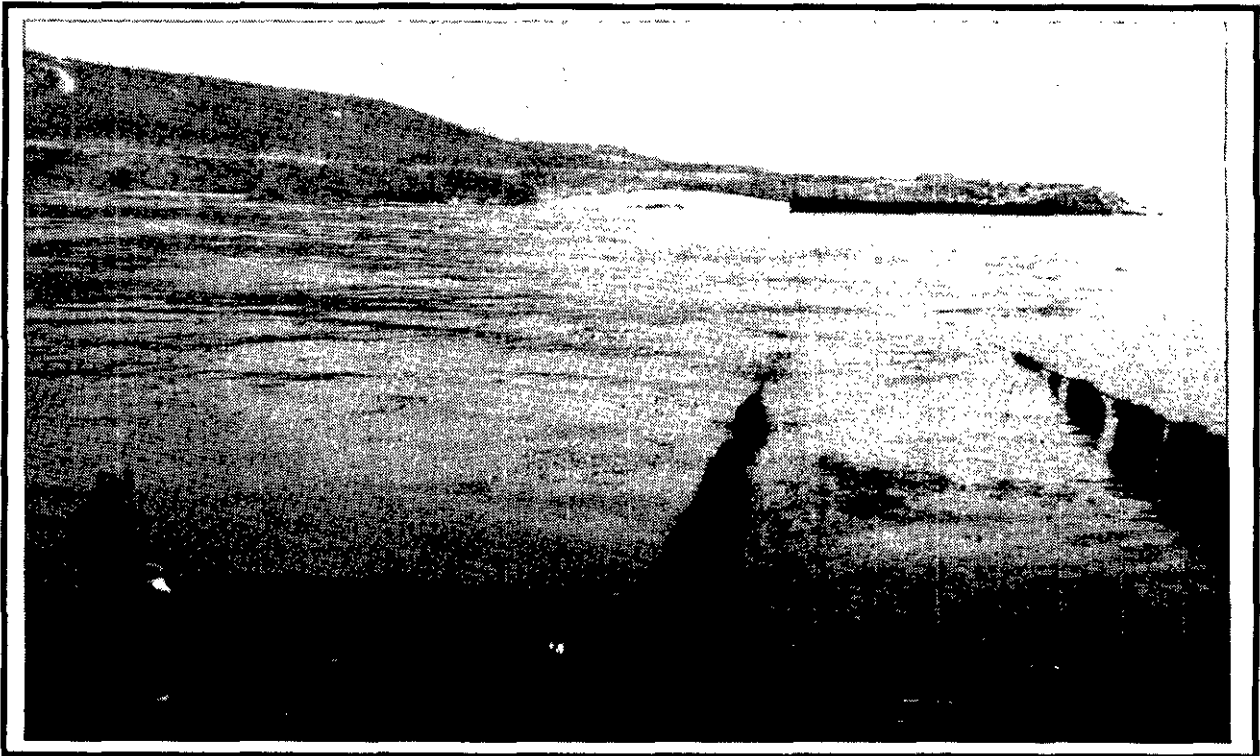
Hook-up of the salvage vessel to TORTUGA was accomplished on 19 August so that the pull could occur at high tide the following day. The decision was made to attempt a pull using ARCTIC SALVOR alone (Figure 5-23). If unsuccessful, NAVAJO would be positioned later with the potential for another 150-200 tons.

FIGURE 5-23. ARCTIC SALVOR in Harness Making Initial Pull.

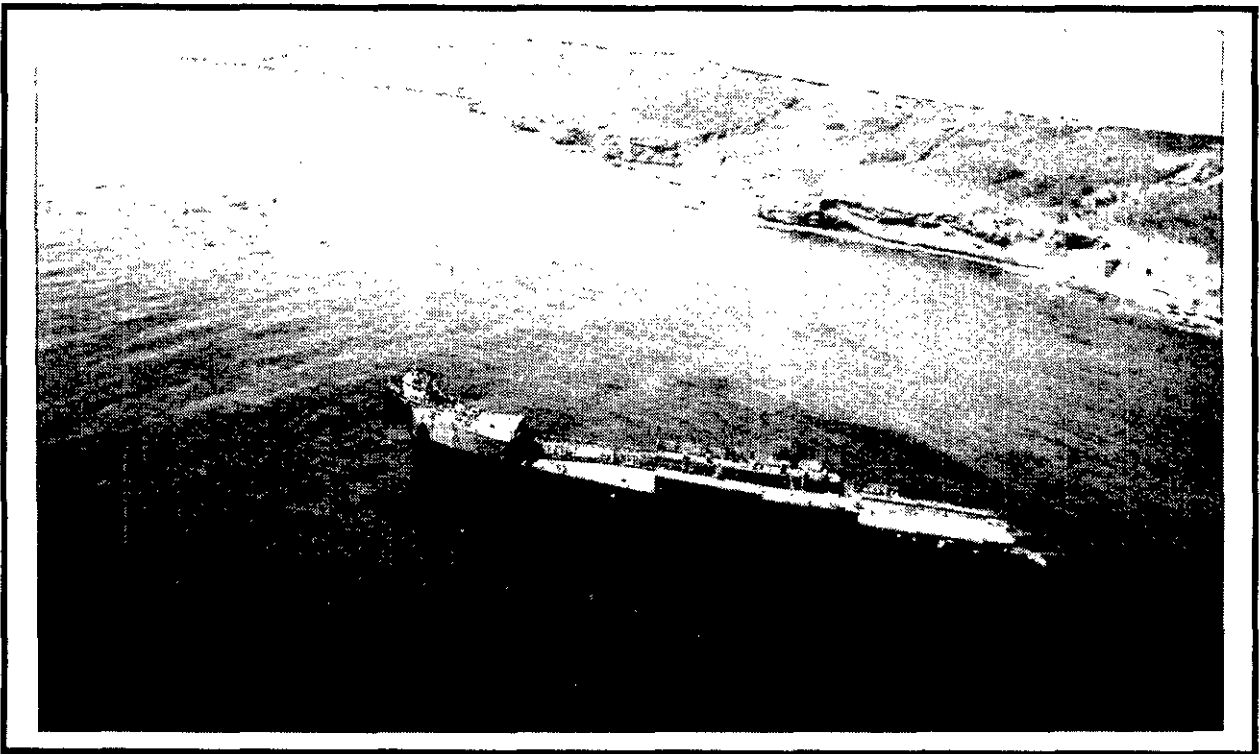
5-4.3 TOWING TO SEA AND SCUTTLING. A 2400-HP SPARTAN-class tug was at the scene when TORTUGA was freed from strand and immediately secured a towing line to the refloated vessel (Figures 5-24 and 5-25). Aboard TORTUGA were four salvage personnel, who cut the two wires connecting the wreck to the salvage vessel. The towing phase of the operation got underway at once (Figure 5-26) while the ARCTIC SALVOR remained at the site long enough to pull in wires, pick up the four anchors and remove kelp.

FIGURE 5-24. Tug Securing Towing Bridle for Tow to Disposal Area.

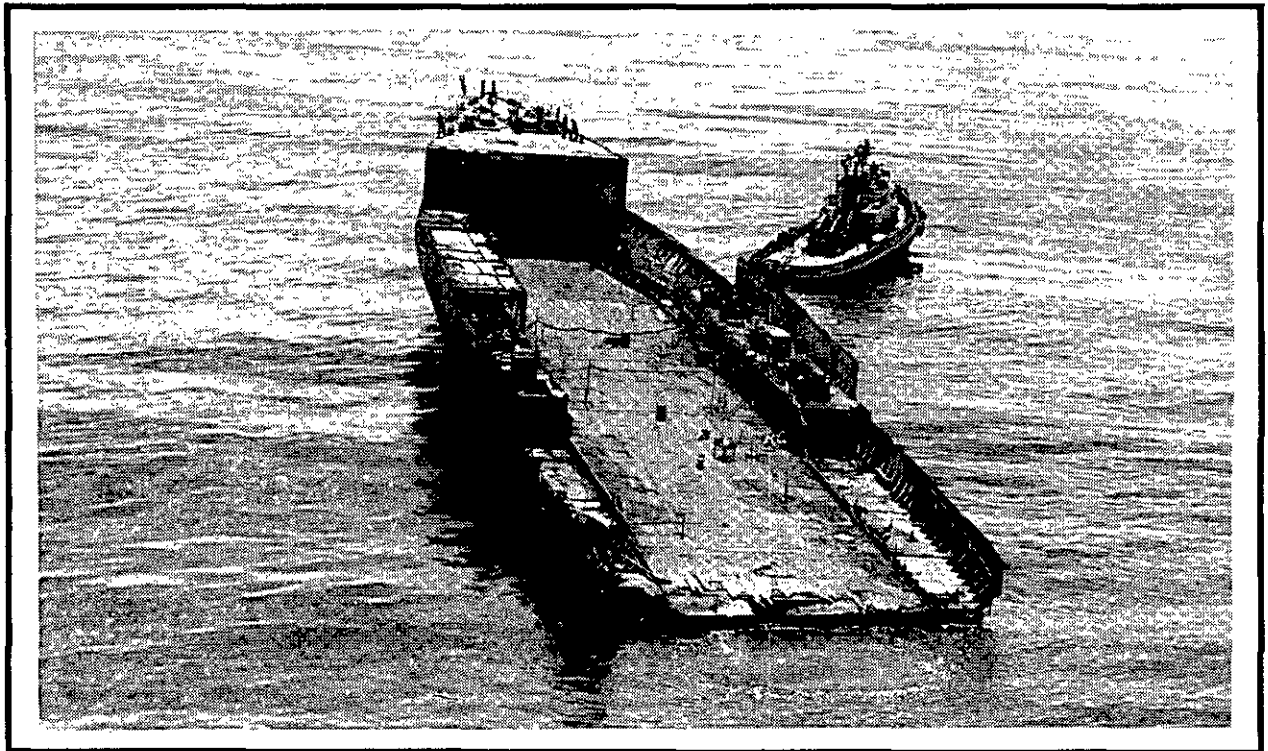
**FIGURE 5-25. TORTUGA Ready for Tow to Disposal Site.
(Note Compressors and Manifolding)**

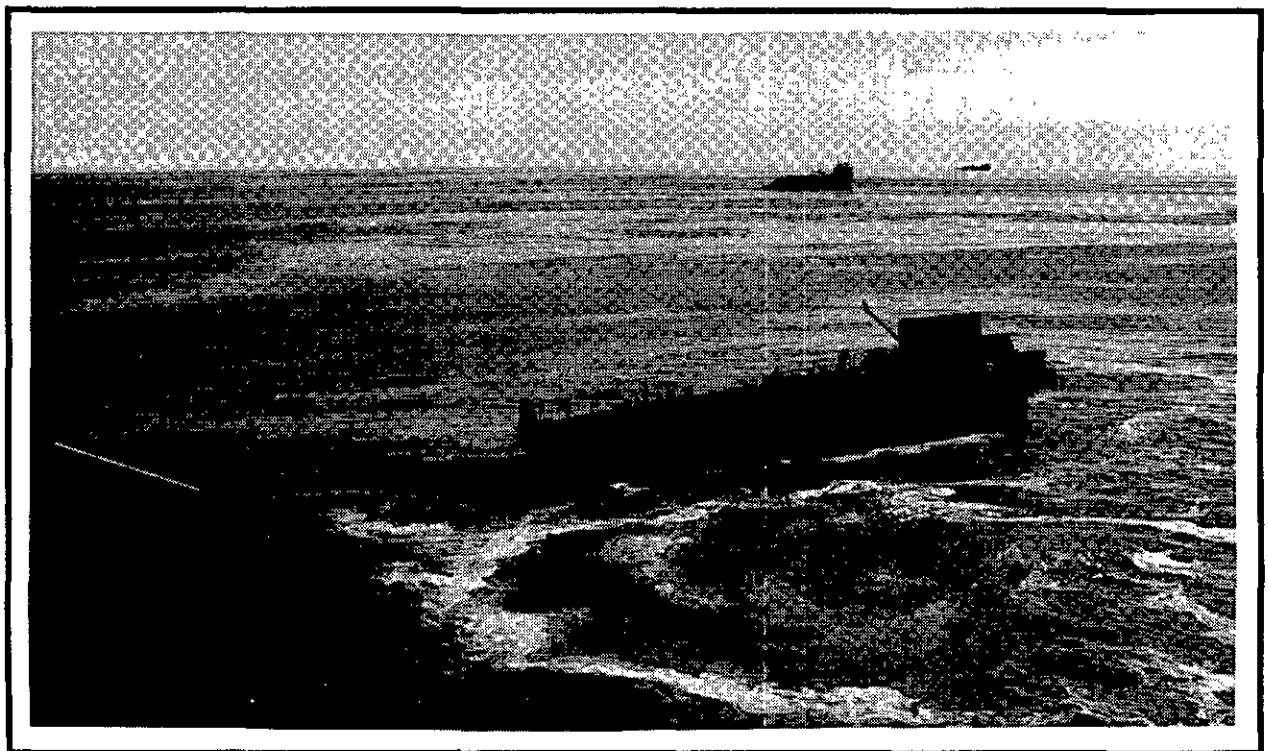
FIGURE 5-26. TORTUGA Hulk Under Tow. Remainder of Stern Section in Foreground.

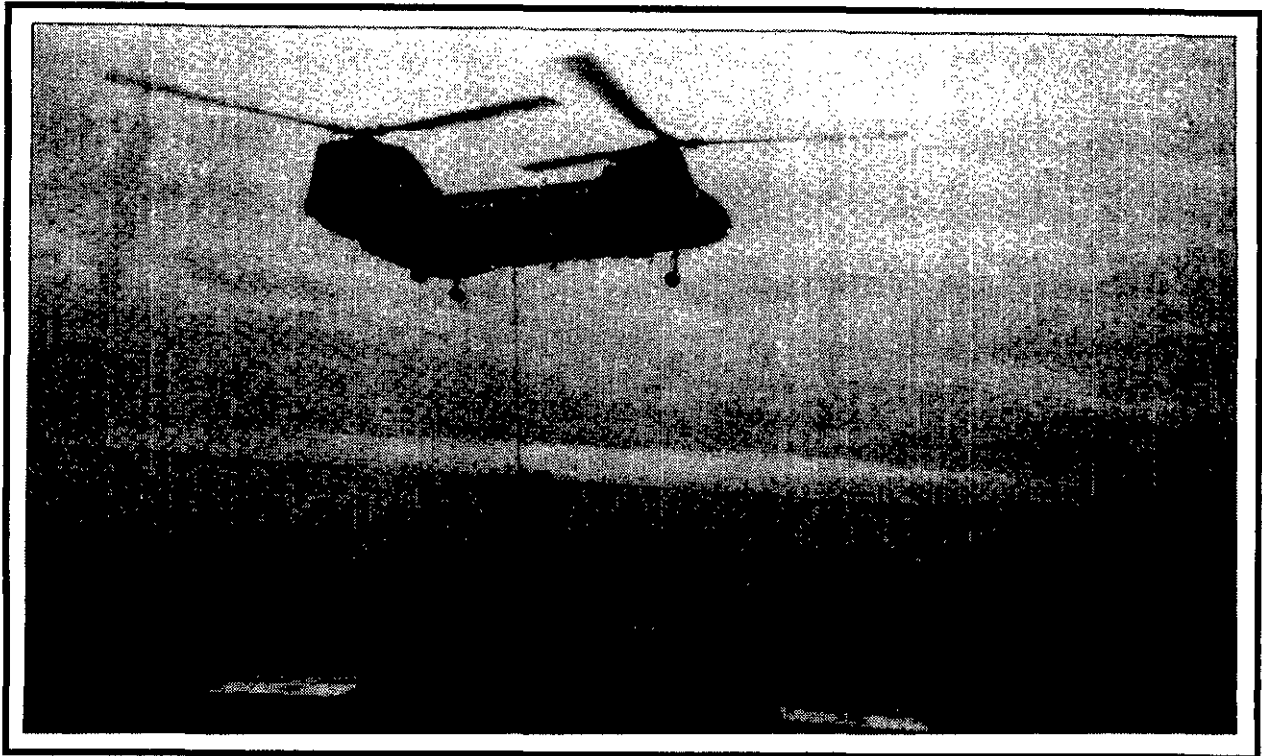
On the morning of 21 August, the helicopter arrived at 0814 and began lifting the compressors off the wreckage, completing the equipment lift-off at 0850 (Figures 5-27 and 5-28). A rubber Zodiac was dispatched from the ARCTIC SALVOR to come alongside the wreck. Two persons left TORTUGA at this time and two remained aboard, one positioned at the bow and the other at the stern. At 0910, lines from the tug to TORTUGA were released. Moving rapidly toward the middle of the vessel, the two remaining salvage personnel opened the valves to let the air bleed off from the tanks. As soon as all valves were open, the final two salvors boarded the Zodiac and pulled away from the wreck. At 0925 the ex-USS TORTUGA (LSD 26) disappeared below the surface of the Pacific Ocean forever.

FIGURE 5-27. Compressor Being Air Lifted Off TORTUGA Prior to Scuttling.

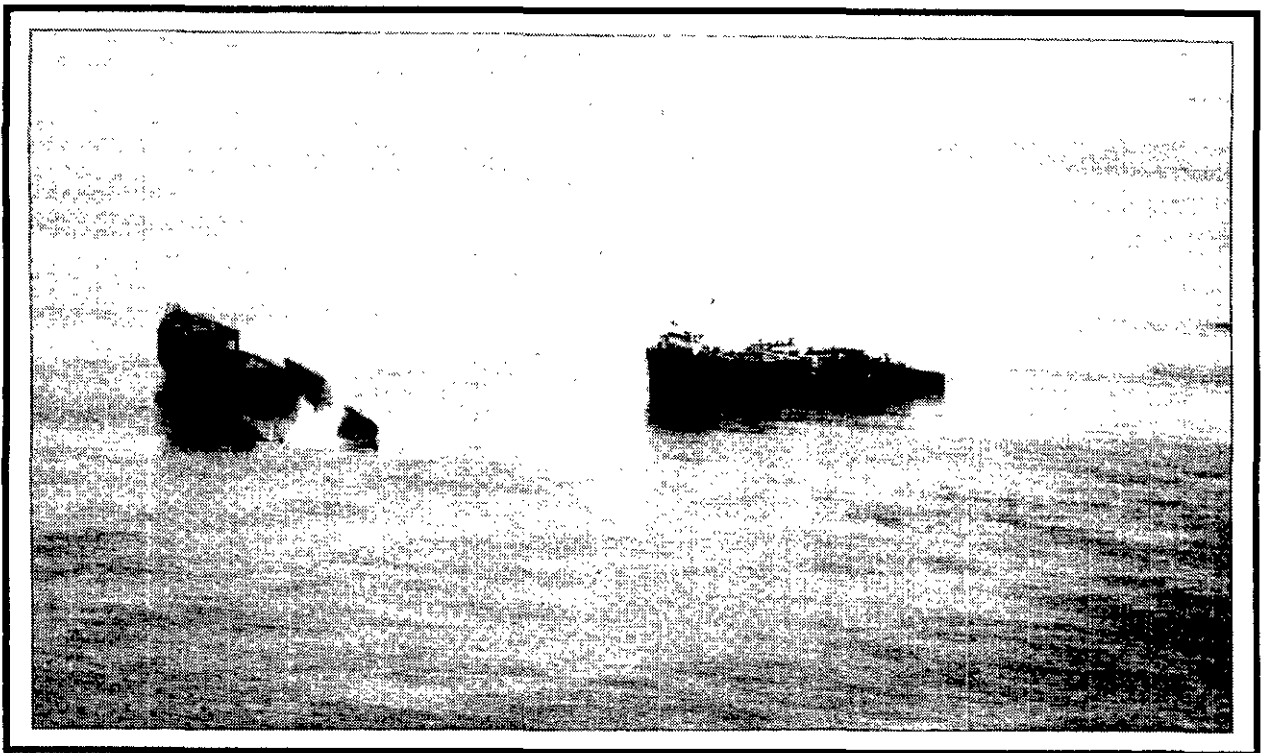
FIGURE 5-28. TORTUGA Just Prior to Sinking. Note That Compressors and Manifold Have Been Removed.
