CAD/PAD International Logistics Meeting (ILM)

USN and USMC CAD/PAD MIST/EI/CODR

- 11 June 2019 -

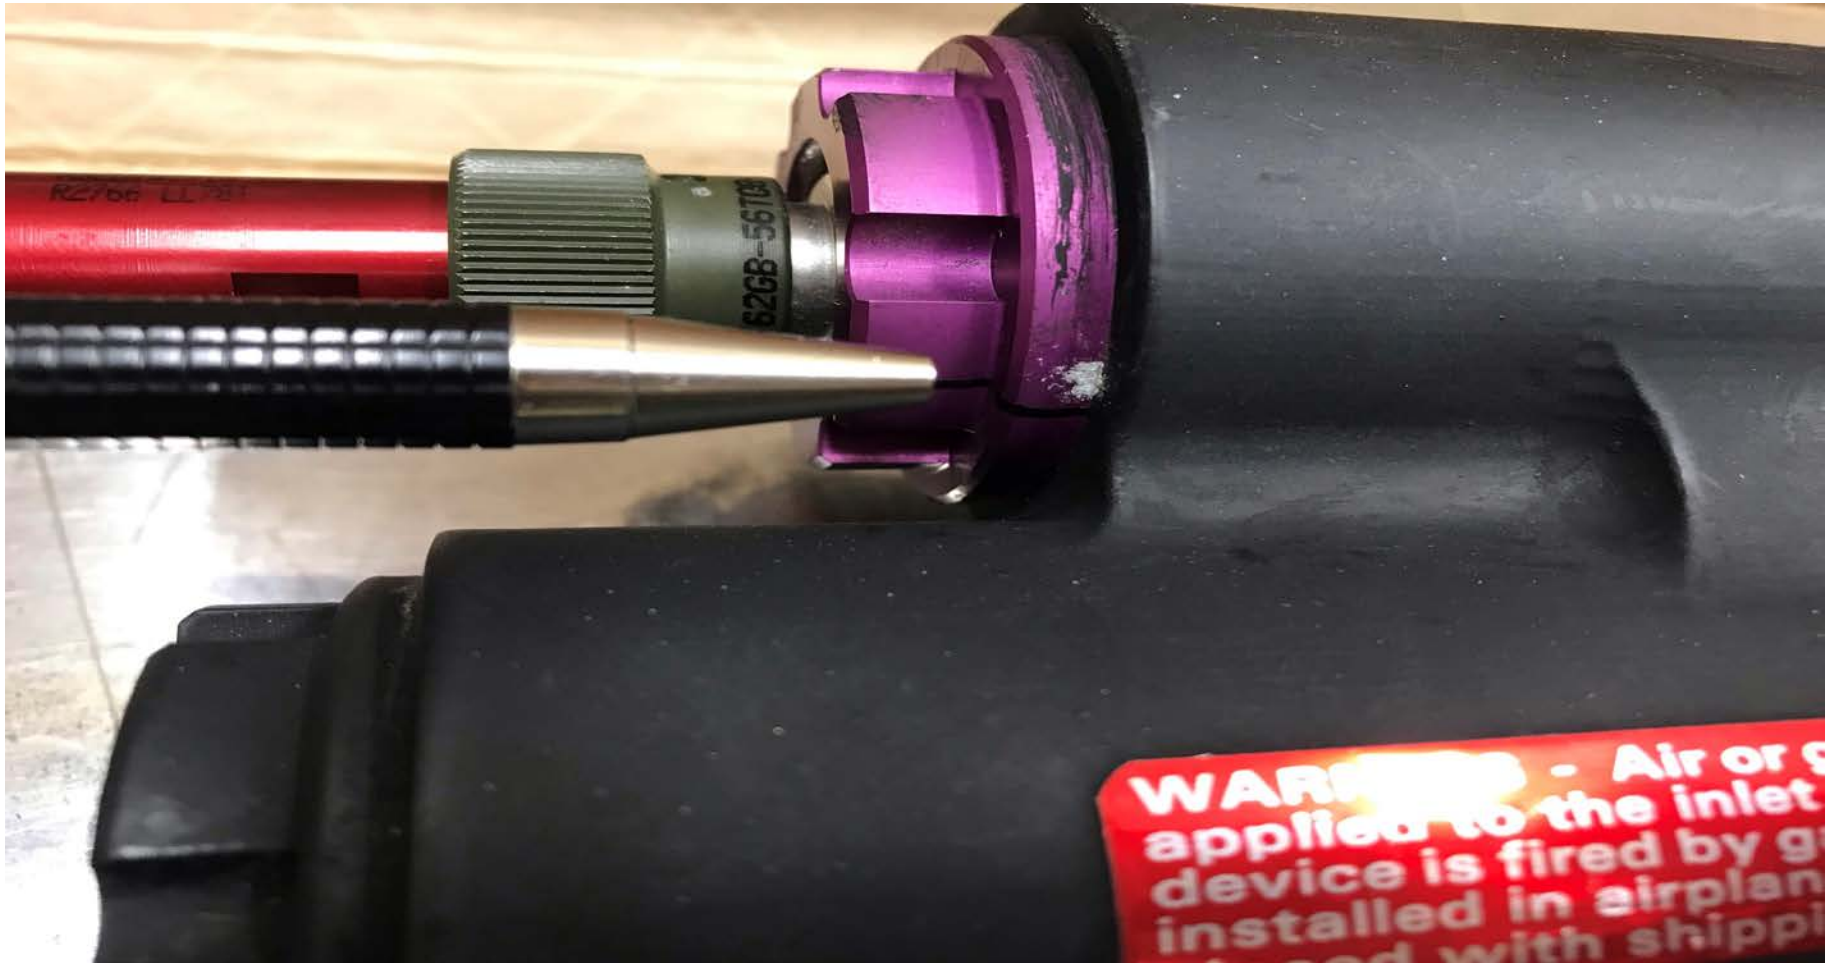
Open Engineering Investigations

- Open (con't):
 - V-22 Rescue Hoist Cartridge: No lot number. Awaiting shipment of device
 - F/A-18 PDRM x4: Corrosion. Awaiting shipment of devices
 - Four PDRM's from the same base, but different commands
 - Corrosion on ignitor upon opening of the barrier bag during initial install
 - All of the PDRM's were reworked from NSWC IHEODTD
 - NSWC IHEODTD is enforcing a more strict inspection criteria for reworked PDRM's
