INDIAN HEAD EXPLOSIVE ORDNANCE DISPOSAL TECHNOLOGY DIVISION

CAD/PAD MIST CODR & EI

06/26/2018

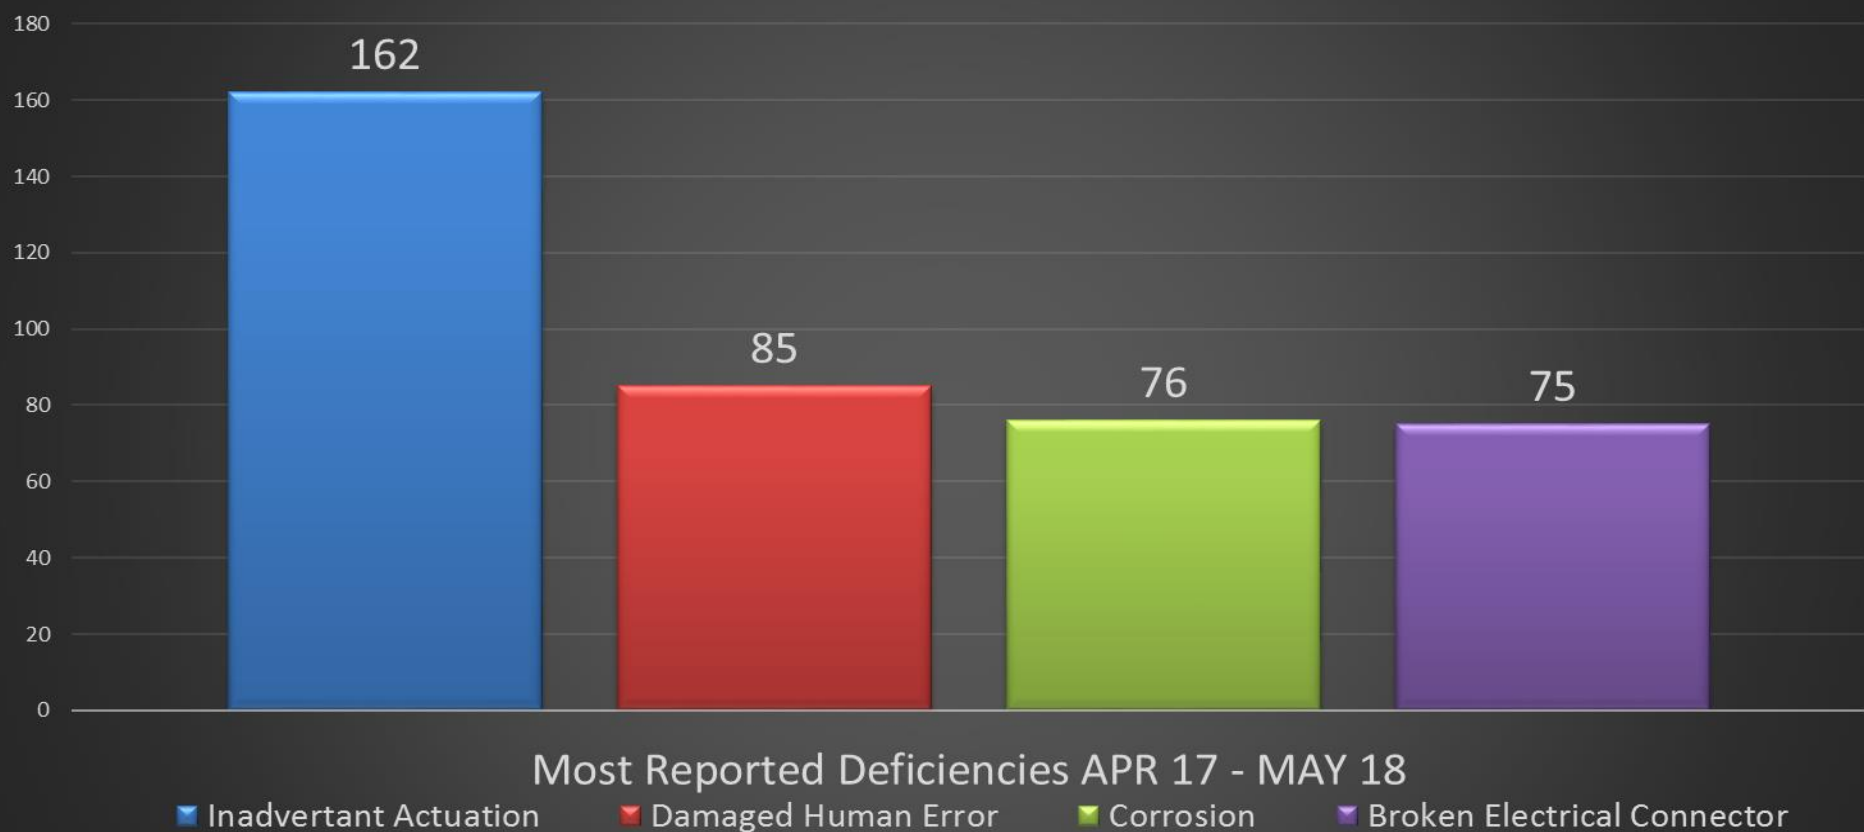
CODR Reporting

- Since April 1, 2017 to present there have been over 600 CAD devices reported and 15 PAD devices reported totaling over 1.1 million dollars worth of devices.

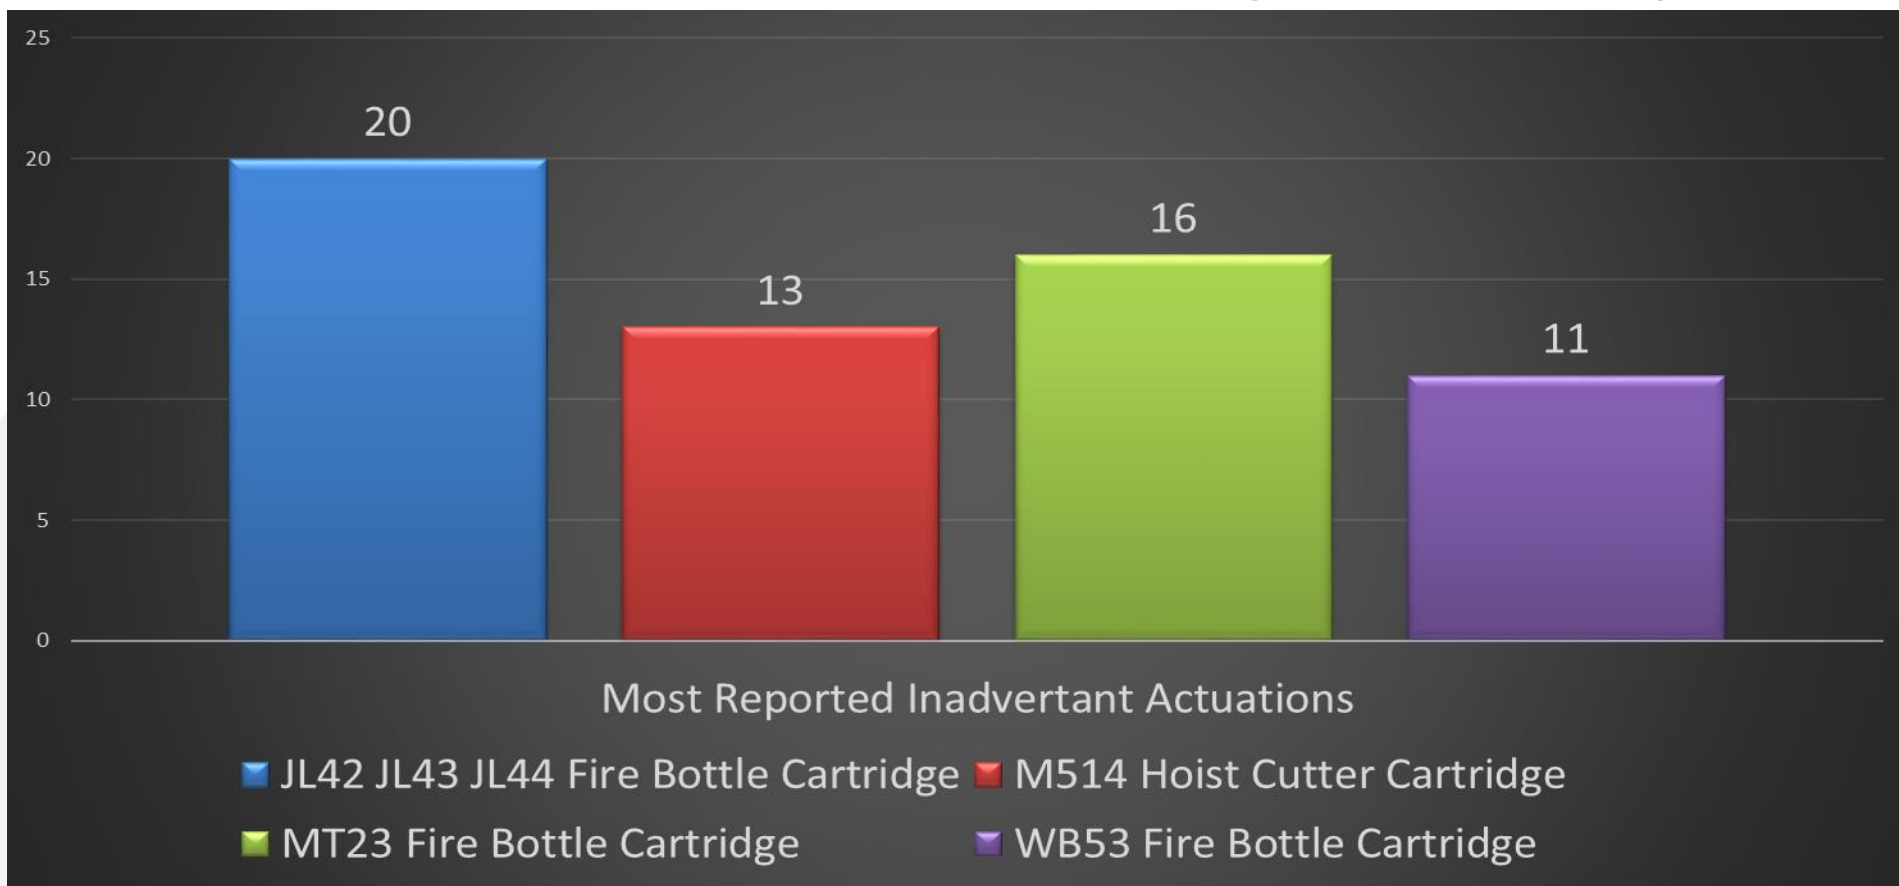
Inadvertent Actuations

- The most reported DODIC's for inadvertent actuations are JL42, JL43, JL44, M514, MT23, and WB53. All of them, except the M514, are fire extinguisher cartridges.

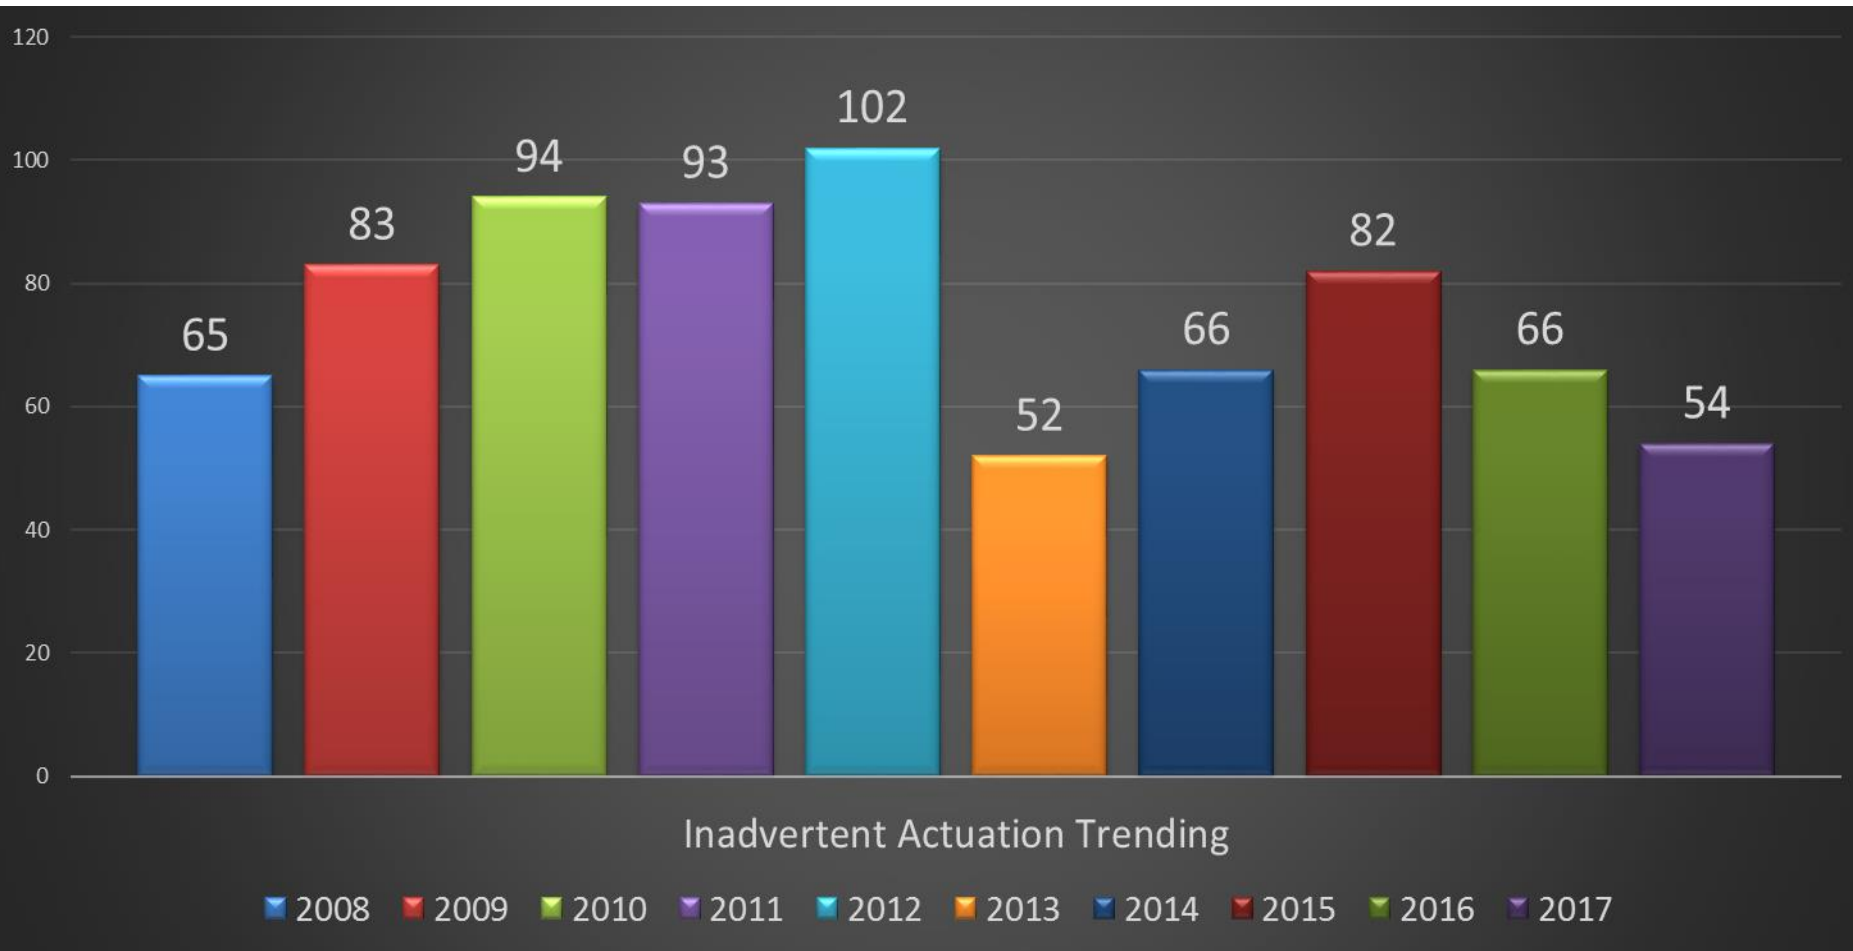
Inadvertent Actuations

- Looking at the data for JL42, JL43, JL44, M514, MT23, and WB53 for ten years reveals some trending.

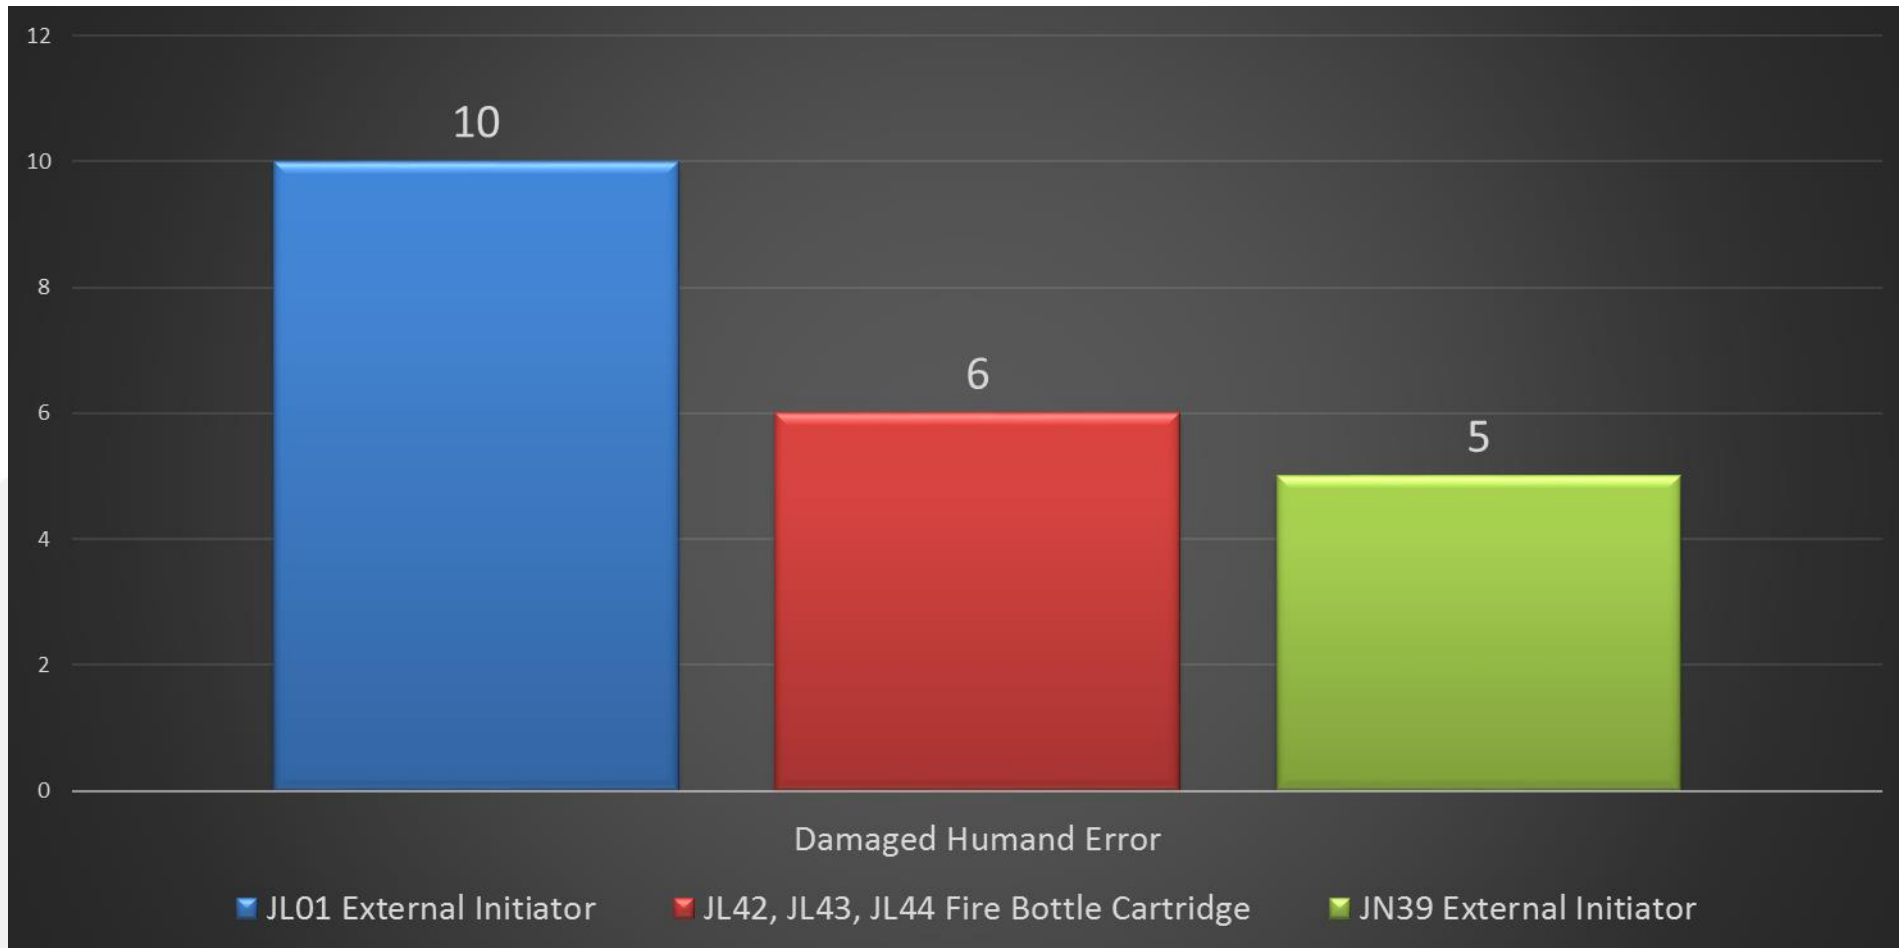
Damaged Human Error

- The most reported DODIC's for "damaged human error" are JL01, JN39, JL42, JL43, and JL44.

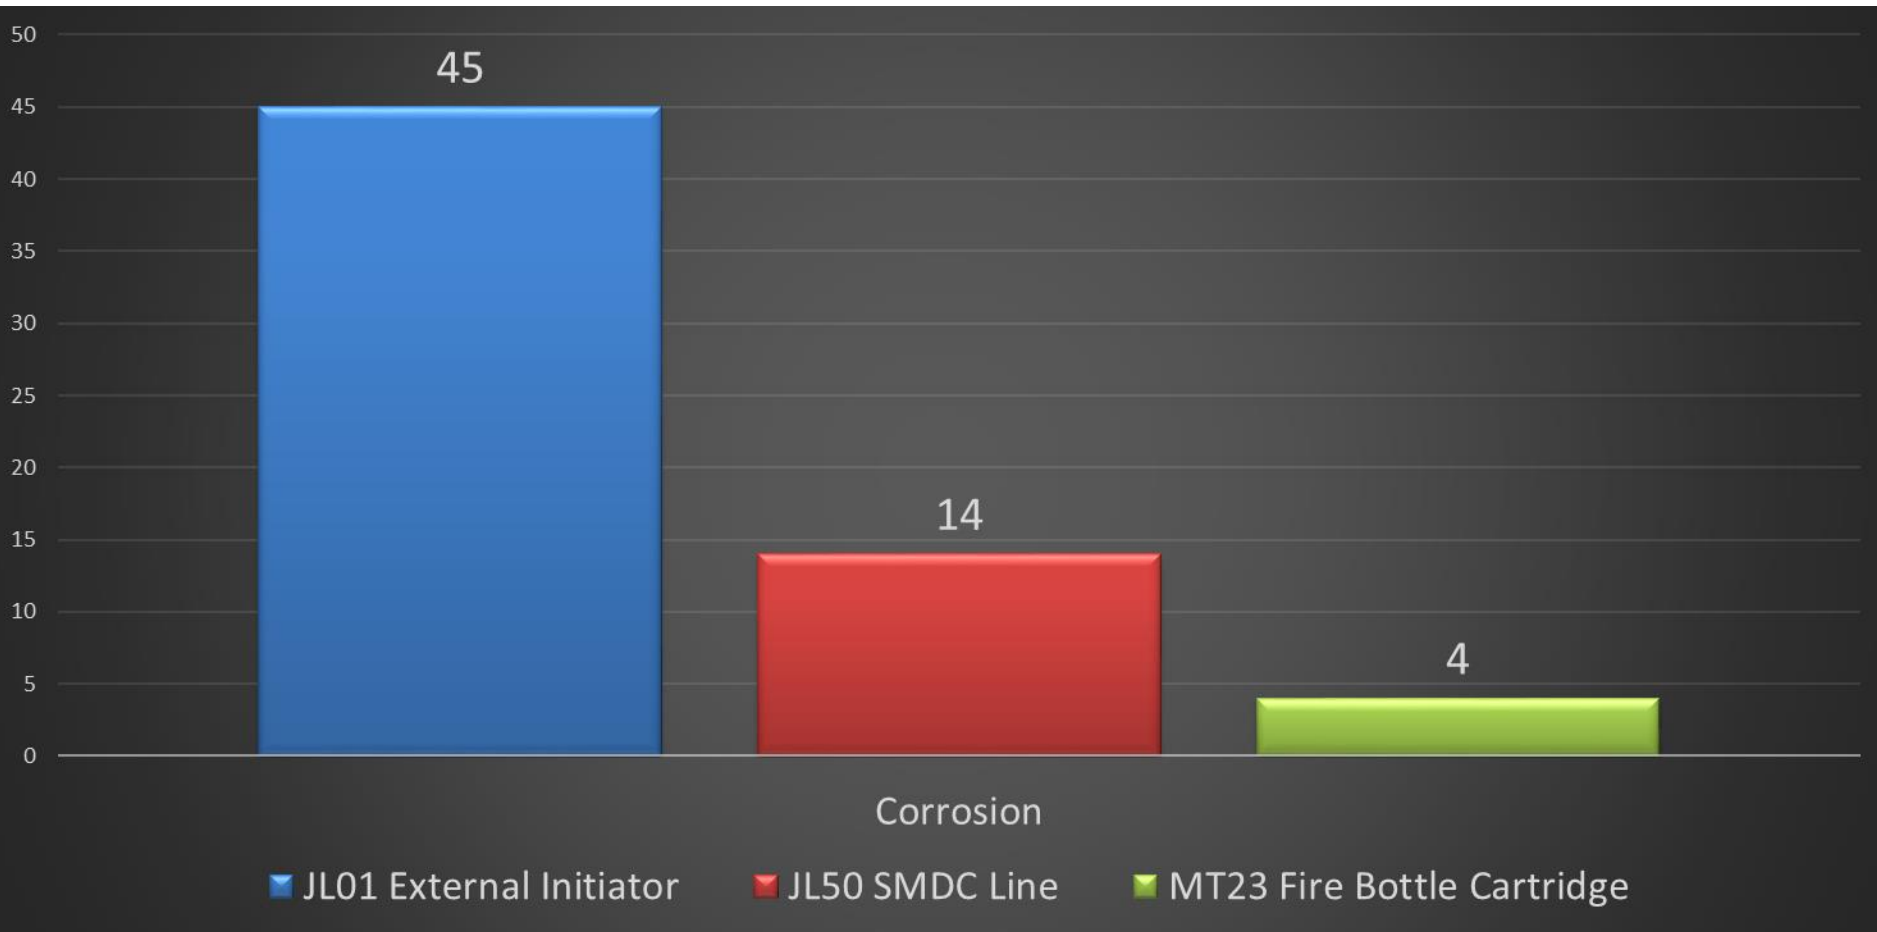
Corrosion

- The most reported DODIC's for "Corrosion" are the JL01, JL50, and the MT23.

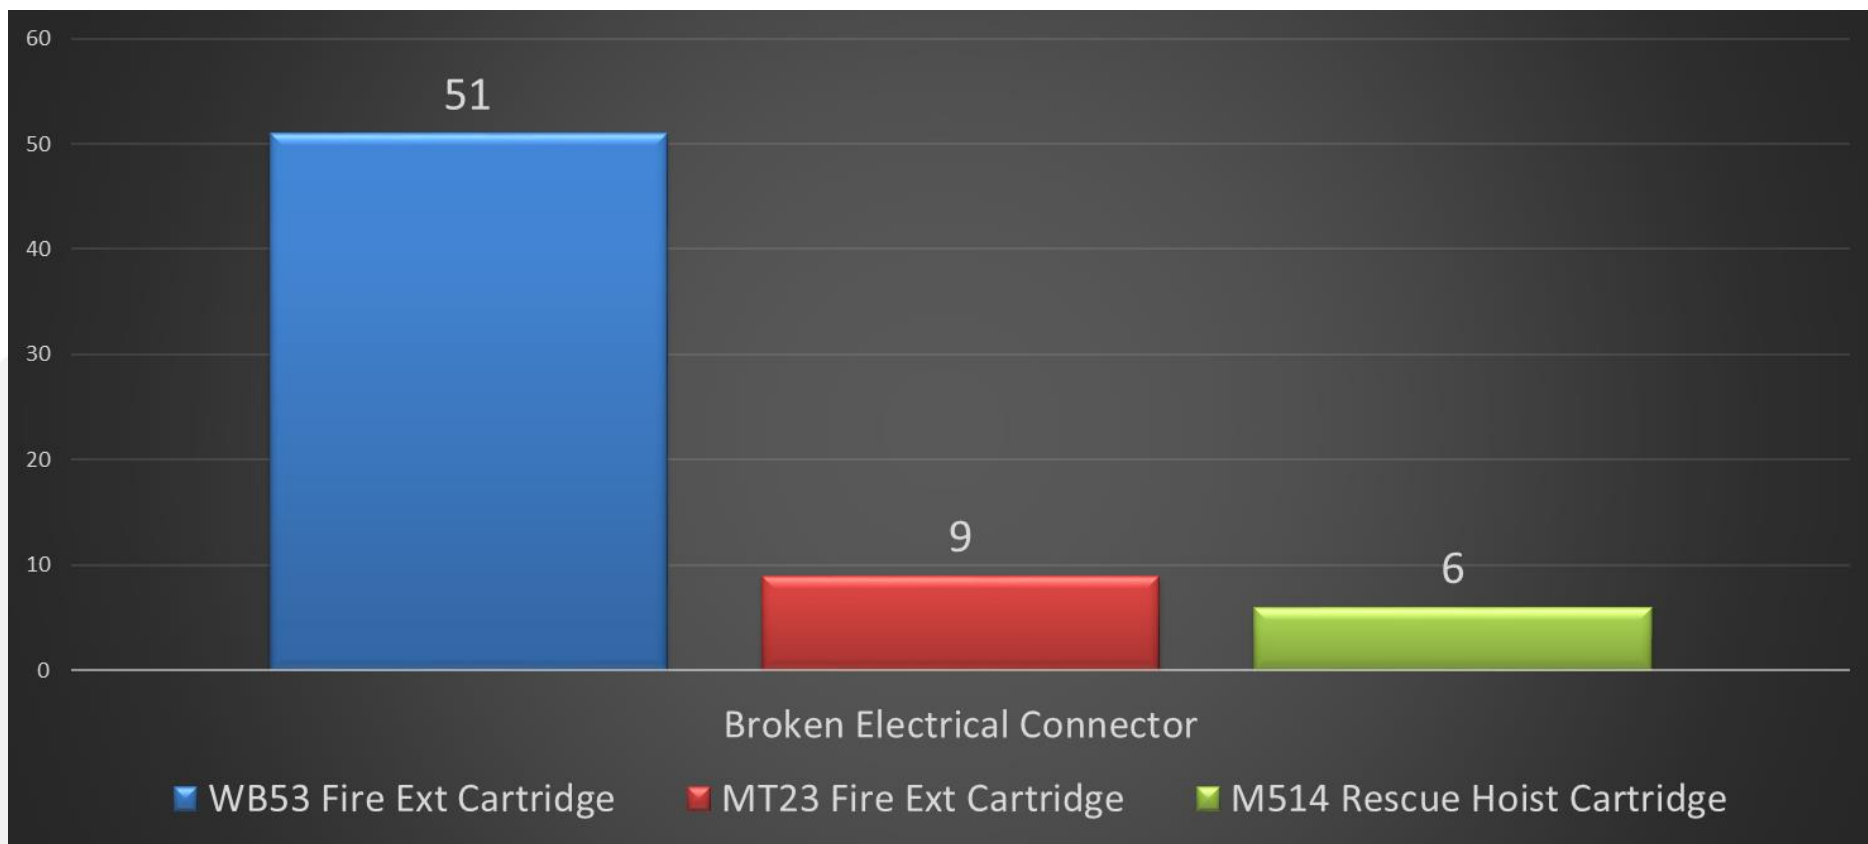
Broken Electrical Connector

The most reported DODIC for broken electrical connector is the WB53 engine fire extinguisher cartridge. The WB53 makes up 68% of the devices reported in this category. We have opened an Engineering Investigation to further understand this failure.
