# Lessons Learned About Pyrotechnic Delays

Frank J. Valenta

Exodynamics Technology, Incorporated

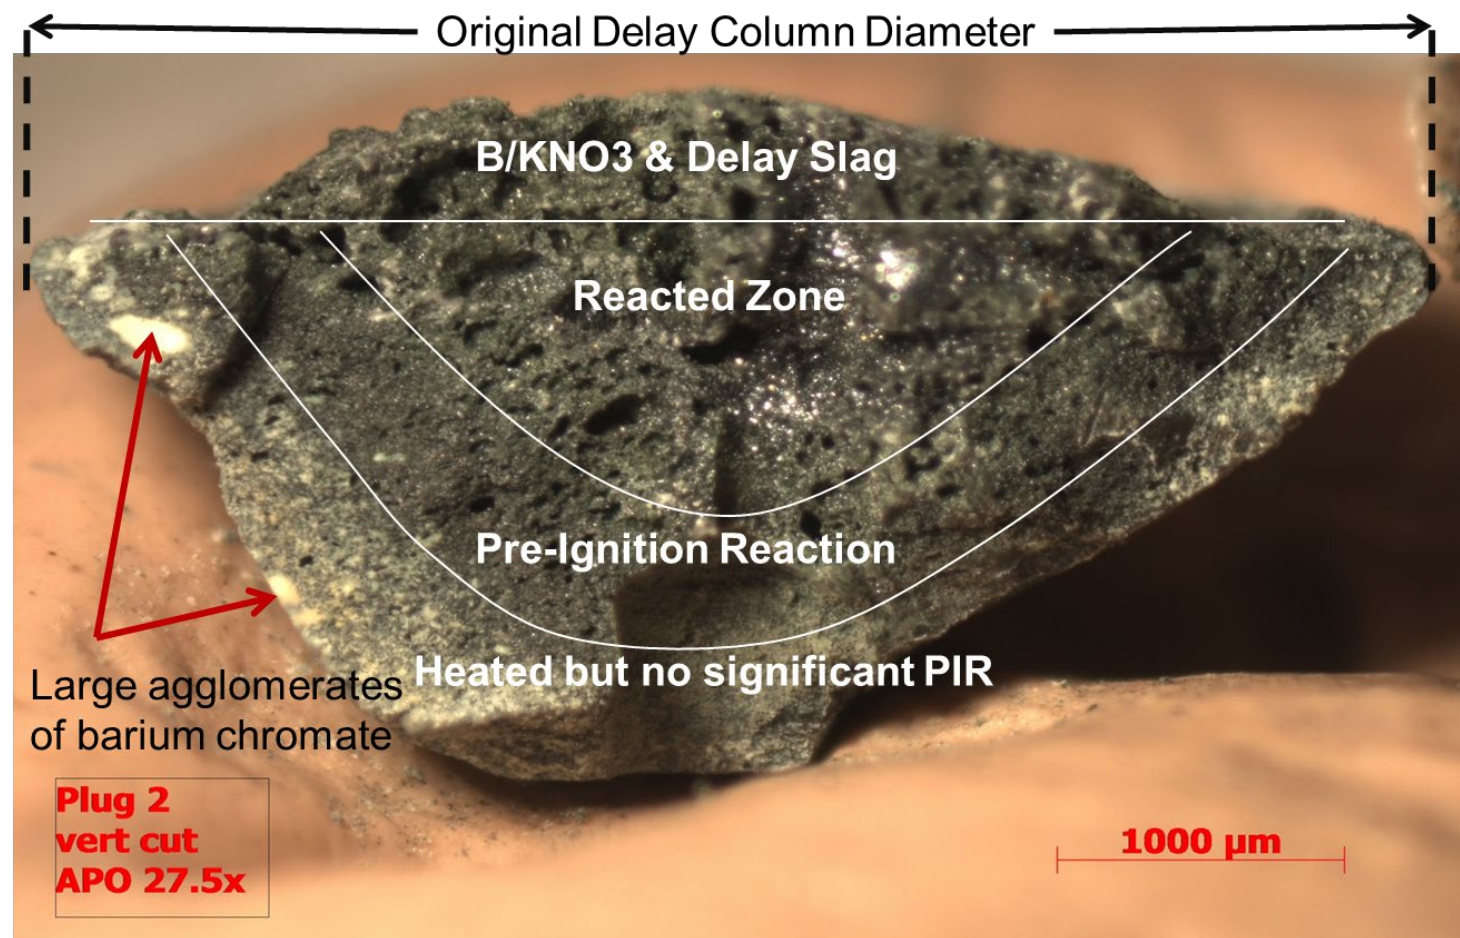
# Sectioning and Analysis of the “Slug”

Assigned Cause: Thin initial thin increment likely broke up and did not maintain sufficient contact with next increment to assure propagation.

# Nested Delay Increments Using a Step Ram
