■ technical report on SALVAGING OF AFDM-2

PUBLISHED BY DIRECTION OF COMMANDER, NAVAL SEA SYSTEMS COMMAND

THE AFTERMATH OF HURRICANE BETSY

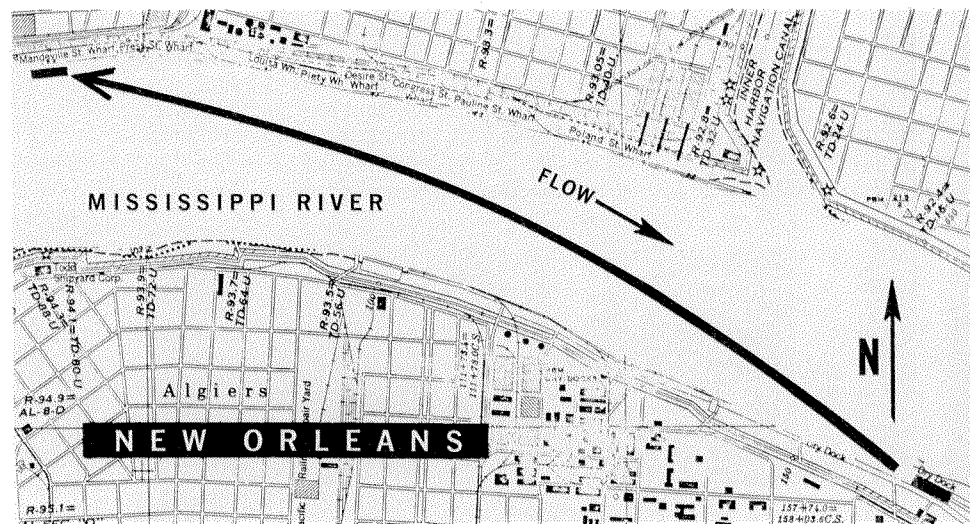
DRYDOCK WAS TORN from her moorings on west bank, blown 1,100 feet across river and three miles upstream. She was found capsized about 300 feet off Mandeville and Press Street Wharves.

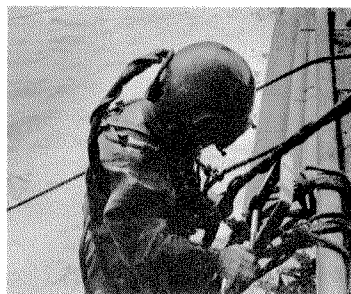
Reports from the divers indicated that damage to the exterior hull plating was not as extensive as had been expected. There were more than 100 holes in the hull structure, but only one major break was considered serious. This was an oval-shaped gash, 20 feet by 15 feet, at one end of the center section, about midway between the upper deck and the chine line, on the outside shell plating. In all probability, this hole shipped most of the water that capsized the drydock on her erratic journey during the hurricane.

Most of the other breaks in the sidewalls were small, apparently resulting from collisions with other ships that also broke loose during the storm. The drydock's pontoon sections appeared to be in good condition, and it was speculated—correctly—that internal structural damage, if any, was minimal.

DIVERS' reports on extent and location of damage helped determine salvage method.

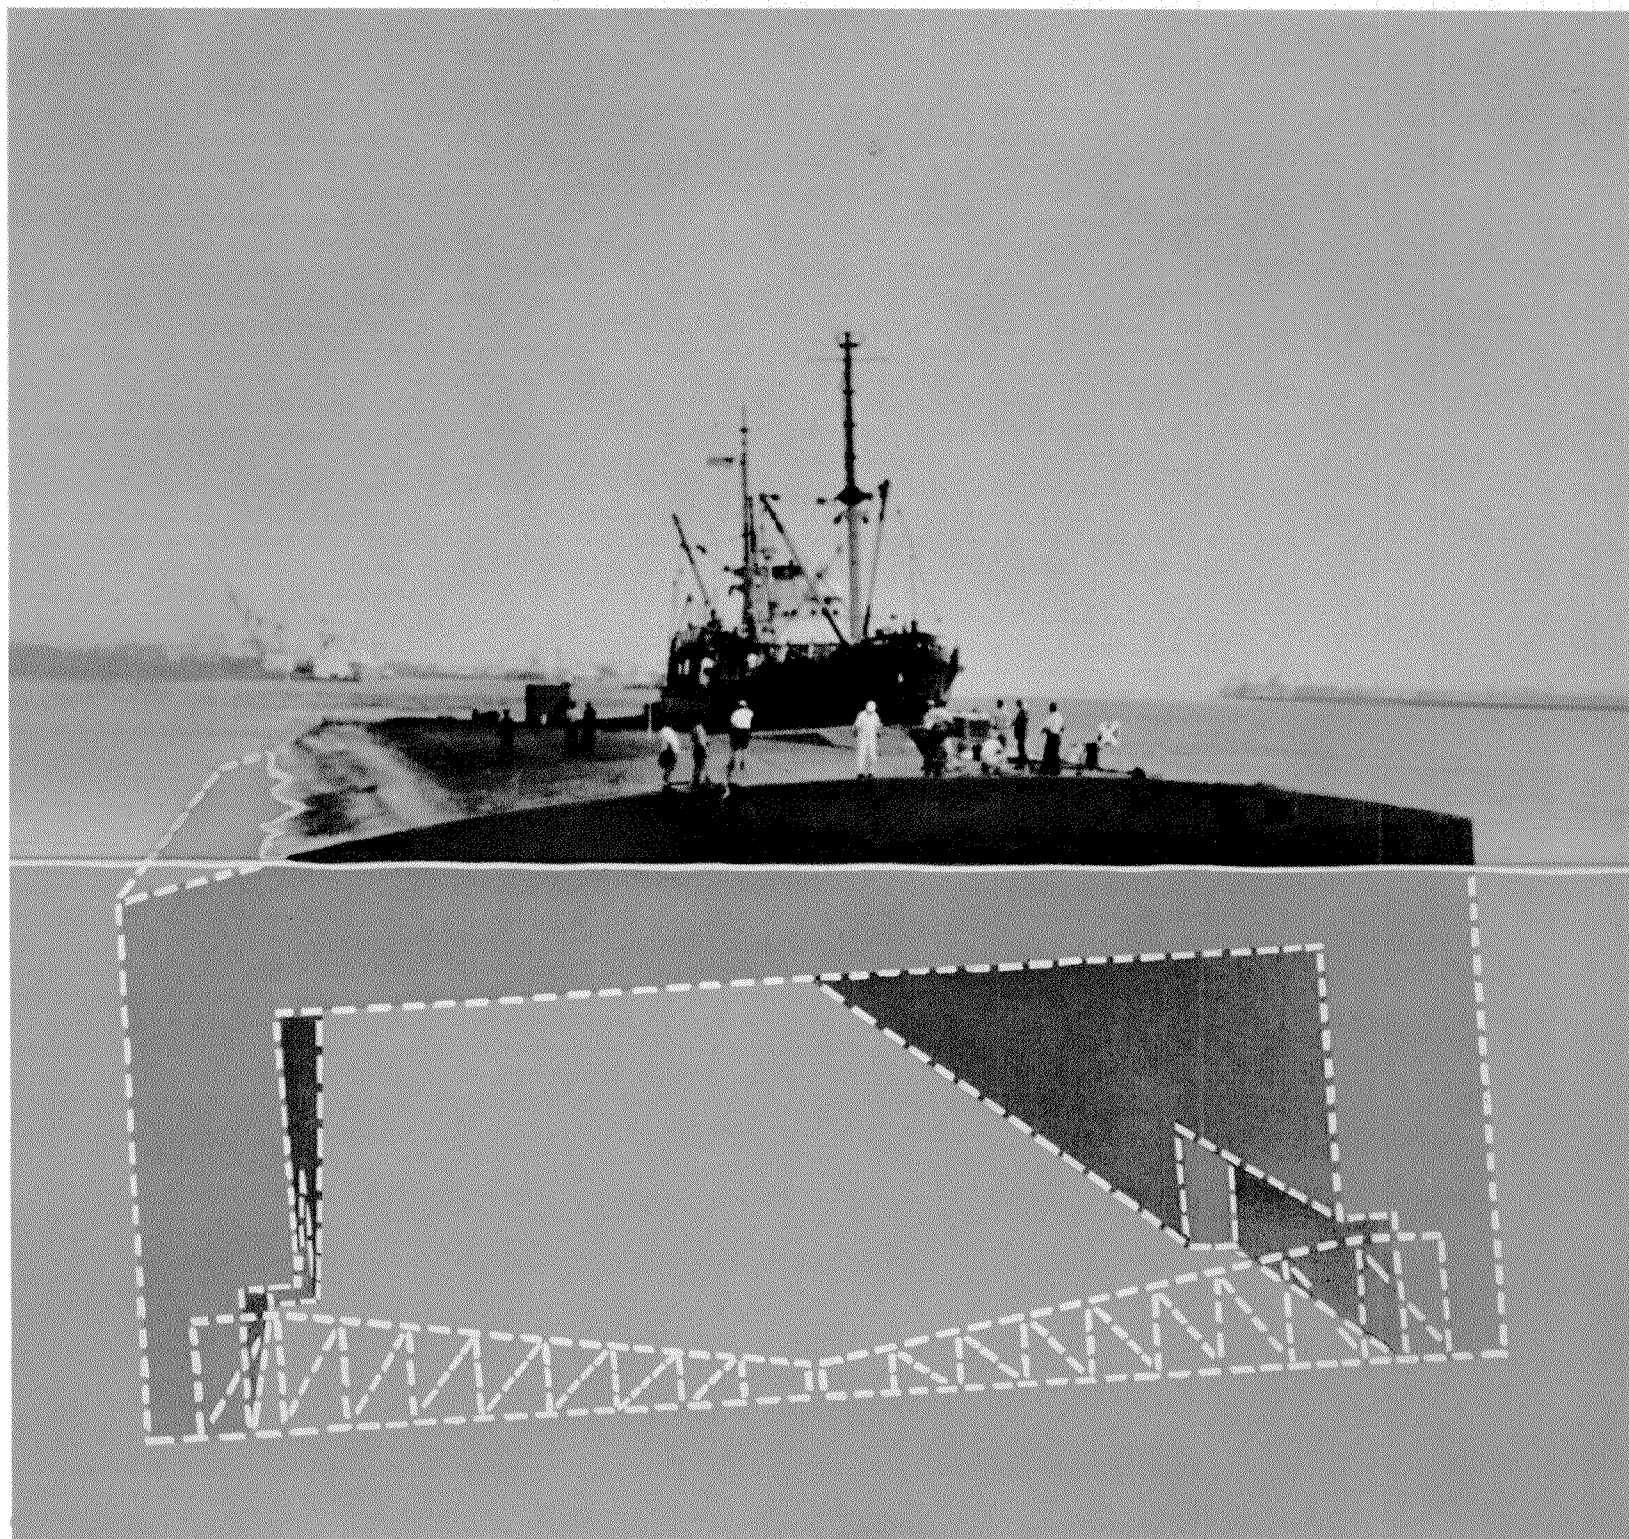
SUBMERGED SIDEWALLS are shown in artist's conception of drydock's position when she was located the morning of 10 September 1965, the day after Hurricane Betsy. AFDM-2 was found aground in about 80 feet of water, some 300 feet off the east bank of the Mississippi River. On 22 September, while deliberations continued on whether to salvage or destroy her, the drydock was towed to the west bank to remove her from the river's busy main channel. Her wingwalls presented a large underwater surface that was equivalent to moving two BB-61 class battleships.

The plan for salvaging AFDM-2, as finally approved, called for snugging the capsized drydock against the river bottom and righting her by rolling her up and over 180 degrees toward the levee. The rolling operation—called parbuckling—was to be accomplished in 12 stages employing a combination of land-based beach gear, inflatable rubber pontoons for an external source of buoyancy, and the judicious use of water ballast and compressed air.

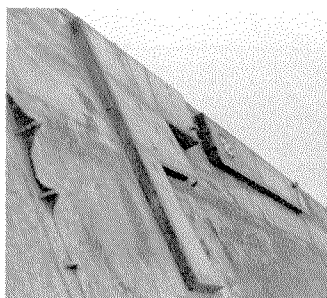
BOX-TYPE steel plates were welded over major breaks in wingwalls.

Utilizing ¾-inch air intake fittings and valves installed in each of the drydock's 16 ballast compartments, compressed air was injected to raise the hull, one side at a time, so that repairs could be made. The hull was heeled from side to side in this manner, and work crews made necessary patches as breaks in the sidewalls of the hull appeared above the water-line. Welders, working from mobile stages and fixed platforms with leads from a 600-amp welding machine, patched the holes with box-type steel plates with little difficulty.

A quick-setting cement compound, placed by divers over small underwater breaks to seal them temporarily for the buildup of air pressure to further lift the drydock, worked very well. When the damage appeared above the surface as the hull was heeled, it was repaired with a steel plate patch.

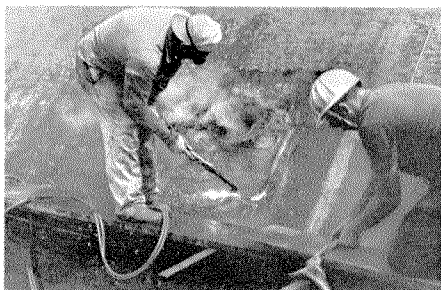
WELDERS used oxy-acetylene torches to gain access to compartments containing excess mud.

However, dense mud had permeated all sections of the hull, especially the offshore wall that had received most of the damage on the night of Hurricane Betsy. As a result, before the drydock could be brought to the Stage I position it was necessary to remove approximately 2,000 tons of mud and water from the pontoon ballast compartments on the offshore side. This was done by jetting with water to turn the compacted mud into a pumpable slurry.

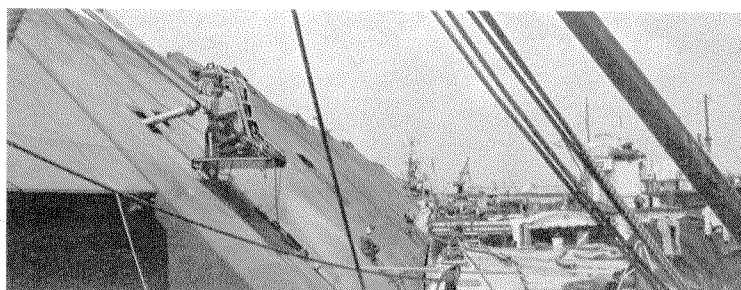
PUMP on platform welded to wingwall was utilized to dewater offshore wall so that inshore side could be grounded on the river bottom.

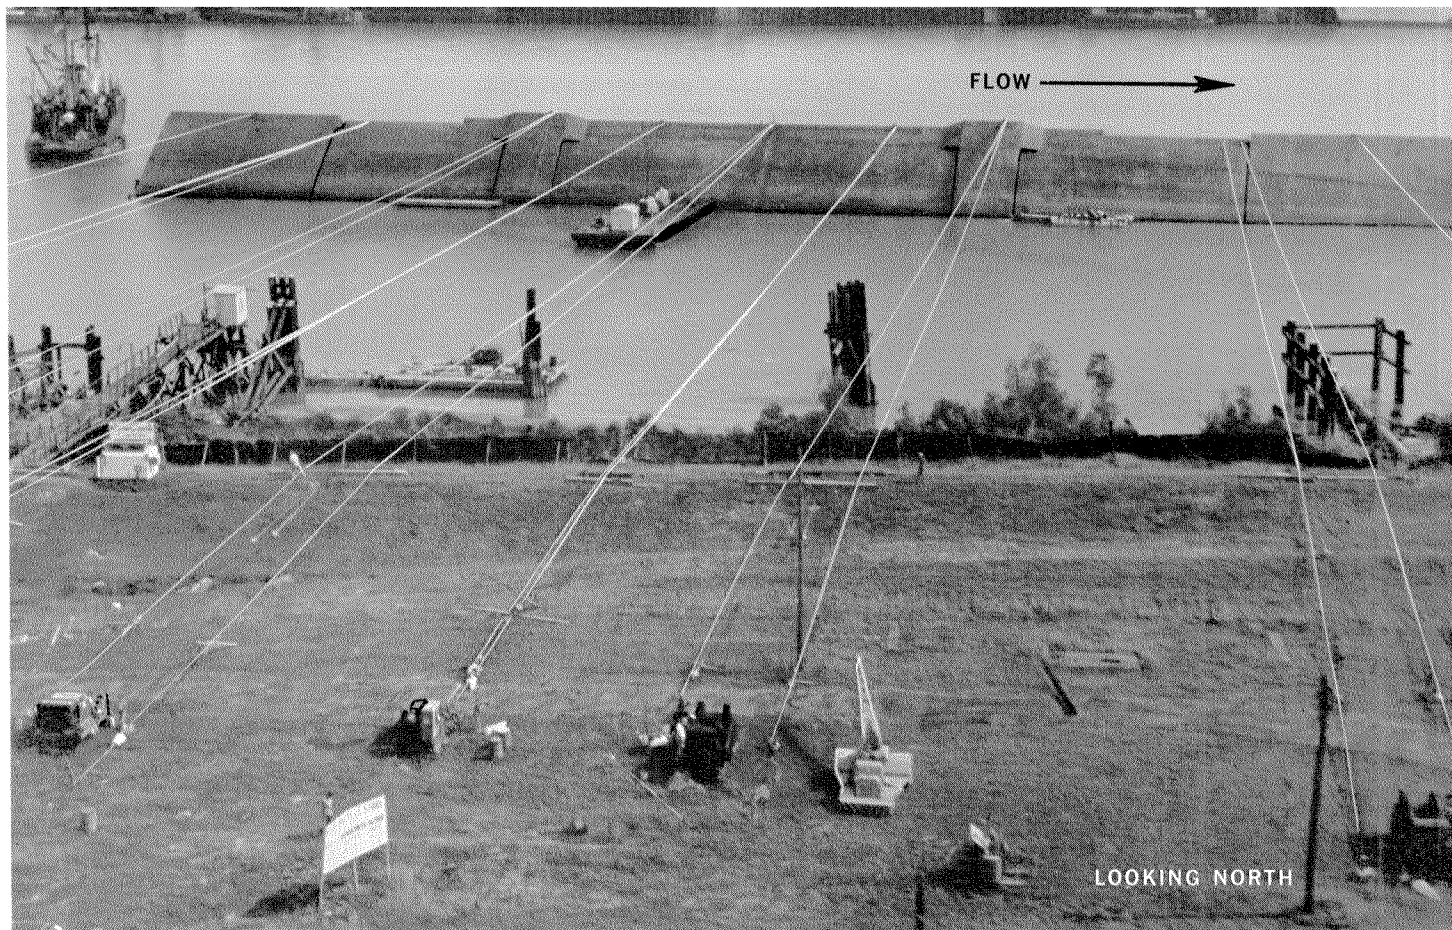
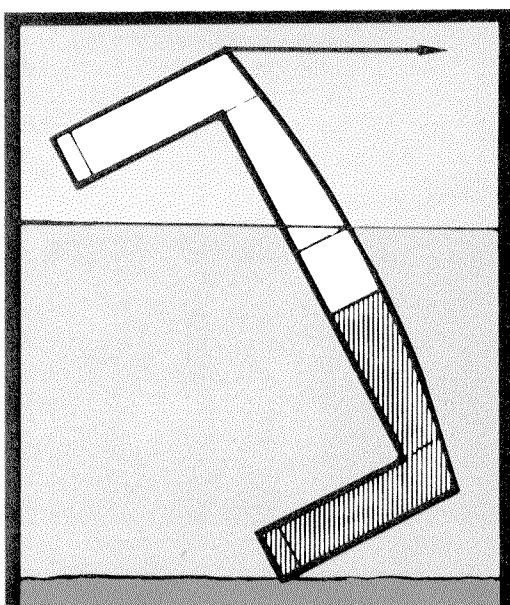
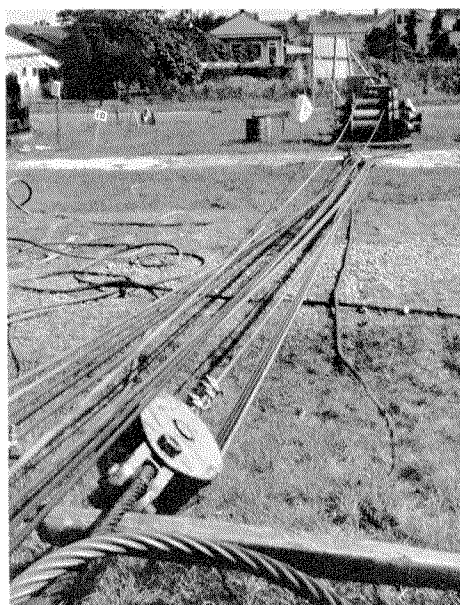
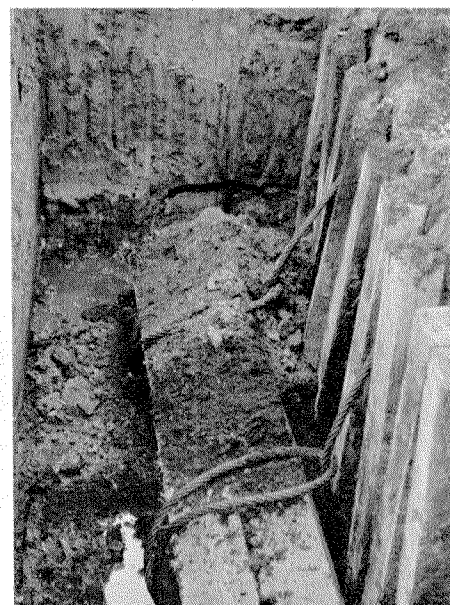
STANDING BLOCKS were secured to timber deadmen—four 12 x 12 timbers, 10 feet long—buried behind levee in six-foot-deep excavations (bottom, right).

ARROW on drawing (bottom, left) indicates direction of beach gear as the drydock was rotated to 60 degrees from the inverted position. Before reaching Stage II, 2,000 tons of mud had to be pumped from offshore compartments.

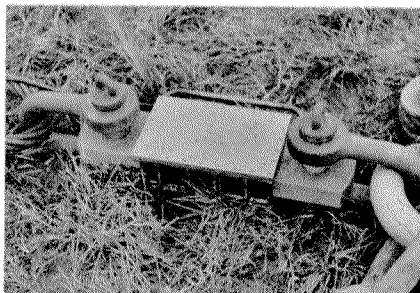
TENSIOMETER was placed between the deadman and standing blocks of each beach gear set.

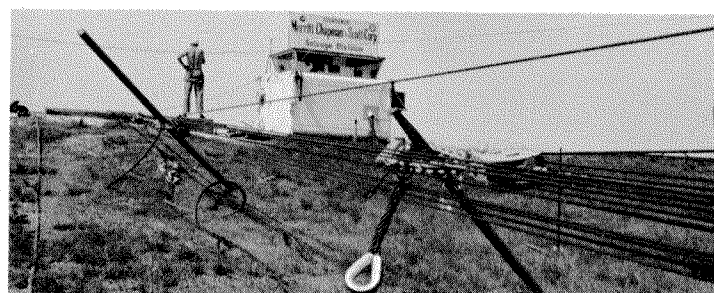
CONTROL CENTER housed stylus recorders that indicated beach gear force. From this central location engineers were able to control rate of pull.

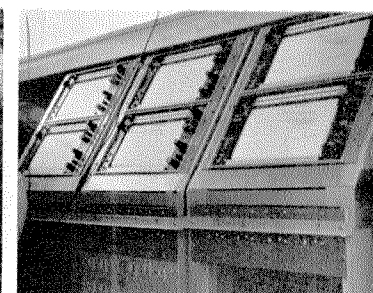
STYLUS RECORDERS provided minute-by-minute record of the operations.

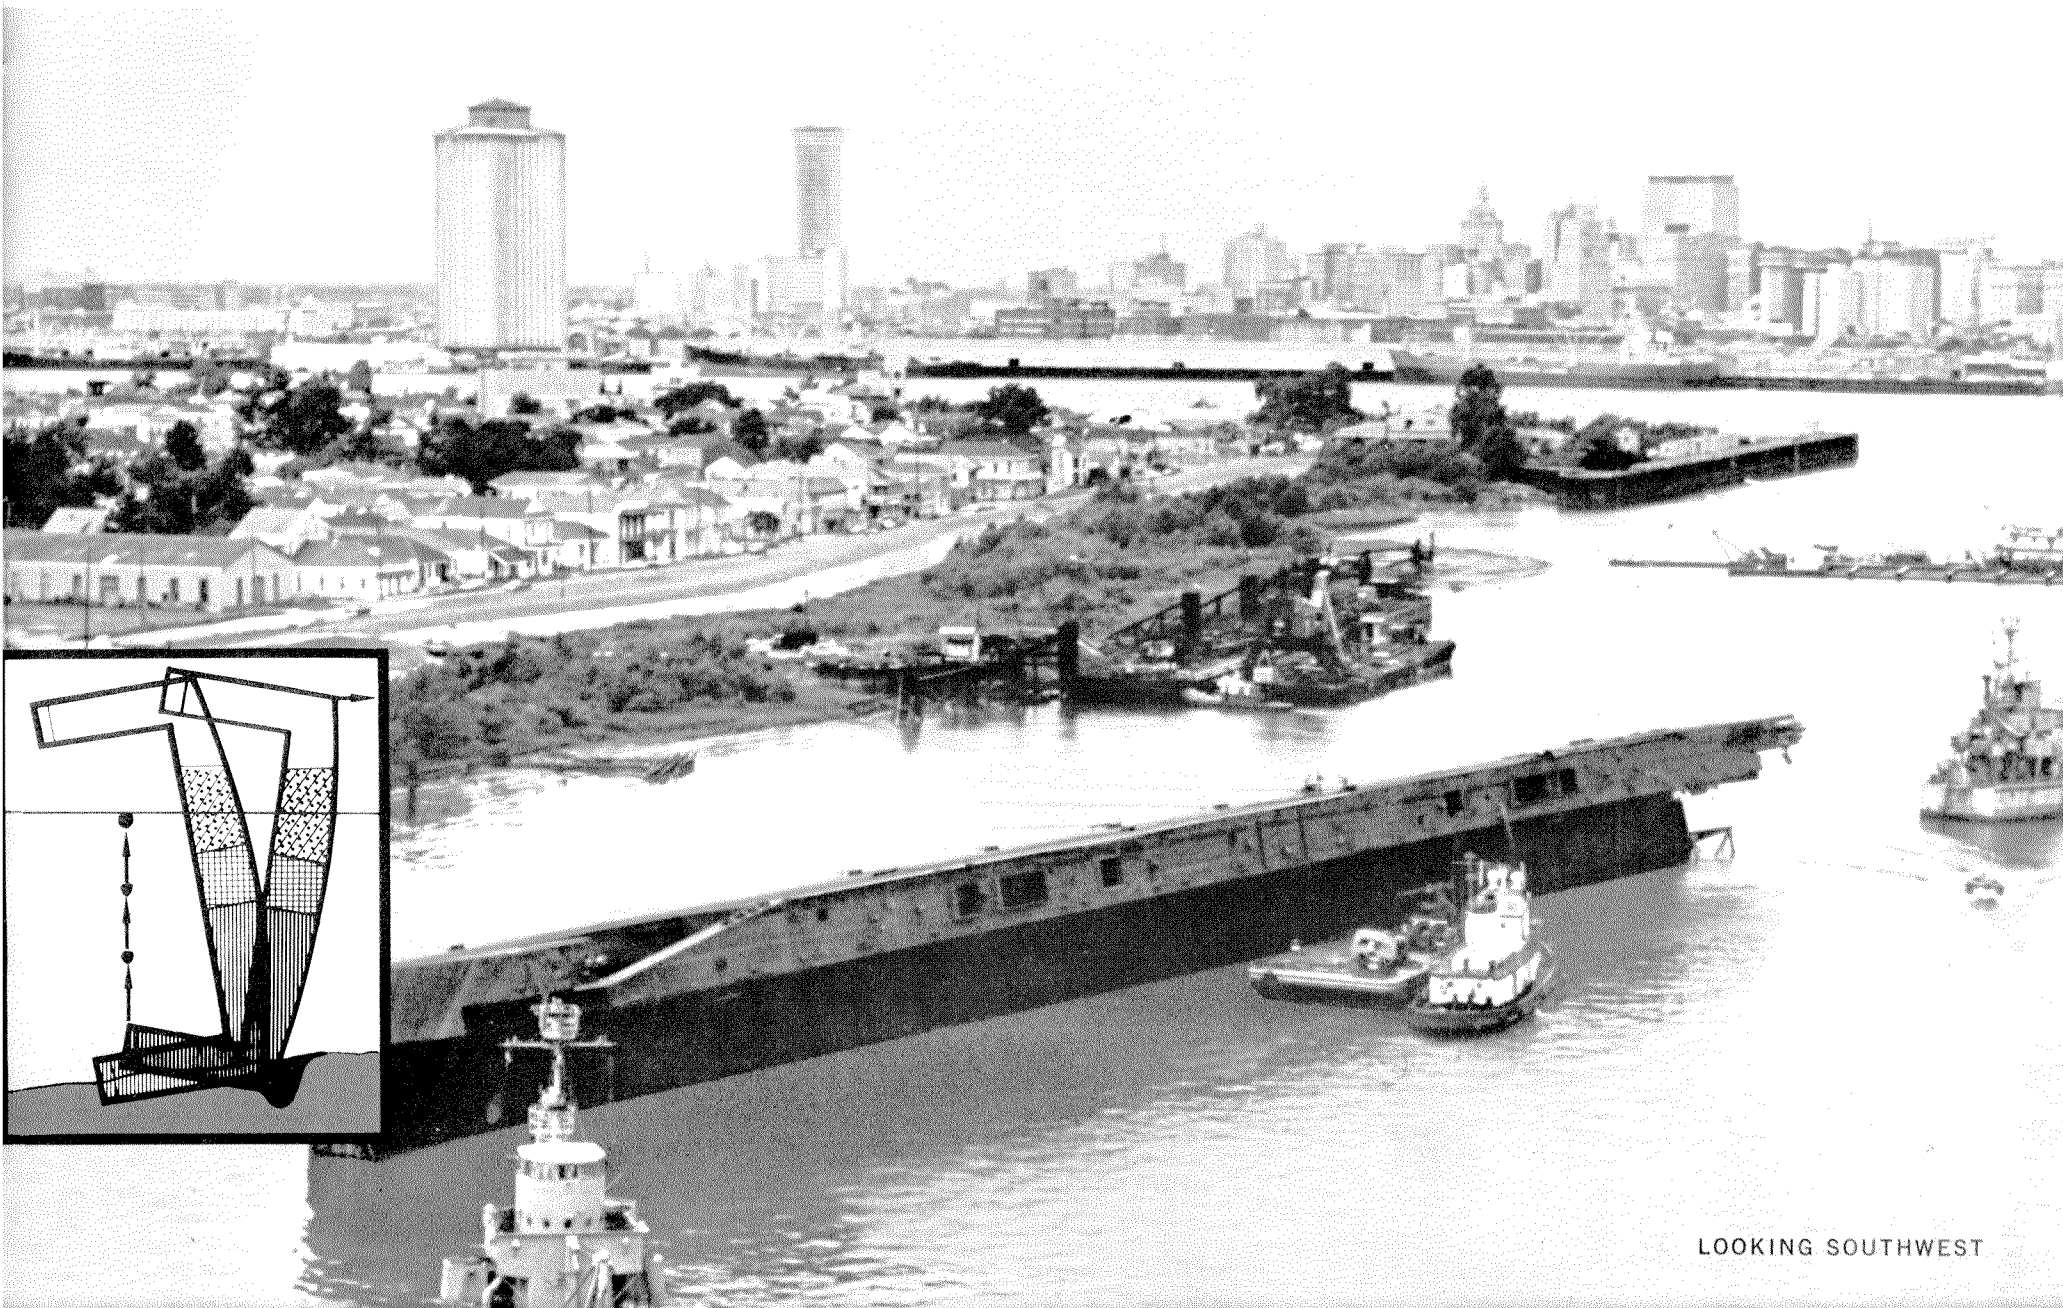
LOOKING SOUTHWEST

DREDGING was necessary to level the river bottom before AFDM-2 could be brought to the 90-degree position (Stage V). After the hydraulic dredge had dug a 10-foot-deep trench along 360 feet of the inshore chine line (shaded area), the drydock moved easily into the trench and rotated past the 90-degree mark.

COMBINATION of beach gear force, inflatable rubber pontoons and water ballast brought the drydock quickly to the Stage VII position (100 degrees) as the dredge (far right) moved out. As the hull rotated, beach gear force was reduced gradually to 250 tons.

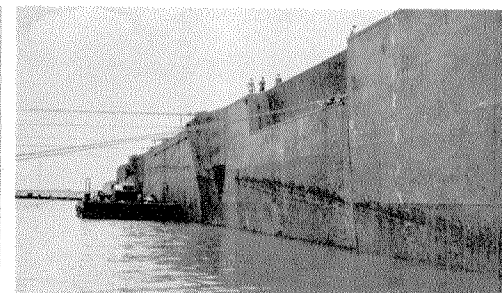
COMPRESSED AIR delivered at 60-psi gauge pressure was placed in B wall to displace 560 tons of water.

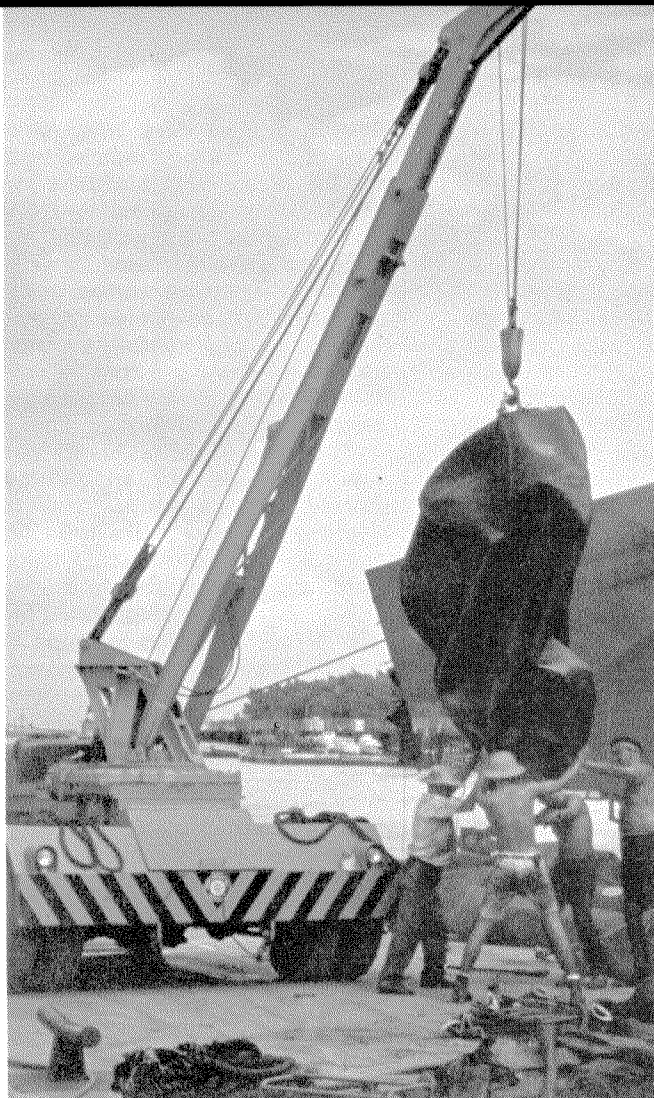
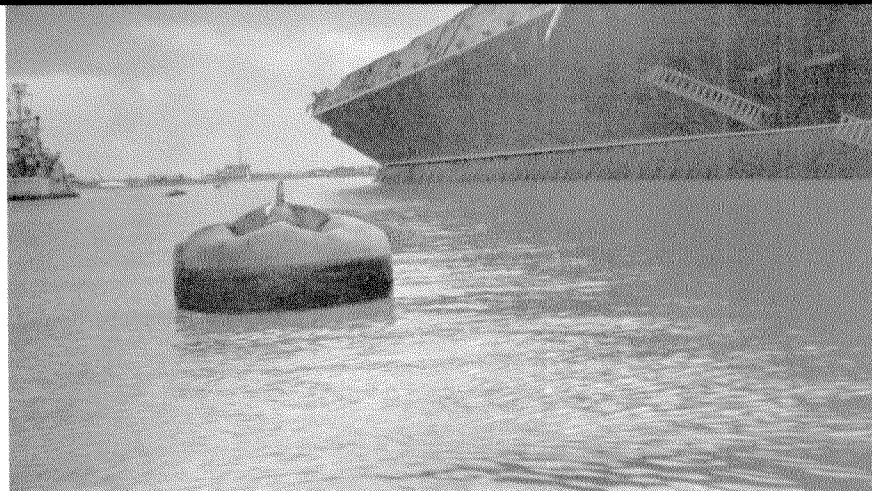
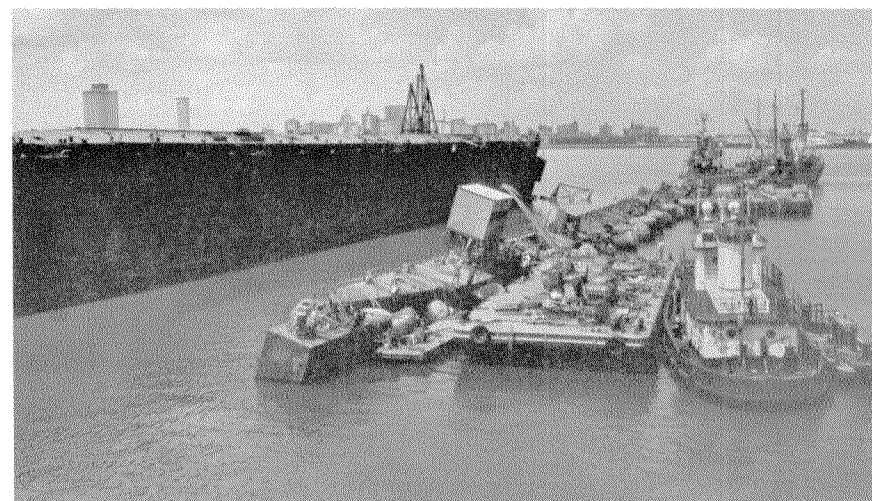
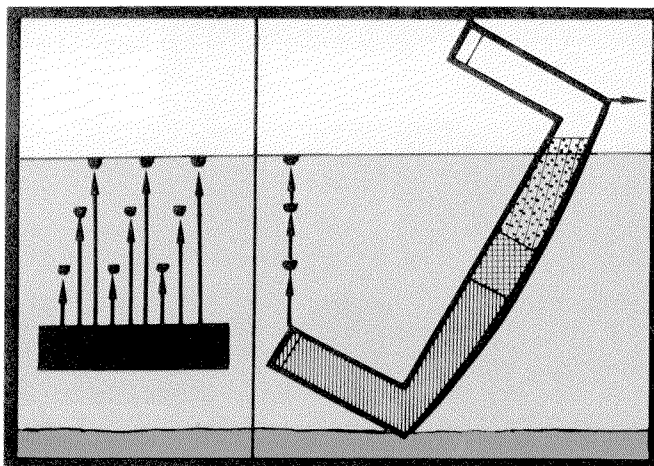
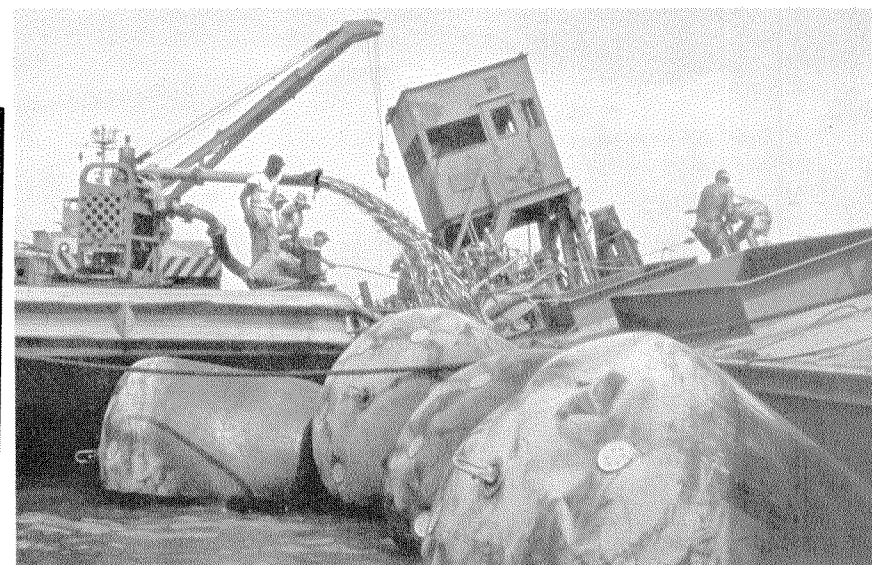
INFLATABLE PONTOONS, eight feet high and seven feet in diameter, were lowered one at a time by crane (right) after operation reached Stage IV. Underwater, the rubber pontoons were attached to preplaced pendants by divers, who then inflated them with air hoses from a barge-mounted compressor. A key element of the salvage plan, the pontoons provided 600 tons of external buoyancy force. In photo at far right, top, the first row of pontoons is shown after it broke the surface, dissipating 200 tons of lifting force. Center, all three rows are on the surface; bottom, a closeup of surfaced pontoon. Long-submerged B wall rose 12 hours after the first pontoons broke water.

BUOYANCY EFFECT of the rubber pontoons is shown in drawing that depicts AFDM-2 in Stage X position (120 degrees). Pontoons were arranged in three levels to help control final ascent of drydock.

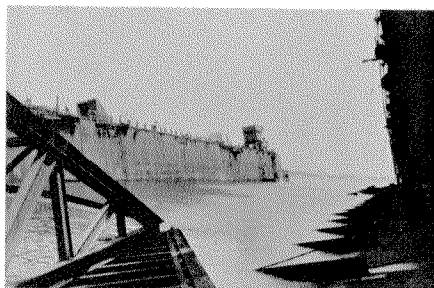
RIISING B WALL shown above surface as drydock rotated to 161 degrees from inverted position.

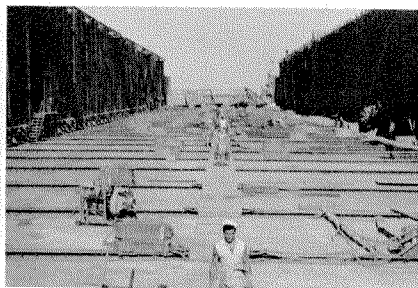
COMPLETELY DEWATERED, AFDM-2 assumed upright position with draft of six feet.

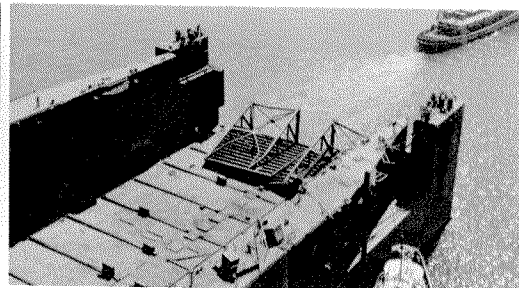
RIGHTED DRYDOCK was cleared of equipment and debris, turned end-for-end off salvage site, then towed to shipyard.

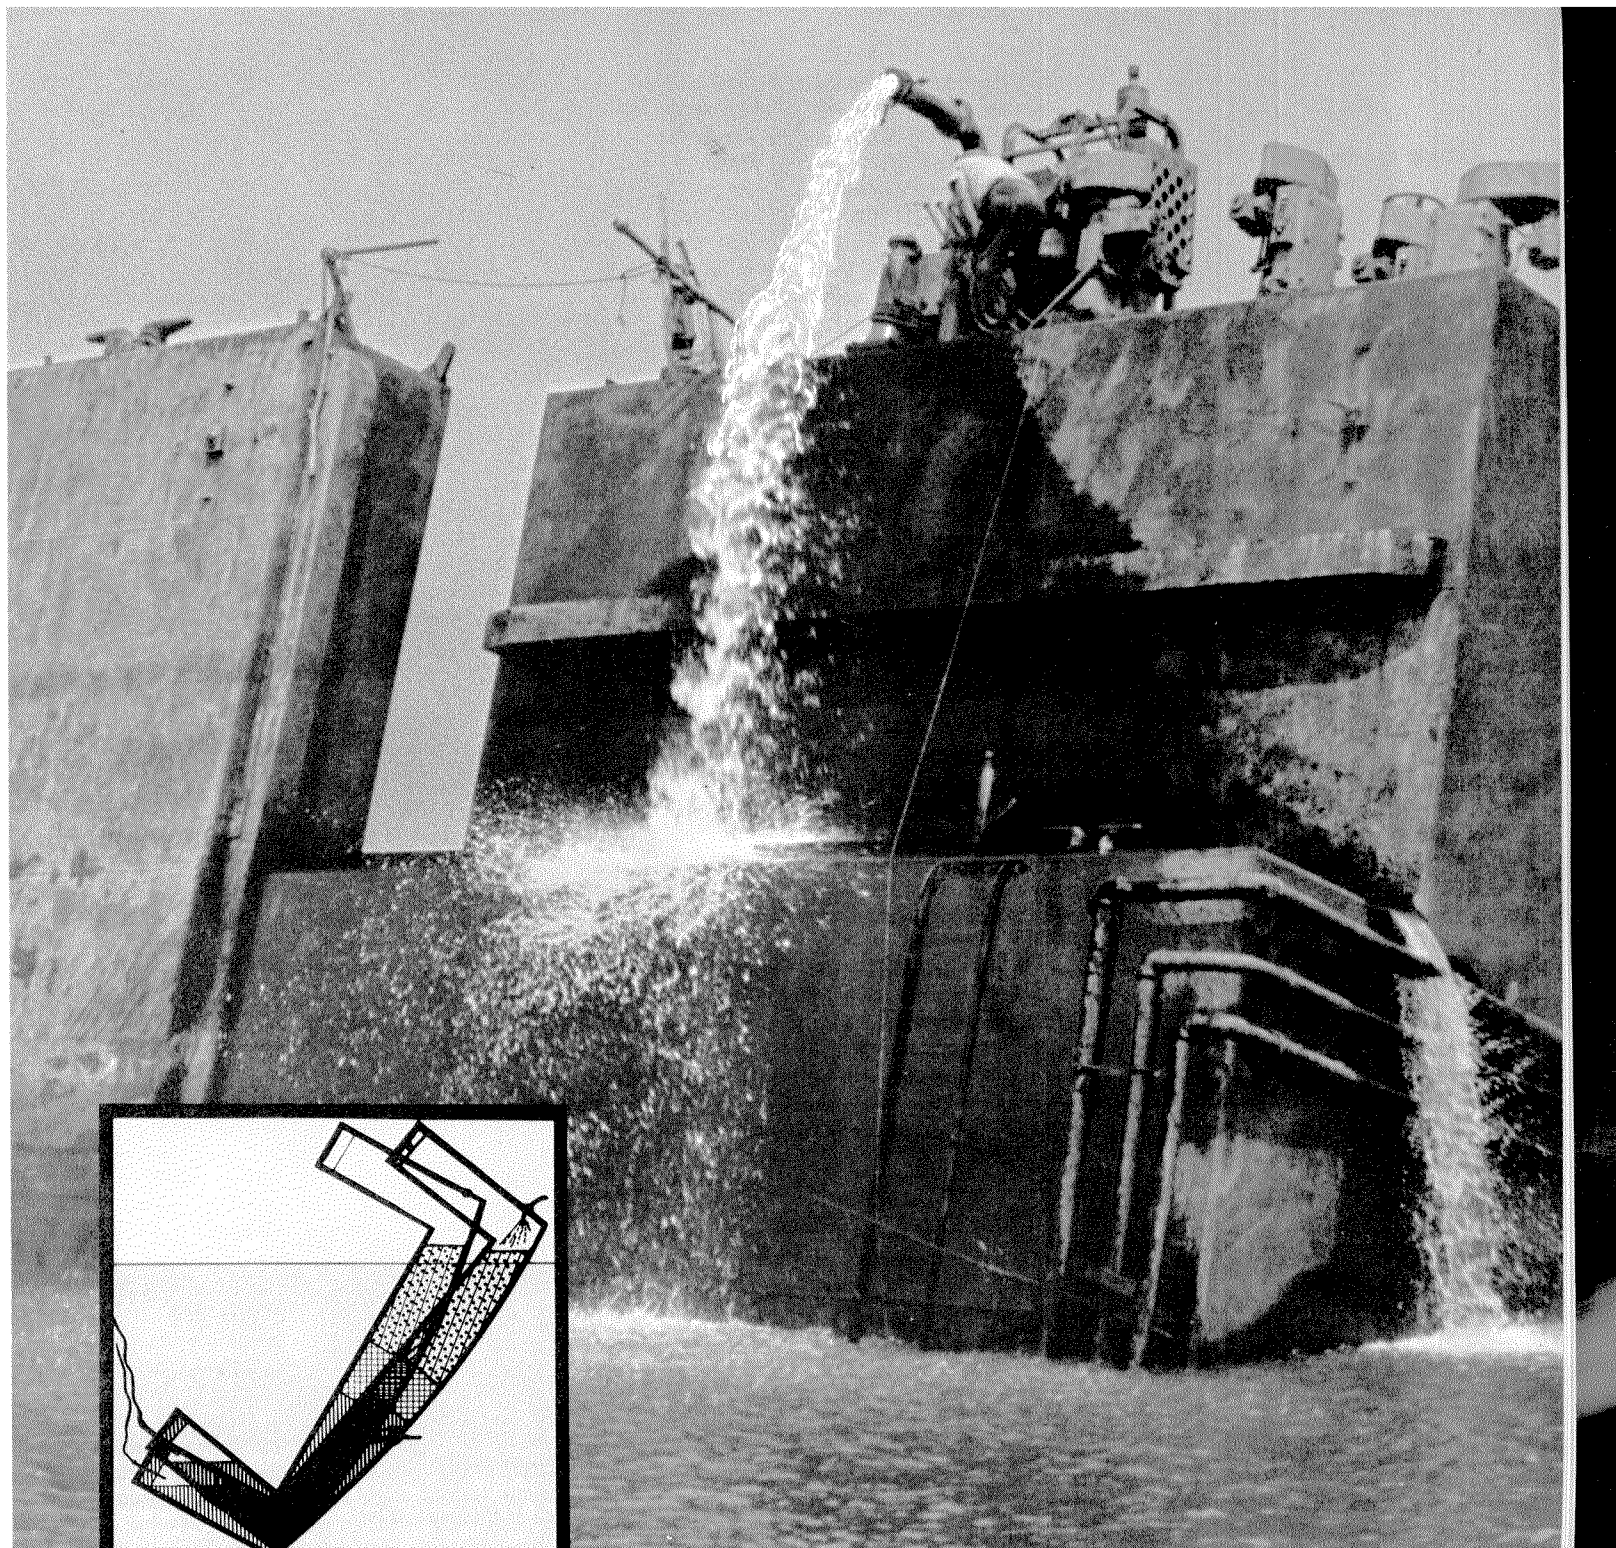
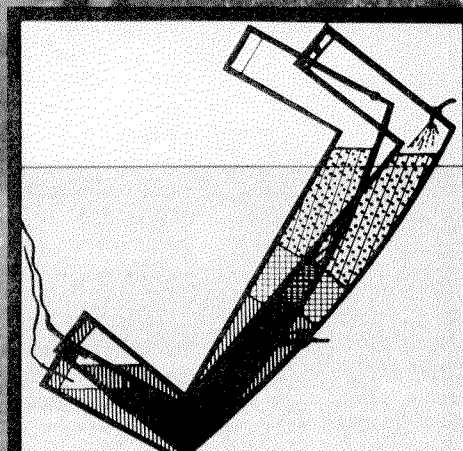
WITH BOTH WALLS of drydock above water, ballast vents were closed and compartments under air were bled down to atmospheric pressure. Then all compartments on both sides of the drydock were dewatered by four-inch and six-inch pumps. In less than four days the drydock reached the 180-degree position.

COMBINATION of compressed air and ballast rotates hull in final stages of salvage operation. Drawing shows water venting as air is pumped into ballast compartments of center section to displace 560 tons of water. Ballast was added to end-section areas at the same time.

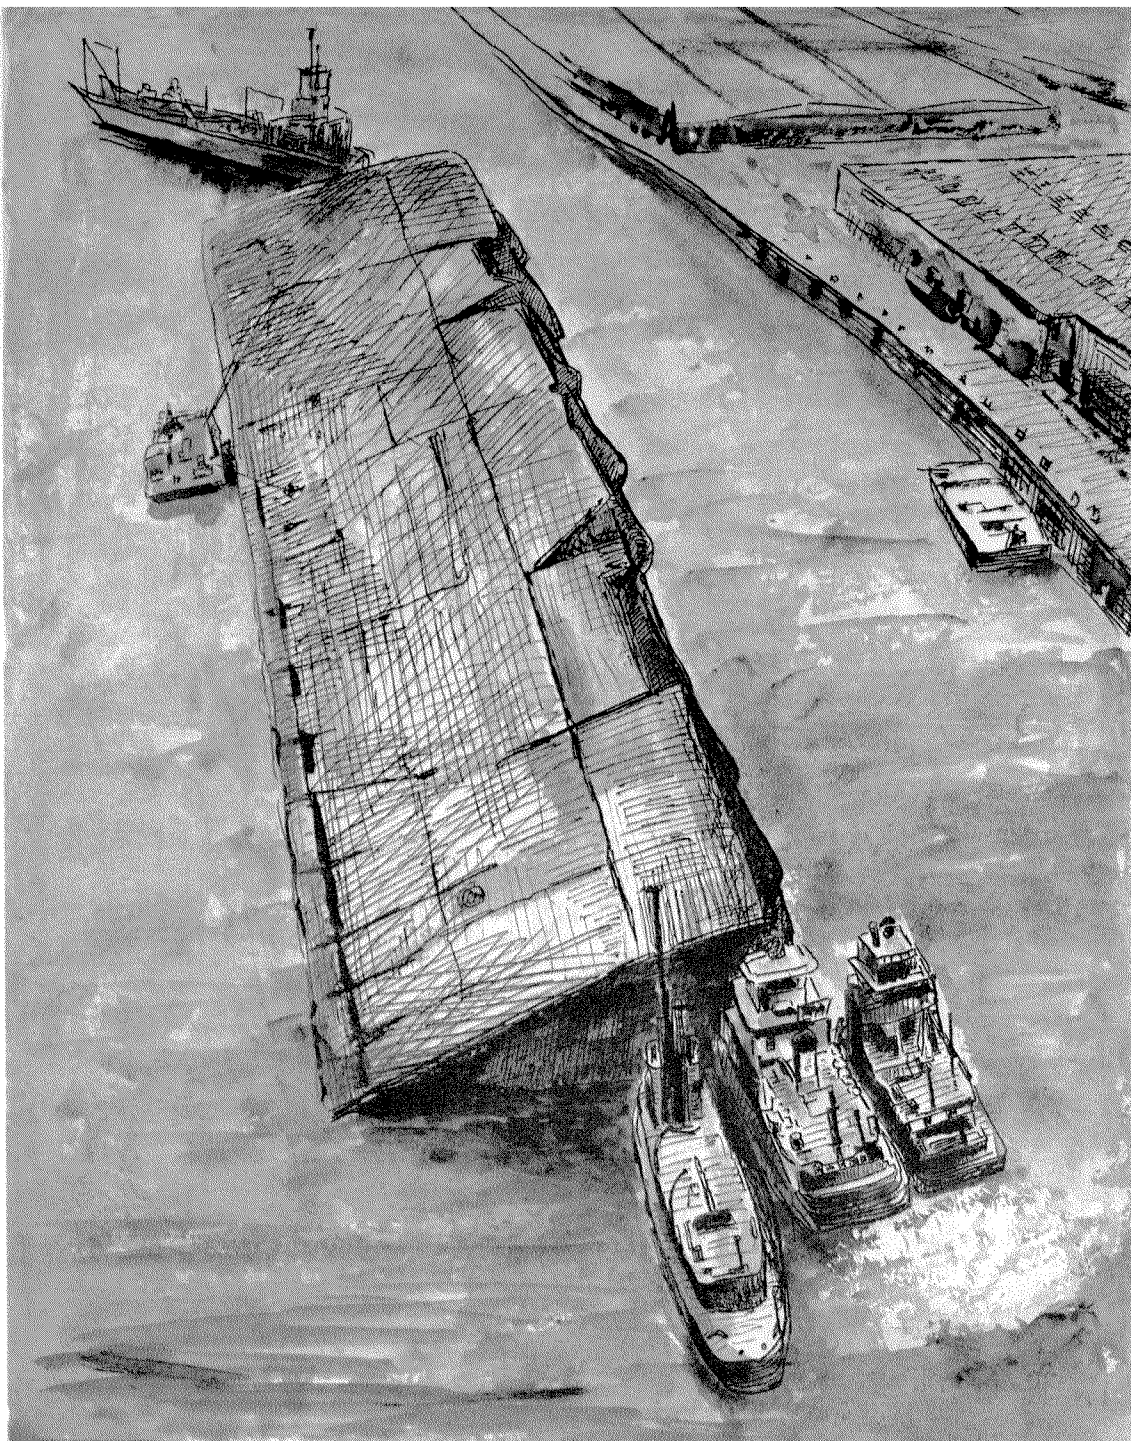
RETURNING DRYDOCK to salvage site on west bank required the services of three Navy ships—salvage ship CURB and lift ships SALVAGER and WINDLASS—and nine tugs. Plan called for AFDM-2 to swing pendulum fashion on four lines fastened to anchors dropped in mid-river as ships pulled and pushed her across. Anchors slipped, however, and move was completed under alternative plan.
