U. S. NAVY SALVAGE REPORT

USS FITZGERALD (DDG 62) AND USS JOHN S MCCAIN (DDG 56) SALVAGE RESPONSE AND HEAVY LIFT OPERATIONS

Published by Direction of Commander, Naval Sea Systems Command

1 MAY 2019

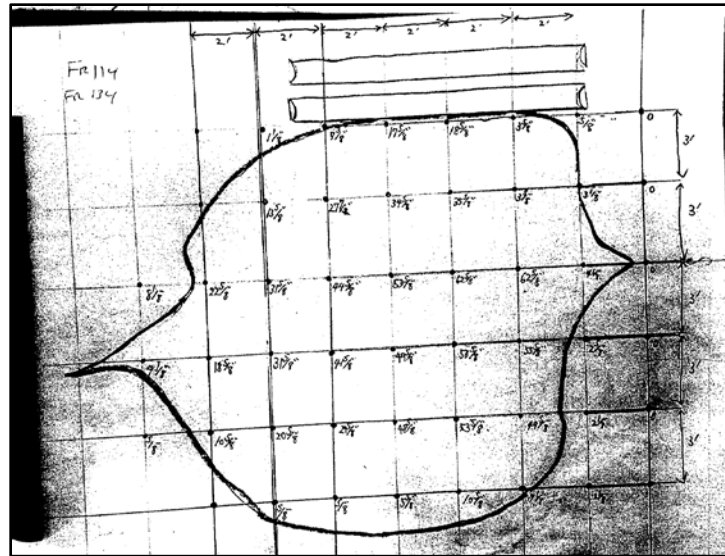
The spaces in the list that follows were damaged by the collision impact damage. Figures 1-2 and 1-3 show the profile and plan views of the damage and the spaces in which they occurred.

Berthing 3	2-300-2-L
Berthing 5	3-310-2-L
Fuel Oil Service Tank	5-300-4-F
Aft Officers Country	1-300-1-L
Crew Library	2-344-2-L
Berthing 7	3-338-2-L
Fuel Oil Storage Tank	5-338-2-F
Air Conditioning Machinery and Pump Room (Shaft Alley)	5-300-1-E

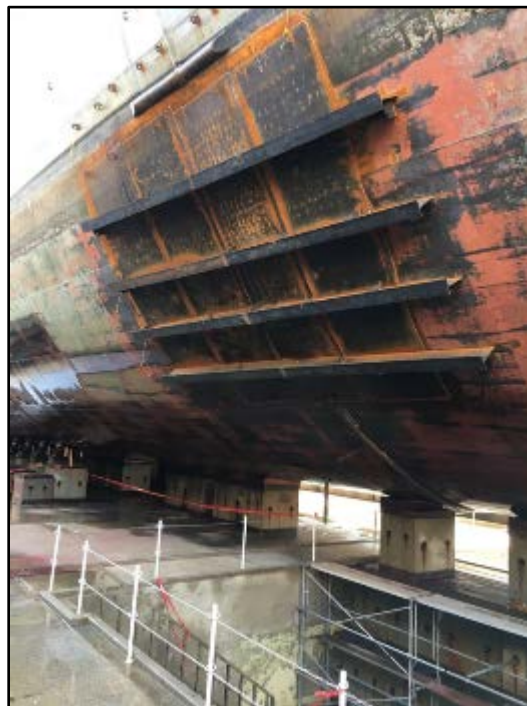
Figure 2-5. View of Fitzgerald's welded patch after dry docking.

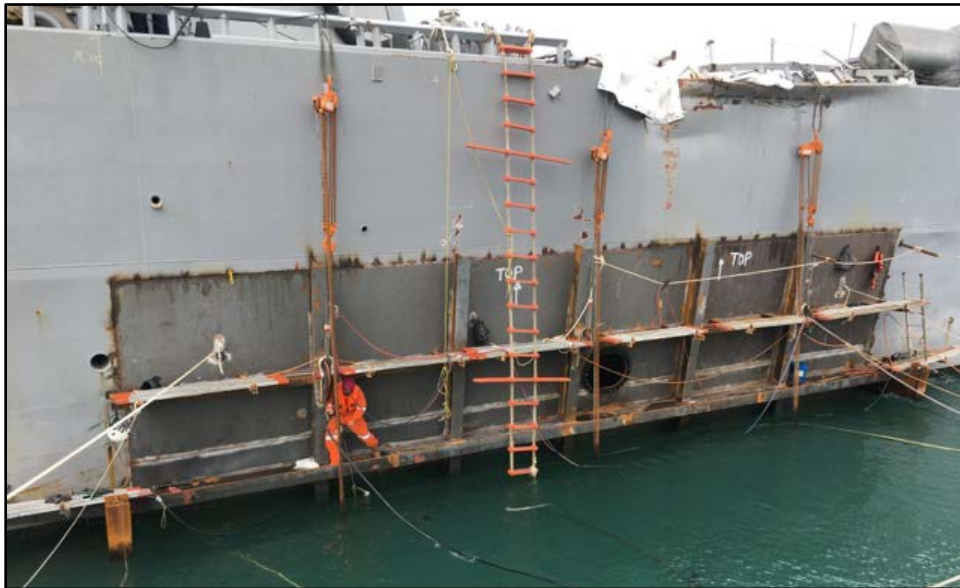
Figure 3-7. John S McCain's patch during installation.

As soon as the patch was fit up against the hull, it was apparent that the shape of the patch did not perfectly match up with the shape of the hull. Some areas of the plating had gaps of up to 2-4 inches and some of the stiffeners had gaps of up to 6 inches. The teams were able to get past these difficulties using a combination of tightening rigging, screw dogs, and added plates covering the gaps. However, it did add time to the overall patch installation process.

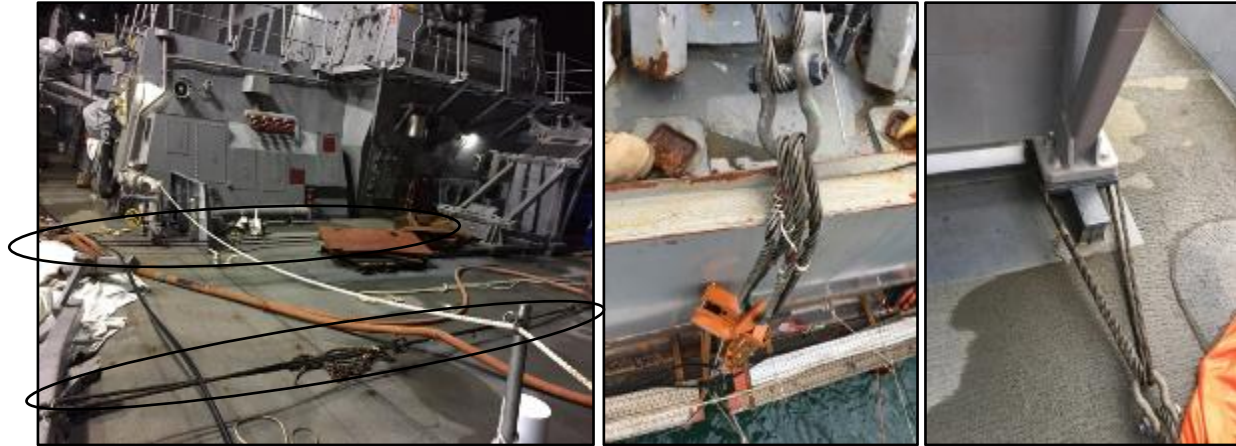
The crane held the patch to the hull as it was welded. The crane rigging attached to four lifting padeyes placed on the vertical frames of the patch. In addition, several L-shaped “frame catchers” were attached to the hull just below the 1st and 2nd platforms at frames 299 and 348 (see Appendix J for drawing). These were designed to catch the longitudinal girders that extended approximately 7 ft beyond the side edges of the patch. Four 5-ton padeyes were also welded onto the ship near the bottom of the patch, which served as attachment points for rigging to pull the bottom of the patch into the hull. Additional rigging was attached to makeshift hard points on the main deck of the ship to prevent the top of the patch from swinging outwards (see Figure 3-7).

Figure 3-8. Rigging patch to hardpoints on USS John S McCain's deck.

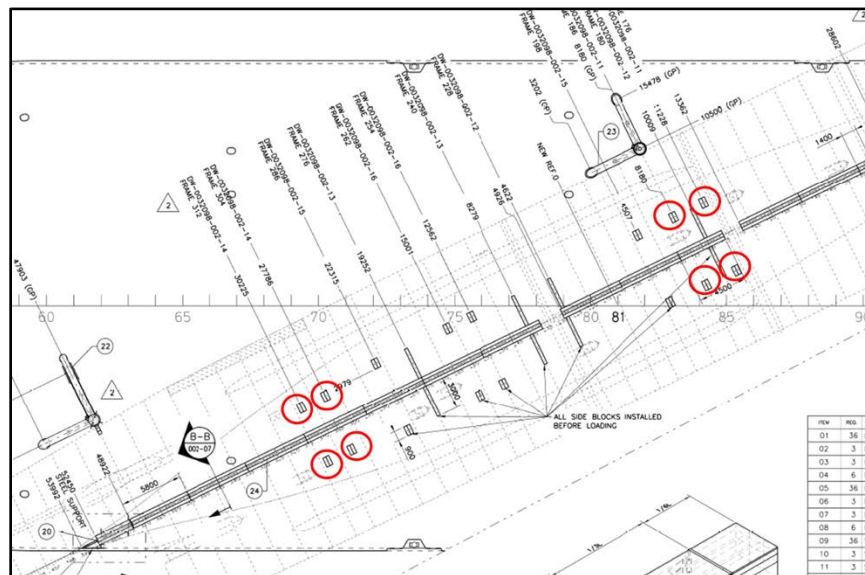
The USS John S McCain's blocking plan called for eight additional side blocks to be installed to properly support and secure the vessel during its transit. These additional blocks, four per side (Figure 4-6) were installed once the vessel had been landed and the deck was dry. See Appendix L for details.

Figure 4-6. Additional side blocks installed prior to transit

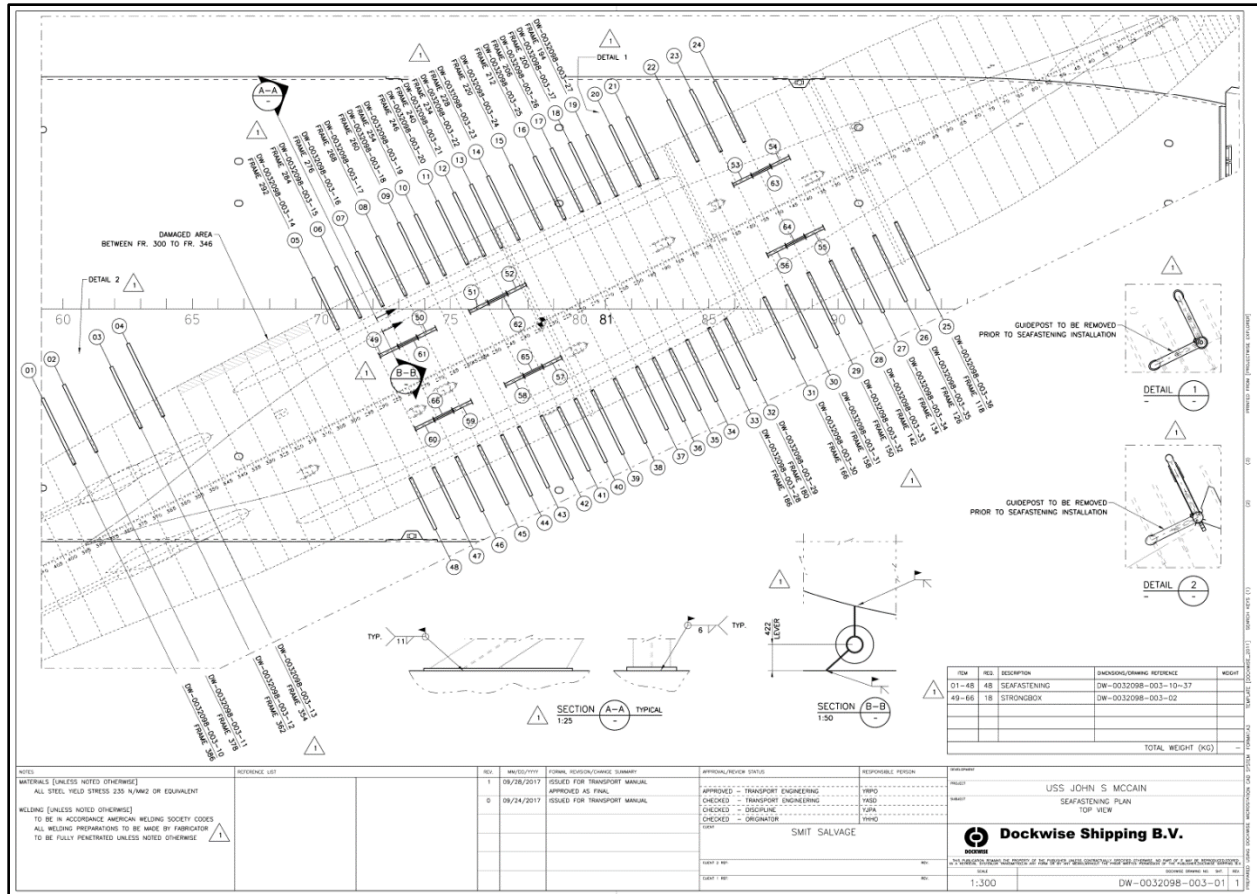
Figure 4-9. USS John S McCain Seafastening Plan

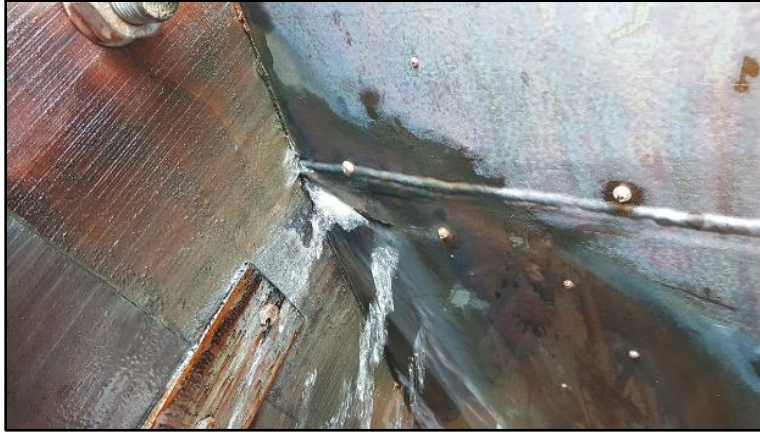
As detailed previously, block placement (Section 4-1.1) and movement of USS John S McCain in transit may have caused hull cracking. During the daily inspection of cargo and seafastening on 19 October 2017, the crew of the M/V Treasure observed water leaking from a crack in USS John S McCain's hull at frame 268, port side. Approximately 100 mm of crack was visible extending beyond the hull block. Approximately 15 mm of hull deflection was noted where the block touched the hull.

Figure 4-10. Crack at frame 268, port side

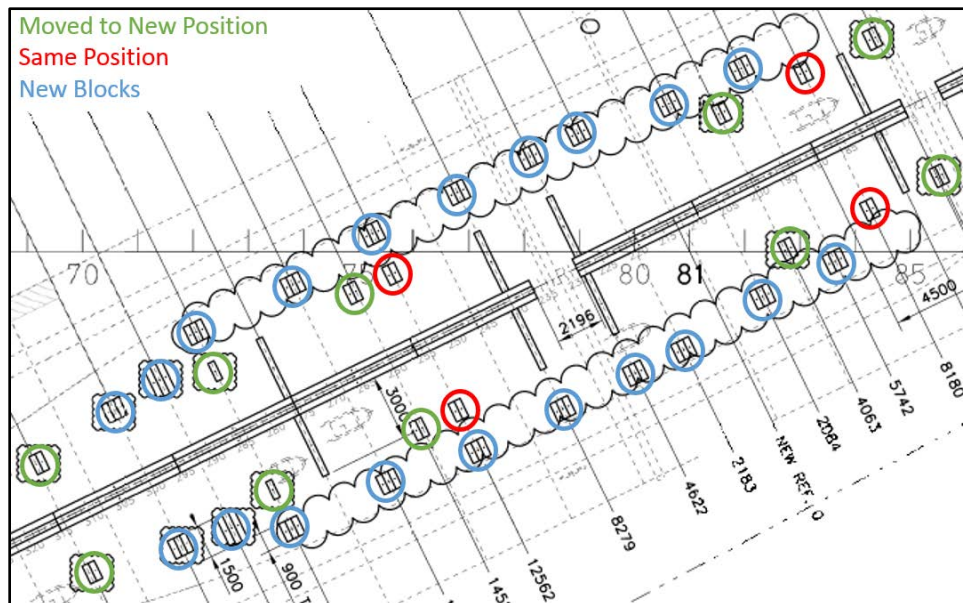
Figures Figure 4-12 and Figure 4-13 show that the shoring on the USS John S McCain was not longitudinally symmetric. This is due to the port side damage and the 26-degree load angle. It is possible that portside shores one through four were so far aft that they were ineffective. Paragraph 4-3 details the damages from the transit and changes made to reduce the risks in the transit from the Philippines to Japan.

Figure 4-12. USS John S. McCain Block Modification Plan

For transport to Yokosuka, 10 of the original side blocks were shifted to align with frames on USS John S McCain and 20 additional side blocks were added. Figure 4-12 shows the location for the repositioned blocks and the new blocks.

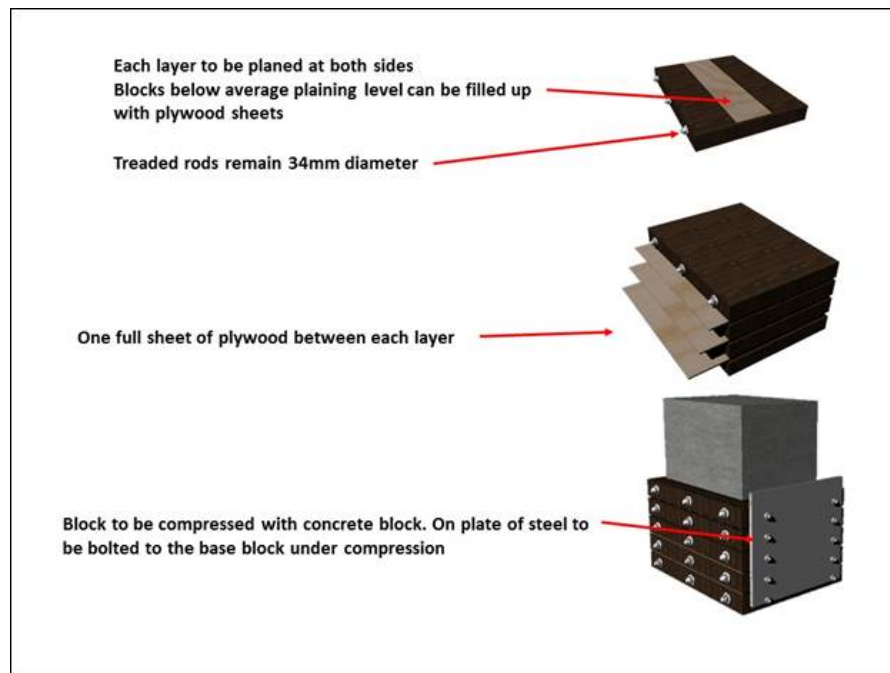
Figure 4-13. Block design diagram at Subic

The heavy lift team and SMIT Salvage Master observed the block construction plan and aided in revising the construction strategy to save time. To mitigate the gaps due to uneven wood block sizes and reduce required planing time, a layer of plywood was placed between each row of blocks, and the blocks were preloaded prior to installing the metal plates on the ends. The end plates ensured the compressed blocks retain their as-assembled configuration, (Figure 4-16 shows blocks under compression). The blocks and soft caps were assembled at Keppel Shipyard and final adjustments were done onboard M/V Treasure. Original estimates predicted 17 days to construct and install the blocking and, with focused management, that schedule was met. Final block installation was completed on 25 November.

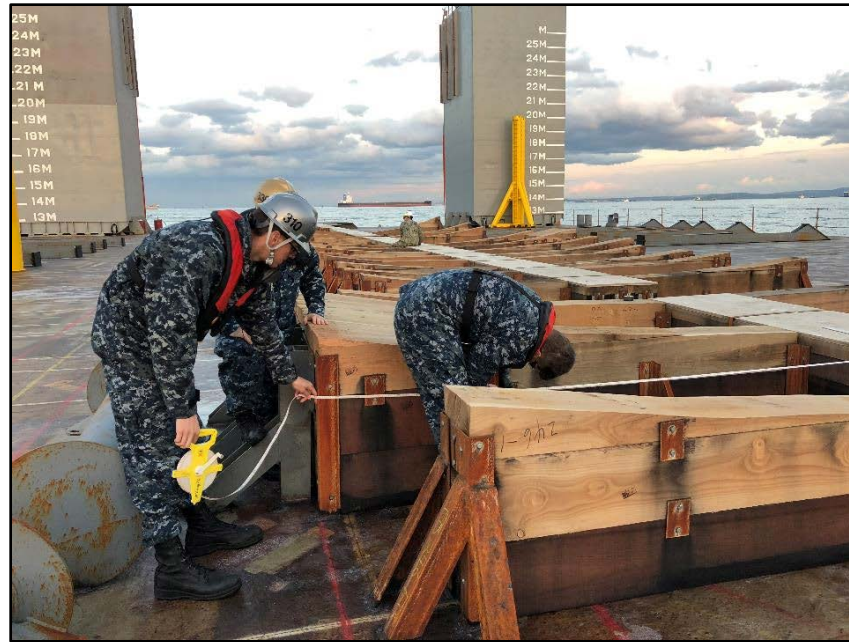
An additional verification was required to ensure blocks were placed at the intersection of a longitudinal and frame. SUPSALV worked with the contractor to identify the structural frames on a docking drawing so that the onload blocking met this requirement. Figure 5-11 shows the heavy lift team measuring the blocks and cradles. Final block configuration is documented in Appendix E.

Figure 5-11. Heavy Lift Team Measuring and Repairing Onload Blocking

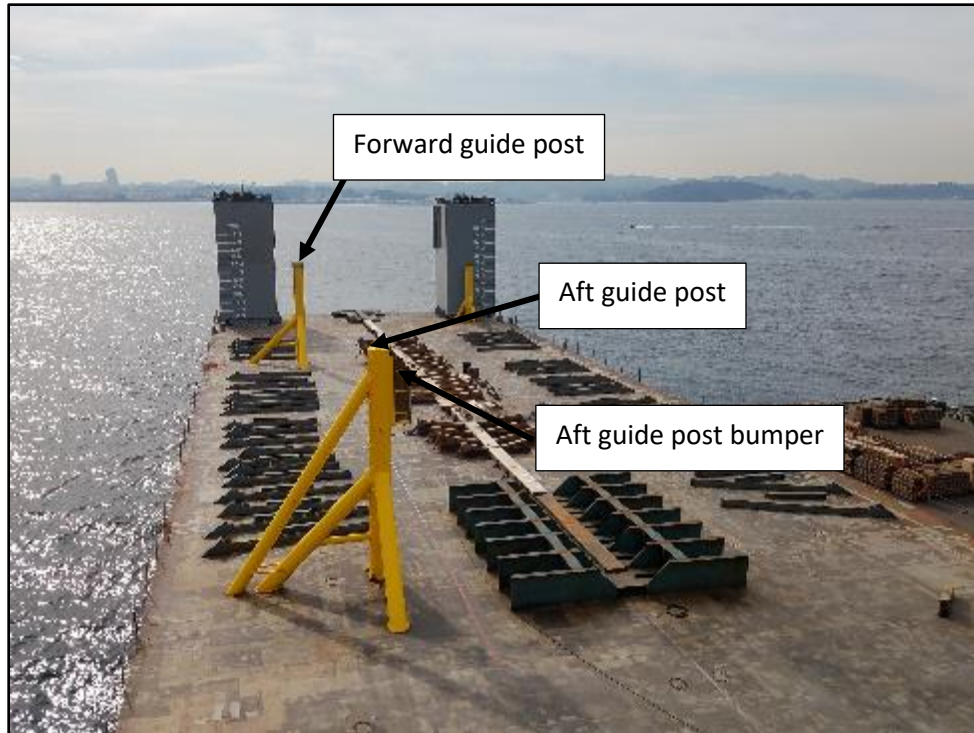
On 21 November 2017, the heavy lift team began working the aft guide post and bumper calculations because the Independent Marine Surveyor (IMS) expressed concern over its location. The result of the investigation was the determination that the bumper block was designed and cut backward. The forward USS Fitzgerald edge had about 20mm less clearance than the aft edge. This caused the cargo to guide down a wood edge rather than a surface. After review, it was confirmed that a minimum clearance of 16mm at lower forward corner allowed for safe landing so the determination was made not to make any changes in the location of the aft guide post. (Figures 5-12 and 5-13).

Figure 5-12. Forward and aft guide posts

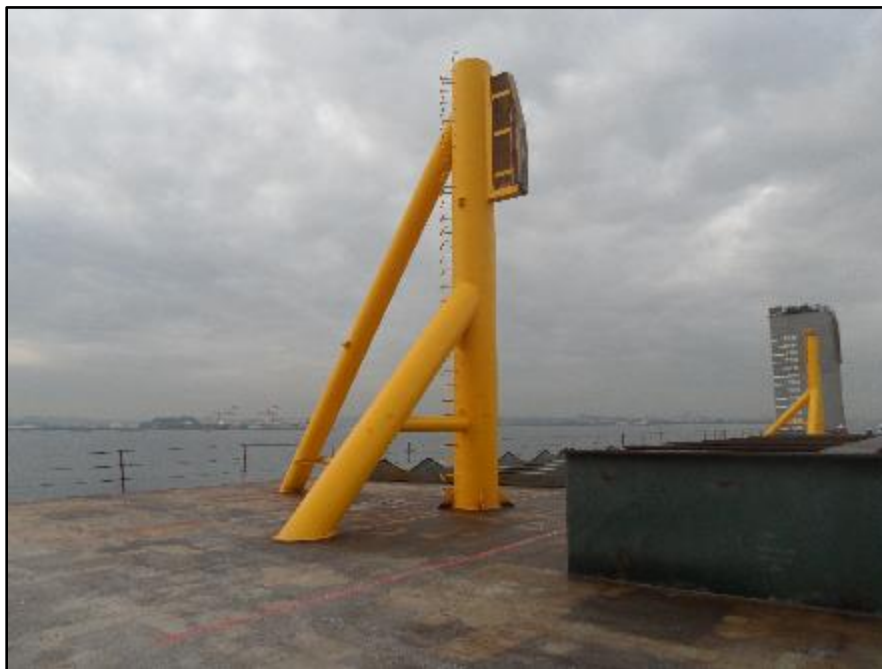
Figure 5-13. Aft guide post and bumper

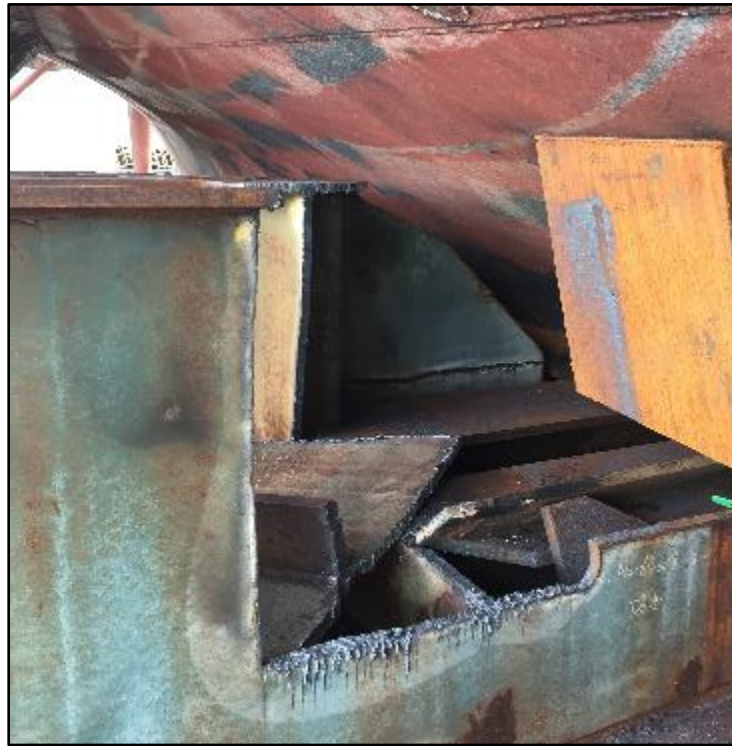
Figure 5-23. Grillage removed prior to offload

Additional grillage was removed to provide adequate clearance for the box patches (paragraph 5-6.6). Figure 5-23 shows the clearance as transported while Figure 5-24 shows the grillage cut away from the box patches prior to offload.

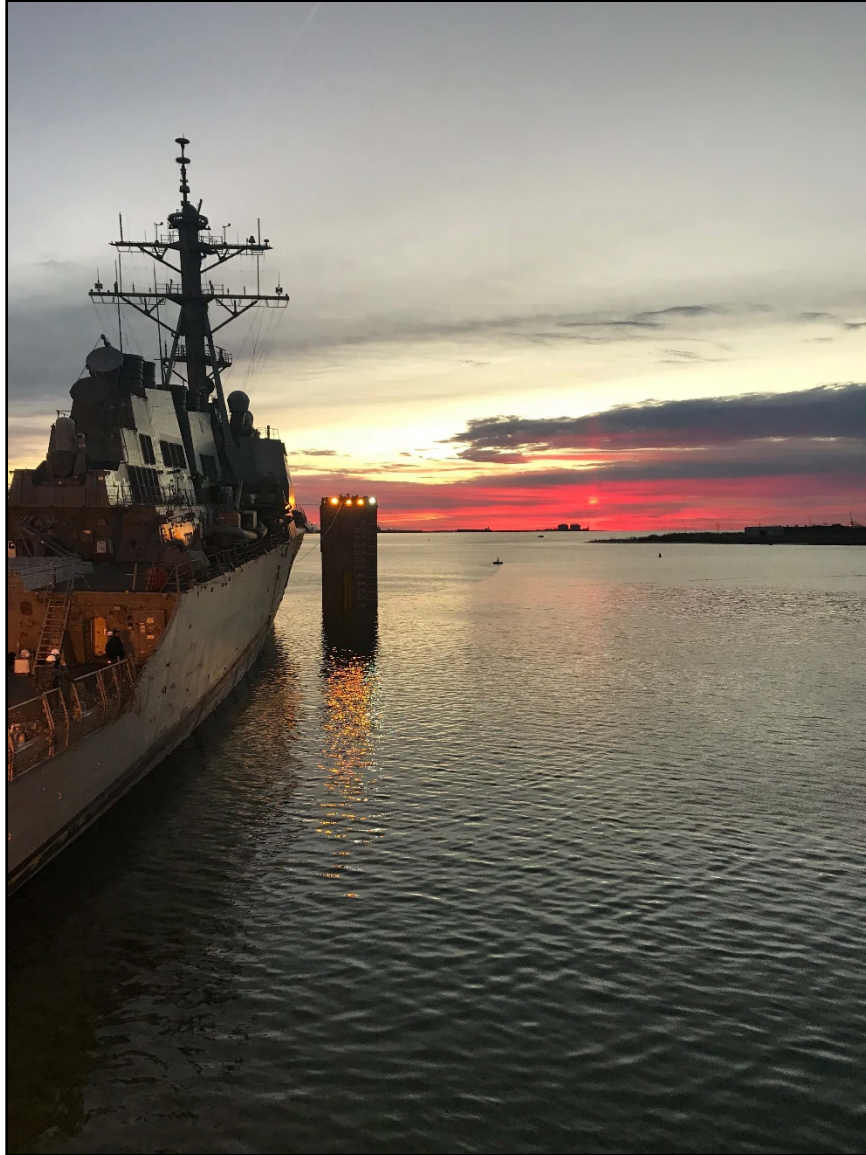
Figure 5-25. USS Fitzgerald nearly ready to float free of M/V Transshelf at dawn the morning of 24 January.

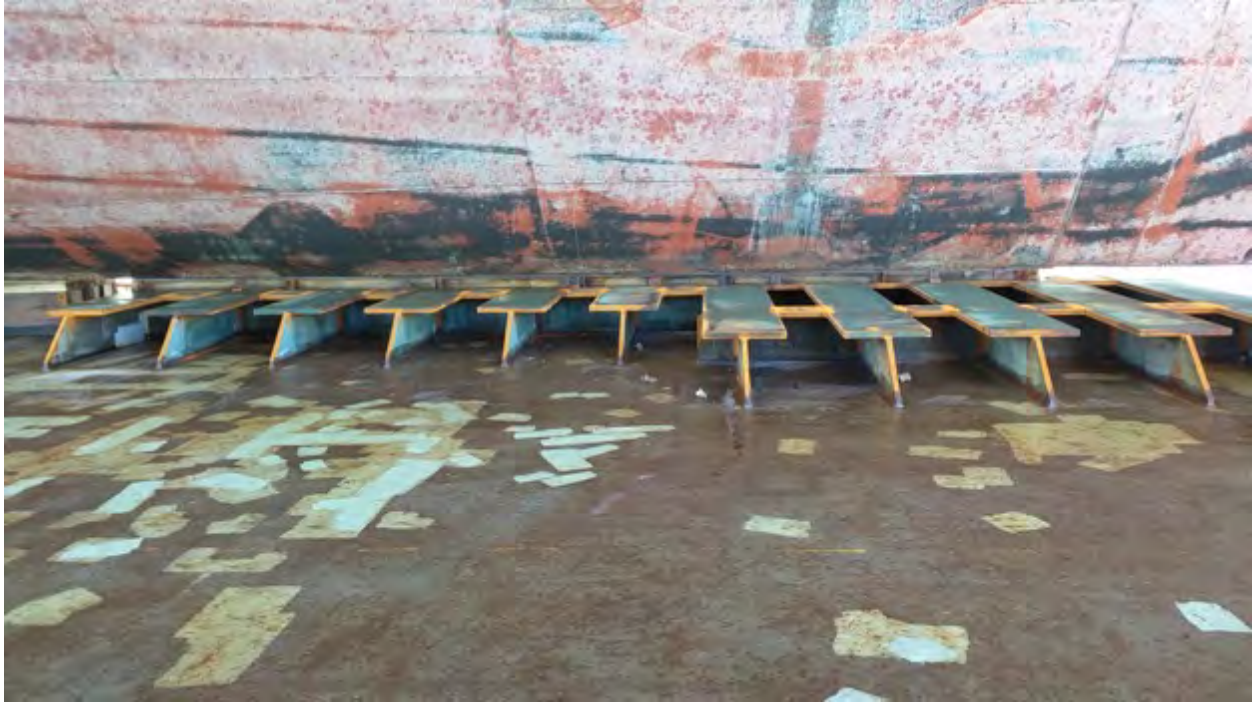
The bow grillage distributing the load of the cargo was implemented successfully (Fig 3) and did not require modification from the design recommended by Dockwise.

Fig 3. Bow grillage constructed on the cargo deck of the HTV with the cargo in-place prior to installation of sea fastening for transport from SRF Yokosuka.

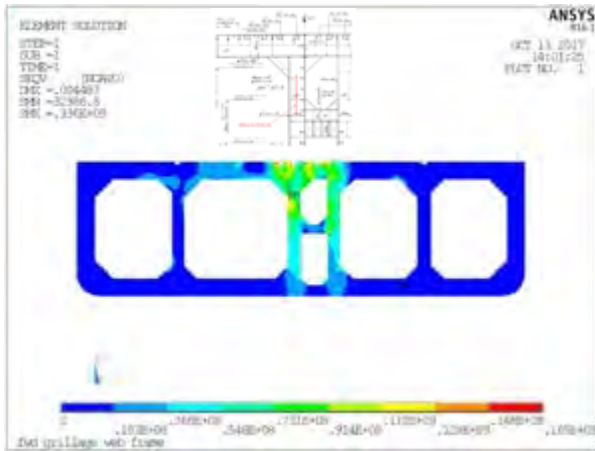
Structural analysis completed by Dockwise also showed that the installation of stiffeners on pillars in the below deck framework (Fig 4) and a tall steel grillage on the cargo deck were needed. As with the grillage under the bow of the cargo, the grillage at the stern of the cargo (Fig 5) was designed to spread loads on the cargo deck in a way that would further protect the support framework below.

Fig 4. Preliminary analysis of stresses in the support framework under the cargo deck of the HTV where the stern of the Fitzgerald would be placed (completed by Dockwise).

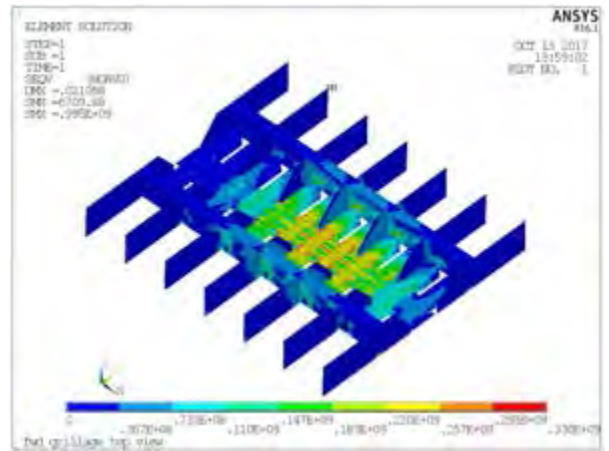
The stern grillage was unsuccessfully implemented. The design of the stern grillage resulted in destructive contact between the cargo and the grillage involving bilateral cargo hull punctures during onloading.

Fig 5. Preliminary analysis of stresses in the proposed stern grillage when loaded with cargo (completed by Dockwise).

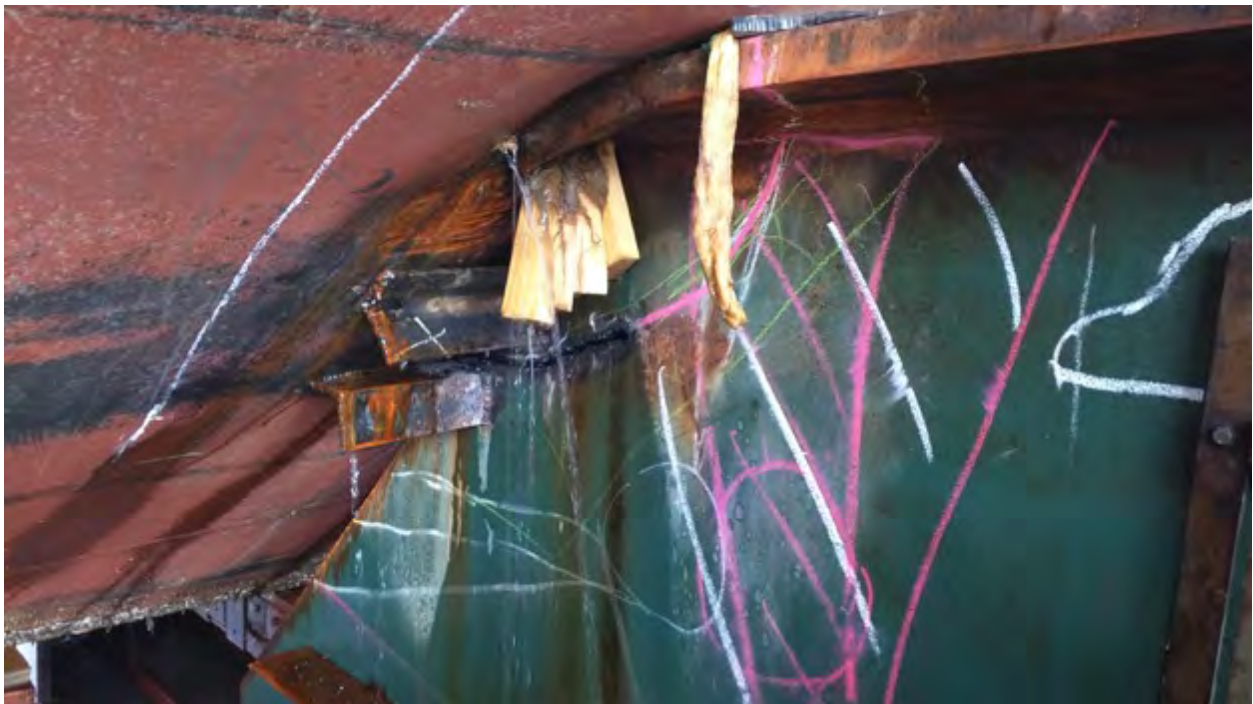
Fig 6. Cargo port side hull puncture resulting from contact with grillage at HTV frame 88.

The bilateral cargo hull punctures resulted in leaks that required urgent containment to prevent spillage of an upper layer of fuel from inside the punctured tank. Box patches to be welded to the surface of the cargo hull were selected as the optimal approach for controlling the leaks with the supporting grillage in-place. The installation of those box patches required significant cuts in the web of the grillage beam at HTV frame 88 (Figs 8 and 9). This was an area of the grillage that was not in direct contact with the hull cargo but it was an element of the support structure associated with the purpose of the grillage.

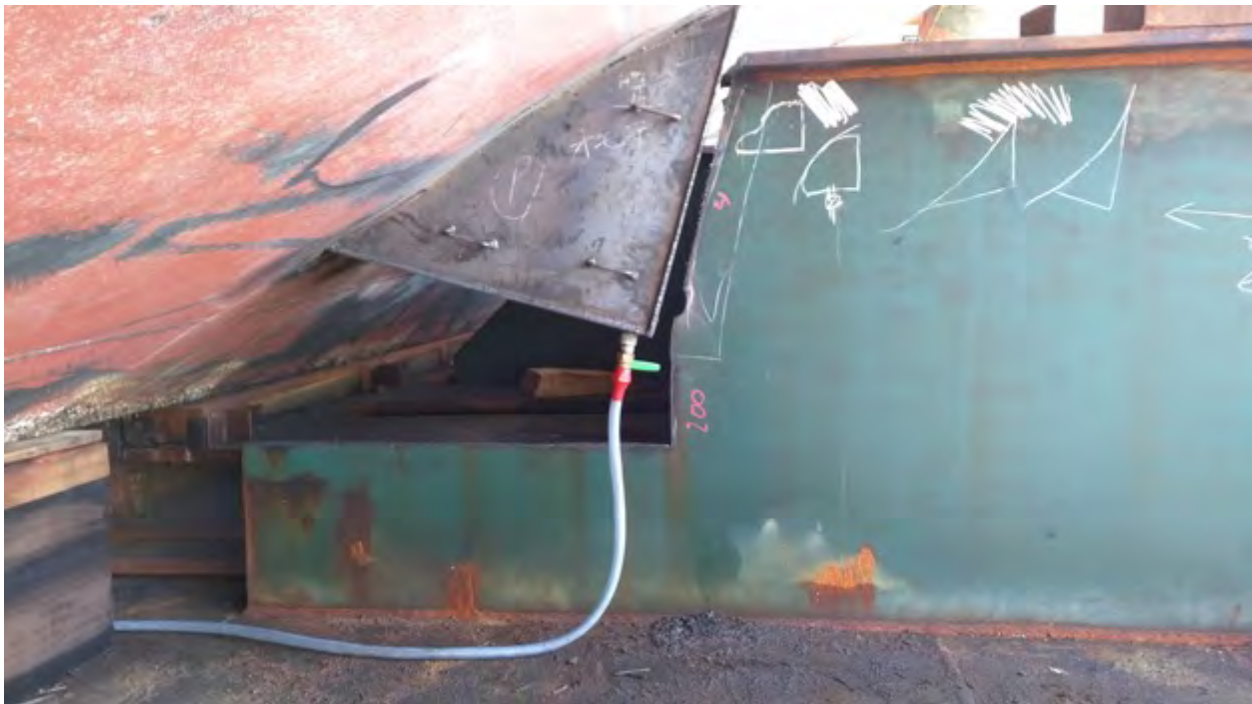
Fig 9. Cargo port side hull puncture box patch.

The box patches were sized to accommodate the cargo hull punctures. Once the box patches were installed, it was found that the cuts in the grillage beam were too close to the box patches on both sides of the cargo hull, creating a risk of damage or puncture to the box patches while in transit. As the HTV underwent routine ballasting operations, the list of the cargo hull changed sufficiently for the grillage to make contact with the box patch on the cargo hull's port side (Fig 11) and to come within 2 inches of the cargo hull's starboard side (Fig 12).

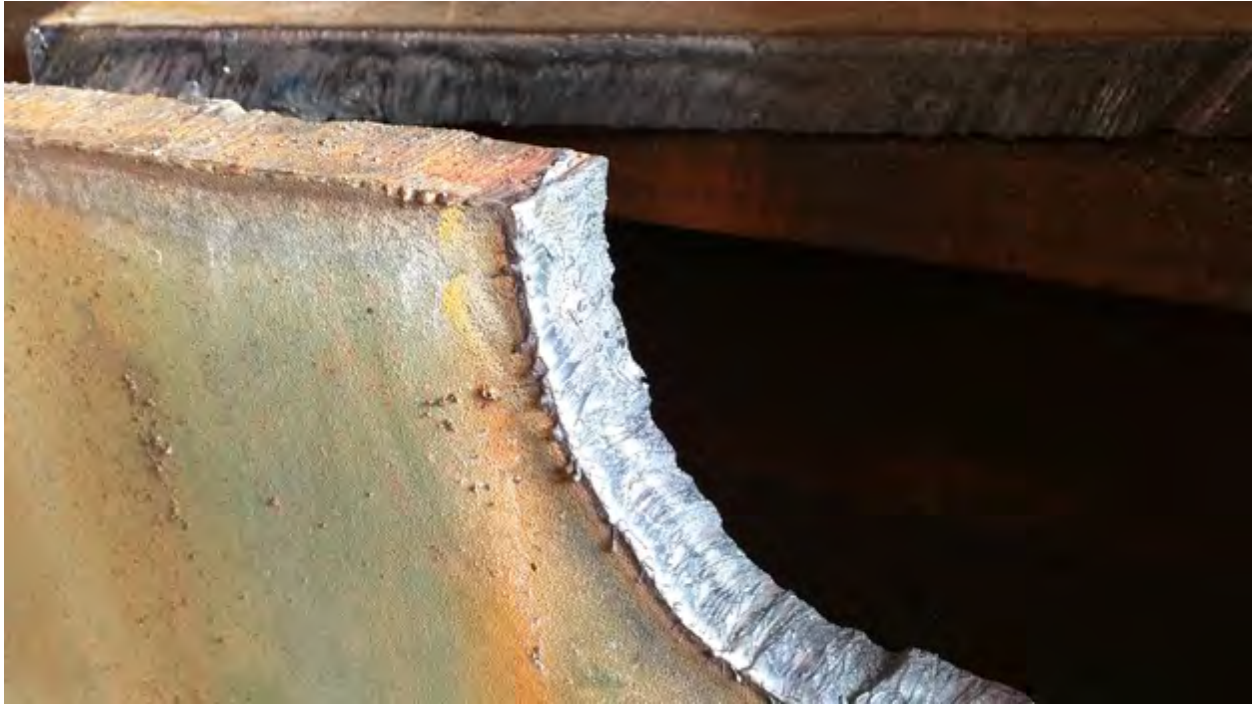
Fig 15. Surface finishing on the rounded grillage cut angle on the cargo hull's port side.

To avoid contact between the box patches and the grillage and to prevent tearing or cracking at the sharp angles of the original cuts, the grillage beam cuts were revised by rounding the angles and removing more of the beam steel to create more space between the beam and box patch on both sides of the cargo hull.

In addition to reshaping the cuts, the rounded angles of the cuts were finished to further protect them from cracking (Fig 15).

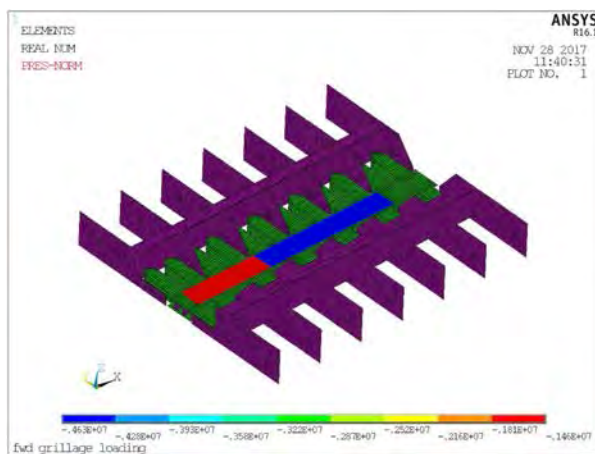
A final analysis completed by Dockwise (Figs 16 and 17) involved a mesh size for the model that was varied by a factor of 2x without any significant changes. This approach demonstrated that the mesh size used was adequate for the objective of the model. Overall, the stress analysis using the revised model indicated that the modified grillage would provide the intended stress distribution in support of all life and safety considerations.

Fig 16. Preliminary analysis of stresses in the support framework under the cargo deck of the HTV where the stern of the Fitzgerald would be placed (completed by Dockwise).

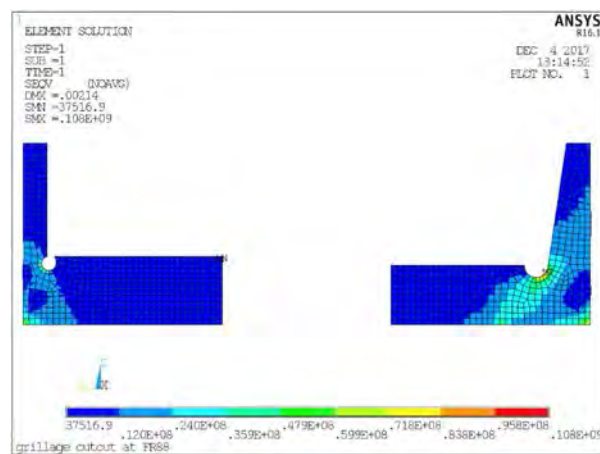
Fig 17. Detailed analysis of stresses of the revised grillage beam at HTV frame 88 (completed by Dockwise).

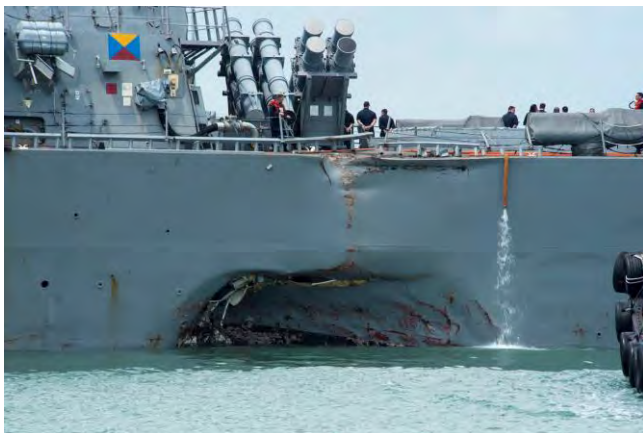
The collision resulted in a hull breach that "resulted in flooding to nearby compartments, including crew berthing, machinery, and communications rooms." Ten US Navy sailors died as a result of the collision.

Fig 1 - Damage to USS John S. McCain (DDG 56)

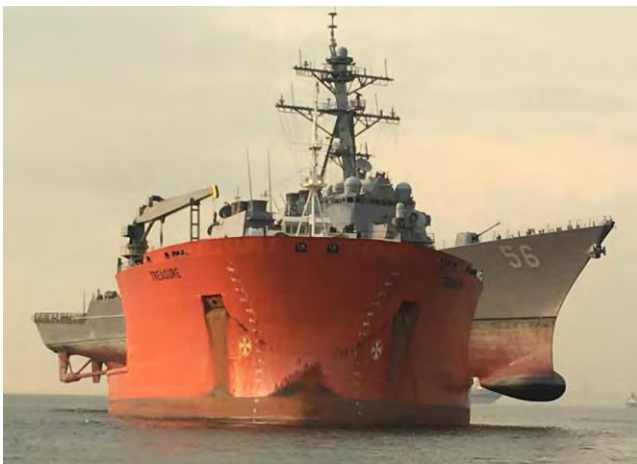
However due to general arrangement of the MV Treasure, the USS John S. McCain would need to be lifted with the destroyer's bow and stern cantilevered off the port and starboard sides of the MV Treasure. This is shown in Figure 3 (Fig. 3), and the docking plan is shown in Figure 4 (Fig. 4).

The problem with this arrangement of the MV Treasure is that it could impart significant rolling periods of the heavy lift ship while the USS John S. McCain is loaded. These rolling periods were proposed by the Heavy Lift Teams to cause a cyclic loading on the destroyer.

Fig 3 – Bow view of the cantilevered USS John S. McCain loaded aboard the MV Treasure

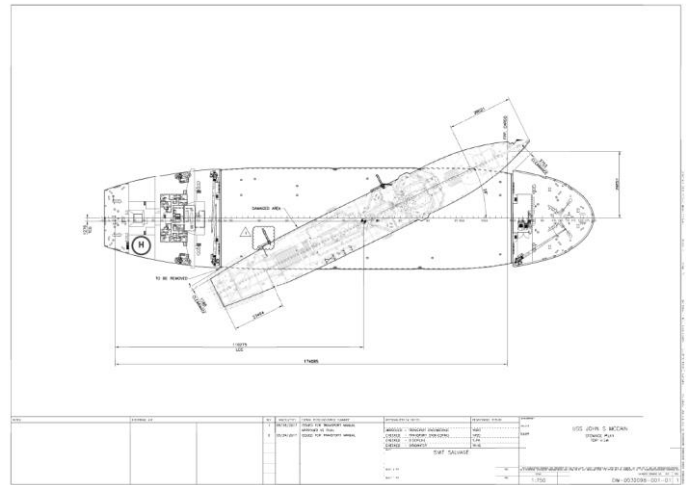
Fig. 4 - Position Layout of USS John S. McCain aboard MV Treasure

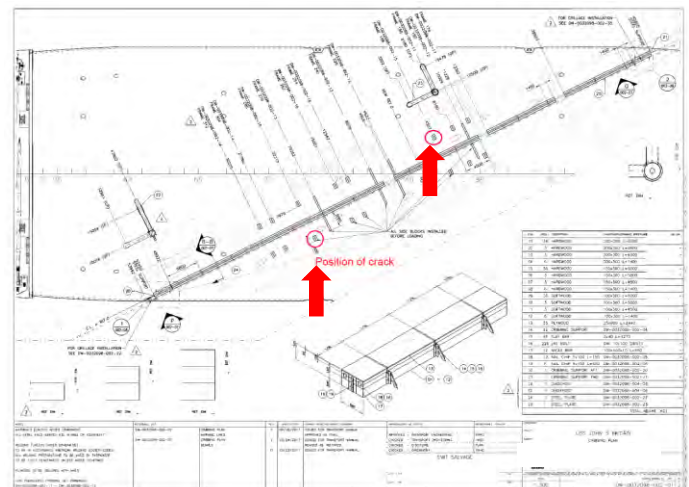
During the loaded transit to Japan, the MV Treasure had to heave-to for five days in the Philippine Sea to allow a typhoon to pass ahead of it. During the five days, the side shoring along the hull of the destroyer was periodically observed to be visibly away from the hull. The voyage data recorder system showed a constant roll of six degrees with a ten-second period.

On the fifth day, the crew observed seeing a linear indication under the support block of frame 286 adjacent to a butt-weld in the hull plate. This block was located on a longitudinal but was about 24-inches from the closest transverse frame of the destroyer. The rolling would place a cyclic bending load into the hull weld. This condition would not have occurred during normal operation of the ship in average weather conditions, or during a standard dry-docking.

The location of the linear indications found after five days of heavy seas are shown in Figure 5 (Fig. 5). The indications were found to emanate from under a docking block is shown in Figure 6 (Fig. 6).

Fig. 5 - Location of liner indications under docking blocks

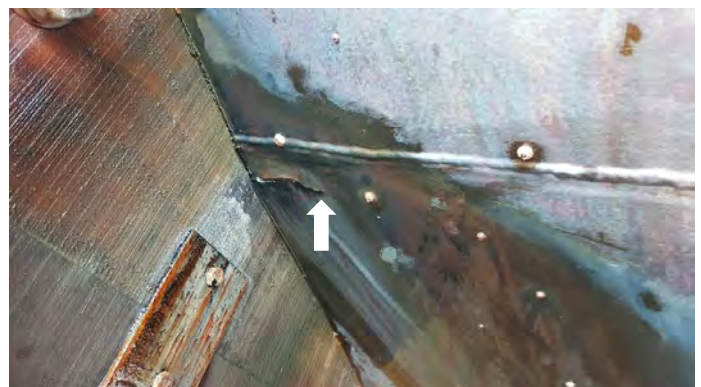
Fig. 6 – Linear indication under the docking block

- If the block is not located at a transverse frame, the maximum pressure load that a block should take and not cause linear indications in the hull welds is 174 psi.
- If the block is located on a transverse frame, the maximum block pressure can be 370 psi.

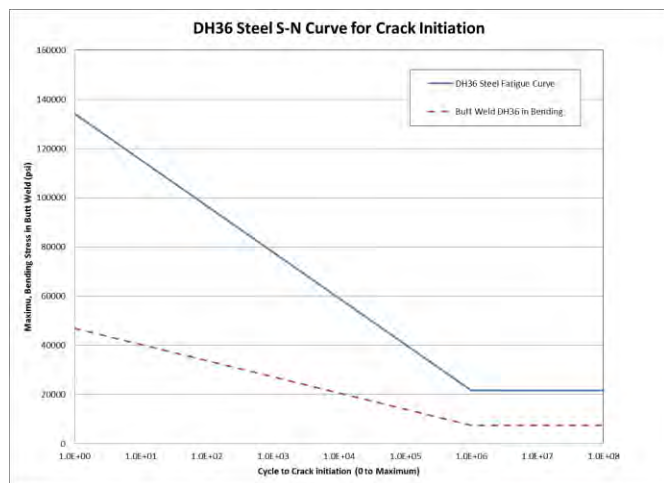
The stress intensity factor for the high cycle stress component should remain below the threshold level for the material throughout the intended design life of the part. The cyclic fatigue in the stress-strain (S-N) Curve for DH-36 is shown in Figure 7 (Fig. 7) with the butt weld knockdown overlaid by the lower curve. The allowable bending stress for infinite life (in bending) of the base material is 21,610 psi.

For a weld, the base material properties must be multiplied by the knockdown factor of 0.35 to obtain the maximum cyclic stress. For bending in a butt weld for infinite life, the resulting calculation is 7,564 psi.

This is the cycle stress level that will cause linear indications to be initiated. For any cyclic stress above 7,564 psi, the bending stress in a butt weld has the potential for a linear indication to be initiated in the area of the weld.

Fig. 7 – S-N Curve for DH-36 Plate and DH-36 Welds

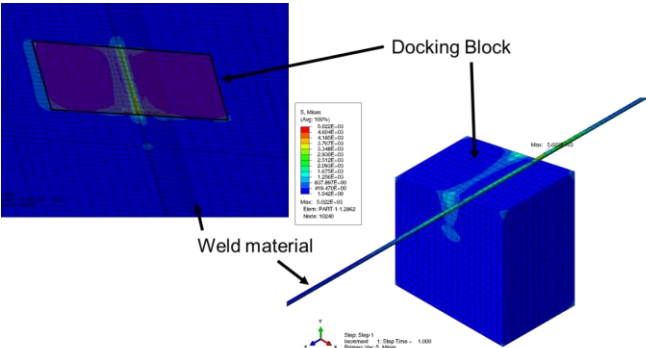
Results of the FEA models for each of these cases defined previously are solved in the ANSYSTM finite element program. The original location of the docking block where the hull linear indications appeared is shown in Figure 10 (Fig. 10). From this,

The stresses in the weld area are shown in the right side of Figure 10 (Fig. 10). The bending stresses in the weld cycles as shown in Figure 11 (Fig. 11). When the block is moved to be centered on a transverse frame, the resulting stresses in the base metal and the butt weld area are shown in Figure 12 (Fig. 12). These stresses are significantly higher in fatigue stresses that that which can be handled for infinite life of a butt weld in a bending condition. To illustrate how the cyclic loading can affect any butt weld, based on the amount of cyclic loading in a given docking block can cause in the butt weld is shown in Figure 13 (Fig. 13).

Fig. 10 - Block Centerline Positioned 24-inches from a Transverse Frame

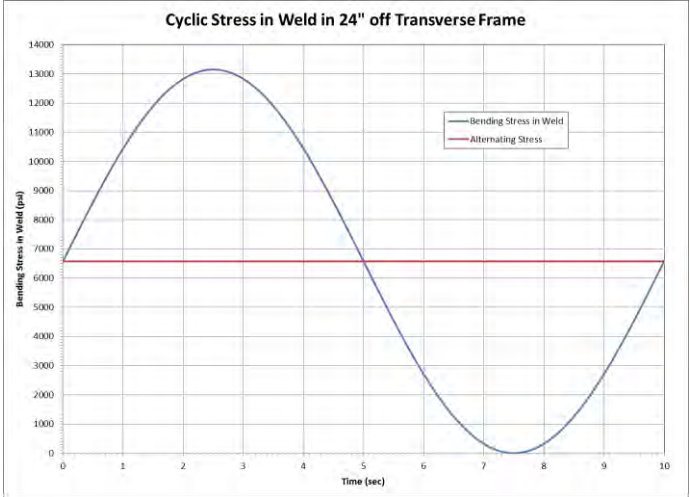
Fig. 11 - Cyclic Stress in a Weld under Docking Block

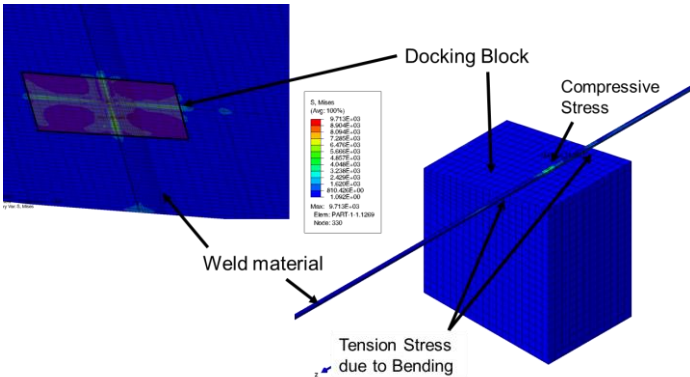
Fig. 12 - Block Centerline Positioned at a Transverse Frame

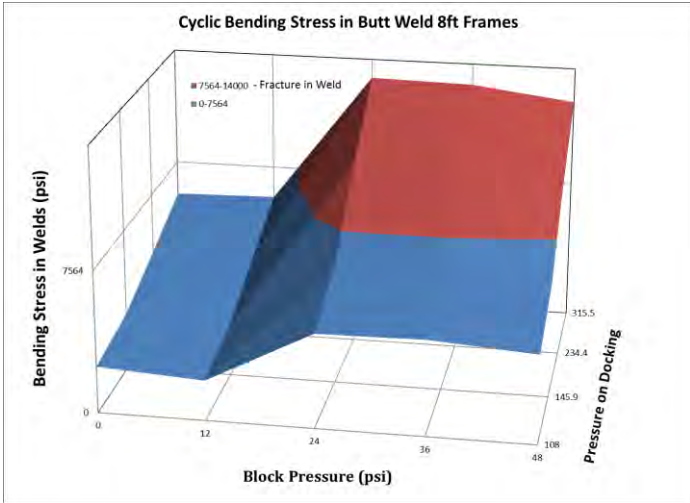
As previously calculated, any cyclic stress above 7,564 psi would cause linear indications and is therefore colored red. The numbers that make up Figure & (Fig. 7) are shown Table 3. Table 3 also shows that the maximum pressure load on the hull, when not on a transverse frame, is equal to 174 psi. The 174 psi peak pressure is equal to a peak load of 147,779 pounds of loading on a given docking block. This process was repeated for a six-foot-on-center transverse frame hull structure. This is summarized in Figure 14 (Fig. 14) and Table 4. The peak cycle load on a given docking block was 177 psi for this spacing. When the block is centered on a transverse frame but moved inboard, the stress does not result in cyclic stress values that would cause hull linear indications.

Fig. 13 - Combined Results based on Block Pressure (8-foot frame spacing)

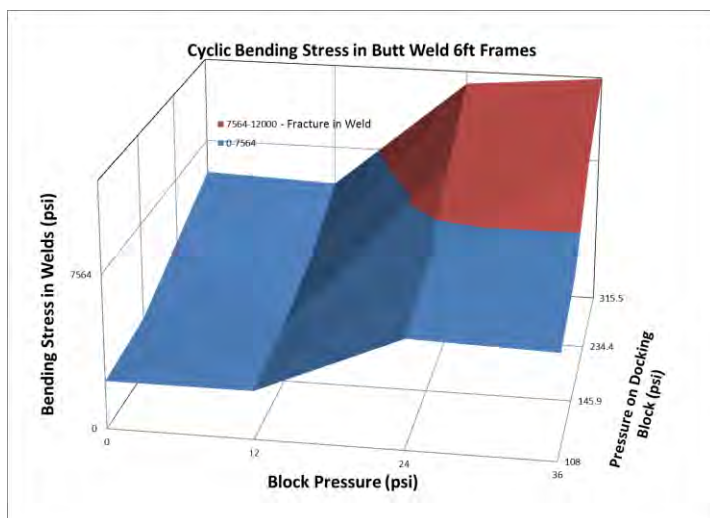
Fig. 14 - Combined Results based on Block Pressure (6-foot frame spacing)
