THE SALVAGE OF THE LITTON LAUNCHING PLATFORM

U.S. NAVY SUPERVISOR OF SALVAGE

NAVSEA 0994-LP-017-5010

LCDR C.A. Bartholomew USN
Office of the U.S. Navy Supervisor of Salvage

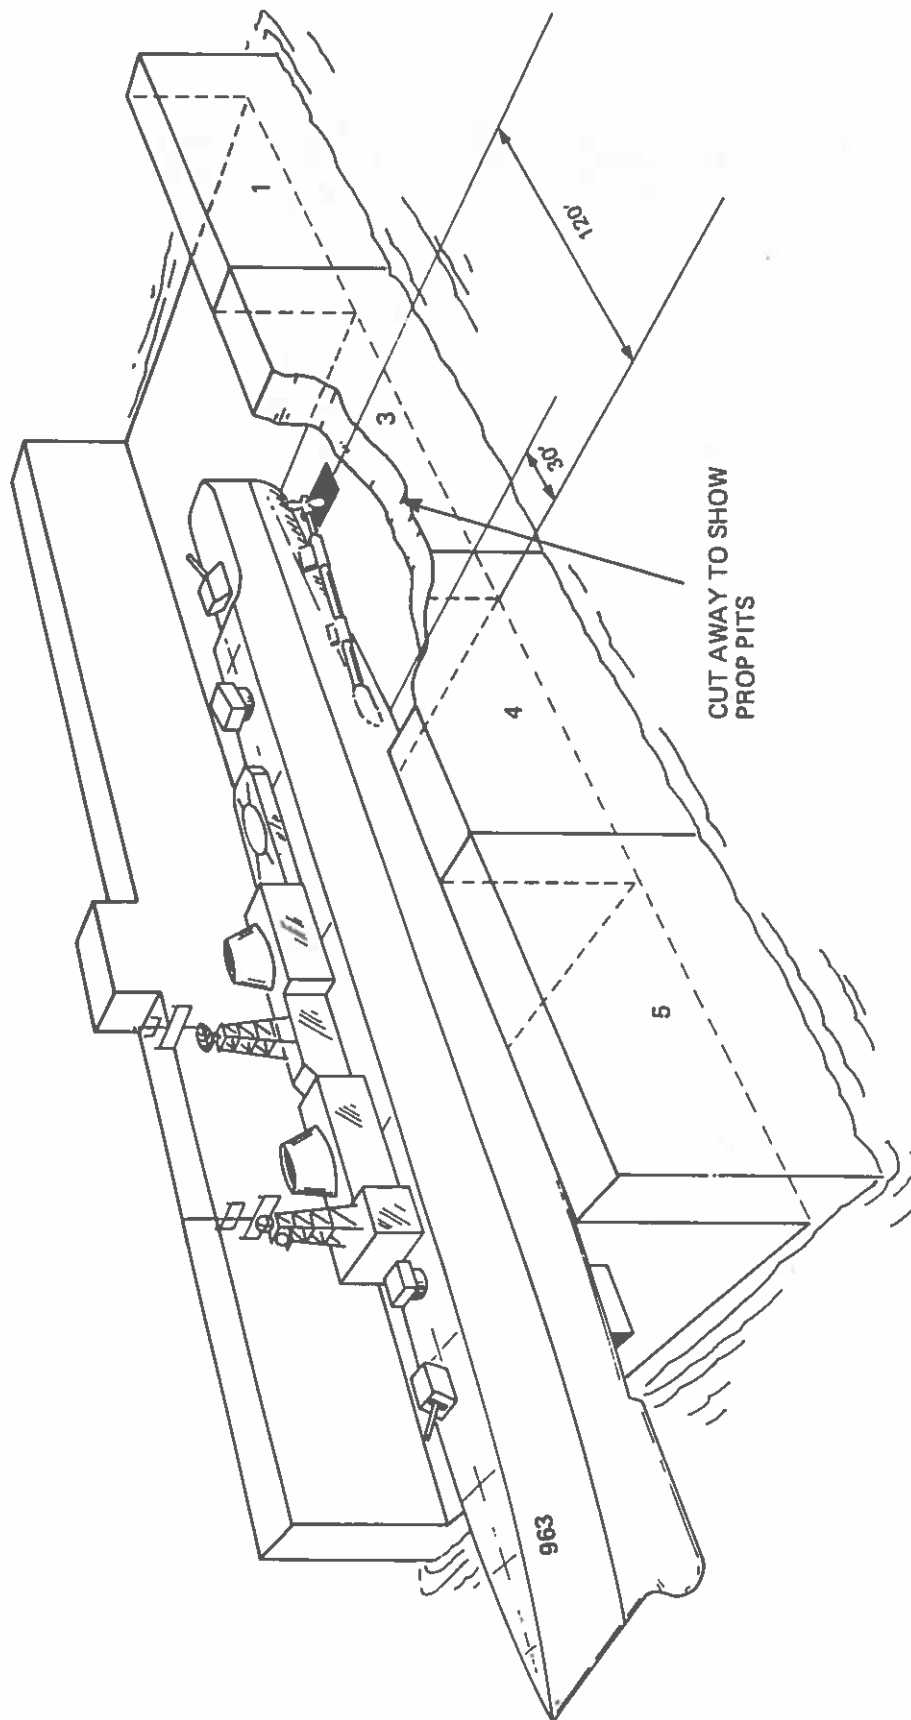
On the morning of 13 March 1975, USS SPRUANCE (DD 963), having just completed Builder's Trials and subsequent sonar dome grooming, was scheduled for a routine undocking. In order to reduce the block buildup, the SPRUANCE had been positioned on the after portions of the dock as shown in Figure 4, thus permitting the sonar dome to hang over and below the Pontoon Deck and the twin screws to protrude into special propeller pits built into the deck. As flooding gradually commenced, a sagging moment was apparently induced and the platform experienced severe buckling amidships. As the morning progressed and corrective action taken to ensure the SPRUANCE did not fall off the blocks, the forward starboard quadrant of portable wing walls broke loose, the combined buckling and

FIGURE 4. DD 963 Positioned on Blocks.

shearing loads broke the platform in two, and the forward half sank to the bottom in 72 feet of water. Photographs 3 and 4 show the breaking up of the platform with the SPRUANCE on blocks. Corrective action continued on the after half until the ship was successfully undocked with minimal damage. In the process, however, the second half also sank adjacent to the first.

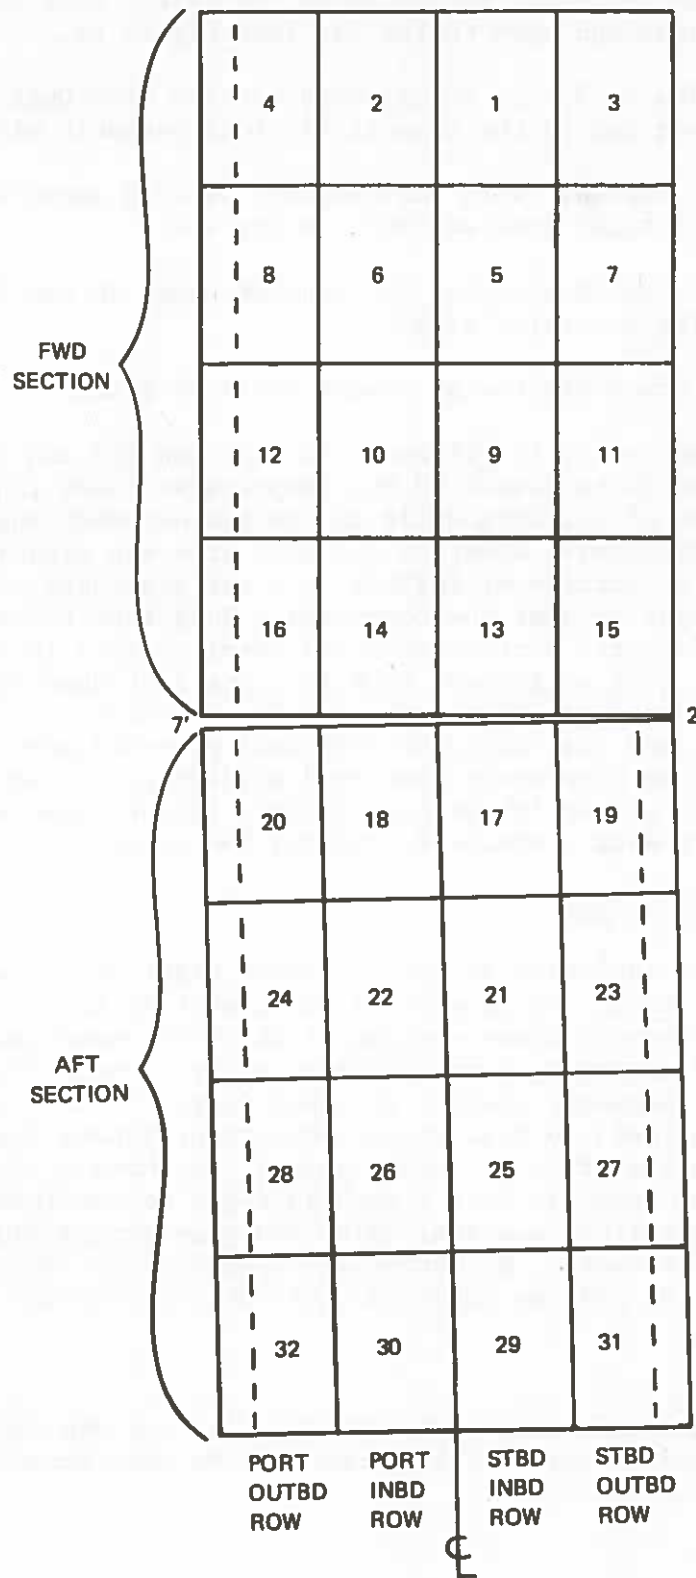
(1) The two sections were lying in approximately the same fore and aft orientation with physical separation varying between 7 feet on the port side and 2 feet on the starboard side. Some minor involvement of plating, stiffeners, etc. existed. A simple plan-view is shown in Figure 5.

FIGURE 5. Tank Numbering Diagram.

* NOTE - The tank numbering system on the platform was somewhat unorthodox. Therefore a simple sequential system will be referenced throughout this report as shown in Figure 5.

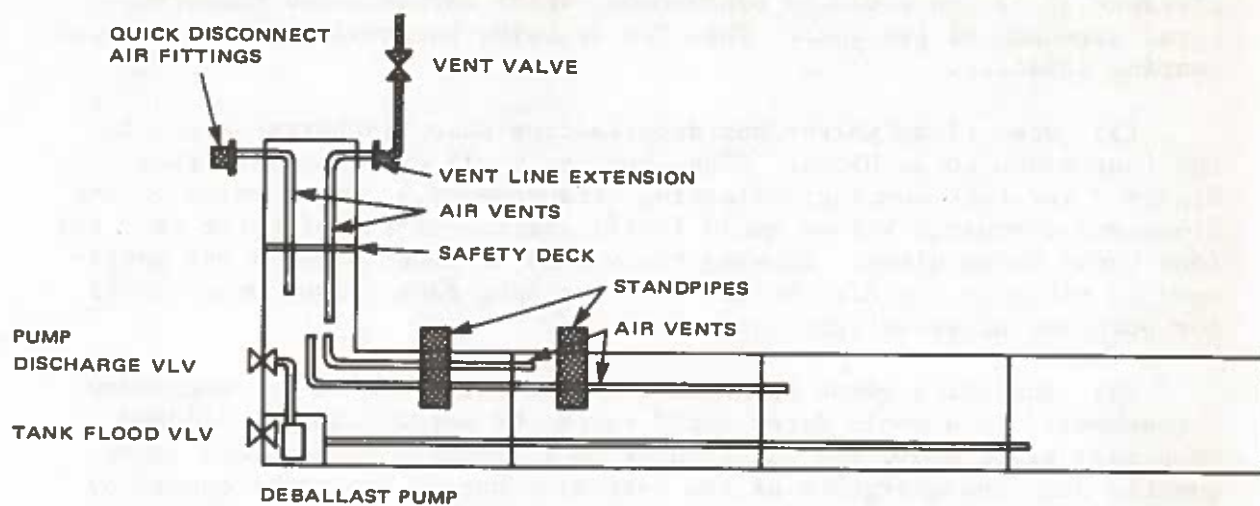
FIGURE 7. Tank Vent, Flooding and Pumping Systems.

(5) Open flood valves and deballasting pump discharge valves for the four tanks to be blown. Close valves in all other tanks. (See Figure 7 for tank pumping/ballasting arrangements.) The opening of the flood and discharge valves would facilitate the egress of water from the four tanks being blown. Closing the valves in Tanks 5 and 9 was necessary to minimize any air entry. The remaining tank valves were closed for purposes of watertight integrity.

(8) As port side rotates upwards (See Figure 9), manually vent tanks via vent line extension valves (Figure 7) in order to avoid structural damage due to air bubble expansion during tank ascent as previously discussed.

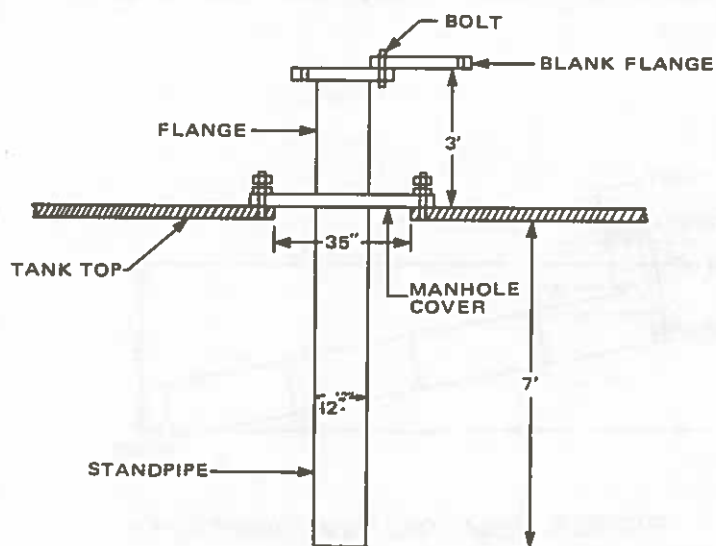
FIGURE 8. Standpipe Assembly.

(3) Install air relief standpipes in the tank top manhole covers in Tanks 6, 8, 10 and 12 as shown in Figure 8; assembly was to be fitted with a blank flange to facilitate later shifting from a blowing to a pumping mode. Calculations indicated that blowing air into these tanks would lift the port side off the bottom when the air bubble extended approximately 5 feet below the Pontoon Deck. The limiting depth of the air bubble below the safety deck was governed by pressure differential considerations on the structure. Since the dock was generally designed to withstand a 7.5 psi differential head with a factor of safety of two on yield (or four on ultimate), it was theorized that the structure could withstand a differential of 15 psi or 34 feet of sea water (fsw). The most severe condition of differential loading would occur when the port side of the platform rotated to the point where the safety deck broke the surface. The air bubble would spill as the dock rose such that the static internal pressure within Tanks 8 and 12 would be controlled by the depth of the standpipes. The geometry of the situation indicated that a depth of 7 feet of the standpipes beneath the pontoon deck could be tolerated. This approach would provide a suitable margin for error and bottom suction (2 feet over the calculated 5 foot requirement) and still maintain the internal pressure within acceptance limits ($23 + 7 = 30$ fsw).

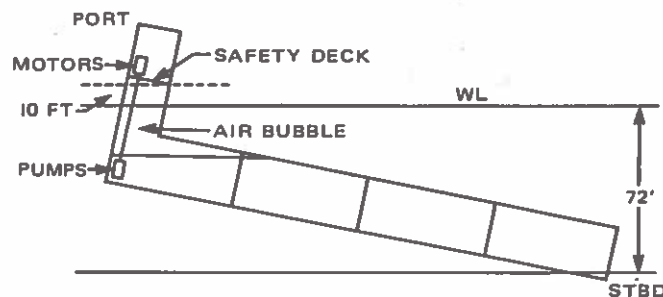
FIGURE 9. Initial Lifting Phase, Forward Section.

(9) With the platform now oriented as shown in Figure 9 and floating on a bubble, render the aforementioned swash bulkhead watertight and remove and replace the pump motors in the blown tanks (6, 8, 10 and 12) plus the starboard, inboard row of tanks (1, 5, 9 and 13).

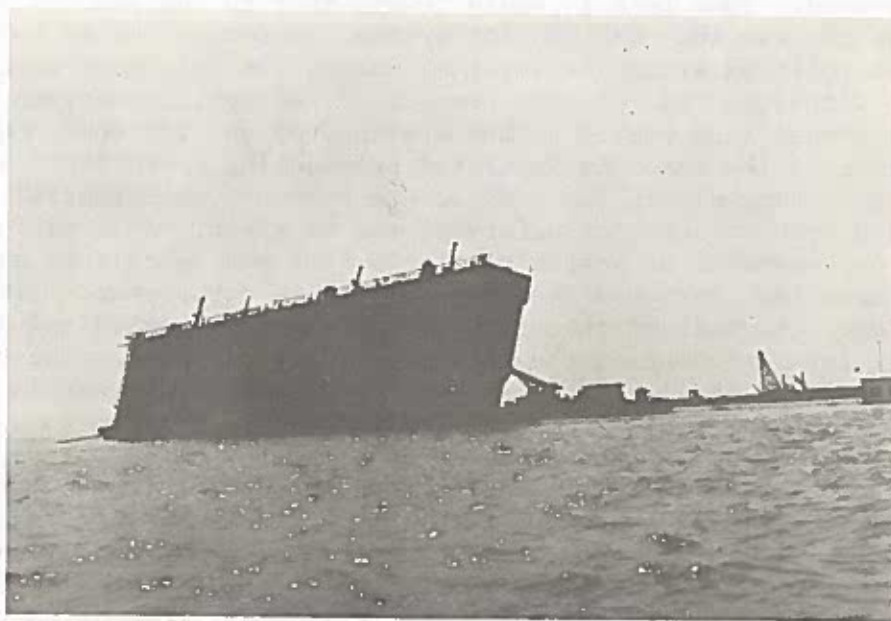
PHOTOGRAPH 13. Starboard side of aft section successfully rotated using four-inch sub pumps supplemented with compressed air.

primarily because of known availability, high pumping rates, and suitable size for installing two units into each tank top access opening; 440 volt 3 phase AC power was also readily available. The successful use of the four-inch sub-pumps on the starboard side of the aft section is shown in Photograph 13.

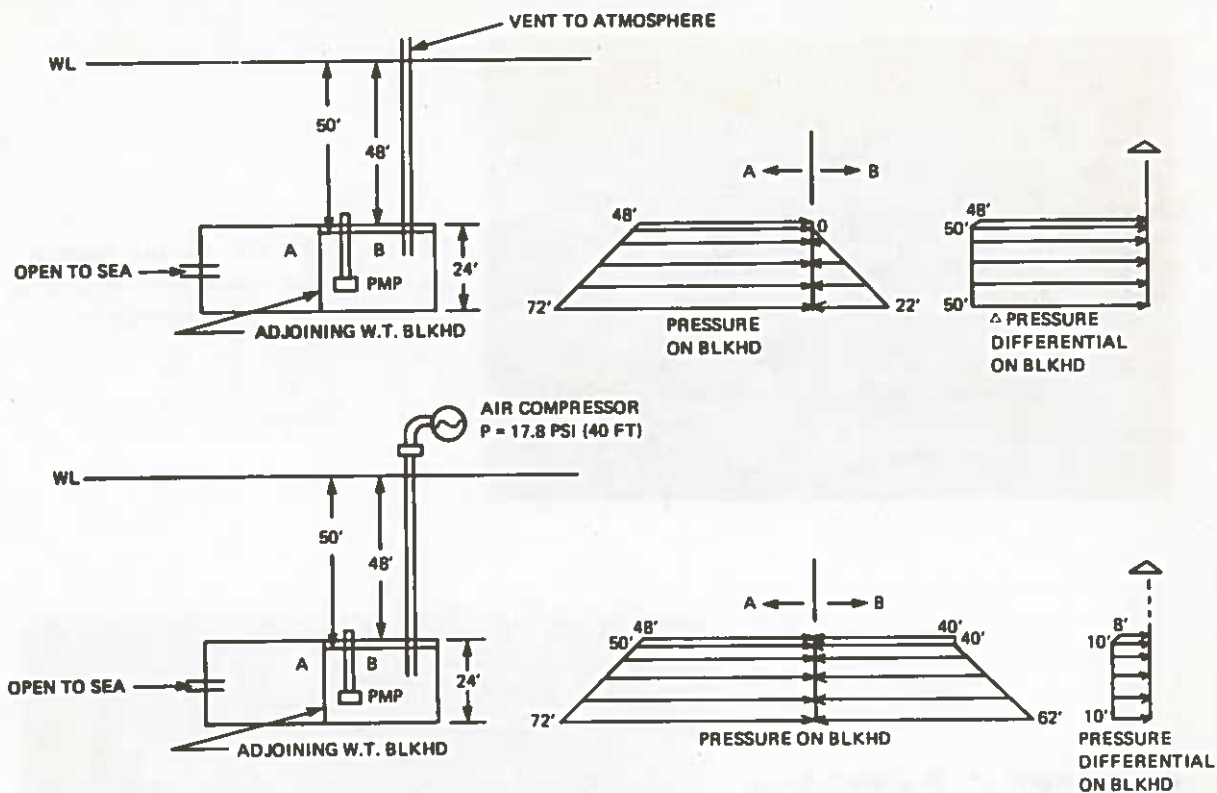
FIGURE 10. Effect of Air Pressure on Reducing Pressure Differential Across Watertight Bulkhead.

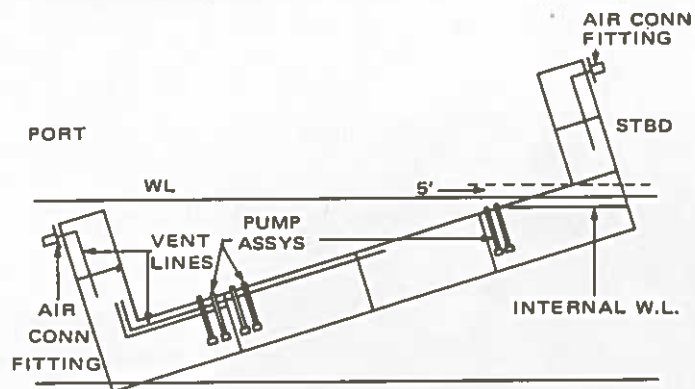
After intensive diver reinvestigation of the damage to the wing wall area of Tank 20 (see Photographs 26 and 27), the salvors begrudgingly agreed that the sustained structural damage rendered it incapable of withstanding the resulting hydrostatic forces if it were made watertight and pumped. Thus Tank 20 would remain open to the sea, as would Tanks 17 and 18, via the tank venting system. A second change to the salvage plan followed since the internal watertight bulkheads were not designed to withstand the required pressure differentials between the tanks being pumped (and vented to the atmosphere) and the ones now remaining open to the sea. As indicated previously, operational ballasting/deballasting discipline limited the pressure differential to 15 fsw, based upon a factor of safety of two on yield. As a minimum, a pressure differential of approximately 25 feet was calculated as required to float the starboard side and 48 feet to subsequently lift off the port side. The salvors therefore decided to pump compressed air into certain tanks to control the internal pressure and thus maintain the pressure differentials across any watertight bulkheads within acceptable limits. A simplified sketch depicting this principle is shown in Figure 10. Actual selection of the air pressure to be used was a compromise since the air pressure needed on the bottom became a potential hazard after the section rose and the counter hydrostatic pressure was removed. As a bonus the air pressure would also reduce the apparent pump discharge pressure and thus increase pump flow rate. The use of air necessitated modifying the vent piping to provide for blanks with air connections as shown in Figure 11.

FIGURE 11. Aft Section After First Phase of Dewatering Complete.

On 1 April pumping/blowing of the four starboard outboard tanks (19, 23, 27 and 31) commenced, and by late evening the section had been successfully rotated to the attitude shown by Figure 11. Immediate pumping of the port side had to be delayed however, due to continued electrical failure of several of the pump motors. Finally, on 2 April the motors had been replaced and those in Tanks 22, 24, 26, 28, 30, and 32 were incrementally lit off. Compressed air was also pumped into the air vents in Tank 24 to provide pressure compensation to the bulkheads bordering Tanks 17, 18 and 20 which were open to the sea. Within 2-1/2 hours the after port corner broke loose from the mud and about two hours and twenty feet of trim later the forward corner broke loose, and the section was afloat. Harbor tugs which had been continuously pulling aft exerted sufficient force to extricate the after platform sufficiently clear of the control house overhang before it rose high enough to interfere. As soon as the damaged portion of Tank 20 emerged from the water, the pumps in Tanks 18 and 20 were energized, and that evening the after half of the launching platform was safely deposited in its normal position over the launching grid on the West Bank.

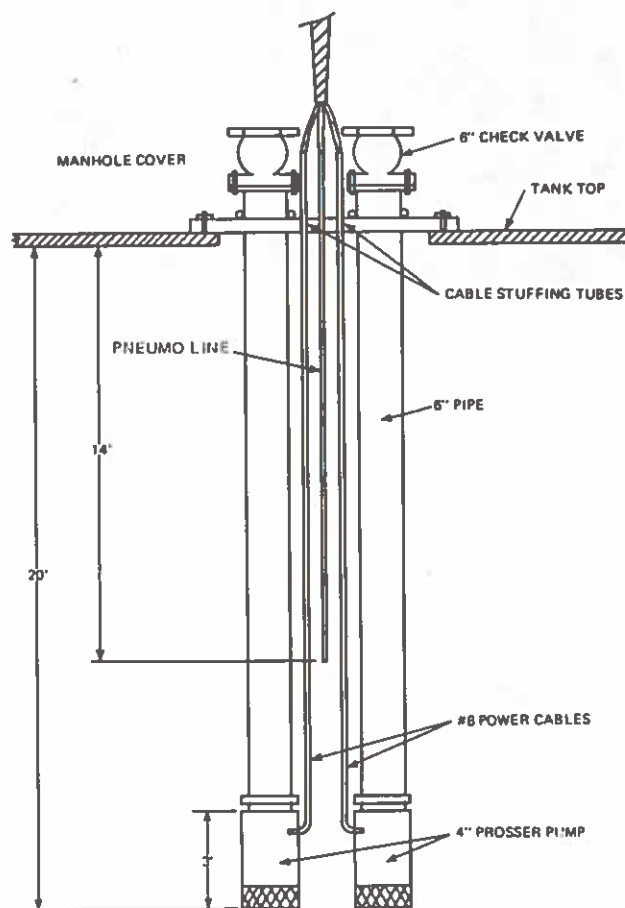
FIGURE 12. Pump Installation Assembly.

As installation and checkout of the sub pumps progressed, a high incidence of pump failure was experienced due primarily to water leaking through the power cable packing gland and into the pump motor. Because the electrical leads provided with the pumps had been too short to reach the two 500 KW power sources, the leads had been replaced "en toto" and the subsequent sealing had not been consistently watertight.

Initial efforts by Litton to obtain sufficient submersible pumps in an acceptable time frame were unsuccessful; therefore, SUPSALV turned on the Navy's Emergency Ship Salvage Material (ESSM) system. By 31 March, twenty-five 440V 25 HP 1000 GPM four-inch submersible pumps had been received from the ESSM system and an additional six had been received by Litton from commercial sources. The typical pump installation assembly details are shown in Figure 12 (note the addition of a pneumo line to permit monitoring of the internal tank waterline).

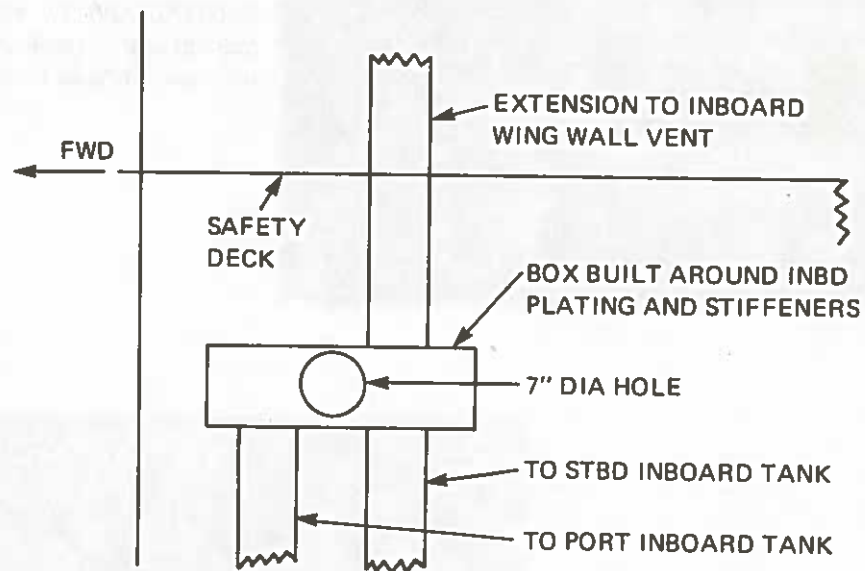
FIGURE 13A. Inboard Tank Assemblies in Tanks 4, 8, and 12.

The critical path for the execution of the salvage plan proved to be the isolation of the vent lines in the starboard tanks from their respective port side tanks. Sketches showing some of the plumbing details are shown in Figures 13A and 13B. The variations in installed venting models of the two inboard rows of tanks evolved due to the desire to improve tank venting efficiency when flooding, which resulted in the "dock-alt" discussed in Section VI. The initial "alt" consisted of installing vent extensions through the safety deck and connecting same to the inboard tank vents with a box structure built into the wing wall inboard bulkhead. After this alteration had been completed in Tanks 4, 8, and 12, it was found to reduce venting efficiency. Thus the alteration was undone by cutting a 7-inch circular hole in each box. Isolation of the tanks possessing the box assy consisted of installing a "Tooker" type patch inside the box (Figure 13A). Two-piece sheet metal sleeves, lined on the inside with neoprene, were installed in Tank 16 which was missing the "boxalt" but not the vent extension "alt" (Figure 13B).

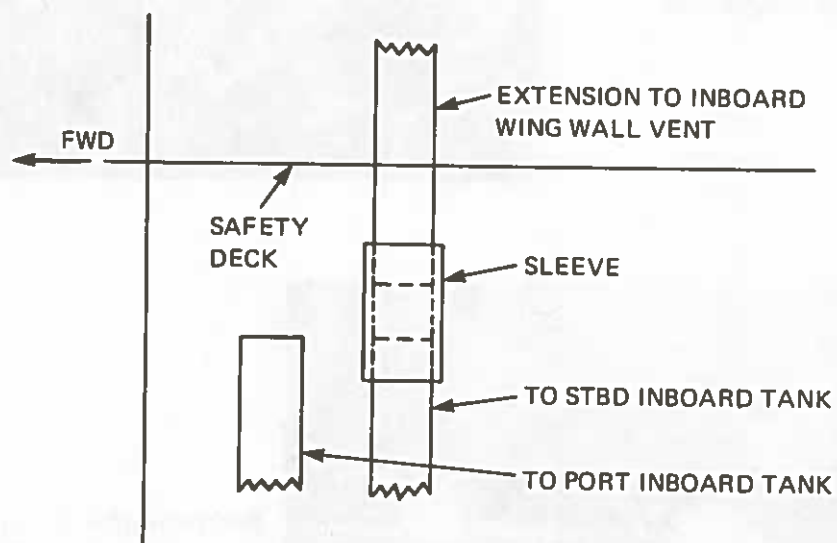
FIGURE 13B. Inboard Tank Vent Assembly in Tank 16 with Sleeve Installed.

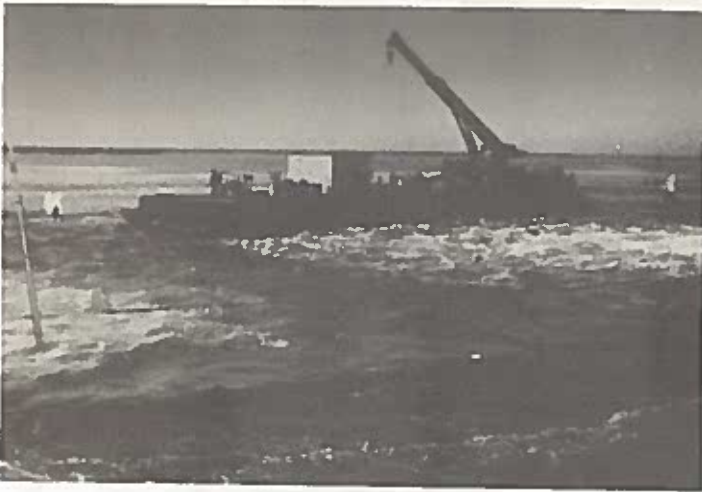
PHOTOGRAPH 33. Pontoon Deck breaks the surface. Forty-eight foot ascent required approximately one minute.

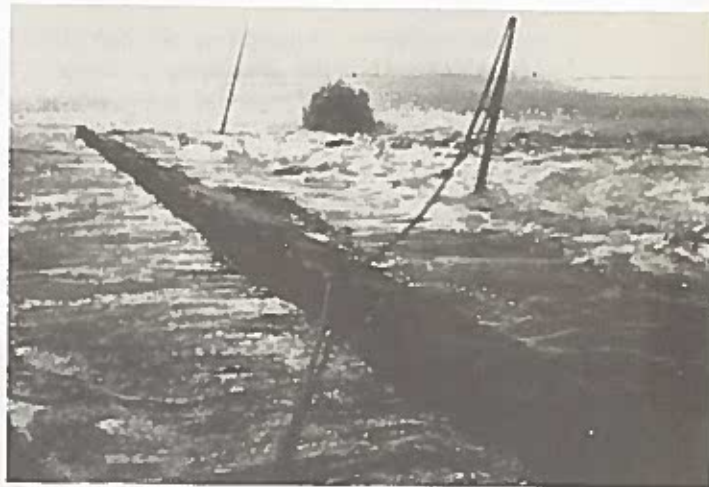
PHOTOGRAPH 34. Pontoon Deck continues to rise.

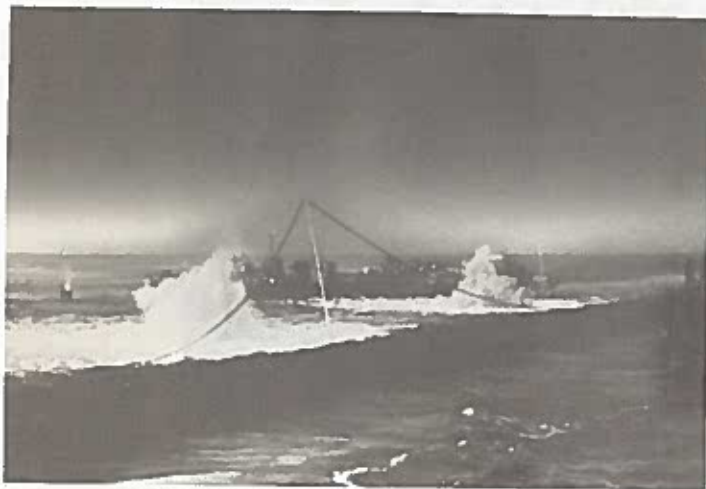
PHOTOGRAPH 35. Pontoon Deck steadies with approximately four feet of freeboard.

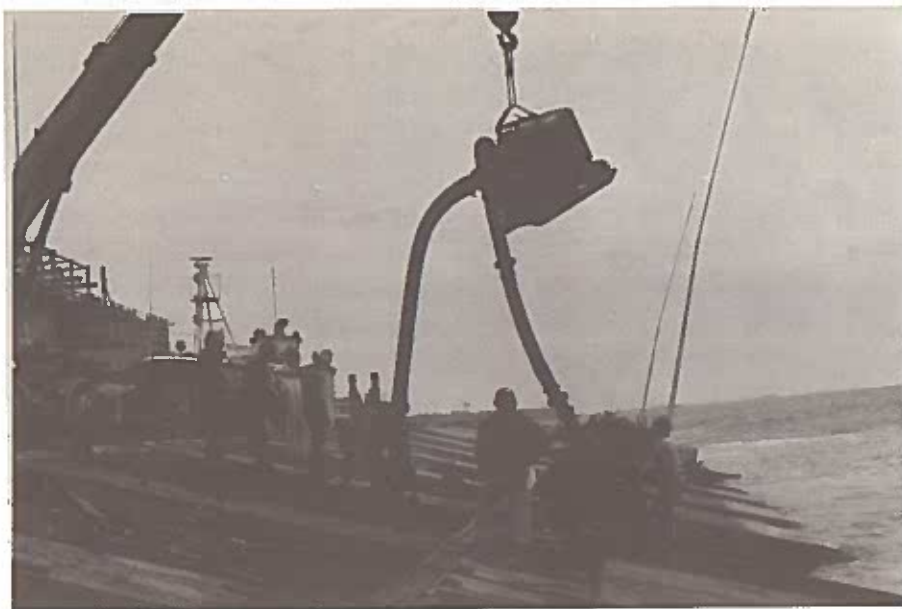
PHOTOGRAPH 36. Conventional six-inch salvage pumps being loaded onto Pontoon Deck for dewatering of Tanks 3, 7, 11 and 15 through missing STBD wing wall openings.

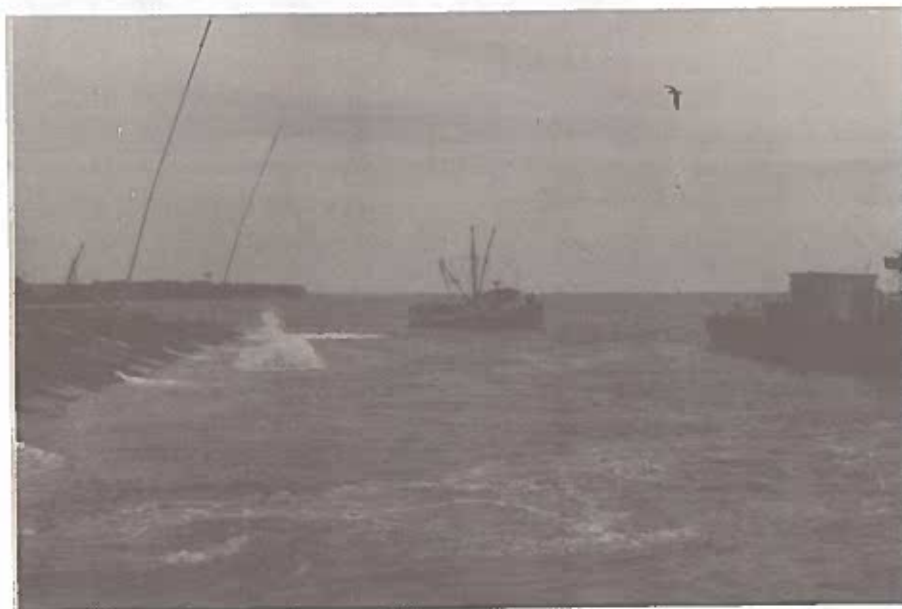
PHOTOGRAPH 37. Dewatering of starboard side almost complete and preparations for pumping port side commencing.

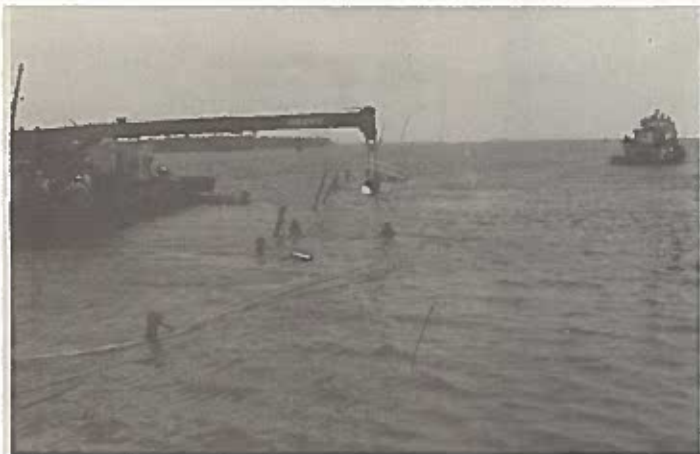
PHOTOGRAPH 38. Preparations nearing completion for dewatering of port side of forward section (Phase Three).

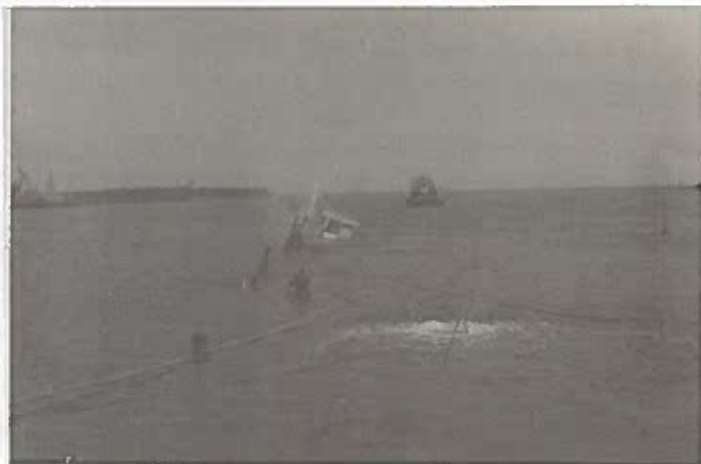
PHOTOGRAPH 39. Dewatering and blowing of port side commences.

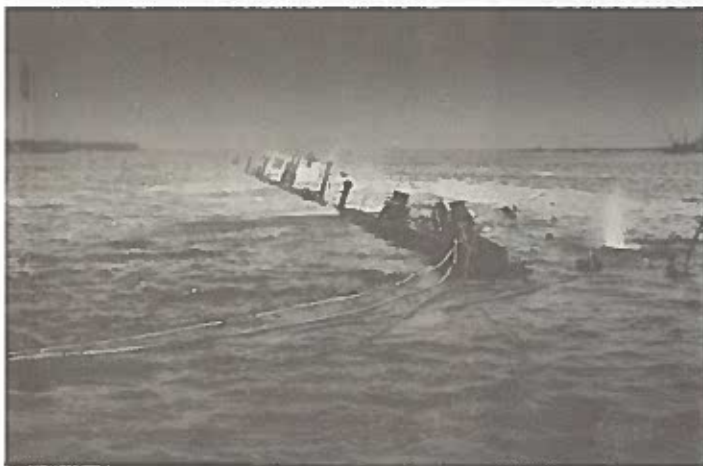
PHOTOGRAPH 40. Port side breakout occurs. Section now completely afloat.

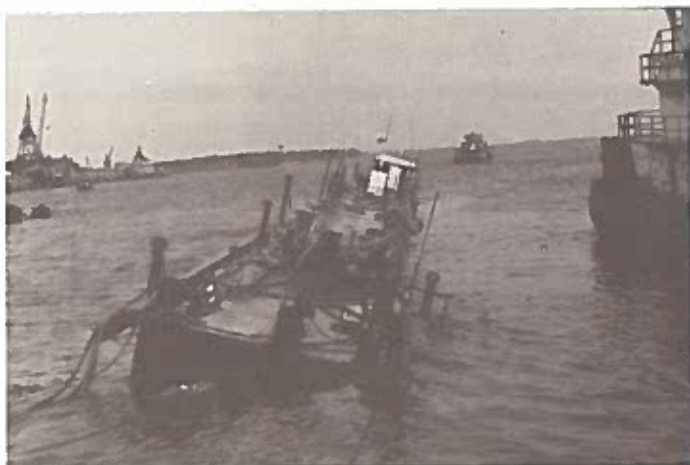
PHOTOGRAPH 41. Port side continues up.

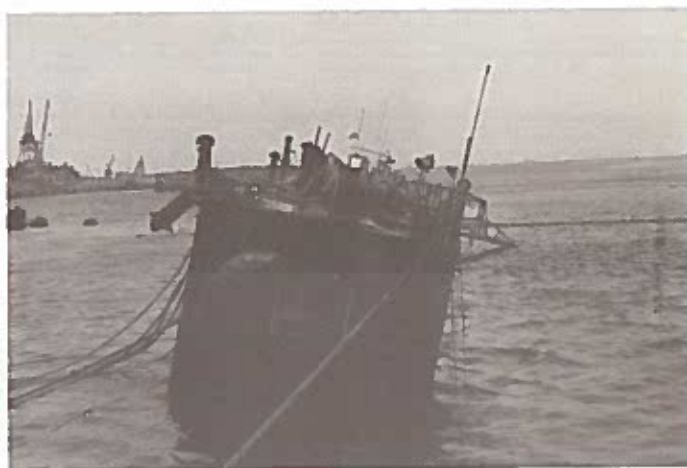
PHOTOGRAPH 42. Dewatering continues as port side rises higher out of the water.

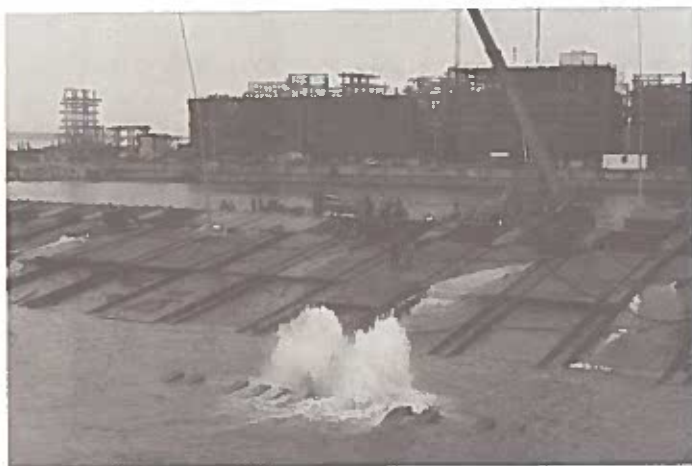
PHOTOGRAPH 43. Pontoon Deck begins to level as keel blocks become visible.

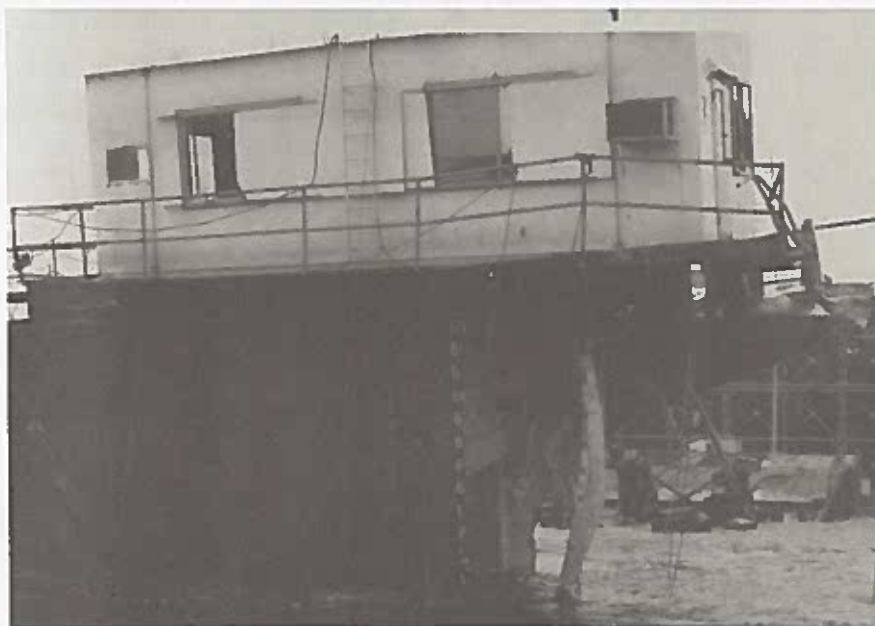
PHOTOGRAPH 45. Underwater oxy-arc cutting performed by divers beneath control house to facilitate snaking of aft section from beneath.

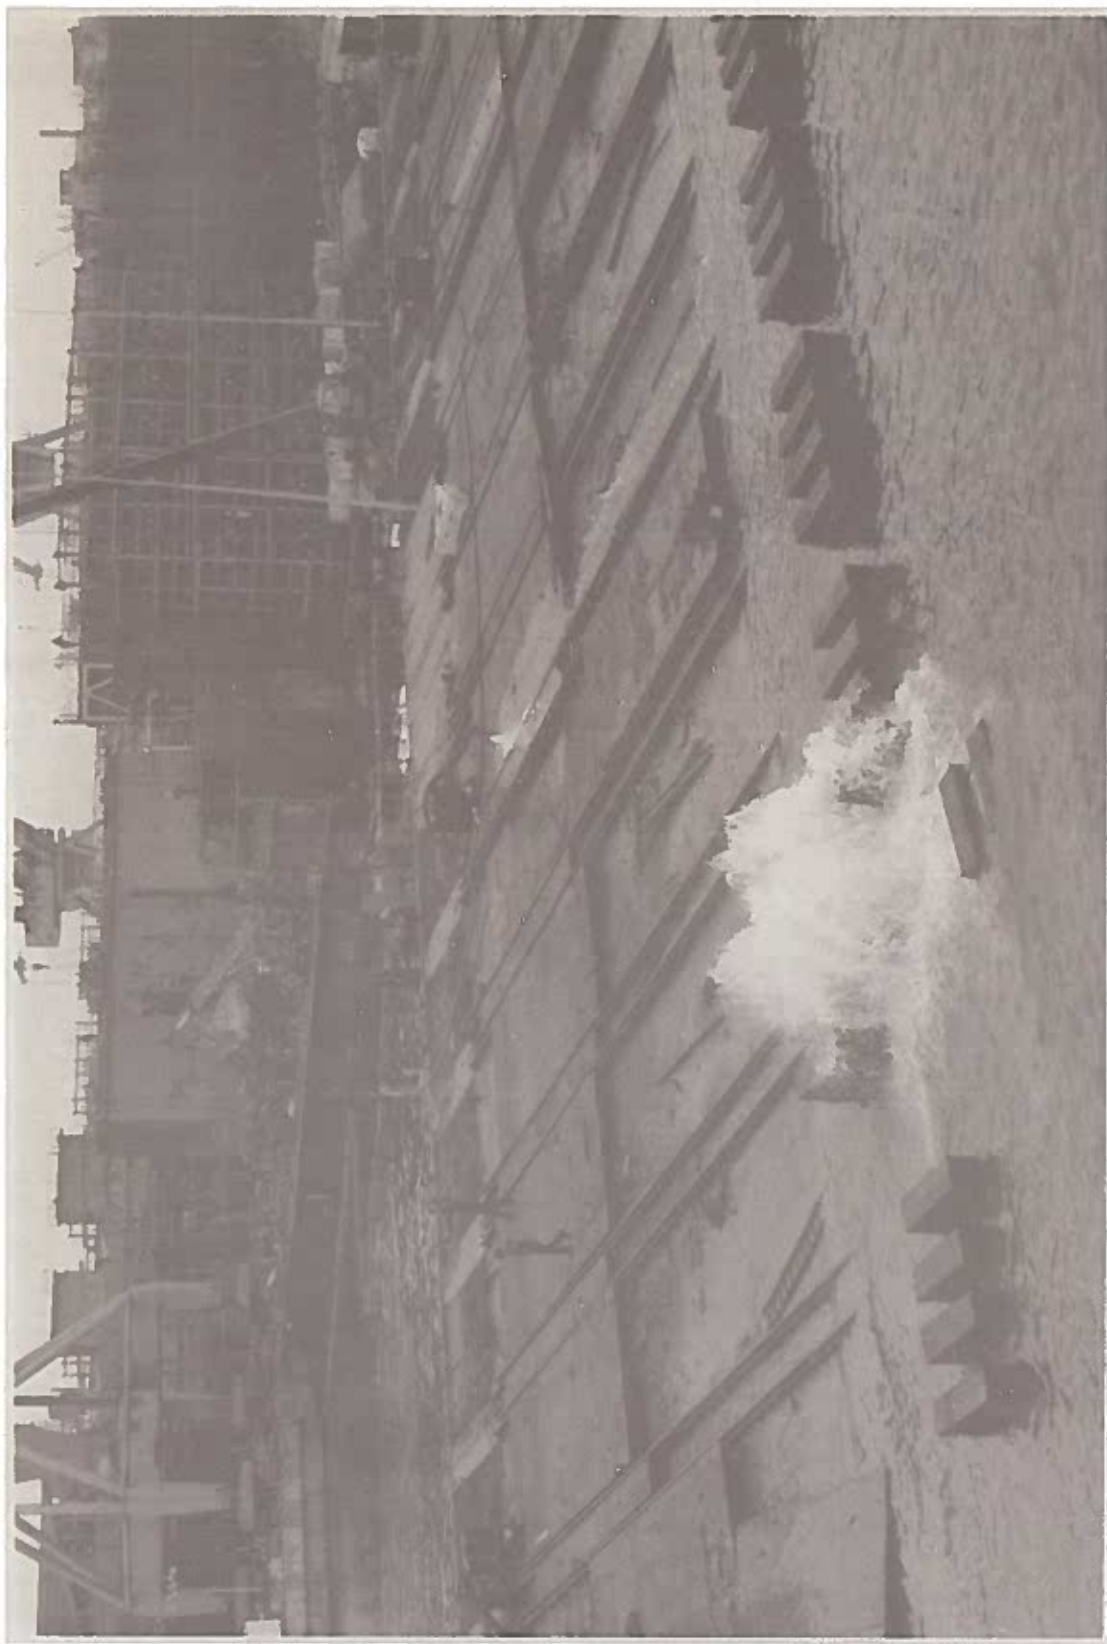
PHOTOGRAPH 46. Dewatering of second half of launching platform nearing completion. Dock was moved over grid alongside aft section approximately six hours later, completing the SALVOPS.

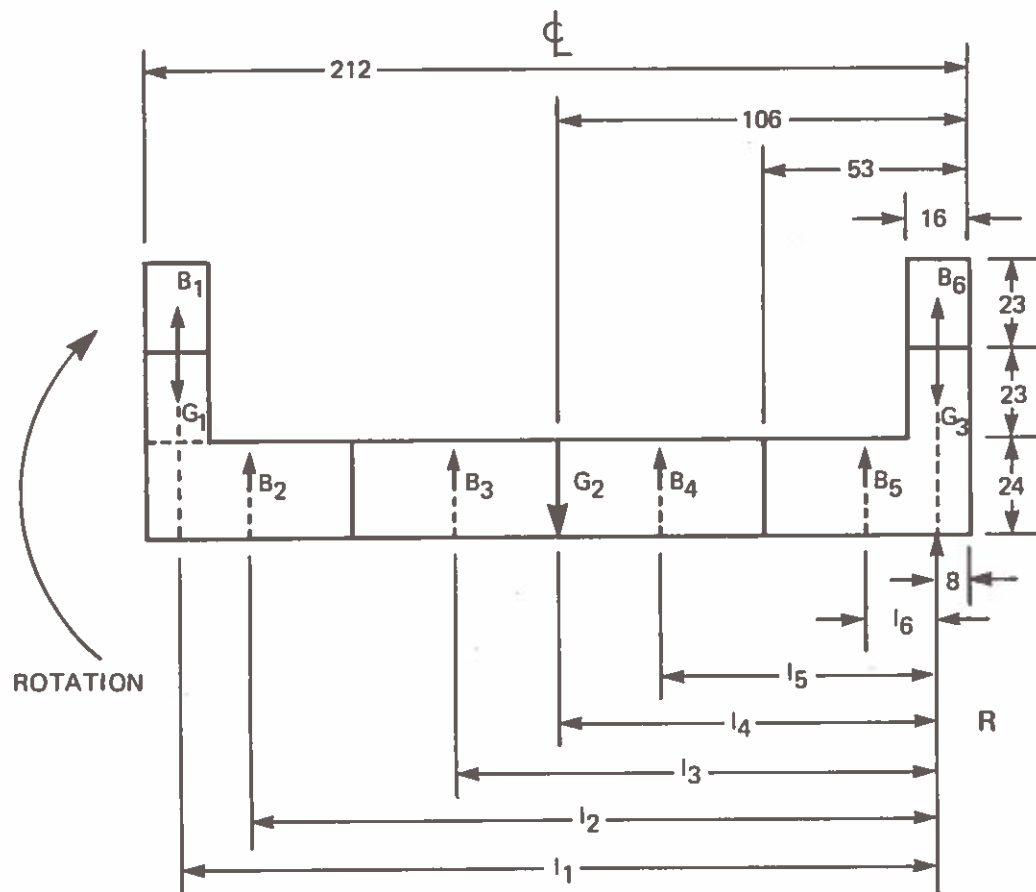
II. During the first evolution of Phase One, the port side was to be rotated upwards by introducing air into Tanks 8 and 12. Once the air bubble was blown beneath the Pontoon Deck, air was assumed to displace water equally rapid in Tanks 6 and 10 through the air vent piping. No water was assumed displaced from Tanks 5 and 9. Referring to Figure 14:
