# **SALVOPS 69**

**A review of significant salvage operations  
conducted by U.S. Navy salvage forces  
and other salvage activities during 1969**

**Department of the Navy  
Naval Ship Systems Command  
Washington, D.C.**

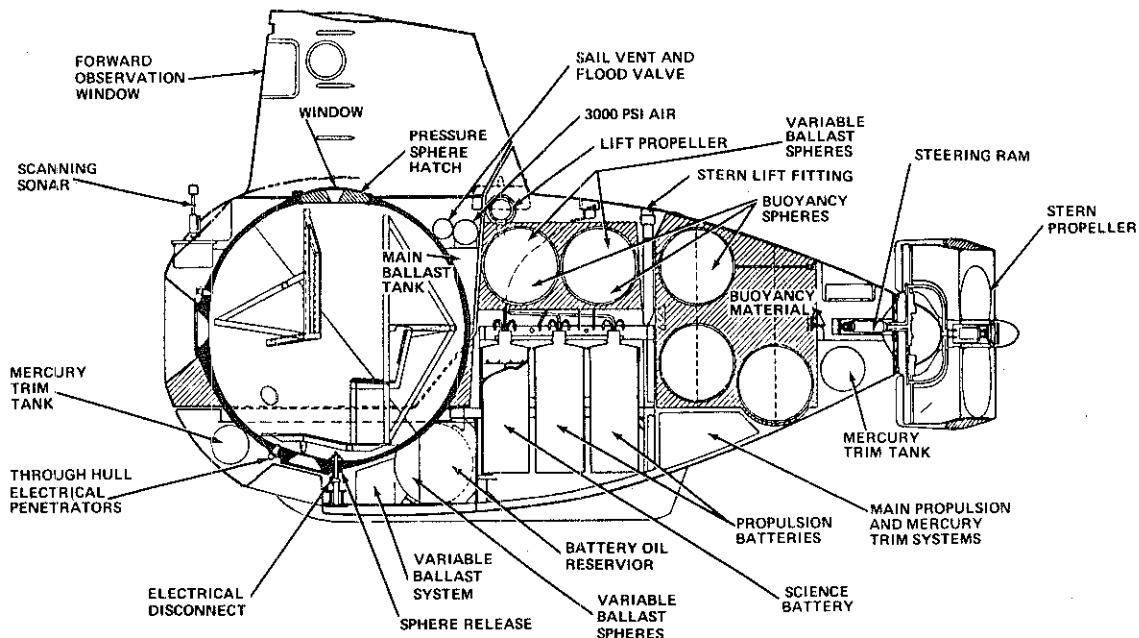
*Salvors were particularly interested in ALVIN's sail hatch and pressure sphere hatch as openings for insertion of lifting devices.*

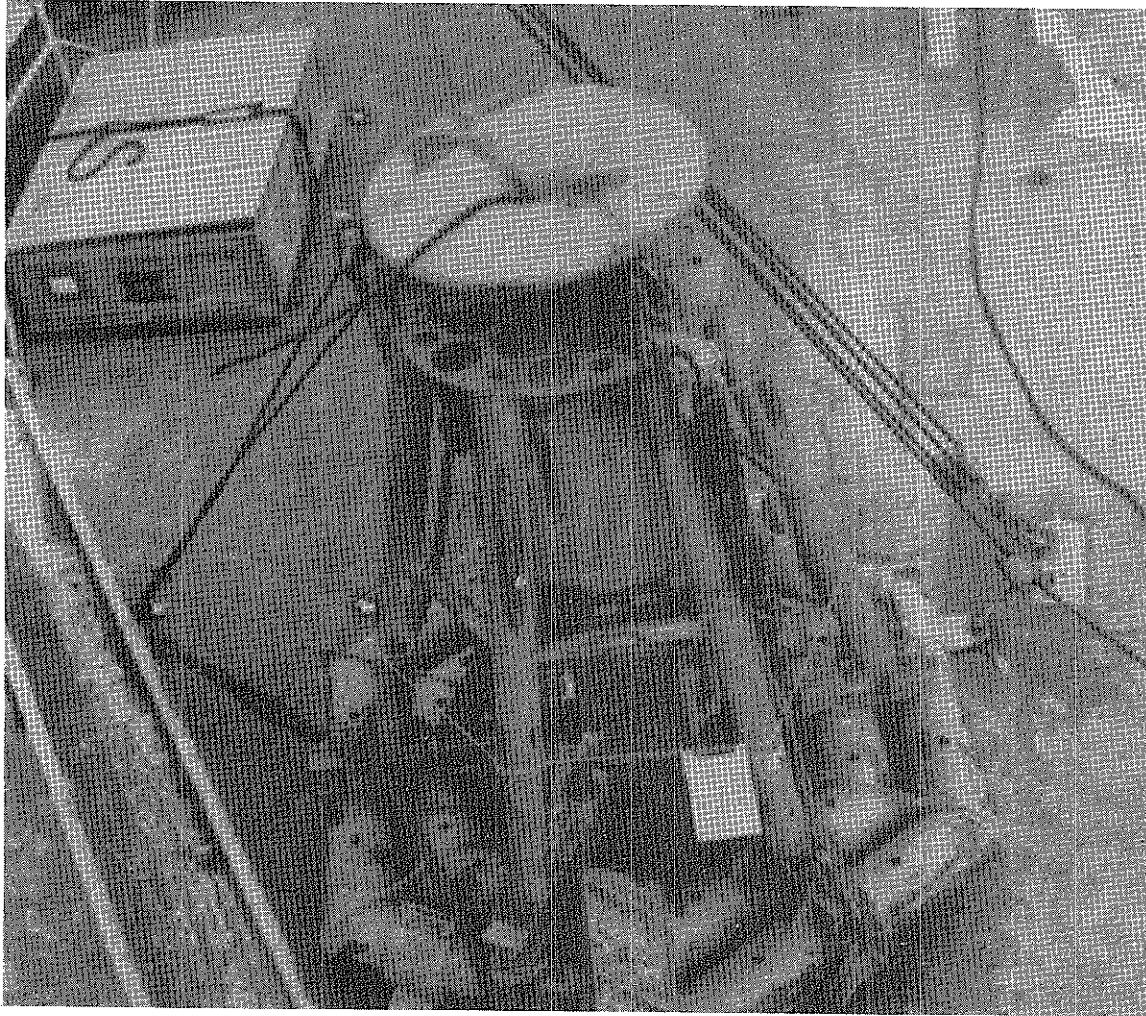
#### **SNAP-7E ABOARD AEOLUS AFTER RECOVERY**

The 6000-pound LWT anchor and its grapnel lines were retrieved early the following morning, 26 November, prior to departing the salvage site. The SNAP-7E transducer and riser buoy could not be recovered. Corrosion in the free end of the riser cable suggested that this cable had parted some time prior to the recovery attempt. The AEOLUS delivered the SNAP-7E and its associated equipment to NAVFAC authorities at Davisville, Rhode Island, a few days later, bringing to successful completion an historic salvage operation.

*The SNAP-7E unit weighed five tons and stood 10 feet high. It was made well secure as shown for the return voyage to Rhode Island.*

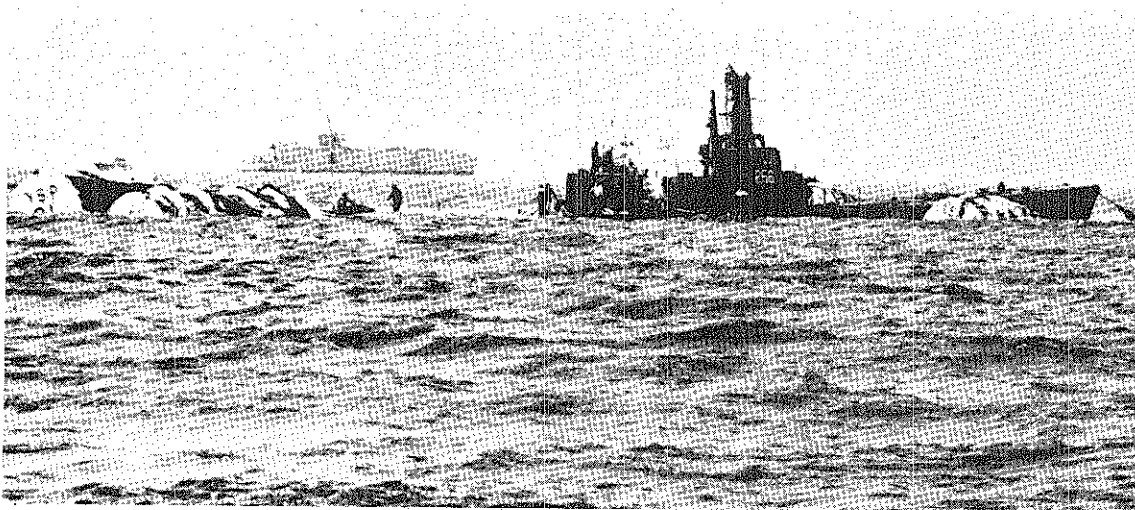
### **ex-HAKE SURFACED**

On-site inspection of the submarine immediately following its surfacing showed that it was stable in all respects. Waterline was approximately at midpoint of the conning tower, with forward main deck dry and aft main deck at wading depth. All internal compartments were essentially dry with the exception of the forward torpedo room bilges which were immersed in about two feet of water.

*ex-HAKE was successfully raised in the second lift attempt without incident or difficulty. Submarine was safely towed to Norfolk, Virginia, by HOIST.*

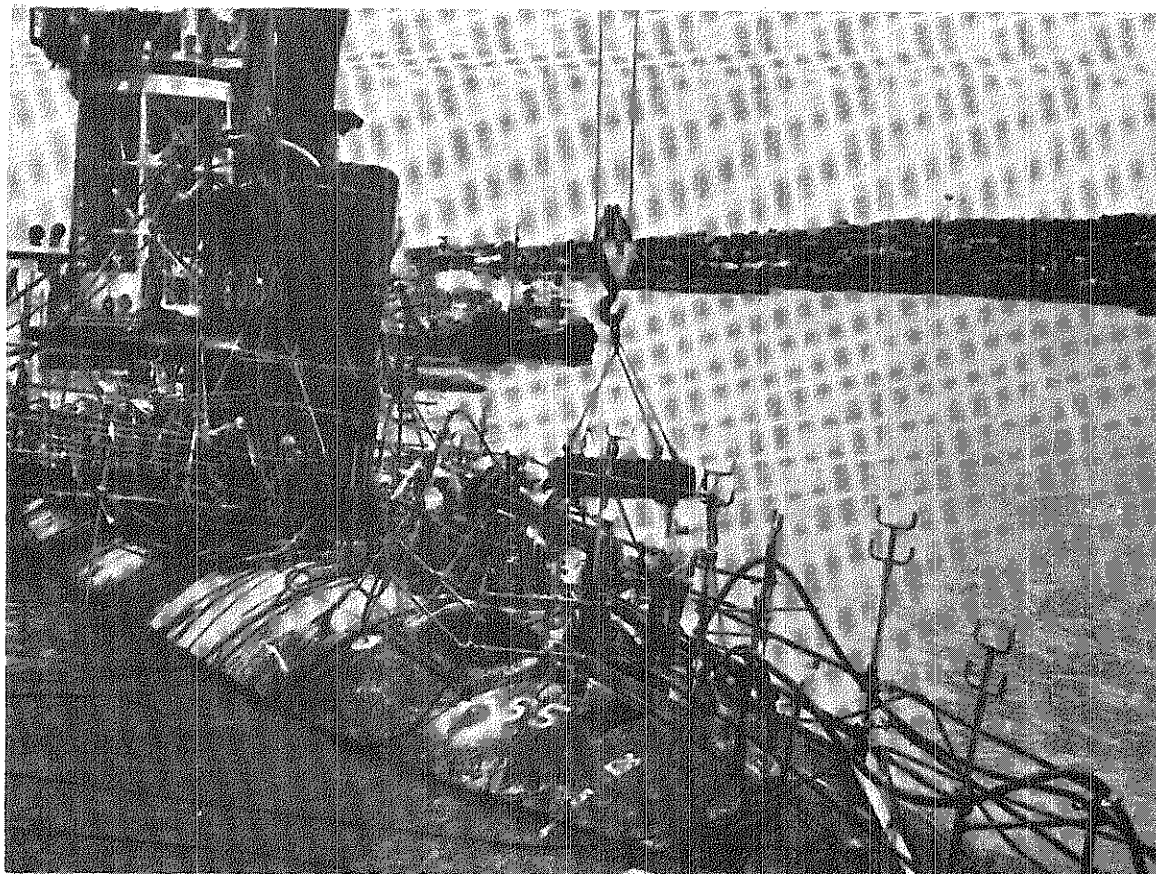
#### **GUITARRO AT SAN FRANCISCO BAY NAVAL SHIPYARD**

*Except for the reactor, most equipment associated with nuclear generation was on board the GUITARRO at the time of her sinking. Many temporary openings existed for installation and construction purposes.*

*The USS GUITARRO, partially submerged and in final stages of construction at the San Francisco Bay Naval Shipyard, sank in 30 feet of water to an almost totally submerged condition as a result of unexplained sudden flooding in the bow section. Water rapidly spread from this point to other bottom areas which caused the submarine to settle quickly on the bottom at a six-degree port list.*

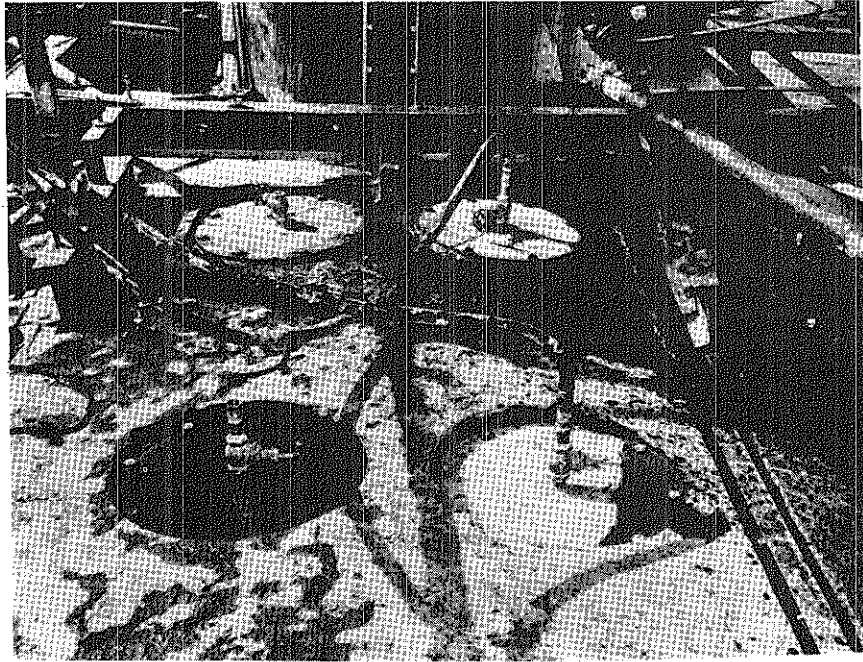
#### **AIR BLOWOUT SYSTEM INSTALLED ON THE GUITARRO**

*Air hoses were rigged to salvage air fittings in the two forward compartments as well as to the forward main ballast tanks.*

Initial efforts were directed at closing all internal watertight doors and hatches and clearing the maze of temporary service wires and vents from the topside of the submarine. Air hoses were then rigged to salvage air fittings in the two forward compartments and air

pressure applied to these spaces. Both compartments were watertight. Hull openings were identified, templated, and patched. To provide additional stability to the hull, a 150-ton crane was connected at GUITARRO's aft section.

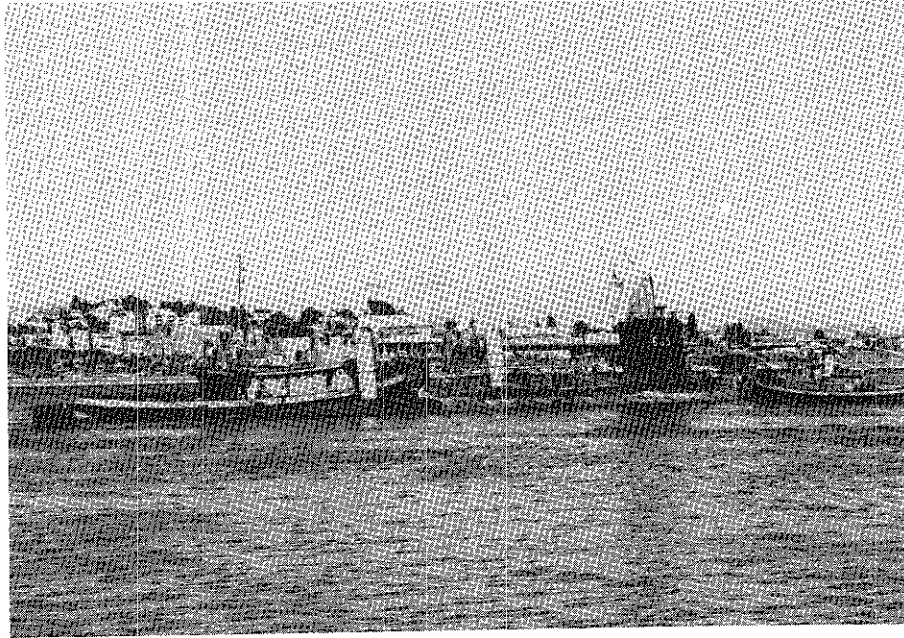
## **GUITARRO REFLOATED AND ON THE WAY TO DRYDOCK**

*Sufficient buoyancy was achieved following the refloating of the submarine which allowed it to enter into drydock. Salvage operations were completed within a three-day period.*

Air blowout commenced in the two forward compartments and continued for 13 hours. Air blowout then ceased and dewatering continued using the submersible pumps. Most of the water within the hull was removed except for the auxiliary machine room which was allowed to retain water to provide ballast control during lift. Dewatering of the machinery room commenced and at the same time a 20-ton strain was taken at the stern by the floating crane. GUITARRO then rose to the surface where salvage crews completed stripping operations. The submarine was then placed in drydock for repairs and restoration.

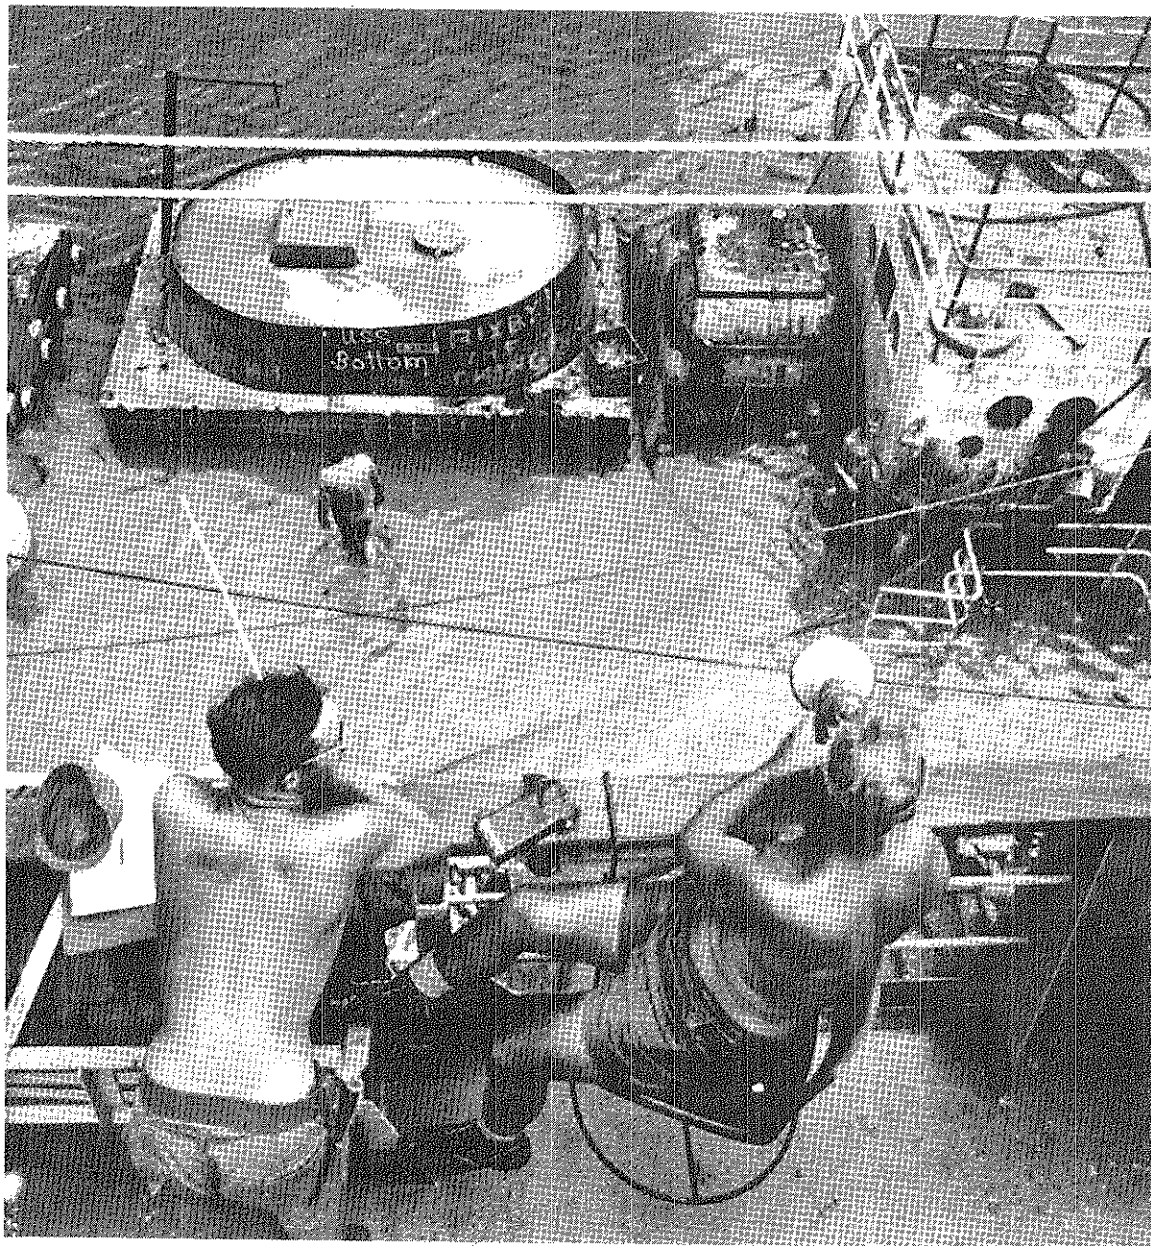
**SALVAGE CREWS INSPECT THE SUNKEN DREDGE, SANDPUMPER**

*Salvage efforts did not succeed in raising the SANDPUMPER, but the operation did achieve a Naval First: a grounded vessel was side-lifted by other ships.*

*On 22 September 1969, while on operational duty in the My Tho River, South Viet Nam, SANDPUMPER (YM 24), a dredge, sustained heavy damage when a live ordnance device was drawn into her suction pump and exploded at this point. The blast rocked the vessel and caused immediate and extensive uncontrolled flooding throughout the bottom areas. Within seven minutes of the explosion, the dredge sank to the bottom in 35 feet of water and came to rest almost totally submerged. Extreme flooding in the bow area caused this section to settle firmly in the mud. The starboard spud had cocked against the spud gates and, as a result, held the stern approximately six feet off the bottom. In the vessel's final position, submerged depth measured 35 feet at the bow and uniformly decreased to 25 feet at the stern.*

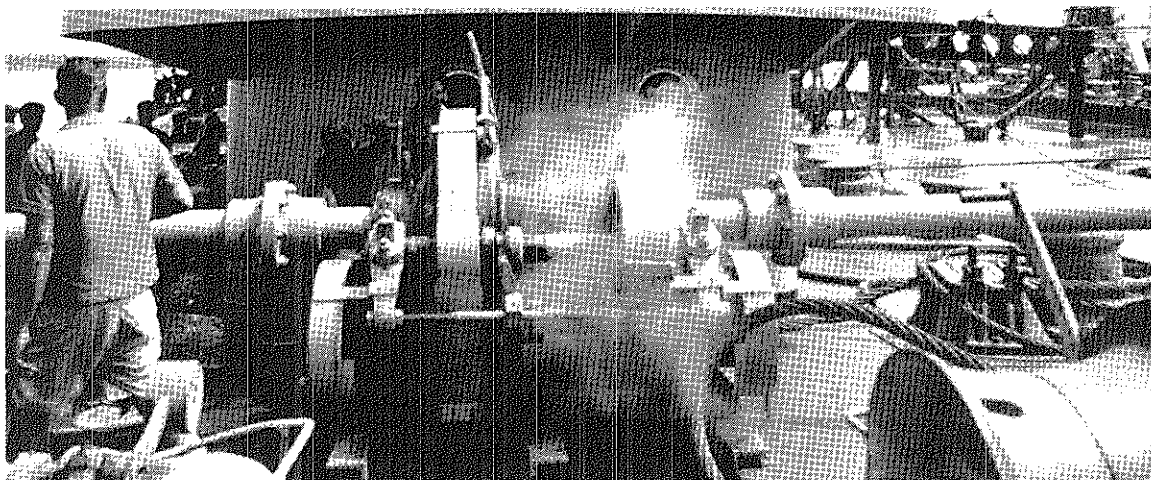
**MAIN WINCH ON CRILLEY IN OPERATION  
DURING TIGHTENING OF LIFT WIRES**

*To effect lift of SANDPUMPER, 24 lift wires were passed under the dredge.*

SANDPUMPER was readied for lift by CRILLEY and CRANDALL. Twenty-four lift wires were positioned under and around the dredge.

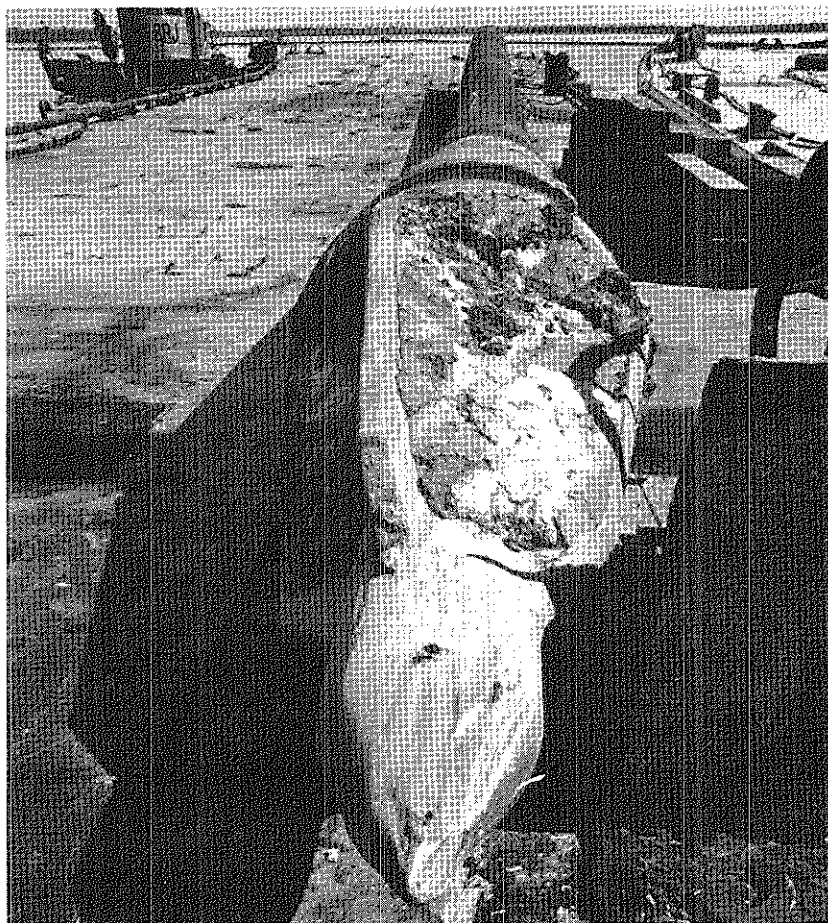
#### **ONE OF TWO SPUDS FROM SANDPUMPER**

*Blasting charges were used to open spud gates prior to removal of starboard and port spuds.*

Before lifting operations could begin, it would be necessary to open SANDPUMPER's starboard and port spud gates and to remove the spuds. Attempts at pulling the gates open failed, forcing the crew to resort to blasting charges (C-4 explosives) for this purpose. Use of these explosives succeeded in opening both gates. The starboard spud was easily removed, but the port spud, mired in 30 feet of mud, would not budge. Tactics then changed to a combination of ramming and the application of a 50–60 ton vertical pull on the port spud. Finally, resistance was overcome and the spud broke off 12 feet above the bottom.

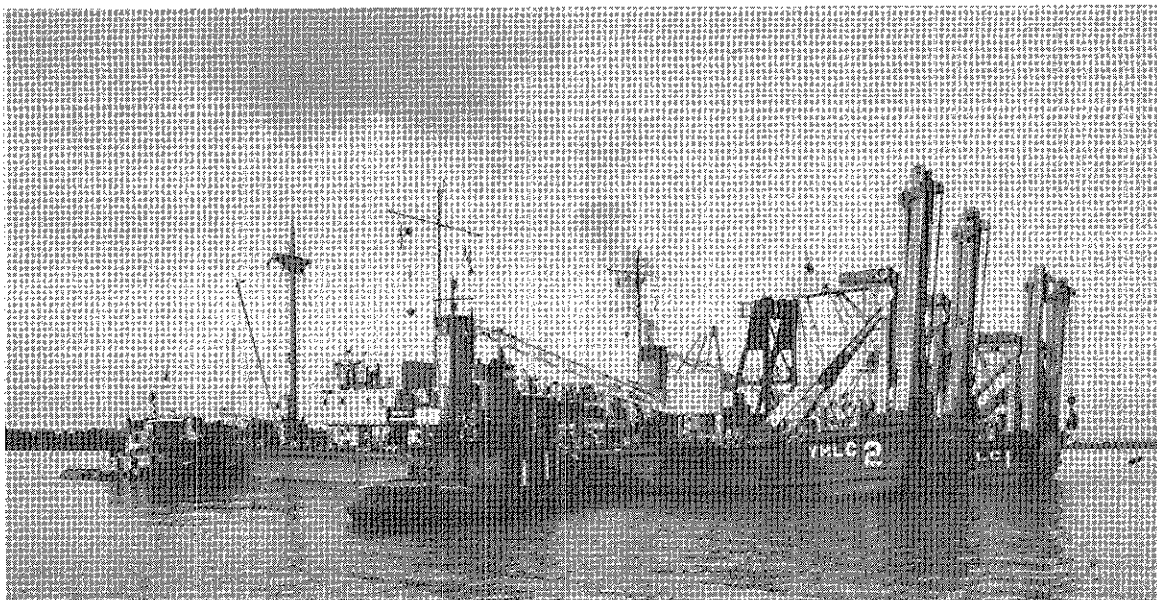
#### HEAVY LIFT CRAFT CRILLEY AND CRANDALL SIDE-LIFTING SANDPUMPER

*CRILLEY and CRANDALL made a series of side-lifts. Tugs maneuvered the non-self-propelled craft toward shallower water after each lift.*

Using their heavy lift capability, CRILLEY and CRANDALL commenced a series of successful side-lifting efforts which finally brought the SANDPUMPER to a resting point, with no list, 200 yards off Thoi Son Island, in 14 feet of water at low tide.

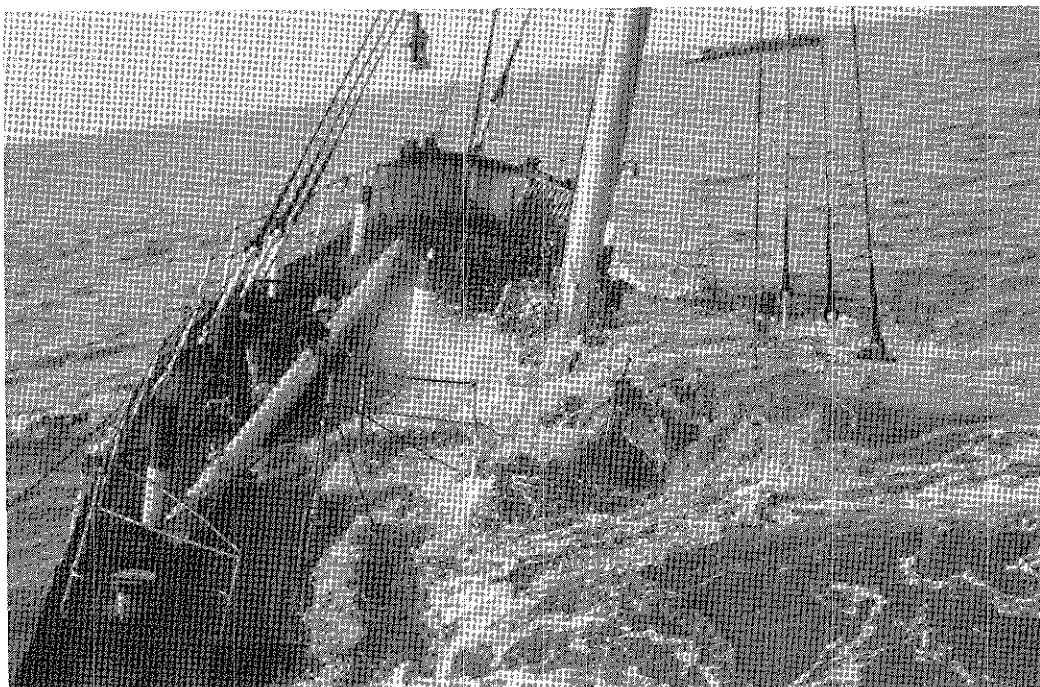
#### **BOW OF POWIS AT HIGH TIDE**

The stern of the POWIS settled about four feet into the muddy bottom. Her port bow remained impinged on the barge, which penetrated the hull approximately three feet. Structural members of both vessels were heavily entangled. The wreck was soon flooded throughout, maintaining a list of 20 degrees to starboard. Seas were running from the east and heavy swells were being experienced, especially during incoming tides.

It was difficult to determine through underwater inspection which structural members were part of the barge and which belonged to the POWIS. Essentially it appeared that the barge's members had pushed up within the inside shell of the transport. They were acting as a hook, holding the POWIS firmly in all directions. The hooking action was not entirely adverse, however, as it would also keep the ship from jumping prematurely off the barge during lift attempts.

*High tides and heavy swells added to the dangers and difficulties anticipated in carrying out the salvage plan.*

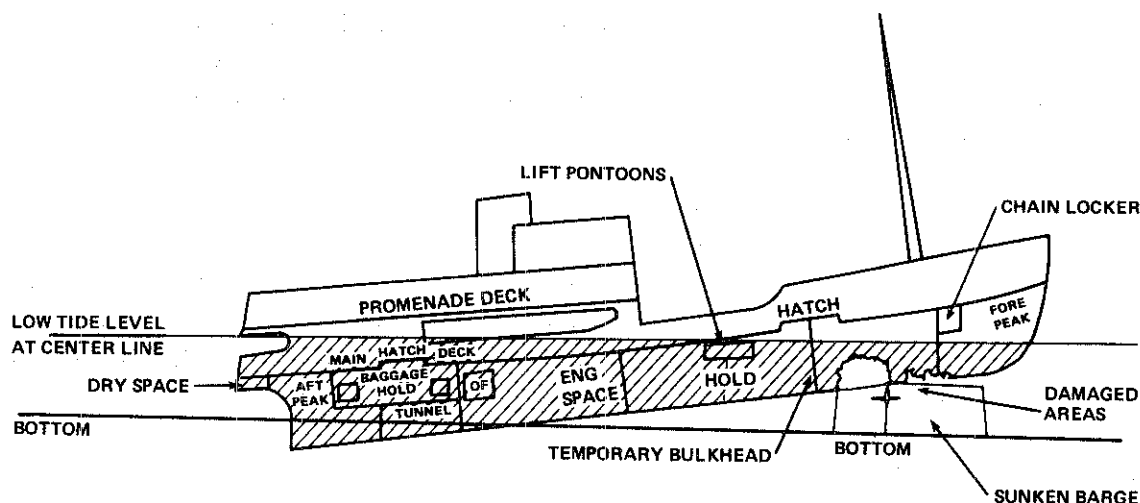
### PROFILE VIEW OF POWIS SUBMERGED AT LOW TIDE

*The salvage plan called for dewatering compartments and controlling list with salvage pontoons. Penetrating members of the sunken barge would be cut to part the two vessels.*

The general plan called for making the POWIS as watertight as possible, dewatering her compartments by pumping, and controlling the lift with makeshift salvage pontoons. It was calculated that the ship, once afloat, would have a good chance of riding free from the barge. Sections still preventing the POWIS from being parted from the barge at high tide would be removed by underwater cutting.

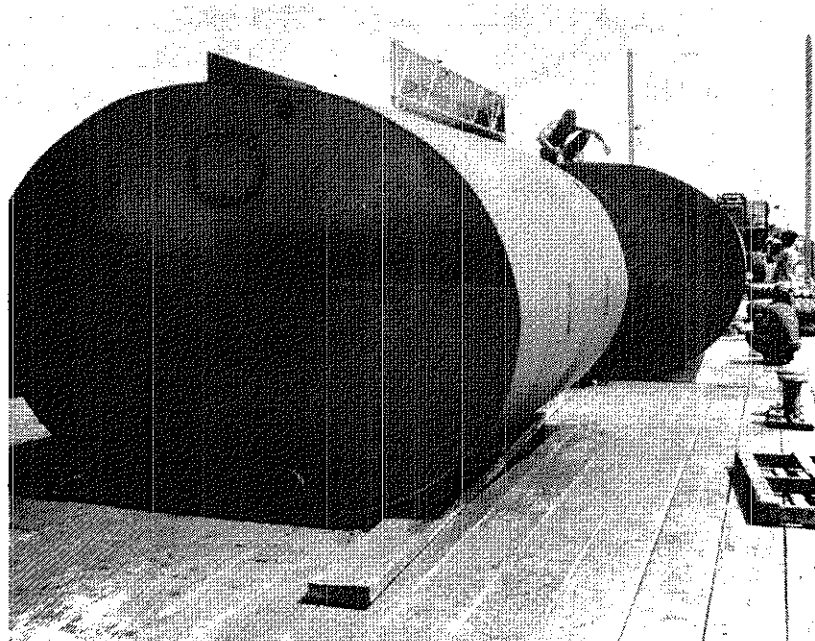
#### **LIFT PONTOONS BEING FABRICATED FOR LIFT ATTEMPTS**

Delays were encountered in converting the two oil storage tanks to lift pontoons. Almost three weeks were required to fabricate them. Further frustrations were experienced when they were finally brought to the wreck site. One sank and the other drifted away. Consequently, the plan had to be altered to use a large pontoon barge in their place. The barge was to be rigged with two logs between it and the starboard side of the POWIS to make a rigid connection. Then chains were to be run underneath the POWIS and connected to the logs.

*Two oil tanks, each having a 40-ton lift capacity, were converted to lift pontoons for the operation. Salvage plan was altered when these two pontoons were lost after arriving at the salvage site.*

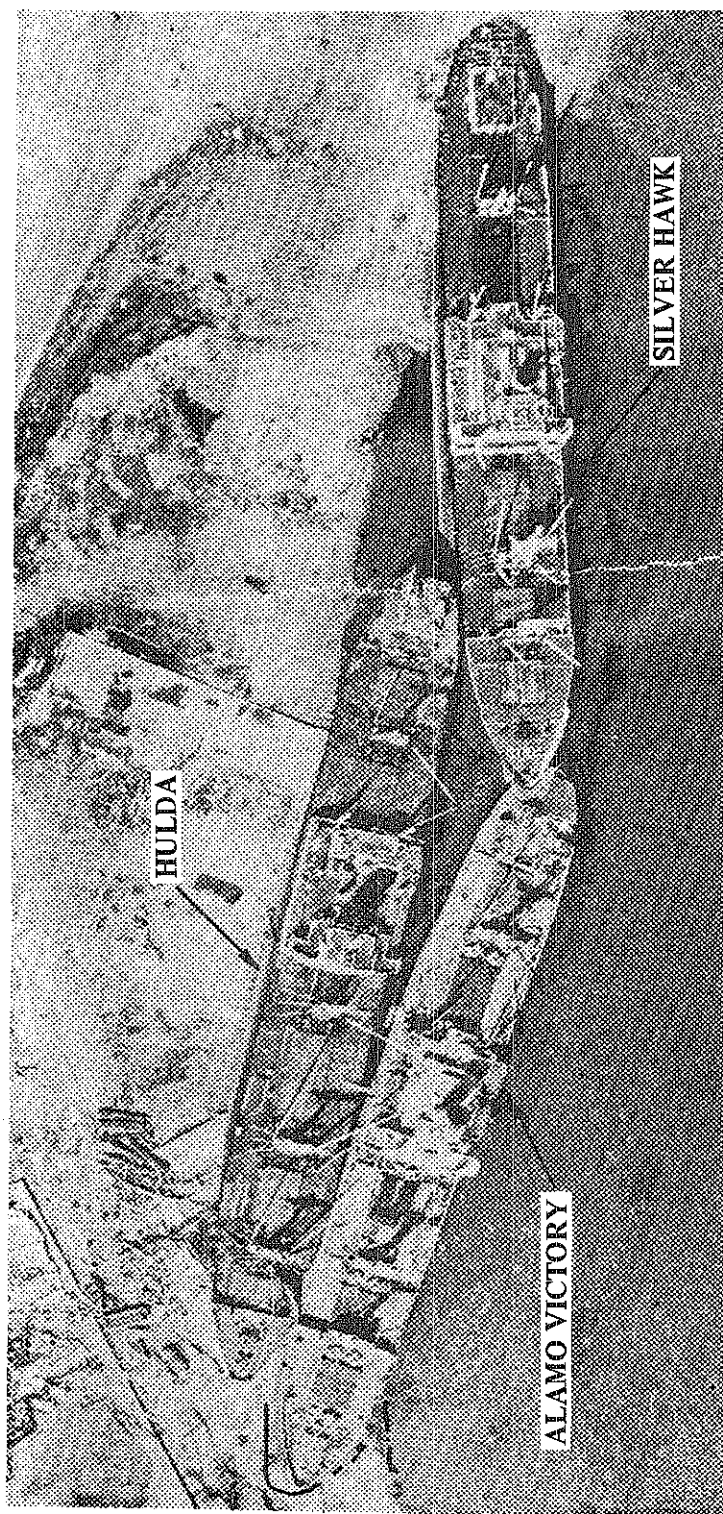
**ALAMO VICTORY WITH TWO OTHER SHIPS AGROUND IN GULFPORT, MISSISSIPPI HARBOR**

*Vessels ALAMO VICTORY, SILVER HAWK, and HULDA were torn loose from their moorings by hurricane "Camille" in August of 1969 and pushed aground within the harbor at Gulfport, Mississippi.*

*In the wake of devastating winds and high tides generated by hurricane "Camille" along the Mississippi-Louisiana coastline in mid-August 1969, three vessels, SS ALAMO VICTORY, SILVER HAWK, and HULDA, were torn loose from their moorings in the Gulfport, Mississippi port and run hard aground within the confines of the harbor. The three ships were beached together in clustered formation (ALAMO VICTORY directly outboard of HULDA, and outboard and ahead of SILVER HAWK), on sandy bottom and among broken sections of reinforced concrete pier pilings and other debris.*

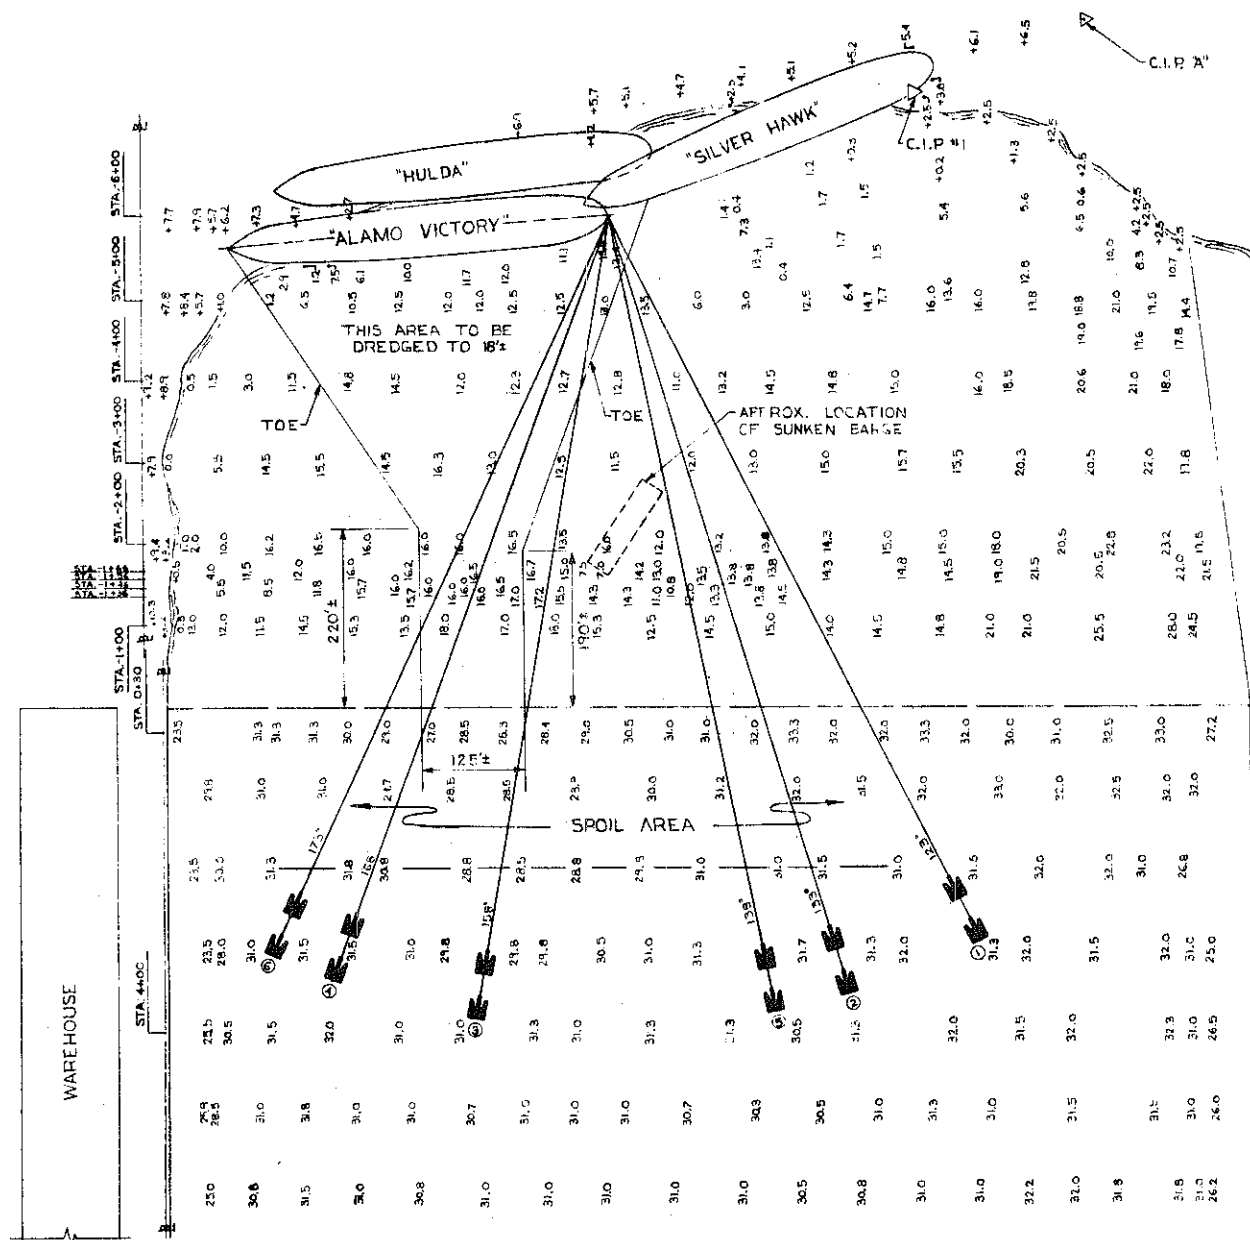
### PLANNED BEACH GEAR ARRANGEMENT

Six sets of beach gear rigged to the stern of the ALAMO VICTORY were to be used in the refloat attempt. Bow would serve as pivot point in swinging the vessel out from the beach.

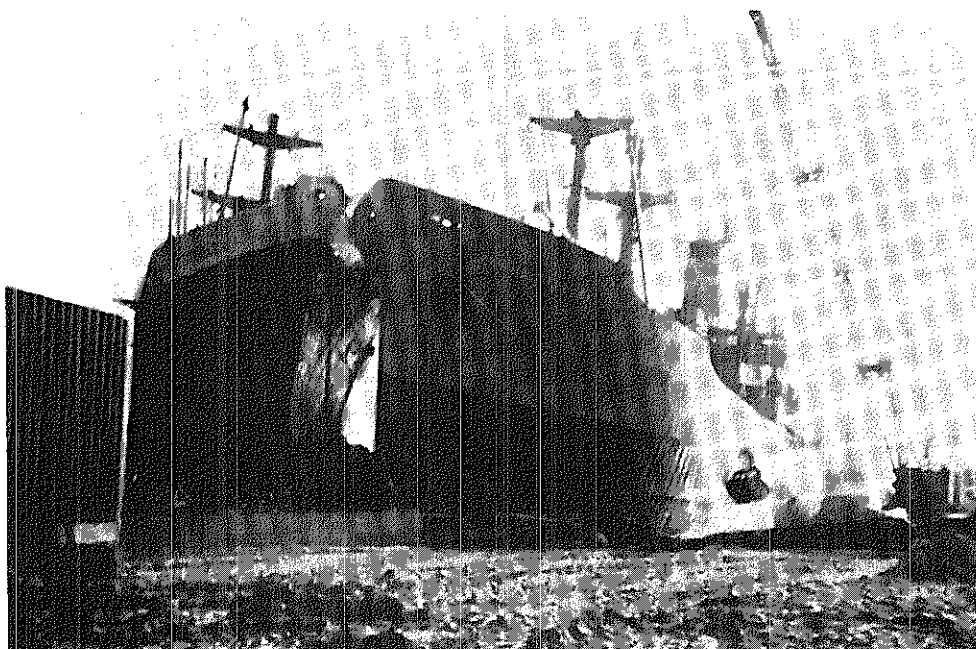
#### **DREDGING OPERATIONS AROUND BOW OF ALAMO VICTORY**

*Mud, dirt, and debris removal was accomplished by use of clamshell bucket at the bow area and by scouring and jet pumping off the port stern section.*

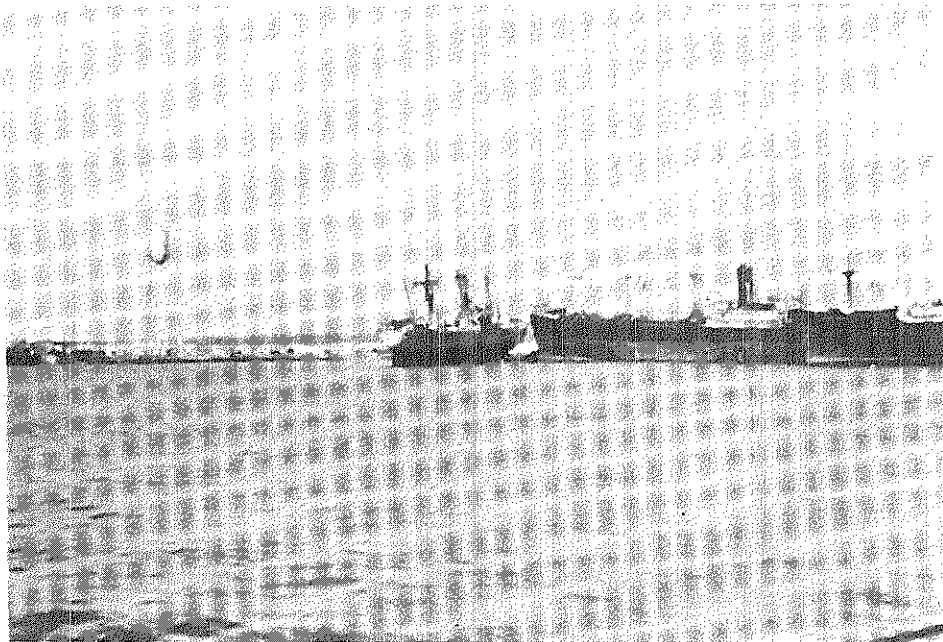
#### POSITION OF ALAMO VICTORY PRIOR TO REFLOAT

*Refloat was achieved by means of six sets of beach gear rigged on the stern of the stricken ship. Bow was used as a pivot point in swinging stern out from the beach.*

in case flooding should occur on refloat. On 20 September, ALAMO VICTORY became increasingly lively as the incoming tide neared its high point. Ground reaction was estimated at 288 tons. At this point, 200 tons of ballast was added to the aft port fuel tank which effected a rise of 11 inches to the bow section and a simultaneous lowering of 20 inches to the stern. With a full strain being taken on the stern by all beach gear, ALAMO VICTORY pivoted at the bow and moved slowly off the beach, free, clear, and afloat. Tugboat COMMODORE then proceeded to tow her to berth in the harbor.

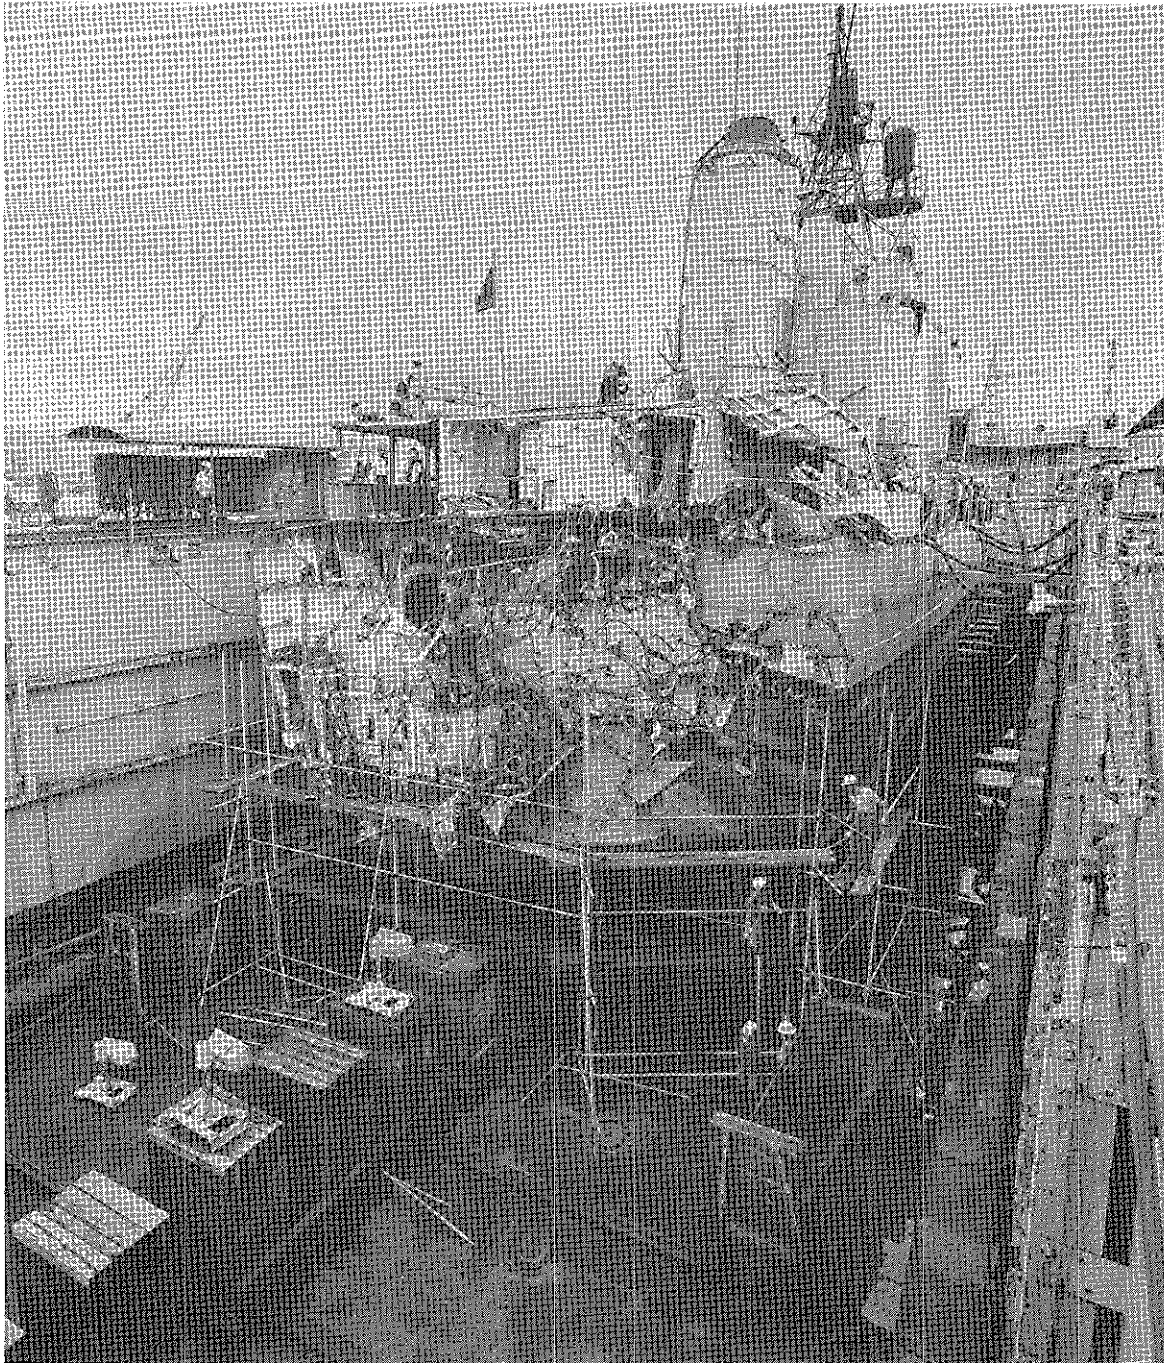
#### **EVANS IN DRYDOCK AT SUBIC BAY, PHILIPPINES**

*Severed stern section of the EVANS was successfully towed from collision site in the South China Seas to Subic Bay, Philippines – a distance of 825 miles.*
