# **SALVOPS 71**

**A review of significant salvage operations  
conducted by U.S. Navy salvage forces  
and other salvage activities during 1971.**

**Department of the Navy  
Naval Sea Systems Command  
Washington, D.C.**

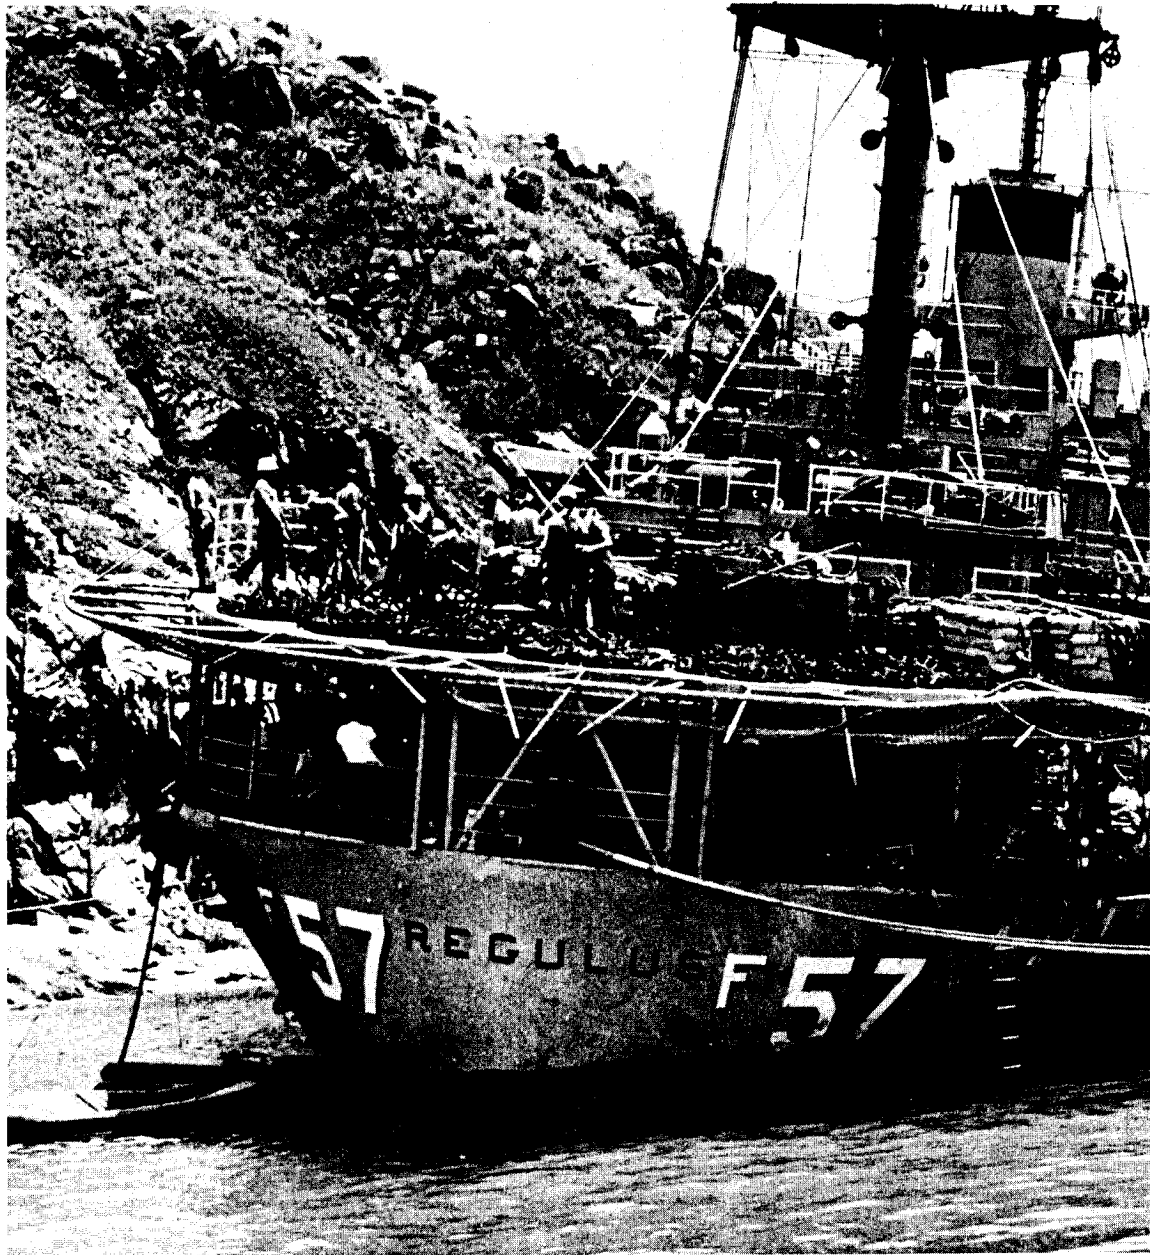
#### **OFF-LOADING AND REMOVAL OPERATIONS ABOARD REGULUS**

*From 17 August to 10 September Task Unit 73.4.2 removed all salvageable equipment. Over 300 tons of topside weight were removed including REGULUS' four boats, the forward masts, search lights, winches and controlled equipment.*

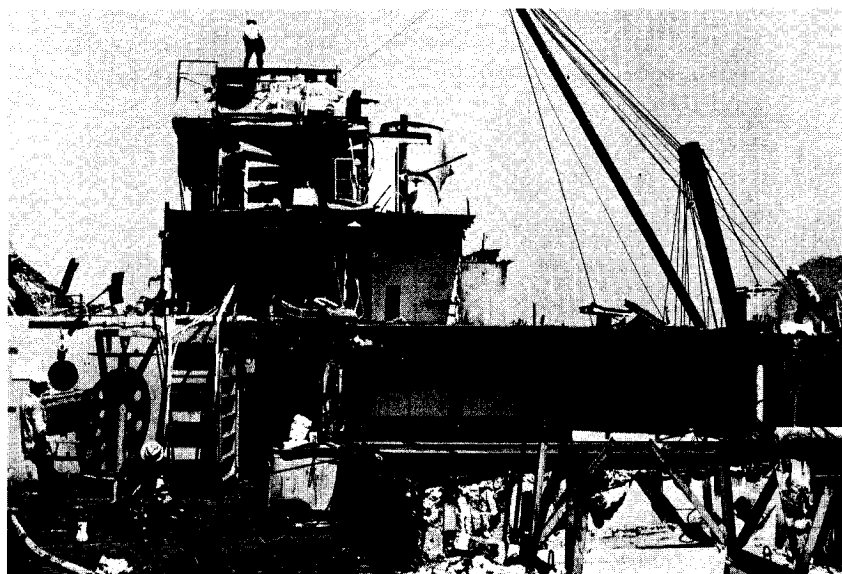
*Stern section with most of topside weight removed. Helicopter platform has been removed; stanchions supporting platform remain in place.*

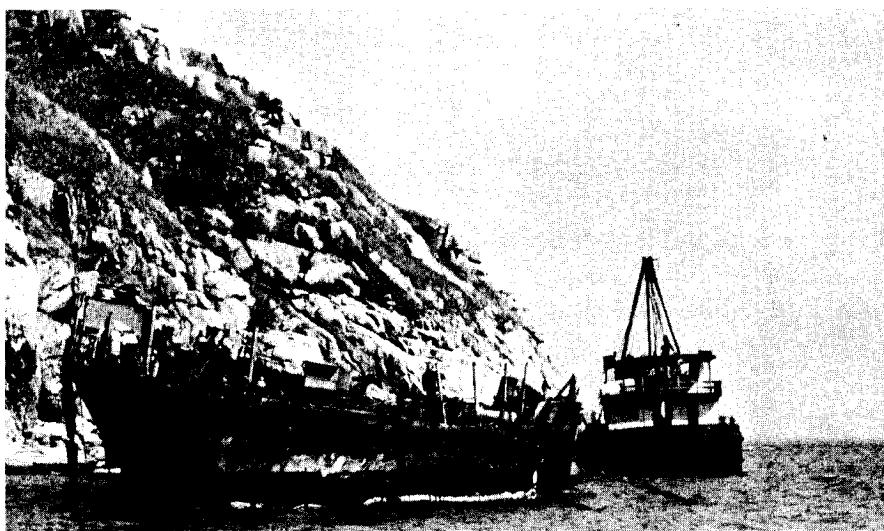
#### **REMOVAL OF ex-REGULUS SUPERSTRUCTURE**

*During the 3-month period from mid-September to mid-December all of the superstructure was cut away and removed.*

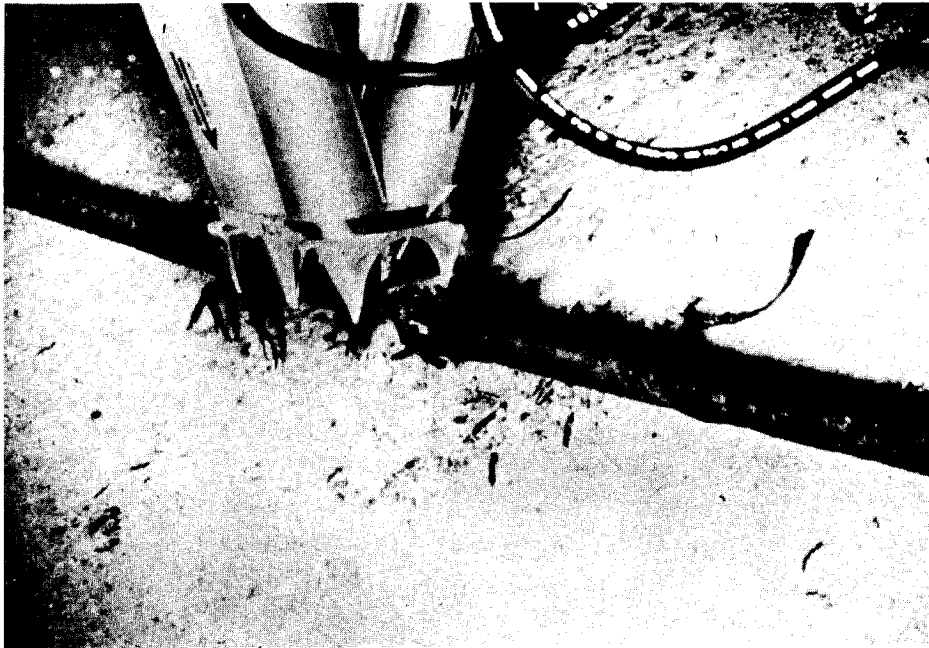
#### **PYRANOL TORCH FOR UNDERWATER CUTTING OF AFAR RANGE CABLES**

*CURV with pyranol torch attached severs cable on the ocean floor.*

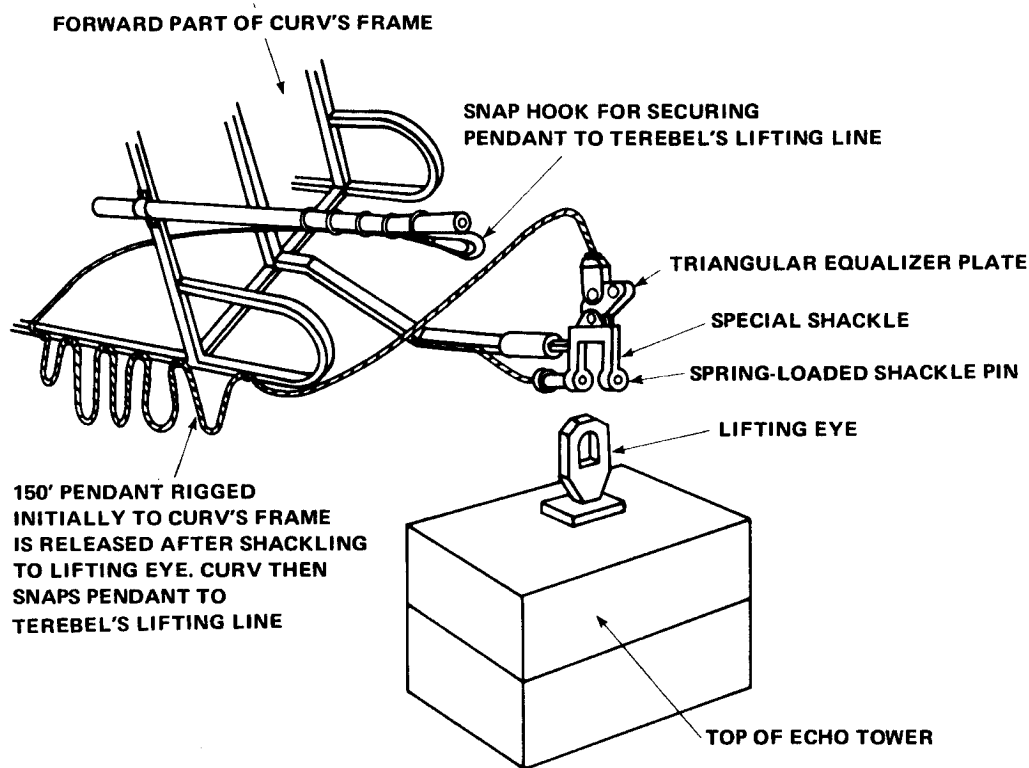
#### **SPECIAL SHACKLE DESIGNED BY SUPSALV FOR INSERTION INTO ECHO TOWER'S LIFTING EYE**

*CURV attaches shackle. Explosive bolt, fired electrically from surface through CURV's tethers, drives home the shackle pin. Mechanism in CURV's manipulator assembly releases shackle.*

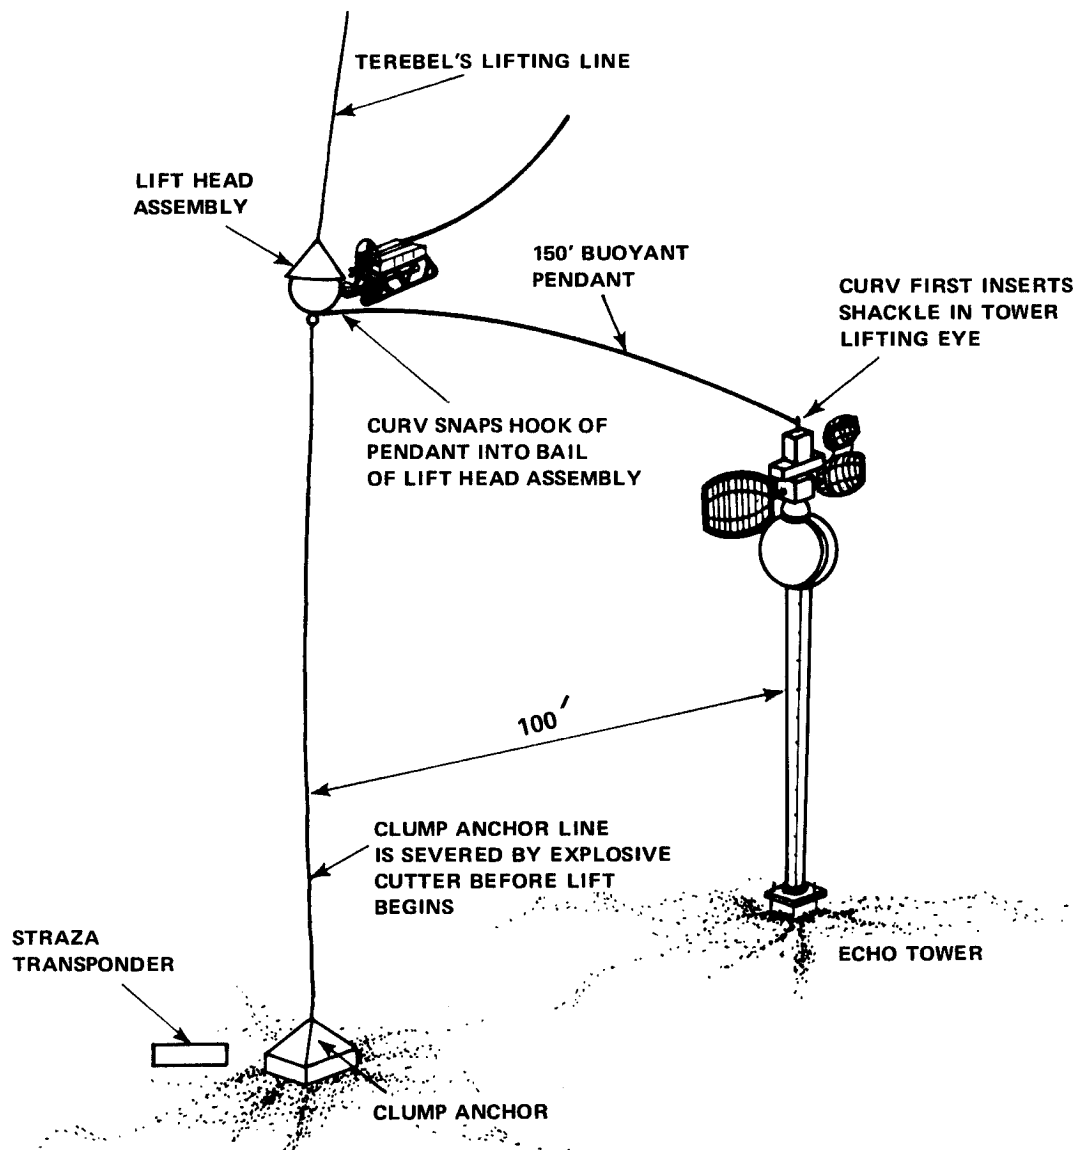
#### **CURV SECURES ECHO TOWER TO TERE-BEL'S LIFTING LINE**

*CURV connects one end of pendant to ECHO tower lifting eye, then uses snap hook to connect other end to TERE-BEL's lifting line. Task force had planned originally to secure pendant to lifting line on the surface. It adopted this procedure to keep lines from fouling.*

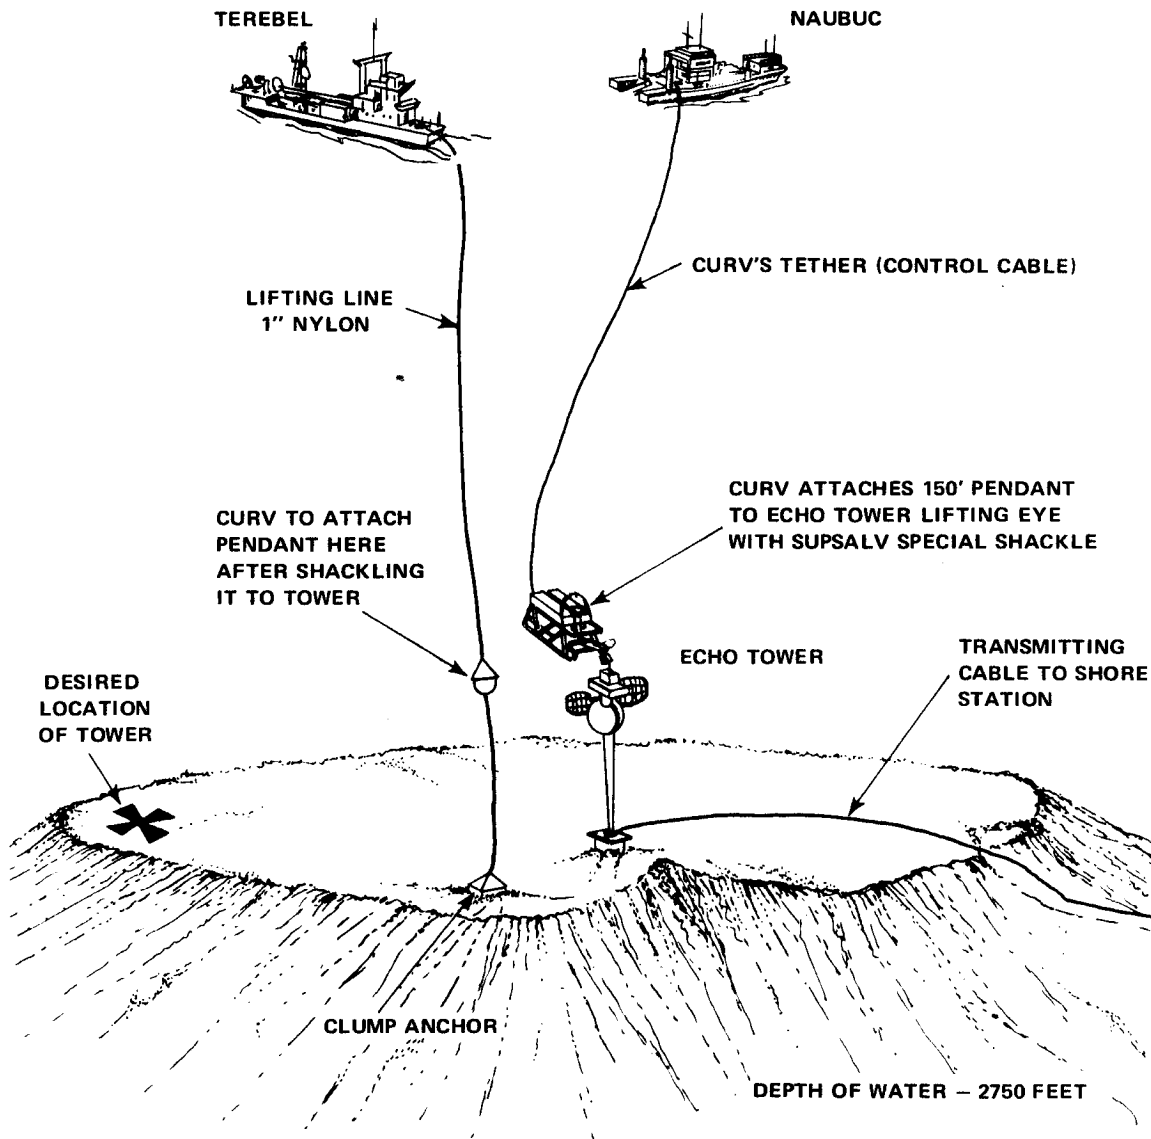
#### **NAUBUC/CURV TEAM ASSISTS TEREDEL IN RAISING ECHO TOWER**

*After CURV acquires clump on its sonar, NAUBUC coaches TEREDEL in "walking" clump to within 25 yards of tower base. CURV shackles one end of pendant to tower lifting eye and the other into TEREDEL's lifting line. The transmitting cable is cut and TEREDEL proceeds with the lift.*

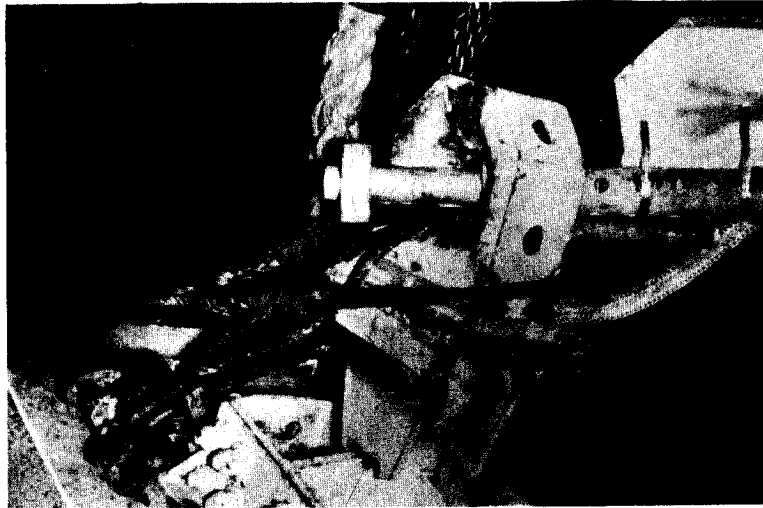
*Special shackle inserted by CURV into ECHO tower lifting eye. Nylon pendant is attached to shackle, snap hook on opposite end of pendant.*

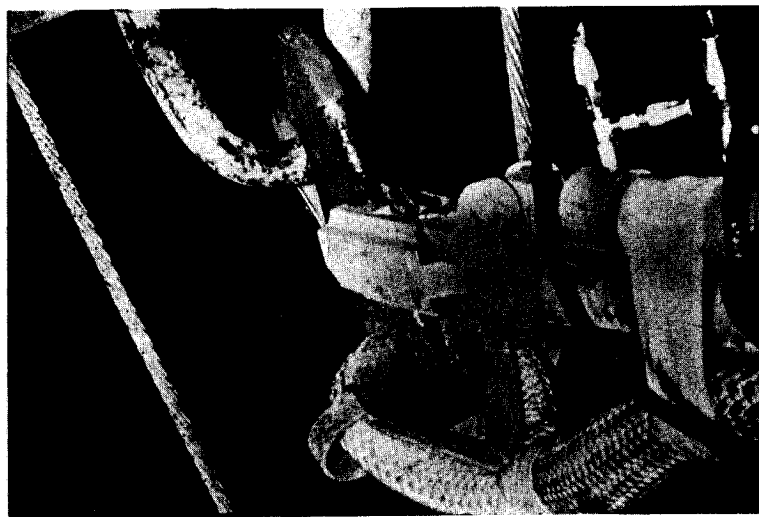
*CURV attaches snap hook to TEREDEL's lifting line, linking tower and lift ship.*

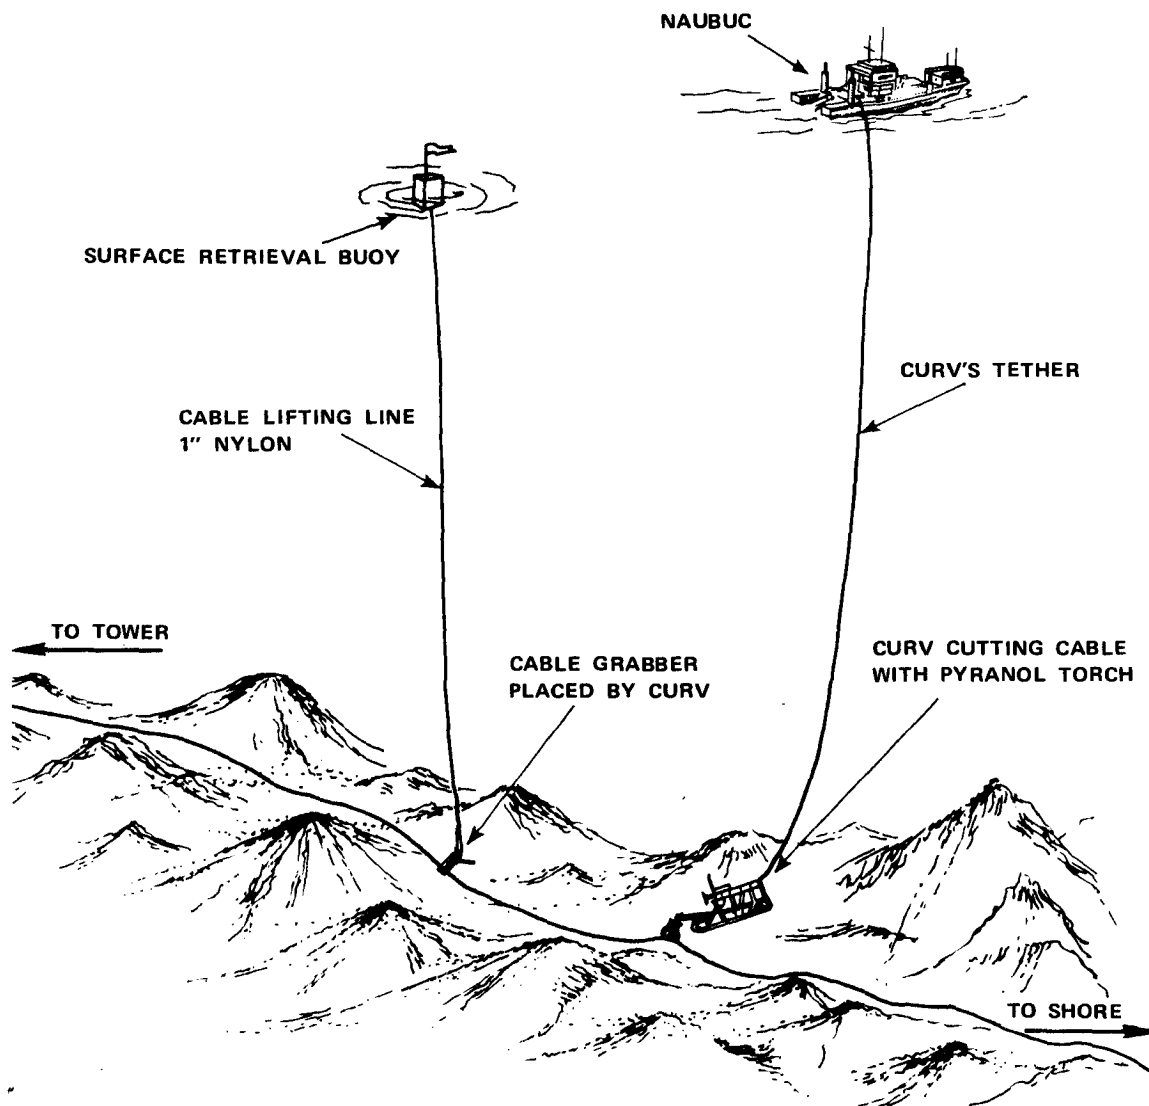
**NAUBUC/CURV TEAM CUTS AND BUOYS OFF AFAR ANTENNA TOWER  
ELECTRICAL CABLES**

*CURV's cable cutting operations were similar for all three towers. In each case, CURV clamped the cable grabber to the cable, thus securing the lifting line and buoy to the cable, and then cut the cable on the shore side. Later this buoyed-off cable stub was picked up by MARCEL BAYARD, and new cable from the shore spliced to it.*

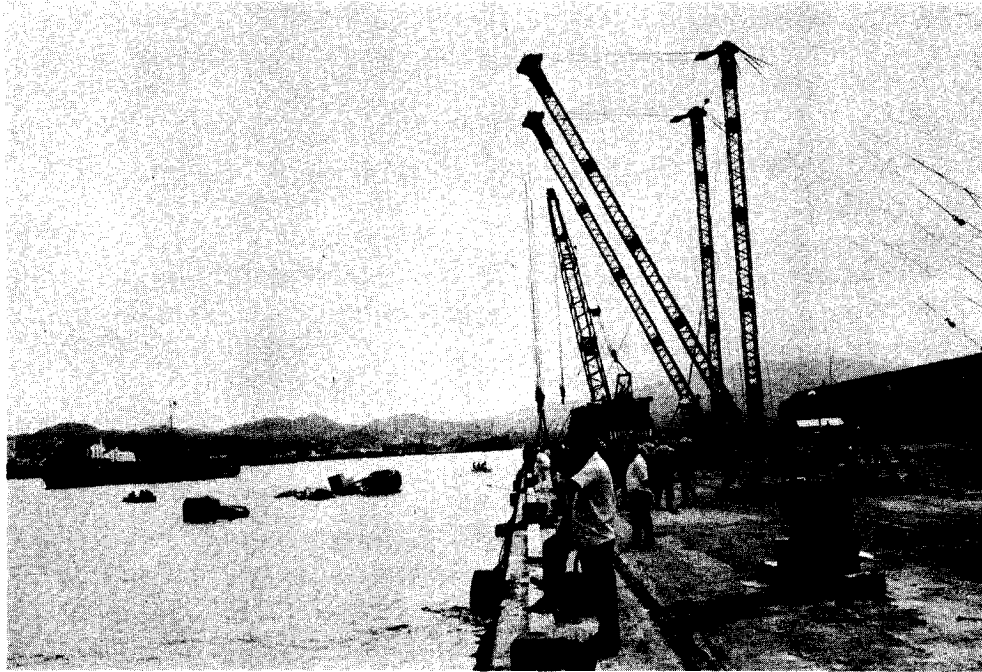
#### **ECHO TOWER ARRIVES IN PONTA DELGADA**

*On 17 July, NAUBUC (shown in photo) assisted in positioning ECHO tower (in water). NAUBUC also planted anchors to hold tower in position under the cranes for subsequent lift to pier.*

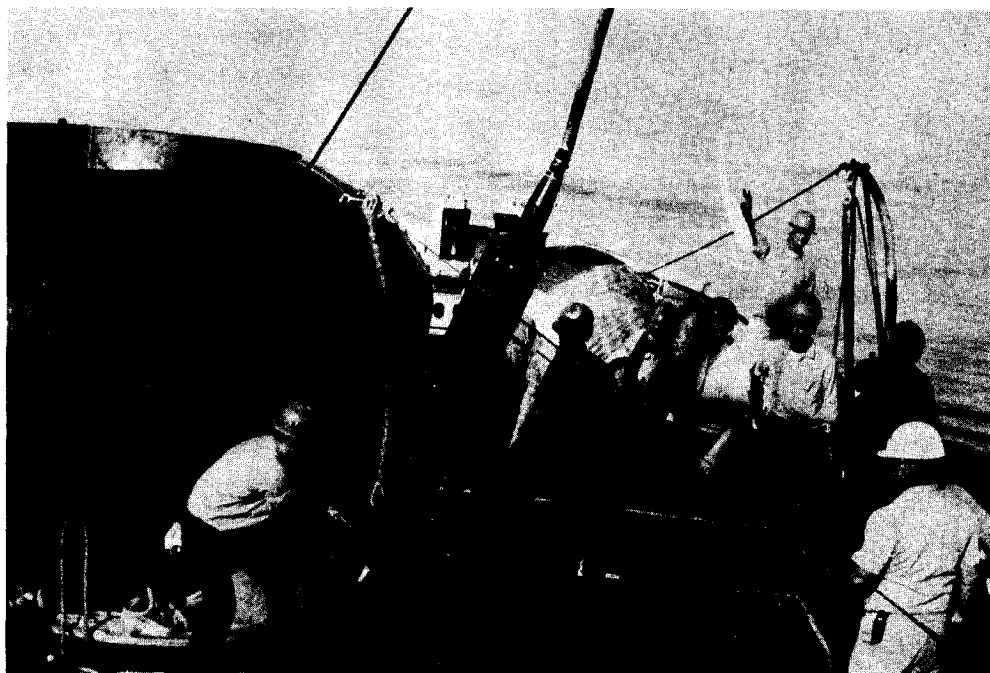
**KIOWA RECEIVES ELECTRONICS PACKAGE  
AND CABLE FOR BRAVO BUOY**

*Electronics package and cable safely aboard, KIOWA detaches spherical buoy (background) and prepares package and cable for attachment to BRAVO buoy, on right.*

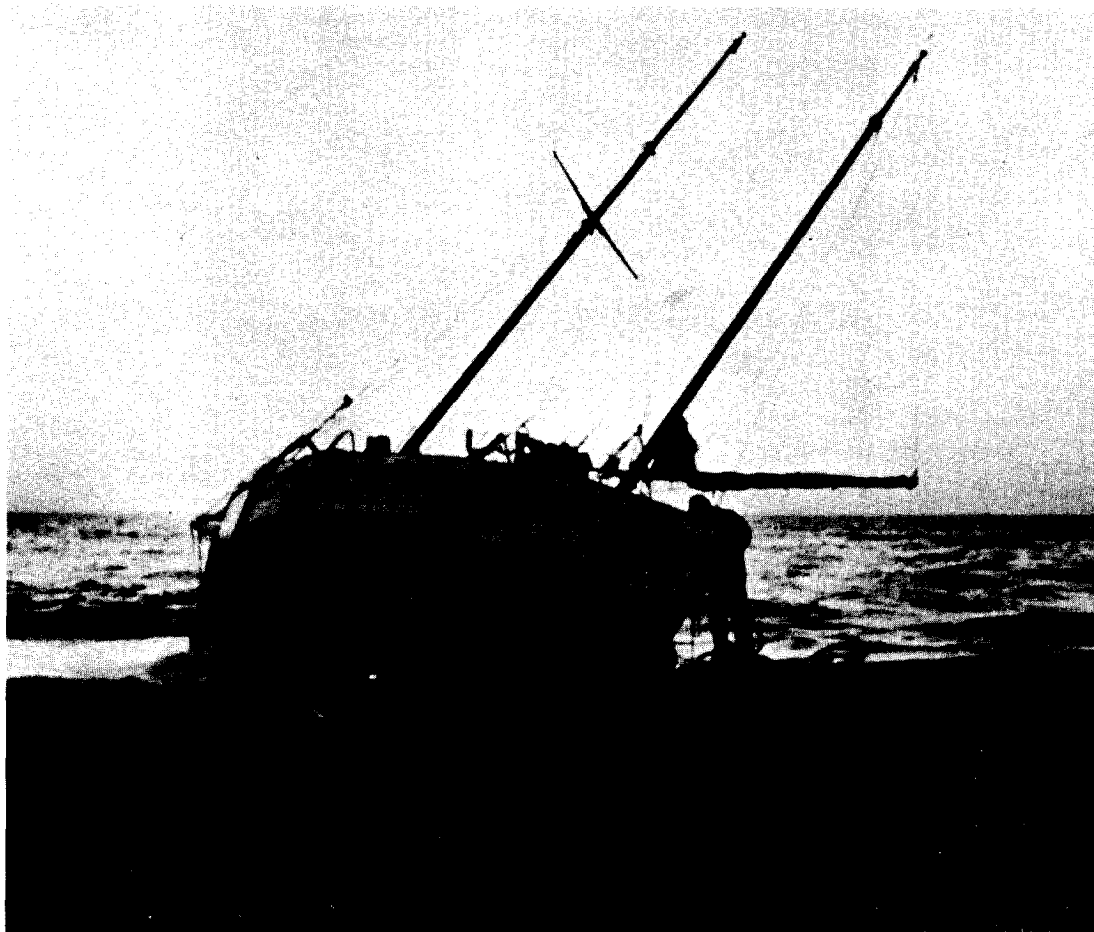
**ATOM AGROUND ON ASSATEAGUE ISLAND**

*Members of the U.S. Navy salvage team prepare ATOM for towing. The 30-foot ketch ran aground during an unusually high tide following an 108-day crossing from Spain.*

After hearing that the ATOM was aground, the Coast Guard sent a vehicle by land and a boat by water to investigate. The Coast Guard personnel found the ketch listing at a 22-degree angle and lying 20 yards above the mean low-water line. It was evident that an unusually high tide had been responsible for carrying the boat so high up on the beach. A further examination revealed that several strakes were broken.

ATOM had now been aground more than 10 days, her condition deteriorating steadily. Her once white topsides were streaked with rust and the seams along her red bottom were beginning to pop open. There was mounting fear that ATOM could not be freed in one piece.

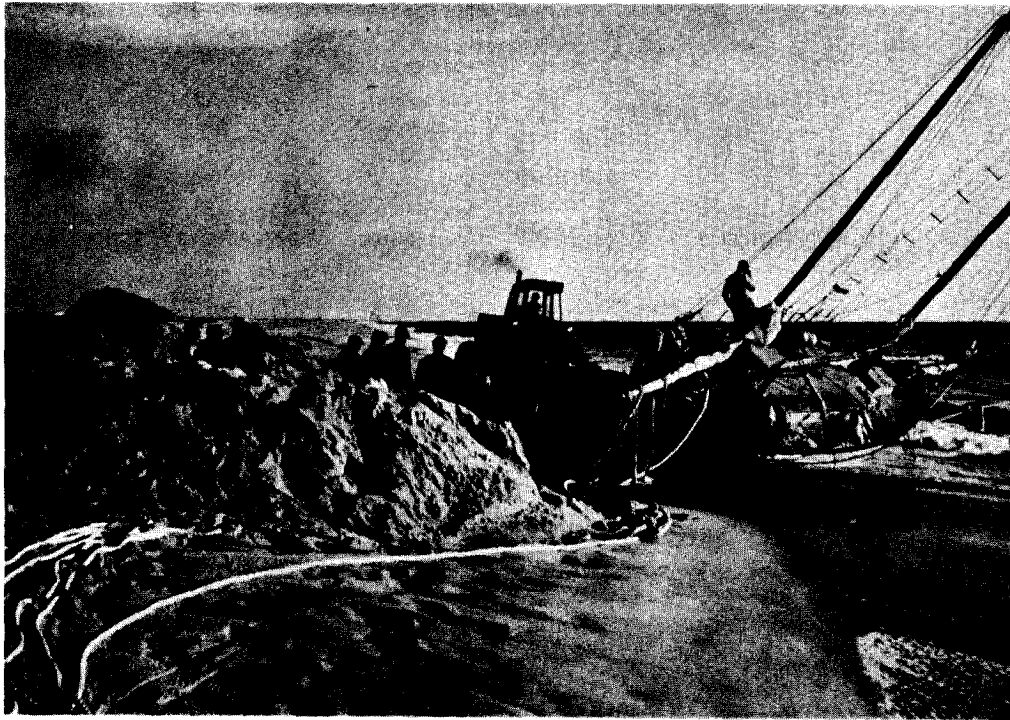
#### **DIGGING SAND AWAY FROM ATOM'S HULL**

*Earth moving equipment dig a trench between ATOM and the sea. During high tide the trench filled with water and ATOM was pulled to sea.*

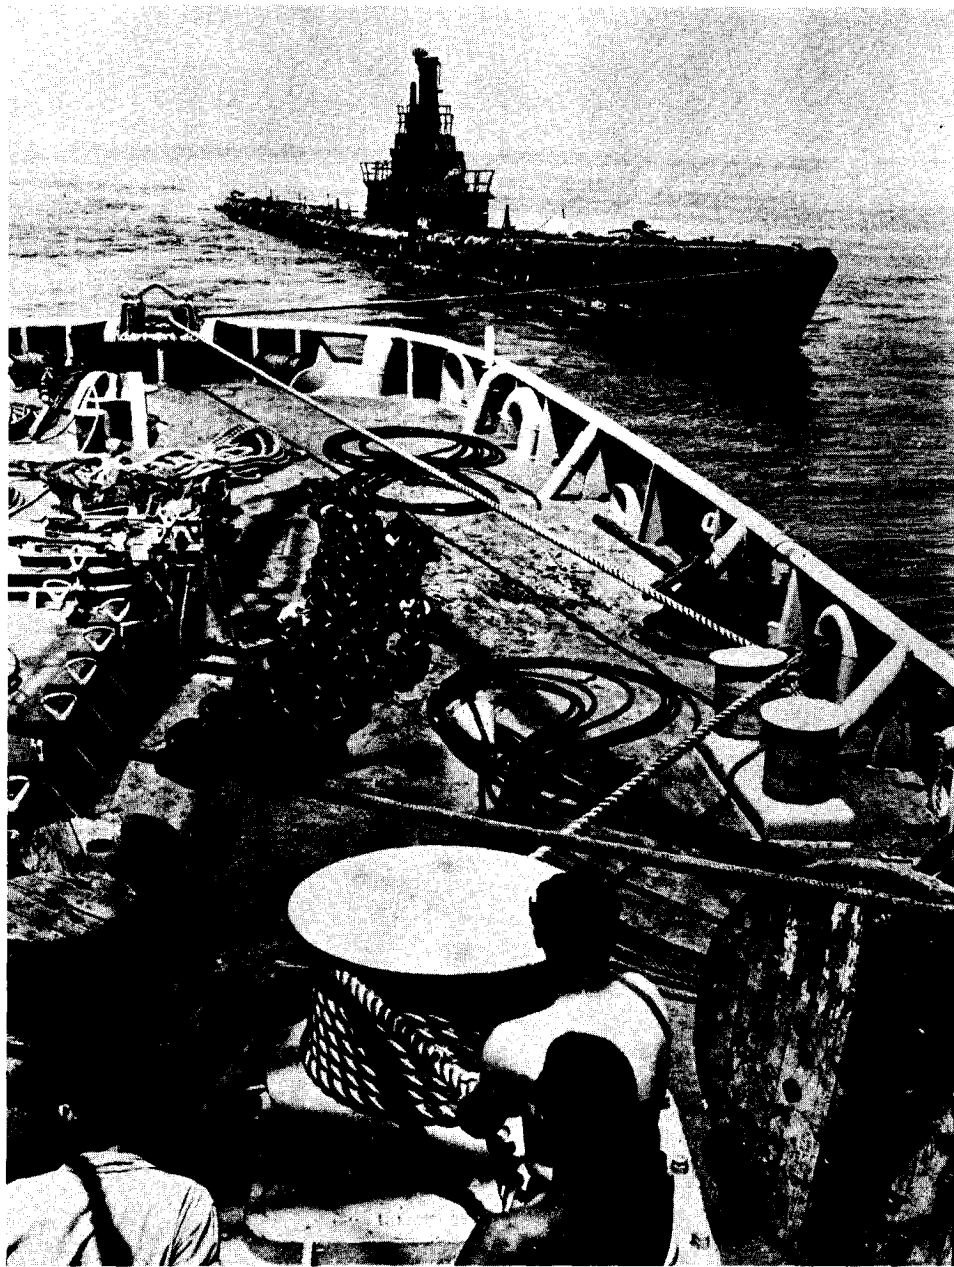
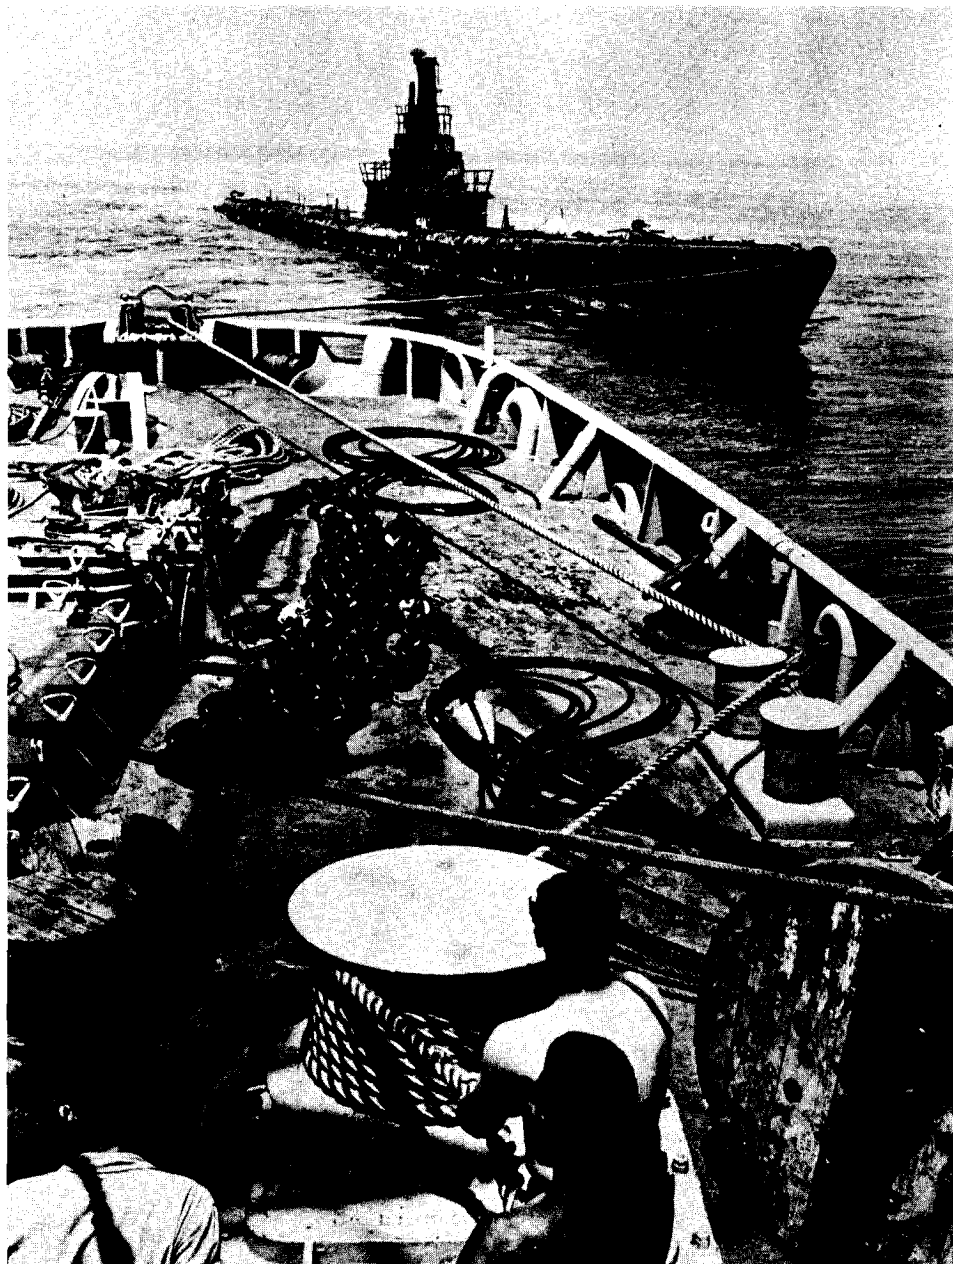
**USS OPPORTUNE TOWS ex-HAKE TO EXERCISE SITE IN  
CHESAPEAKE BAY**

*USS OPPORTUNE (ARS-41) towed ex-HAKE to the exercise site on 9 August 1971. During SUBSALVEX-71, the forward pontoons were rigged and lowered from OPPORTUNE's fantail.*

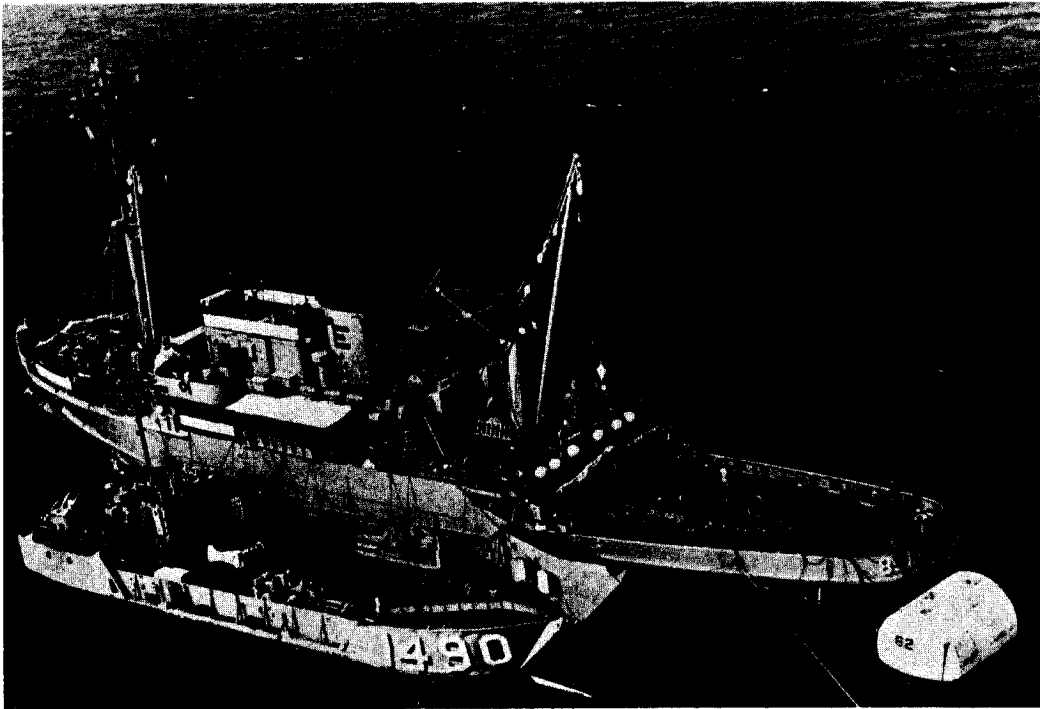
**USS PRESERVER (ARS-8) AND LCU 1490 PREPARE  
YSP-62 FOR LOWERING**

*Working side by side, PRESERVER and LCU 1490 rig the stern lift pontoon, YSP-62, for lowering. The well deck of LCU 1490 provided a good area for handling air hoses and the lowered ramp provided an excellent way for divers to enter and leave the water.*

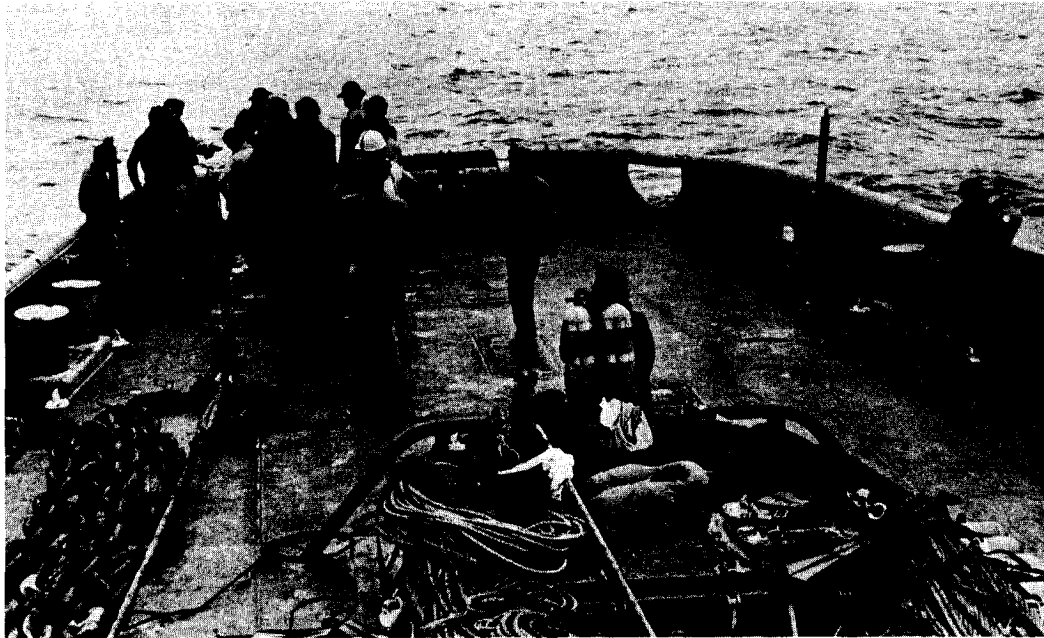
## PREPARATIONS ON BOARD PRESERVER

*Members of the salvage team on PRESERVER's fantail prepare to reeve lifting chain under the sunken ex-HAKE.*

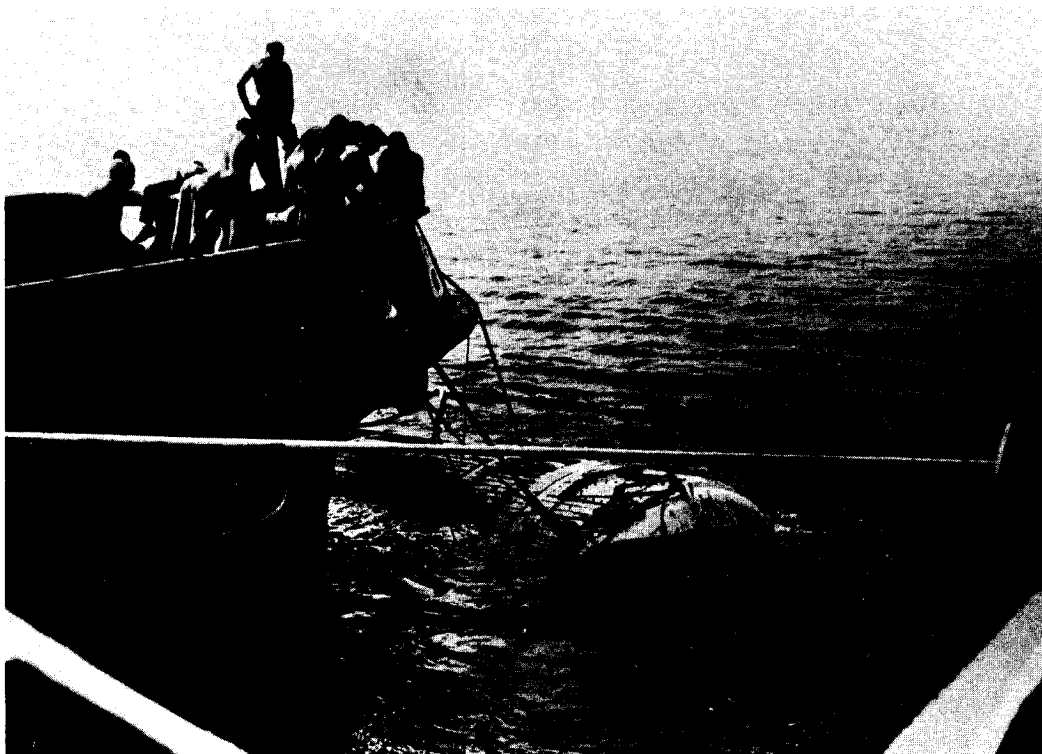
#### **THE SALVAGE TEAM LOWERS ONE OF THE PONTOONS**

*In lowering a pontoon, hoses were disconnected from the vent valves. The pontoon was then lowered with the blow hoses connected and vent valves open. As long as the lifting slings were taut, the descending lines were able to control the pontoon and keep it level.*

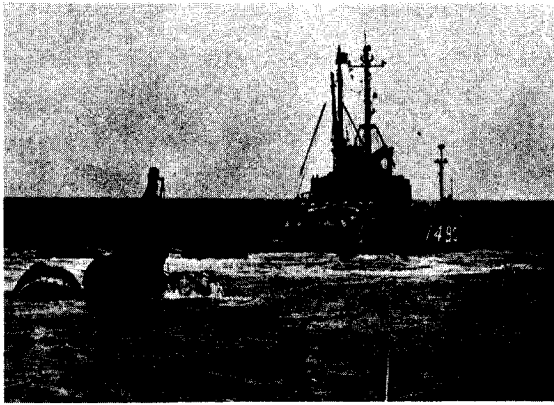
*To lift the submarine to the surface, six inflatable pontoons were used in addition to the four YSP's.*

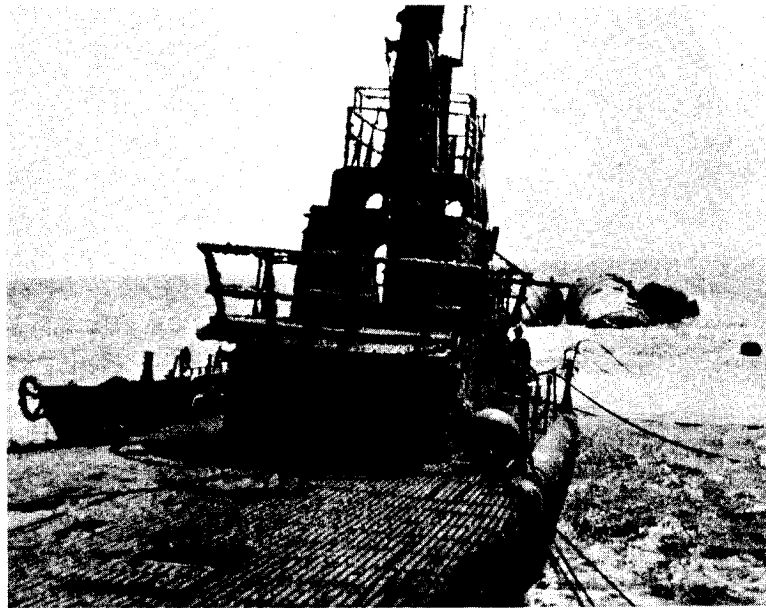
#### **ex-HAKE ON THE SURFACE**

*After 5 weeks on the bottom of the Chesapeake Bay, ex-HAKE was finally surfaced. Note the open hatches. Pumps were lowered through these hatches to dewater the internal compartments.*

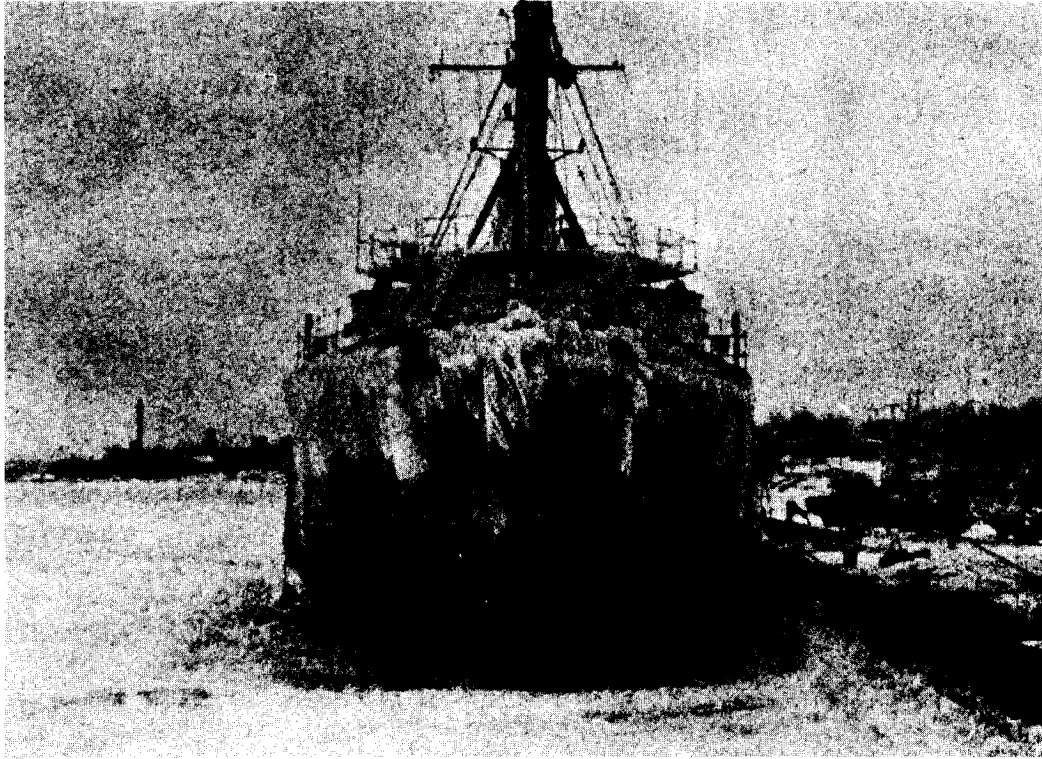
**U.S. COAST GUARD CUTTER WOODBINE ALONGSIDE  
PIER AT CHARLEVOIX**

*WOODBINE, the working platform for Phase I operations, was covered with ice 90 percent of the time. Ice covered everything, including the diving gas cylinder racks, steam generating equipment, and mooring lines, thus making working conditions very difficult and extremely hazardous.*

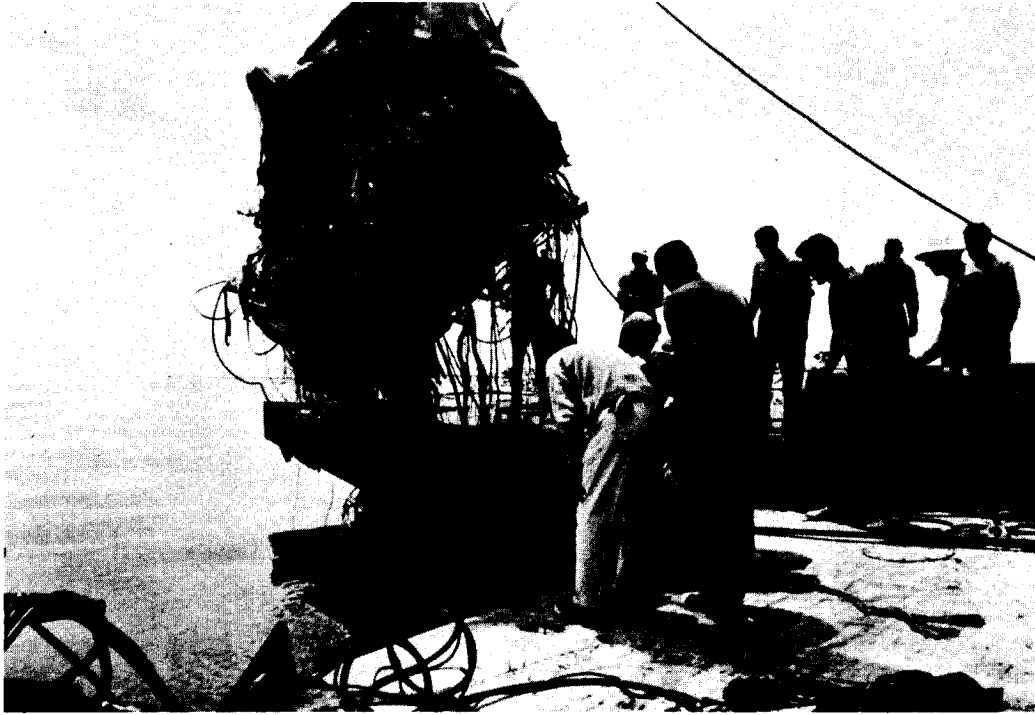
#### **SALVAGE TEAM RECOVERS WING SECTION WITH WIRE BUNDLE**

*Only pieces of wreckage deemed significant in determining the cause of the crash were recovered. Air Force representatives used underwater TV to help identify pieces for recovery.*

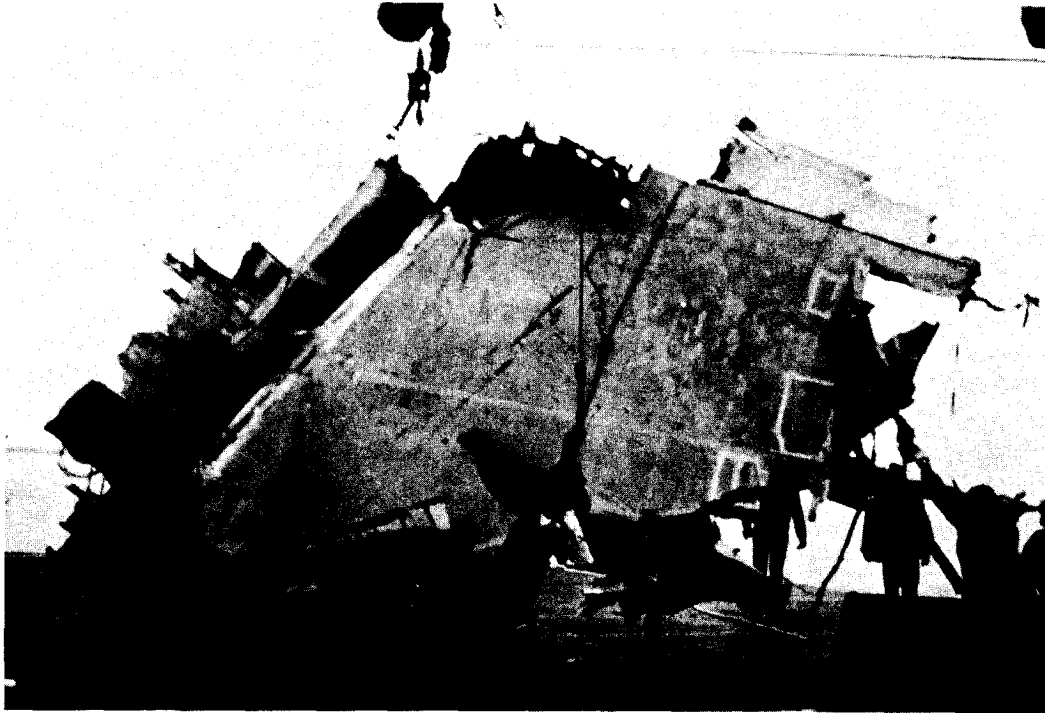
**ADS-IV CRANE RAISES THE ELEVATOR SECTION  
OF THE B-52 FROM LAKE MICHIGAN**

*During Phase II operations, 12 May – 11 June 1971, various parts of the B-52 were recovered. From this wreckage Air Force investigators hoped to determine what caused the crash.*

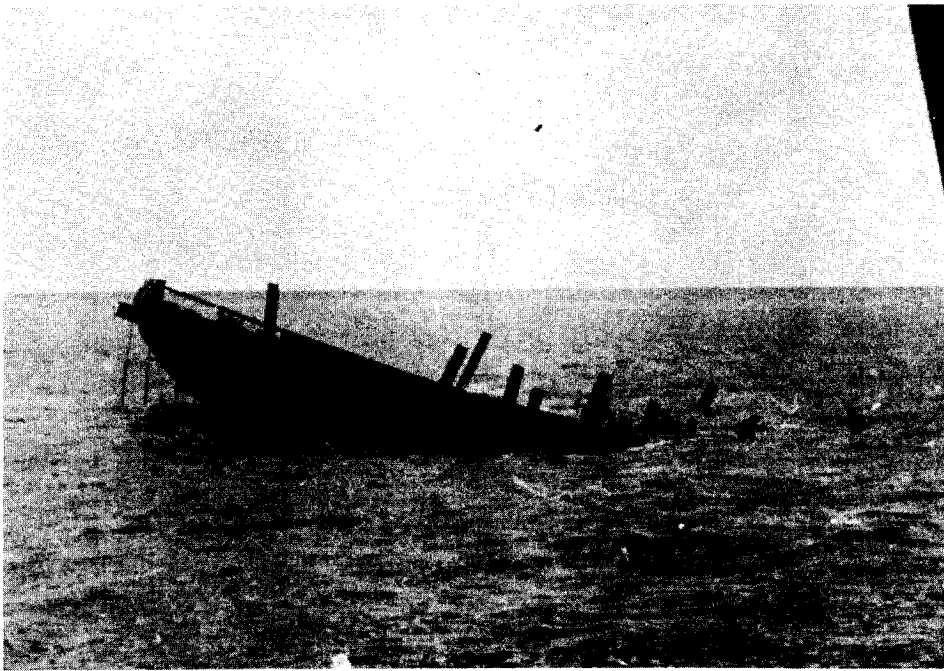
### **BOOTH SURFACES AFTER 2 YEARS ON BOTTOM**

During the preliminary preparatory work, divers surveying the sunken barge discovered that apparently another vessel had collided with the sunken barge despite a lighted buoy marking the site. The damage to the barge indicated that it had been a heavily laden freighter or tanker with a draft of more than 30 feet that had collided with the BOOTH. Although the collision was not reported, it was believed to have occurred during the preceding 5 months; an underwater survey of the hull in March 1971 had revealed no such damage.

The apparent collision left a portion of the barge deck strewn with rubble. Divers reported that an area from about the center of the barge to some 70 feet back was littered with piping, conduit, motors, assorted other dislodged equipment, and sections of the barge wheelhouse torn loose by the impact. Parts of the deck were depressed 3 to 4 feet by the collision.

*The pipelaying barge, BOOTH, comes to the surface. Note the standpipes on the deck of the barge. Through these standpipes passed thousands of 11-inch spheres to provide the buoyancy to raise the barge.*

The extent of the damage necessitated clearing the rubble from the barge's deck prior to cutting holes for the standpipes through which the PSI spheres were to be delivered. On 12 August special salvage teams began to inject the spheres into standpipe openings in the sunken barge. In all, divers cut eighty 12-inch in diameter holes in the hull's compartments and attached standpipes to receive the delivery tube.

On 23 August the barge was raised. Enough 11-inch diameter spheres pressurized to the depth of the sunken vessel had been propelled through standpipes into the vessel's holds and compartments to create the necessary buoyancy. As the barge rose, the system's two-way valves built into every sphere automatically released pressure.

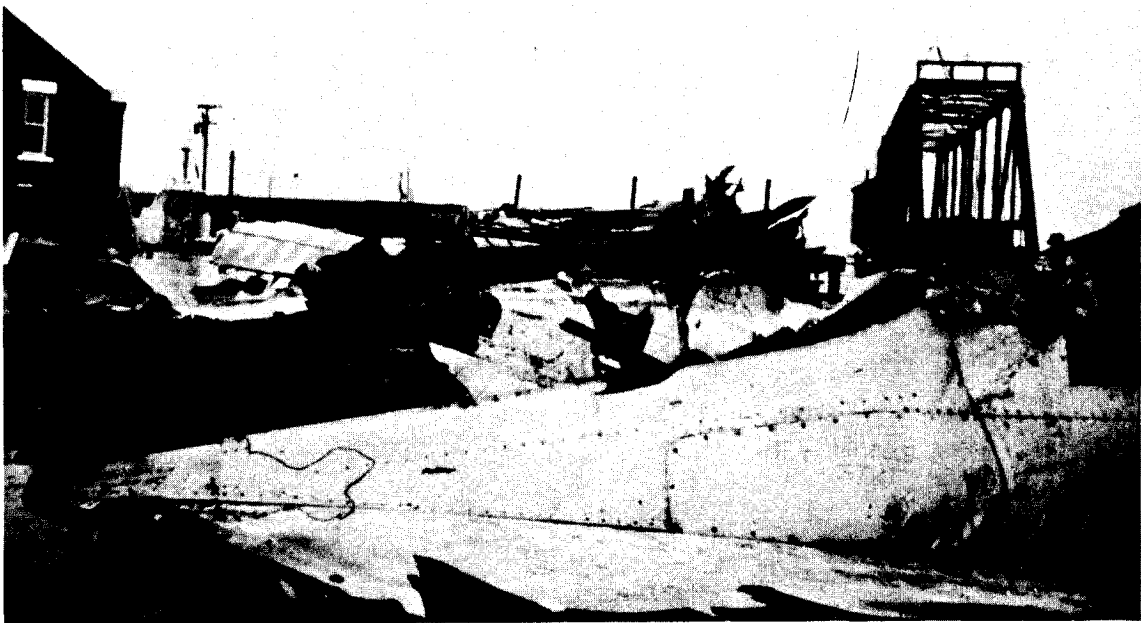
**B-57 AIRCRAFT WRECKAGE RECOVERED FROM GREAT SALT LAKE**

*Despite minimum bottom visibility and remote crash site, salvors recovered approximately 40 percent of fragmented wreckage of Air Force B-57 aircraft.*
