# **SALVOPS 71**

**A review of significant salvage operations  
conducted by U.S. Navy salvage forces  
and other salvage activities during 1971.**

**Department of the Navy  
Naval Sea Systems Command  
Washington, D.C.**

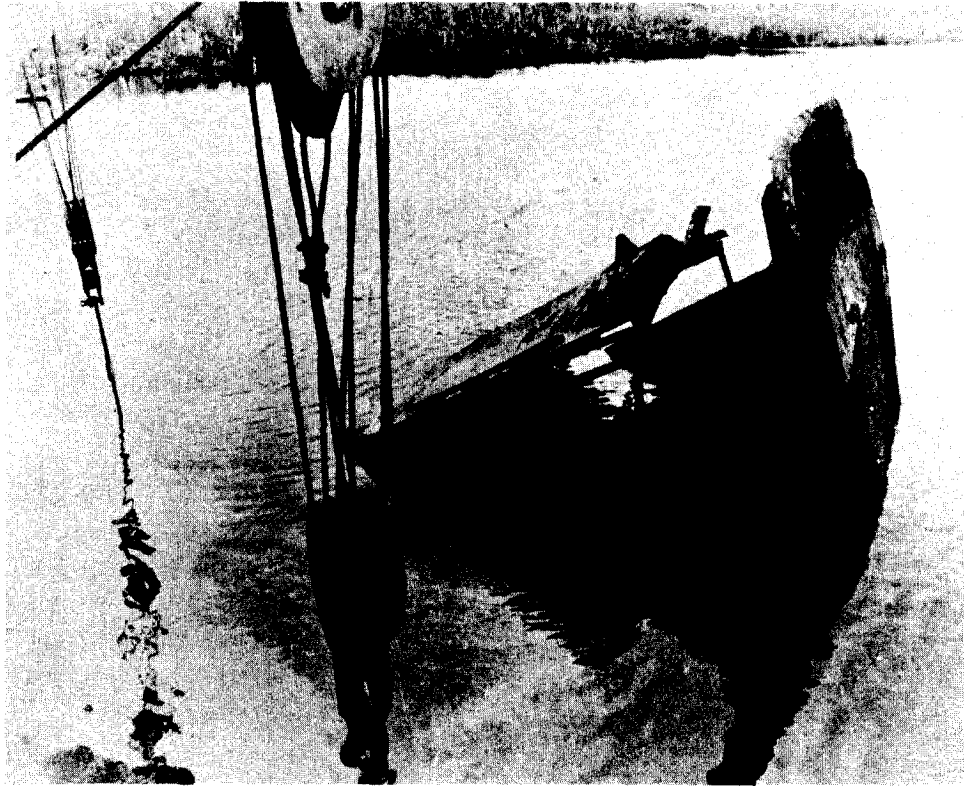
#### **WRECKAGE LIMITED THE USE OF INLAND WATERWAYS**

*Bow of a sunken craft protrudes from the water after HCU-1 salvage team parbuckled the wreck to an upright position.*

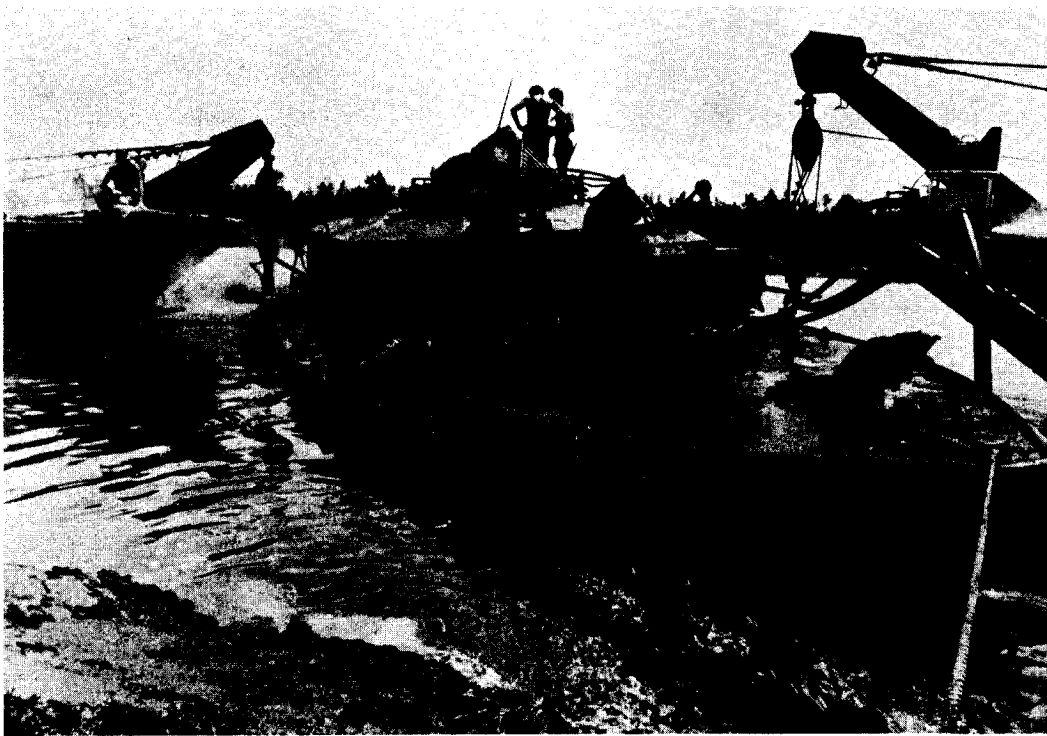
#### **A-FRAMES AT WORK IN SALVAGE OPERATION**

*Two LCM(S)'s hold wreck on the surface as the salvage team patch, dewater, and prepare it for tow.*

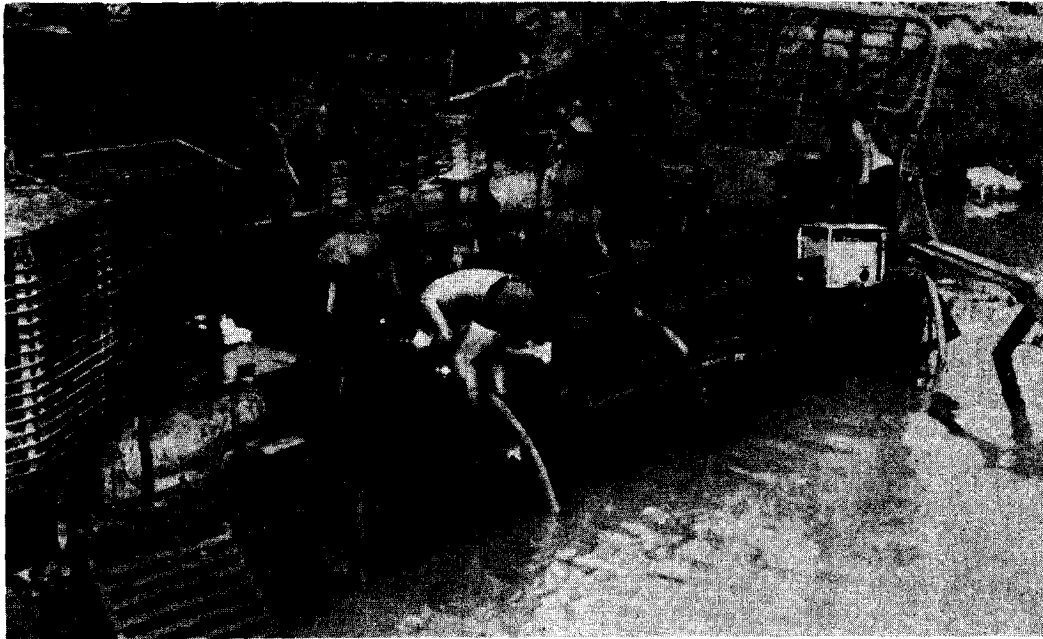
#### **HCU-1 SALVORS PREPARE TO DEWATER DAMAGED CRAFT**

*Although each task had to be handled as an individual salvage operation, many followed a similar pattern. In most instances if the craft were salvageable, the wrecks had to be lifted, patched, dewatered, and demudded prior to tow.*

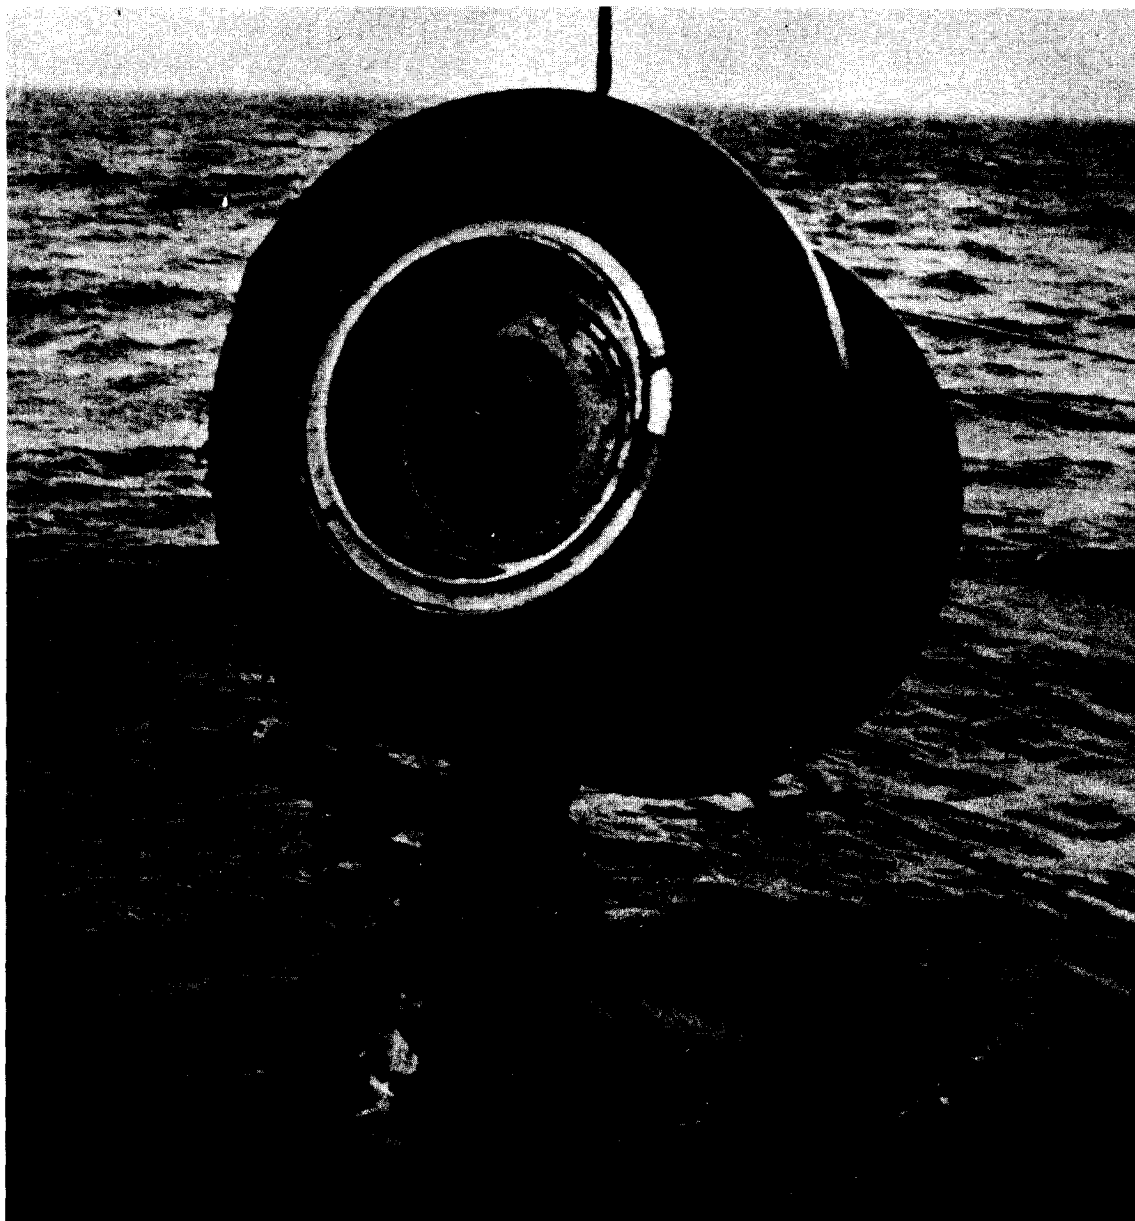
**AIRCRAFT WRECKAGE PROVIDES VITAL CLUES TO  
CAUSE OF CRASH**

*Search and recovery of downed aircraft is a major, continuing salvage task. Recovered wreckage provides essential evidence for investigating and determining causes of the crash.*

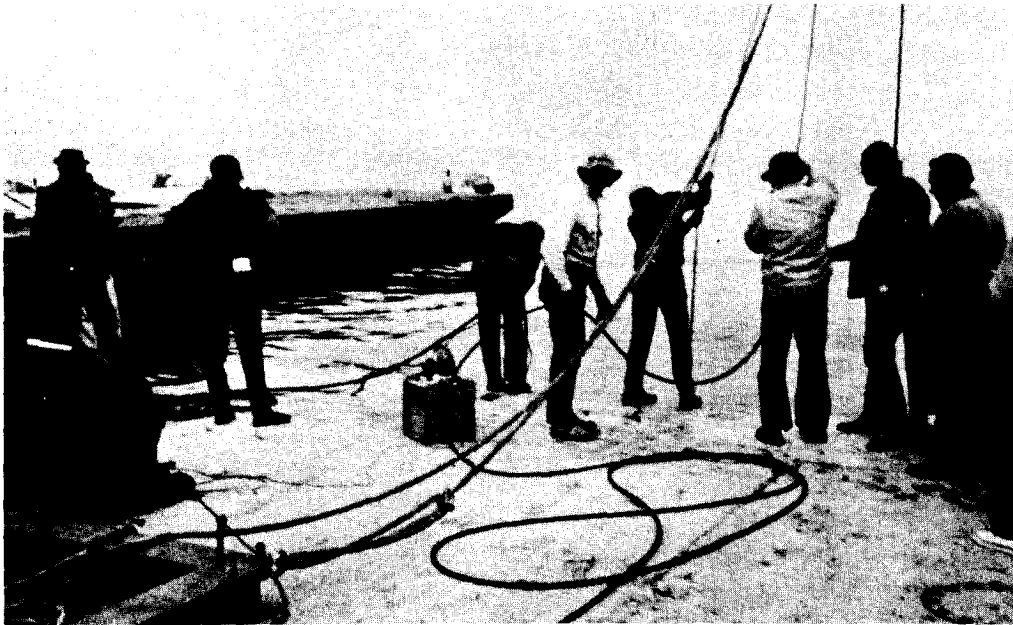
#### **SALVORS PREPARE TO RAISE AIRCRAFT WRECKAGE**

*Aircraft wreckage is recovered in a number of ways: small, light pieces are collected in baskets; larger pieces are raised via attached surface lines; and extremely heavy sections require special lifting equipment.*
