SALVOPS 72

A review of significant salvage operations
conducted by U.S. Navy salvage forces
and other salvage activities during 1972

NAVSEA 0994-LP-012-6040

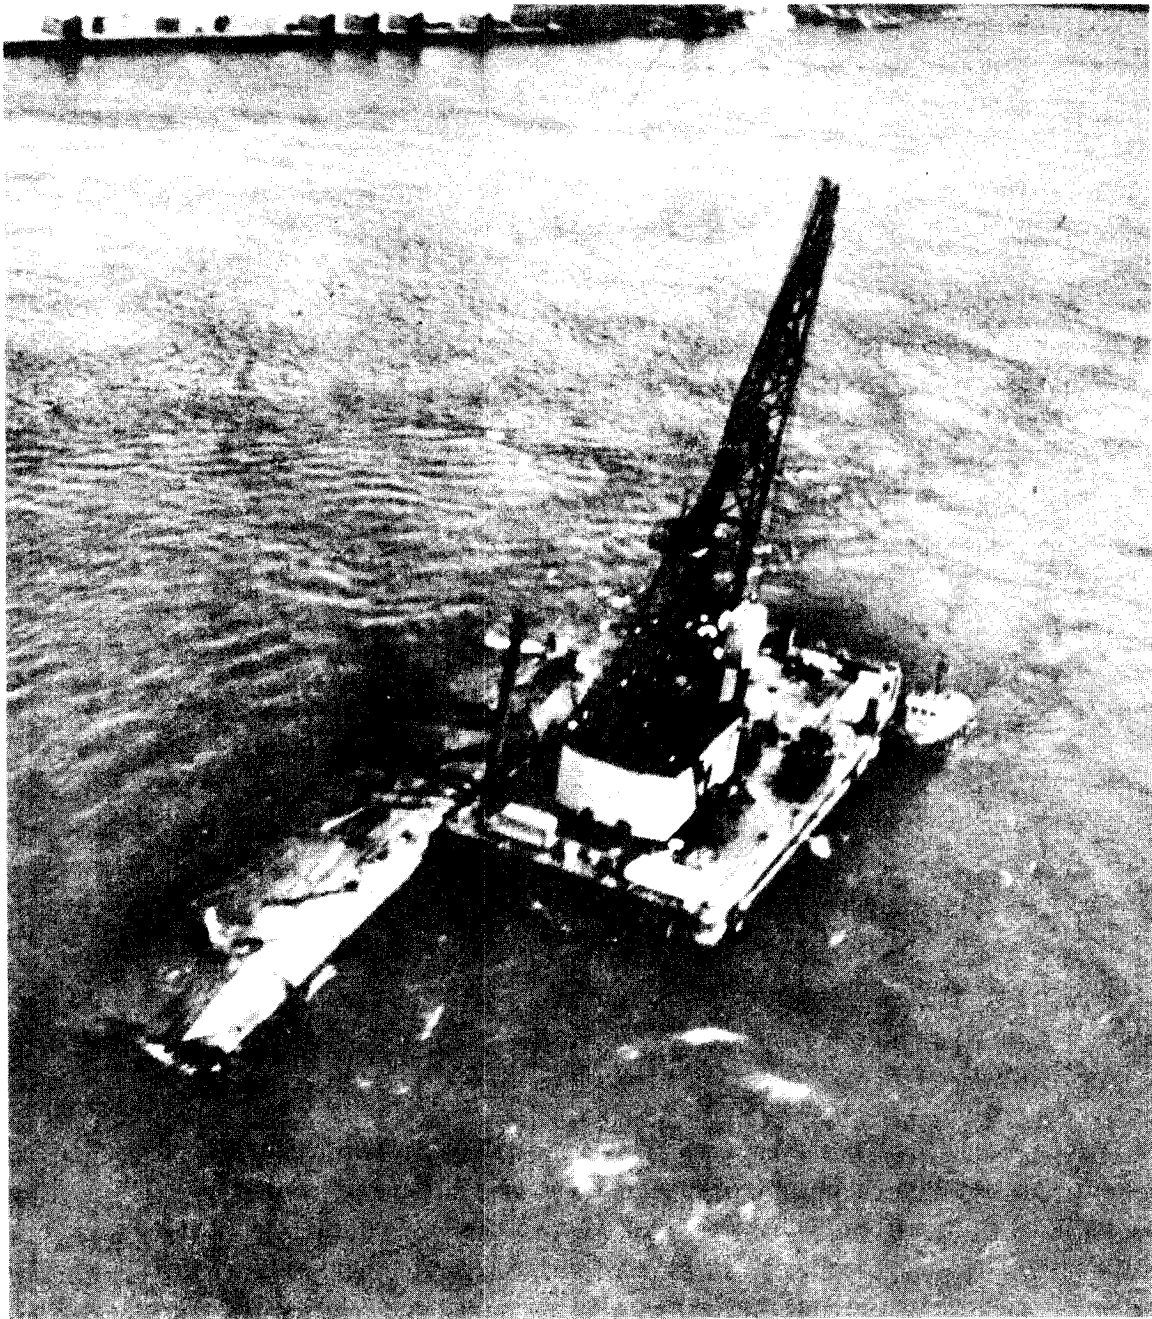
CORPS OF ENGINEERS' DERRICK BARGE, PRINCIPAL WORK PLATFORM FOR SALVOPS

Versatile barge provided large stable platform for salvops and heavy lift capability with huge, 60-ton crane. Barge, shown here moored to stern section, supported all phases of the operation. Salvors dubbed it the "Big D".

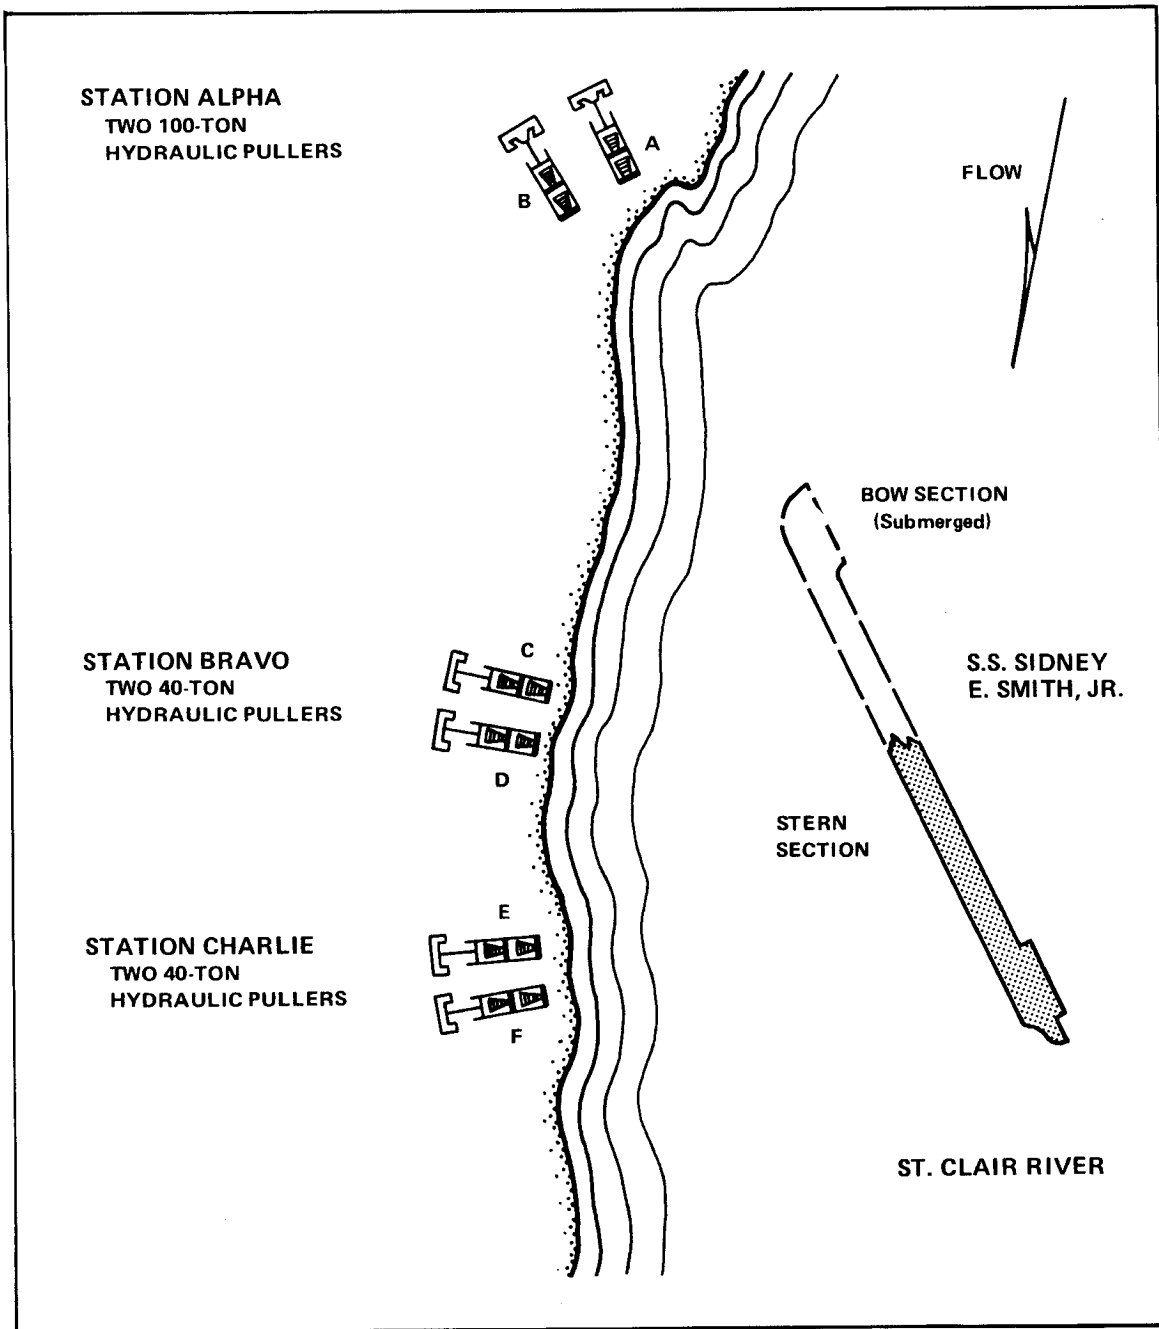
LOCATION OF PULLING STATIONS

Three pulling stations were established in an arc along riverbank opposite wreck. Pair of anchor blocks at each station anchored hydraulic pullers, which were interchangeable between stations. Arrangement above shows placement of the six hydraulic pullers at start of pulling operation on stern section.

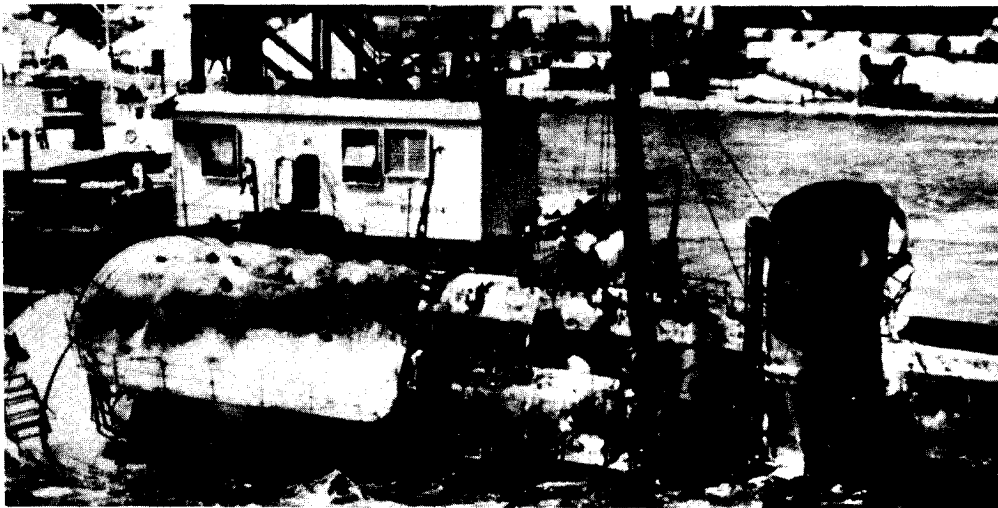
STERN SECTION JUST PRIOR TO FINAL PULL

Foaming operations are nearing completion. Stern is held against shallow underwater ridge initially. River current washed away ridge peak, helping free the hulk for shoreward pull.

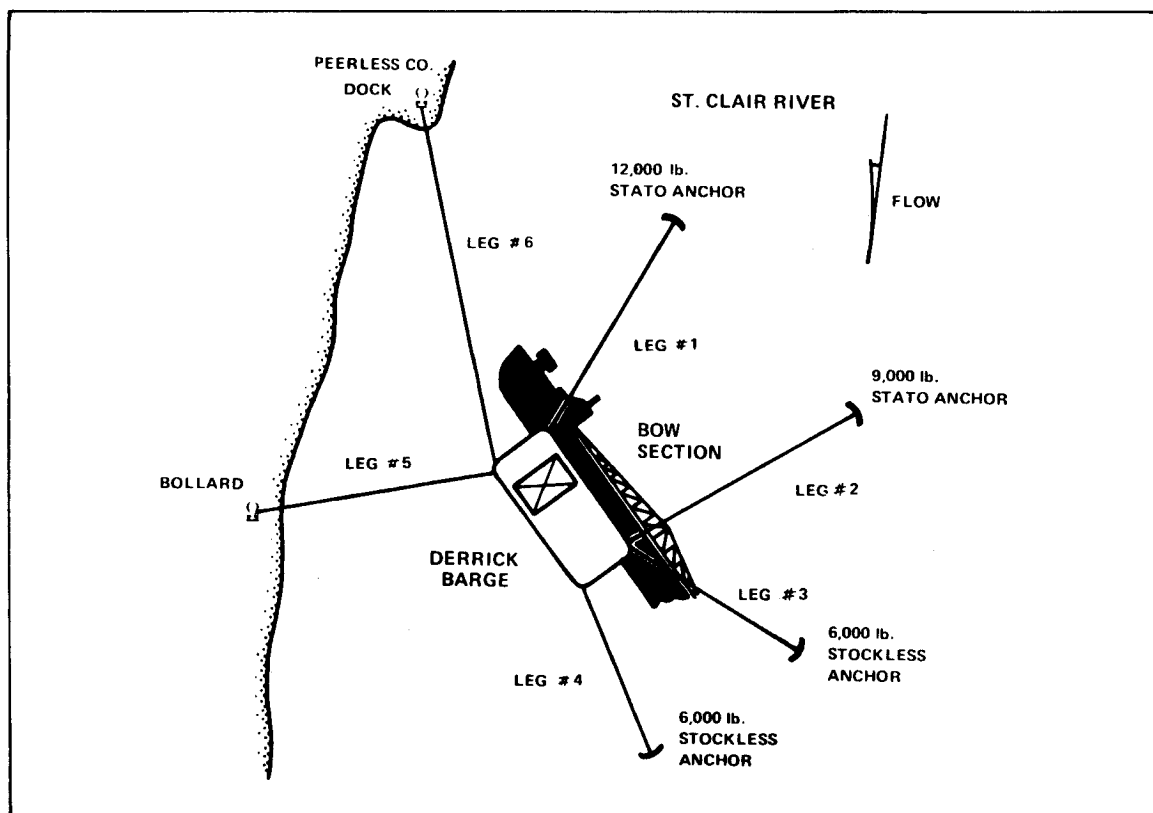
CONFIGURATION OF BARGE'S MOOR OVER SUNKEN BOW SECTION

Moor is designed for stability and precision maneuverability necessary for mid-channel salvops. Mooring legs use 1-1/4" wire rope. Strongest anchors are positioned upstream.

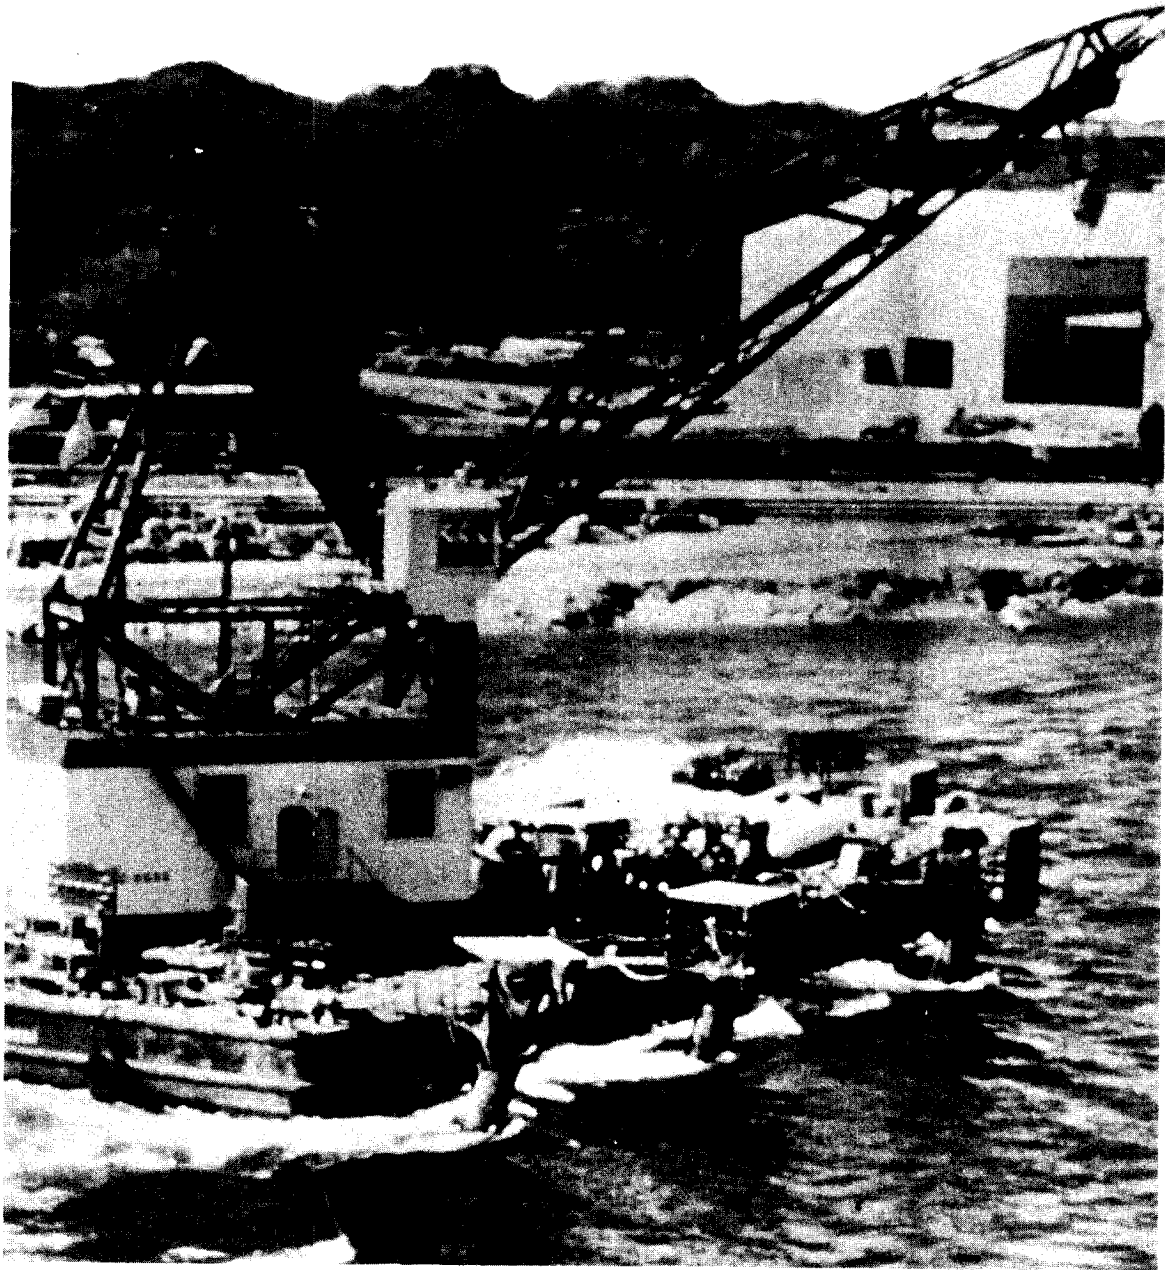
PHASE II OF SALVOPS — REMOVAL OF BOW SECTION

Derrick barge, moored over bottomed hull, supports foaming operations. Divers use three cofferdams (foreground) for protected access to underwater spaces. Rigging of improved on-shore pulling system is also underway while bow section is being lightened.

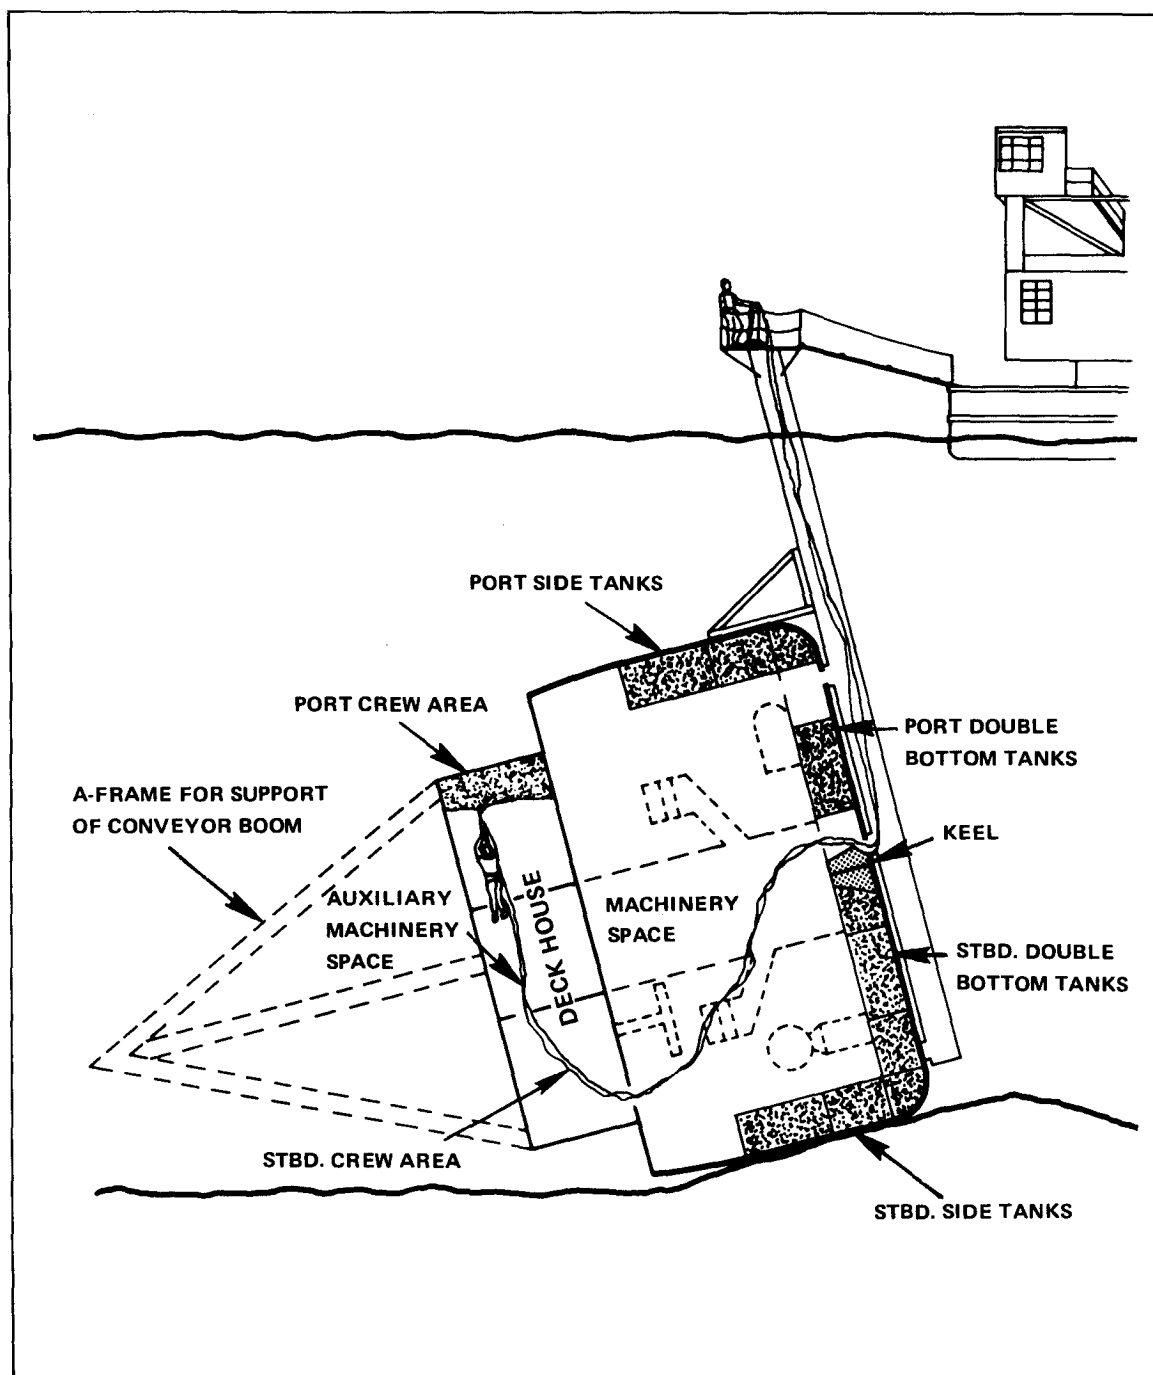
FOAMING THE DECK HOUSE, FRAMES 26 TO 35

Diver foamed deck house after completing side and double bottom tanks. Completion of deck house marked half-way point; forward area, machinery space and conveyor tunnel remained to be foamed.

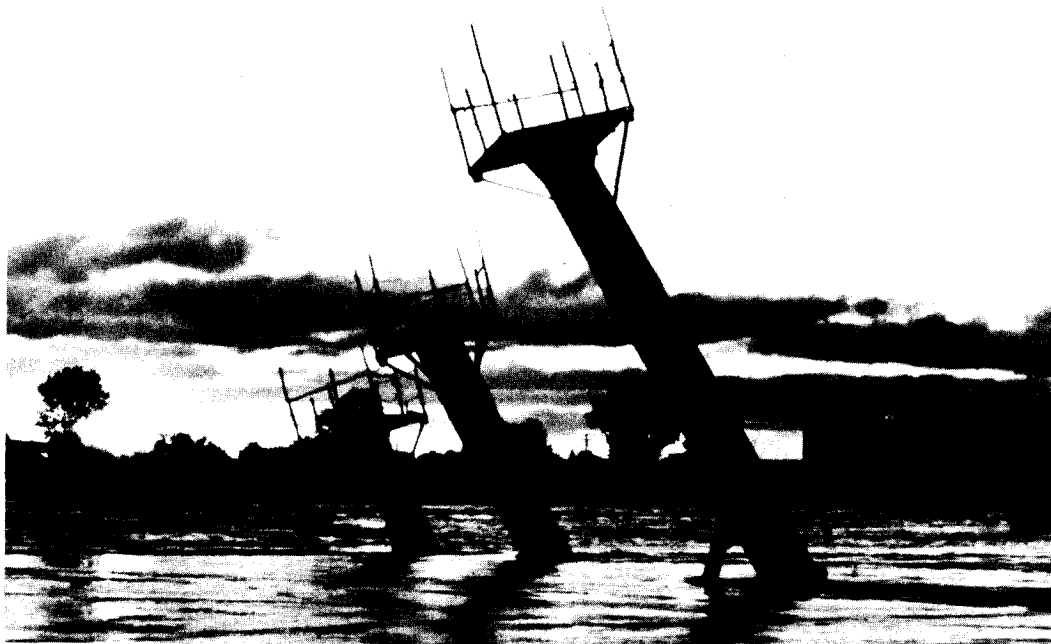
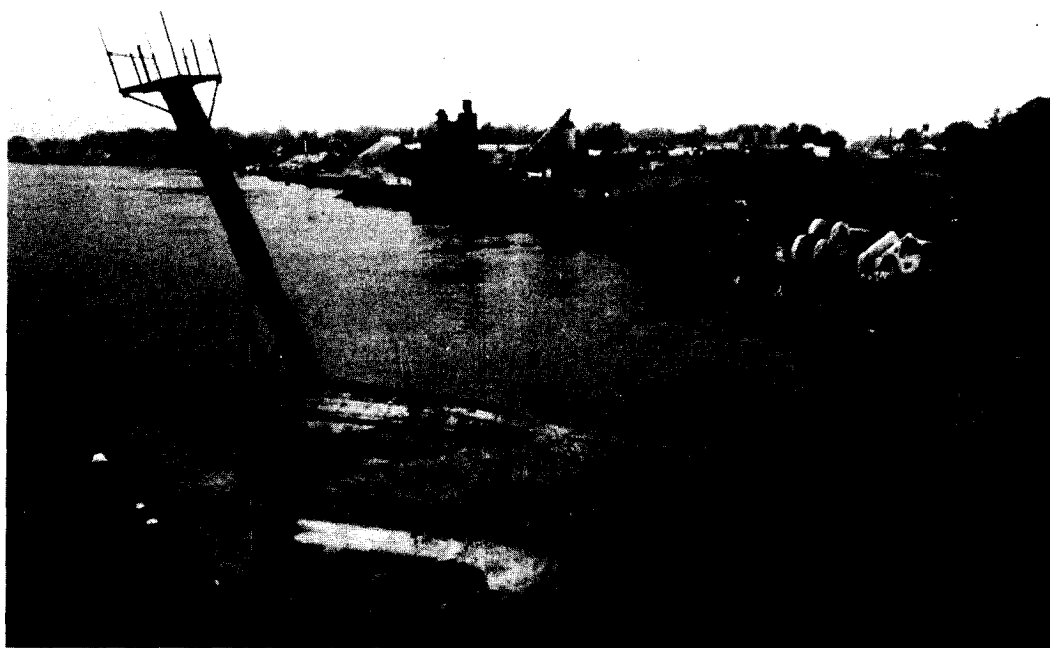
INCREASING HEIGHT OF COFFERDAMS MARKS PROGRESS OF PULL

Bow broke surface 100 feet from shore near end of all night pull, 21-22, September, after 3½ months on river bottom.

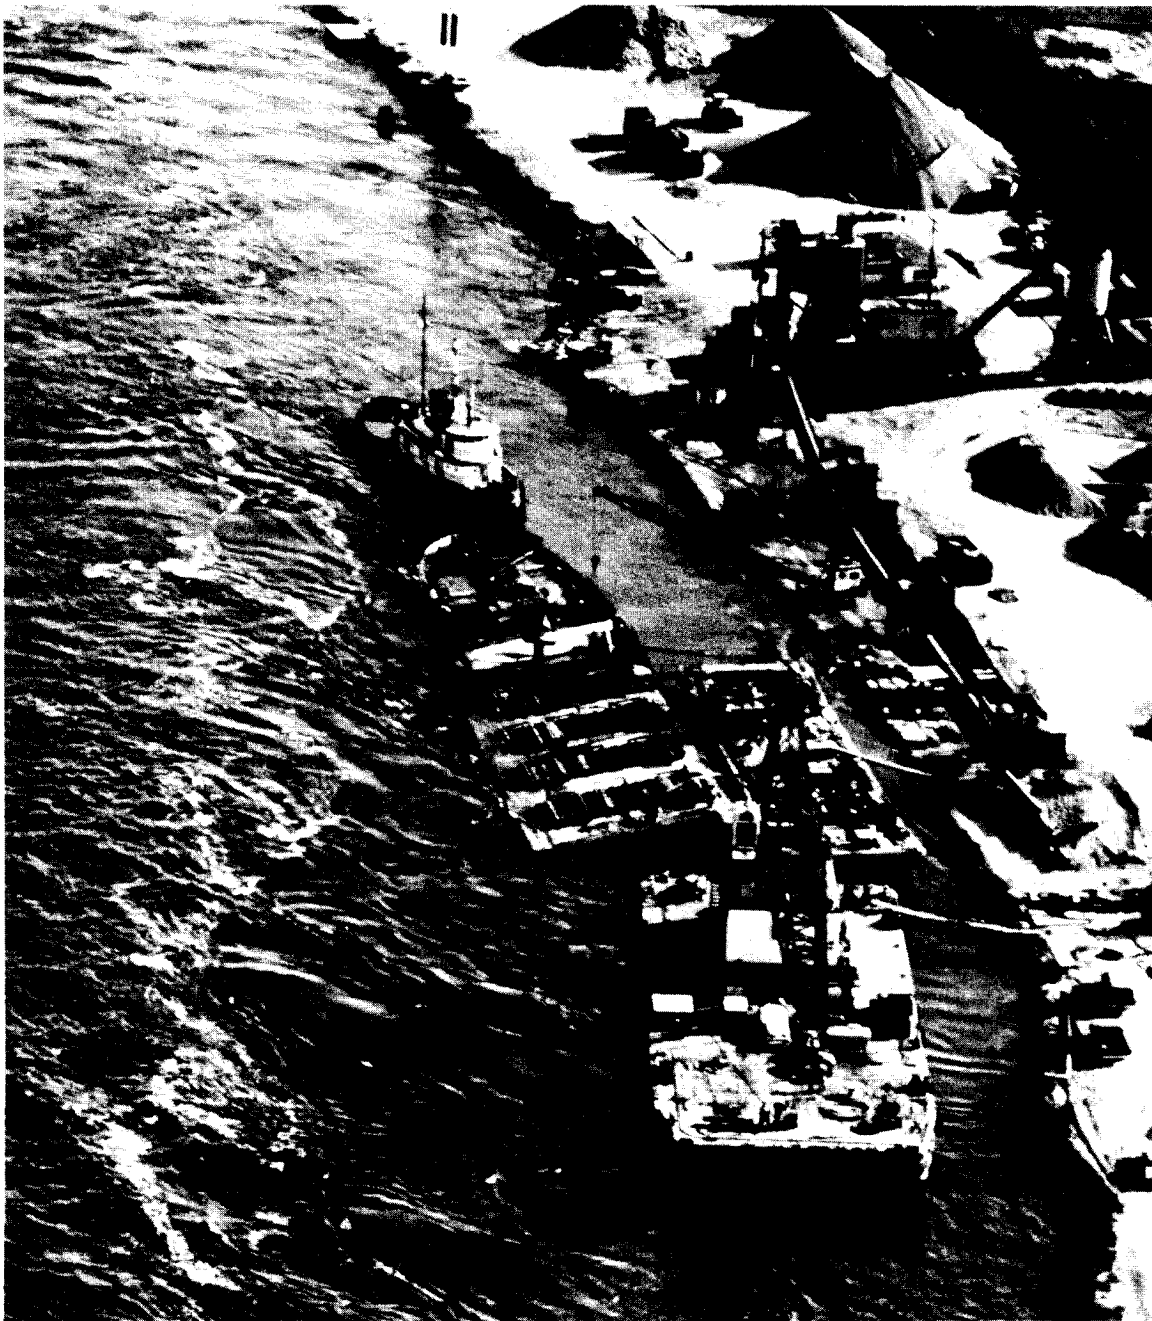
DISPOSAL OPERATIONS IN PROGRESS ON STERN SECTION

Phase III, disposal operations, began on each wreck section as soon as it was pulled from channel. Barges and mobile land cranes tended stern section (above) as it was refloated and stabilized for final tow to disposal site.

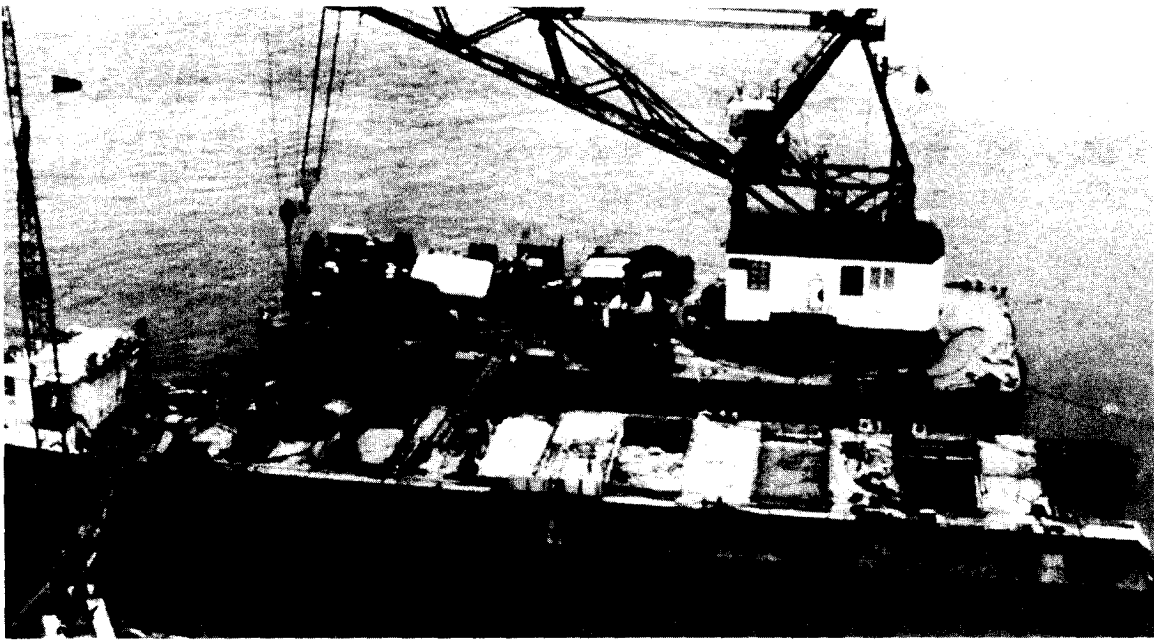
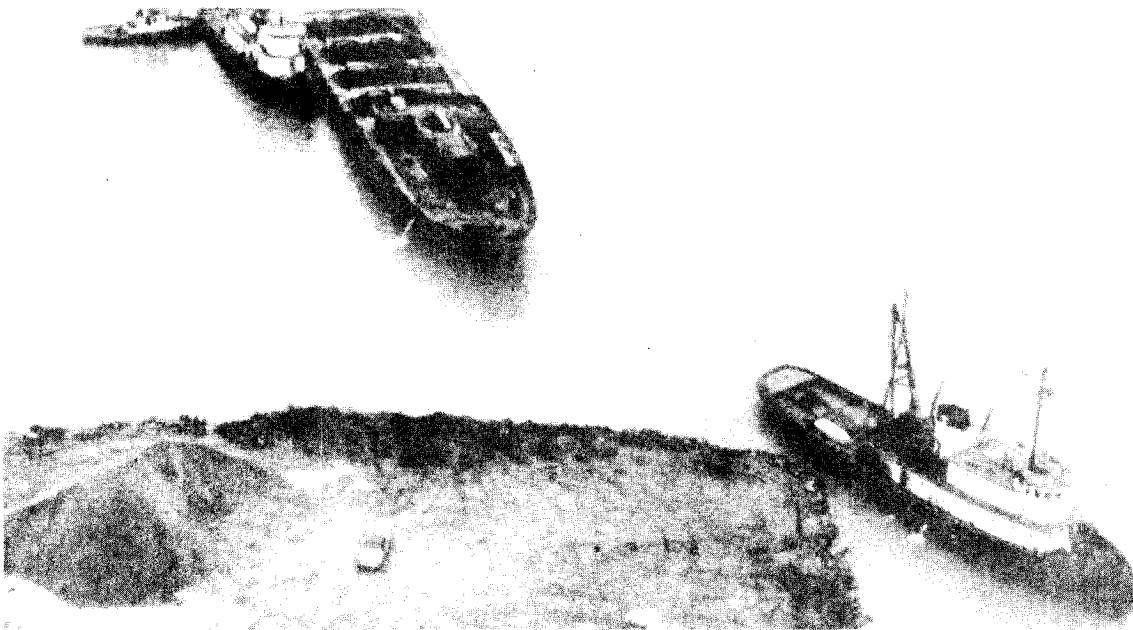
BOW AND STERN SECTIONS PRIOR TO FINAL DISPOSAL

After bow section (top) was floated and stabilized, it followed stern section (bottom) in tow across St. Clair River to Sarnia, Ontario. Both were then sunk in excavations dredged along riverbank.

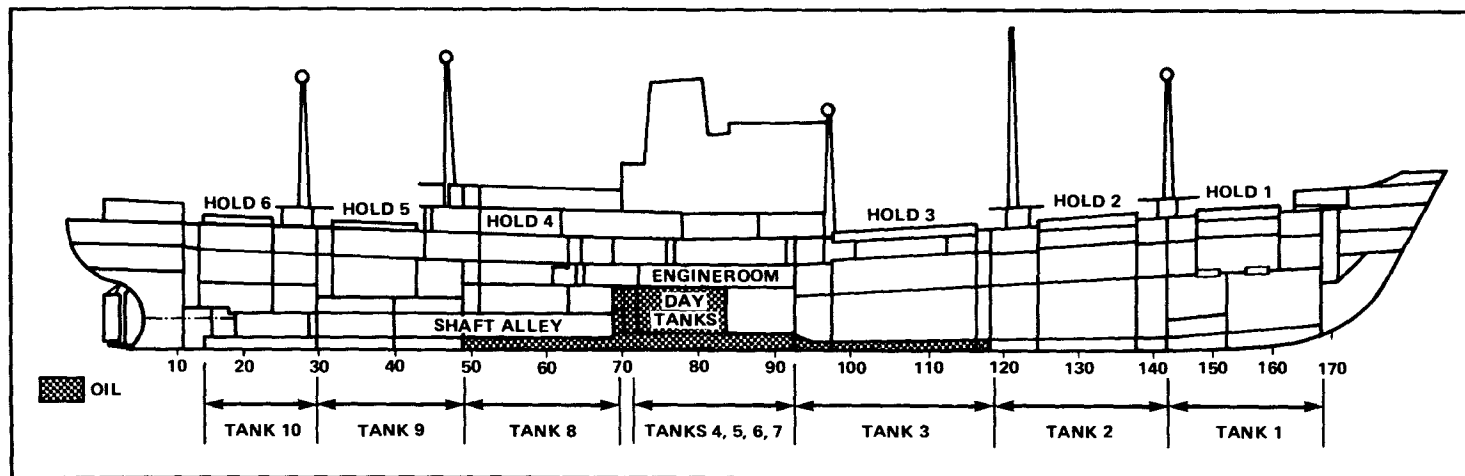
DEBUNKERING SUMMARY

Shaded areas show original locations of oil. Fire damage and flooding caused oil to spread to surrounding holds, passageways and engineroom, necessitating use of variety of oil recovery methods.

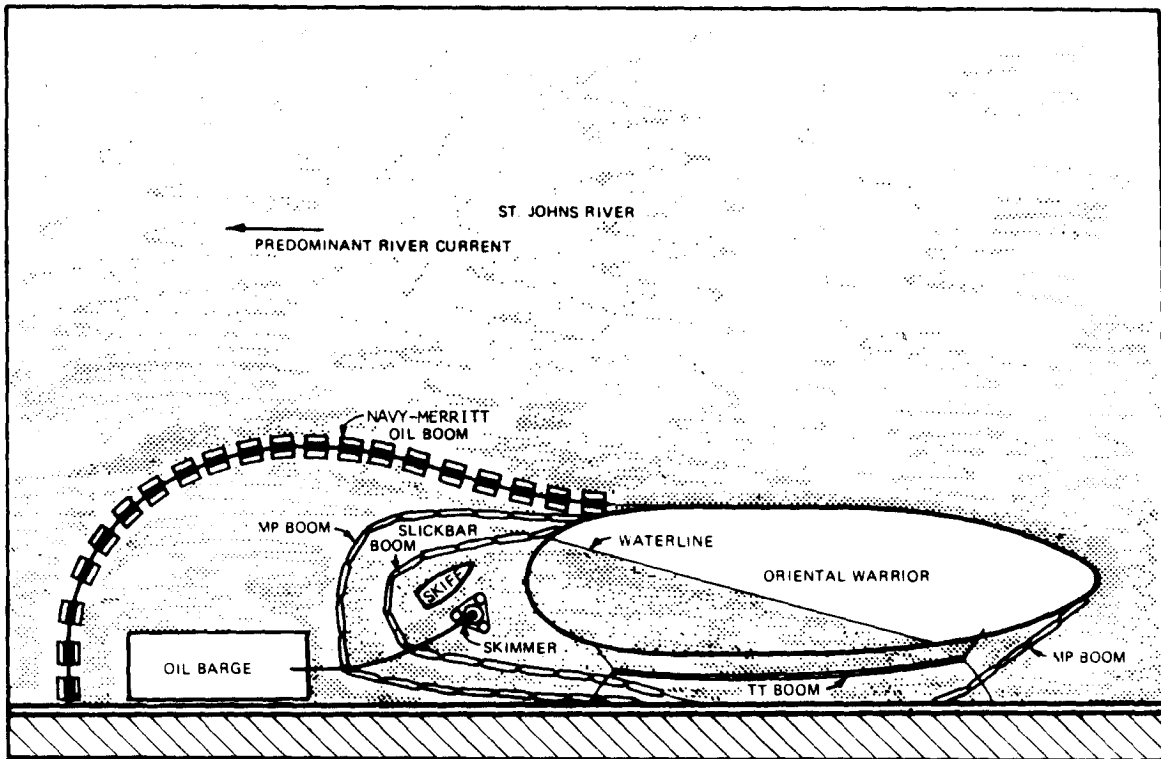
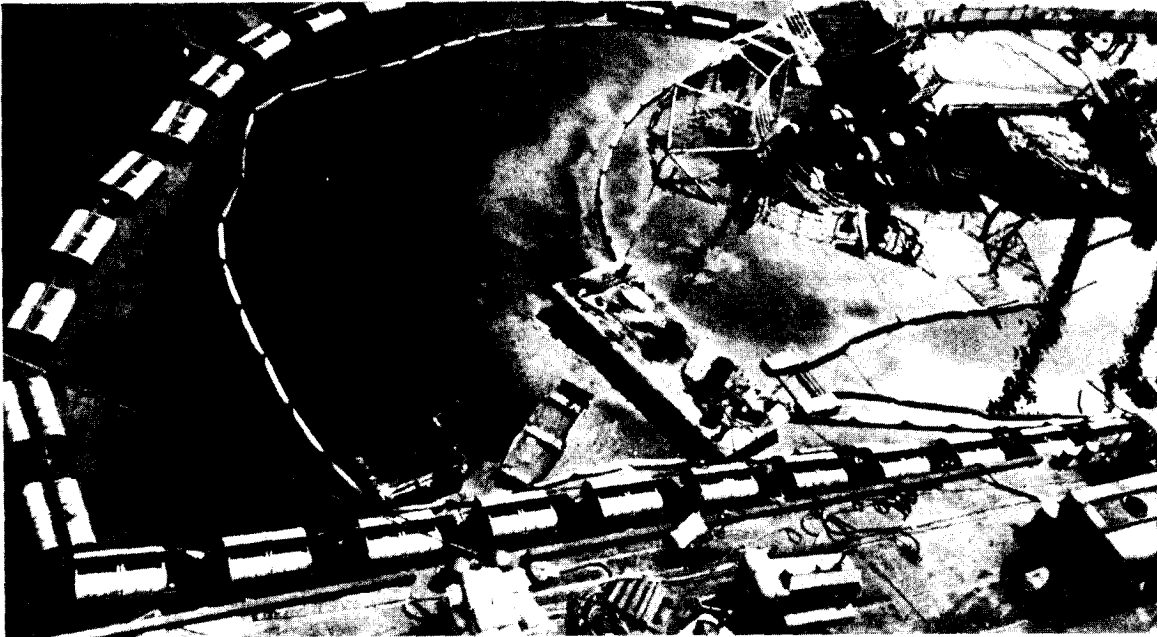
DEPLOYMENT OF OIL CONTAINMENT BOOMS

Three-boom barrier was placed around stern area to contain WARRIOR's leaking oil. A fourth boom (TT type) was placed between ship and pier. Ends of TT boom could be opened to form catch basin for skimmer (photo).

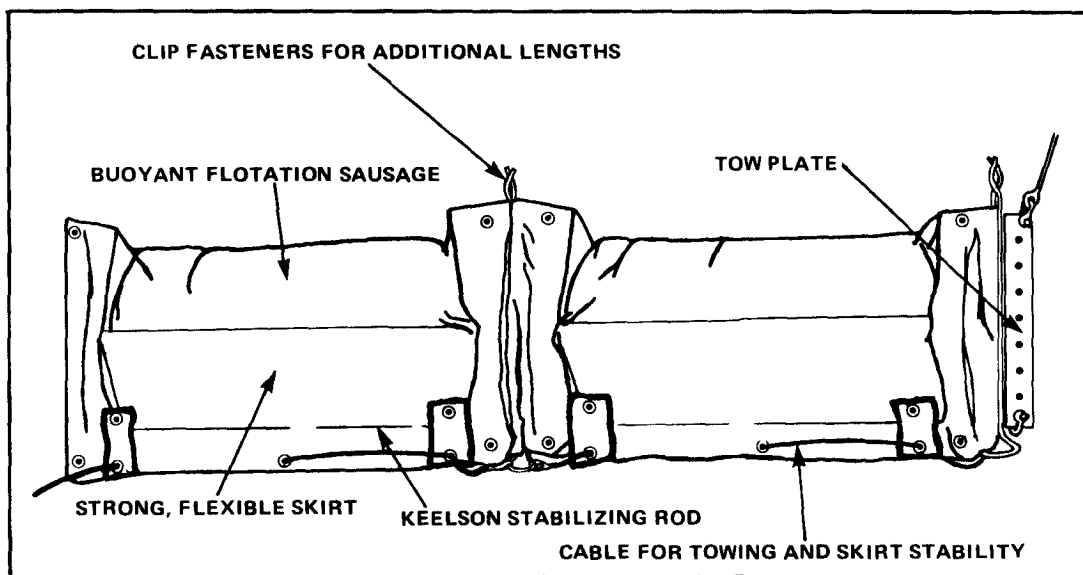
CONSTRUCTION FEATURES OF NAVY-MERRITT OIL BOOM

Navy-Merritt boom was largest and most substantial of four booms that contained WARRIOR's leaking oil. It extended 1,000 feet, from ship's port quarter to pier, and served as outermost protective barrier against river current and waves.

The Navy-Merritt boom consists of segments of vertically positioned 4- x 8-foot pieces of marine plywood held afloat by oil drums strapped to each side. A plasticized canvas skirt

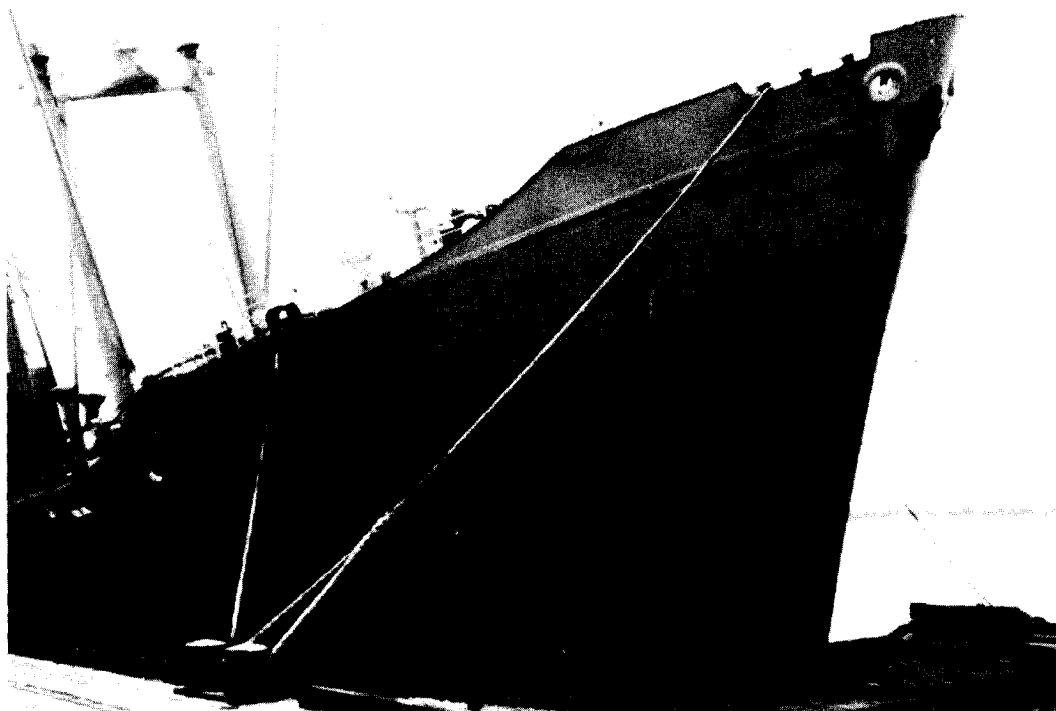
CAMEL BREAKWATER AT BOW OF ORIENTAL WARRIOR

Oil recovery team placed camel upstream at bow to break St. Johns River current, which reached speed of five knots at ebb tide. Ship's hatch covers were suspended from camel to provide additional water breaking action.

To break the force of the river and tidal currents around the ship, the salvors moored an aircraft carrier type camel (a large wooden barrier, or "fender") upstream at the WAR-RIOR's bow. From the camel, the ship's hatch covers were suspended down into the water. This breakwater arrangement replaced a tug which had previously been moored at the bow for the same purpose.

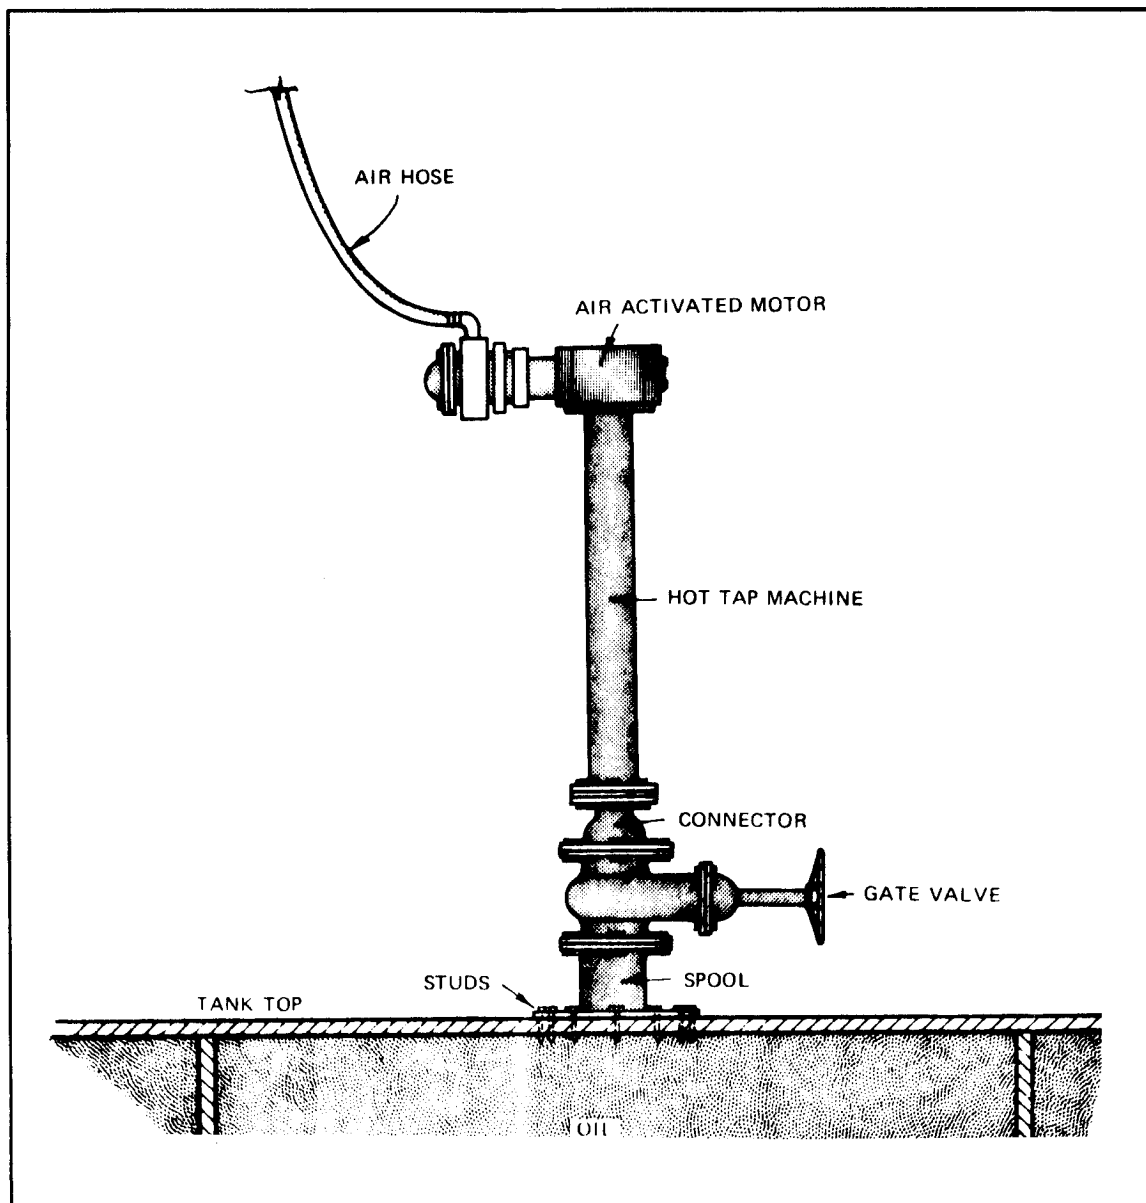
HOT TAP OIL RECOVERY METHOD

Divers bolted hot tap machines to top of inaccessible tank 8 in attempt to extract oil inside. Rotary cutter inside machine descends through spool to penetrate tank. Gate valve controls flow of oil leaving tank. Suction hose carries recovered oil to surface.

On the WARRIOR, fire and flooding had either damaged or prevented access to certain oil manifolds. The hot tap method was therefore used to tap three tank tops below hold 4. Although divers encountered little difficulty in positioning the hot tap equipment and making cuts, the tanks were found empty. It was also the recovery team's intention to tap other tanks under the engineroom, but this action was ruled out when the oil flow began to decrease and oil recovery neared the total onboard estimate.

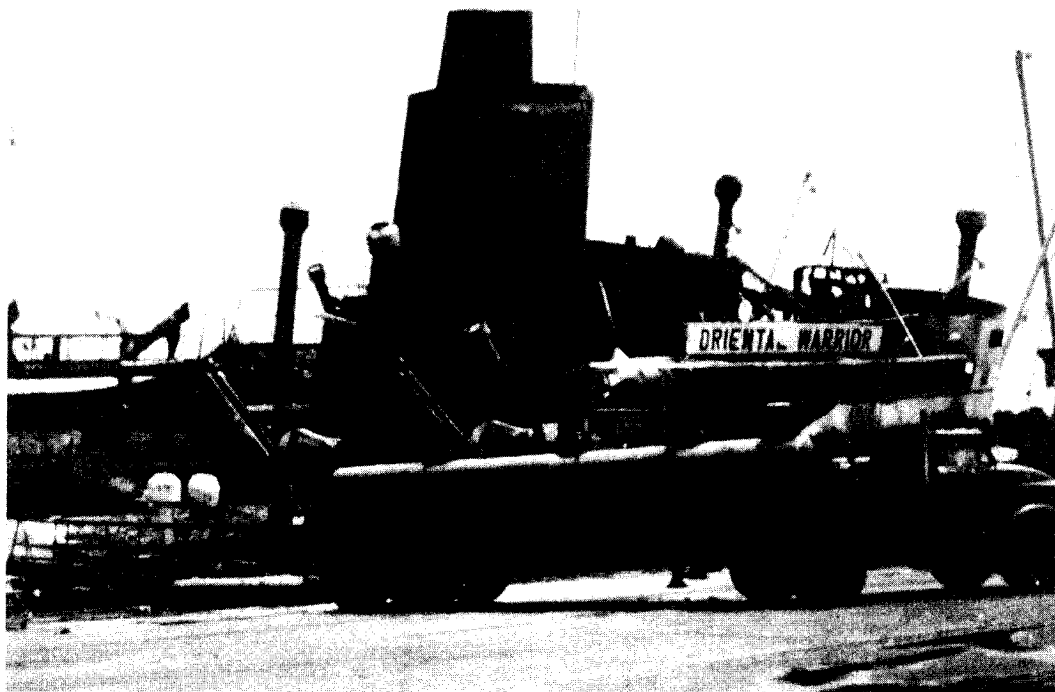
VACUUM TRUCK SKIMMING OIL FROM CARGO HOLD 4

Two trucks equipped with vacuum pumps and hoses were used to recover surface oil from holds 4 and 5, engineroom, and adjacent passageways. The two trucks recovered approximately half of WARRIOR's oil.

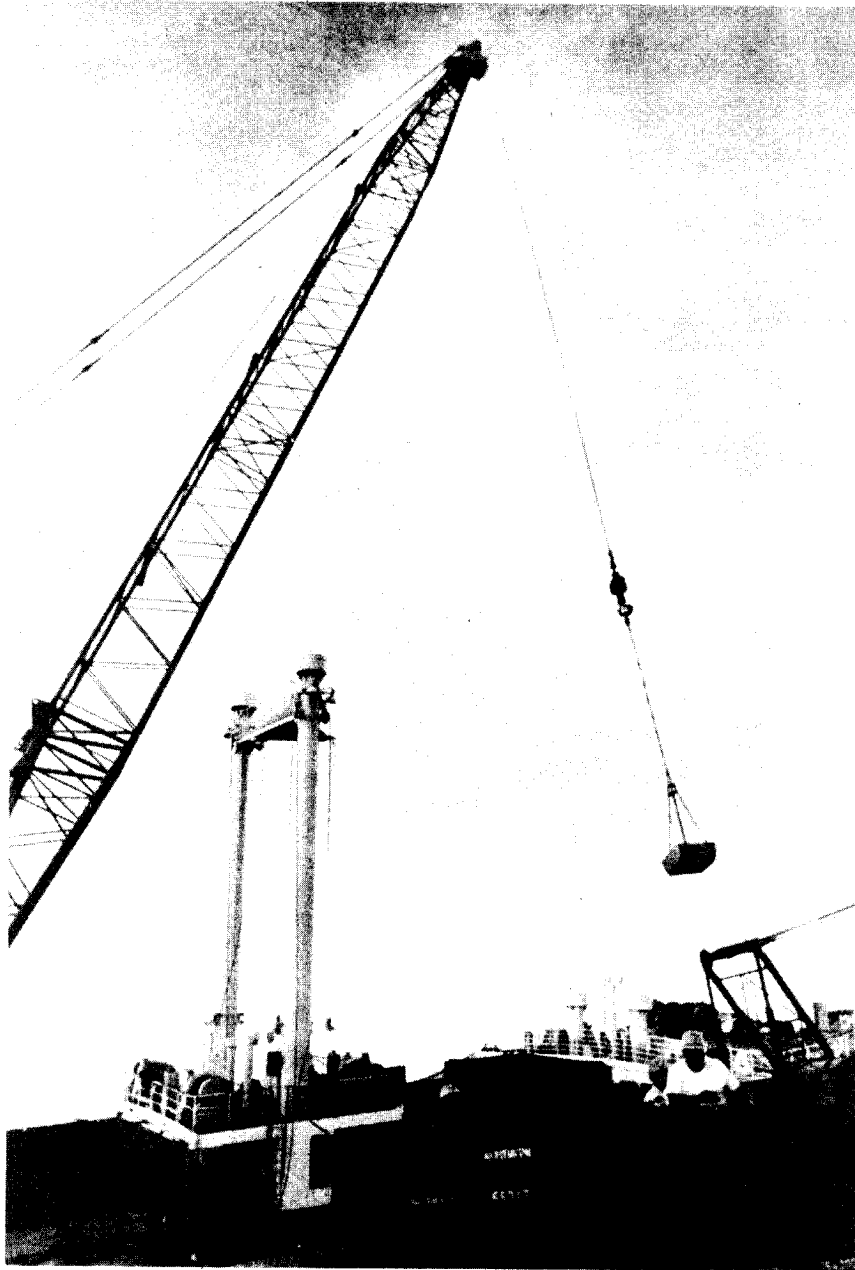
**PLACEMENT OF LEAD BALLAST IN FORWARD HOLDS
ASSURES SUCCESSFUL REFLOATATION OF ORIENTAL WARRIOR**

After successful debunkering operation, salvage team undertook task of refloating ORIENTAL WARRIOR. Strategic placement of solid ballast was necessary to prevent weakened ship from sagging and breaking up in midship area during refloating efforts.

The salvors' primary concern in developing the plan to refloat the WARRIOR was the ship's structural condition. Since the midship area was more damaged and weaker structurally than the buoyant forward and after areas, the ship was in danger of sagging during the refloatation attempt. Raising the ship in sagging condition would almost certainly cause the ship to snap in half. To avoid this, the salvors devised a plan to raise the ship in a hogging condition, whereby the damaged midship area would be kept slightly higher than the ends. The addition of ballast to the ship fore and aft would maintain tension in the upper strength decks amidships, and prevent sagging and breakup.

On 10 September, salvors began adding the first of 1266 one-ton lead pigs to the flooded vessel in holds 1 and 2. Lead pigs were chosen for their ease of handling and availability from a U.S. Government stockpile in Louisiana on a no-cost loan basis. With the assistance of shorebased cranes and longshoremen, placement of the lead pigs was completed by 15 September.

In preparation for receiving the 865 tons of lead intended for hold 2, salvors cleaned and dewatered the hold and installed a longitudinal timber bulkhead along the double bottoms from frame 106 to 117 for support. The remaining 401 tons of lead pigs were placed in hold 1, D deck, on a 4-inch concrete pad which had previously been laid to prevent water seepage.

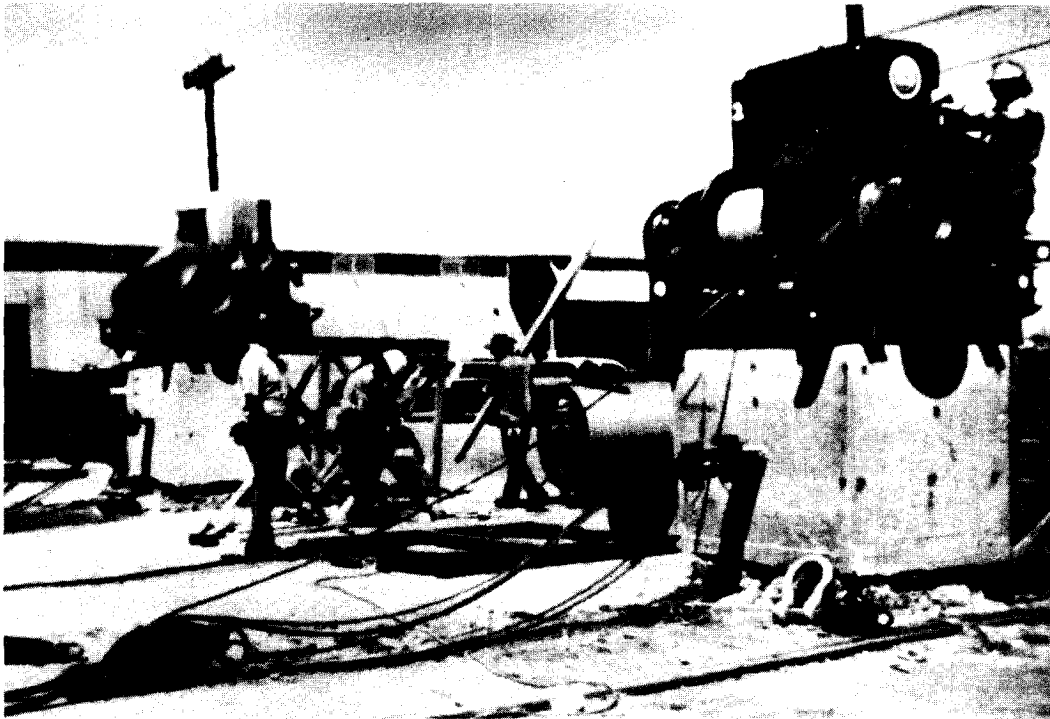
**DEADMEN ANCHOR BLOCKS AND WINCHES AT
STATIONS 4 AND 5**

Six-ton winches were positioned atop deadmen blocks at stations 3 through 8. Base of each winch was bolted to two 4-inch I-beams cast in place on top of block. I-beams were secured to block's steel reinforcement bars.

Conventional beach gear rigging was used at stations 3, 4, 5, 6, 7, and 8. Each beach gear purchase was pulled by a winch, positioned on top of the anchor block, and had an effective pulling force of approximately 6 tons.

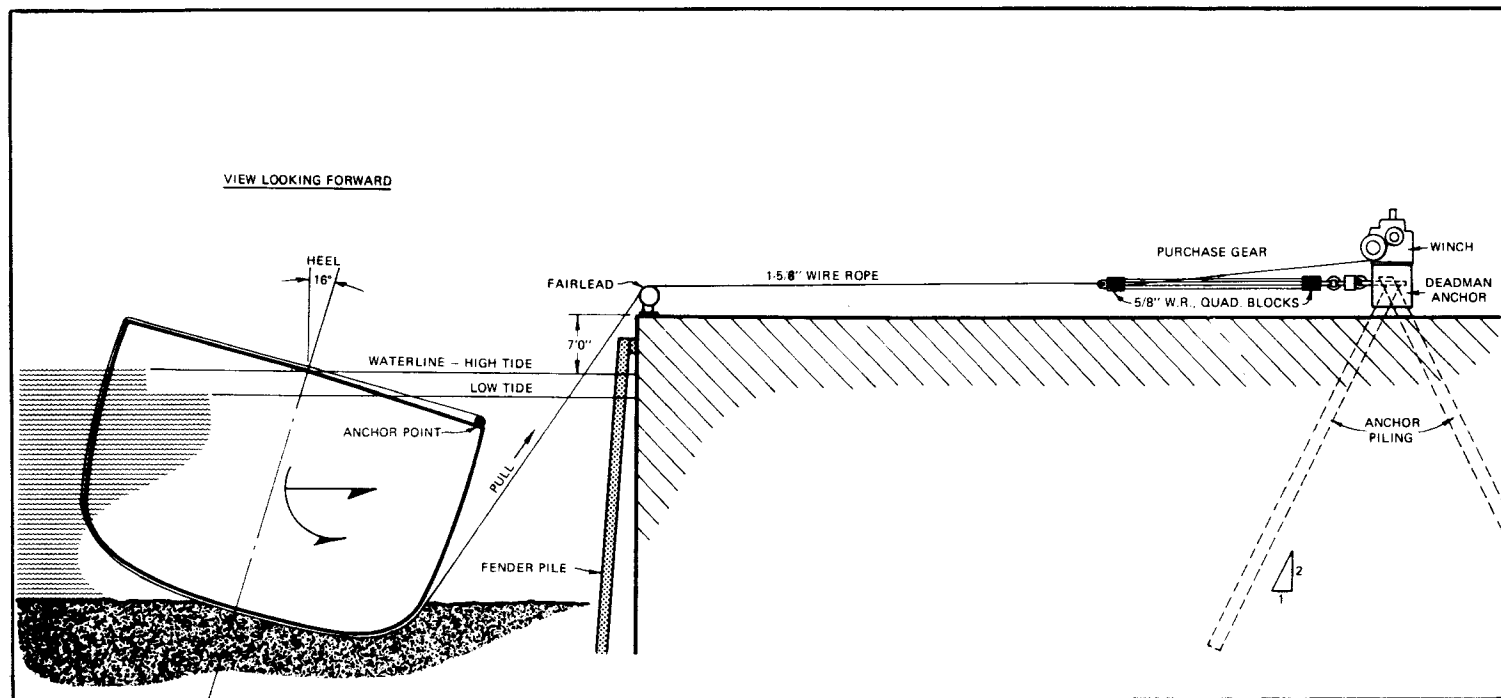
PARBUCKLING WIRE AND PURCHASE GEAR ARRANGEMENT

Eight wires for parbuckling to port were passed underneath ship and secured to bitts or special pads on main deck, starboard side. (Two remaining wires for parbuckling to starboard were attached to port rail.) Wires ran over fairleads at face of pier to purchase gear or hydraulic pullers which were anchored by deadman blocks.

Eight of the 10 parbuckling wires were rigged to rotate the ship to port. They were run from connecting points on the main deck, starboard side, around and underneath the ship to the pulling stations ashore. Wires 3 and 7 were run through and over the ship respectively from connecting points on the port side; these were used to rotate the ship to starboard.
