SALVOPS 72

A review of significant salvage operations
conducted by U.S. Navy salvage forces
and other salvage activities during 1972

NAVSEA 0994-LP-012-6040

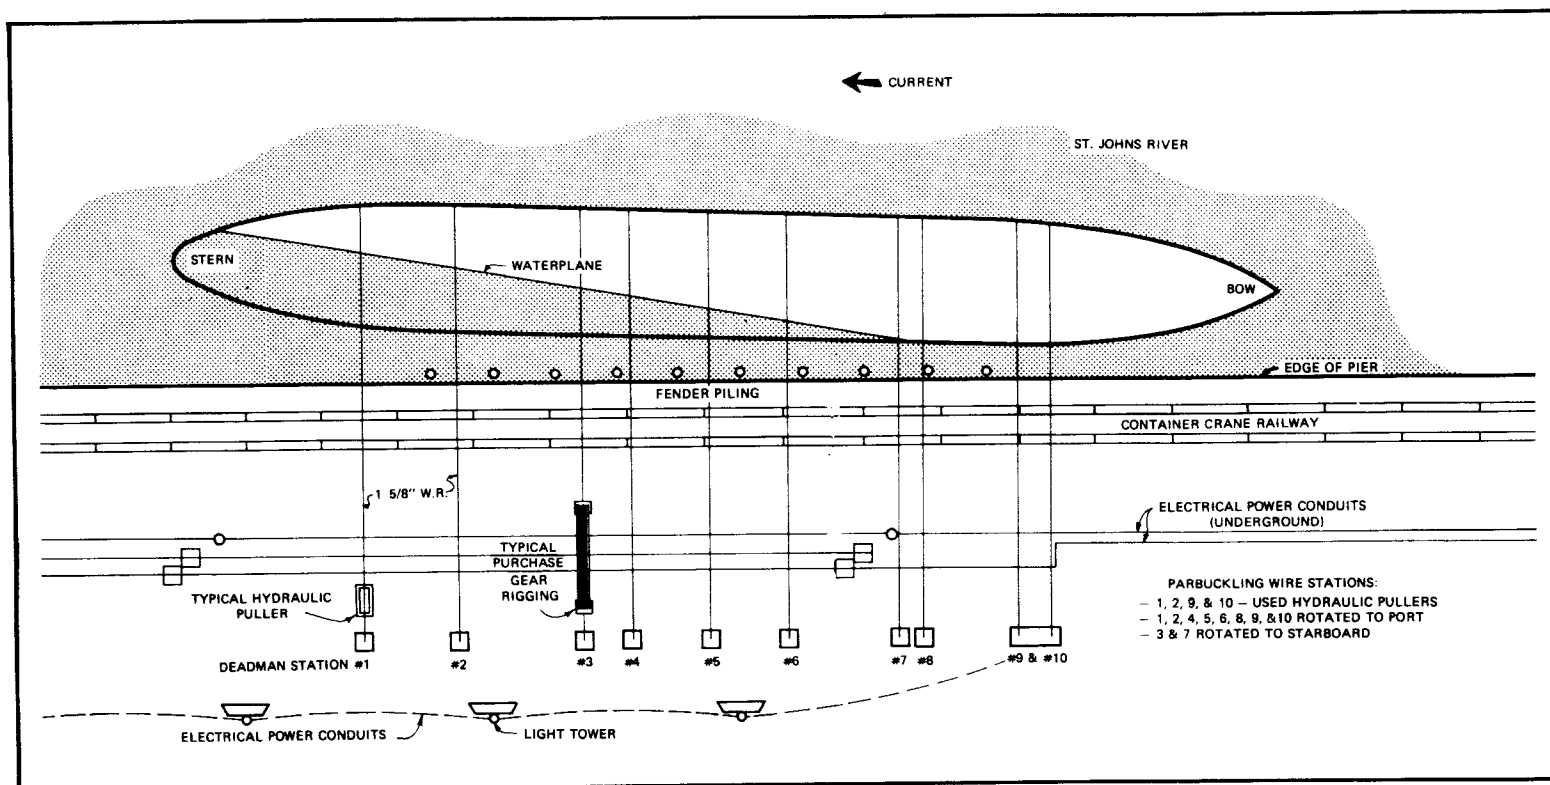
POSITIONING OF PULLING STATIONS AND PARBUCKLING WIRES

*Pulling system ashore consisted of four hydraulic pullers flanking six purchase gear riggings to bring **ORIENTAL WARRIOR** alongside pier and prevent refloated vessel from capsizing.*

It was expected that the primary upsetting moments would be to starboard due to loose water, off-center cargo, and the existing 17-degree starboard list. Thus, only wires 3 and 7 were rigged for parbuckling to starboard. The eight remaining wires were rigged for pulling to port.

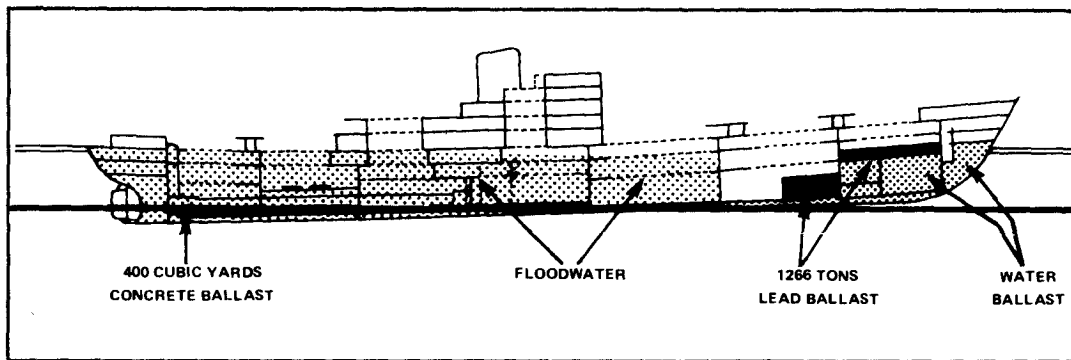
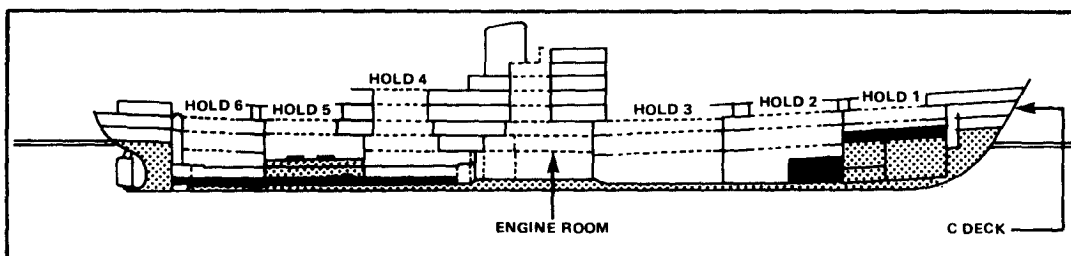
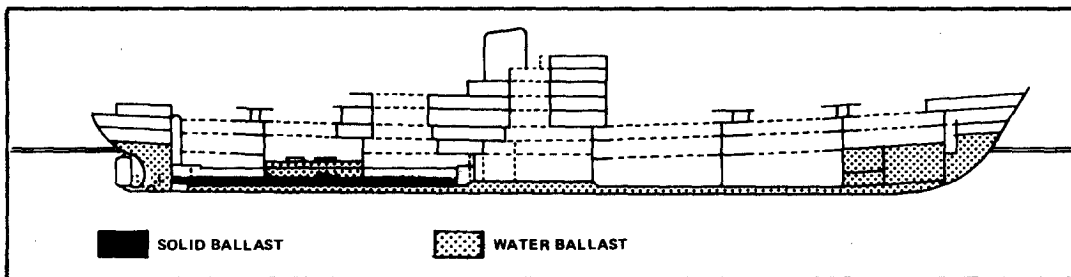
BALLASTING AND DEWATERING SEQUENCE FOR REFLOATING MV ORIENTAL WARRIOR

First, salvors added water ballast to flooded vessel's forward tanks and placed solid ballast in forward holds and shaft alley.

Second, water was removed from C deck, engine room, afterhouse, and holds 3, 4, 5 and 6. Forepeak, afterpeak, double bottom tanks and deep tanks below holds 1 and 5 were left pressed with water for ballast, keeping vessel in desired hogging condition.

Third, lead ballast was removed from holds 1 and 2. Concrete ballast was left in shaft alley. All spaces were stripped of loose water prior to towing to disposal site.

The pulling wires were tensioned and pumping began in the engineroom and hold 3. The removal of floodwater from the mid-portion of the ship, plus the presence of ballast forward, kept the ship in the desired hogging condition and prevented the badly distorted upper strength decks from snapping.

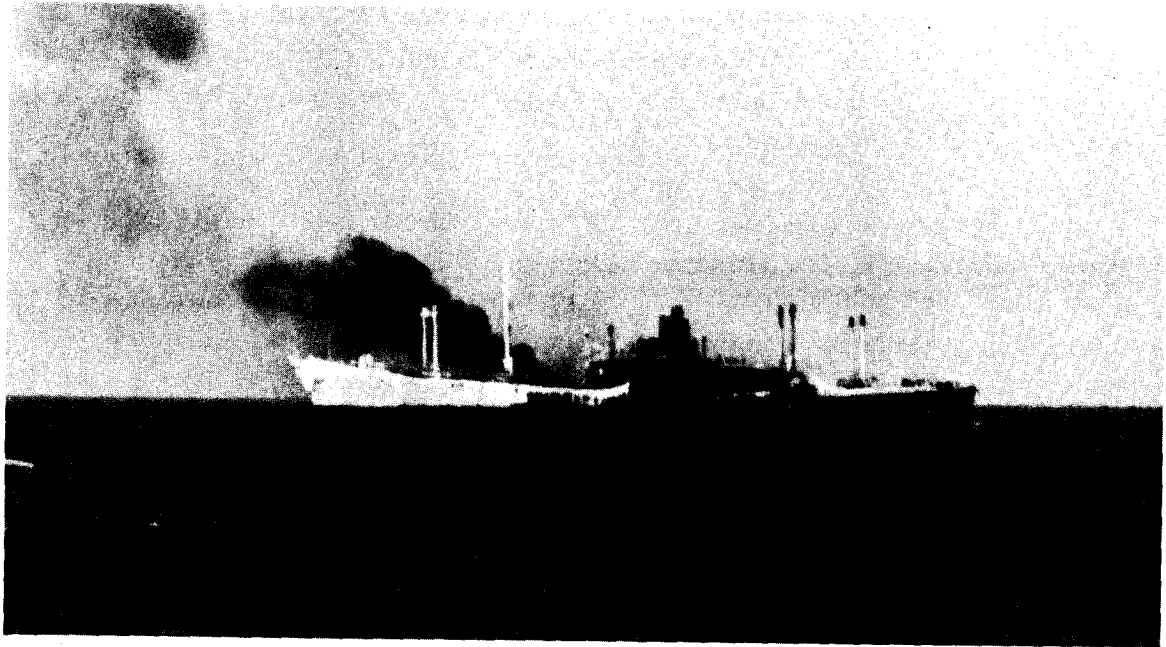
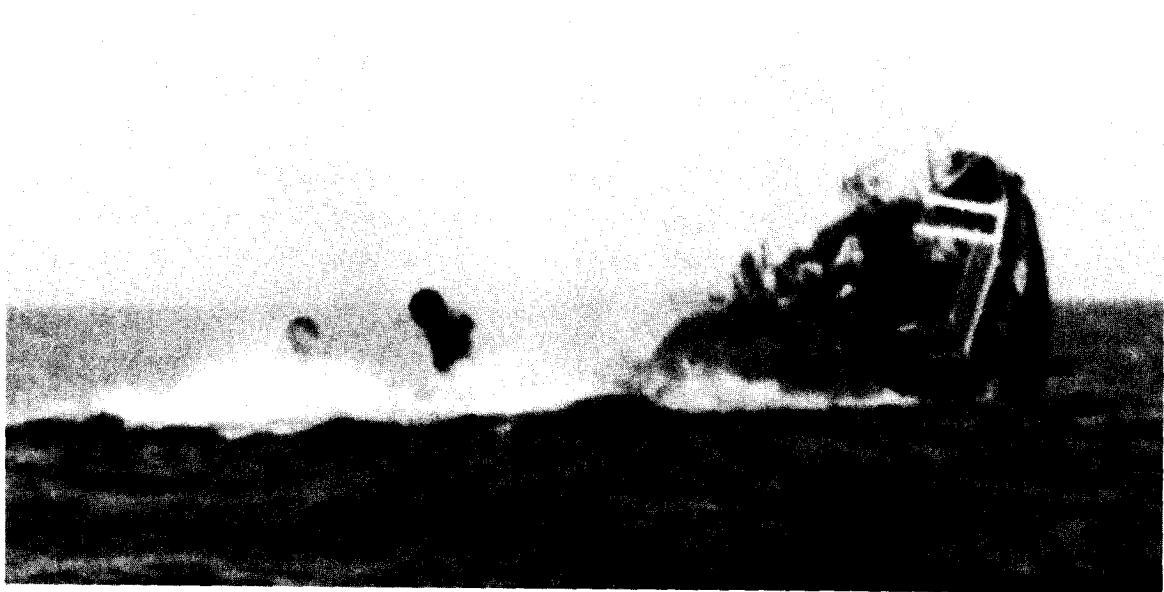
SINKING OF MV ORIENTAL WARRIOR AT SEA

Salvors rigged explosive charges to WARRIOR and towed ship to disposal site 115 miles east of Jacksonville. Moments after charges were detonated, ship took on water and sank to 400-fathom depth.

Despite the successful refloating operation, the structural condition of the WARRIOR's decks and bulkheads was still basically unsound. The ship remained a casualty and had to be disposed of as quickly as possible.

The WARRIOR's condition afloat remained fragile and cargo decomposition was sure to increase. Since these conditions could lead to fire, flooding, breakup or generation of toxic or combustible gases, both SUPSALV and the Corps of Engineers recommended that the WARRIOR immediately be towed to sea past the 100 fathom curve, and sunk.

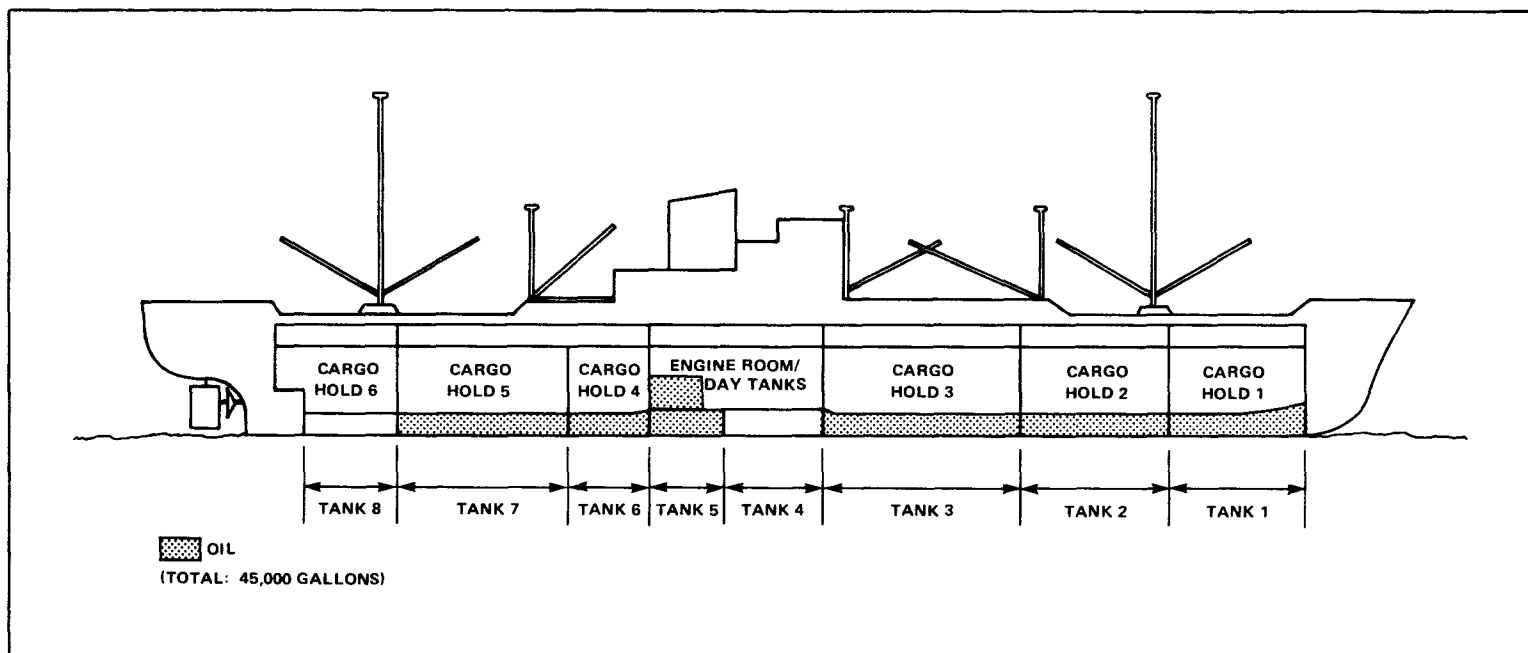
LOCATION OF OIL ABOARD MV SOLAR TRADER

Salvors pumped oil from double bottom tanks to SOLAR TRADER's day tanks which served as central collection reservoir during debunkering operations. Soundings of double bottom tanks on 9 and 10 July showed presence of 1 to 5 inches of topoil, but later inspections revealed accumulations of up to 10 inches in several tanks, plus large amount of recoverable oil in tank 5 which was previously believed filled with sea water.

Additional inspections on 13 July revealed cracks on the tank tops of double bottom tanks 6 and 7 (starboard). Although the tank tops were below water, no oil was leaking out. The tank tops to double bottom tanks 2 and 3 were also below sea level. In addition, the entire starboard air vent was missing, leaving openings on the tank tops. Fortunately, no oil was escaping from these vent openings. Double bottom tank 8 (starboard), however, was found open to the sea. The salvors also found a recoverable amount of diesel topoil in double bottom tank 5 (port and starboard) which was thought to contain sea water only; this was probably not detected when sounded earlier because of the oil's light viscosity.

While soundings were being taken, the salvors worked to restore SOLAR TRADER's 75kW auxiliary generator and transfer pump to operating condition. It was decided to employ four portable pumps to pump oil from the double bottom tanks to the day tanks, which would act as a central collection reservoir. The transfer pump would then be used to push the collected oil to the receiving barge.

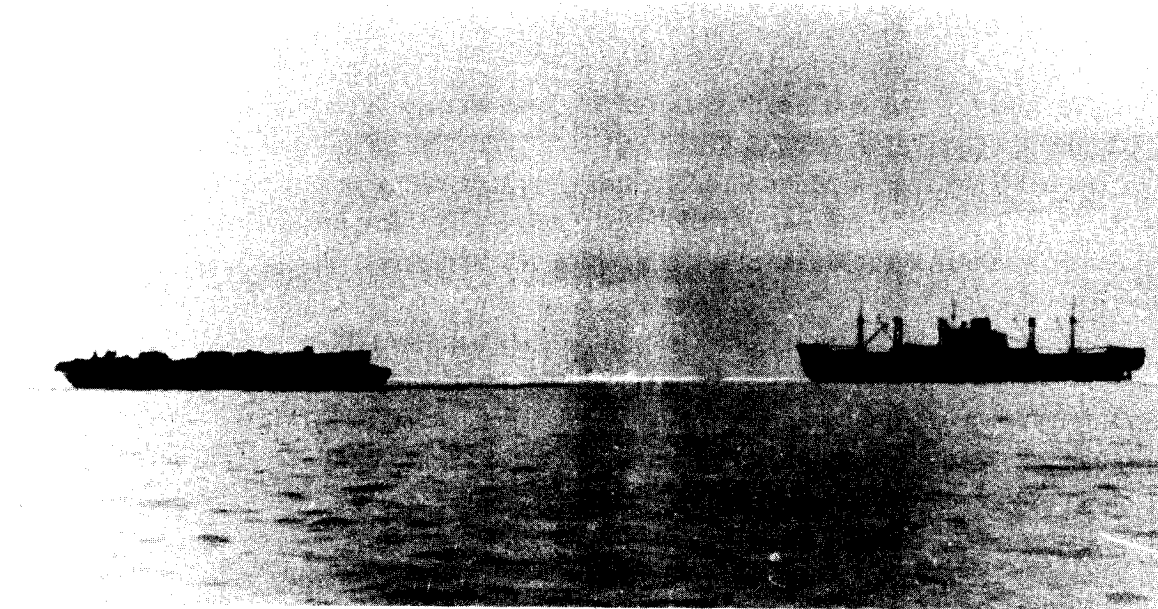
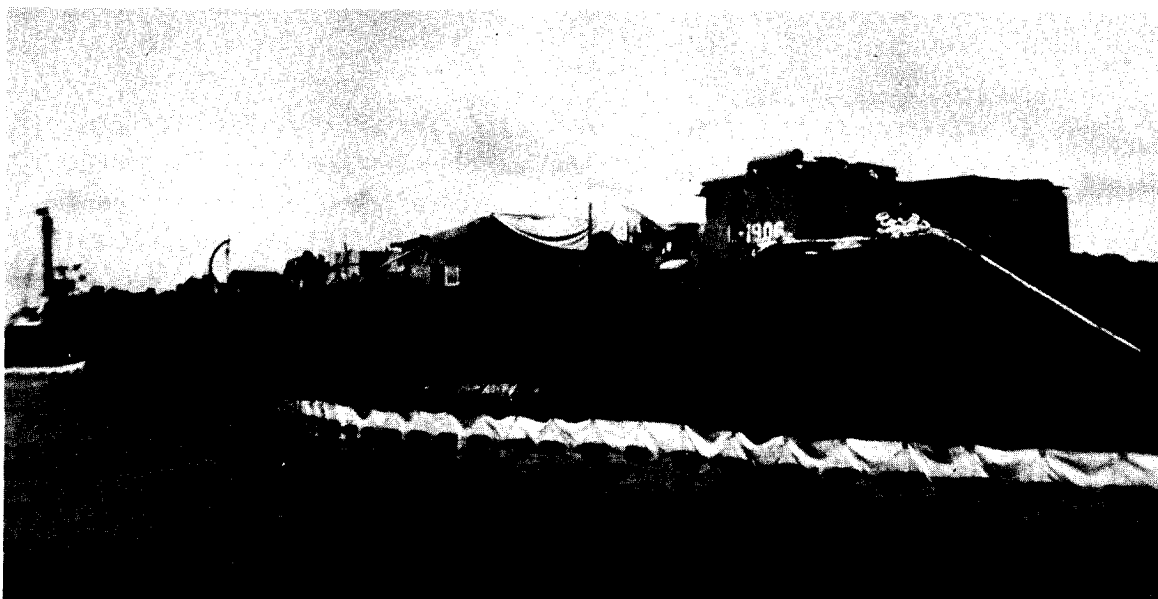
**BARGE MOORED INSIDE LAGOON RECEIVES OIL FROM
MV SOLAR TRADER**

Heavy seas forced salvors to moor barge inside lagoon during oil recovery operations instead of adjacent to SOLAR TRADER as originally planned. Oil containment boom was placed around 144-foot long barge as precaution against accidental spills.

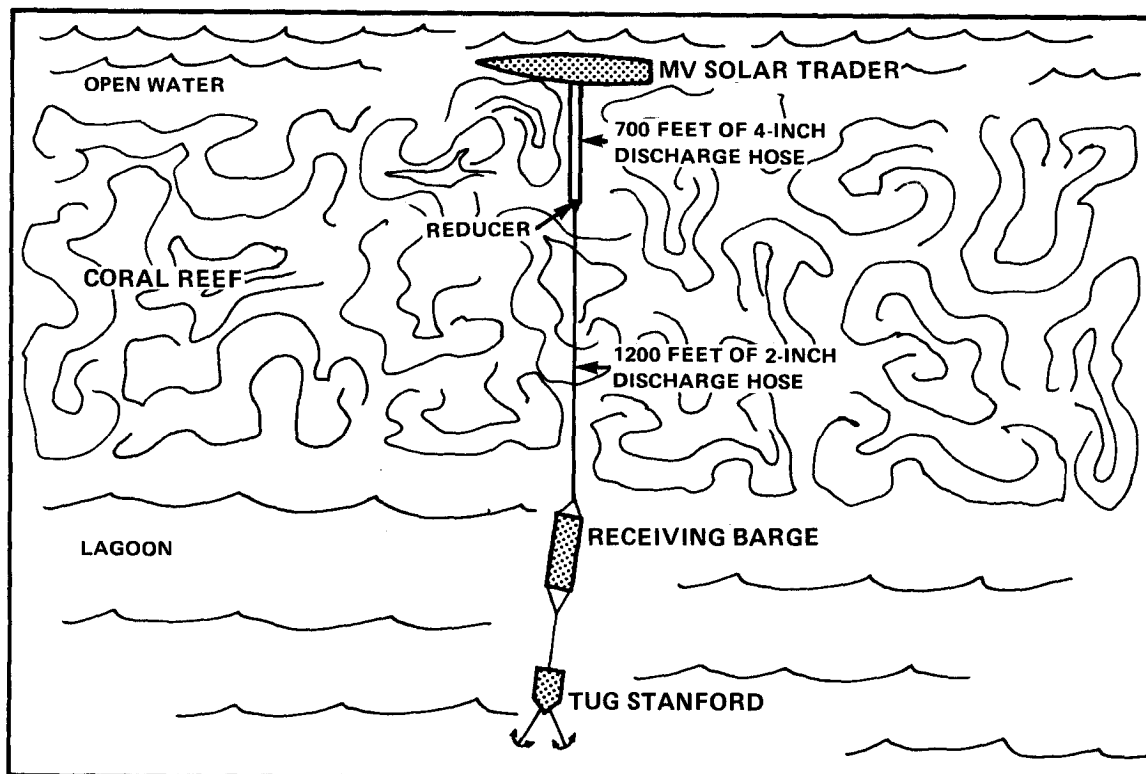
CONFIGURATION OF DISCHARGE HOSE AND BARGE MOORING

Oil discharge hose led from SOLAR TRADER across reef to barge along 7/8-inch wire rope steadying line. Barge's forward mooring line was secured to coral head with 1 1/2-inch (cir.) nylon rope to tug. Port and starboard anchors held tug in position.

Surf action over the reef during high tides had begun to cause wear in the discharge hose. The salvors made repairs on 20 July and resumed pumping from double bottom tank 3 (port), which had exhibited an alarming rise in topoil contents during the night from 1 inch to more than 10 inches. This oil was removed over the next two days, as was topoil from double bottom tank 5 (port and starboard), bringing the total to approximately 35,000 gallons.

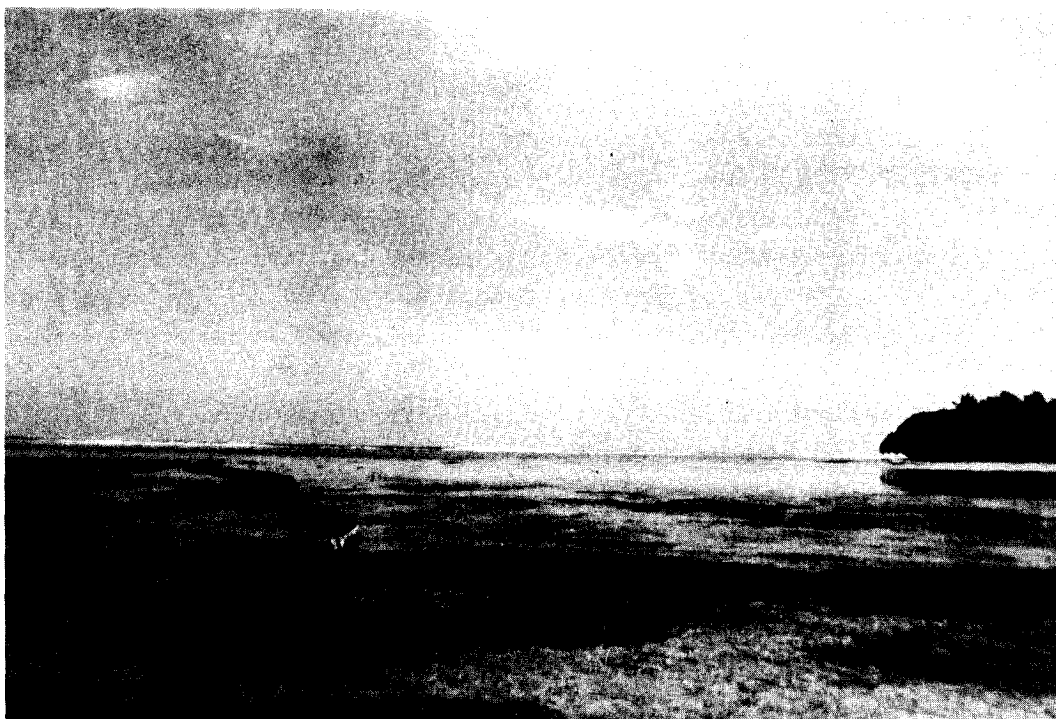
OIL CONTAINMENT BOOM IN POSITION INSIDE LAGOON

Salvors placed 1,900 feet of oil containment boom inside lagoon to protect west side of island from 600-gallon spill which occurred on 17 July after heavy surf washed oil from double bottom tanks 6 and 7. Oil was completely recovered from surface by skimmer within 2 days.

Careful attention to leaks in the discharge hose prevented spillage onto the reef during the 9-day debunkering operation. The only serious problem was the 600-gallon spill from double bottom tanks 6 and 7 on 17 July. The winds and heavy surf conditions caused by the passage of several typhoons to the north of the island could easily have spread the spillage over a wide area. However, the oil was quickly contained and recovered. On 22 July, a Peace Corps marine biologist (who had arrived at the atoll to survey the nesting ground of the green sea turtle) certified that the oil recovery operation had not disturbed the turtles at West Fayu Island.

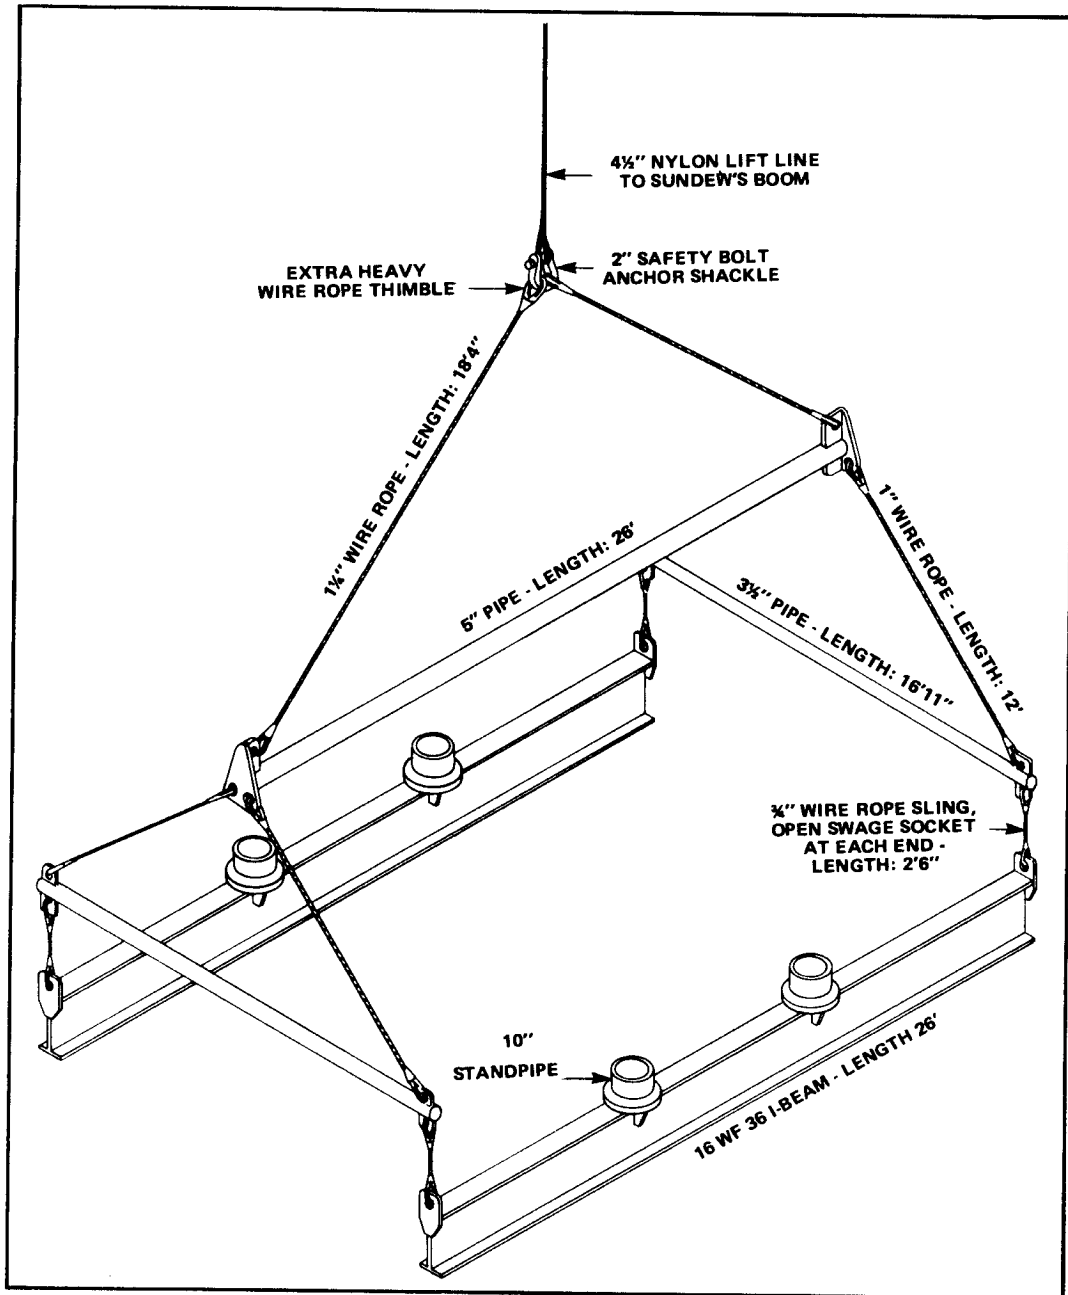
DESIGN OF LIFT SLING FOR ACV-3

The salvage force had used the ACV's normal lift sling during the abortive December recovery attempt. Divers had attached this sling to the four lift pads on the craft's deck. The rigging failed in two ways when the SUNDEW began rolling in choppy seas with the craft suspended at a depth of 40 feet. First, the after lift pads were wrenched out of the deck and then the forward legs of the sling parted. These failures, even though they occurred as a result of unusually severe stresses with the cutter towing the submerged craft, convinced the salvors that a much more substantial sling would be required for the renewed recovery effort.

Lift sling, constructed after abortive December 1971 recovery attempt, was key to successful recovery of ACV-3 in spring 1972. To support craft while in sling, ACV-3's four underside landing pads fit into corresponding standpipes welded to sling's I-beams.

The two after landing pads would thus have to withstand a greater load than the forward pads as the craft was pulled up through the water and hoisted aboard. The base of the sling was composed of two steel I-beams. Each beam would run laterally under the forward and after pair of landing pads respectively. Sockets for the landing pads would be made up of 10-inch standpipes, 5 inches high, welded to each beam. This 5-inch height was slightly less than the vertical length of the landing pad so that the base of the pad would rest directly on the I-beam when fitted into the socket. In calculating the required size of the I-beams, the greater lift requirement of the after beam was used as the criteria for both beams.

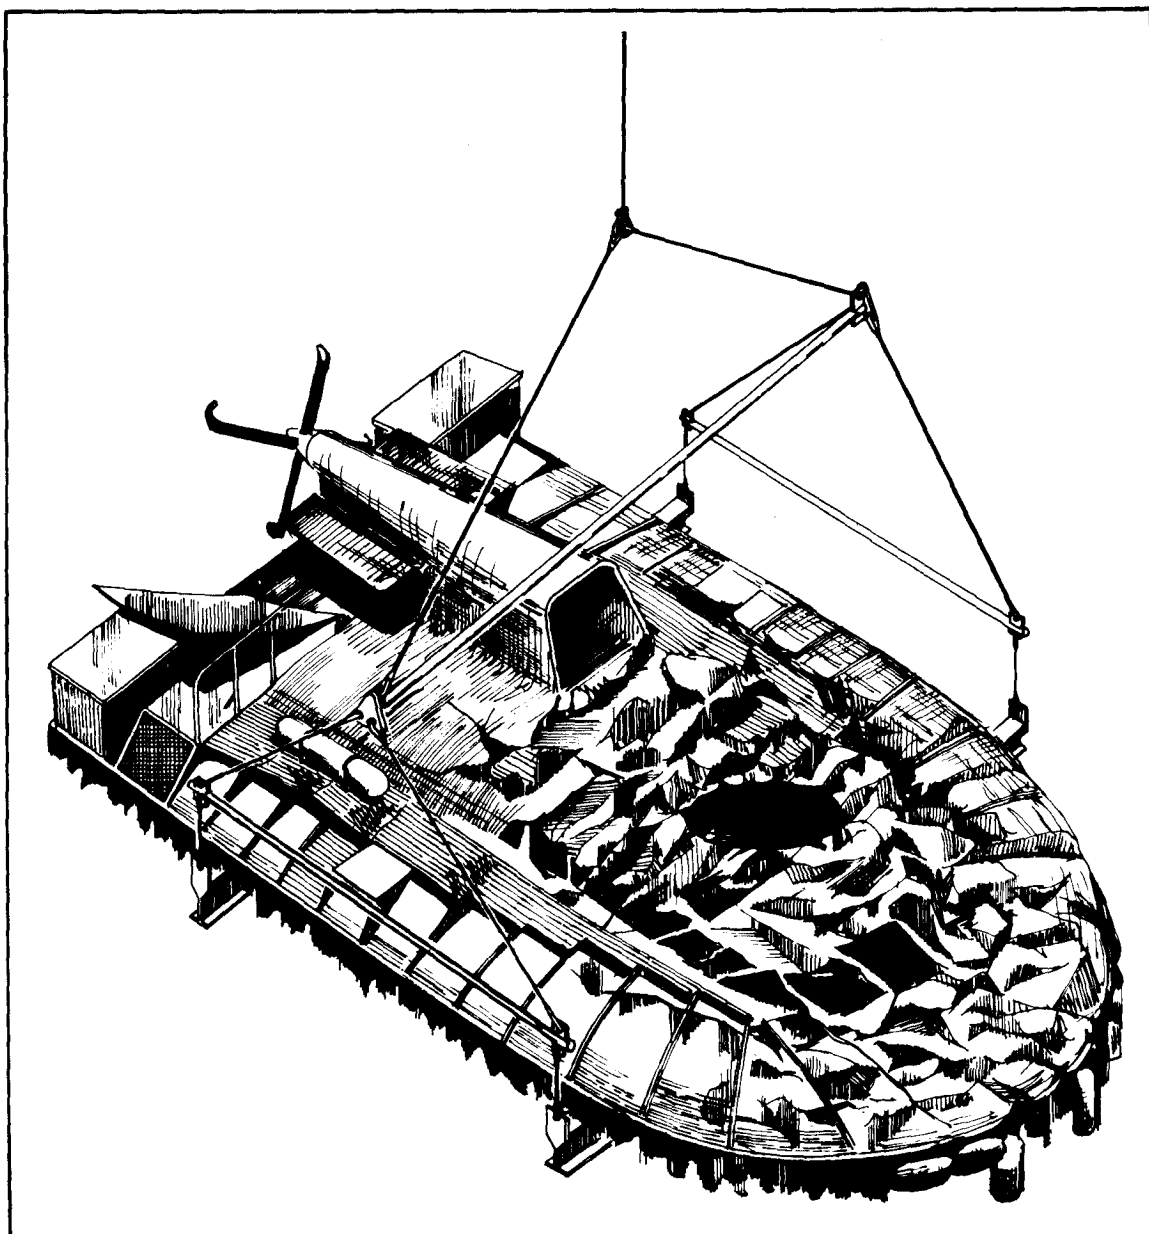
ACV-3 IN LIFT SLING

Sling was designed to hold ACV-3 on horizontal plane during hoist from shallow depth to deck of Cutter SUNDEW. Damaged craft rested in sling slightly forward to compensate for heavier weight aft.

- The craft was resting upside down on the port side of the cabin and decking area.
- Stabilizing fins were torn loose and after tow pads were unusable.
- Forward tow and lift pads were undamaged.
- Bottom of craft was undamaged except for portion attached to stabilizing fins.
- Damage to craft's upper forward portion could not be assessed.

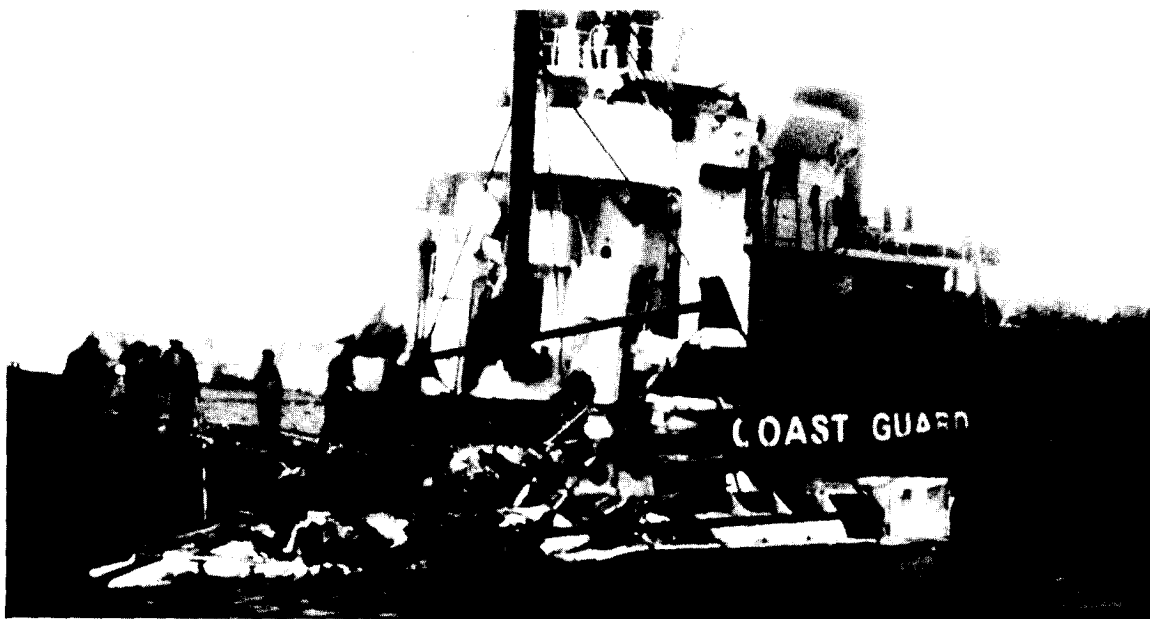
**ACV-3 BREAKS SURFACE AND IS HOISTED ABOARD SUNDEW
AFTER NEARLY 7 MONTHS ON BOTTOM**

As SUNDEW's anchor windlass held ACV-3 suspended at 20-foot depth, cutter's boom lowered sling into water. Divers then rigged sling around ACV-3, enabling boom to hoist craft on deck on even plane.

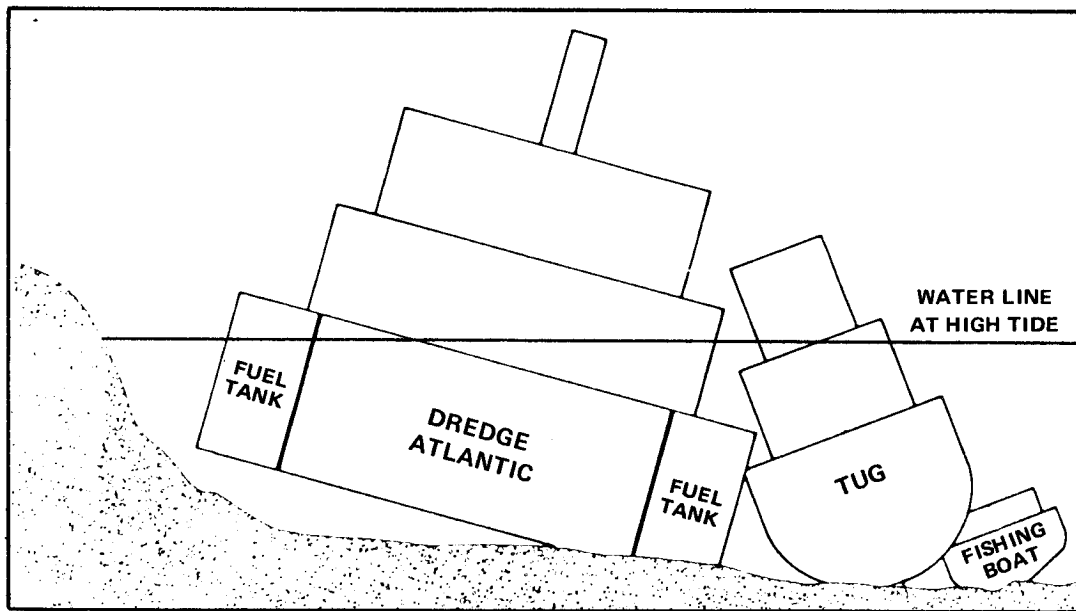
ARRANGEMENT OF VESSELS PRIOR TO SALVAGE OPERATION

An inspection of the casualty site by divers in mid-August revealed the dredge, tug and fishing boat resting adjacent to each other in various degrees of submergence.

Casualty site consisted of three craft in various degrees of submergence: 120-foot Dredge ATLANTIC, 60-foot Tug MARQUETTE and 30-foot fishing boat. Only Dredge ATLANTIC posed pollution threat.

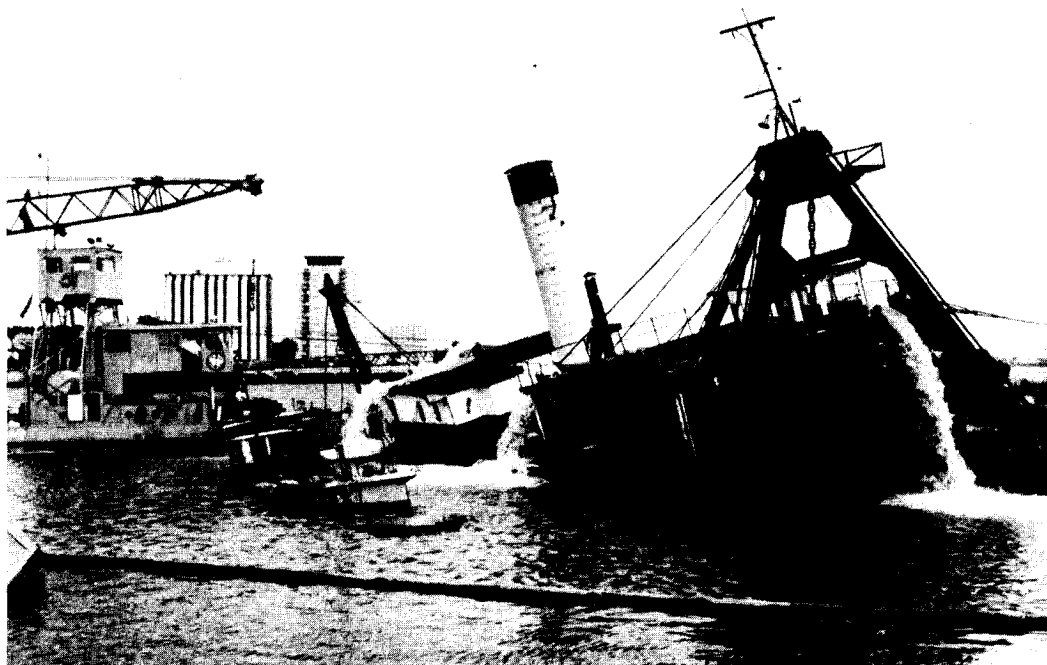
DEWATERING OPERATIONS IN PROGRESS

As the pumping progressed, however, the newly-installed double door patch failed to hold. Pumping operations were halted and postponed until a stronger, plywood patch could be fabricated and installed.

Following containment of oil pollution by boom (foreground) and removal of tug and fishing boat (left), salvors began pumping operations to refloat Dredge ATLANTIC. Wire attached to A-frame (right) led to deadman anchor block on beach and acted to prevent dredge from capsizing during dewatering operations.

The salvors concluded that the double door patch which was carried away should have been more stoutly constructed and shored from the inside to support the substantial pressure against its large, 6-foot by 9-foot area. The replacement patch was constructed from three layers of 3/4-inch plywood with 2-inch by 6-inch framing and mid-section support. Only marginal success was experienced with the hard rubber gaskets that were used for all but the two steel patches. The neoprene gaskets for the steel patches, however, stopped leakage completely.

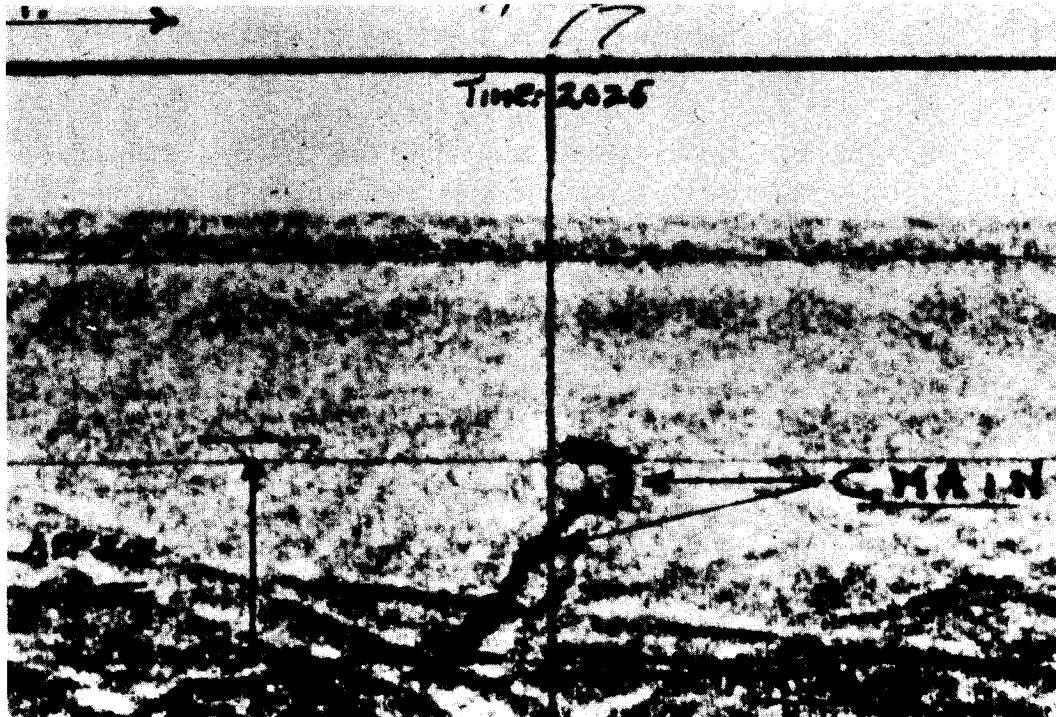
SONAR TRACE OF BANCROFT'S ANCHOR AND CHAIN

After side scan sonar detected missing anchor and chain on 11 July, USS NIPMUC successfully hooked onto objects on fourth dragging attempt. Anchor and chain were brought aboard NIPMUC within hours.

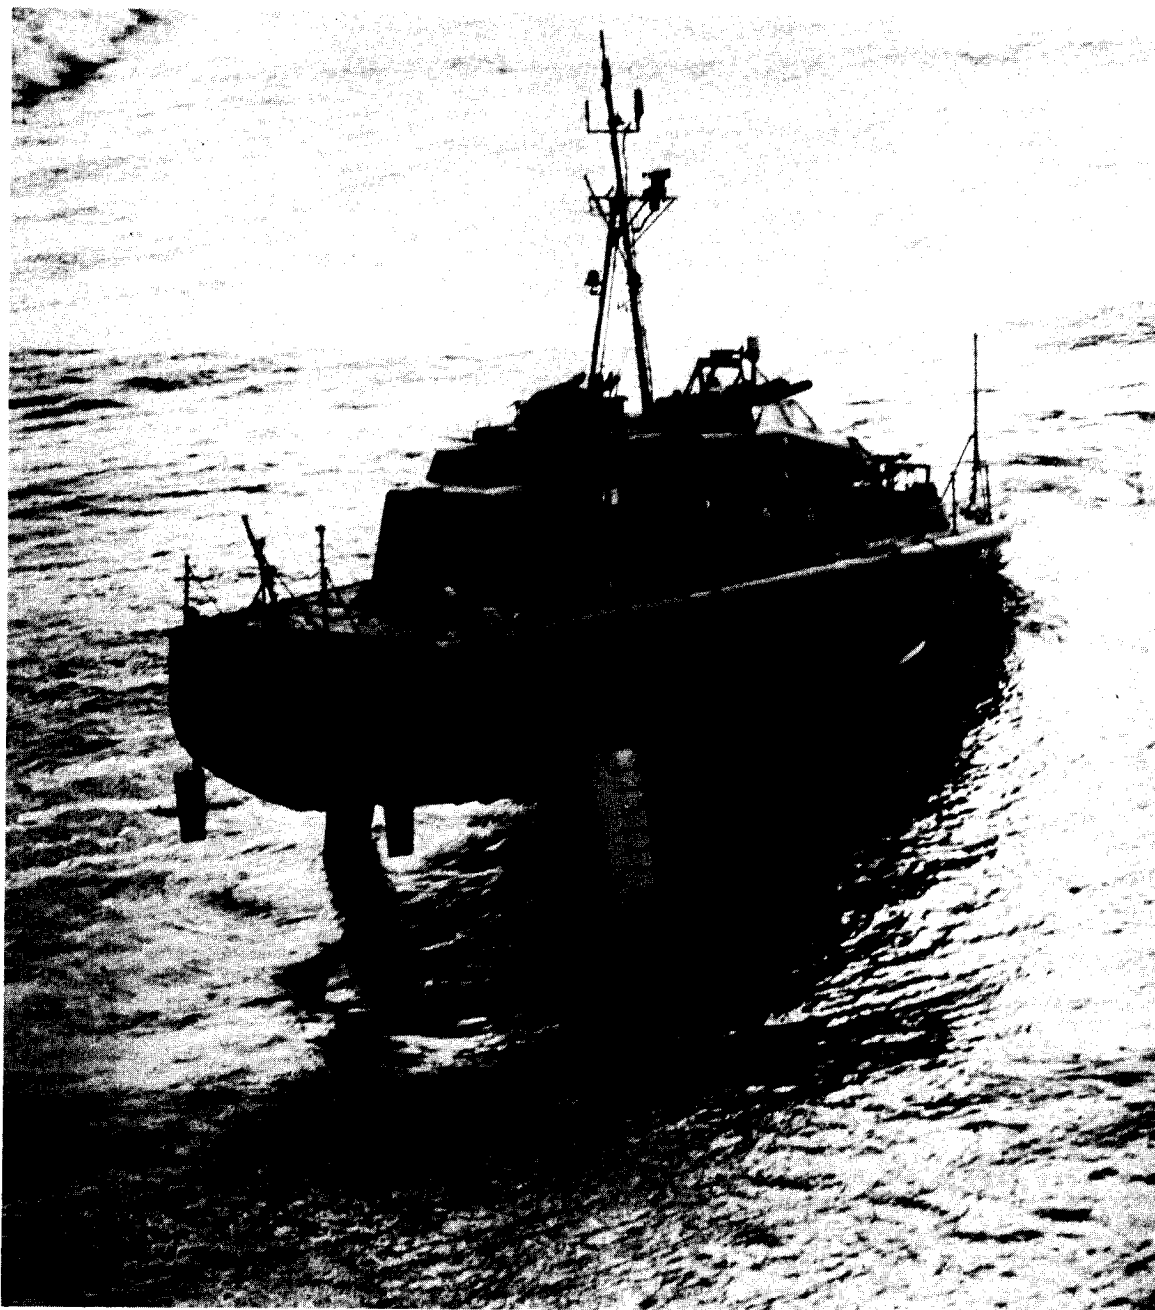
**USS TUCUMCARI (PGH-2) STRANDED
AT CABALLO BLANCO REEF OFF PUERTO RICO**

Hydrofoil gunboat USS TUCUMCARI crashed into reef east of Puerto Rico during special night operations on 16 November. Main struts became embedded in coral, making retraction of craft by salvors highly difficult.

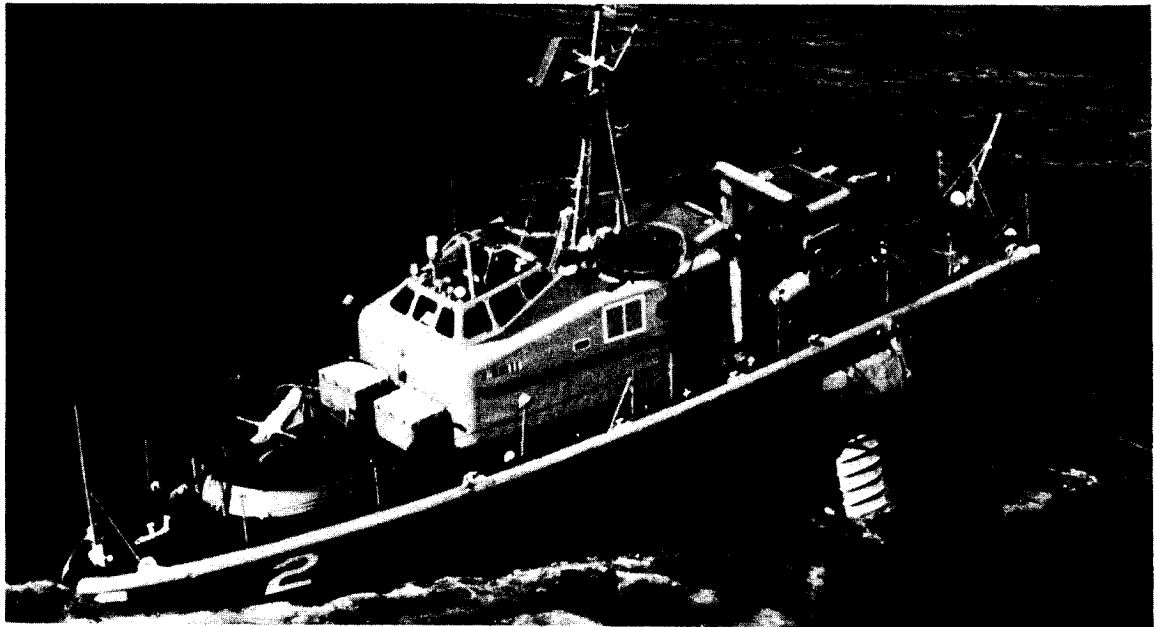
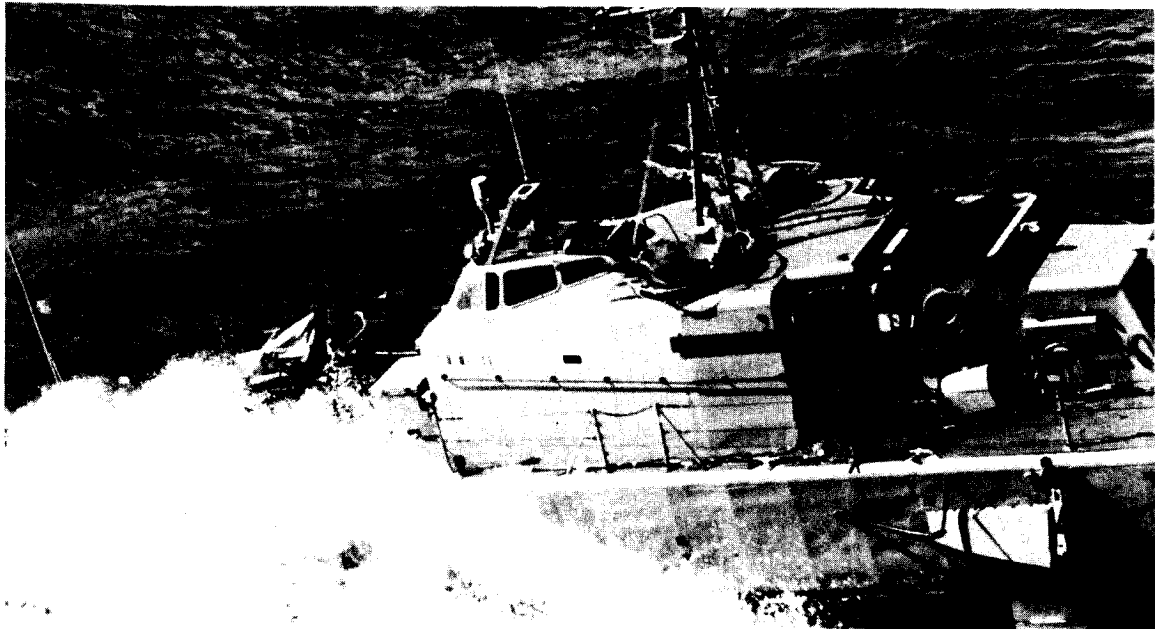
- (1) This damage to the PGH may seem extensive. However, had a conventional gunboat grounded on a reef at 45 knots, its entire bottom would have been ripped open and the craft rendered unsalvageable.

TUCUMCARI suffered extensive bow damage as a result of crash. Although surf conditions over reef were frequently rough, main struts held stern of craft above water, preventing flooding aft of frame 8.

**STRANDED TUCUMCARI ESCAPES
SERIOUS FLOODING**

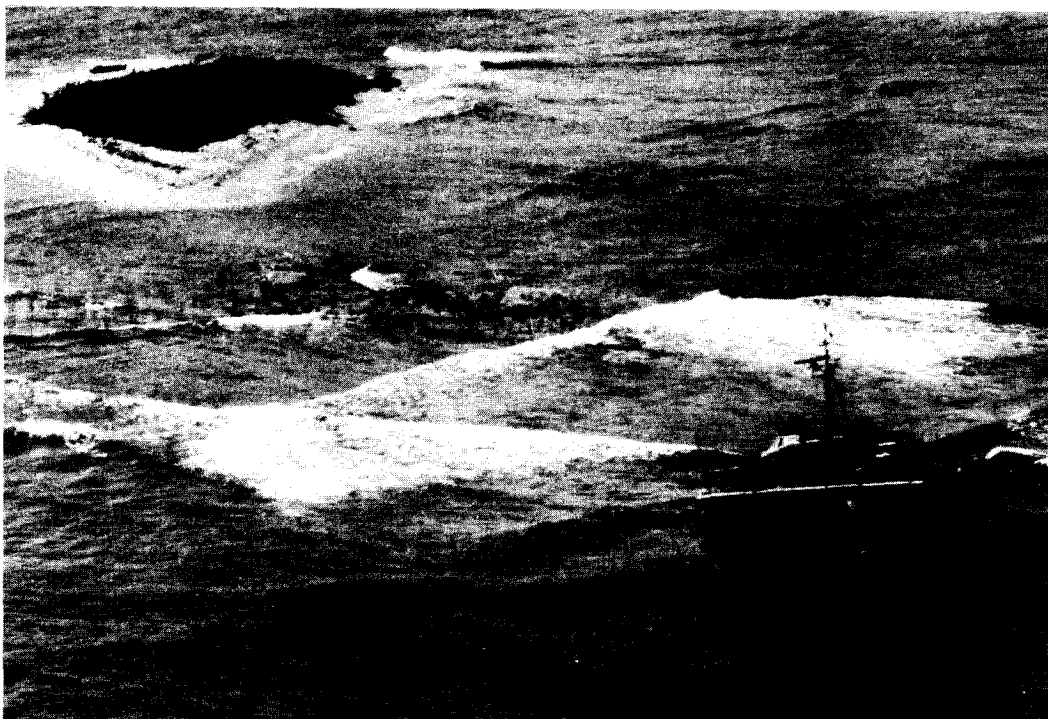
TUCUMCARI'S POSITION DICTATES RETRACTION FROM STERN

Salvors planned to blast a channel through coral to deeper water astern of TUCUMCARI, raise midships area with pontoons, and pull with beach gear off craft's starboard quarter.

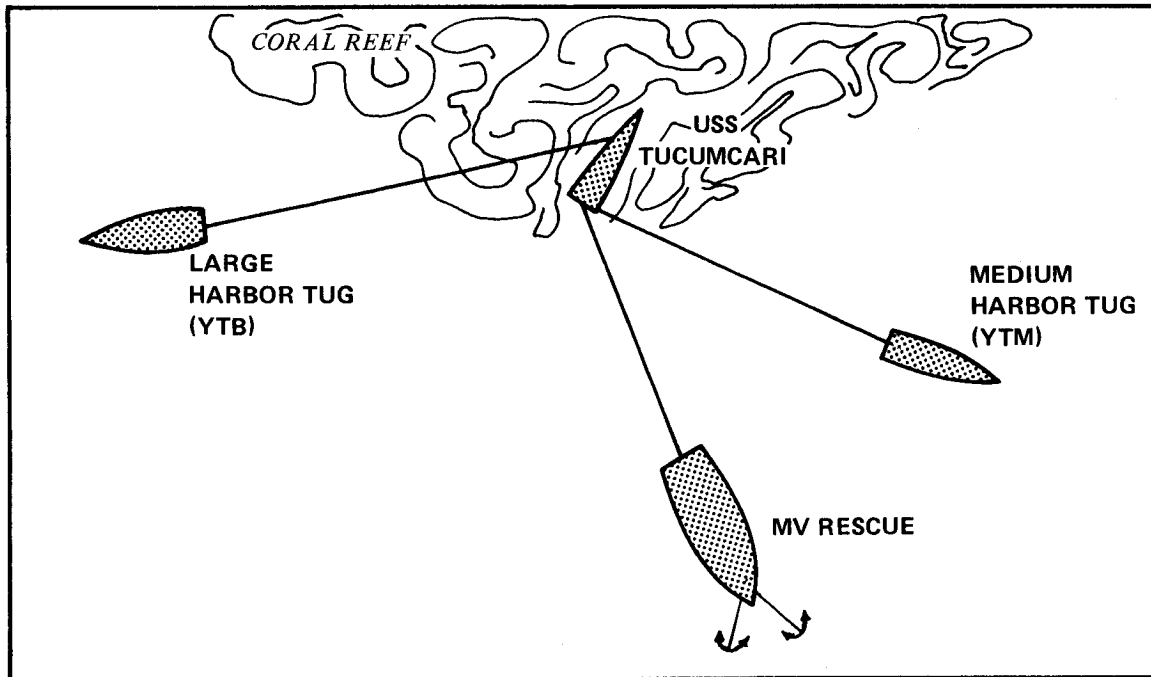
PULLING ARRANGEMENT FOR INITIAL RETRIEVAL EFFORTS

Two pulling efforts with YTM, YTB and MV RESCUE on 20 November failed. On first effort, YTB's 8-inch towline parted. During second effort, shank on one set of beach gear to RESCUE parted; also, TUCUMCARI's bow bitts were torn away under pull of YTB.

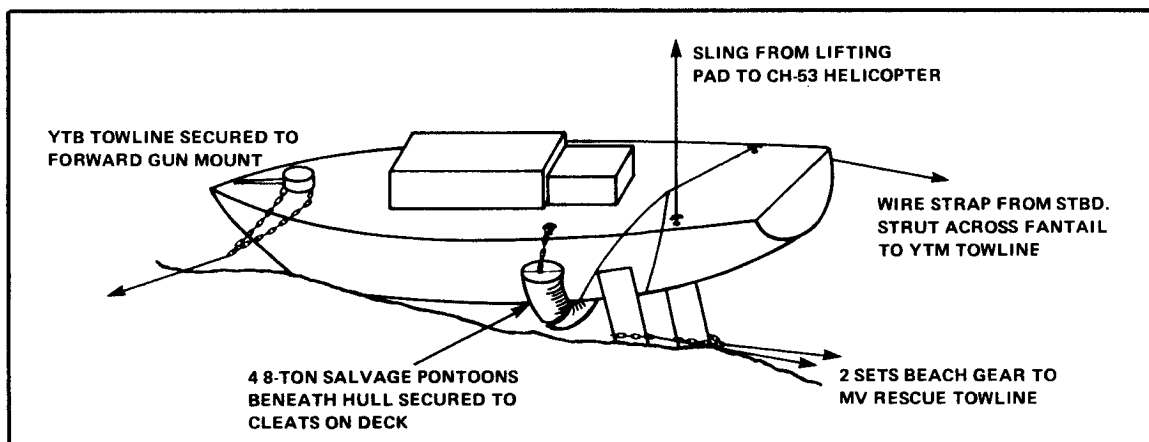
REVISED PULLING ARRANGEMENT FREES TUCUMCARI FROM REEF

A one-foot-square hole had also been punctured in the starboard side amidships, 5 feet above the waterline, as a result of the brief capsizing of the vessel. The salvors patched this and then rerigged the pulling system to complete the retraction. Another bridle was rigged from the starboard strut to the YTM which was repositioned off the TUCUMCARI's stern.

Pulling system was modified to free port strut embedded 6 inches into reef. Pulling and lifting efforts on 21 November caused TUCUMCARI to capsize to starboard briefly, but moved craft back 30 feet. Retraction was completed later by YTB and RESCUE pulling in tandem from starboard strut.

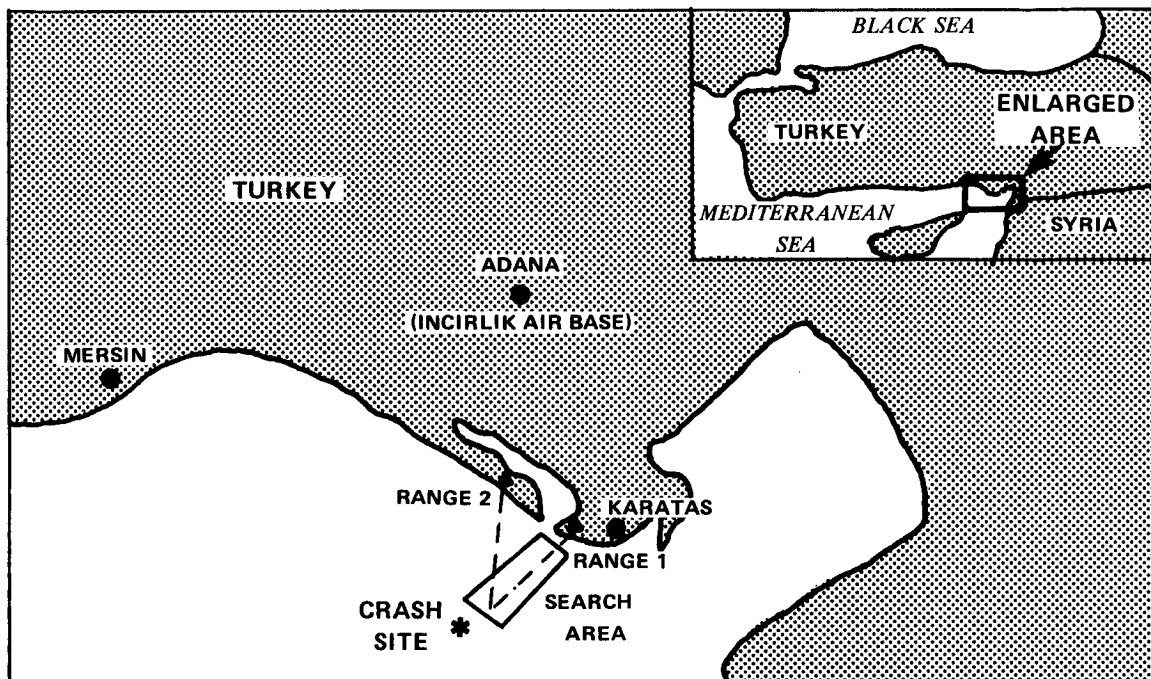
SITE OF U.S. AIR FORCE F-4E CRASH

Acting on eyewitness account of F-4E aircraft crash, search team set up ranges for precision navigation equipment and covered 23-square mile area with side scan sonar. Wreckage was detected on eighth day of search, just outside original search area, 8.5 miles from shore.
