SALVOPS 72

A review of significant salvage operations
conducted by U.S. Navy salvage forces
and other salvage activities during 1972

NAVSEA 0994-LP-012-6040

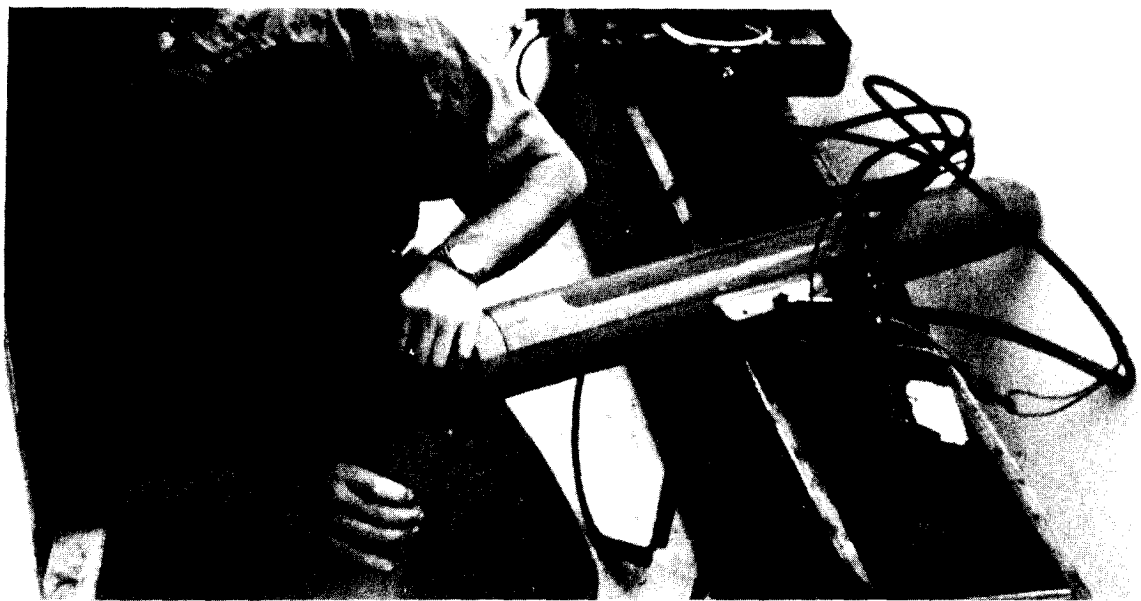
Streamlined capsule, towed from search vessel, emits high frequency sound pulses. Sonic energy is reflected back to capsule, then transmitted to recorder, yielding shadow picture of bottom features. Wreckage appears as large, dark mass against more regular bottom topography.

**SIDE SCAN SONAR DETECTS TA-4J WRECKAGE
IN 246 FEET OF WATER**

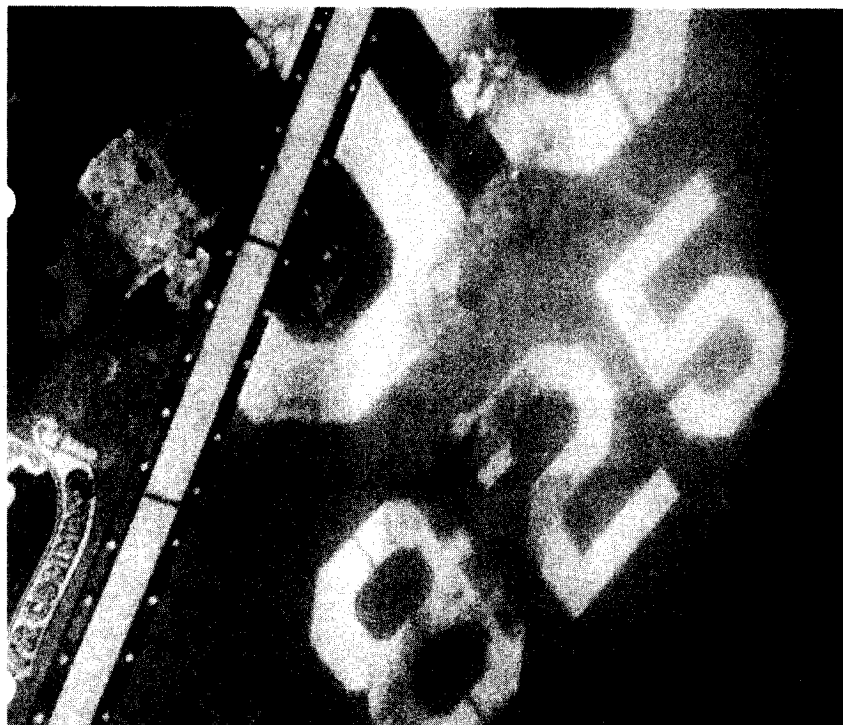
Positive identification of aircraft 650825 was made by divers on fourth day of search. Wreckage of second aircraft involved in mid-air collision was discovered 1,000 yds away. No trace of crewmen of second aircraft was found.

**RIGHT WING OF USAF RF-4C AIRCRAFT
IN 60 FEET OF WATER**
