# SALVOPS 74

**A review of significant salvage operations  
conducted by U.S. Navy salvage forces  
and other salvage activities during 1974.**

**SUPERVISOR OF SALVAGE, U.S. NAVY  
NAVAL SEA SYSTEMS COMMAND  
WASHINGTON, D.C.**

**NAVSEA 0994-LP-012-6060**

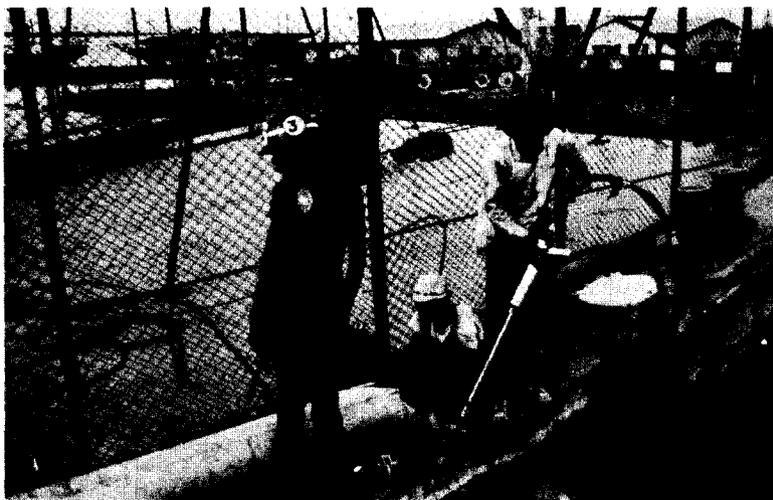
**NATIVE WORKMEN INSTALLING FOAM IN A SHIELD BARGE**

*Liquid injection of polyurethane was performed by local labor under the direct supervision of representatives of SUPSALV and SUPSALV contractors.*

The liquid installation of foam was performed by indigenous personnel at Saigon under the direct supervision of SUPSALV and contractor representatives. Material and equipment were supplied by SUPSALV and SUPSALV contractors, including the 120,000 square feet of foam used to fill designated voids on the barges.

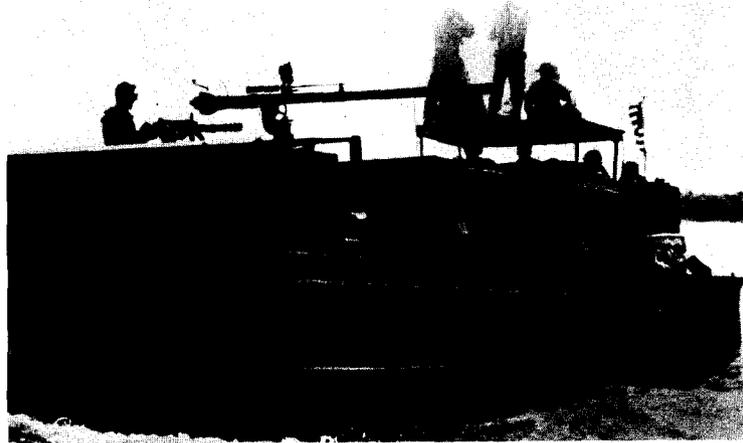
**ARMED LCM-6 SHOWING SIDE BLISTERS**

*Addition of foam-filled tanks around sides of rear and stern protected engine spaces against damage from rocket attack.*

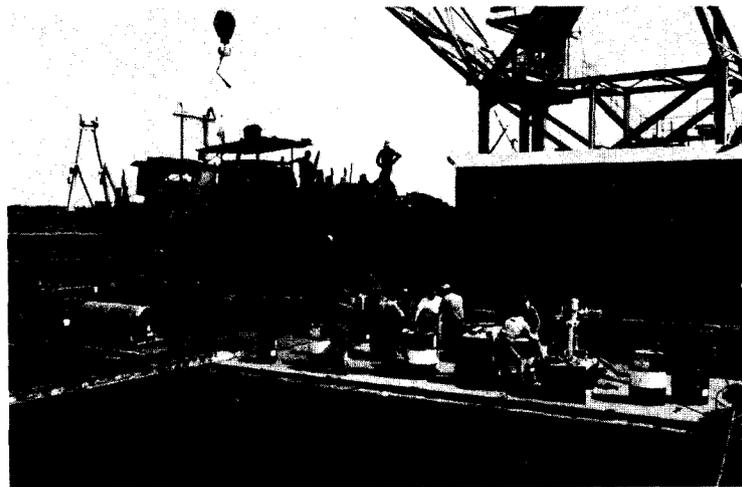
**LCM-6 UNDERGOING FOAM INSTALLATION**

*It should be noted that side blisters on this particular craft are of an unfoamed standoff variety with a chain link trigger shield outboard.*

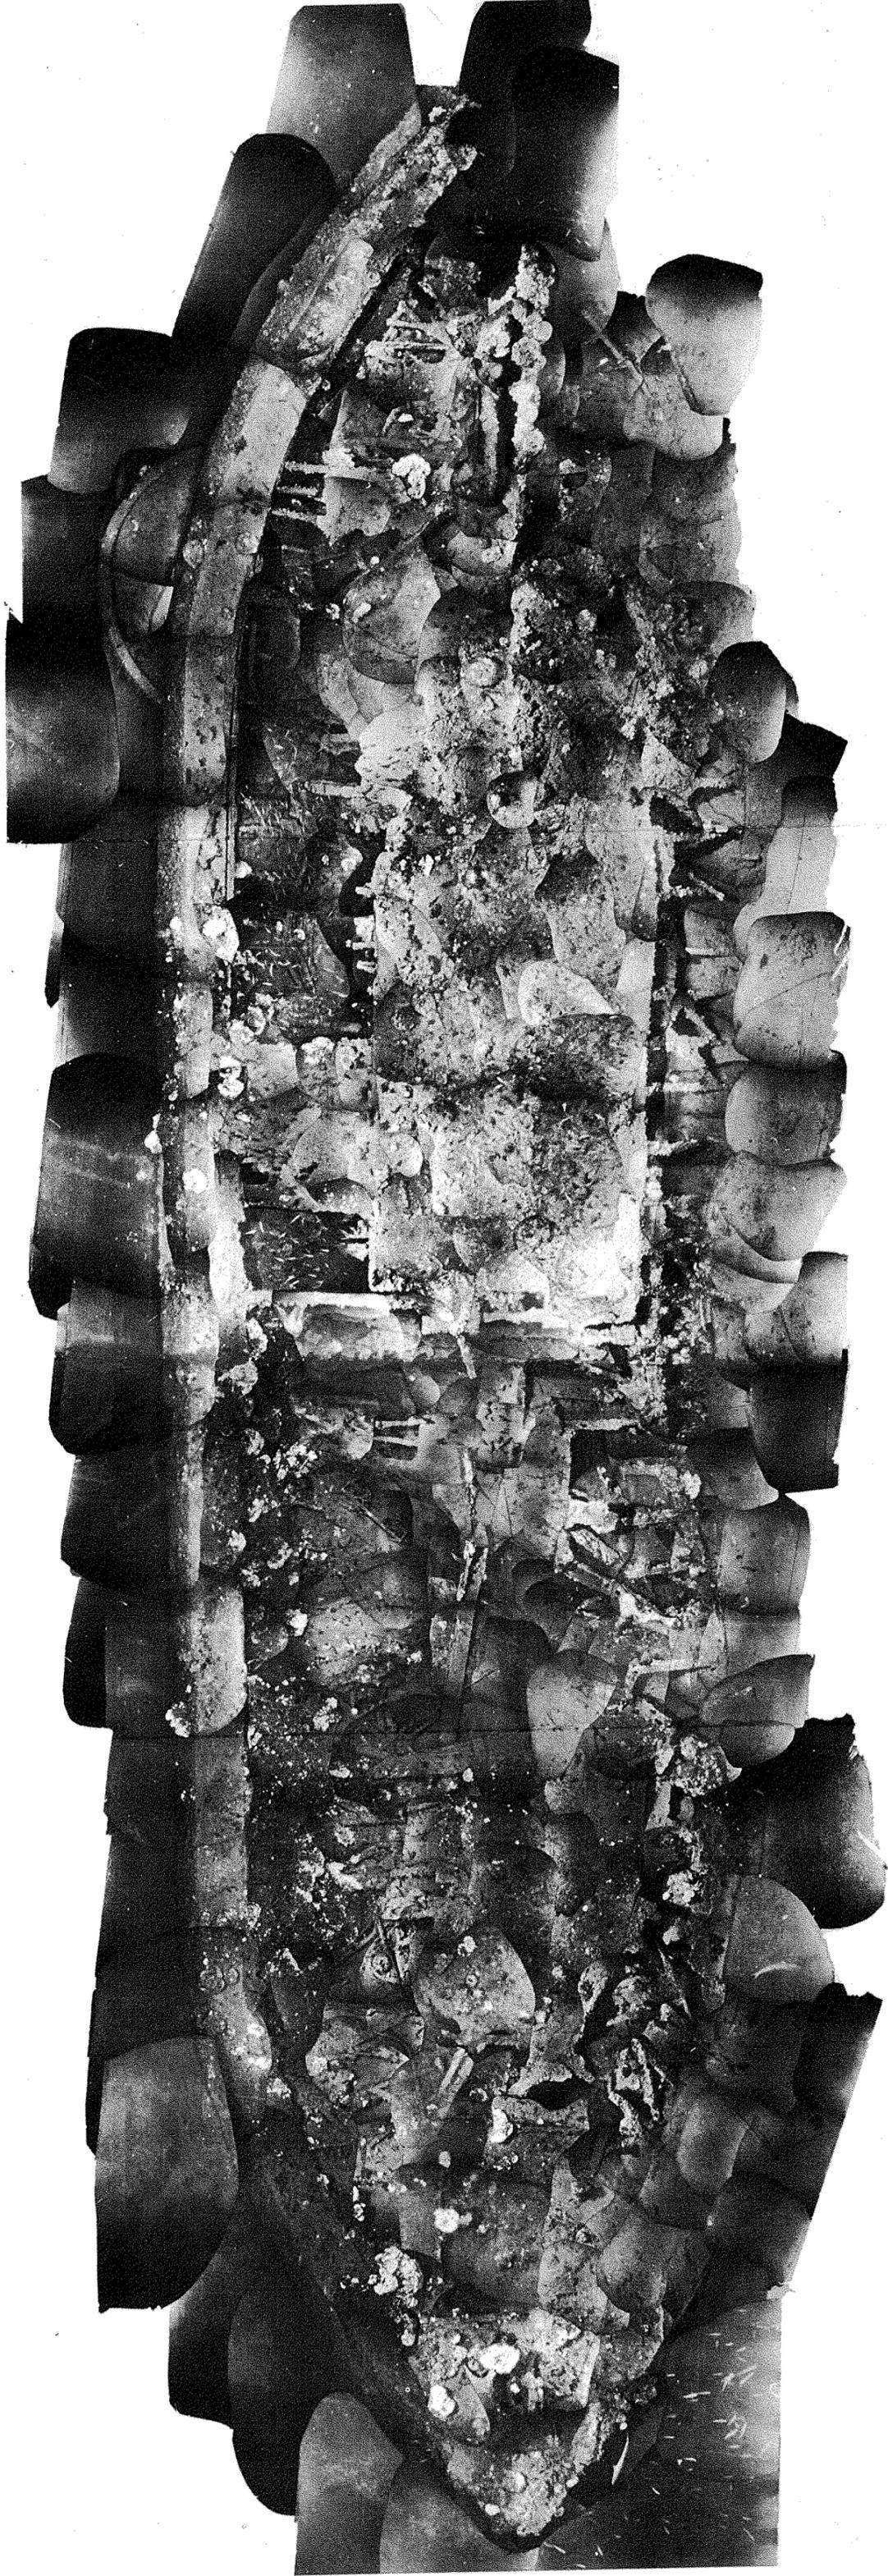
**UNDERWATER PHOTOMOSAIC OF USS MONITOR**

*This composite was reconstituted by the Naval Intelligence Support Activity by using aerial photo interpretation techniques. It required several weeks of careful work assembling hundreds of frames of underwater strip photography obtained from the search and reconnaissance operations by SUPSALY.*

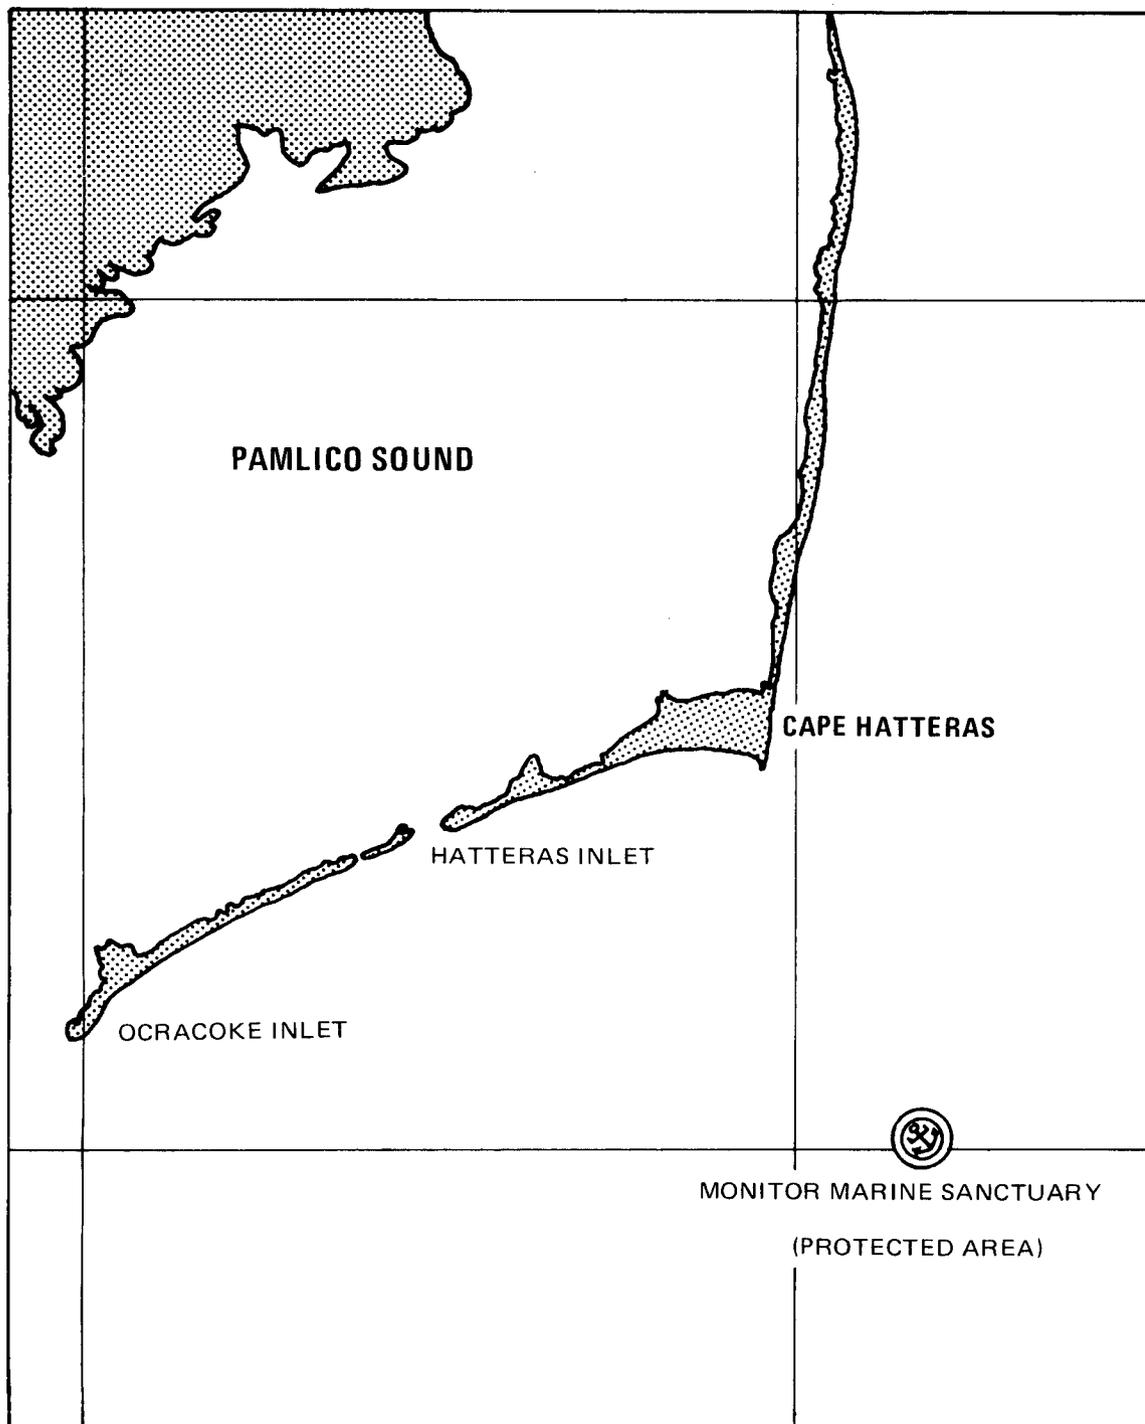
**LOCATION OF MONITOR WRECK**

*The remains of MONITOR.*

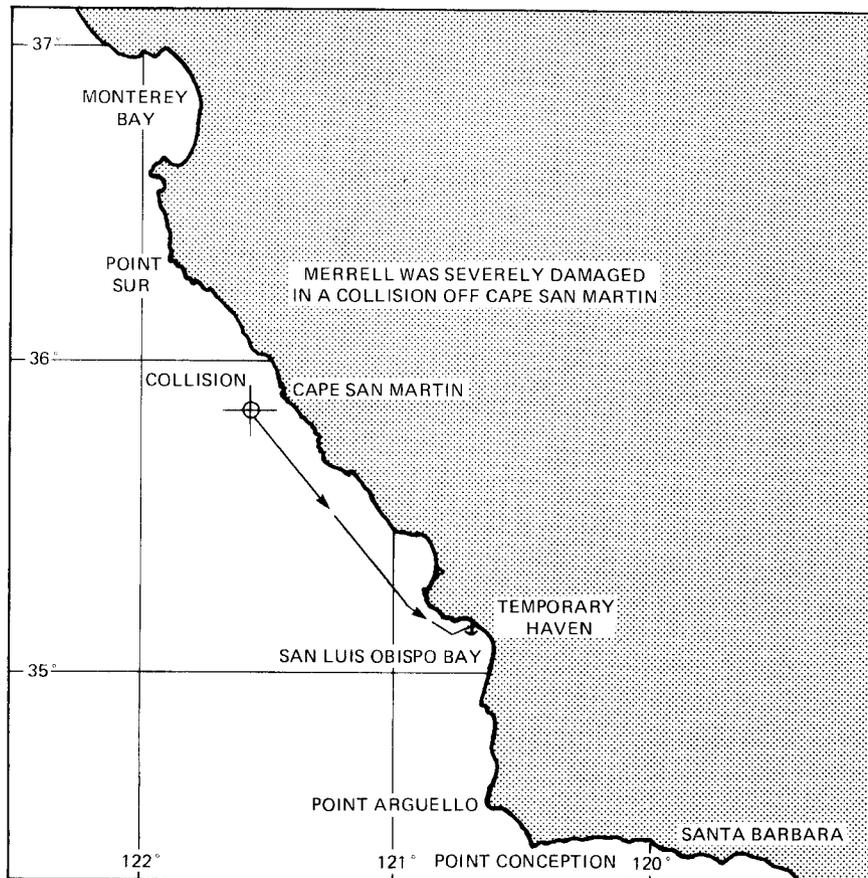
**MERRELL'S COLLISION AND TOW**

*MERRELL was severely damaged in a collision off Cape San Martin. She was left dead in the water and the M/V GEAR was sent to tow her to an anchorage in San Luis Obispo Bay for temporary repairs.*

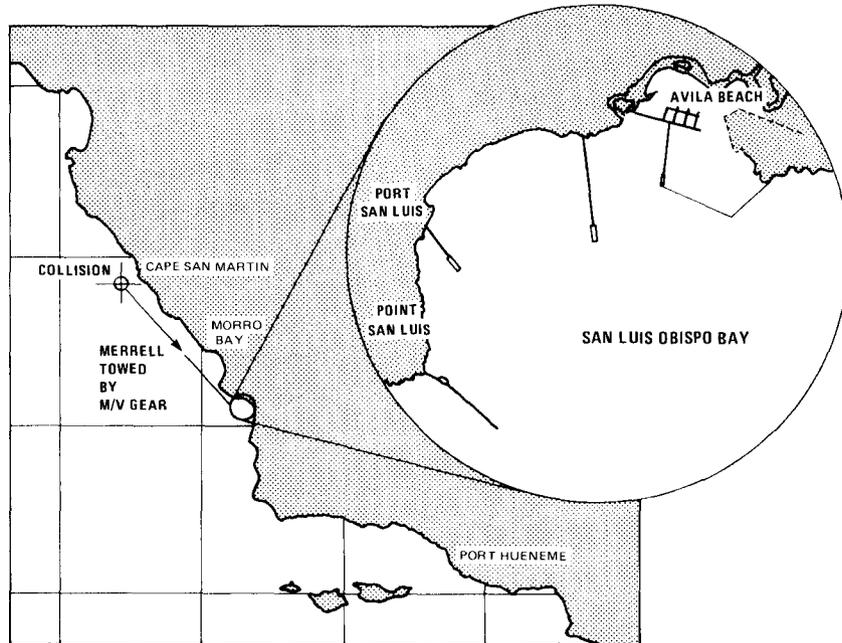
**MERRELL HAD TO BE TOWED TO TEMPORARY HAVEN**

*The damage to MERRELL necessitated tow to an anchorage in San Luis Obispo Bay for damage inspection and repair.*

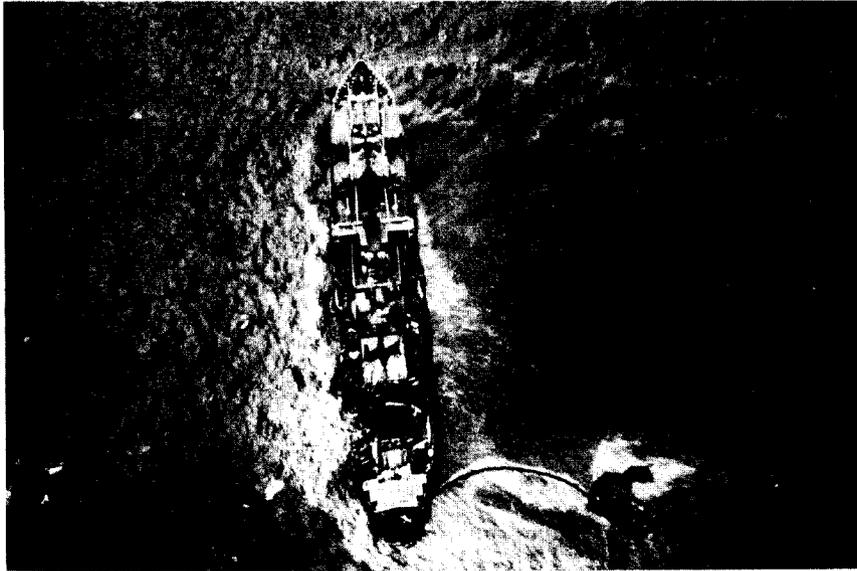
**OIL CONTAINMENT BOOM AROUND MERRELL WAS BLOWN AWAY**

*The glaze of escaped oil can be seen on the water around MERRELL, as well as the skimmer redeploying the boom.*

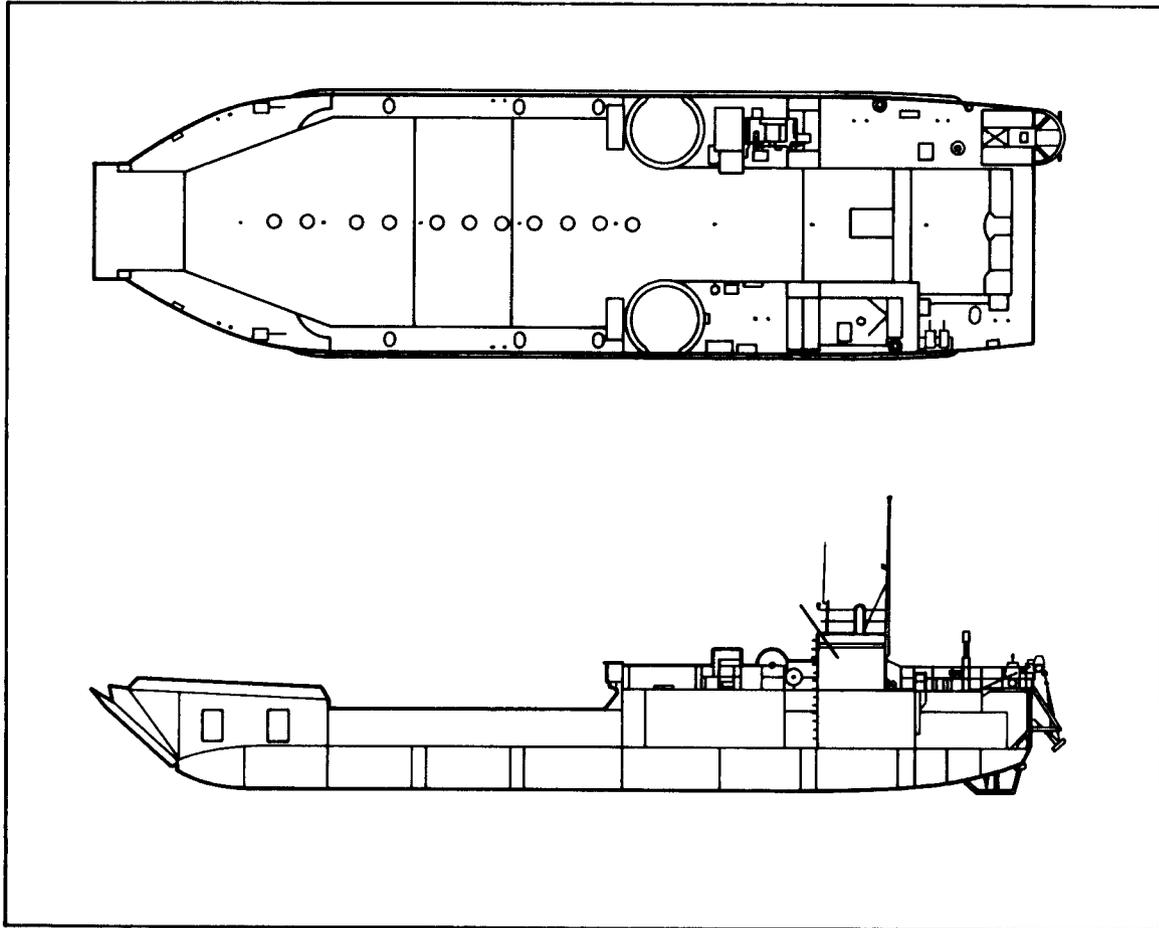
**YDT-9 SANK IN YORK SPIT CHANNEL, CHESAPEAKE BAY**

*YDT-9 was a diving tender converted from a World War II LCU/LCT Mk VI built in 1944. After years of use, it was being towed, stripped, from the Inactive Ship Facility.*

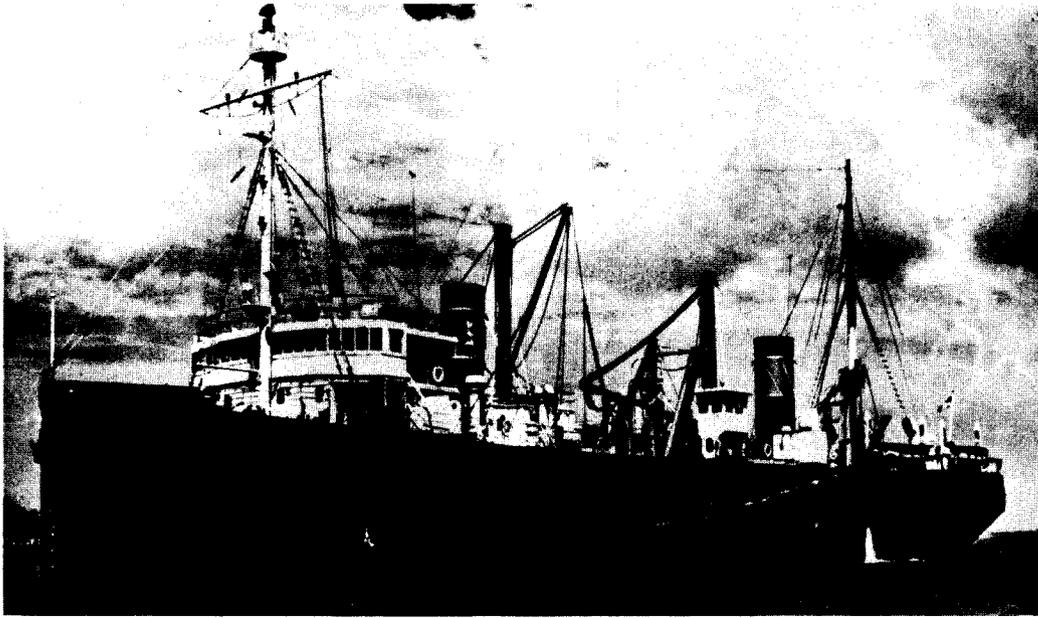
**MACKENZIE HAD A COLLISION WHILE DREDGING GALVESTON CHANNEL**

*A tanker collided with the U.S. Army Corps of Engineers dredge A. MACKENZIE while she was dredging Galveston Inner Bar Channel.*

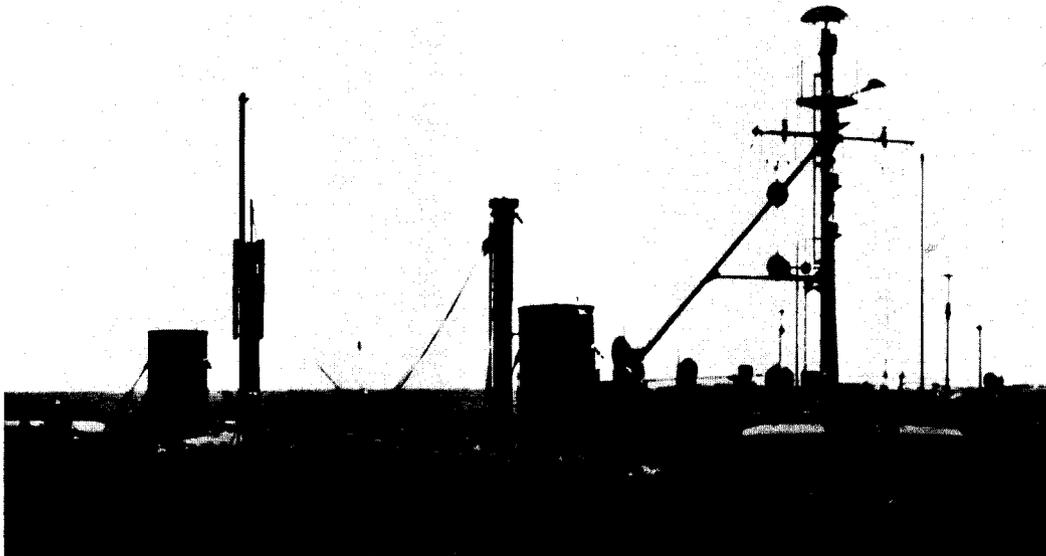
**MACKENZIE SANK RAPIDLY, BLOCKING A BUSY CHANNEL**

*MACKENZIE sank within 15 to 20 minutes, swinging perpendicular to the channel, but with no loss of life. She is seen here resting on bottom in 42 feet of water before the soft bottom and scouring lowered her further.*

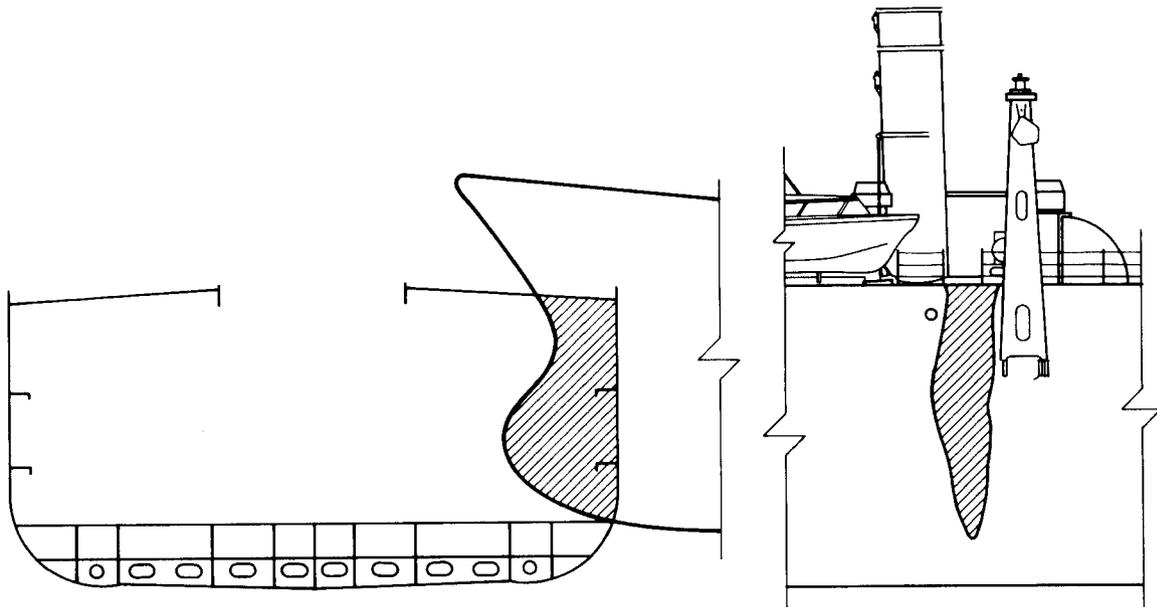
#### **MACKENZIE'S STARBOARD SIDE WAS DEEPLY PENETRATED**

*The bow of the Norwegian bulk carrier penetrated the starboard side of MACKENZIE at frame 40, for a distance of over 15 feet, about 8 feet wide, resulting in massive flooding.*

On 25 April, J and J Marine Diving Corporation of Pasadena, Texas, surveyed damage to the sunken dredge. They found the MACKENZIE upright, almost perpendicular to the channel. The top of the pilot house was above water, indicating about 18 to 20 feet over the main deck. Divers reported a large, jagged hole from the collision in the after engine room to starboard, at about frame 40, extending down from the boat deck to about two feet above the bilge keel. In this area, the wooden boat deck was badly splintered and the steel main deck jagged and pierced inward for about 5 to 6 feet.

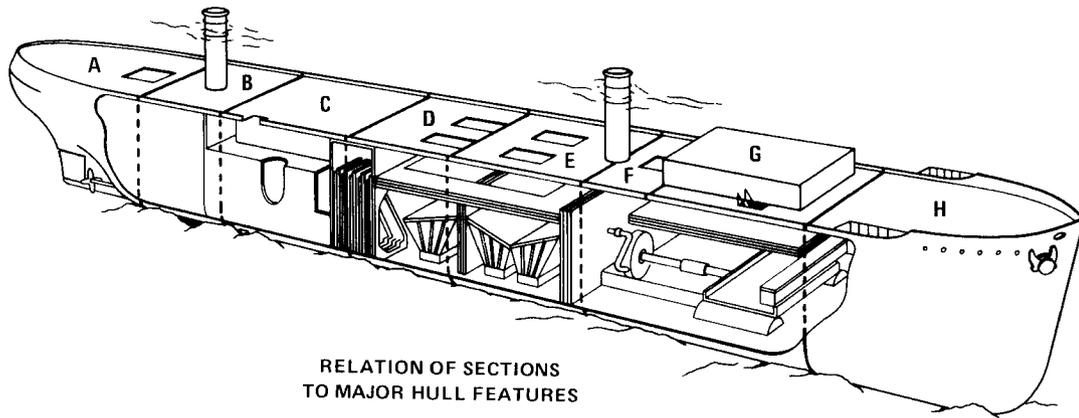
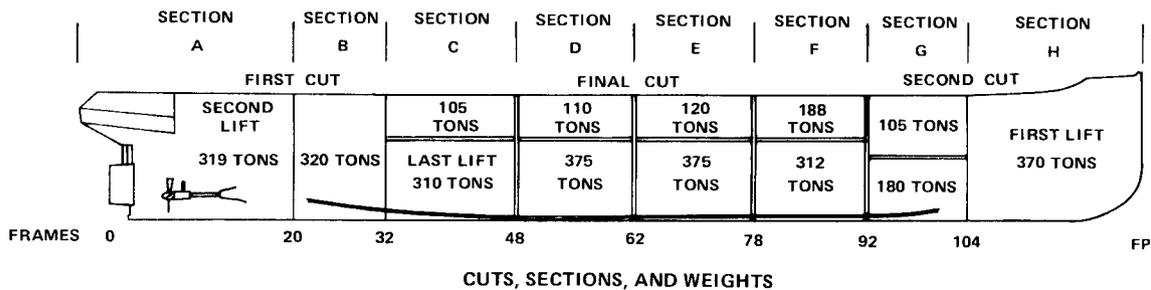
### SALVORS OPTED TO CUT MACKENZIE FOR REMOVAL

*Based on estimates of sectional weights, it was decided, initially, to cut MACKENZIE into eight sections for removal from the channel by crane lift.*

The initial decision was to cut the ship into eight major transverse sections. The schematic drawing shows the hulk after the preliminary removal of top hamper for lightening and diver access. Two major methods of hull section cutting were used: oxyarc burning and explosives. The A section (the stern to frame 20) and H section (the bow to frame 104) were the first cuts removed, and use of a 500-ton derrick barge crane was planned.

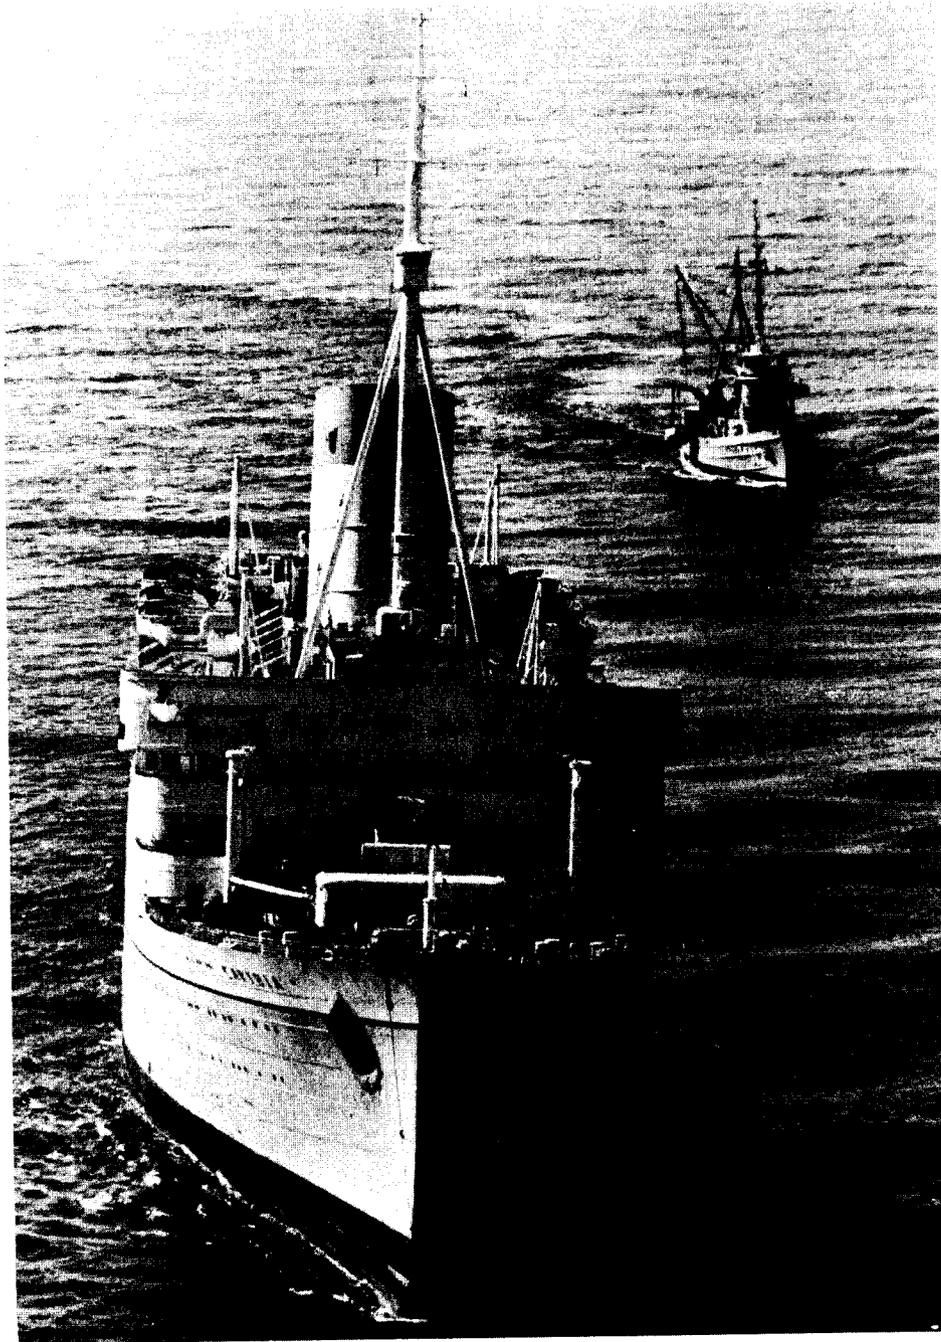
**NEARING HAWAII, CARIBIA REQUIRED NAVY HELP**

*CARIBIA was being towed from New York to Taiwan and developed flooding aft. A team of Navy salvage specialists was sent to her aid aboard the fleet ocean tug USS TAKELMA (ATF-113), seen here astern.*

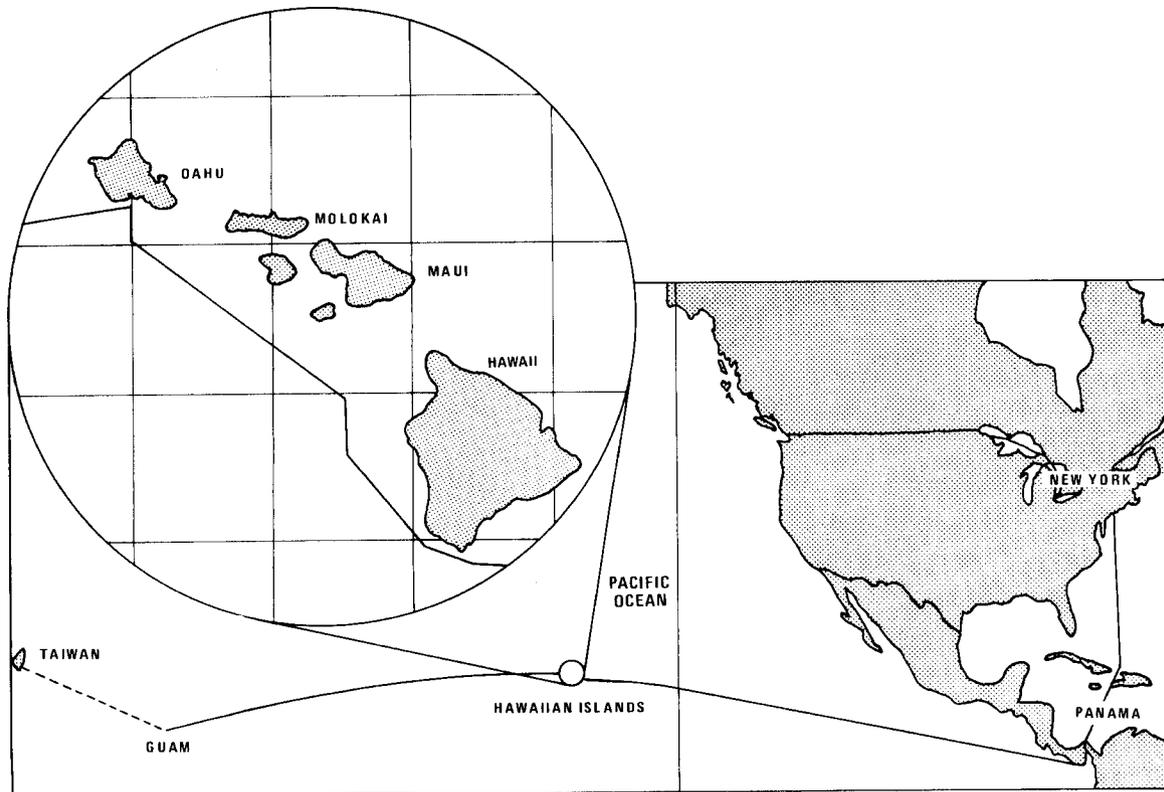
#### **CARIBIA WAS IN TOW FROM LAY-UP IN NEW YORK TO SHIP-BREAKERS ON TAIWAN**

*Flooding, near Hawaii, required Navy help. Again requiring help off Guam, CARIBIA was lost before Navy help could come to bear.*

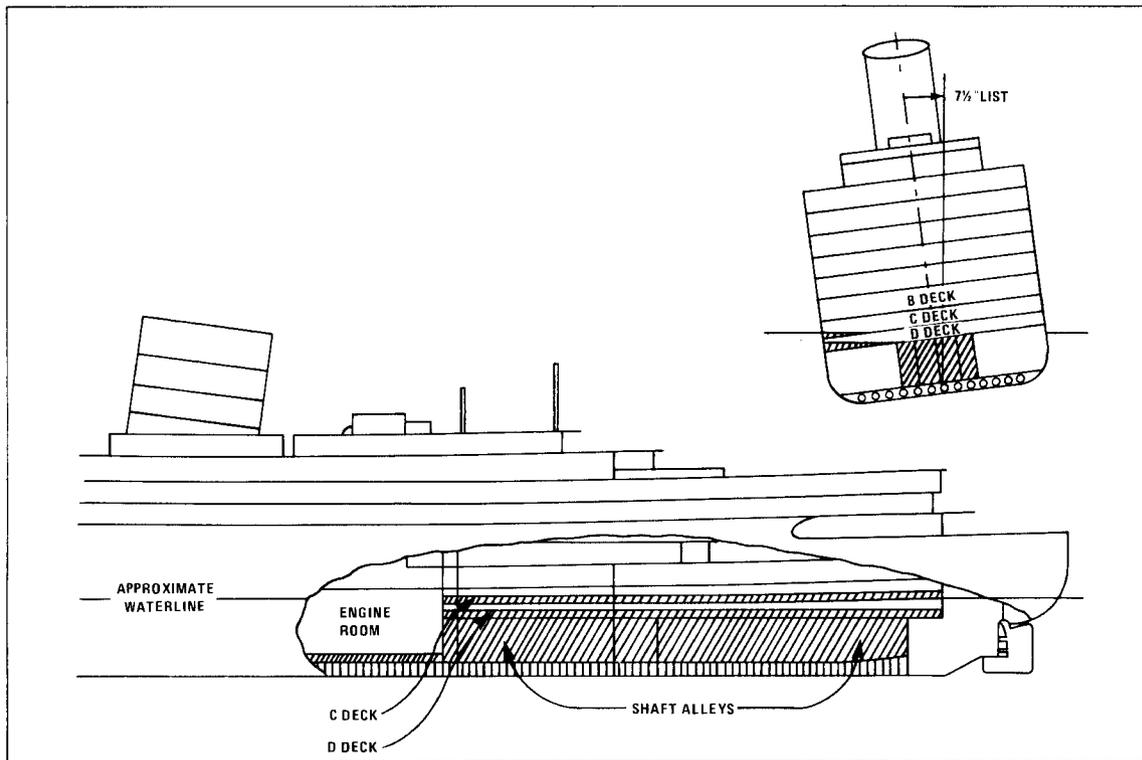
### CARIBIA'S FLOODING

After boarding, the HCU-1 salvage team was briefed by the CARIBIA's three-man riding crew on her flooding condition. It was learned that the flooding had originated in the shaft tunnels about 12 days earlier, and had progressively worsened. The cause of flooding was unknown.

*CARIBIA* suffered flooding of her shaft alleys, as well as wedges on deck D, deck C, and in her engine room from progressive leaking.

On CARIBIA, pumping of the shaft tunnels continued and after water in the forward shaft tunnel was pumped below the deck plates, a hole was discovered in a 3-inch salt water cooling line to the starboard shaft. Salt water was being discharged from this hole at a rate of approximately 50 to 75 gallons per minute. Bleed-off valves were found open at three of

the shaft bearings, discharging a steady flow of seawater. The valves and piping in this area and the engine room were in a high state of deterioration. The valves were closed, the 1-inch hole soft patched, and the 3-inch cooling line was isolated at the main cutoff valve.

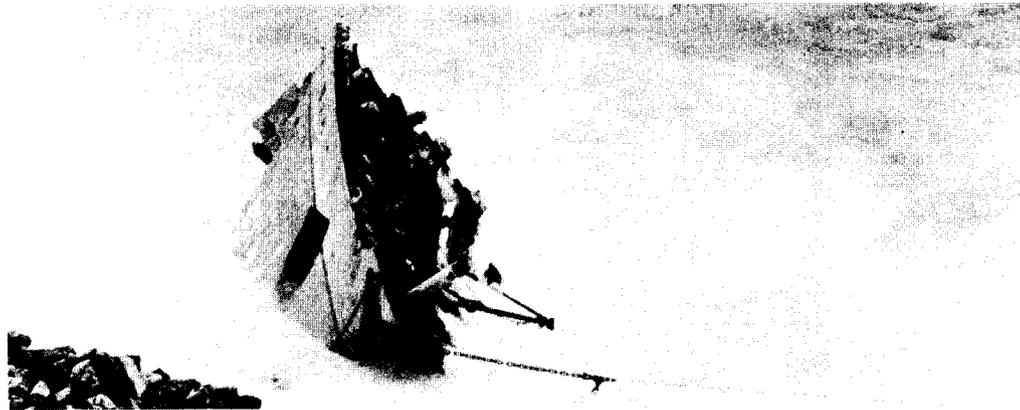
**CARIBIA BREAKING UP**

*Gone. CARIBIA's hull sliding down into the channel, with her bow remaining on Spanish Rocks.*

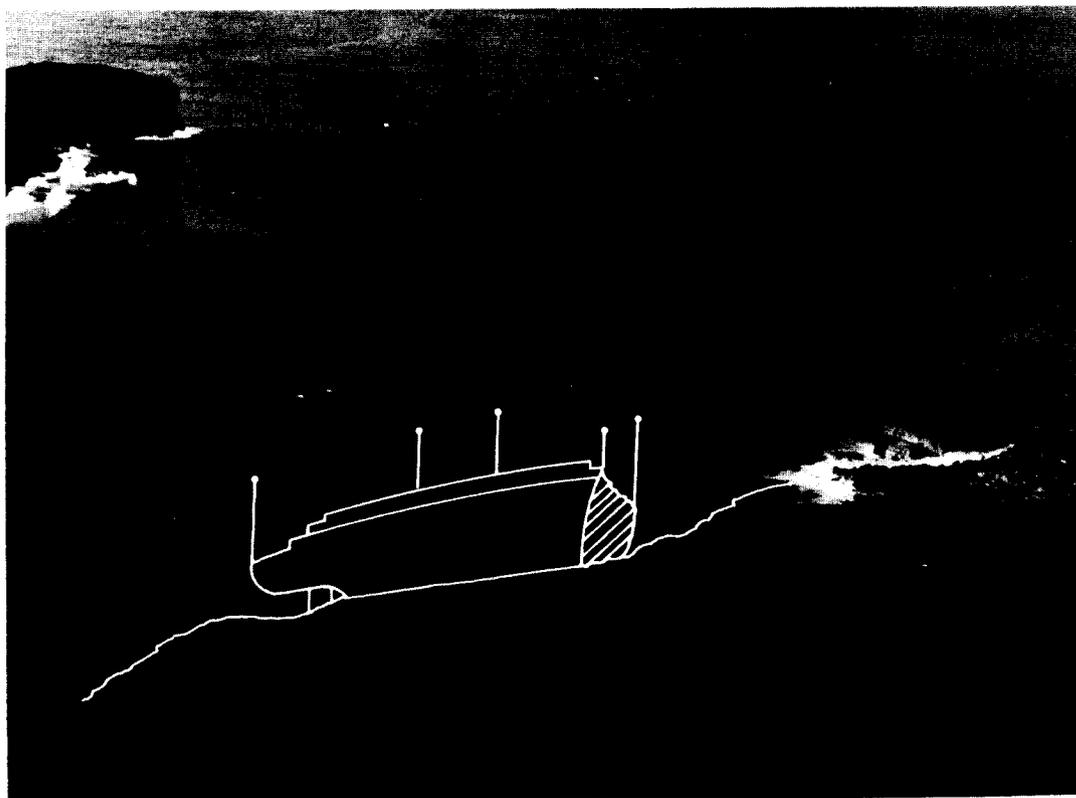
**CARIBIA'S FINAL POSITION**

*A sketch shows CARIBIA's hull positioned under the buoys set to mark location of the obstacle on the edge of Apra Harbor entrance channel.*

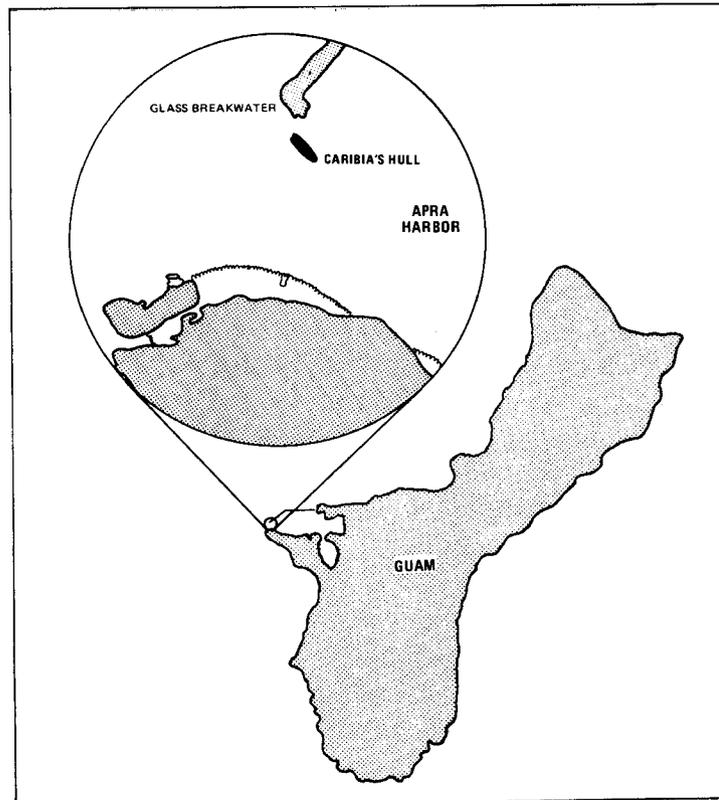
**CARIBIA'S BROKEN HULL ENDED UP IN APRA HARBOR'S ENTRANCE CHANNEL**

*After breaking up on the end of Glass Breakwater, the CARIBIA, minus its bow, slid down the Spanish Rocks into the channel edge.*

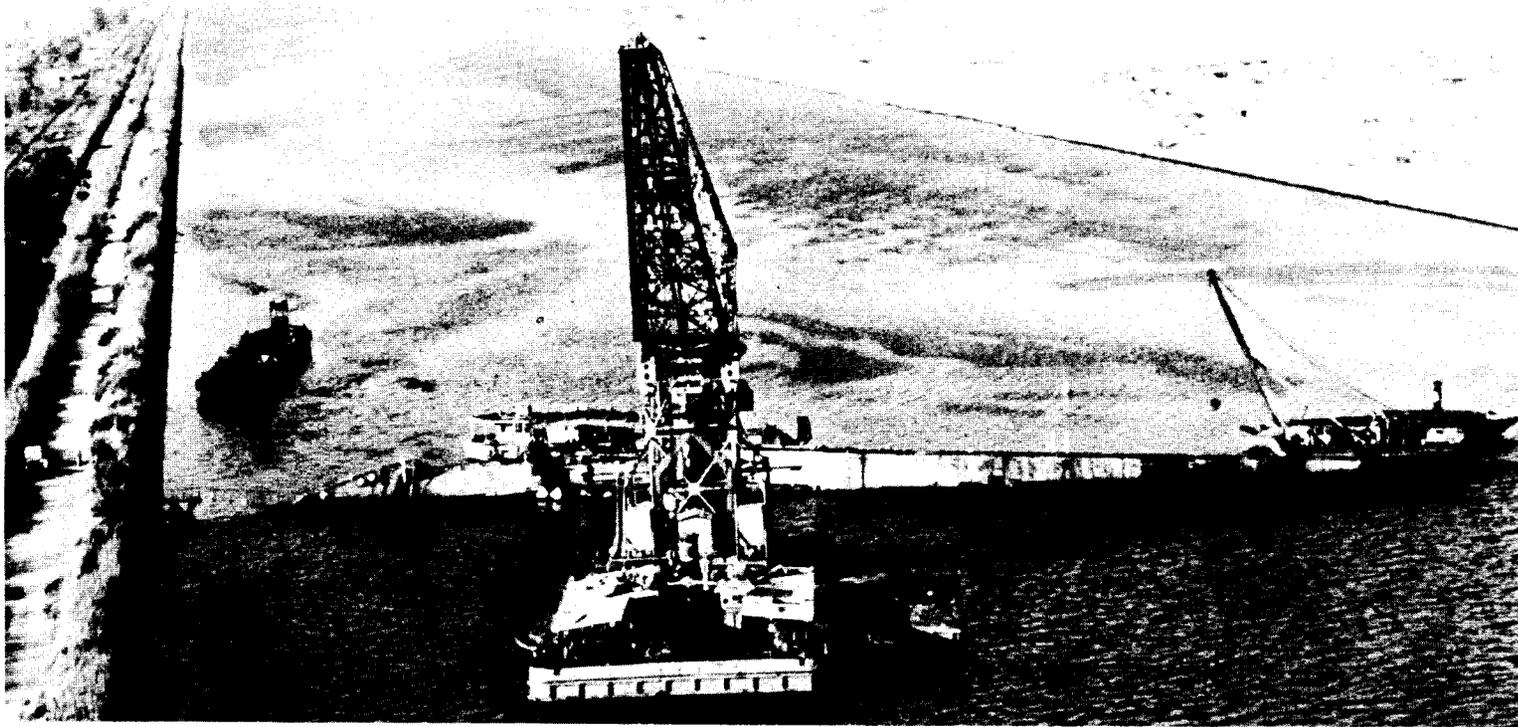
#### SCUTTLED WRECK BLOCKS THE SUEZ

*At the end of the Yom Kippur War in 1973, ten such wrecks blocked all Suez Canal traffic. The successful U.S. Navy operations to clear this vital Egyptian waterway contributed directly to improved Middle East relations.*

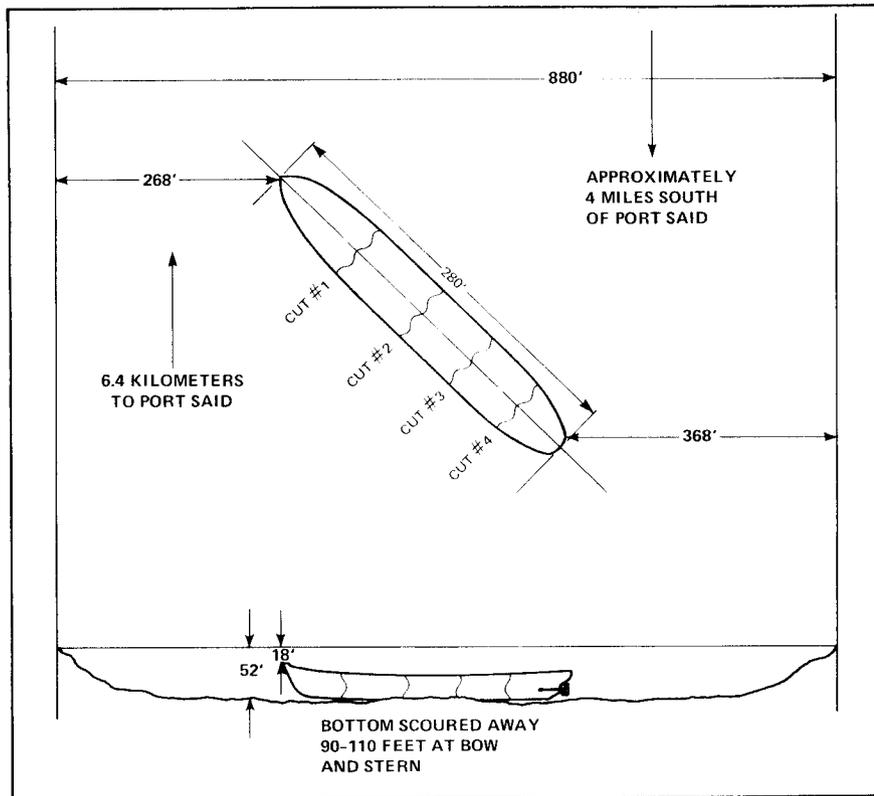
**SITUATION OF THE CARGO SHIP ISMAILIA**

*ISMAILIA, the northernmost wreck, was scuttled in the canal about 4 miles south of Port Said. Her superstructure and propulsion machinery, except boilers, had been removed. She was supported amidships in the bottom mud, but current scouring had left about one-third of her bow and stern cantilevered. ISMAILIA was dismantled into sections for removal along the cut lines indicated.*

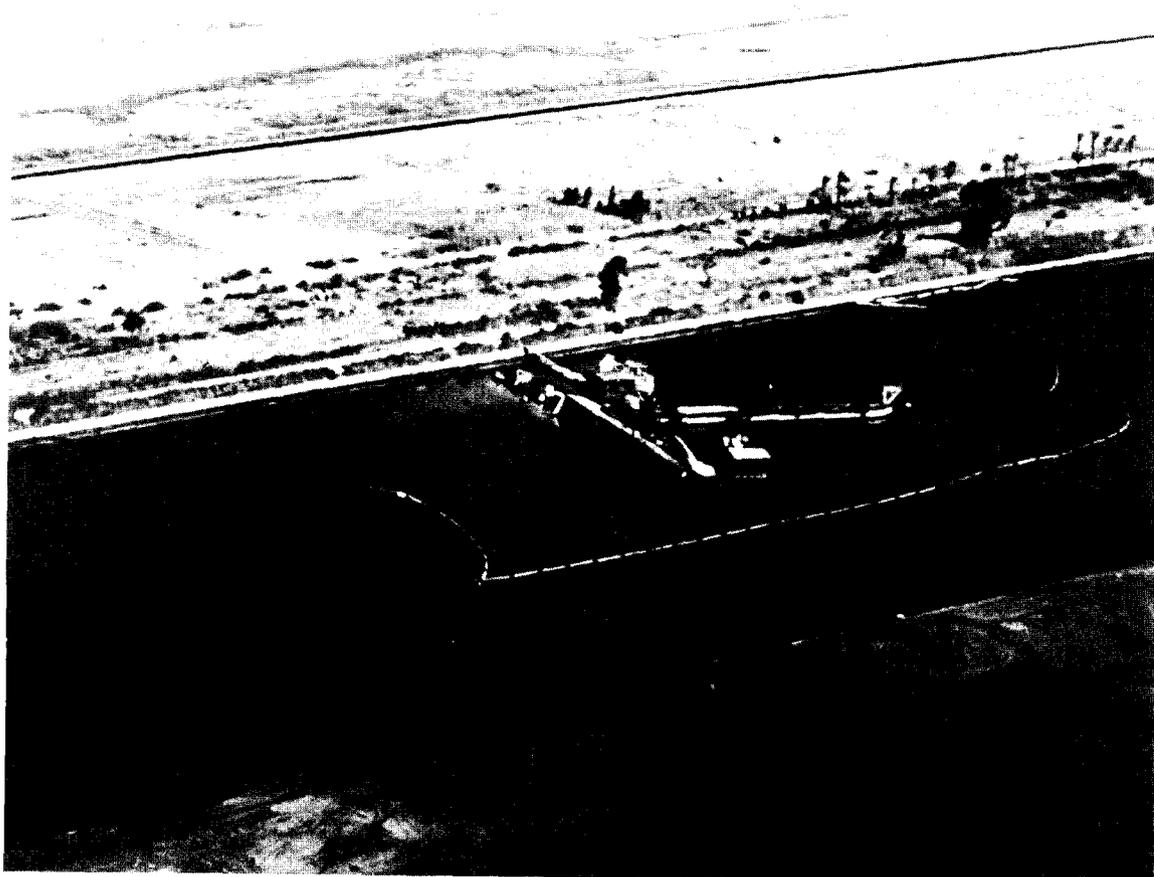
#### CONTAINMENT BOOM FOR OIL SEEPAGE

*During oil removal from MECCA, seeping oil was collected in bight shown at the right.*

The surface oil essentially was removed without difficulty in a day, but seepage continued to reappear and required collection when significant amounts accumulated. Spray and air curtains were rigged to minimize interference with divers.

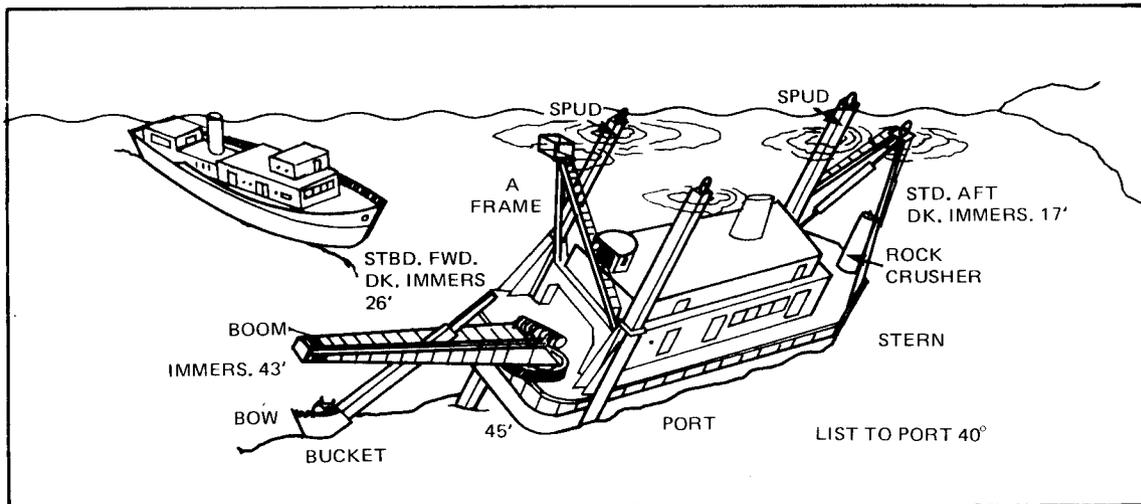
### MONGUED AND KASSER LAY ALMOST SUBMERGED IN CLOSE PROXIMITY

*The tug MONGUED was on an even keel on the gently sloping bottom. The bucket dredge KASSER was tilted 45° to port by her starboard mooring spuds, which were jammed in an extended position when she sank.*

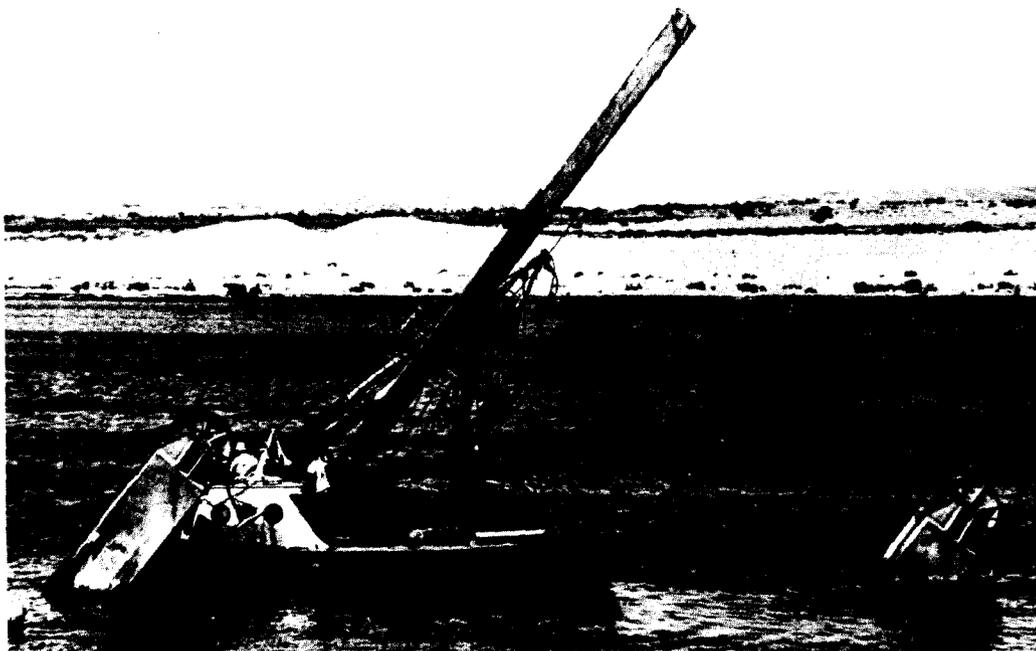
**DREDGE KASSER WAS TILTED 45° BY AN EXTENDED MOORING SPUD**

*The extended spud was sheared with an explosive charge and KASSER leveled herself.*

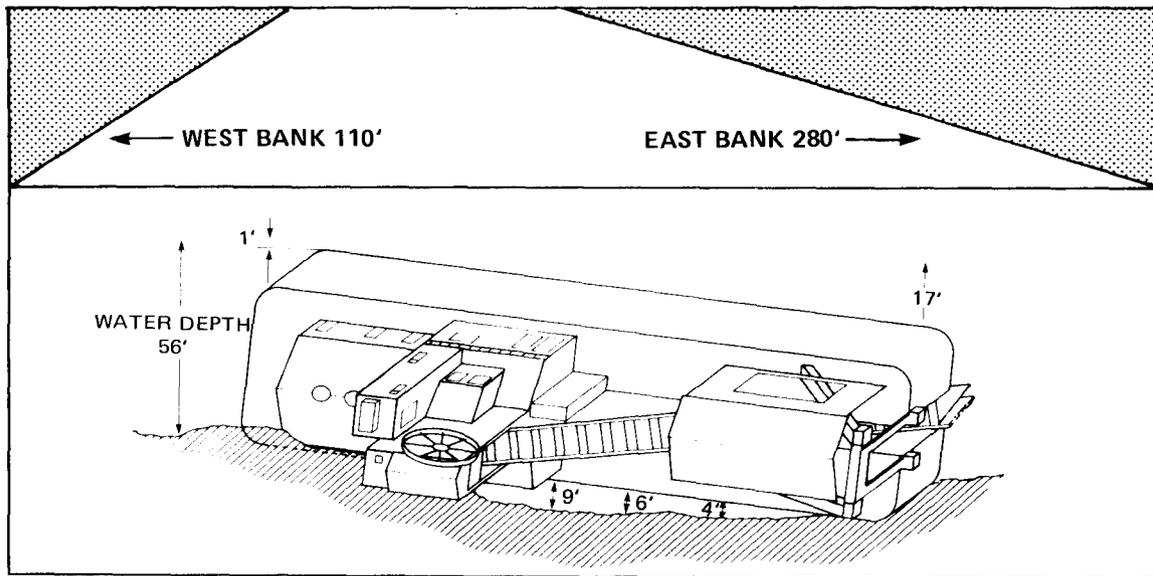
**POSITION OF DREDGE 23 AT KILOMETER 92**

*Just north of Ismailia, DREDGE 23 lay on its side blocking the western half of the canal.*
