# SALVOPS 74

**A review of significant salvage operations  
conducted by U.S. Navy salvage forces  
and other salvage activities during 1974.**

**SUPERVISOR OF SALVAGE, U.S. NAVY  
NAVAL SEA SYSTEMS COMMAND  
WASHINGTON, D.C.**

**NAVSEA 0994-LP-012-6060**

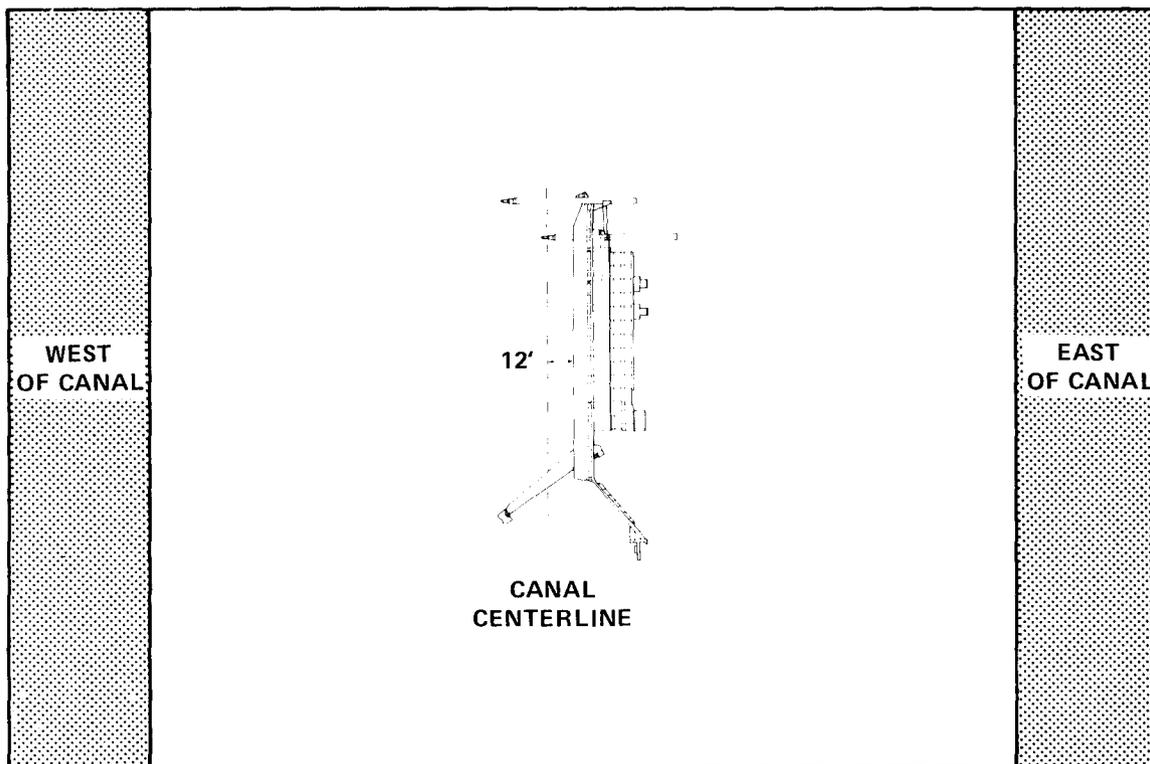
**POSITION OF DREDGE 15 SEPTEMBER AT KILOMETER 98**

*This dredge was the one vessel scuttled in the canal deemed worth salvaging and rehabilitating. Her recovery involved desilting, patching, and parbuckling to an upright position before she could be pumped free of water, refloated, and delivered to the Suez Canal Authority yard at Ismailia.*

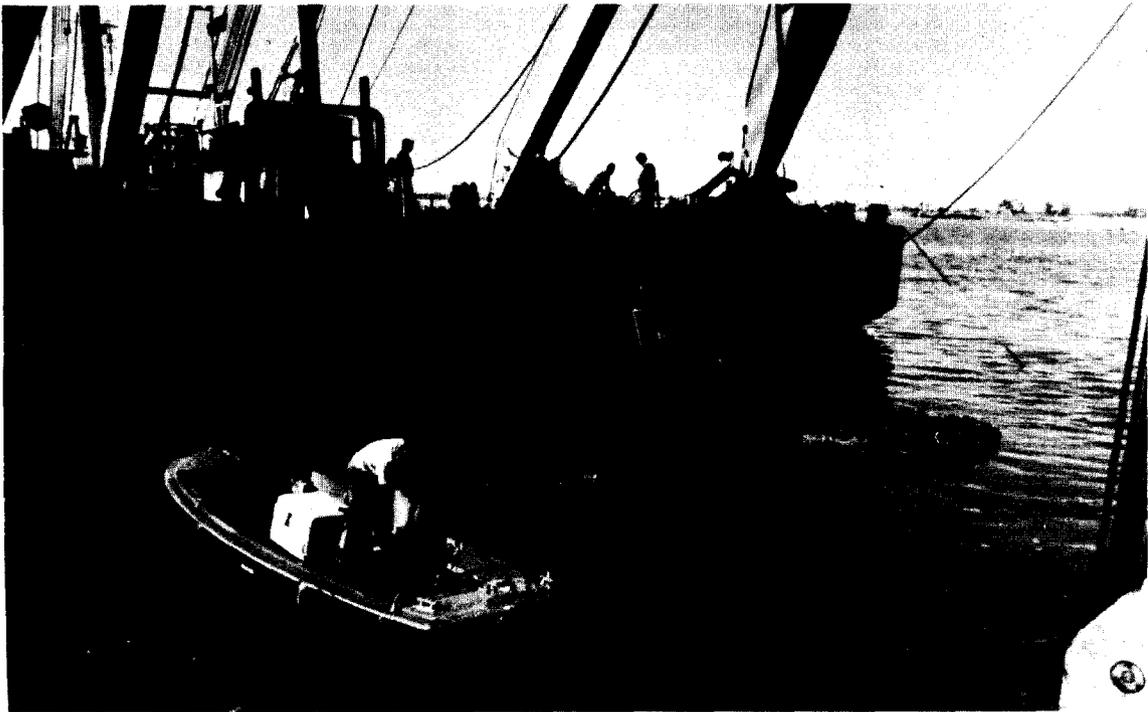
**STACKS OF DREDGE 15 SEPTEMBER APPEAR**

On 25 November, the trim and rig team, working with the crane crews, began recovering messenger wires that had been rigged previously, and running messengers for the remaining lift wires required. On 30 November, parbuckling required just 27 minutes but the parbuckling force of 950 tons had caused minor damage to the hull of the dredge. THOR's starboard wire cut 3 feet into the deck and port side gunwale. Four additional lift wires and chafing plates were rigged, and lifting operations commenced shortly after noon on 2 December. After application of 1,600 tons of lift, THOR's and ROLAND's main hooks and gin tackle lifted the dredge off the bottom. As the hull was raised above the surface, buoyant lift progressively was lost and the amount of lifting force had to be increased. Continuous lightening of the wreck became necessary for further lifting. Remaining silt and debris were washed out of each deck as it surfaced, and drain holes were burned when natural drainage did not exist. Then, with application of maximum load on THOR and 10-percent overload on ROLAND, 15 SEPTEMBER was raised until the main deck was 5 feet out of the water forward and 5 feet beneath the surface aft. It became evident that additional buoyancy would be required to surface the remainder of the main deck to pump out the hull.

*Workers in small craft inspect, as the heavy lift cranes THOR and ROLAND raise the dredge.*

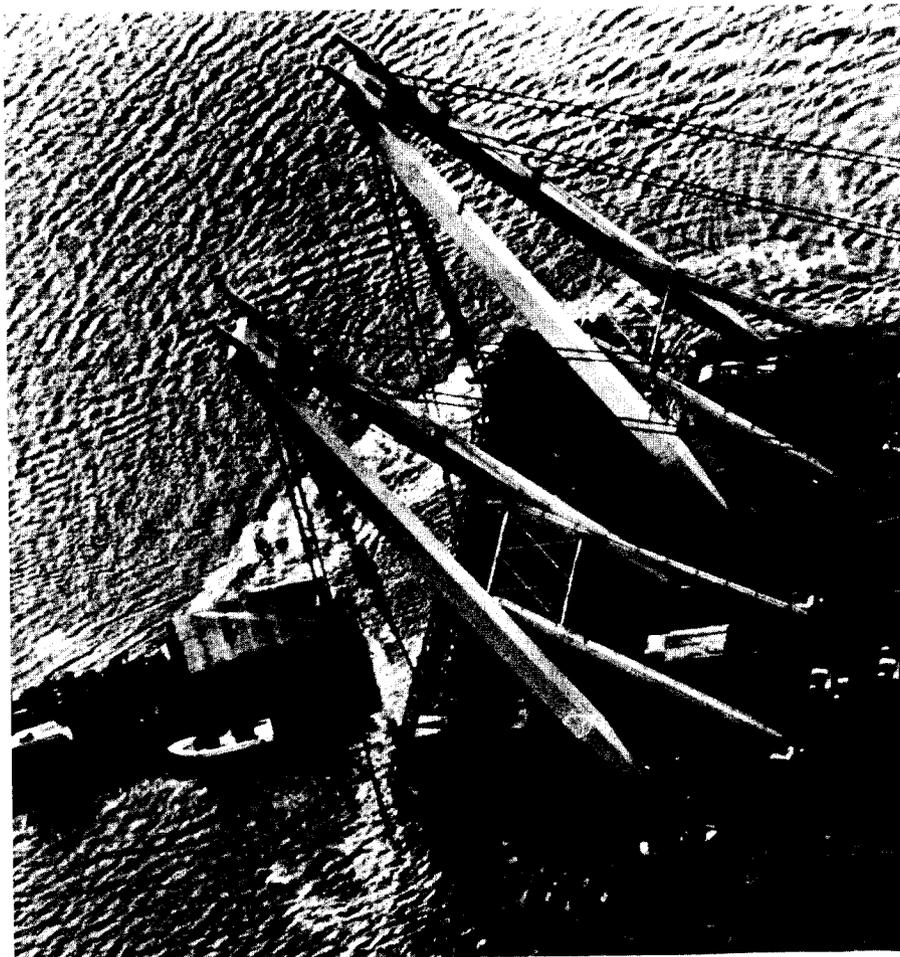
#### 15 SEPTEMBER'S MAIN DECK HELD CLEAR OF SURFACE

*With the dredge still suspended by the heavy lift cranes THOR and ROLAND, pumping is carried on continuously to maintain buoyancy.*

The after ballast tanks were patched and blown for more buoyancy, but numerous leaks detracted from this measure. Pumping was undertaken, with the bulkheads of the main deckhouse as a cofferdam, using one 6-inch, nine 3-inch, and several small submersible pumps. Care was taken during the dewatering to prevent shifting the center of gravity of the suspended wreck toward the already overloaded ROLAND, and pumping was concentrated aft to trim the wreck and lighten the load on ROLAND. With the dredge still suspended by THOR and ROLAND, pumping continued until the 15 SEPTEMBER was afloat. The following day, 15 SEPTEMBER was taken under tow by the German tug BUGSIER 26, with THOR trailing astern holding the 200-ton ladder off the bottom. After an uneventful 22-kilometer tow up the canal, 15 SEPTEMBER was delivered to the SCA yard in Ismailia at dusk on 6 December.

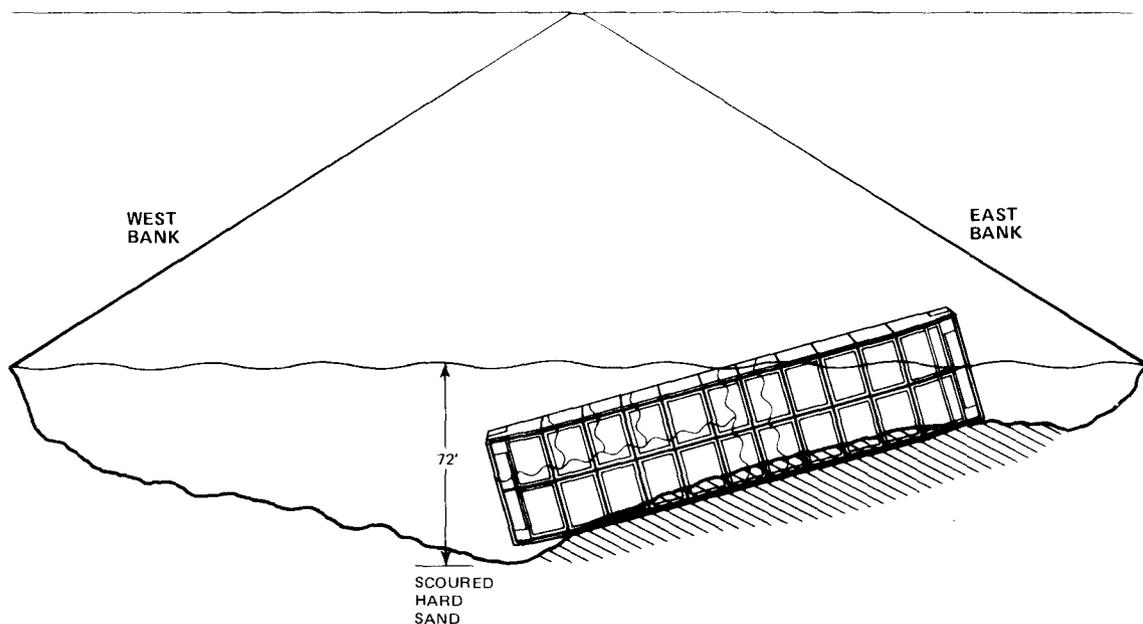
### POSITION OF CONCRETE CAISSON AT KILOMETER 87

Operations on the 3,800-ton caisson commenced on 30 August when the trim and rig team, aided by the crane barge **BAYOUMI**, arrived and began a second survey. This revealed that there was more additional damage than identified earlier. A crack originally 2 inches wide had opened up to 8 inches. In addition, it appeared that explosive charges, probably for fish killing by fishermen, had been detonated alongside since the survey 48 days earlier. These explosives had created a 12-foot-diameter hole in one end and a 5-foot-diameter hole in the other, and coupled with stresses on the cantilevered western end, had opened the crack amidships. The additional damage did not preclude the original salvage plan of sectioning and lifting.

*This 3,800-ton craft was removed after sectioning by the heavy lift craft **CRANDALL** and **CRILLEY**. The concrete was severed by explosive charges, and the reinforcement bar by oxyarc cutting.*

Lightening the western end required severing and removing the upper compartment. All explosive charge cutting was done from the outside so divers would not have to risk working inside a badly cracked concrete structure. The removal of five sections, totaling about 550 tons, required cutting 514 linear feet of reinforced concrete. This used 500 pounds of C-4 explosive; 258 pounds of burning rod, and 185 hours of diving time during an 18-day period.

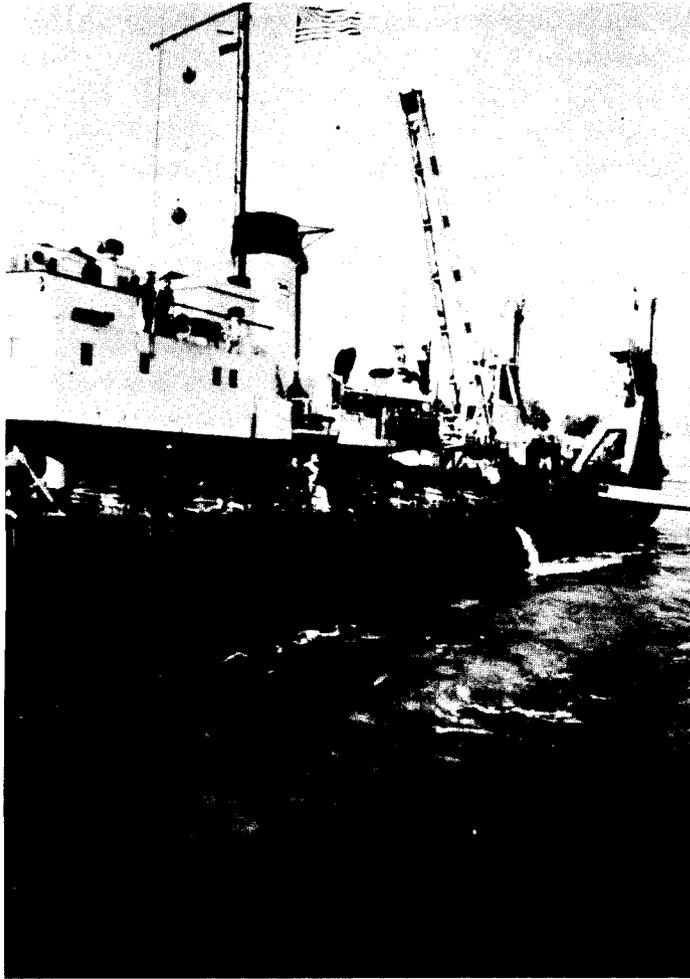
**SIDE LIFT BRINGS CONCRETE CAISSON TO SURFACE**

*YHLC is pumping ballast to raise the lightened caisson.*

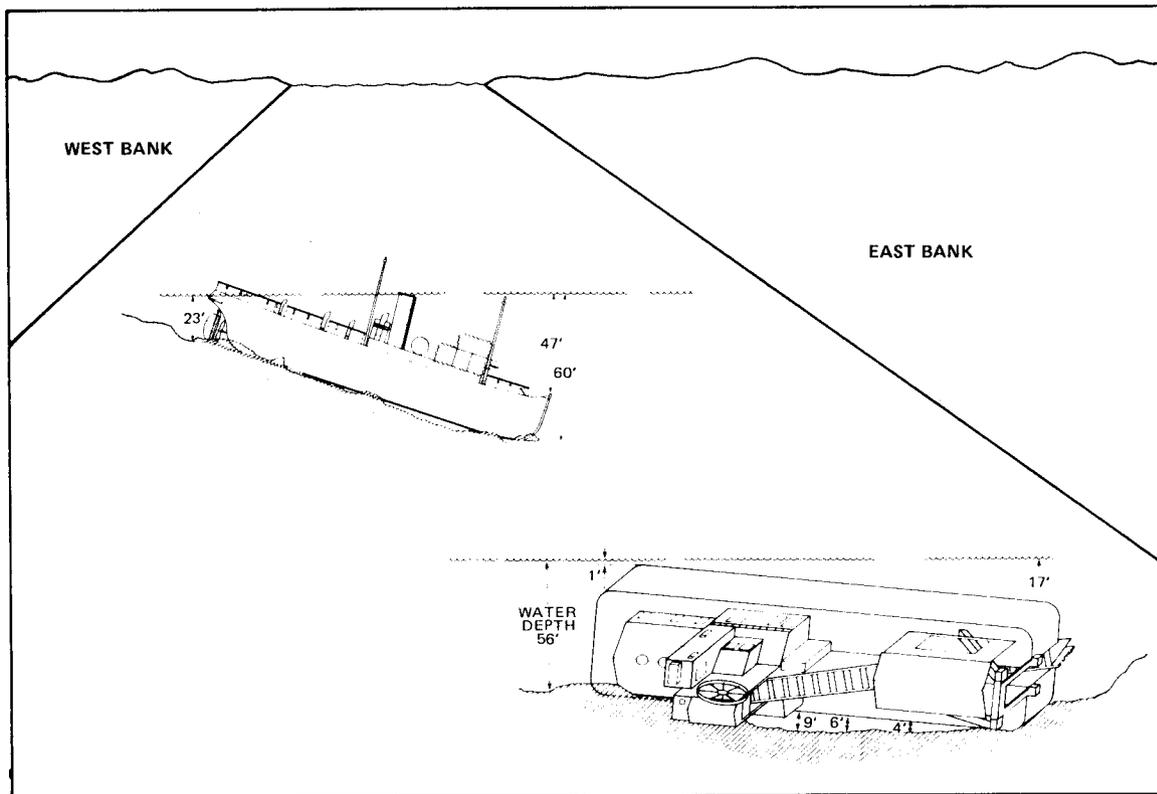
#### POSITIONS OF BARREH AND DREDGE 22 AT KILOMETER 158

DREDGE 22, displacing 1,200 tons, lay bottomed on its starboard side, approximately  $22^\circ$  past horizontal. Its position was perpendicular to the canal centerline with the bow 144 feet from the east bank and the stern 150 feet from the west bank, in an average depth of 52 feet. The hull was in poor condition from rusting and possessed numerous holes in the turn of the bilges to both port and starboard. In addition, sections of the main deck had been blown open and were rusted through, and the shelter deck had been carried away, leaving only steel framing.

*Despite the problems of interference due to close proximity and strong tidal currents, BARREH and DREDGE 22 were removed by the heavy lift cranes THOR and ROLAND, after trimming away superstructure and parbuckling DREDGE 22 to an upright position.*

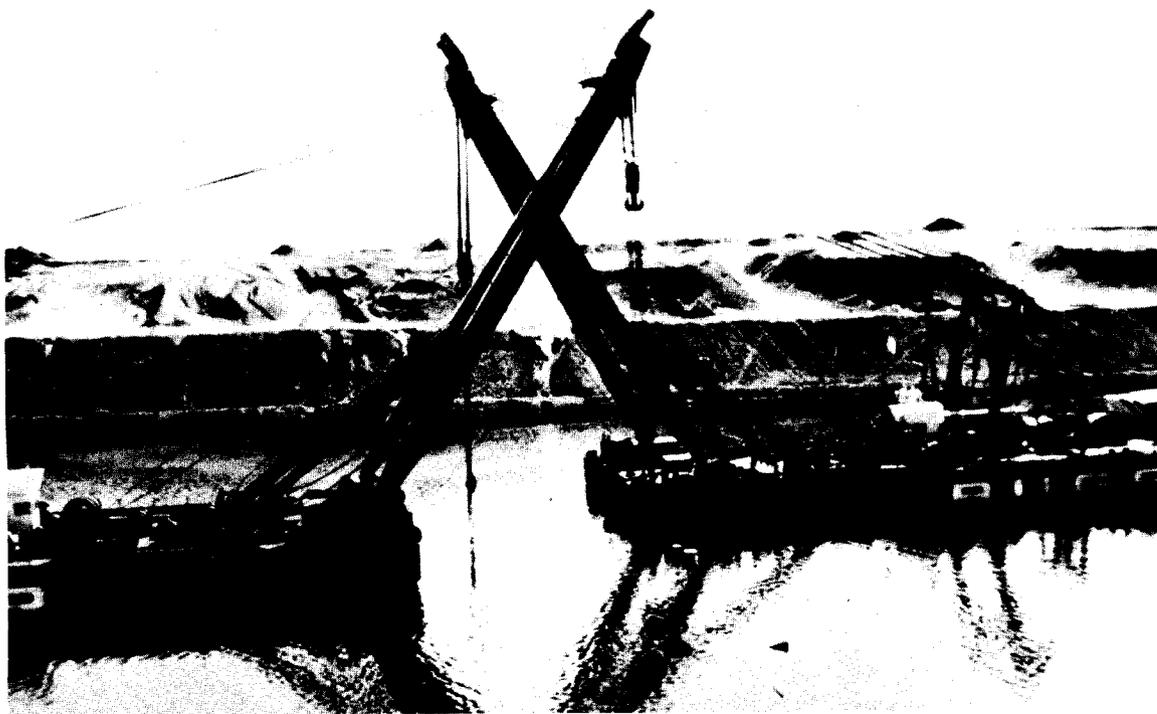
**PARBUCKLING DREDGE 22**

After parbuckling, it was discovered that a 3/8-inch-thick by 4-foot-long steel bolster at the turn of the bilge had been crushed into the hull approximately 4 feet. Precautions were taken to distribute the lifting loads over an even wider area by constructing larger bolsters of 3/8-inch plate stiffened with five sections of railroad rails welded to the plate. Two such bolsters 20 feet long were fitted on each side at the stern, and two similar 33-foot bolsters were fitted to the bow.

*Parbuckling was readily accomplished by the heavy lift cranes THOR and ROLAND working in concert. It did, however, result in some crushing of DREDGE 22's rust-weakened hull.*

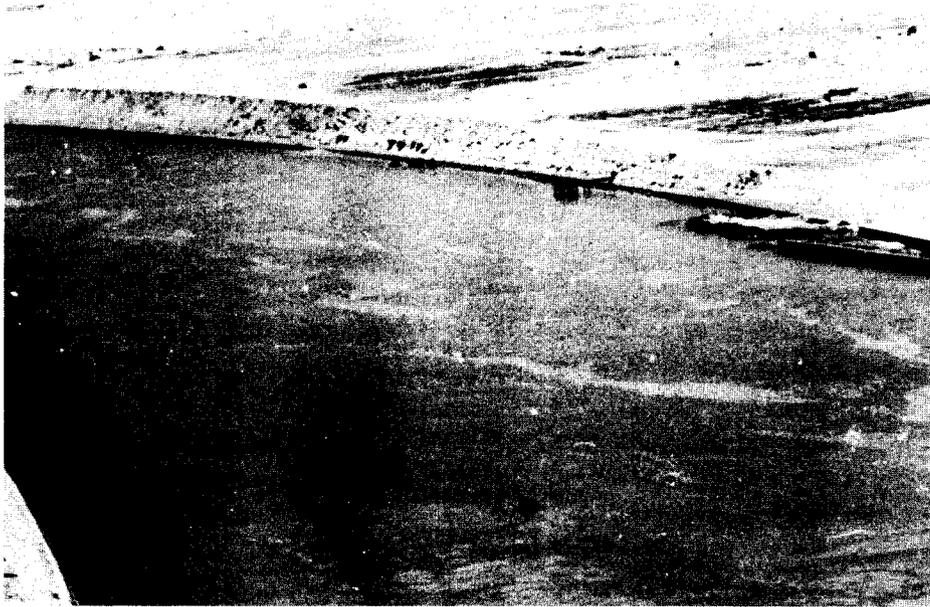
**TUG BARREH BOTTOMED**

The hull was sound, although the stack and the superstructure above the 01 level had fallen to port, the wheelhouse lay detached on the canal bottom, and eight portholes were broken, open, or missing. The hull was silted to a depth of 4 feet in the engine room, and to 3 feet in the boatswain locker aft of the engine room.

*The stern and stack of BARREH are visible protruding above water in the foreground.*

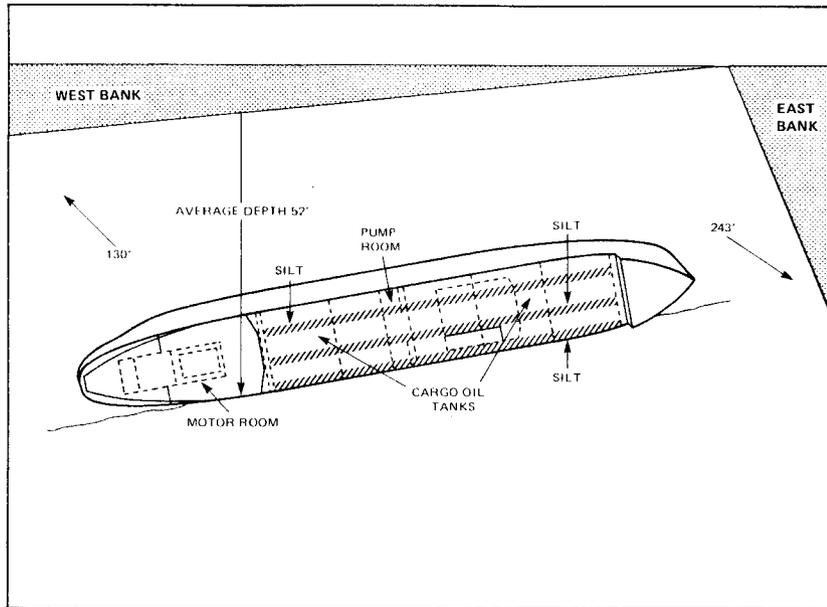
**POSITION OF TANKER MAGD AT KILOMETER 157**

The 2,400-ton tanker MAGD lay on her starboard side, 30° to the canal centerline, with her bow approximately 130 feet from the west bank. In 10 feet of mud on the canal bottom and 14 feet of water clear above it, the hull was in poor condition. Although the

superstructure was intact, cargo tank tops were buckled, plating and rivets were missing, and damage in the tankage was widespread. MAGD was silted to a depth of 2 to 4 feet in the starboard and center tanks, and 4 to 6 feet in the port tanks. Mud was pocketed throughout the engine room in depths varying from 3 to 10 feet.

*MAGD lay on her starboard side just east of midchannel, pointed 30° west of midchannel. She had collected heavy deposits of silt on the starboard bulkheads of all her tanks as a result of lying on her side in the extremely muddy water.*

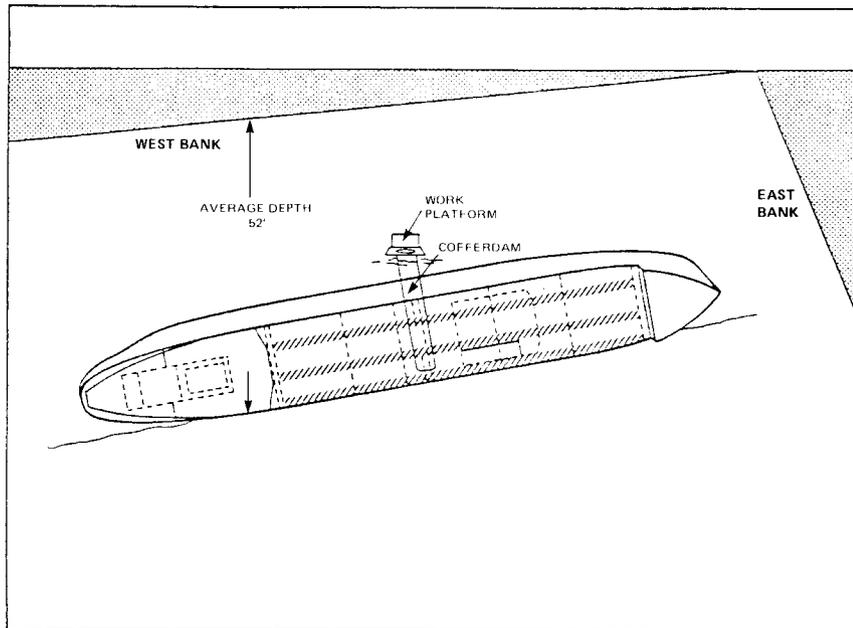
**COFFERDAM INSTALLATION**

*Cofferdams were installed on MAGD's upward-facing port side to facilitate diving operations inside her hull.*

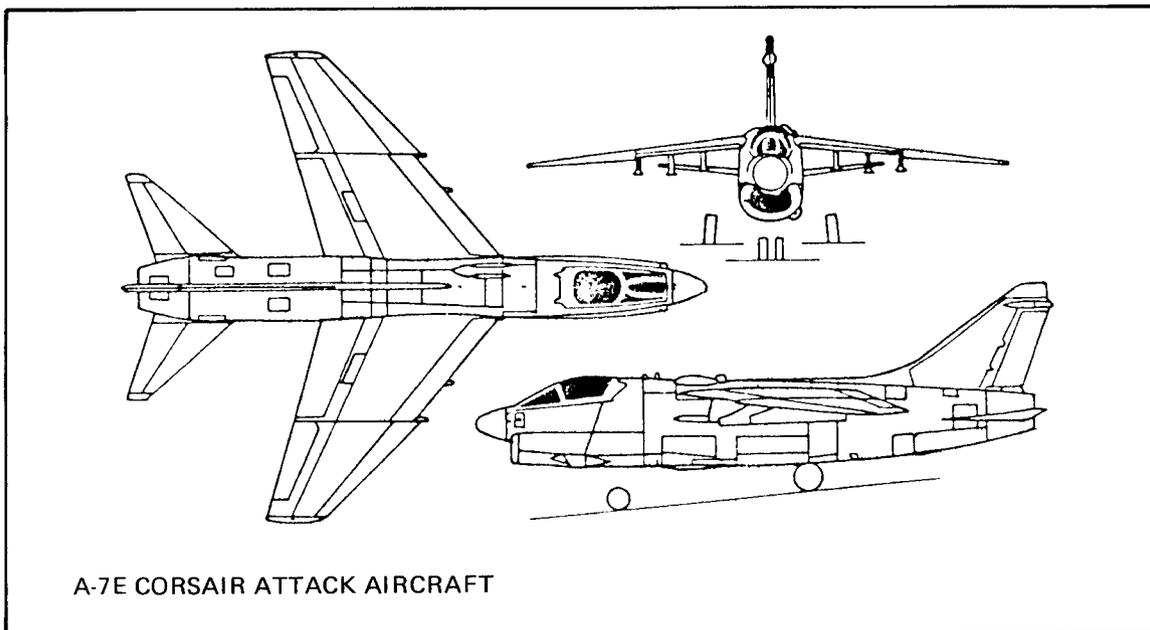
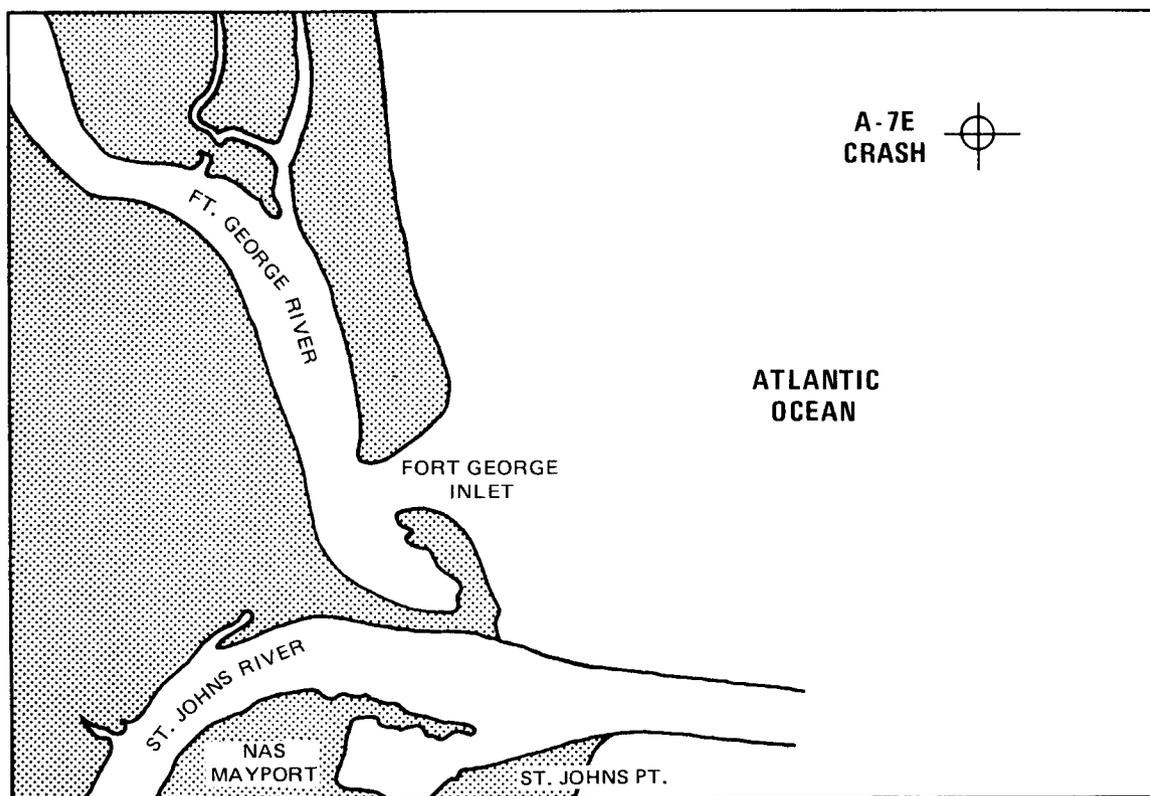
LOCATION OF NAVY CRASH OFF NAS MAYPORT, FLORIDA

information, corroboration from a police helicopter that had been on the scene, and the jetty eyewitness's bearing line, the most probable search area was redetermined to be well north of the initial search area. A three-square-mile search area was set up, therefore, which encompassed the new estimated position, that of the reported oil slick, and the eyewitness bearing line.

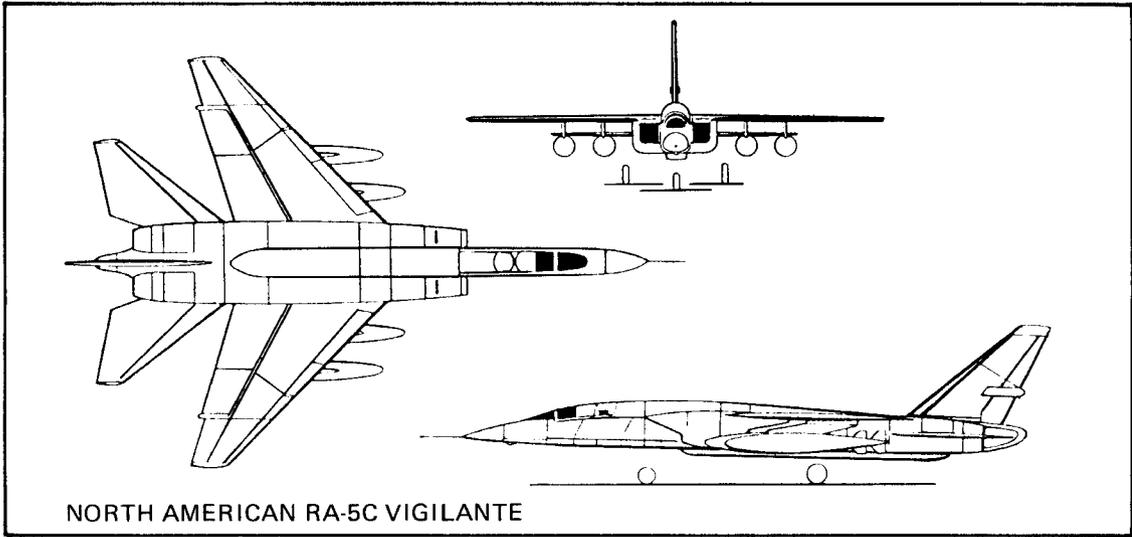
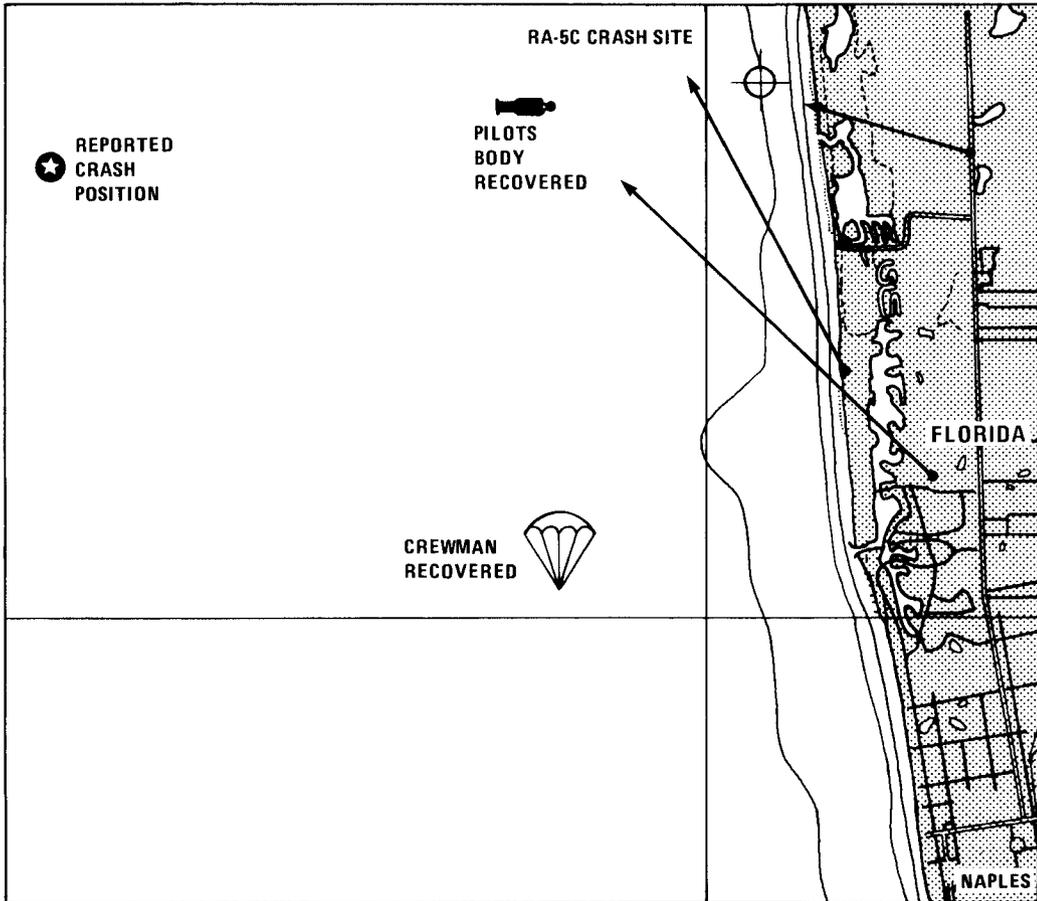
LOCATION OF NAVY RA-5C CRASH OFF NAPLES, FLORIDA

three-man team of Explosive Ordnance Disposal (EOD) divers from Key West was called in to search the area. This diver search, with hand-held sonar, proved fruitless as did several other diver searches conducted 3 to 5 miles from the buoy based on oil slicks and other information.

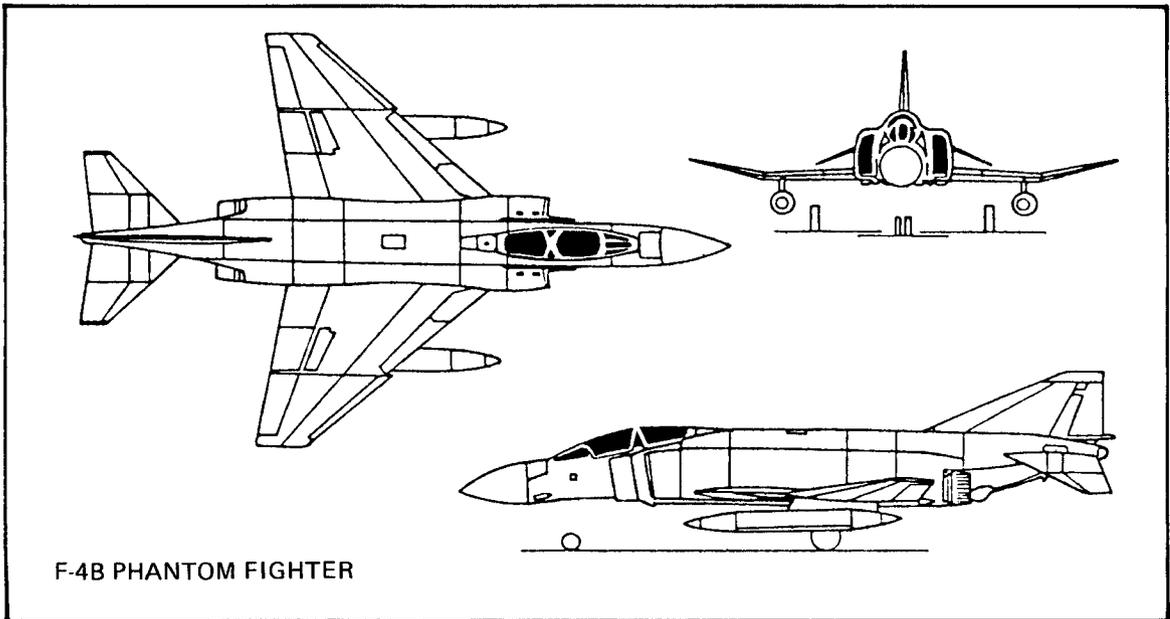
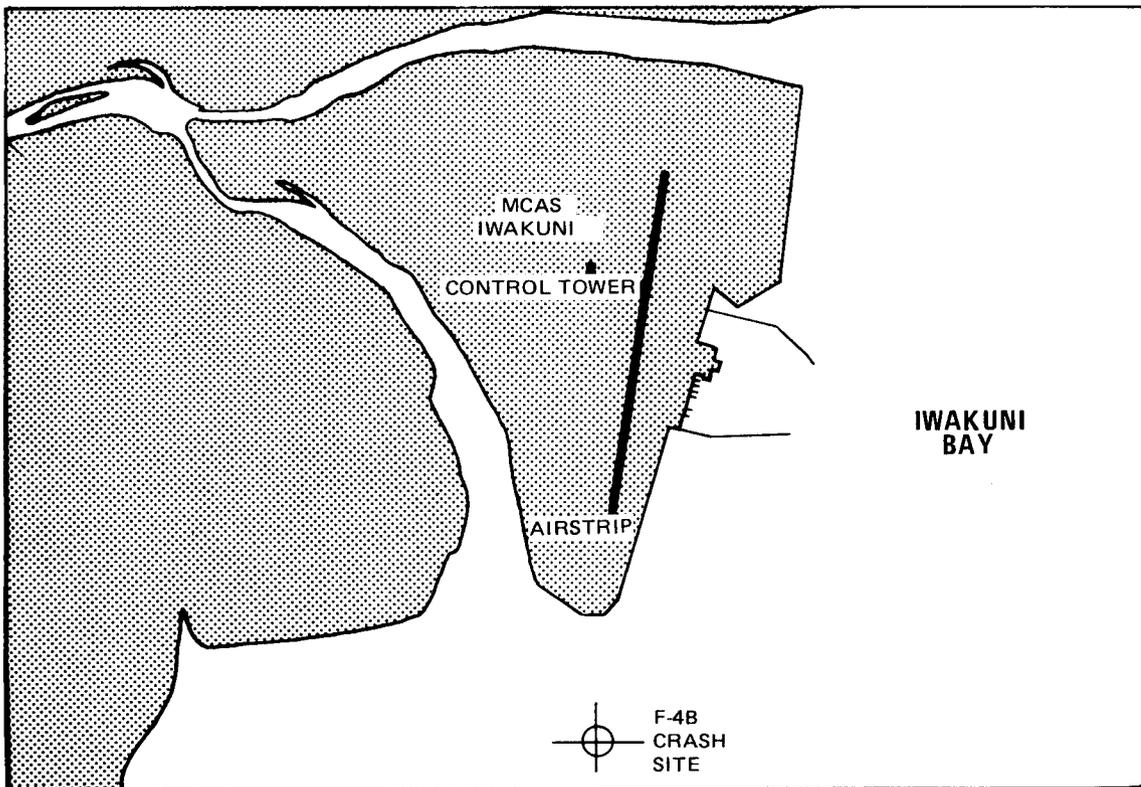
LOCATION OF MARINE CORPS F-4B LOST IN JAPANESE INLAND SEA OFF MCAS IWAKUNI

unsuccessfully through the arrival of SAFEGUARD on 25 October. SAFEGUARD's first effort was to plant crown buoys to define the area already covered by dragging. The following morning, local fishermen reported fouling a net between two of the buoys, and bringing up aircraft wreckage. Dragging was focused in this area and part of an inflight fueling probe was recovered. This location was then buoyed for the next day's search.
