SL740-AC-RPT-010/SUPPSALV

USCGC MESQUITE SALVAGE OPERATION DEC. '89 - JULY '90 KEWEENAW PENINSULA, MICHIGAN

19 JULY 1991

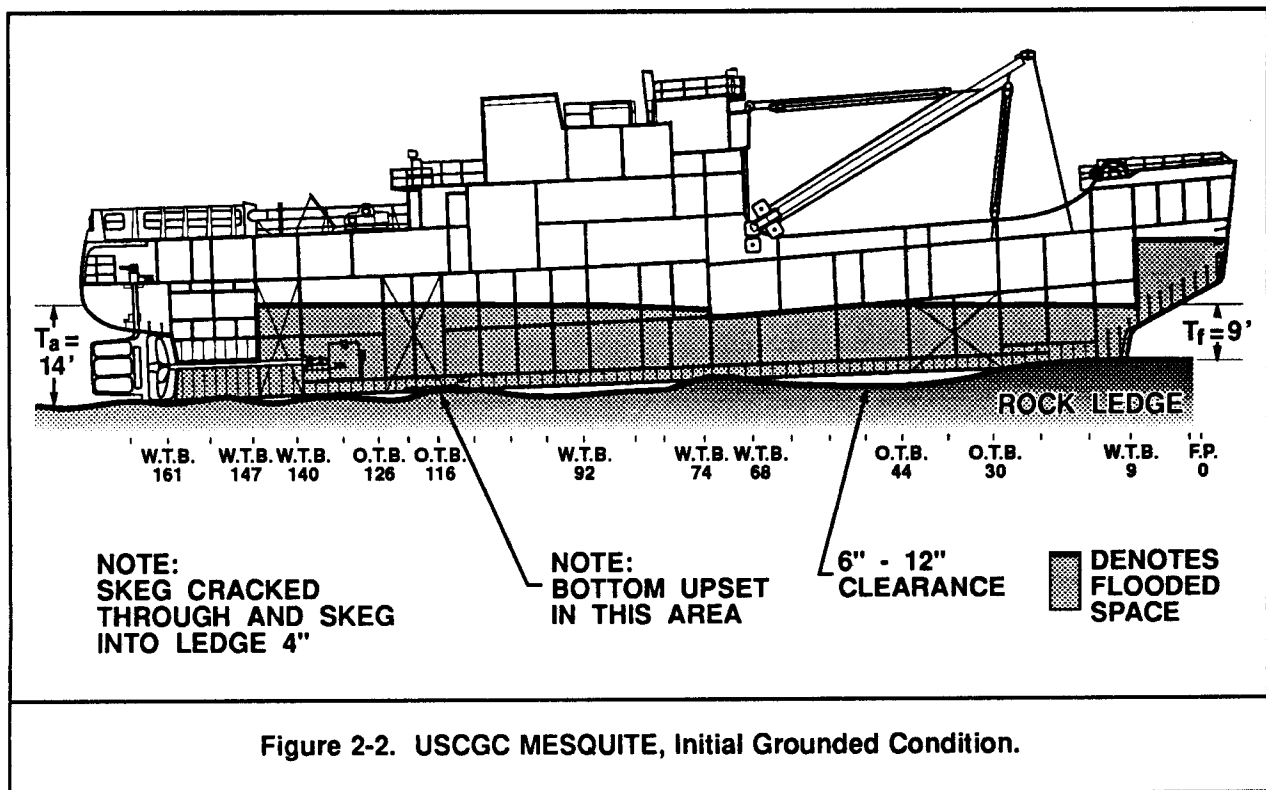
Figure 2-1. Slippery Deck Conditions on MESQUITE.

The ship was supported intermittently along its length, with about 25 percent of the keel in contact with the bottom. The longest bearing areas were at the stem, skag, starboard-side Frame 116, and the port side from Frames 44 to 62. There were many locations where the vessel did not bear on the rock ledge, but in several areas there was not enough clearance between the keel and the bottom for divers to see the keel or A-strake. Damage to the hull consisted of upset hull plating along the ship's length, primarily along the keel and 8 to 10 feet outboard of the centerline, to port and starboard. There was significant upsetting in way of the main cargo hold and the engineering store room; the latter was holed. Three large cracks began in the engine room at Frame 115 and extended aft into the centerline fuel tank, B-2-F.

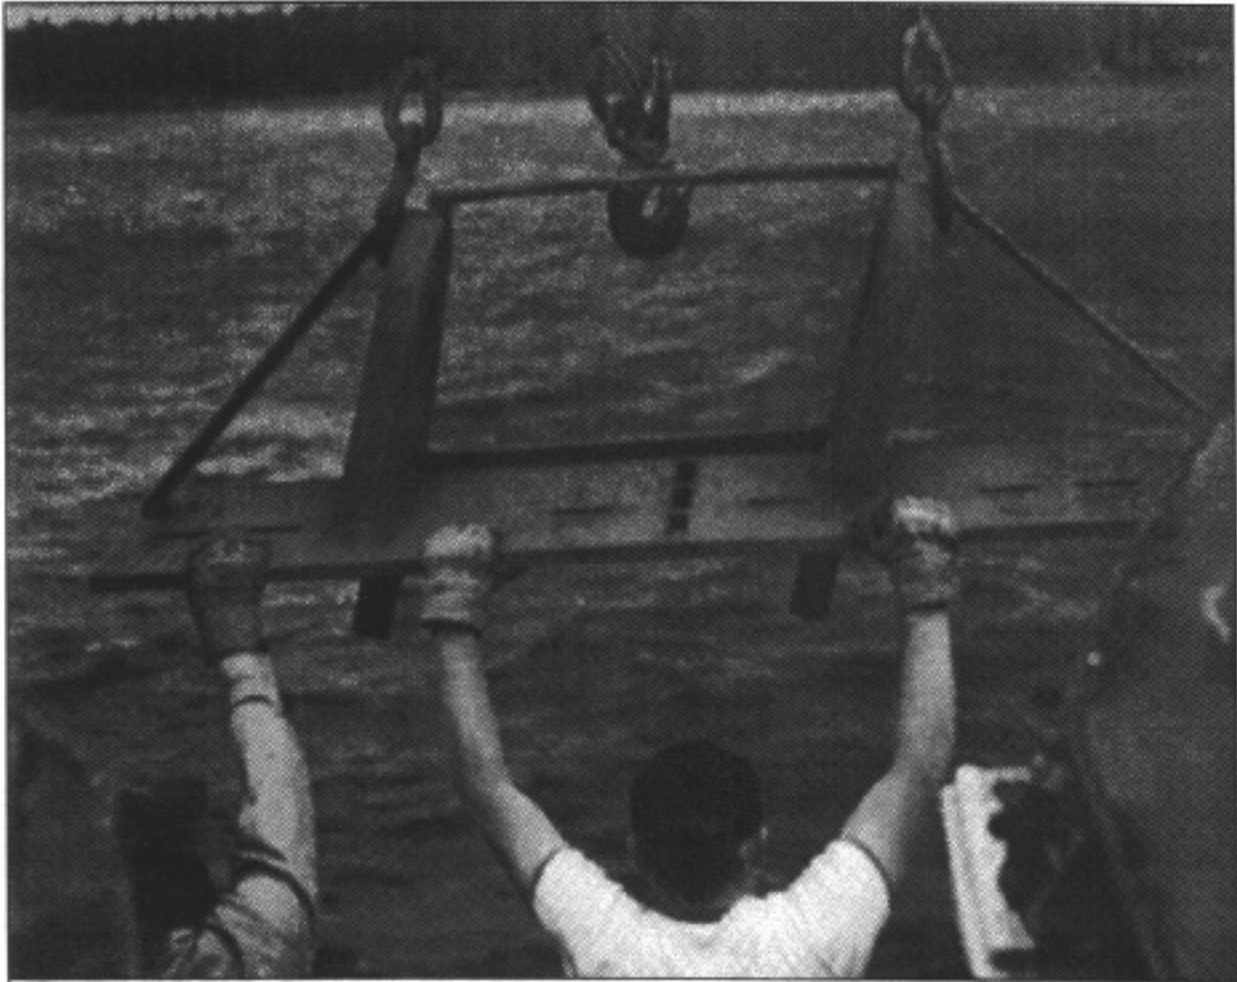
Figure 3-15A. Lift Pad Being Lowered into Place.

The aft lift pads had been prefabricated, and utilized some of the ships' framing drawings. The pads were then brought to the site and installed by suspending them from the crane hook and aligning them by hand to the list of the deck. The aft starboard pad assemblies were installed first and fit perfectly, as seen in Figure 3-15a and 3-15b.

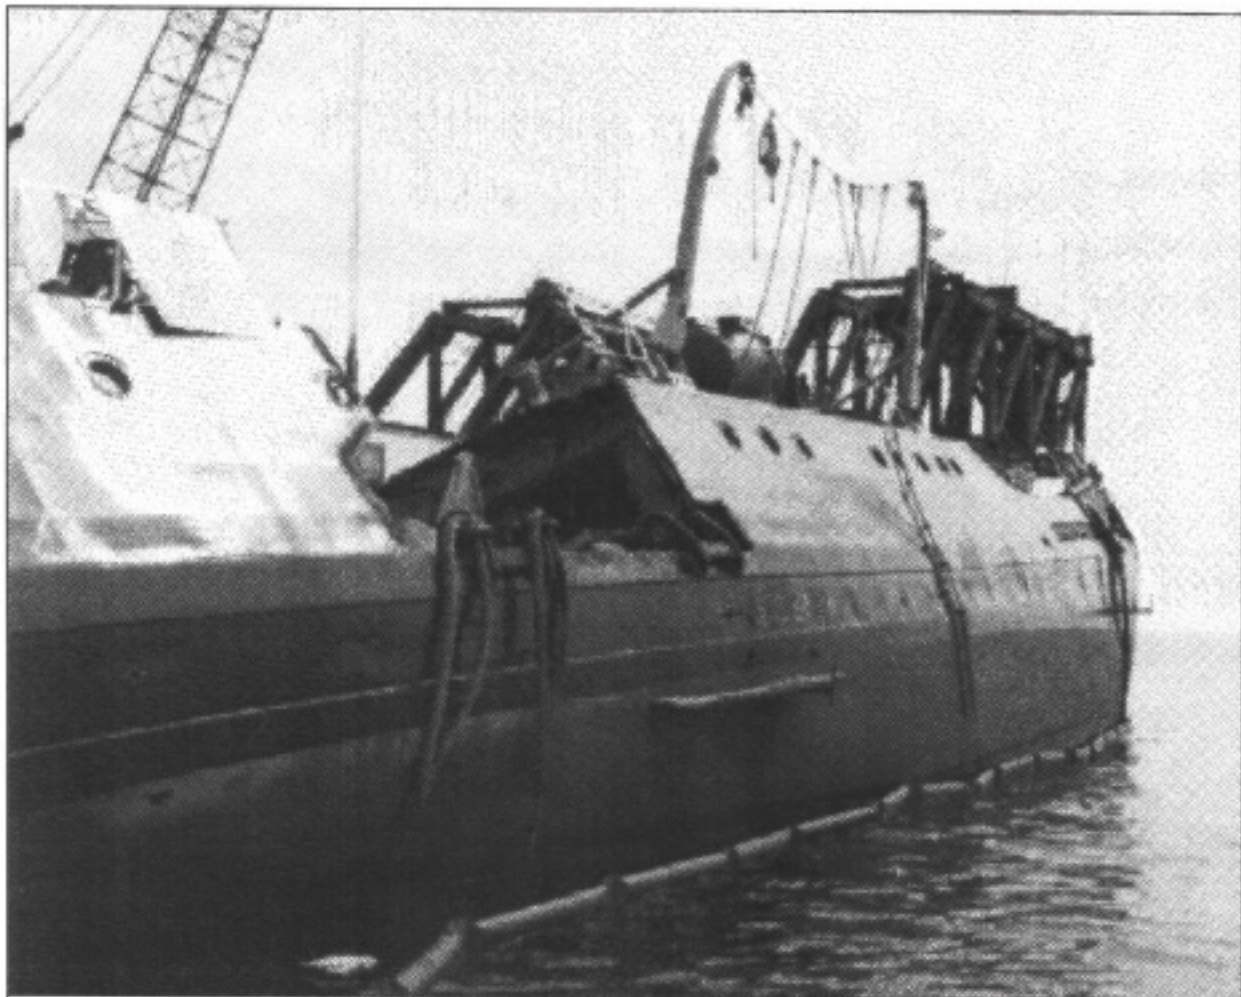
Figure 3-17. Hauling Lines Attached to Lift Pads Prior to Parbuckling the Wreck to Even Keel.

After the starboard lifting padeyes were welded in place, a messenger wire was passed under the hull by the divers so that a doubled 2½-inch wire pendant could be hauled under the hull for parabuckling the wreck to even keel. The doubling was to get the right length. At this point, a suggestion was made to use the aft end parabuckling wire alone to roll the hull. Using a single parabuckling wire would decrease the rigging time and also free up the second lift truss when it came time to hook it into the forward lift pad. The single parabuckle wire idea was accepted as it looked promising, and the original plan could be easily reinstated if it failed. The crane, lifting bights of the messenger, pulled the parabuckling pendant under the hull until its two end fittings came up even with the after-most starboard lift padeyes and were bent onto them with 2-inch safety shackles, seen in Figure 3-17. Next, the bight of the parabuckling wire was bent onto the running block of the barge's port lifting truss. The block and wire was heaved in and the wreck gently rolled back to even keel.

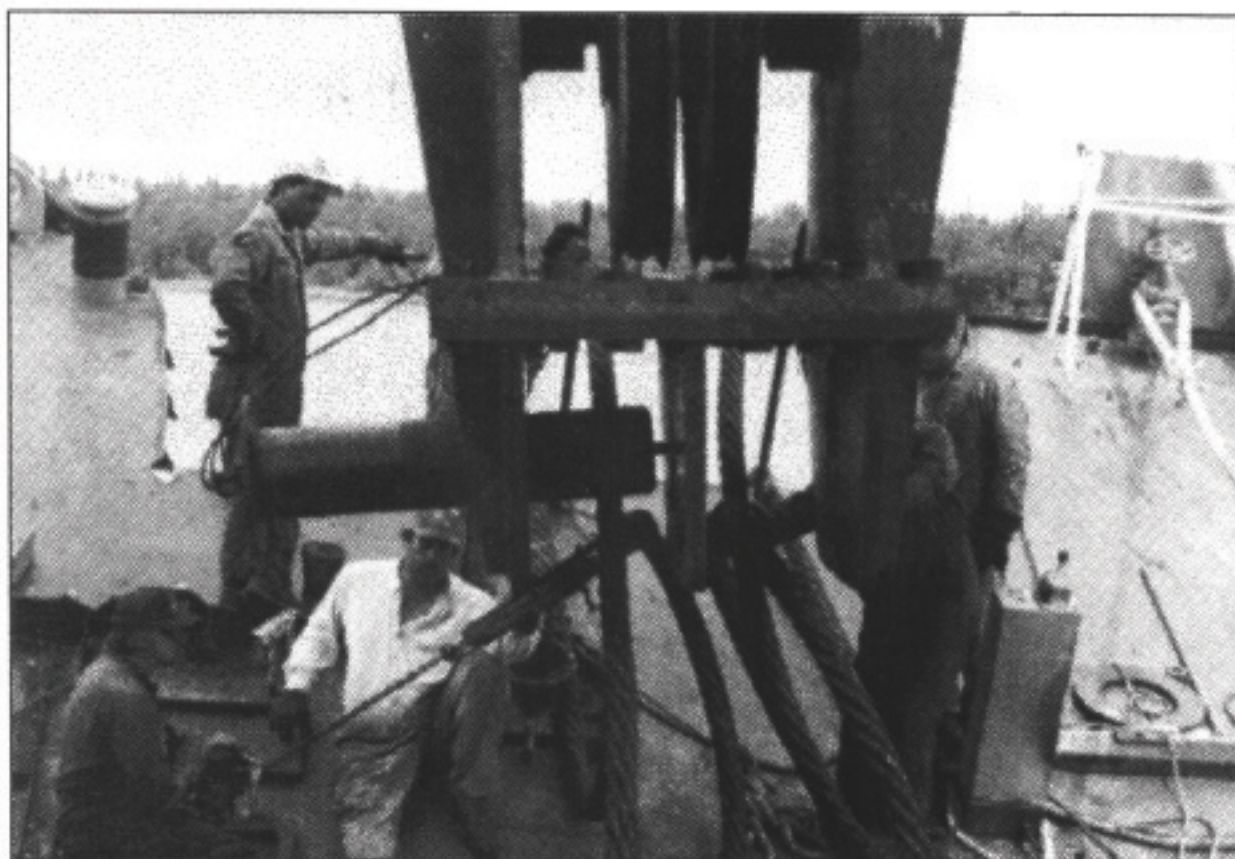
Figure 3-18. Lifting Pin Set to Capture Sling.

With the help of a come-a-long, the running block was aligned to the angle of the deck and maneuvered into position for the lifting pin to be pulled home. The pin was then secured, as shown in Figure 3-18.

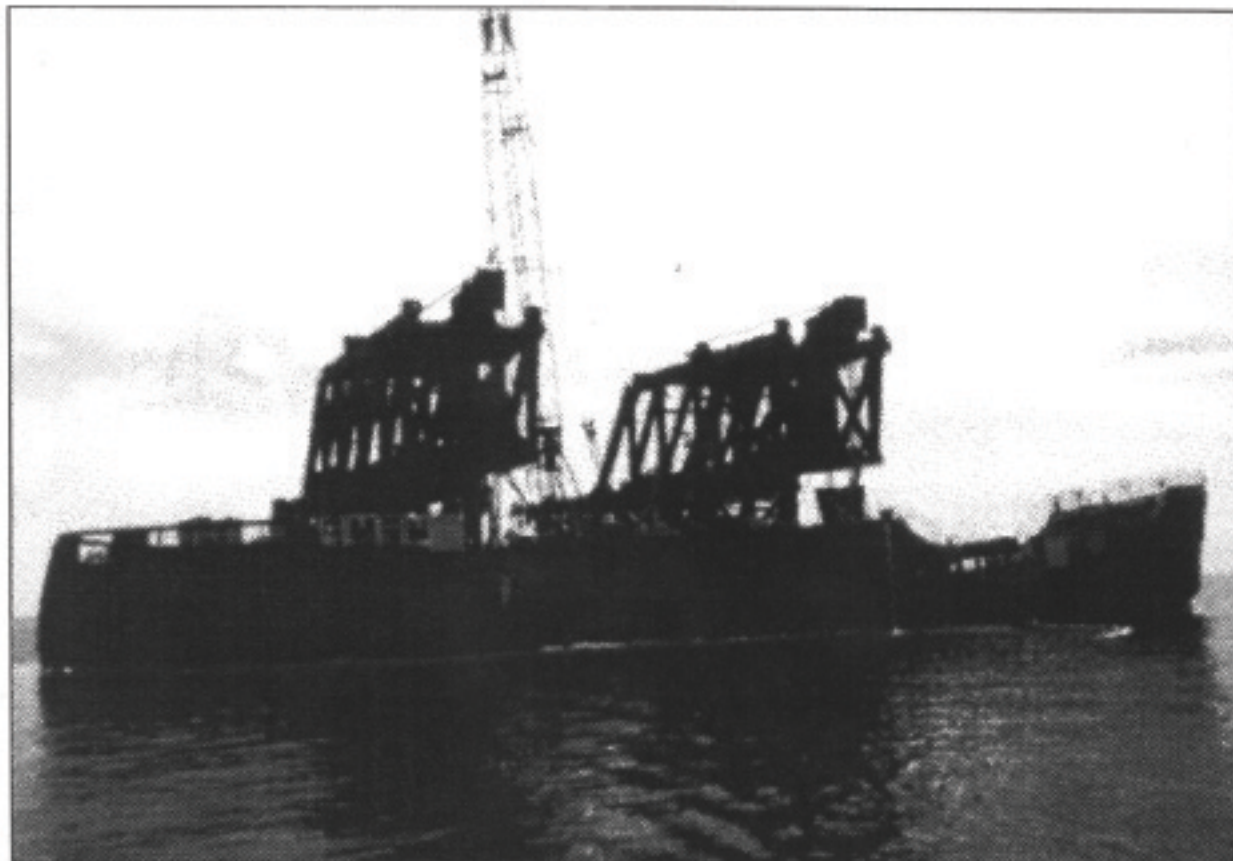
Figure 3-20. Wreck Being Lifted.

3-4.6.3 Lifting the Wreck. The lifting operation commenced with the slack being taken out of the lift slings. The plan called for the lifting load to be countered by taking on ballast in the barge's forward tanks. The pumping operation was taking more time than anticipated and would require an additional 5 to 6 hours. The salvors decided to go ahead with the lift with the barge only partially ballasted. A watch was posted to call out the draft marks as the wreck was lifted. The lift trusses took the strain and the wreck rolled easily to no list. The lifting continued with the lift barge pulling herself down into the water as the wreck's displacement load was being transferred to the barge. When the wreck finally lifted off the bottom, the lift barge had less than a 6-inch clearance under its starboard skeg, shown in Figure 3-20.

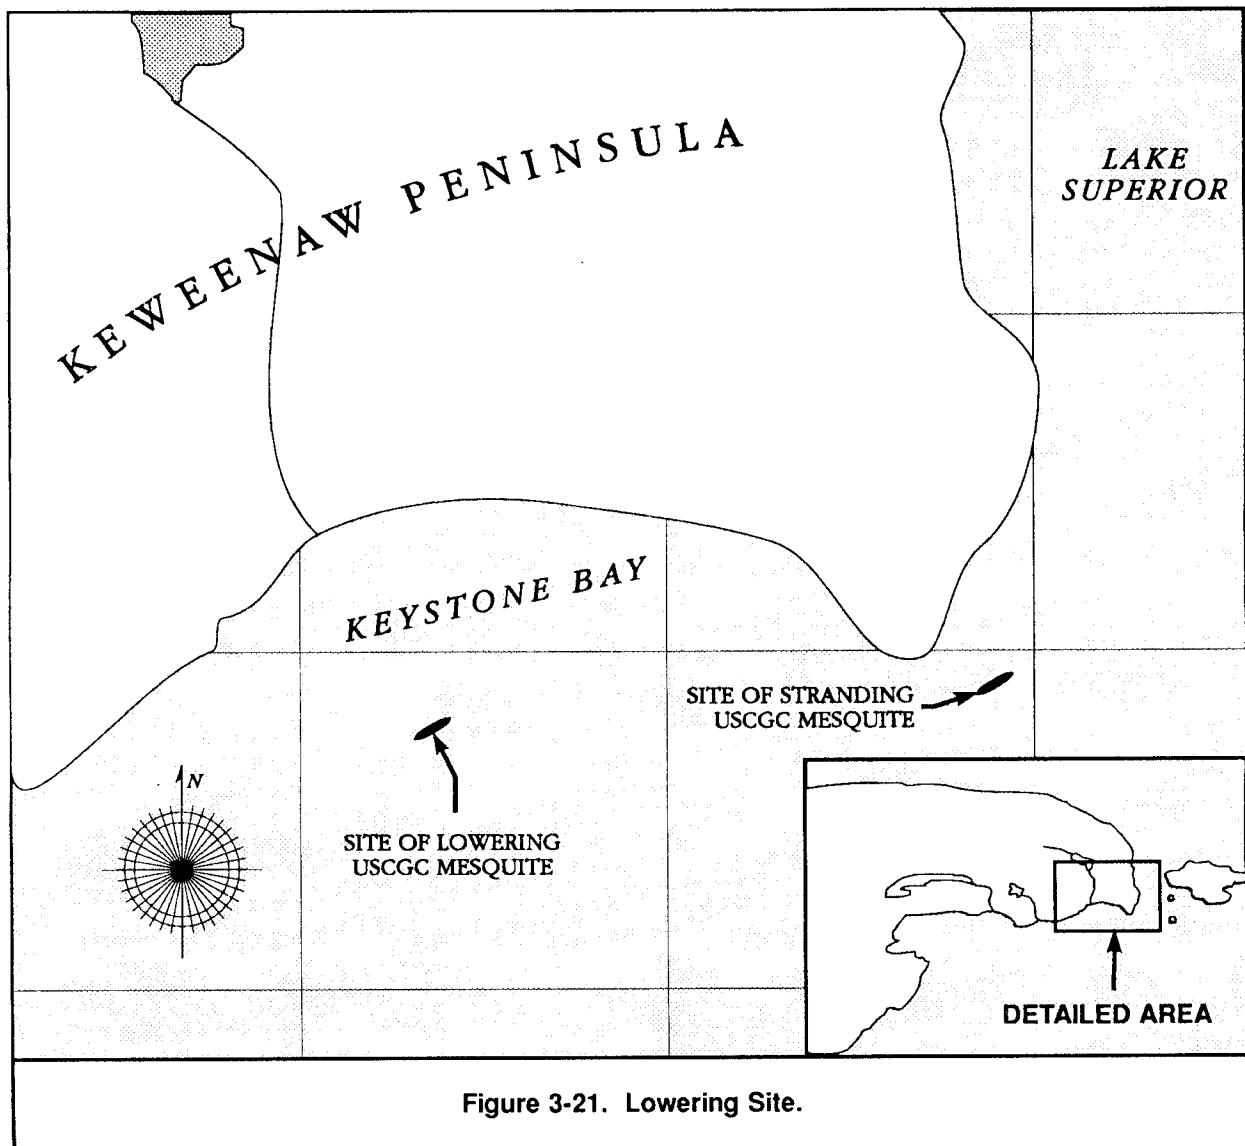
Figure 3-21. Lowering Site.

3-4.6.4 Lowering. When MESQUITE was clear of the bottom, the tug proceeded to pull the tow to deep water by making way northeast, picking up the mooring anchors along the way. Once in deep water, the tug master opted to continue backing, and backed the tow 1½ miles to the lowering site (Figure 3-21).

Once MESQUITE was positioned over the disposal site, the purchase wires were slacked and the hull started to sink. It took 10 minutes of paying out the lift wires to lower MESQUITE's deck to the water level. As soon as water began to pour over the deck, she quickly took on a dead weight of approximately 350 long tons as the buoyancy was lost. The lowering was straightforward and continued evenly until the bottom was reached at 117 feet with 75 feet clear over MESQUITE's davits.

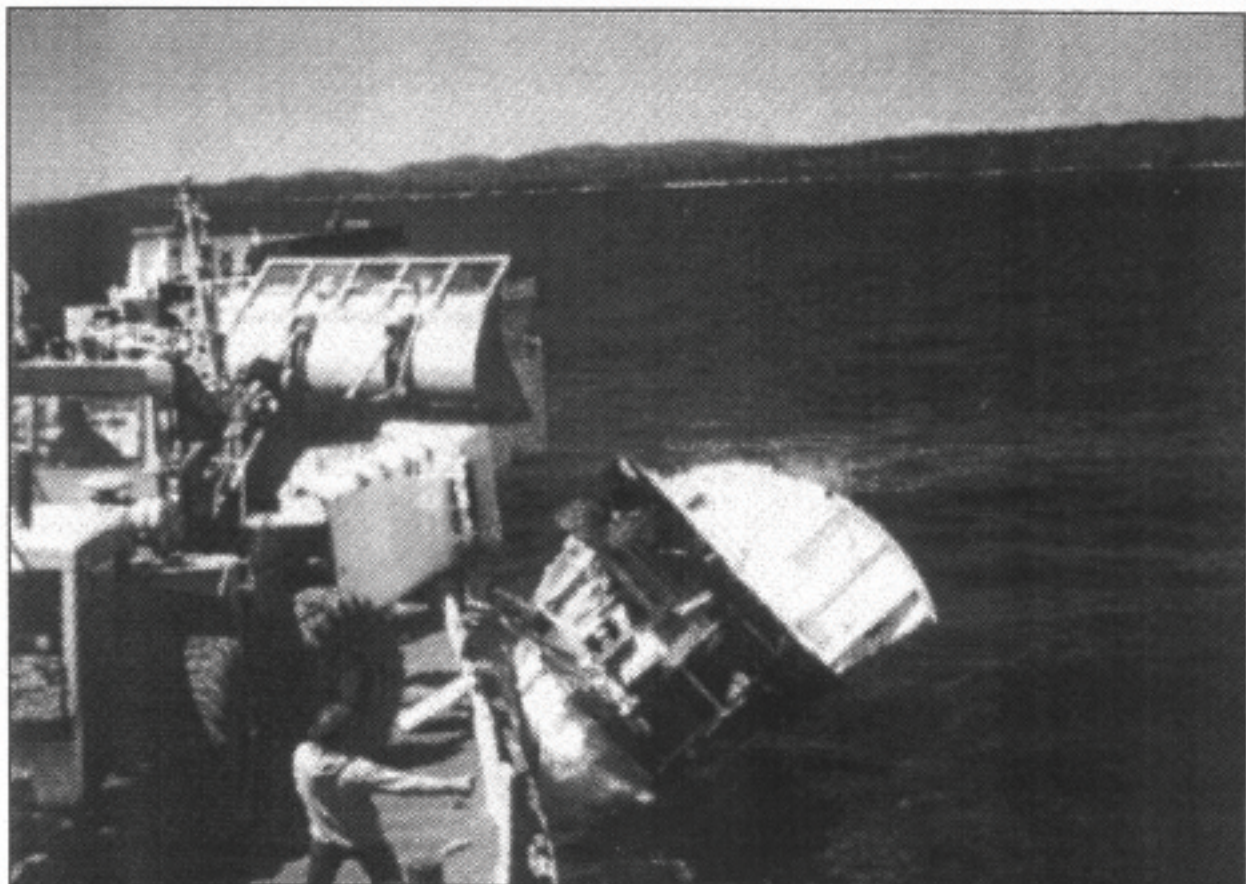
Figure 3-23. Superstructure Being Pushed Overboard at Disposal Site.

The superstructure and other expendable items taken from MESQUITE had been pushed overboard at the site, prior to moving MESQUITE (Figure 3-23).

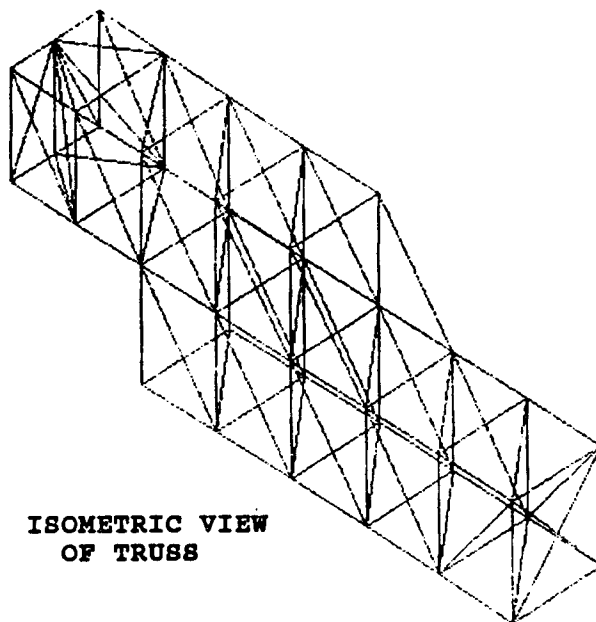
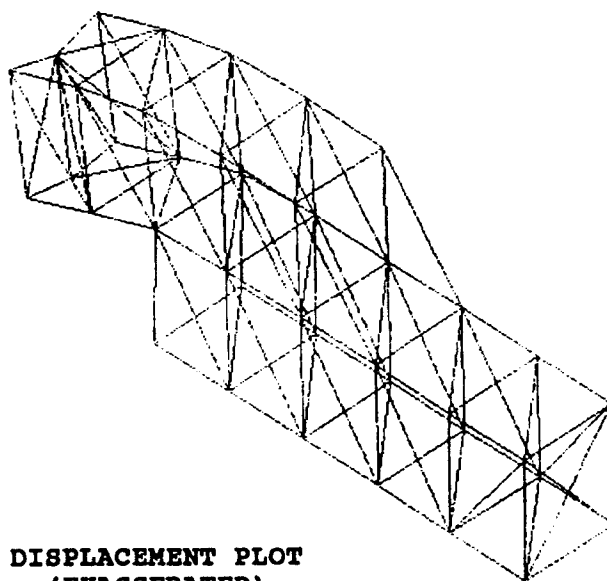
**Figure D-6. Lift Truss Load Analysis – Drawing F1125-002
"Truss Type 7 and Type 8 Heavy Lift Modifications"**

500 LT. per truss at fixed block.

425 LT. weight of truss.
