USNS Chauvenet (T-AGS 29) Stranding Salvage Operations

82-01 SUPSALV REPORT

USNS CHAUVENET (T-AGS 29)
SALVAGE OPERATIONS

by
Capt. C.A. Bartholomew, USN

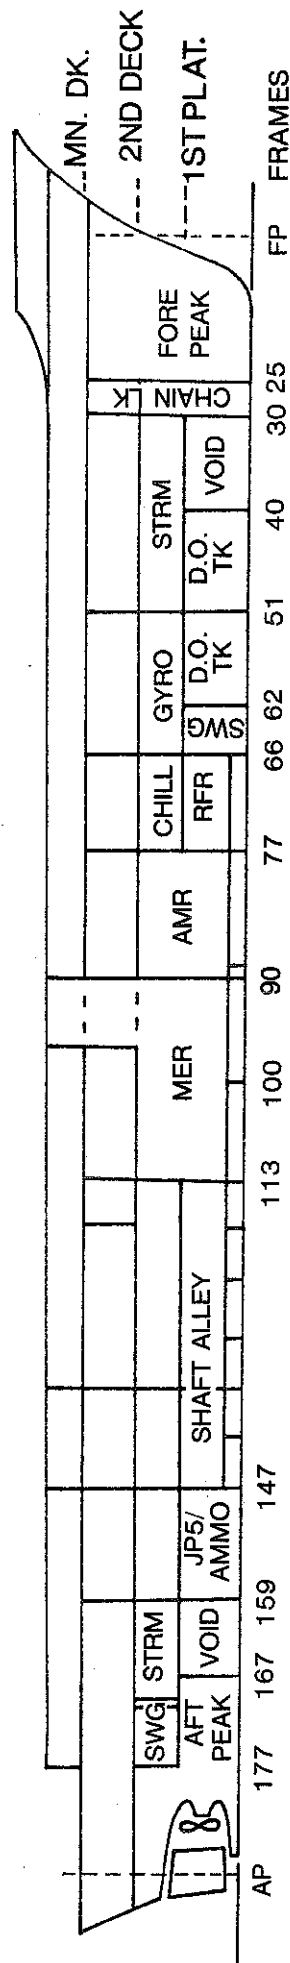
FIGURE 4

Inboard Profile Noting Key Spaces

and 77, and the auxiliary machinery room between frames 77 and 90 (Ref. Figures 4,5,6,8,9). Additionally, the spaces on the first platform over those compartments were also found to be tidal. All other spaces appeared to be watertight. The casualty lay approximately portside to the reef with a heading of 209 degrees True. At high tide an 8 degree port list was reported which decreased to 4 degrees to port at low tide. During the early phases of the salvops the list was somewhat variable and could actually be controlled by raising/lowering the ship's 10-ton survey boats in their davits, a clear indication of the instability of the casualty.

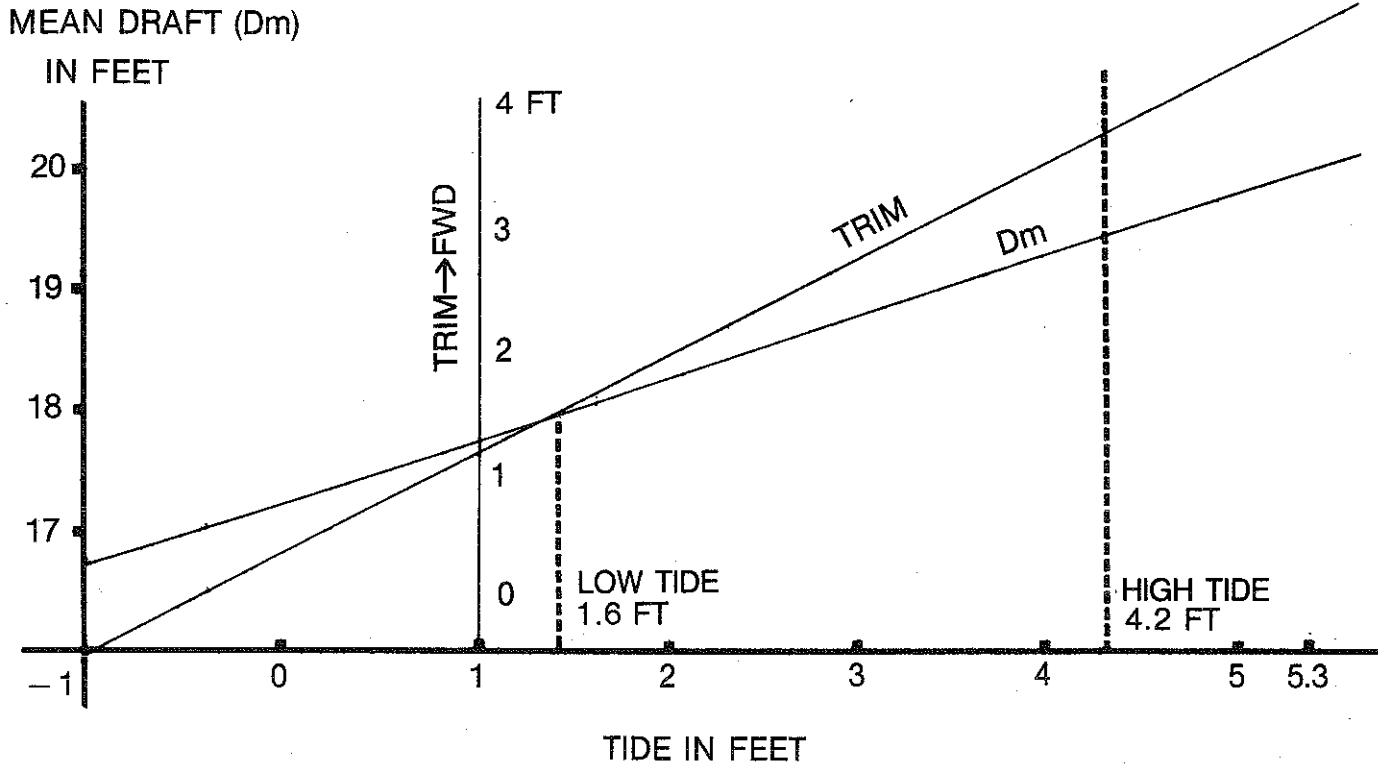
FIGURE 27
TIDE AND DRAFT INFORMATION

Dm = 18.0 FT
TRIM = 1.6 FT BY BOW

Sufficient draft readings were taken during the 25 - 28 May time frame to permit development of Figure 27 which plots mean draft and trim versus tide.

Extraction efforts were scheduled to commence at low tide 29 May (1.6 feet at 0637) and conclude at or near high tide (4.2 feet at 1416). From Figure 27, mean draft and trim at low tide were predicted to be 18 feet and 1.6 feet by the bow, respectively. Through reference to computer generated hydrostatics (Appendix 5.2) provided by Pearl Harbor Naval Shipyard for drafts exceeding 18 feet, low tide displacement was predicted to be 5,020 tons. High tide displacement, predicted to be 5,550 tons, indicated a gain of 530 tons of buoyancy with the tide change on that date.

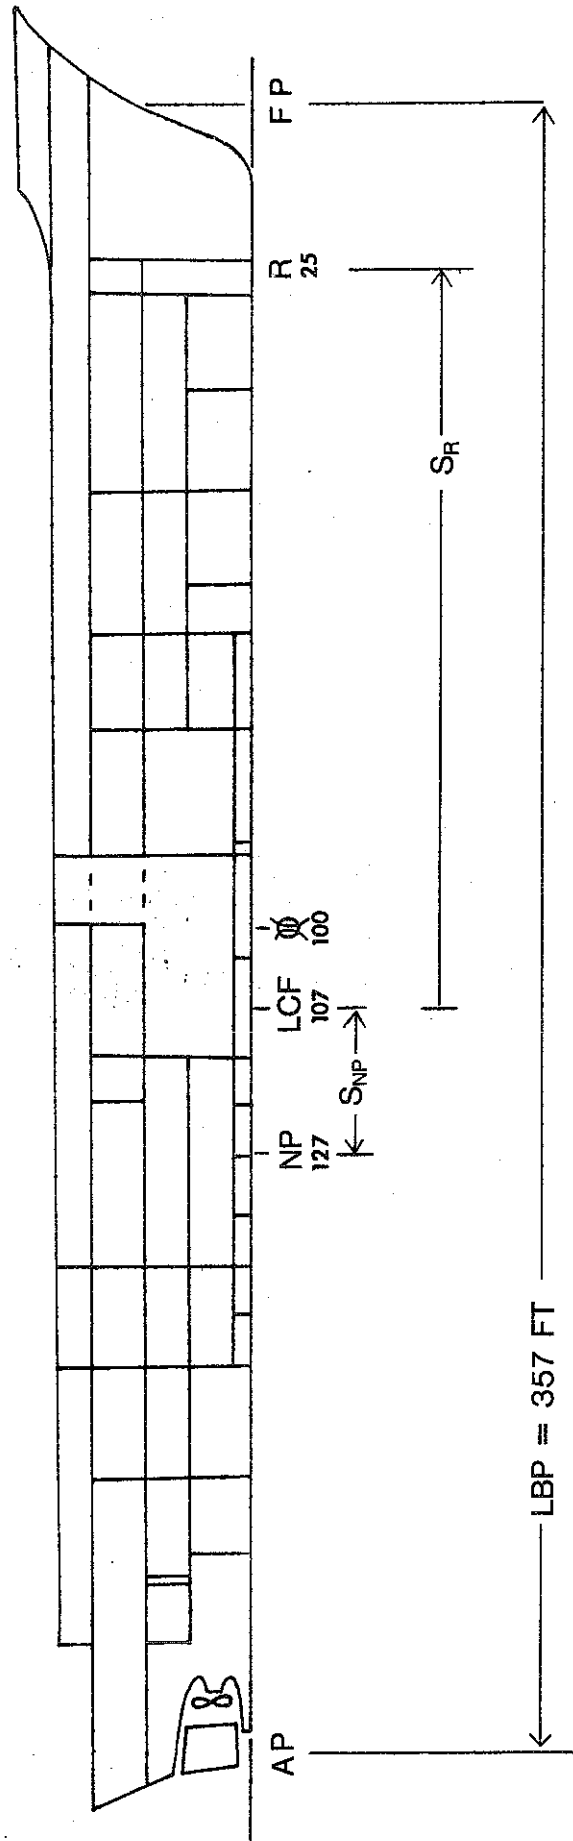
FIGURE 28

Neutral point may be determined with the following equation (See Figure 28):

Determination of the Neutral Loading Point

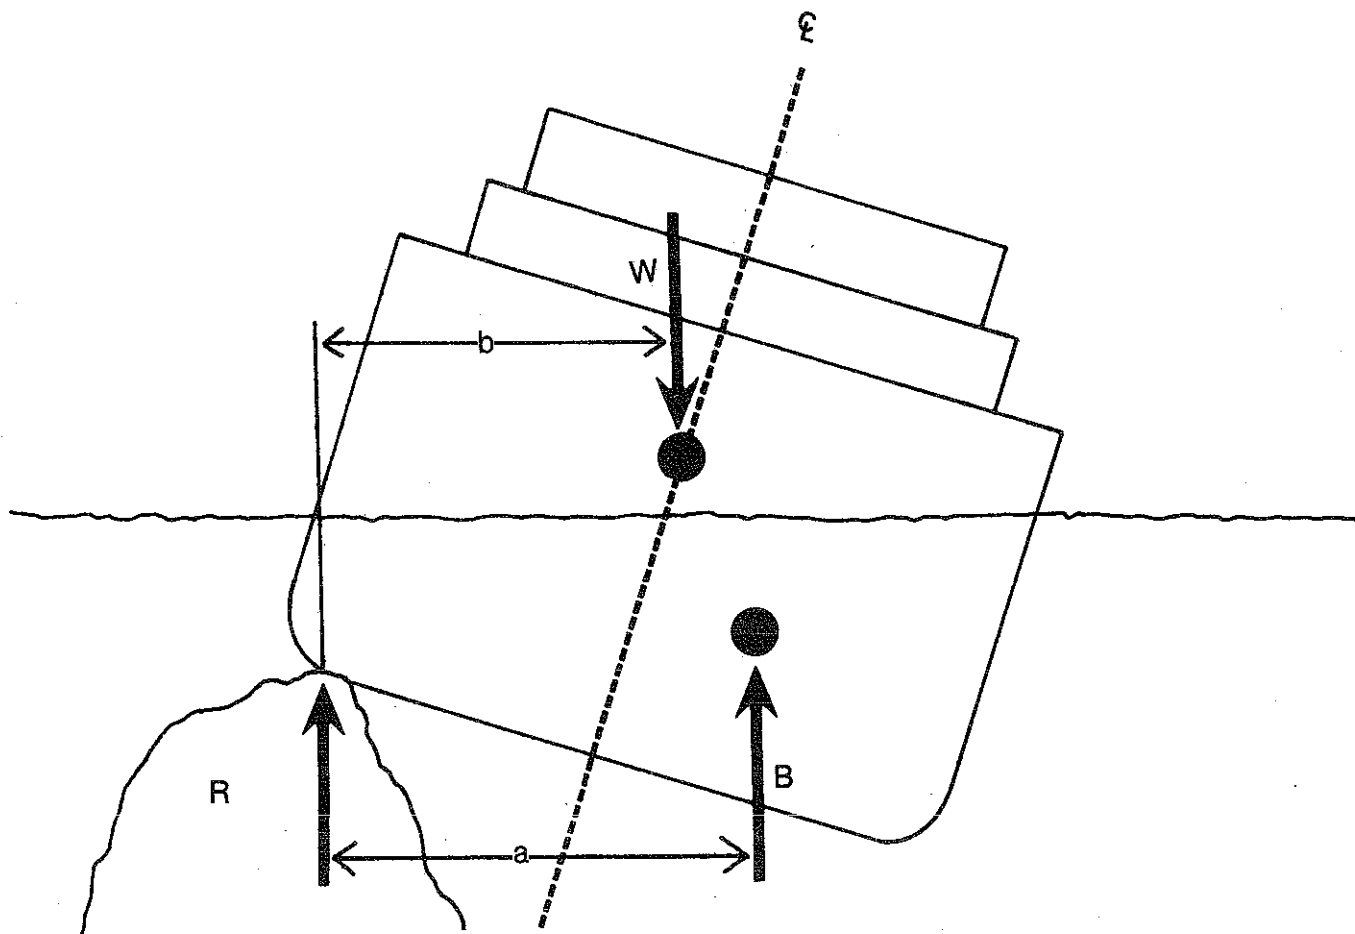
FIGURE 31

EFFECT OF GROUNDING ON STABILITY

"Then, since (W)(b) equals (B)(a), a and b would be equal, or W would be directly above B in Figure 31. The situation would be the same as if the ship were heeled to its range (maximum angle) of positive stability and the angle of heel could be determined from the statical stability curve corresponding to the ship's weight, and position of its center of gravity. It can therefore be said that a stranded ship will not capsize in the absence of other upsetting forces until it reaches an angle of heel equivalent to its range of positive stability if it were afloat.
