# U.S. NAVY SALVAGE REPORT USNS SGT MATEJ KOCAK (T-AK 3005) SALVAGE AND TEMPORARY REPAIRS

This salvage report documents the recovery and temporary repairs conducted by NAVSEA 00C, Supervisor of Salvage and Diving, for the Military Sealift Command. The operations took place off the east coast of Okinawa from 22 January 2015, the date of the grounding, to 20 February 2015, when the temporary repairs were completed. Details of the efforts and accomplishments are provided in this report.

## USNS KOCAK (T-AK 3005) Refloating and Temporary Repairs

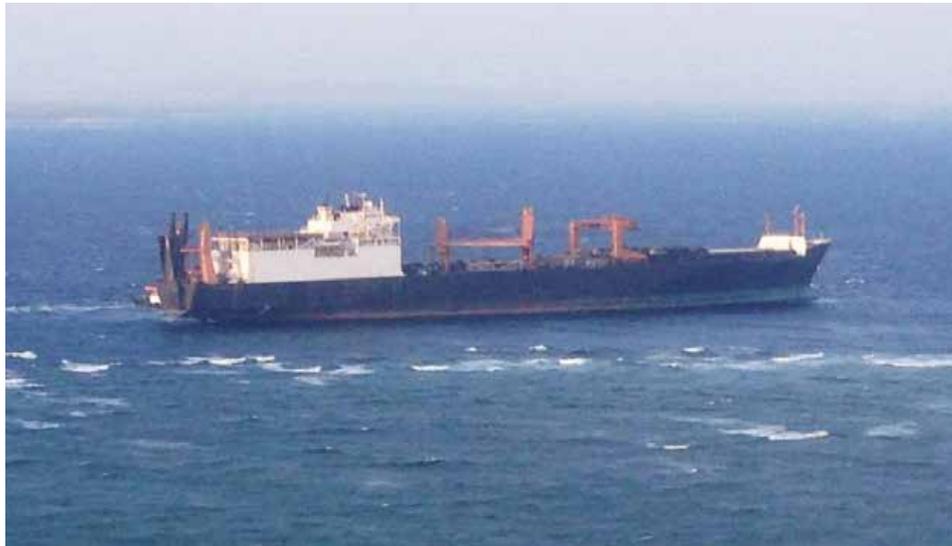
While underway outbound from White Beach, Okinawa, Maritime Prepositioning Ship USNS SGT MATEJ KOCAK (T-AK 3005) grounded on a reef in vicinity of buoy #1 at approximately 1110 local time on 22 January 2015. The ship was underway enroute to Thailand following ammunition on load to support Exercise COBRA GOLD. Approximately 91 personnel were on board to support this exercise.

**Figure 1-1. USNS KOCAK grounded on Ufubishi Reef, Okinawa, Japan. Reef shoal is marked by breaking waves in the foreground.**

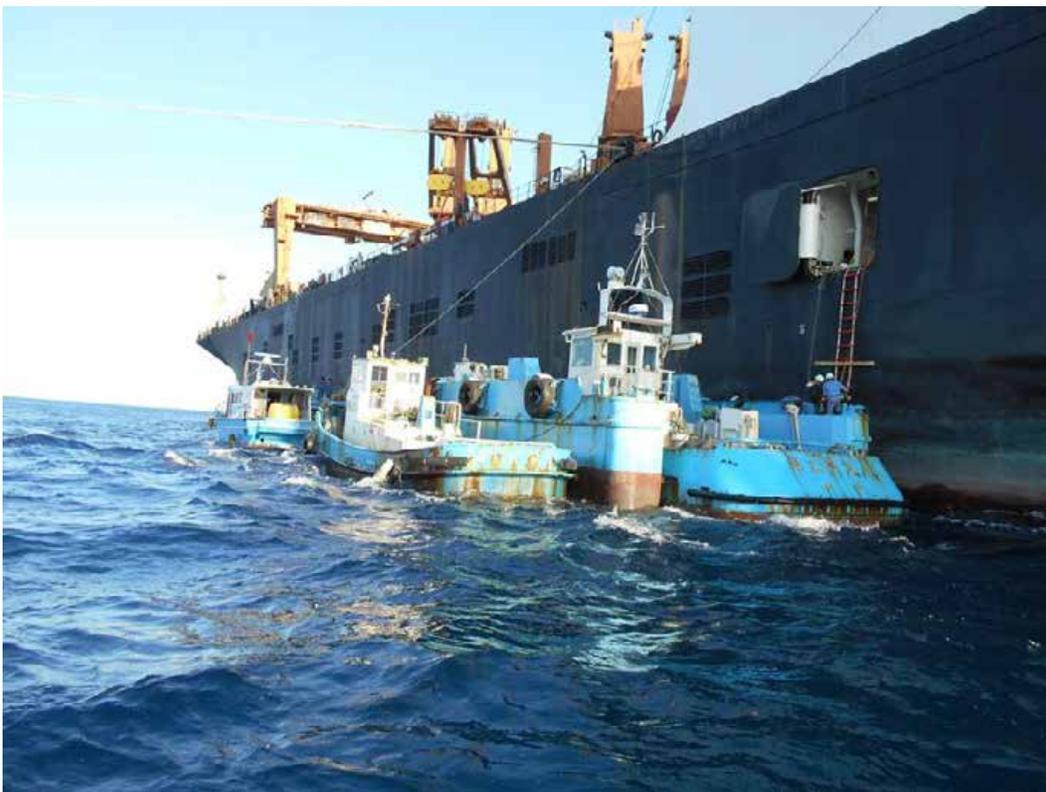
On 25 January, they began offloading oily waste tanks to a waste oil containment barge that was assigned to White Beach. The ship's oily waste tanks were full from ship's force pumping contaminated flooding water into them. The offloading did not result in significant weight reduction but it did free up tank space on KOCAK for more contaminated water.

**Figure 3-4. KOCAK grounded with U.S. Navy Commander Fleet Activities Okinawa (CFAO) White Beach waste oil containment barge, Kanto 18, alongside for collection of oily bilge water.**

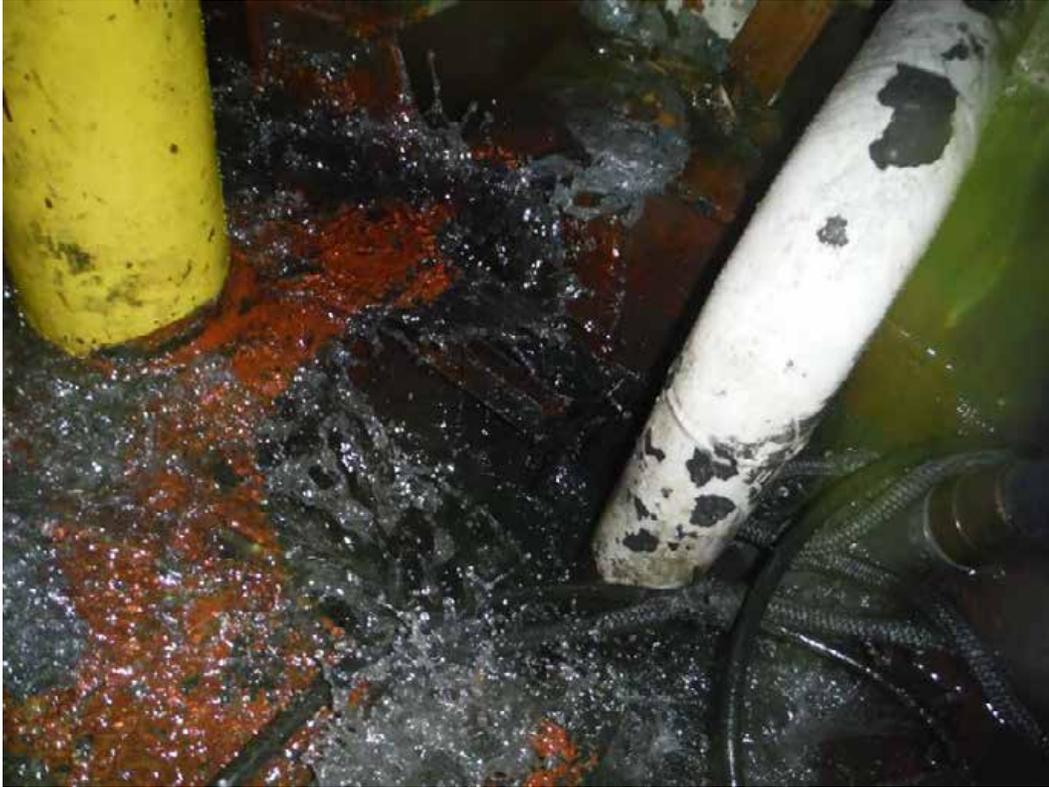
On 27 January the salvors took a step back in progress against the flooding on the ship. Specifically, the patching in Hold 3A, which had been holding up since right after the grounding, gave way over night on the January 26. The result was that water levels rose in 3A and the head pressure exceeded the capability of the temporary patching under the dislodged watertight doors between Holds 3A and 4 and under the door between Holds 4 and 4A. Water levels in all three holds began to rise again. Ship's force and the SMIT/Nippon salvors were initially able to keep up and were making head way against the flooding waters but due to some hose ruptures they lost pumping capacity and water levels began to rise again. At that point, SUPSALV indicated more help was needed and MSC contacted CTF-76 with an immediate request for assistance. USS BONHOMME RICHARD (LHD 6) which was steaming in the region answered the call and within 15 minutes the team received a response saying they were mobilizing. The Damage Control Chief Petty Officer was aboard within 2 hours making assessments and a Rescue and Assistance team was rigging equipment into the spaces within 4 hours. By 2200 that evening, reports from the ship indicated the water levels were retreating in all 3 holds.

**Figure 3-5. Seawater freely flowing from sump in Hold 3A.**

The recharged and reinforced salvors continued pumping down the 3 Holds. Once the water level in Hold 3A was down far enough, they worked plugging the cargo door, this time from Hold 3A side. As they continued to get the water level down, it was easier to get to the crux of the problem and begin plugging the leaks. The sailors and salvors achieved success with the cargo door between Holds 3A and 4. They re-established the water tight boundary by reseating door and dogging it tight.

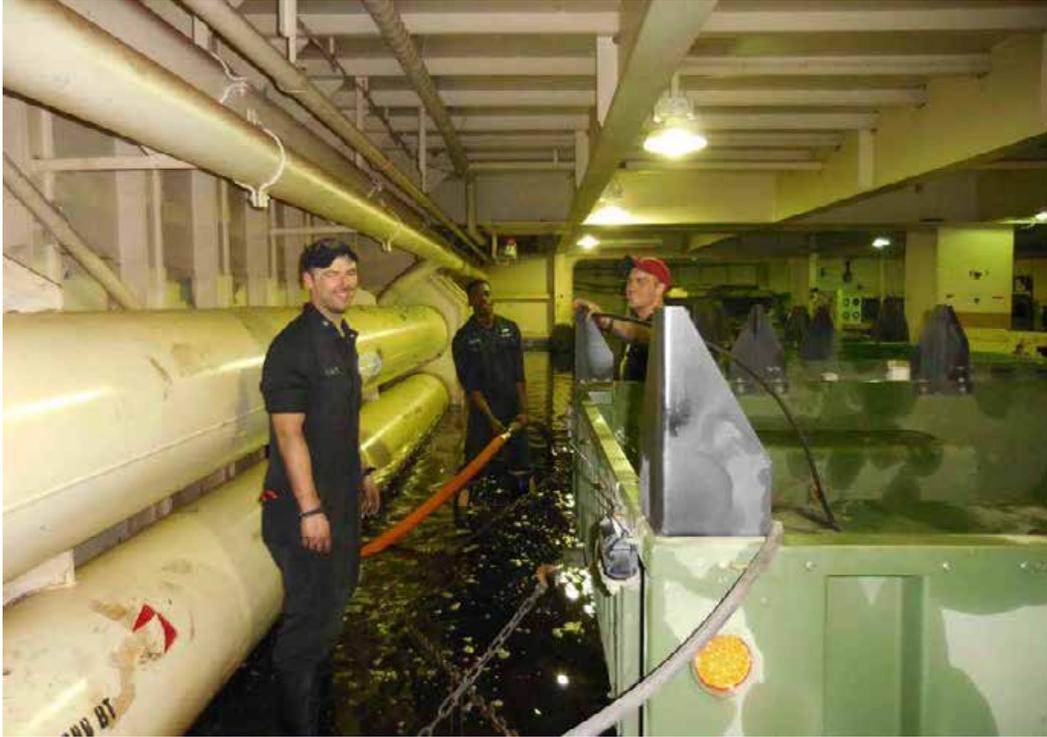
Over the next several days KOCAK continued to remain stable and showed no signs of serious structural failure. Despite the arrival of strong winds and heavy seas, the salvage team made excellent progress in controlling the flooding in Holds 3A / 4 / 4A. The game changer was the arrival of the USS BONHOMME RICHARD Damage Control teams and the follow-on arrival of the additional SMIT and Nippon salvage mechanics. Figure 3-6 shows a team of BONHOMME RICHARD sailors knee deep in Cargo Hold 3A.

**Figure 3-6. USS BONHOMME RICHARD Damage Control Team members conducting dewatering operations.**

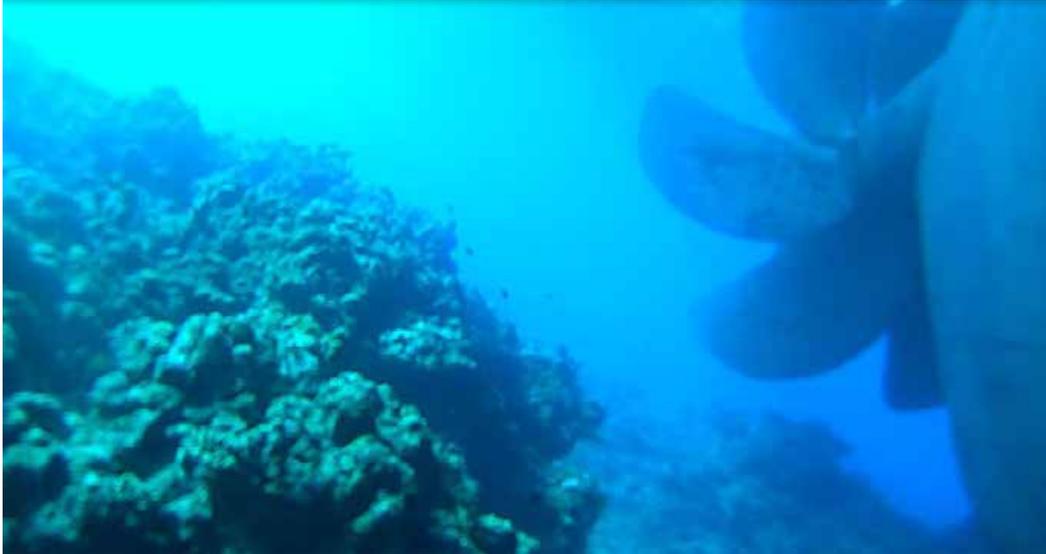
On 29 January, Nippon Salvage conducted another dive survey of the hull. After reviewing the video which provided better detail than the first preliminary dive survey video, the team had a much better understanding of how tight it would be to remove the ship from its grounded position. Specifically, the clearance between the prop/rudder and the reef was approximately 1 meter. During the lightering evolution, the ship was expected to trim down by the stern. The reason for that is simple. The weight was being removed from forward and amidships tanks and the stern would predictably drop as a result. It was planned that to better monitor what was happening during the lightering and deballasting evolution, Nippon Salvage divers would be staged to go in the water to periodically give a real time assessment of where the ship's propeller and rudders were relative to the reef.

**Figure 3-13. Propeller clearance to reef from 29 January dive survey video.**

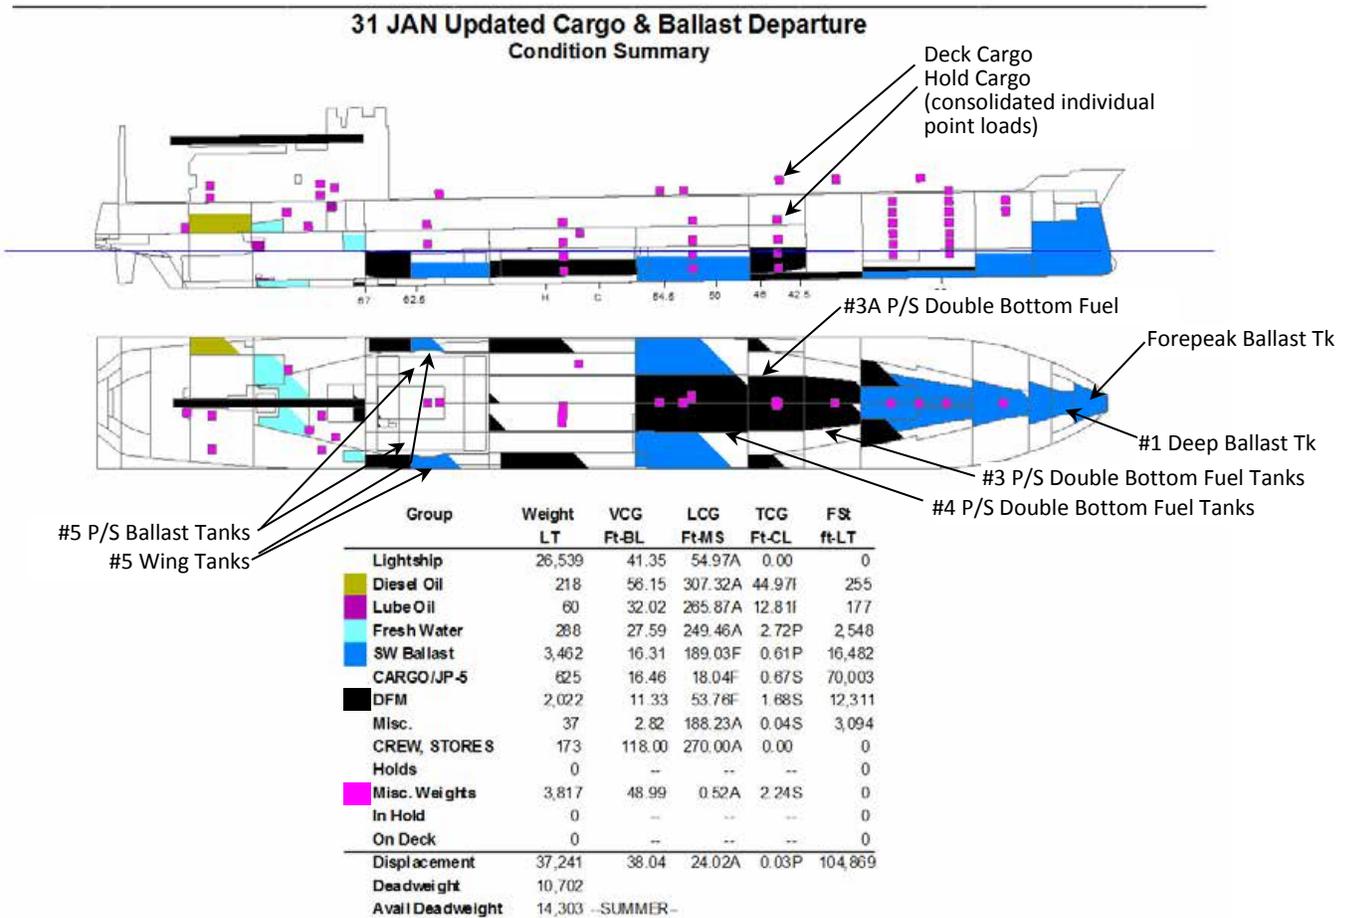
Two diving surveys had been conducted, the initial, by U.S. Army Special Forces divers on 25 January and a more detailed survey by Nippon salvage divers on 30 January. These confirmed the limited external damages to the ship's hull. SUPSALV's Naval Architect, Vince Jarecki and MSC's Naval Architect, Paul Handler worked together to model the ship in its current condition and assessed that the structural damage, while not insignificant, would not hamper the refloating of the ship. The refloating plan incorporated the fact that Holds 3A, 4 and 4A, which had previously been partially flooded, were currently dewatered and would remain empty during the refloating process. Figure 3-14 is the POSSE profile and plan view defining the liquid and cargo loads on the ship prior to beginning the refloating process.

**Figure 3-14. POSSE Profile and Plan View of Liquid Loads and Deck and Hold Cargo.**

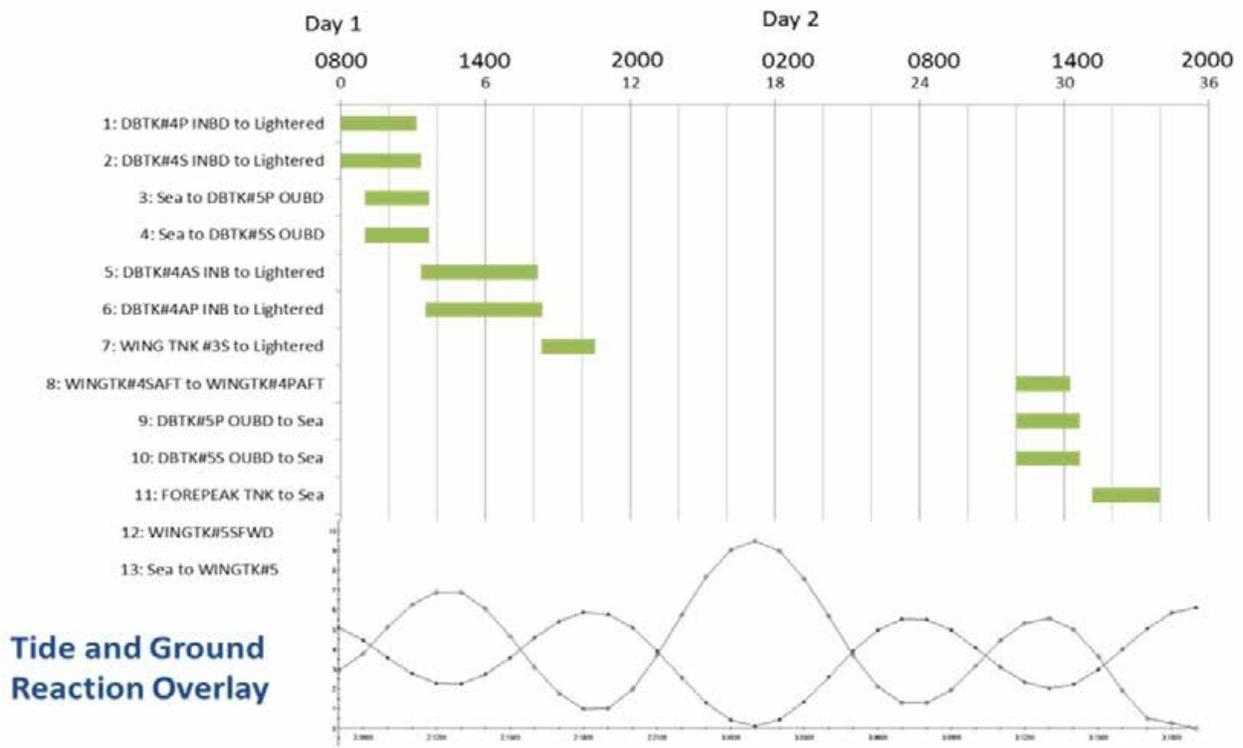
Figure 3-15. Liquid offload timeline as briefed on 1 February to the Japanese Coast Guard.

finalizing the fuel tanks to be pumped, the timeline for lightering fuel and the timeline for debalasting. That plan is included as Attachment A, Liquid Offload Plan.

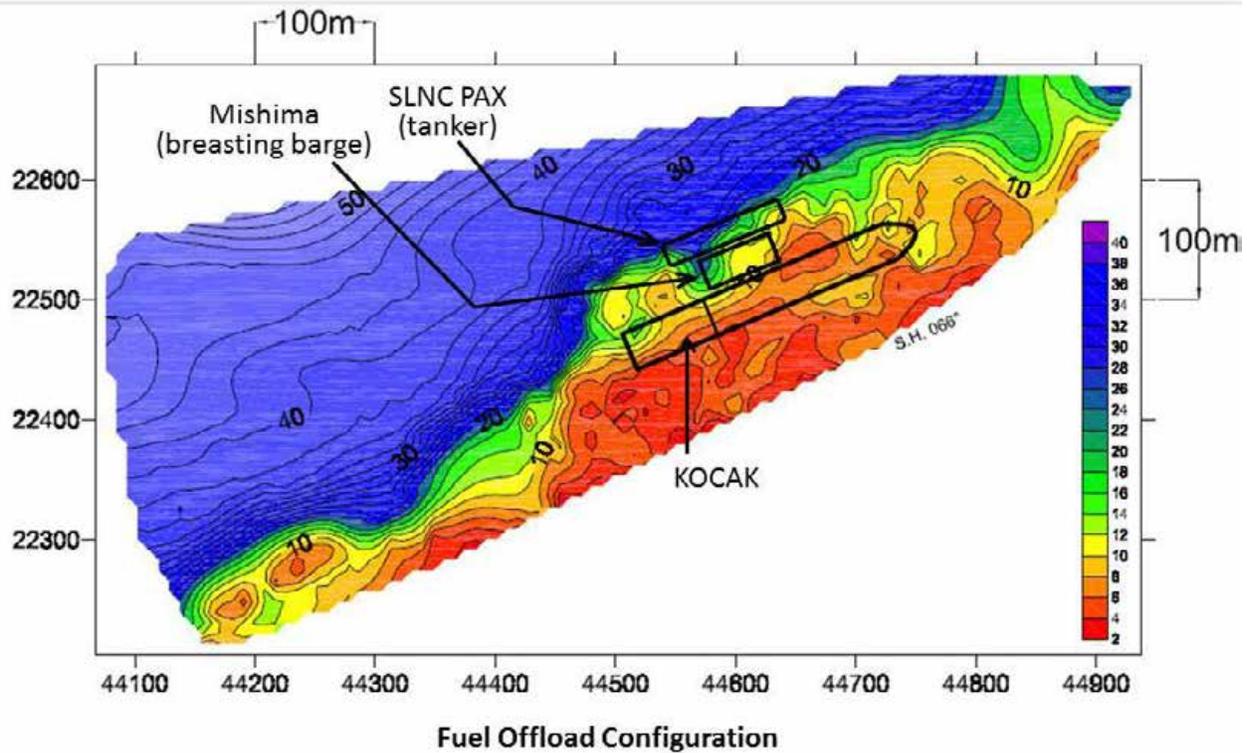
**Figure 3-16. Arrangement of KOCAK, Mishima, and SLNC PAX during defueling operations.**

The plan was to breast the tanker, SLNC PAX off MSC's KOCAK using Nippon's salvage barge, Mishima, which had a beam of 24 meters. The Nippon barge depth was 4 meters and draft approximately 2 meters. SLNC PAX design draft is 7 meters. The most recent survey of the bottom adjacent to KOCAK showed bottom depths between 6 and 8 meters on the port side just forward of amidships. Since the shallow water would prevent SLNC PAX from going directly alongside the Nippon barge was employed. Figure 3-16 shows the planned arrangement of the vessels during the fuel offload.

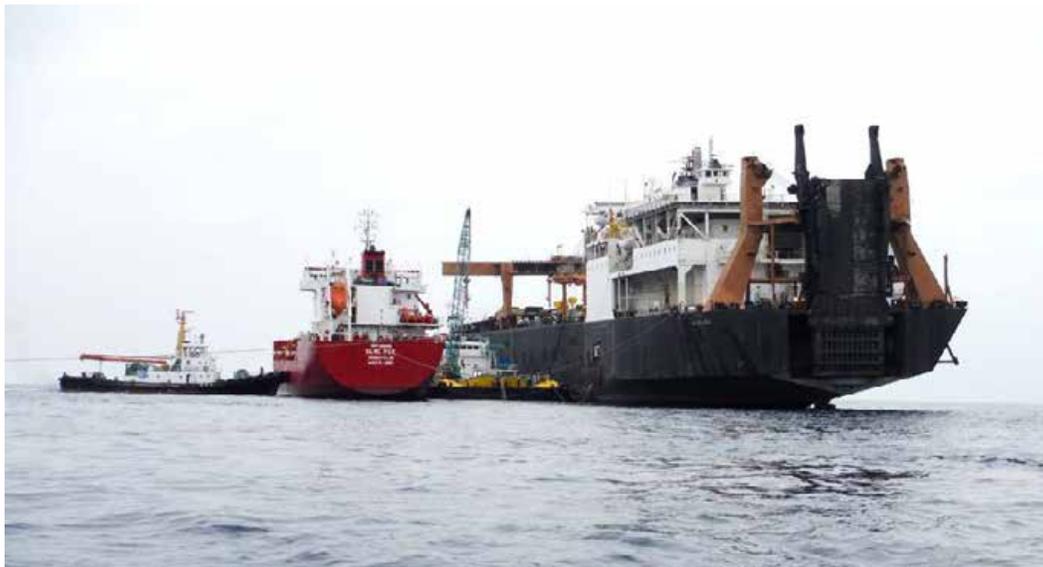
**Figure 3-17. Tanker, SLNC PAX, Nippon salvage barge, Mishima, and USNS KOCAK during the 2 February fuel offload. As portrayed, calm seas supported the defueling operation.**

Throughout the fuel offload process, sea water was added to the ballast tanks to keep KOCAK firmly on the bottom during the high tides. At the end of the day, 11,000 barrels of fuel were offloaded to the SLNC PAX. No oil leaks occurred.

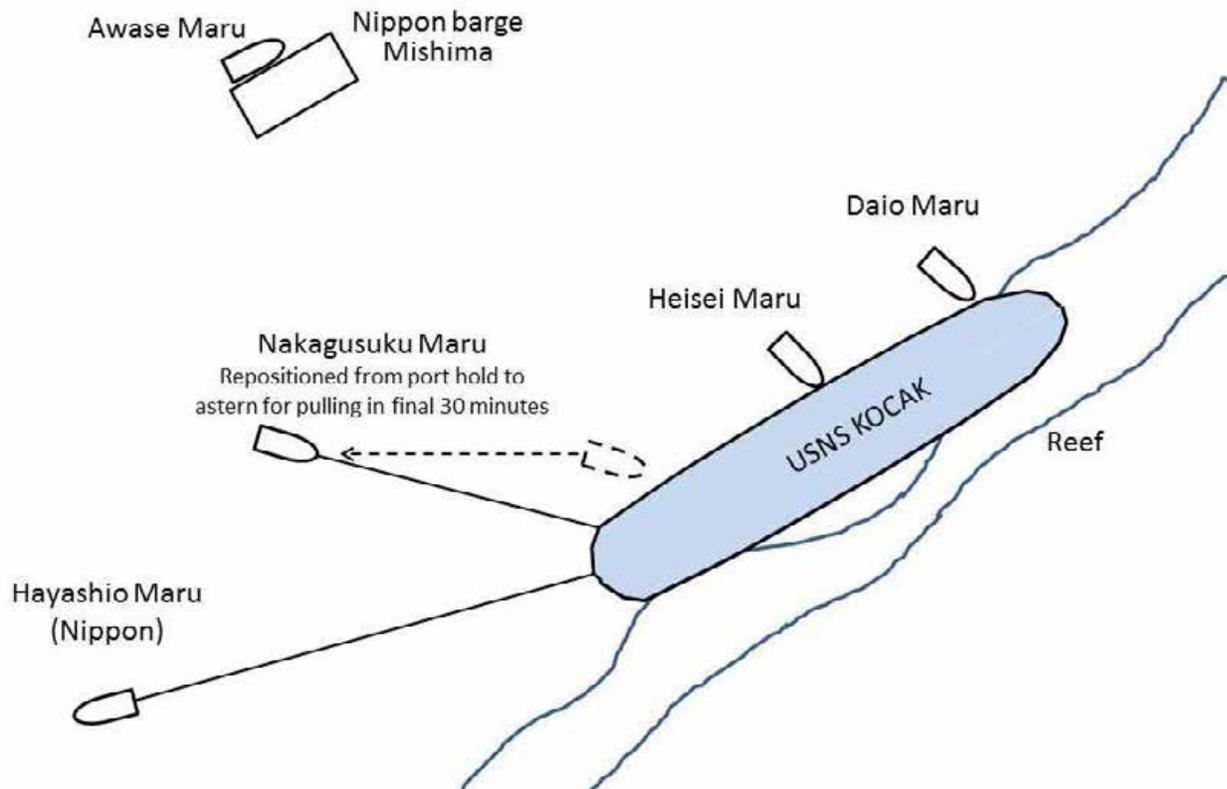
**Figure 3-18. Arrangement of tugs to support float off of KOCAK on 3 February.**

- At 1700, two tugs with a combined bollard pull of 100 MT began to periodically take strain on the stern. Figures 3-18 and 3-19 provide a graphic and photographic documentation of the extraction arrangement.

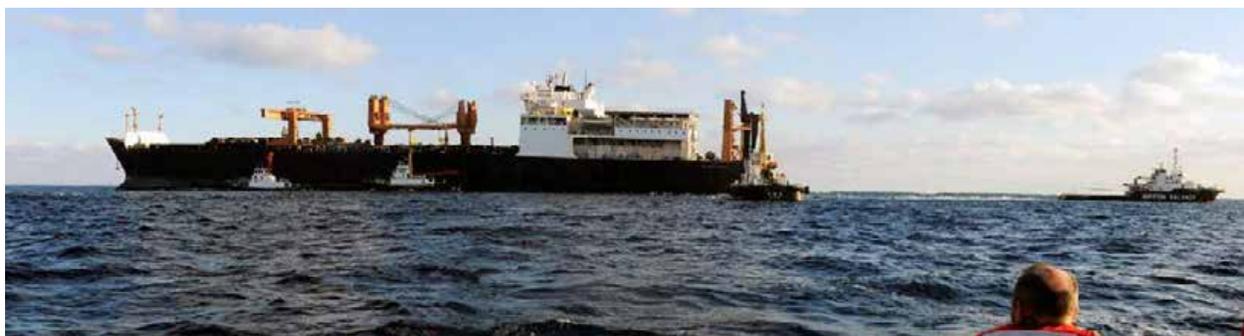
**Figure 3-19. Two tugs pulling KOCAK (astern) and two tugs stabilizing KOCAK's bow at approximately 1700 on 3 February.**

- At 1730 KOCAK floated free of the reef without damage to propeller or rudder.
- Corrected list (2 degrees port) and KOCAK was spun around (by tugs) and steamed back to White Beach on her own power.

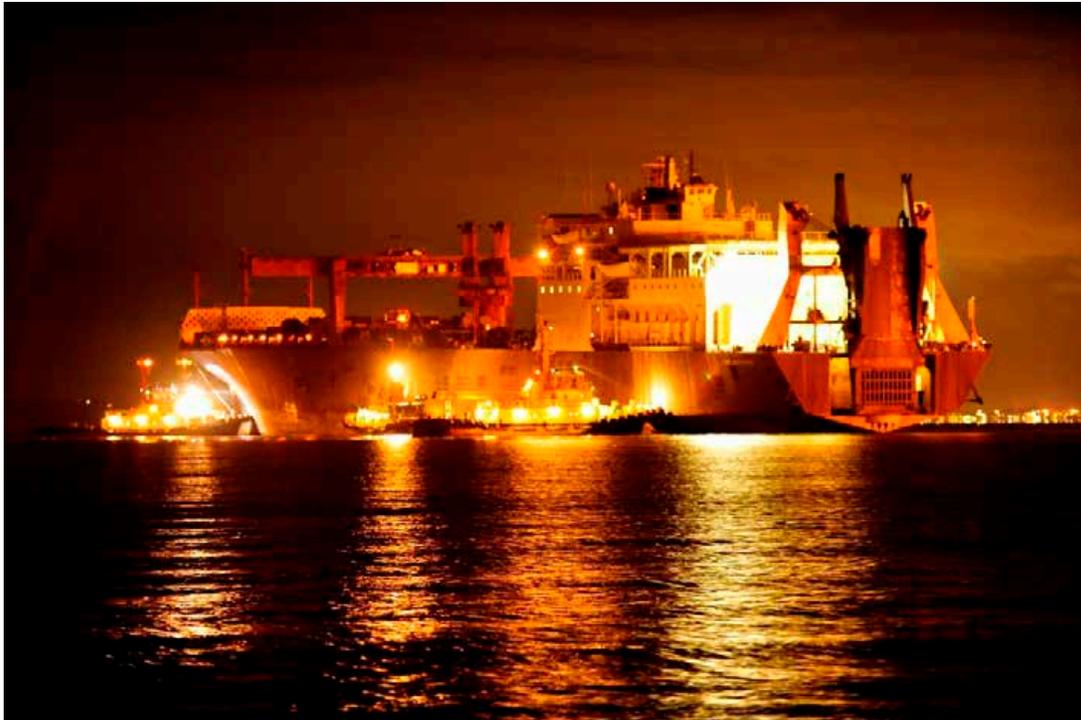
**Figure 4-1. KOCAK back at the pier the evening of 3 February.**

After KOCAK was successfully pulled from the reef without contact of propeller or rudder she was trimmed to an even keel, steamed back to White Beach on her own power and was assisted to the pier bow out. At 1942 the first line was heaved over to the pier. Docking complete, accommodation ladder deployed, it was the end of long couple of days and a major accomplishment. Port Operations had laid oil containment boom under the pier and by 2115 the boom was pulled around the ship providing a measure of protection against possible oil spill.

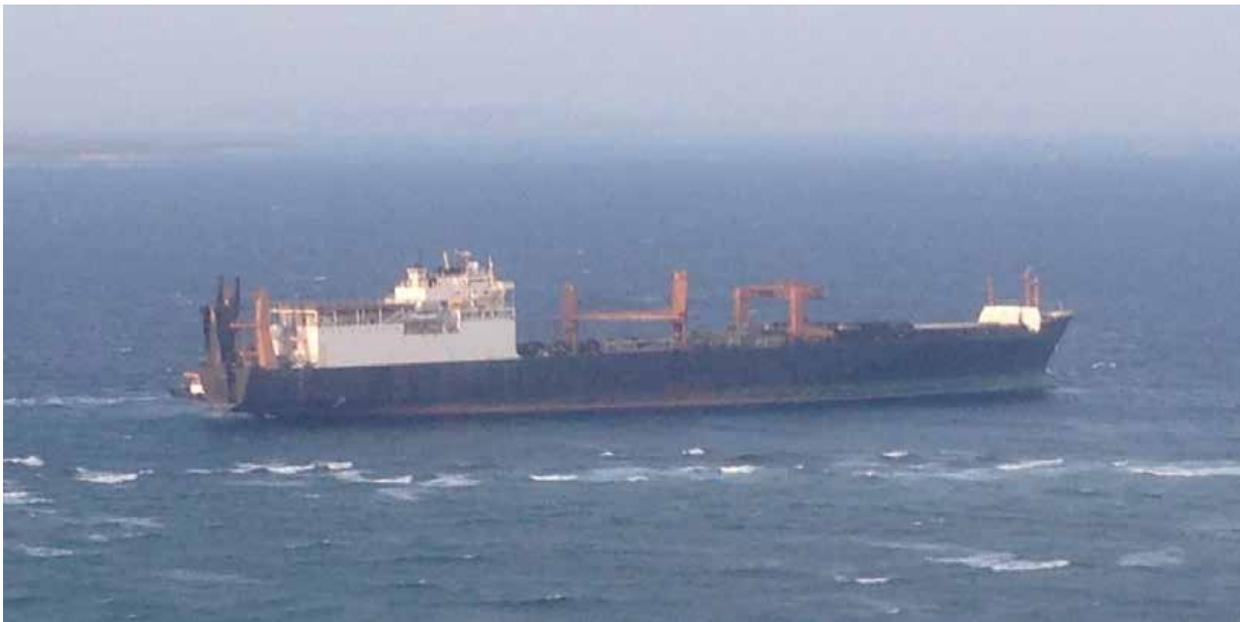
Figure 1: USNS KOCAK Aground

After loading cargo and ammunition for Exercise COBRA GOLD, USNS SGT MATEJ KOCAK (T-AK 3005) ran aground exiting Okinawa harbor on 22 January 2015 at 1110 local time. The grounding caused no personnel injuries or oil pollution. Harbor tugs were summoned to stabilize and attempt to refloat the vessel. KOCAK did not refloat on the next (spring) high tide.

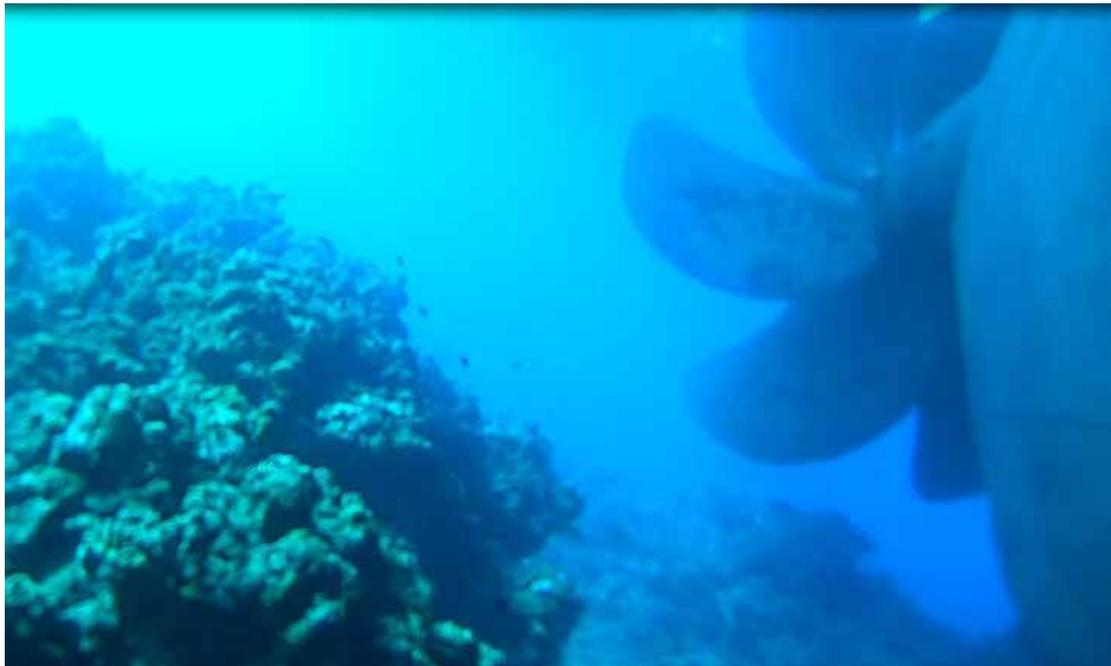
Figure 5: Propeller Clearance

KOCAK was hard aground throughout the tide cycle. Multiple dive surveys were performed to identify ground locations. KOCAK was aground on a coral shelf running diagonally beneath Cargo Holds 4 and 3A (Fig. 4). Additionally, a smaller coral pinnacle was beneath the starboard side forward of the house (not shown). KOCAK was afloat at the bow and stern but clearance below the rudder and propeller was only about 1m. This complicated refloat efforts as additional trim had to be limited.

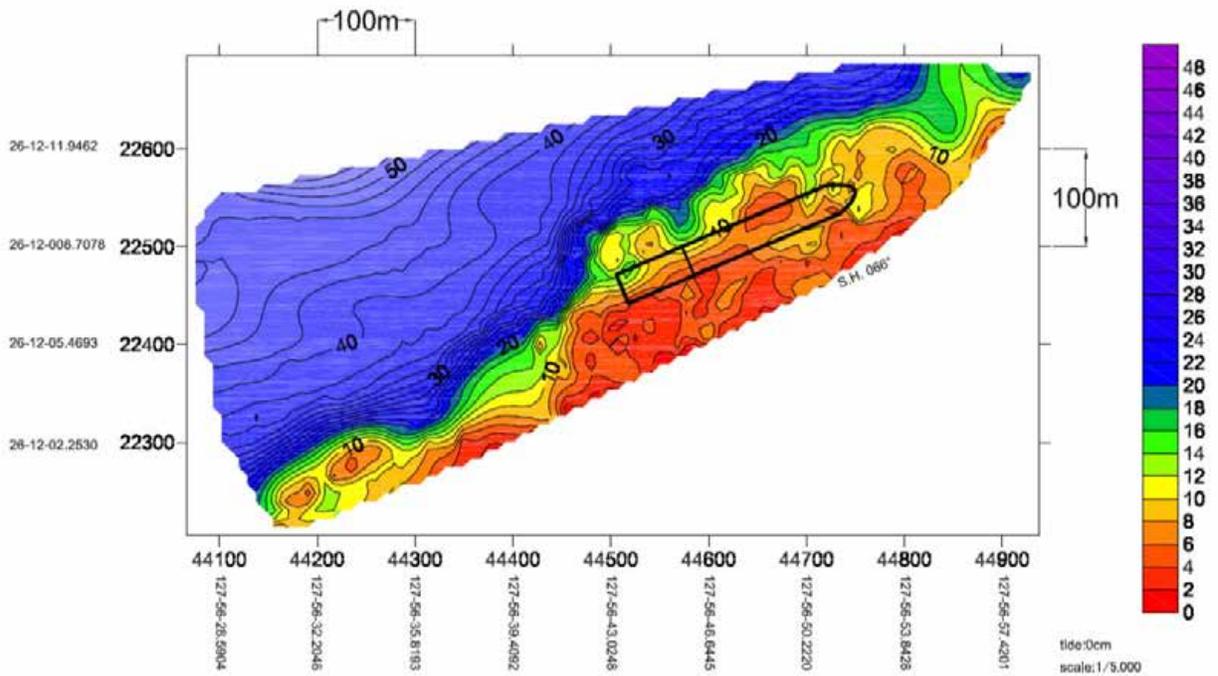
Figure 6: Bathymetric Survey

A bathymetric survey was performed in the area around KOCAK. In addition to identifying a shallow coral outcropping to port even with the deckhouse the survey showed clear water astern and guided the extraction route.

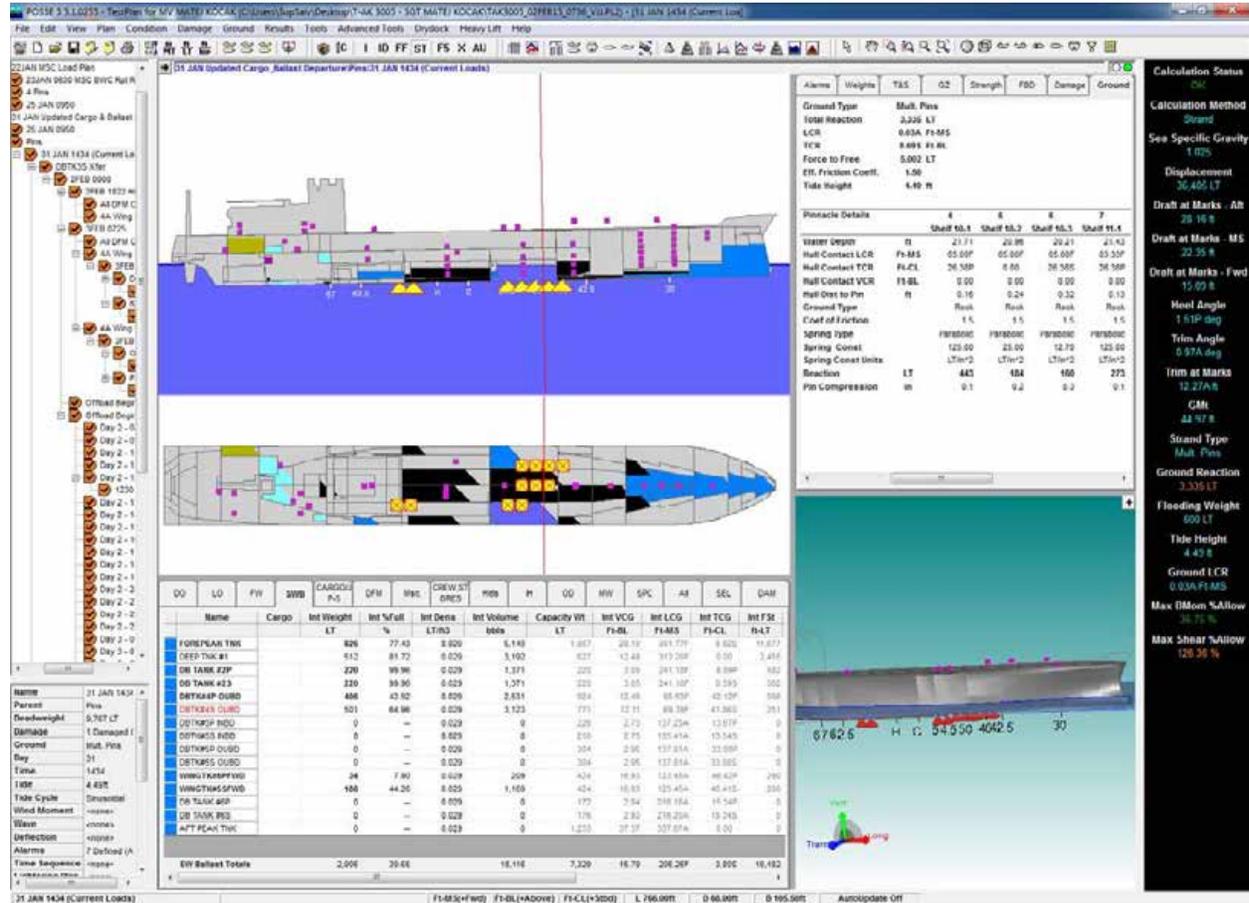
As an initial dive survey had been performed within 48 hours of the grounding the location of grounding points was well known early in the salvage. The ground was modeled in POSSE as a bed of pinnacles representing the coral shelf beneath Holds #3A and 4 and two individual pinnacles representing the smaller ground point farther aft on the starboard side.

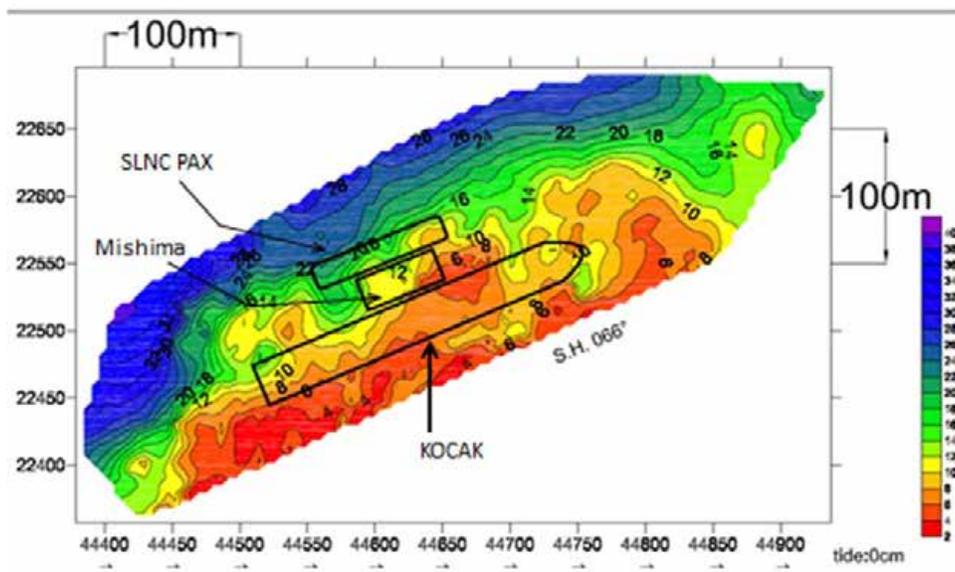
Figure 14: Lightering Arrangement

MSC tasked the small tanker SLNC PAX to receive fuel from the KOCAK. The Nippon Salvage barge MISHIMA was used as a breasting barge between KOCAK and PAX to keep PAX in the deep water to port of KOCAK.

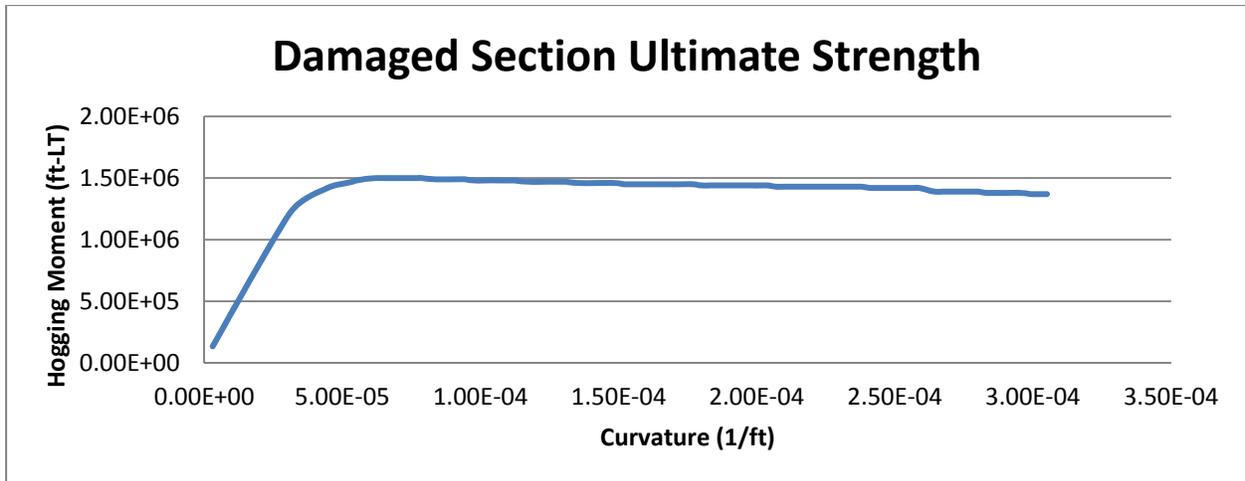
Figure 19: Damaged Section ULTSTR

An Ultimate Strength (ULTSTR) analysis was performed on both the intact and damaged sections. Initial failure of an individual structural member of the damaged section occurred at 1.2E6 ft-LT with cascading complete failure at 1.5E6 ft-LT. Bending stress at Frame 45 was kept below 0.7E6 ft-LT providing a Factor of Safety of approximately 2 or greater throughout the refloat.

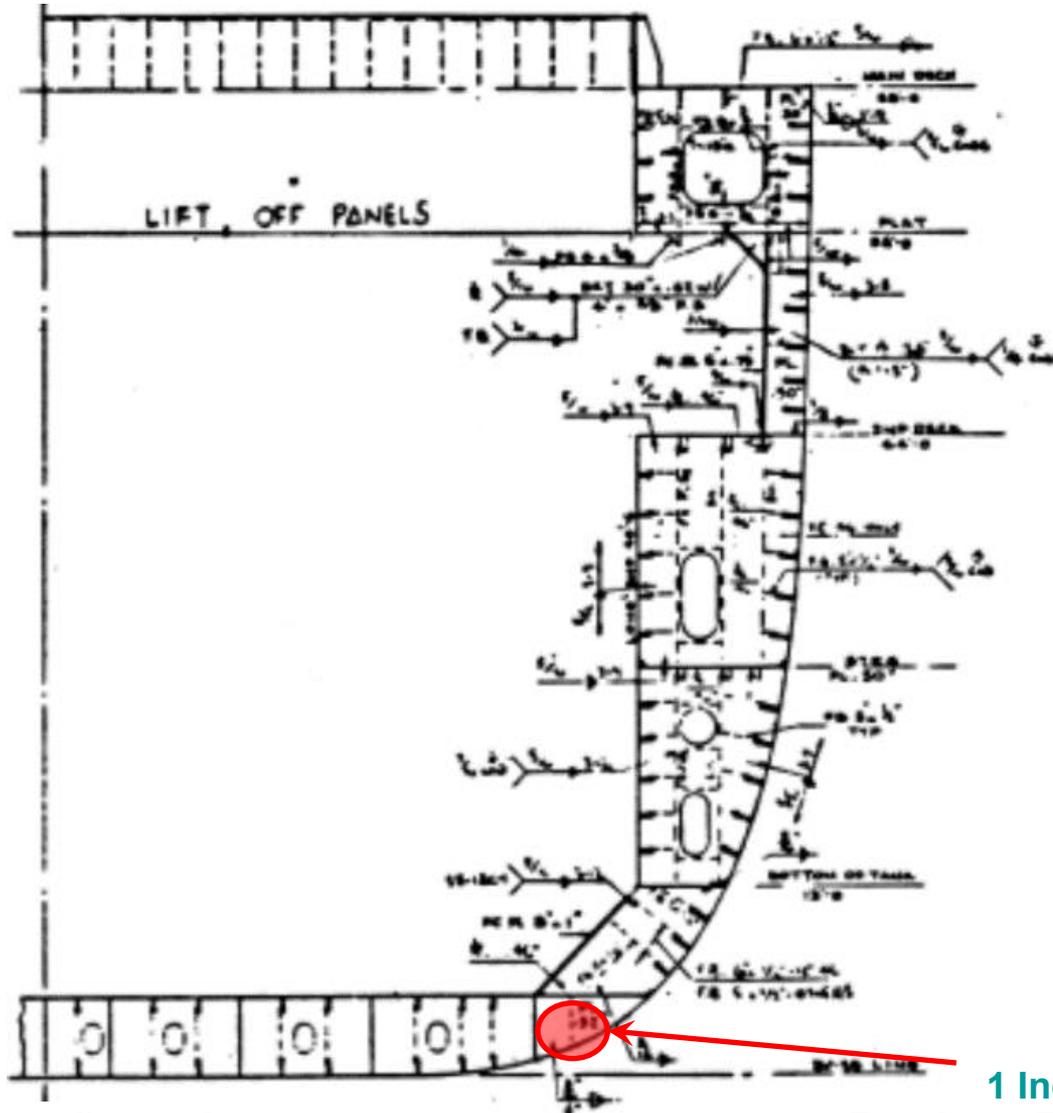
# Overview: FR 47 WTB

P12  
1 Indication

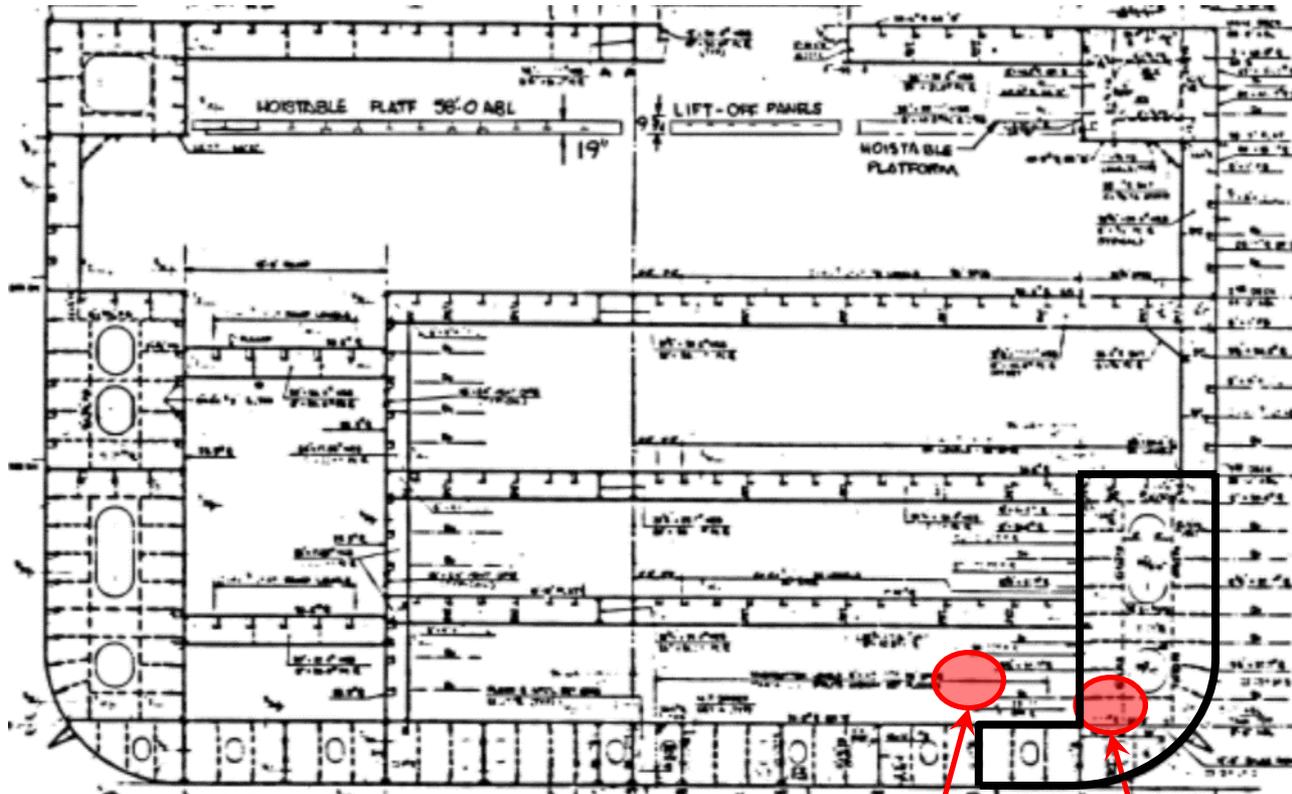
# Overview: FR 57 WTB

**P14**  
WTD Seal

**P13**  
1 Indication

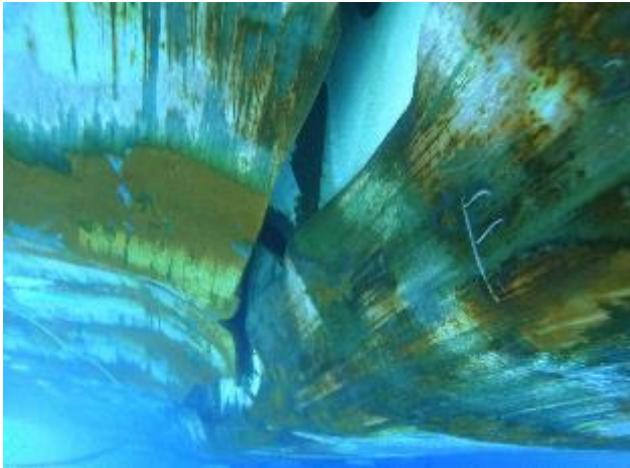
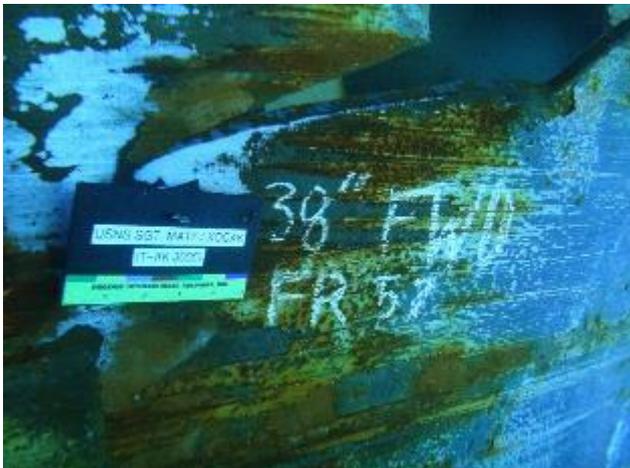
# S1

Stbd, round bilge, into #4 O/B D/B wing tank (SWB): 55'-9" gash, 58" aft of FR50 to 38" fwd of 57, average 8" opening.

2. Starboard Shell Crack Arresting - VT, MT, arc gouging (min dia = 2X crack width)

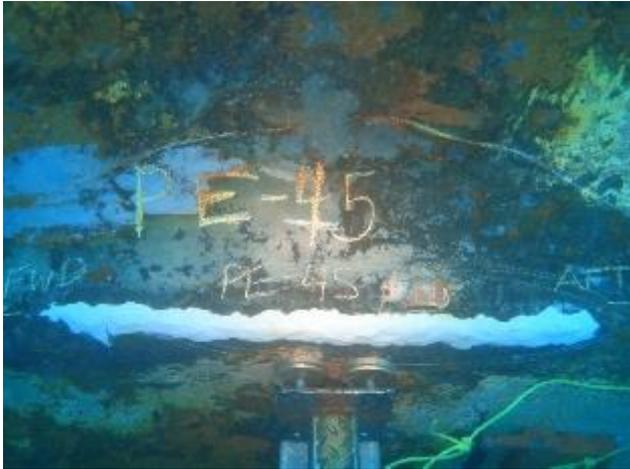
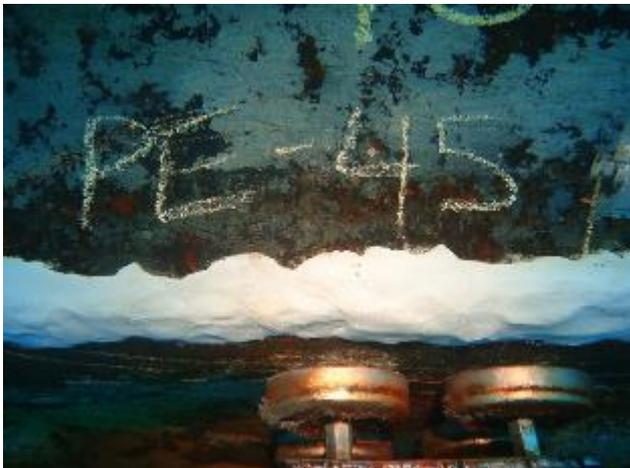
# P1: Weld Repair (41" x 8" doubler)

Port, round bilge, into #3 O/B D/B wing tank (FB): 28" indication, across FR 45 (PE-45)

1. Restore Port Shell Plating: Weld Repairs (P1, P2, P3)
  - a. Arrest/remove cracks (VT, MT, arc gouging, drill stop (min dia = 2X crack width)).
  - b. Port shell plate sealing (P1, P2, P3) with doubler plates (3 locations) and elliptical head patches as required to fit (min 1/4" plate for doublers, 3/8" plate for elliptical heads).
  - c. Underwater wet welding IAW ABS approved procedures
    1. austenitic (Ni) electrode for high C and CE (2 locations)
    2. mild steel electrode for low C and CE (3 locations).

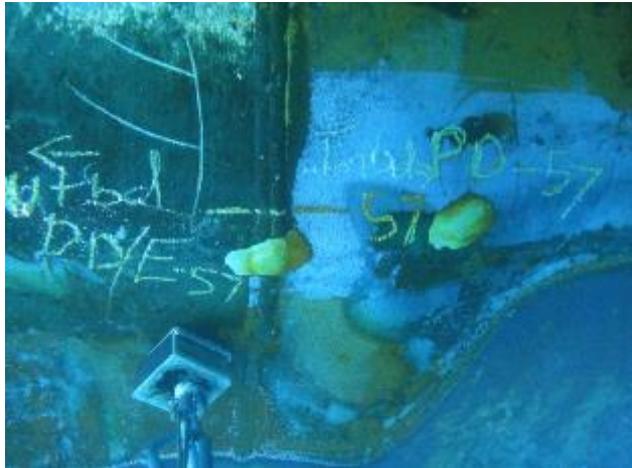
# P3: Weld Repair (8" dia elliptical head, 10" x 4" doubler, 13" x 5" doubler)

Port, flat bottom, into #4 O/B D/B wing tank (SWB): 3 indications between FR56-57, ~31' from CL, up to 3" in length. Port, round bilge, into #4A O/B D/B wing tank (FB): 1 indication on FRA, 4" in length (PD-57I, PD-57 and PD-56)

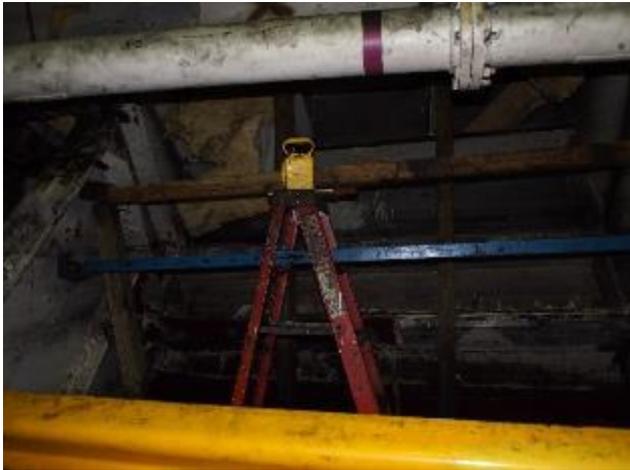
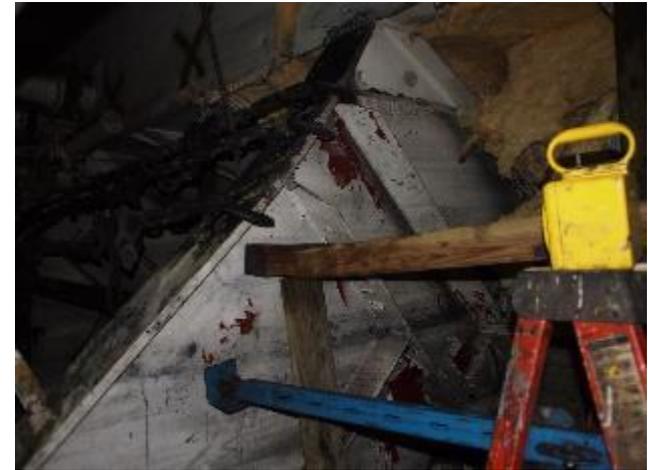
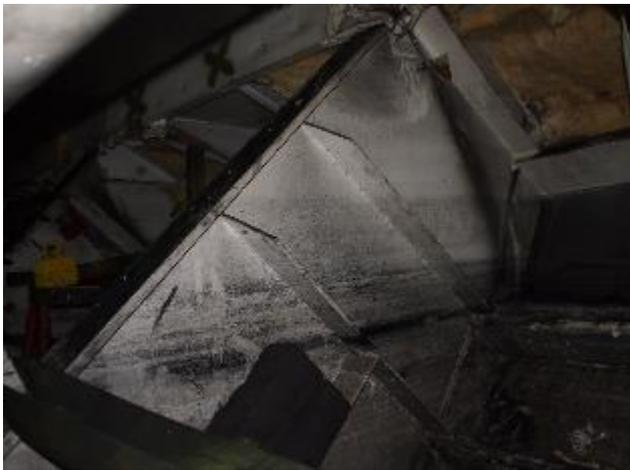
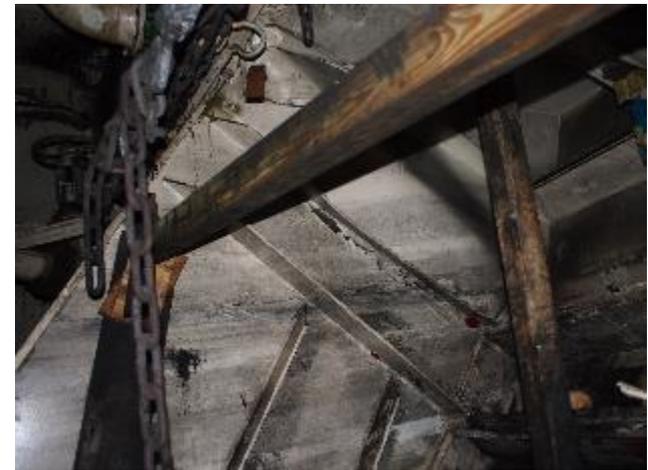
# P6

Transverse frames 44, 45, and 46 that have partially buckled between the decking and the longitudinal at the bottom of #3 O/B wing tank.

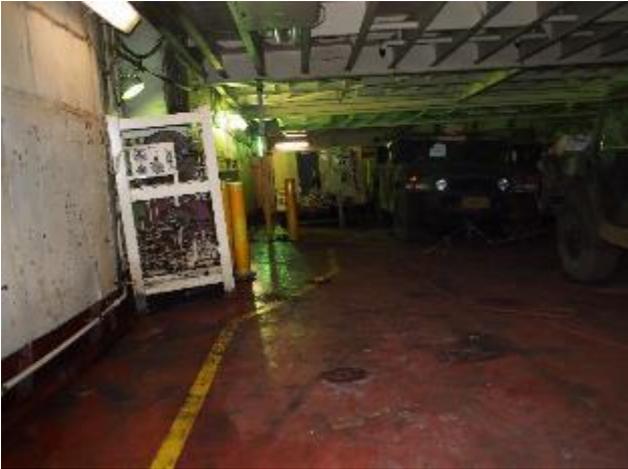
# P7

Tank top decking deflected upwards, 0"-9", between FR43 and FRC.
