# U.S. NAVY SALVAGE REPORT USNS SGT MATEJ KOCAK (T-AK 3005) SALVAGE AND TEMPORARY REPAIRS

This salvage report documents the recovery and temporary repairs conducted by NAVSEA 00C, Supervisor of Salvage and Diving, for the Military Sealift Command. The operations took place off the east coast of Okinawa from 22 January 2015, the date of the grounding, to 20 February 2015, when the temporary repairs were completed. Details of the efforts and accomplishments are provided in this report.

## USNS KOCAK (T-AK 3005) Refloating and Temporary Repairs

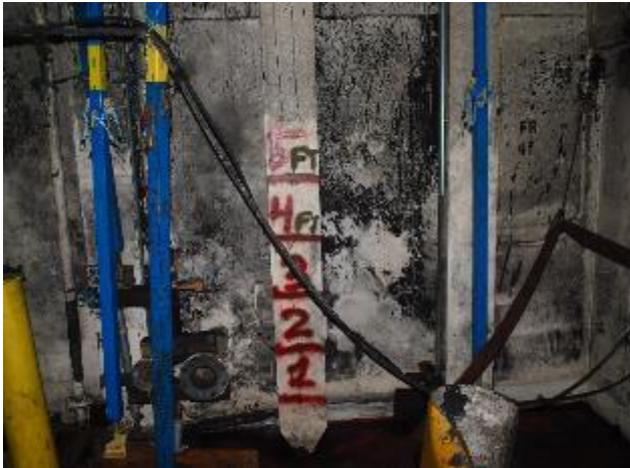
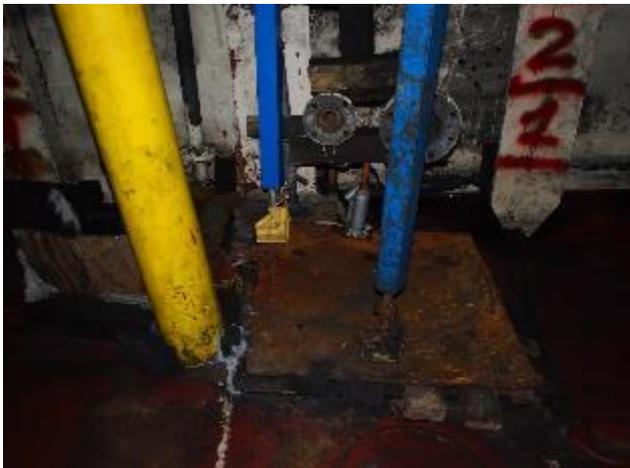
# P8: Weld Repair

#3 O/B D/B (FB) leak into #3A tank top deck: 4 locations where the fillet welds between the decking and the WTB have failed.

3. Isolate Port tanks 3A, 4 and 4A from the Cargo Holds: P8, P9, P10 and P11
  - a. Crack in 3A (FB) - weld repair tank top to cargo hold boundary.
  - b. Crack in 4A (FO) – epoxy repair inside tank with shoring inside the tank to support.
  - c. Cracks in 4 (SWB) - epoxy repair inside tank with shoring inside the tank to support.

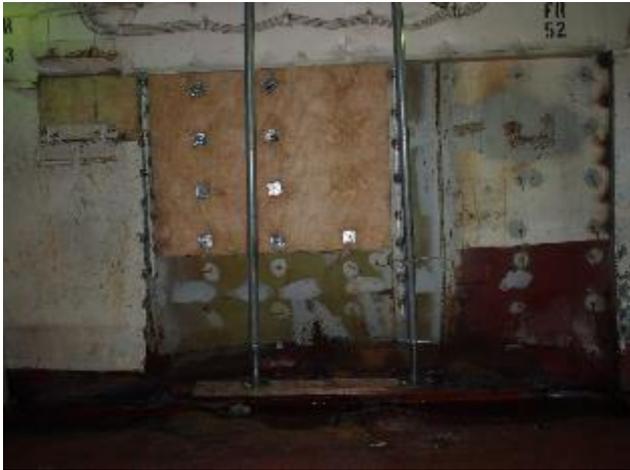
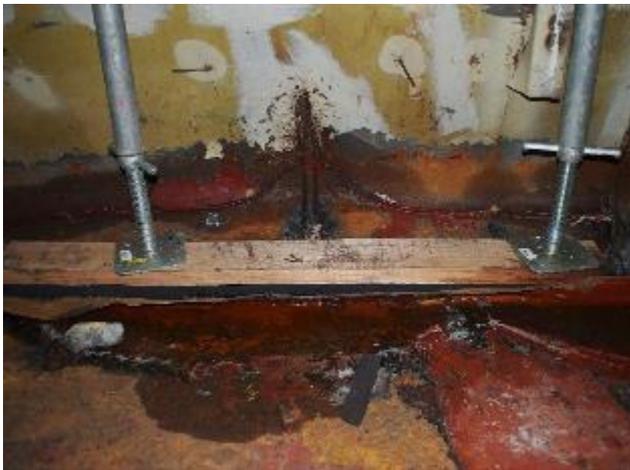
# P9: Epoxy Repair

#4 O/B D/B (SWB) leak into 4 tank top deck: 48" long indication.

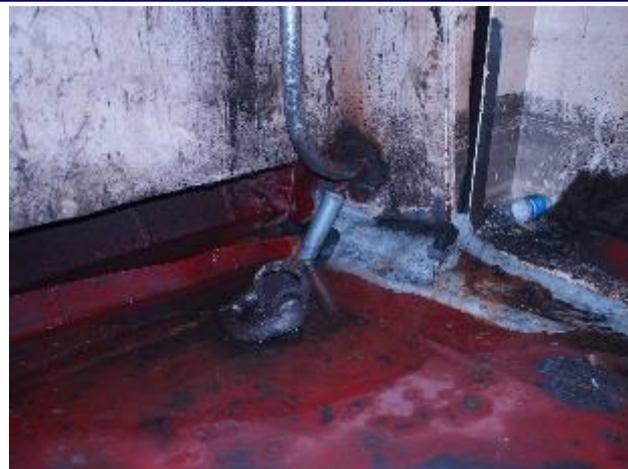
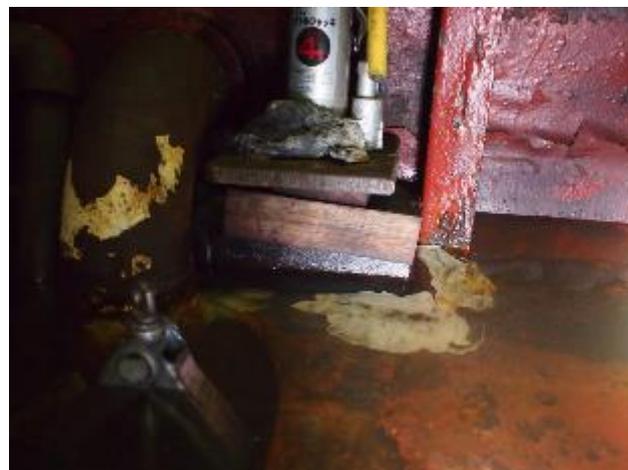
# P10: Epoxy Repair

- . #4 & #4A O/B D/B (SWB/FB) leak into tank top deck: 4 indications around WTD foundation. Location is patched and shored. No leaks when #4 O/B D/B tank is below tank top (5'-6" ABL), leak rate of less than 1 GPM when full.

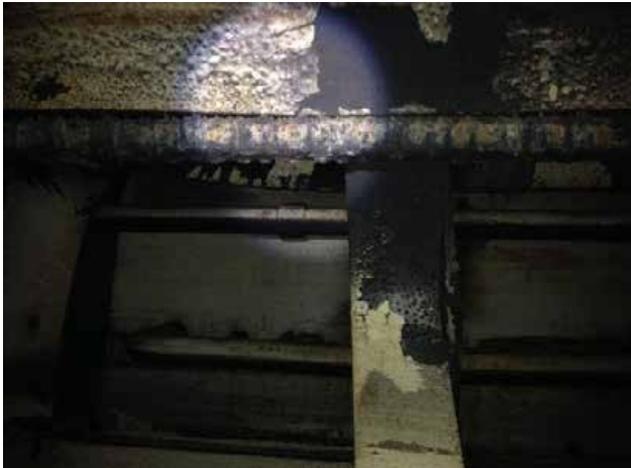
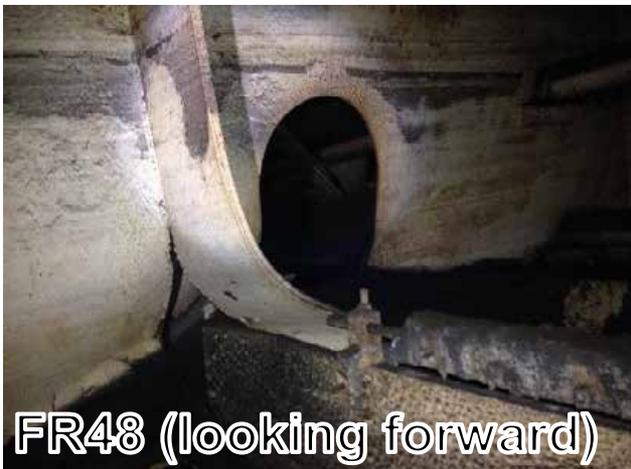
# P12: Epoxy Repair

Port side. WTB between #3 O/B D/B (FB) and #4 O/B D/B (SWB). Leaks at P4 stopped when #4 O/B D/B was dewatered.

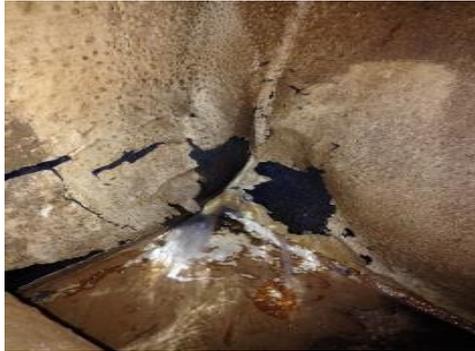
# P13: Soft Patch

Port side WTB, between #4 O/B D/B (FB) and #4A O/B wing (DFM). Cracked fillet weld.

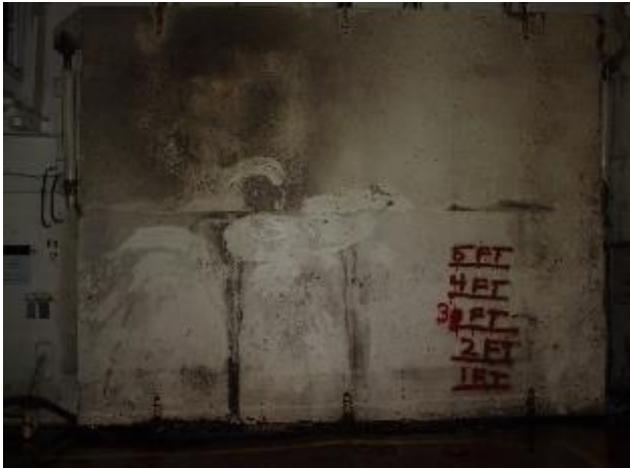
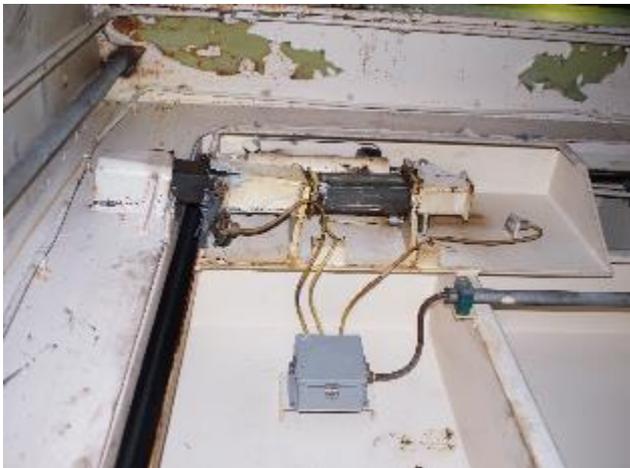
# P14: Weld Repair

Port side WTD, floor deflections leave gap between door and floor and vertical sealing surfaces.

6. Restore cargo hold watertight integrity between holds 4 and 4A with door modification ( P14).
  - a. Cut bottom of door to match tank top contour
  - b. Replace existing shoe plate with ½” shoe plate
  - c. Install door seal channel below the shoe plate
  - d. Cut back the bottom 24” of the outboard side of the door to match the contour of the bent frame and modify side seal channel to match contour
  - e. Secure closed door with turnbuckles to replace upper and lower door locks that were removed to facilitate door opening.

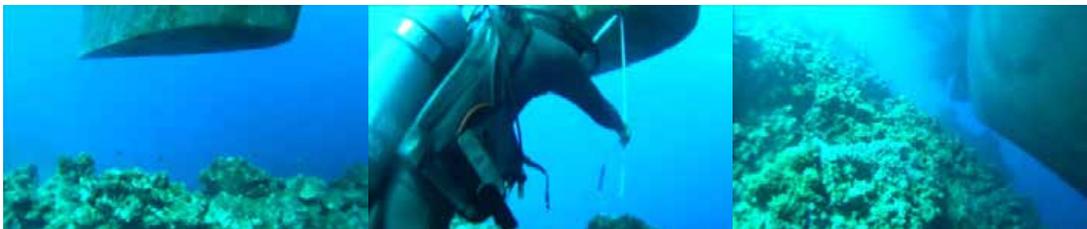
During refloating there was concern for the running gear potentially contacting a coral pinnacle 80 cm (30 in) under the rudder (Figure 4) and propeller. Another pinnacle at 7 m (24 ft) depth off the port quarter was also noted as a potential hazard to be avoided when backing off the reef.

**Figure 4.** Vessel rudder and propeller in relation to clearance on the reef.

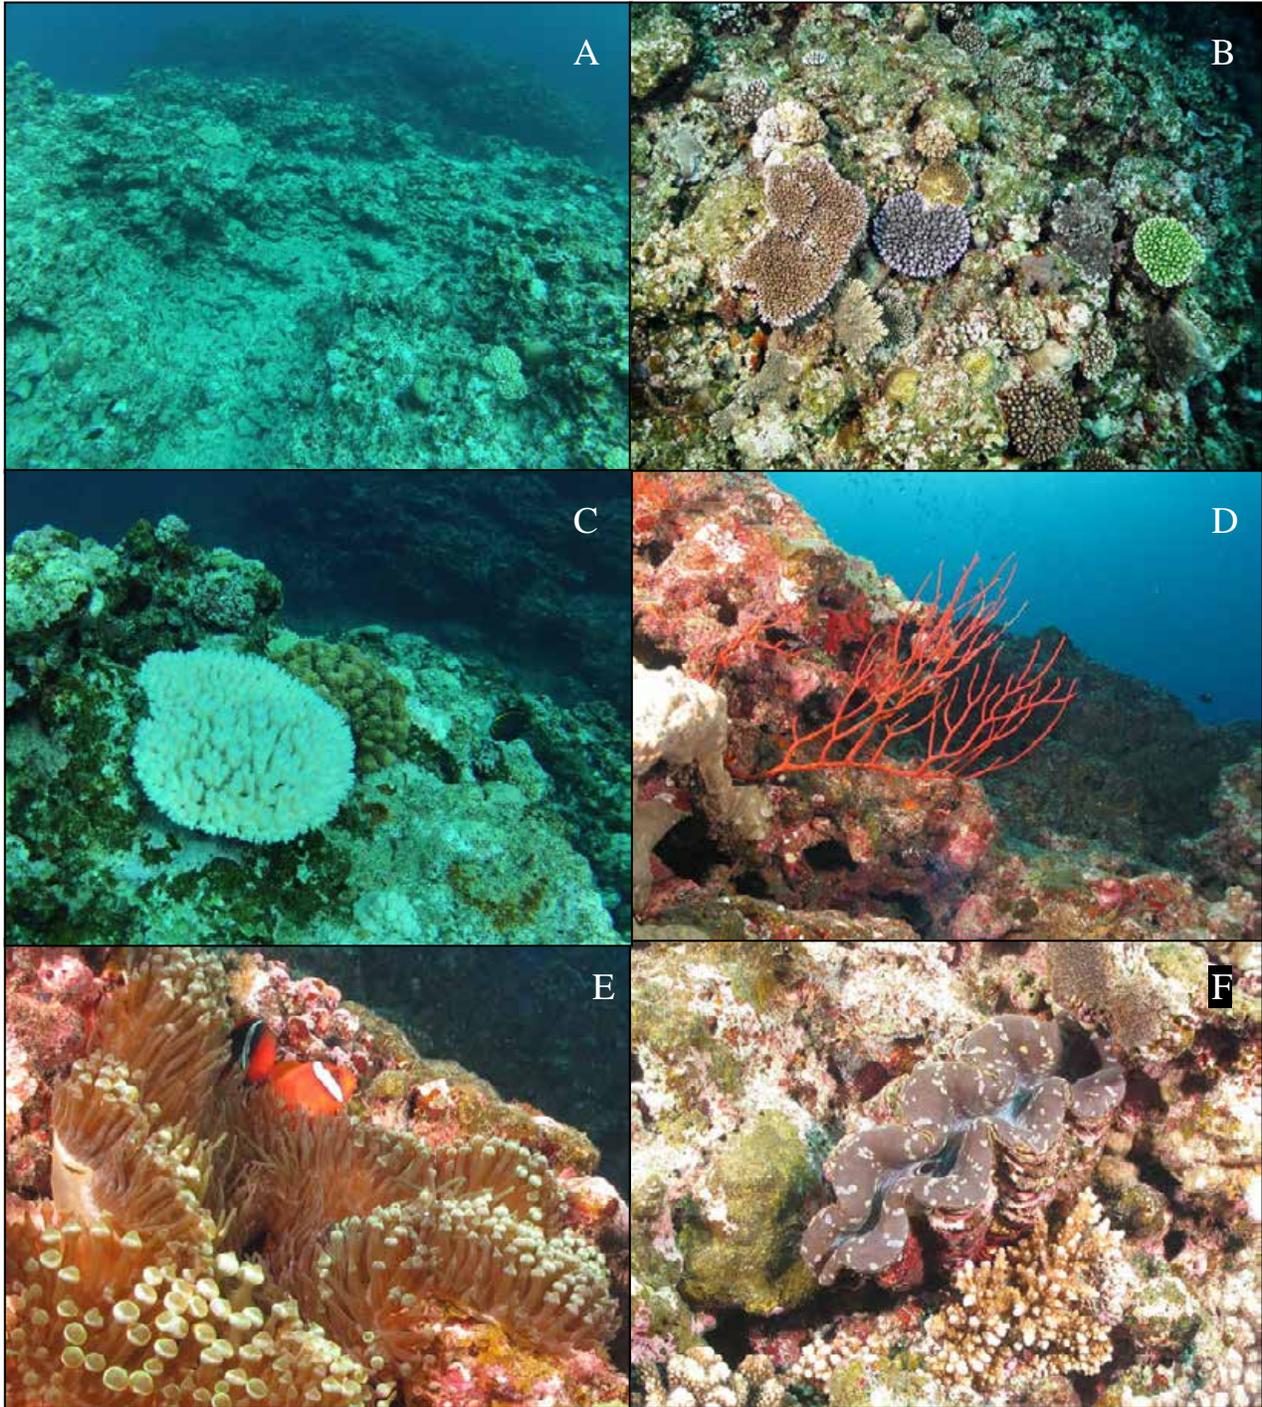
Coral bleaching was evident throughout the reef indicating a previous bleaching event that affected this area. However, bleaching did seem to be higher near the grounding site, under the position of the vessel. If corals in the area were already naturally under stress, the shade from a vessel grounded for several weeks could cause others to become affected.

**Figure 5.** A) typical reef relief common at site, B) standard coral size (<30 cm, ~12 inches), C) a bleached coral next to a live coral, D) live coral cover and size present on deeper/slope areas, E) anemone (*Actinaria*) near grounding site, F) giant clam (*Tridacna* sp.) found near grounding site.
