# USS FRANK KNOX (DDR-742) STRANDING SALVAGE

NAVSHIPS 0994-002-6010

DEPARTMENT OF THE NAVY  
NAVAL SHIP SYSTEMS COMMAND  
WASHINGTON, D.C.

1968

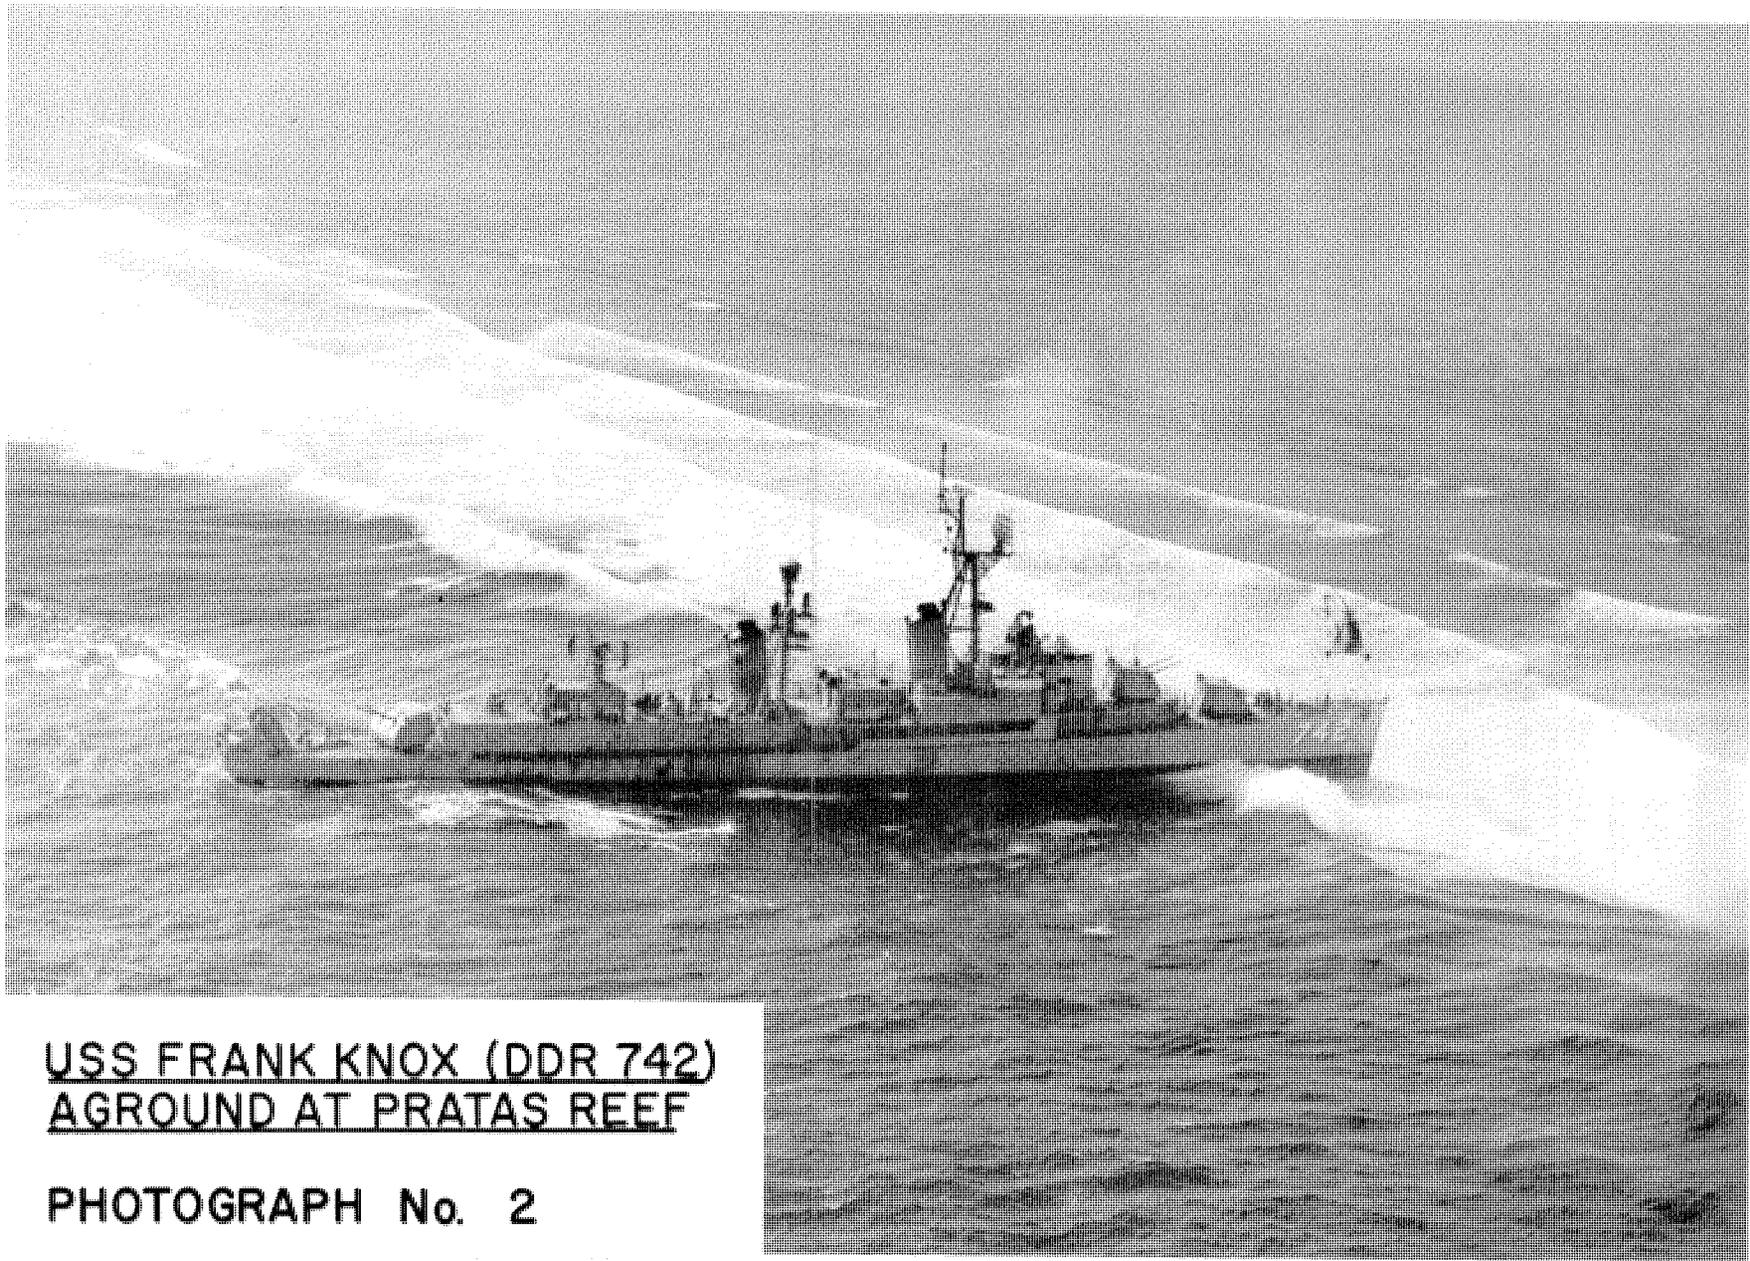
PHOTOGRAPH No. 2

USS FRANK KNOX (DDR 742)  
AGROUND AT PRATAS REEF

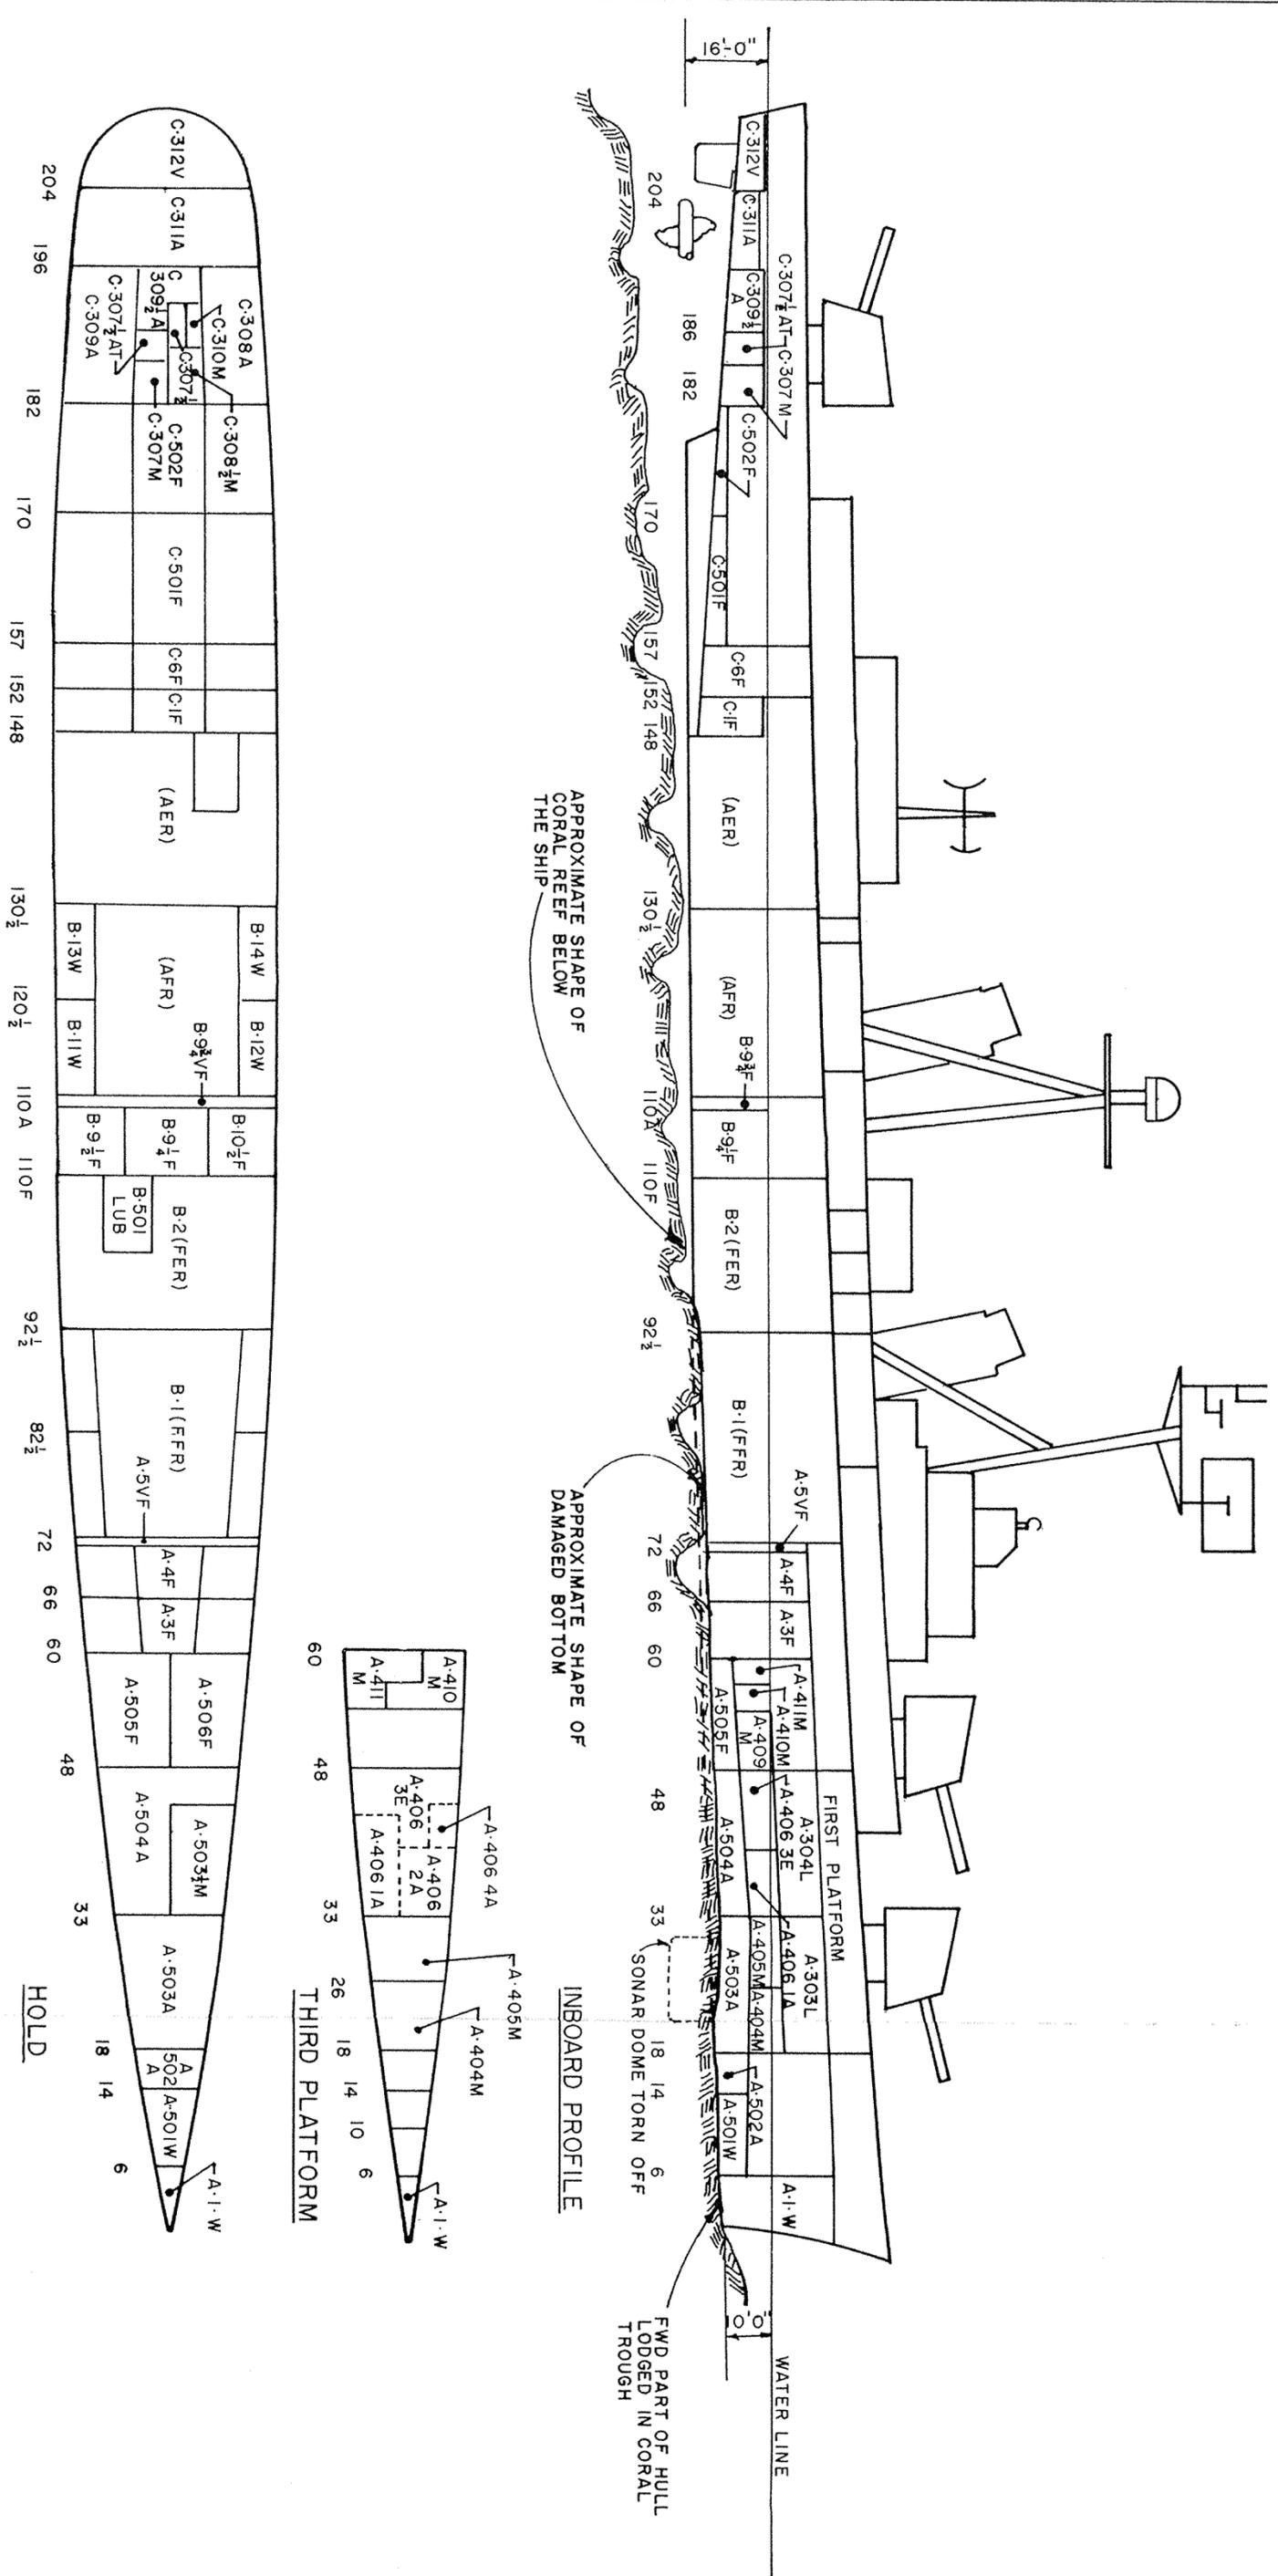
USS FRANK KNOX (DDR 742)  
SCALE: NONE  
FIGURE B

NOTE: Figure B, page 5, presents the FRANK KNOX compartmentation plan. The condition presented here shows the ship in her grounded state on the reef shortly before the successful salvage. FRANK KNOX's situation changed during the early phases of salvage and continued to vary until the freeing of the ship. This plate will be a useful reference to the reader in following the several phases of the salvage operation.

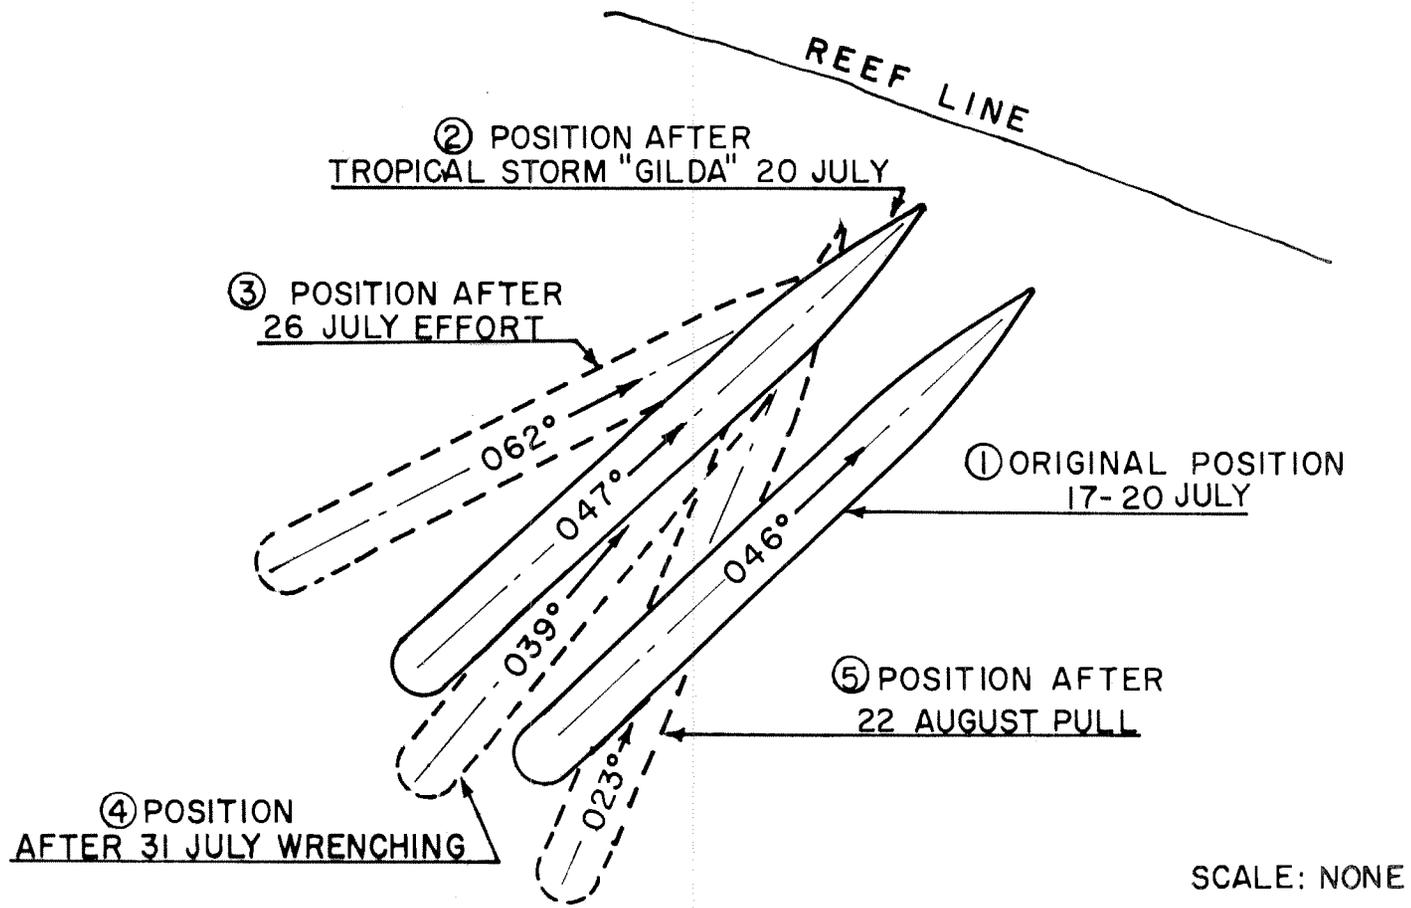
FIGURE D

VARIOUS POSITIONS OF THE STRANDED FRANK KNOX

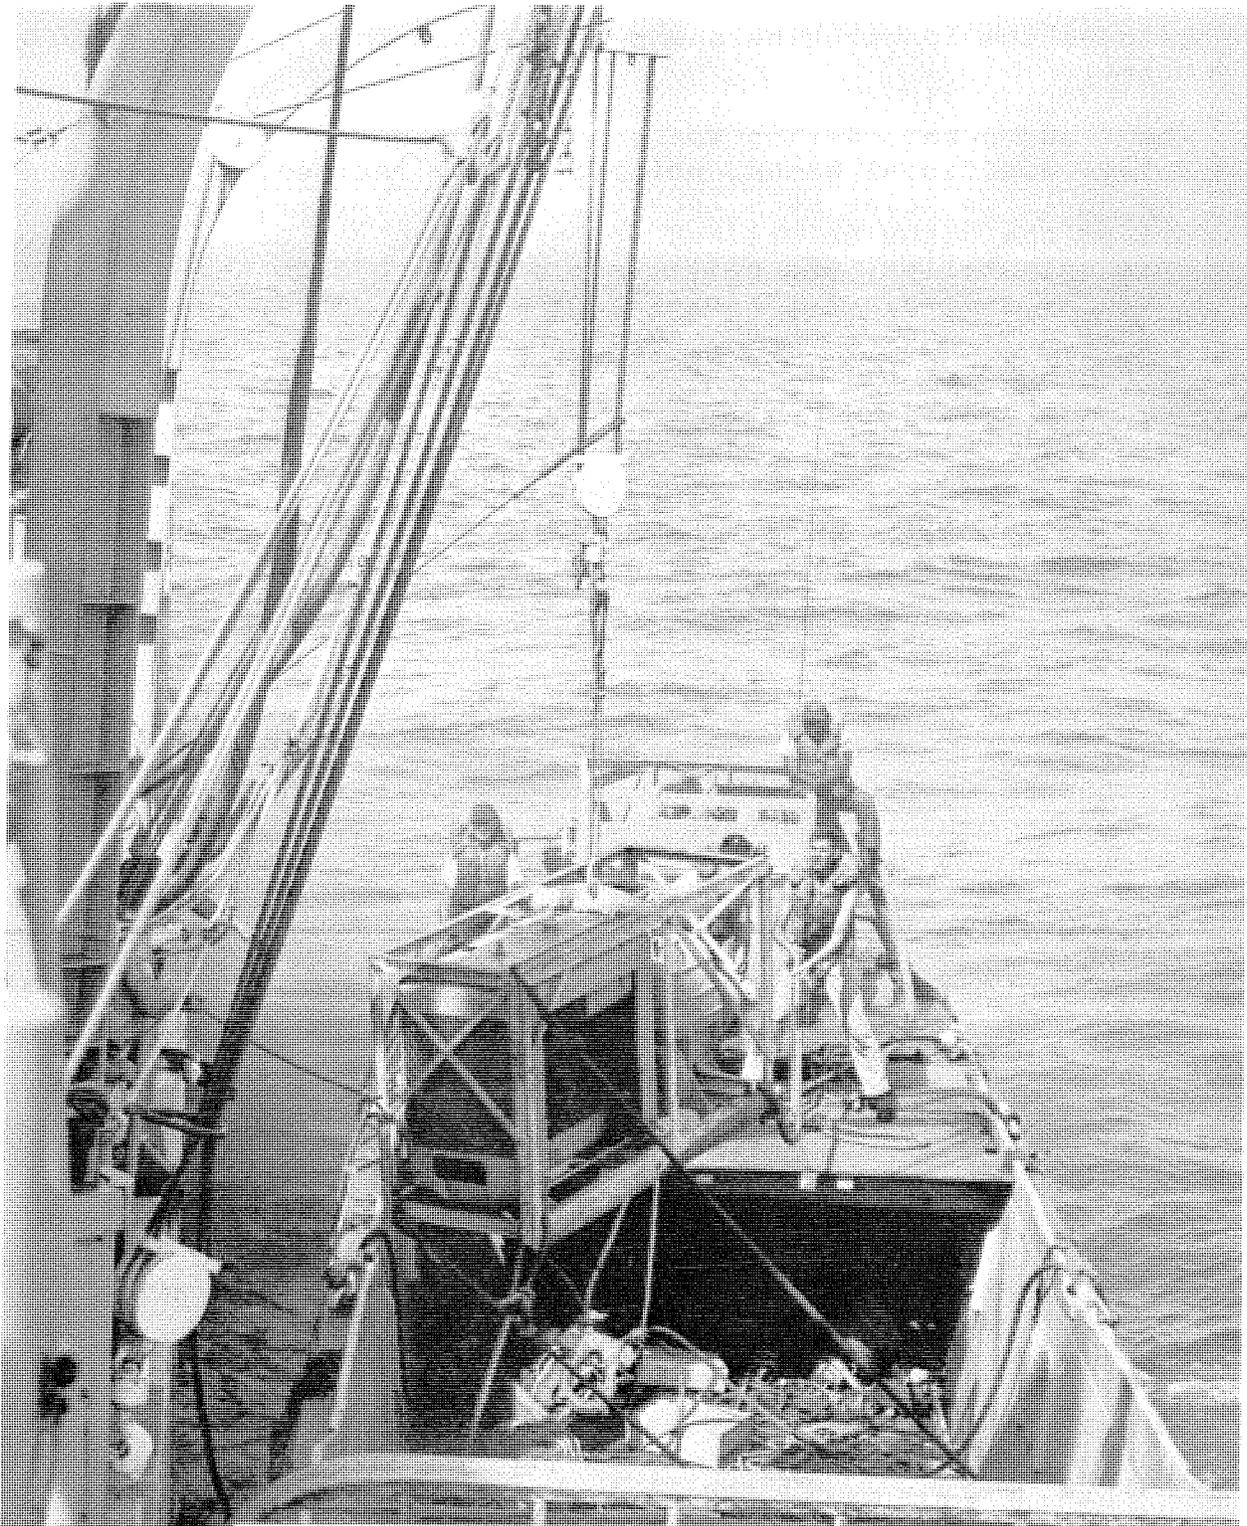
PHOTOGRAPH No. 5

TRANSFERRING 10 INCH PUMP FROM  
LCM ON BOARD FRANK KNOX

1. Transferred two 10-inch pumps from CONSERVER by MARS helicopter. These pumps were rigged in the starboard side accesses to the flooded engineering spaces.
2. Improved the tank/compartment blowing system and procedures.

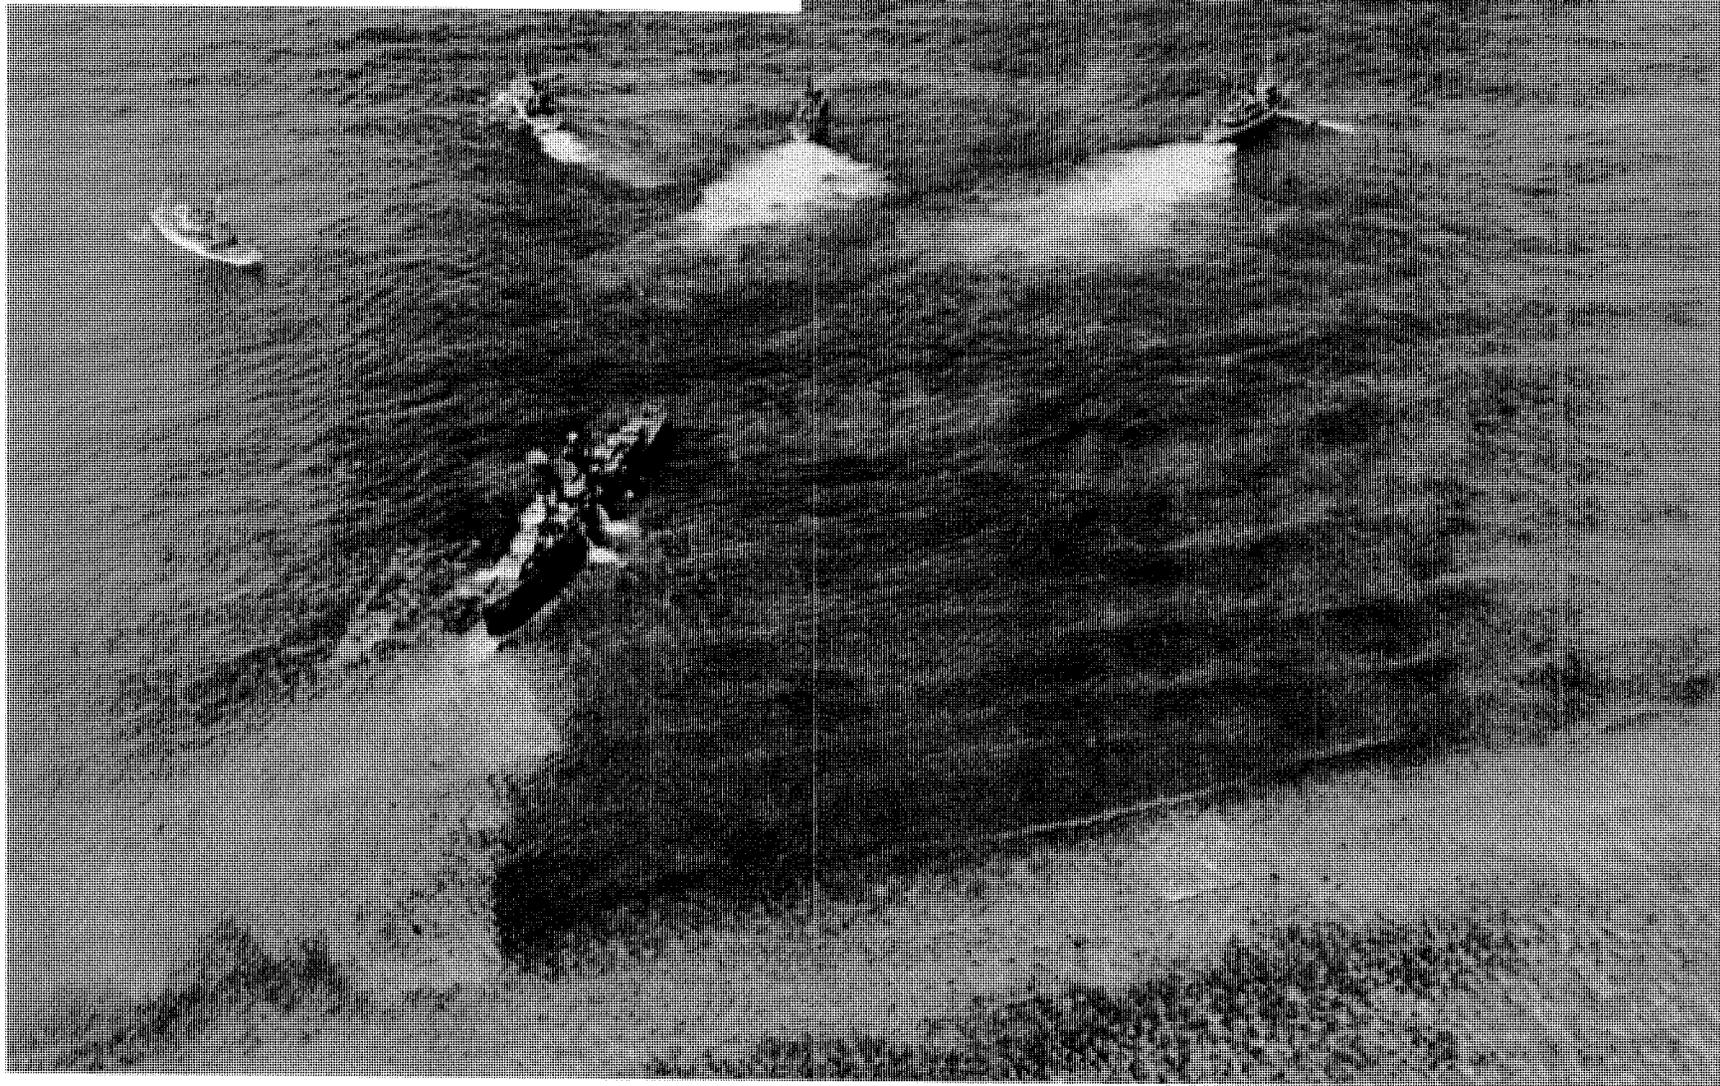
PHOTOGRAPH No. 6

PULLING EFFORTS ON 31 JULY

NOTE: In Photograph 6, page 27, note the general view of pulling effort on 31 July 1965. Shown clockwise from FRANK KNOX are USS GRAPPLE (ARS 7), USS CONSERVER (ARS 39), USS SIOUX (ATF 75), (each with two sets of beach gear), and USS GREENLET (ASR 10); GREENLET pulling with engines only. USS COCOPA (ATF 107) (shown at upper right) assisting GREENLET in holding her position in a 5-knot lateral current. (Note wash on port side of the two ARS produced by the current.) CONSERVER and SIOUX used main engines to supplement the pull on their beach gear anchors which were not holding well. This effort was successful in rotating the stern of FRANK KNOX into deeper water, which left the ship in a much better position. The original grounded position of the stricken ship can be seen about 75 feet to starboard of its present position. The ship had bounced laterally along the reef the night of 20 July during tropical storm "Gilda." It was at this time that the majority of the serious damage to FRANK KNOX occurred. The white area forward of FRANK KNOX is a deposit of fine coral sand which was ground by the action of the destroyer's hull pounding and working against the bottom.

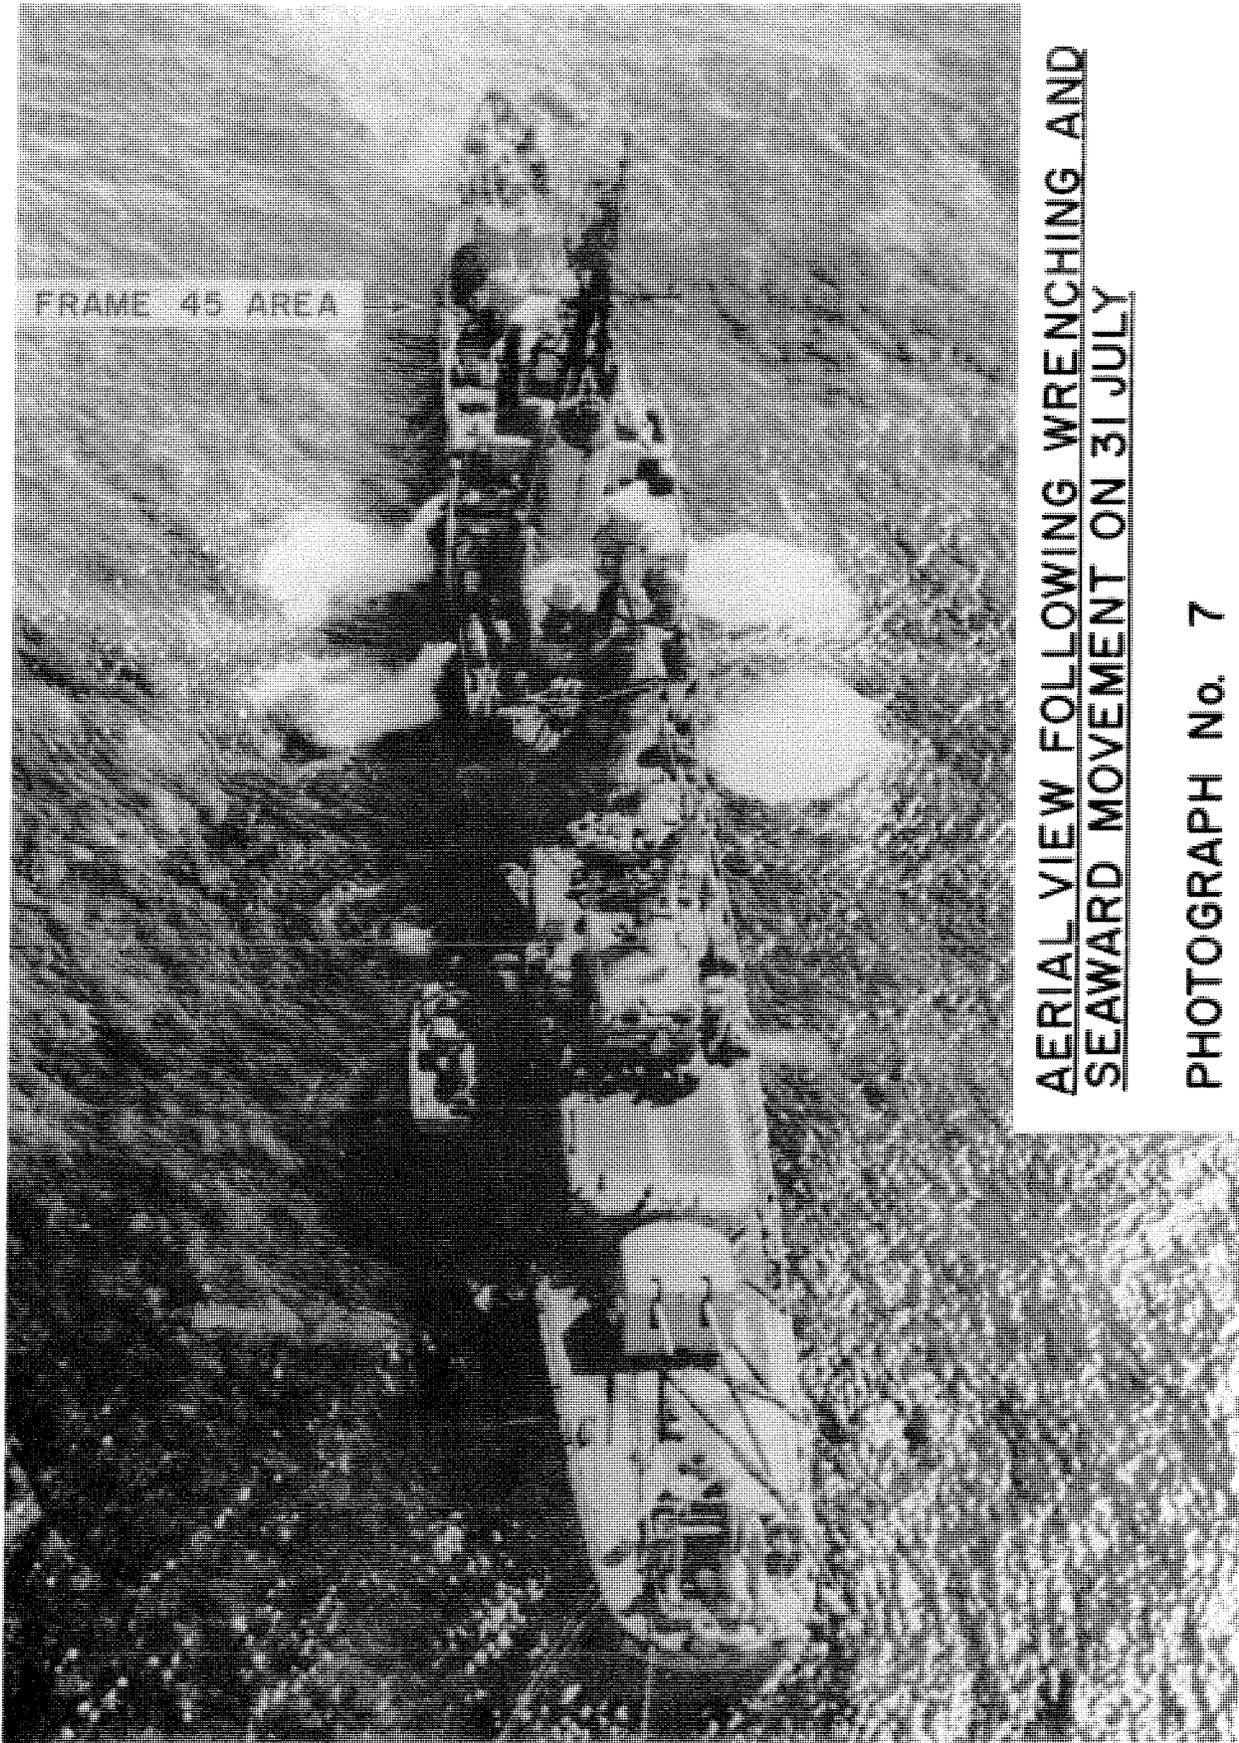
PHOTOGRAPH No. 7

The well coordinated effort with an estimated maximum strain on each of three tow wires, plus GREENLET's and COCOPA's engines, resulted in wrenching the ship around from a heading of 062° to 039° and moved the ship about six feet astern. This effort was successful in getting the stern to deeper water and the bottom of the after fireroom off the coral during all tides. At high tide, all of the forward engine room and most of the forward fireroom were clear of the bottom. The grounded area appeared to be centered at about frame 45. (See Photograph 7, page 29. Arrow indicates approximate position of frame 45.)

AERIAL VIEW FOLLOWING WRENCHING AND SEAWARD MOVEMENT ON 31 JULY

NOTE: In Photograph 7, page 29, note an aerial view of FRANK KNOX following the successful wrenching of the stern to starboard and moderate movement to seaward on 31 July. The original grounded position was at the upper right; the position prior to wrenching was off the port side. The scar on the coral to port of mount 53 was caused by the propellers when the ship bounced along the reef during the storm of 20 July. The connections for the tow wires are made up on the fantail. Clockwise, the wires are GRAPPLE's, CONSERVER's and SIOUX's (each with a 2 1/4-inch chain bridle passed around the base ring of mount 53), GREENLET's (with a two-inch wire bridle around mount 53), and the beach gear wire for the set being heaved on by the destroyer.

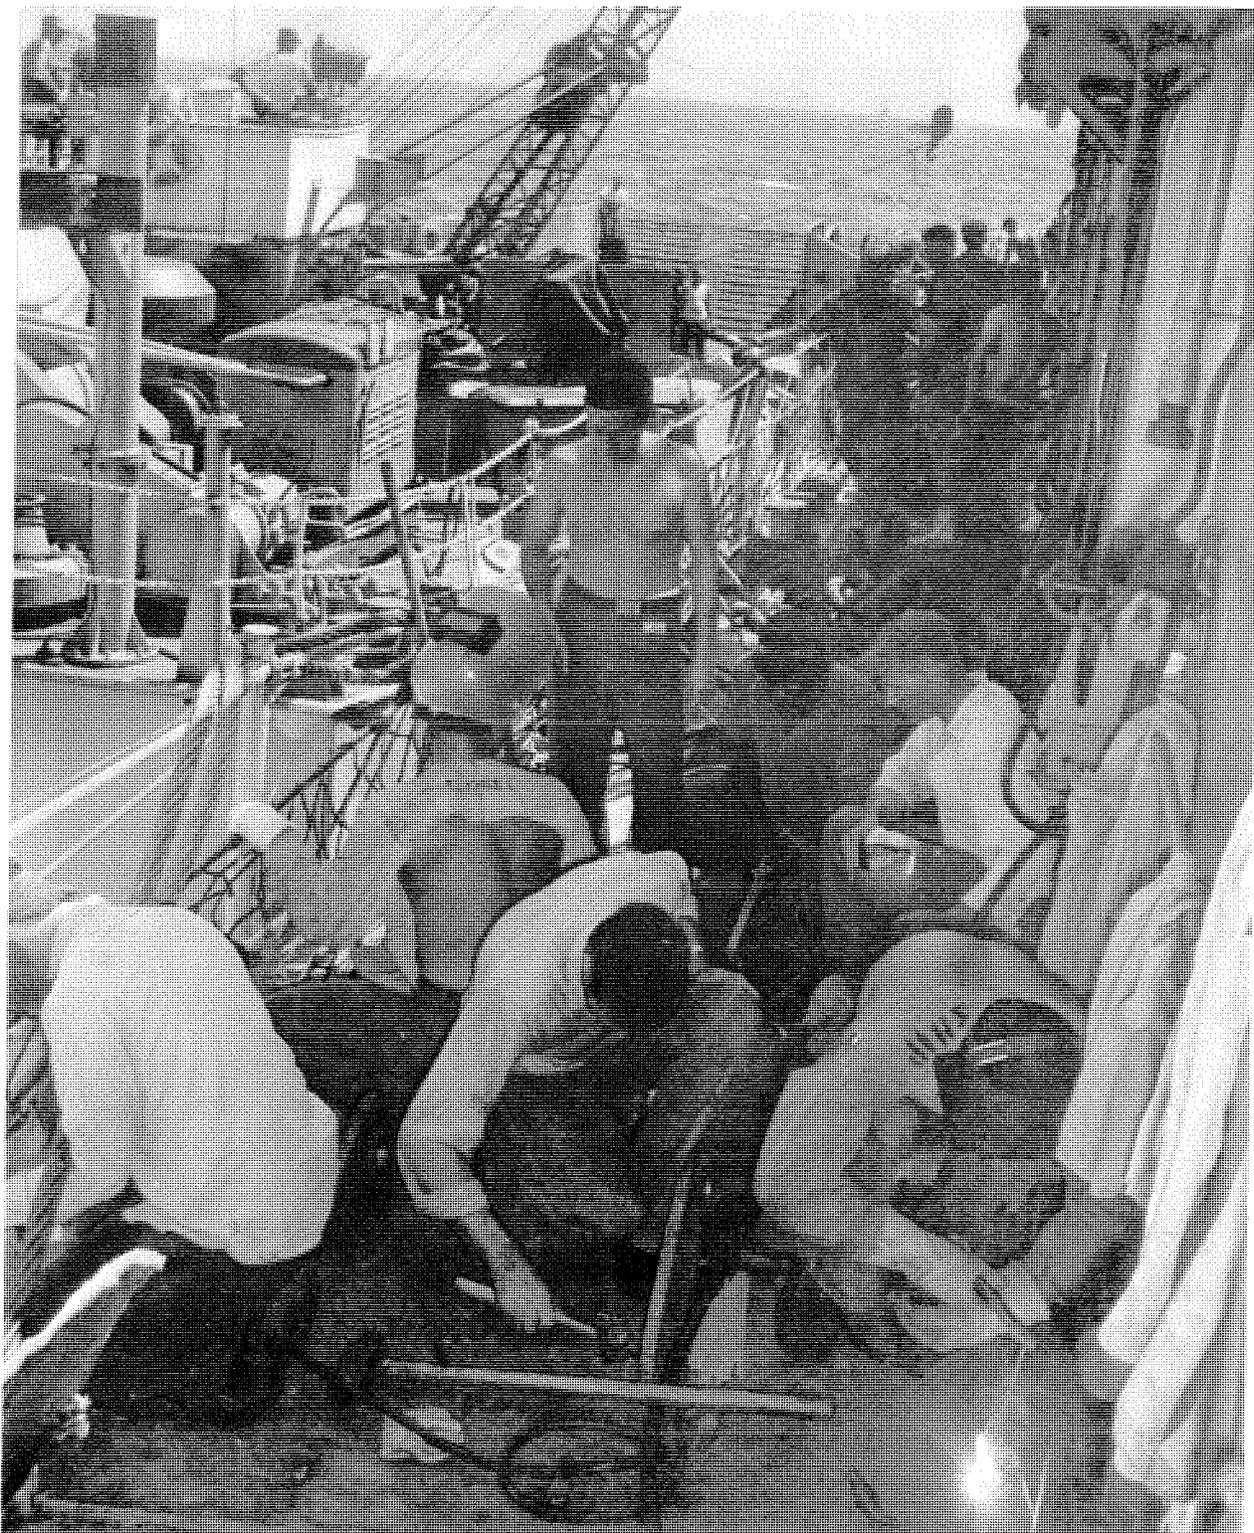
PHOTOGRAPH No. 8

WELDING PLATES WITH PADEYES AT FRAME 112  
STBD FOR HOLDING STANDING BEACH GEAR BLOCKS

NOTE: In Photograph 8, page 35, note welders from USS PRAIRIE (AD 15) welding a heavy plate with two padeyes for the standing beach gear blocks at frame 112, starboard side, on FRANK KNOX. These men also welded two heavy "T" stiffeners along each side (port and starboard, frame 72 to 130) to strengthen the hull. An LCU with a crane embarked is alongside to starboard. This craft, with its crane, proved very valuable from its arrival on 4 August until the salvage operation was completed on 24 August.

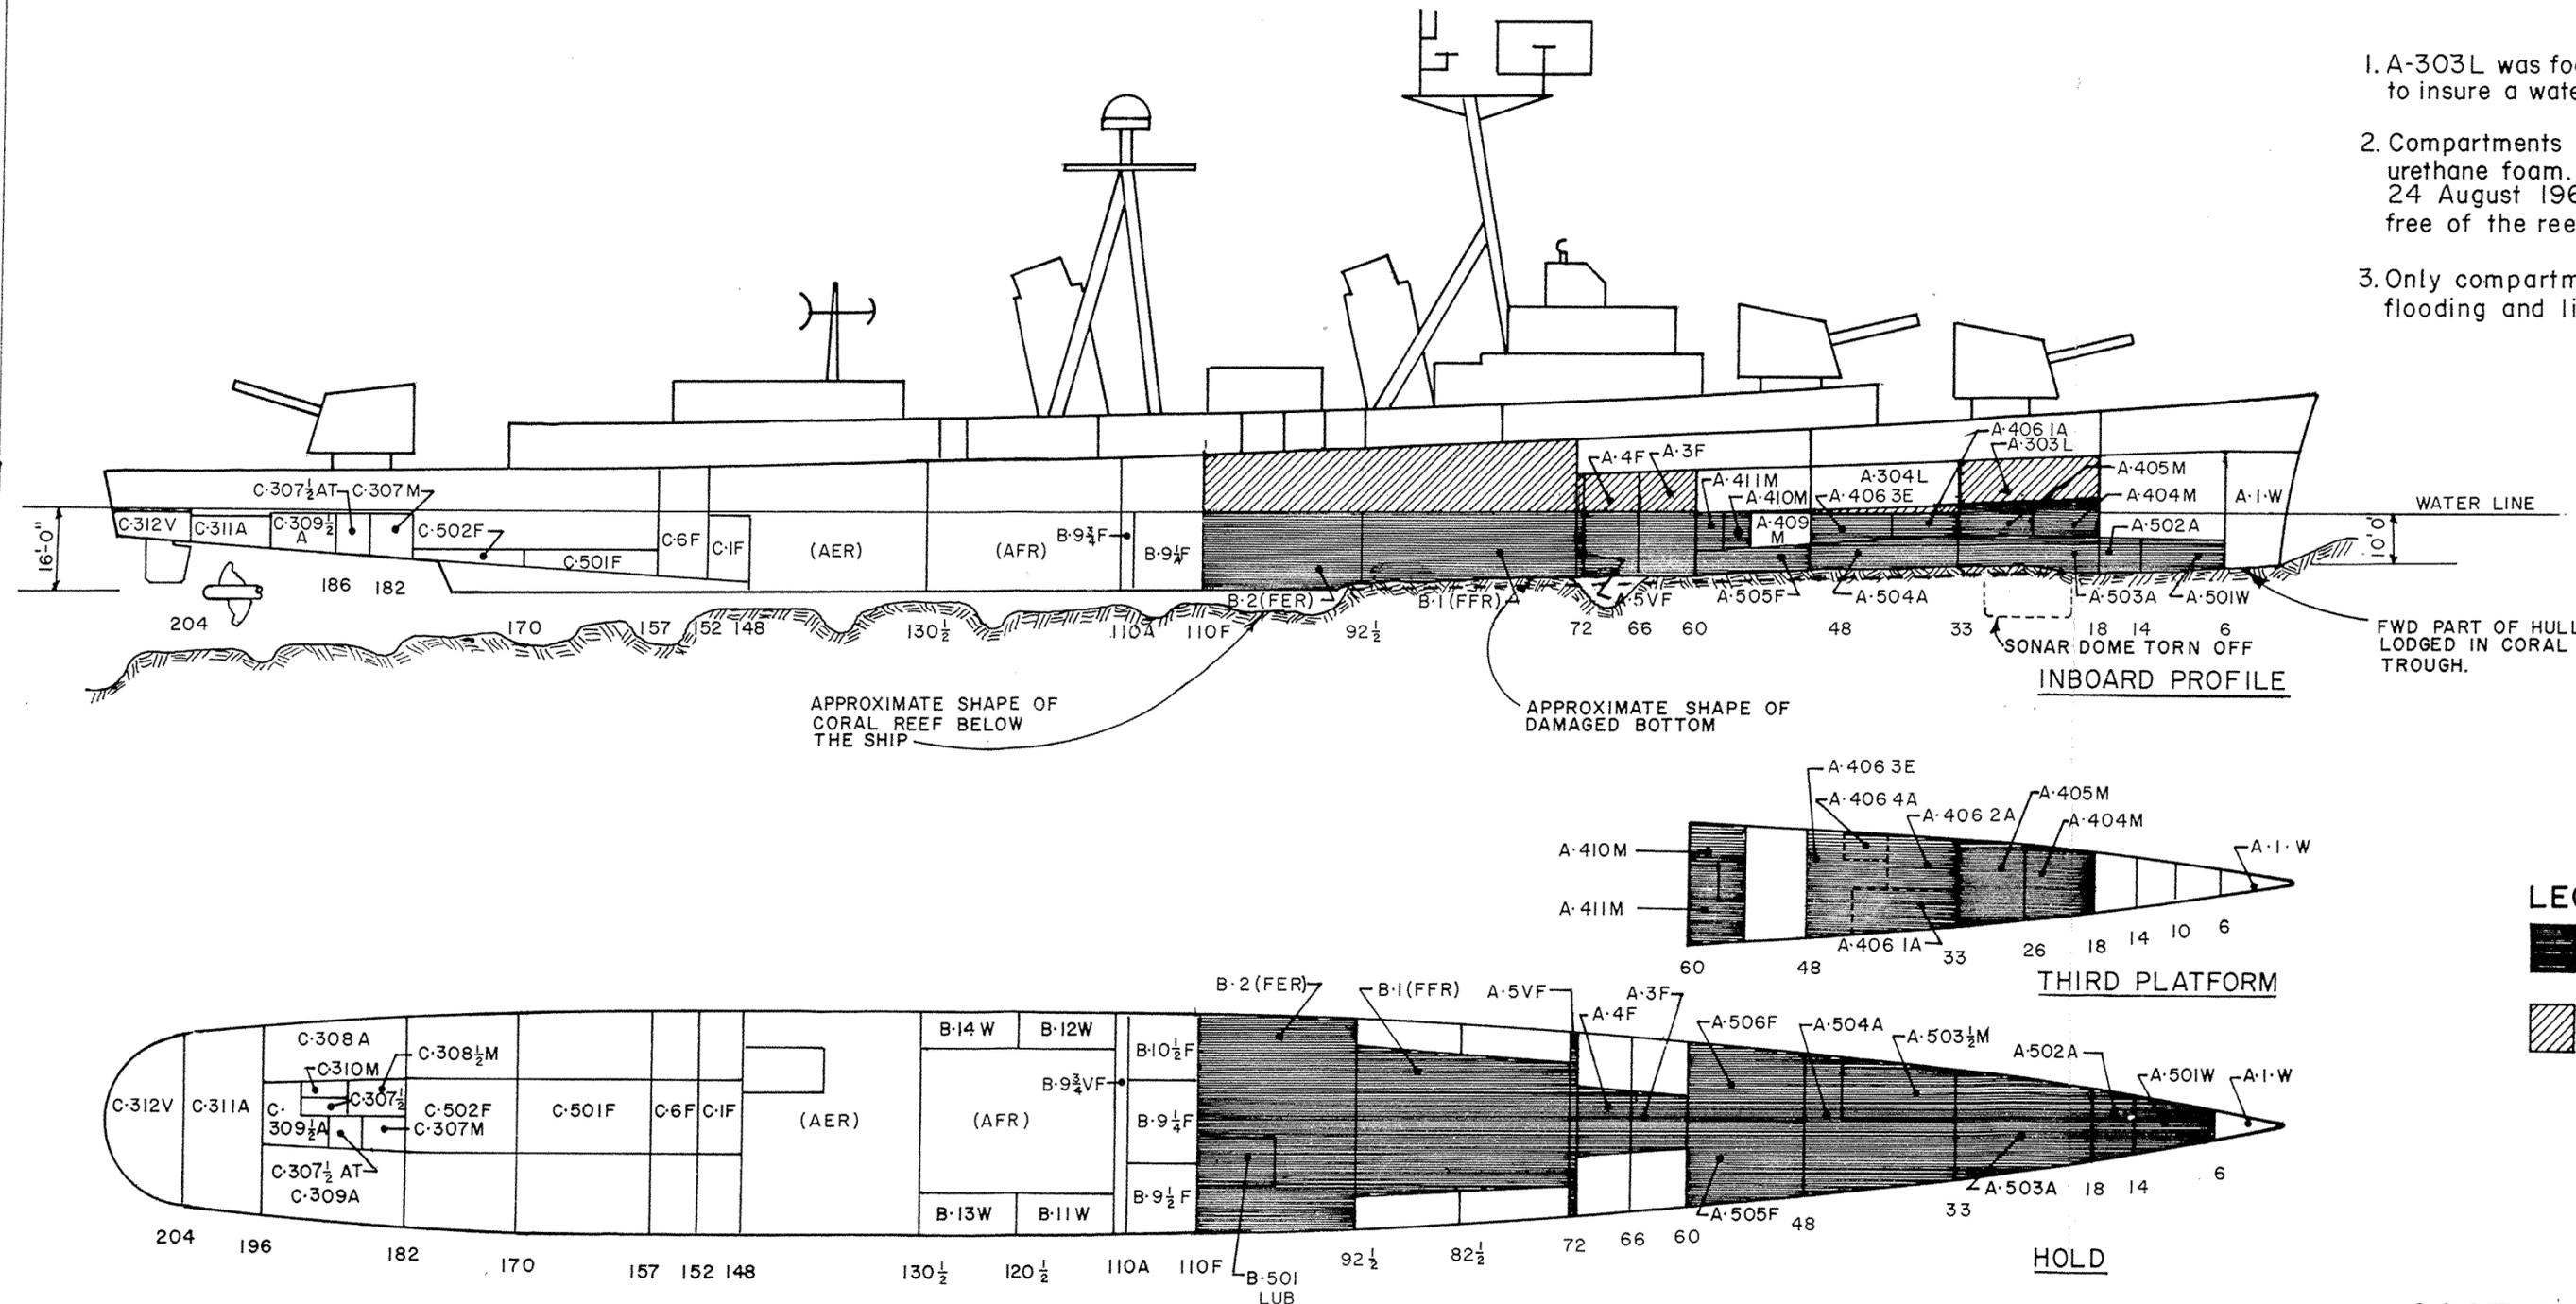
1. A-303L was foamed as a damage control measure to insure a water seal from A-405M & A-404M.
2. Compartments shown shaded were filled with urethane foam. Condition shown was as of 24 August 1965 prior to time ship was pulled free of the reef.
3. Only compartments and details relative to flooding and liquid loading are shown.

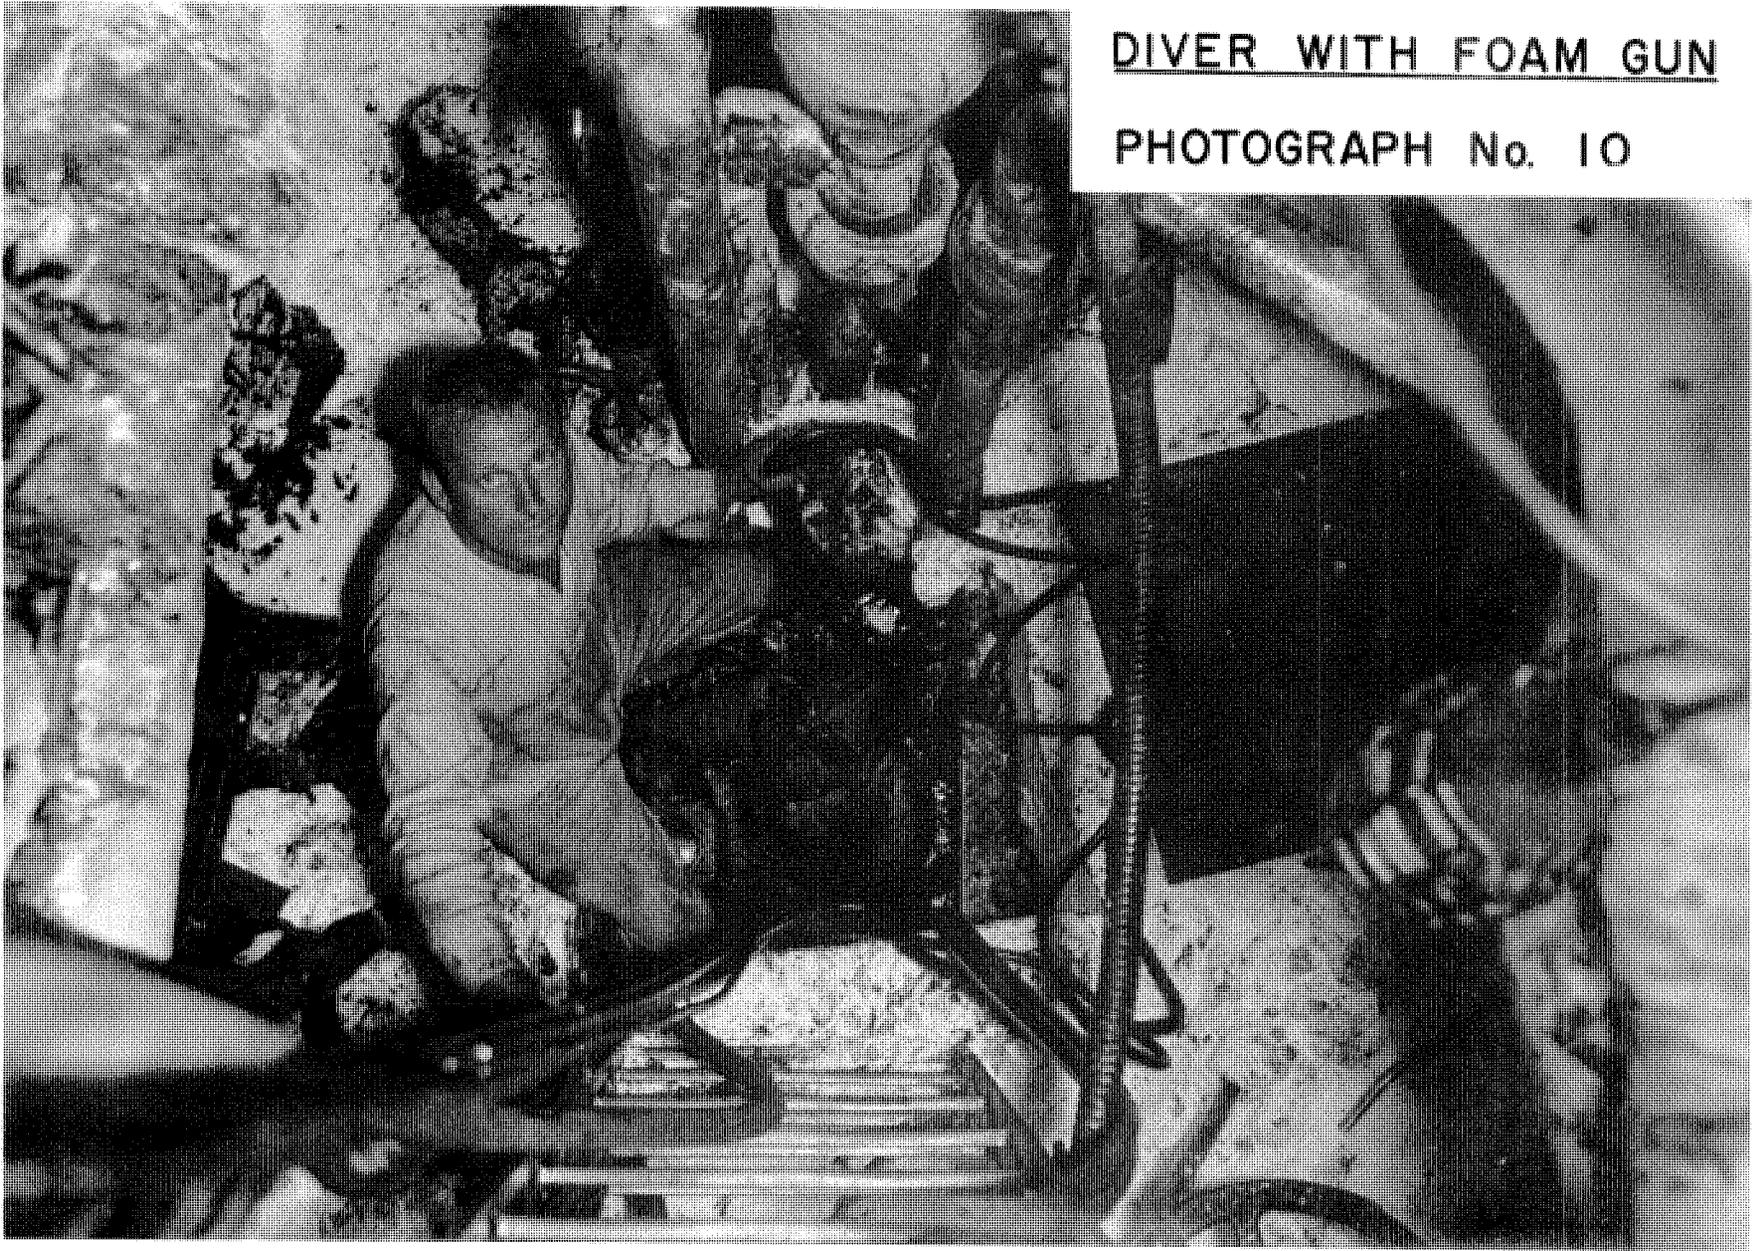
PHOTOGRAPH No. 10

DIVER WITH FOAM GUN
