# USS FRANK KNOX (DDR-742) STRANDING SALVAGE

NAVSHIPS 0994-002-6010

DEPARTMENT OF THE NAVY  
NAVAL SHIP SYSTEMS COMMAND  
WASHINGTON, D.C.

1968

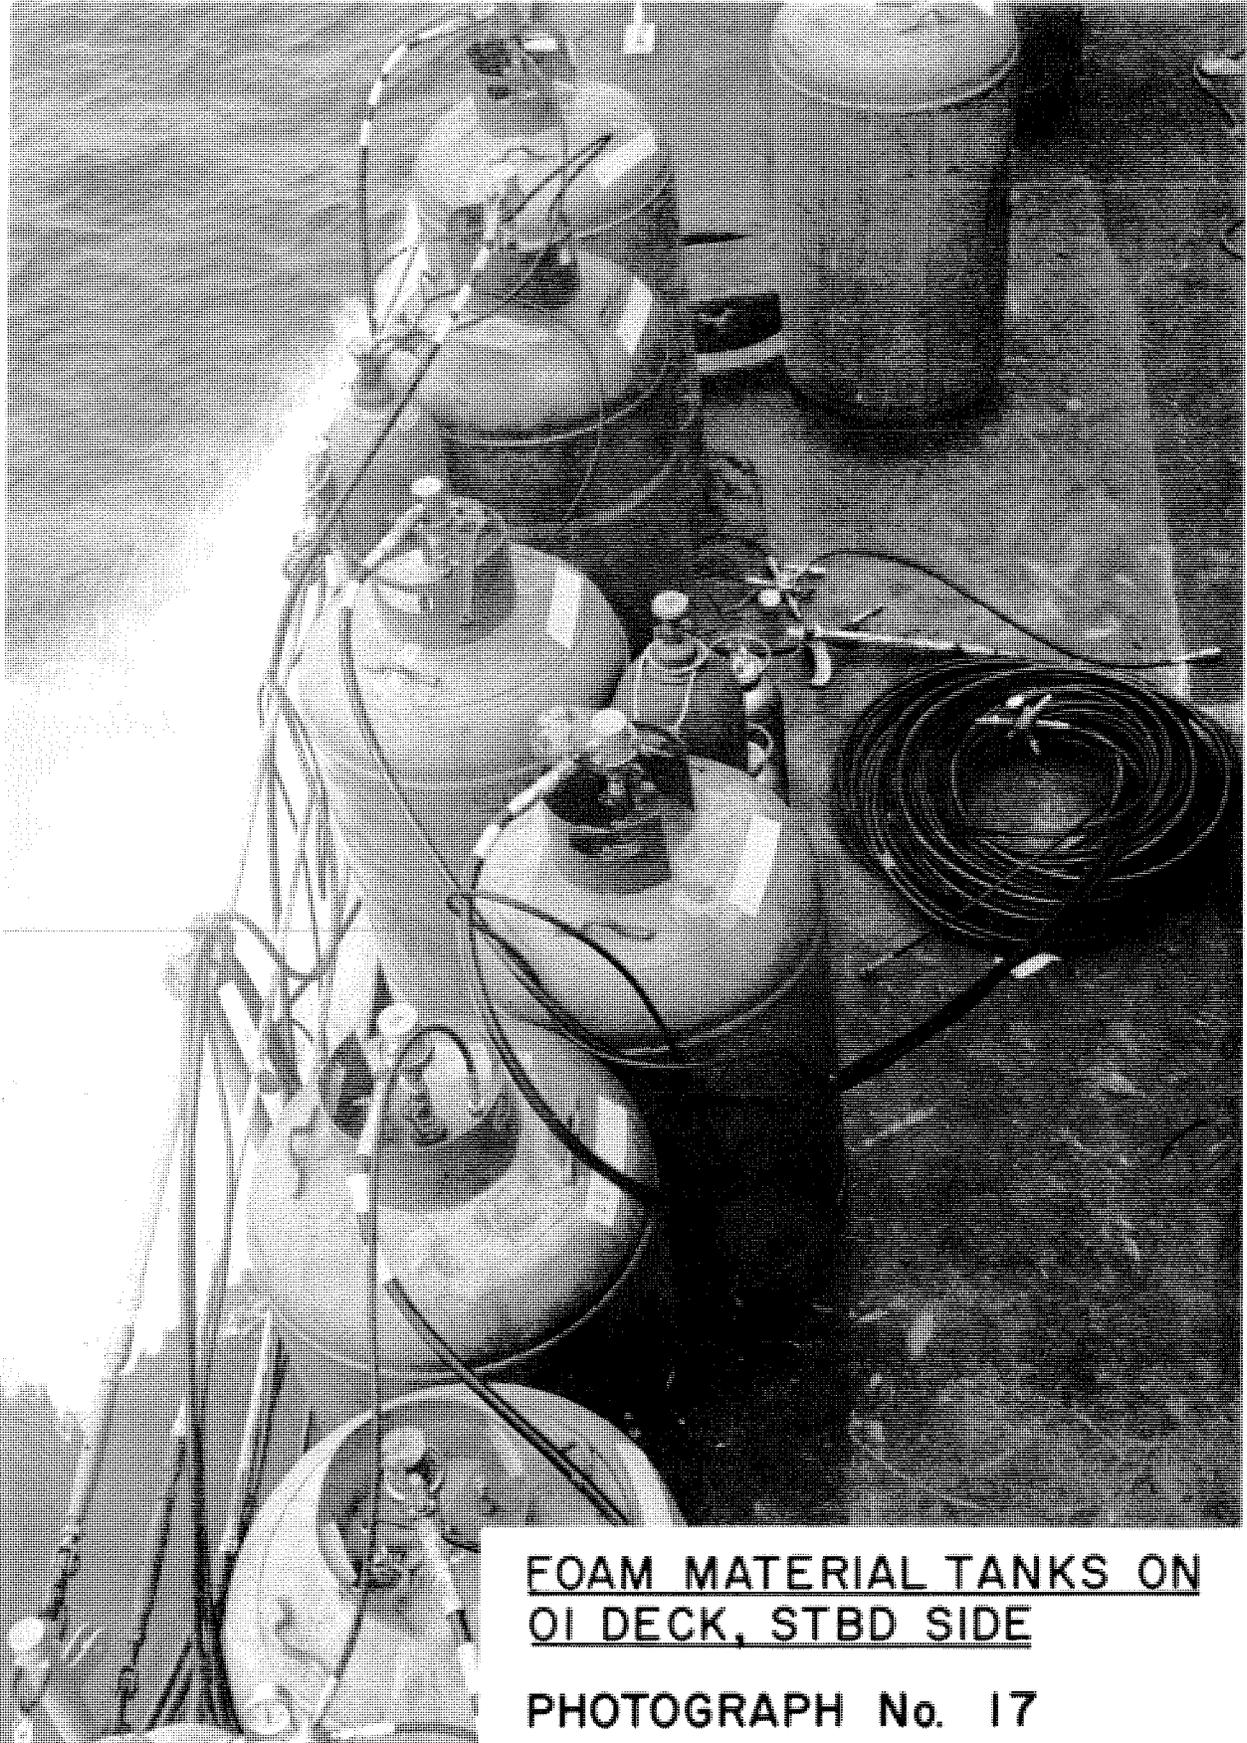
PHOTOGRAPH No. 17

NOTE:        In Photograph 17, page 70, note several "pairs" of foam mixing tanks aboard USS FRANK KNOX. At the foam filling station (not shown here), resin and Freon are pumped into one tank, while the other tank is filled with a catalyst and Freon in the proper proportions. The materials are then mixed by rolling the tanks. For the foaming operation, the filled tanks of a pair are connected to the gun by separate hoses where the materials are mixed together. The Freon forms small bubbles in the mixture which quickly expands and hardens in a matter of minutes. The materials are forced through the hose under pressure by an inert gas, nitrogen, in this case. Each pair contains about 1000 lbs. of material that will displace approximately 10 tons of water when mixed and expanded. It takes approximately one hour to expand one pair through one gun.

FOAM MATERIAL TANKS ON  
OI DECK, STBD SIDE

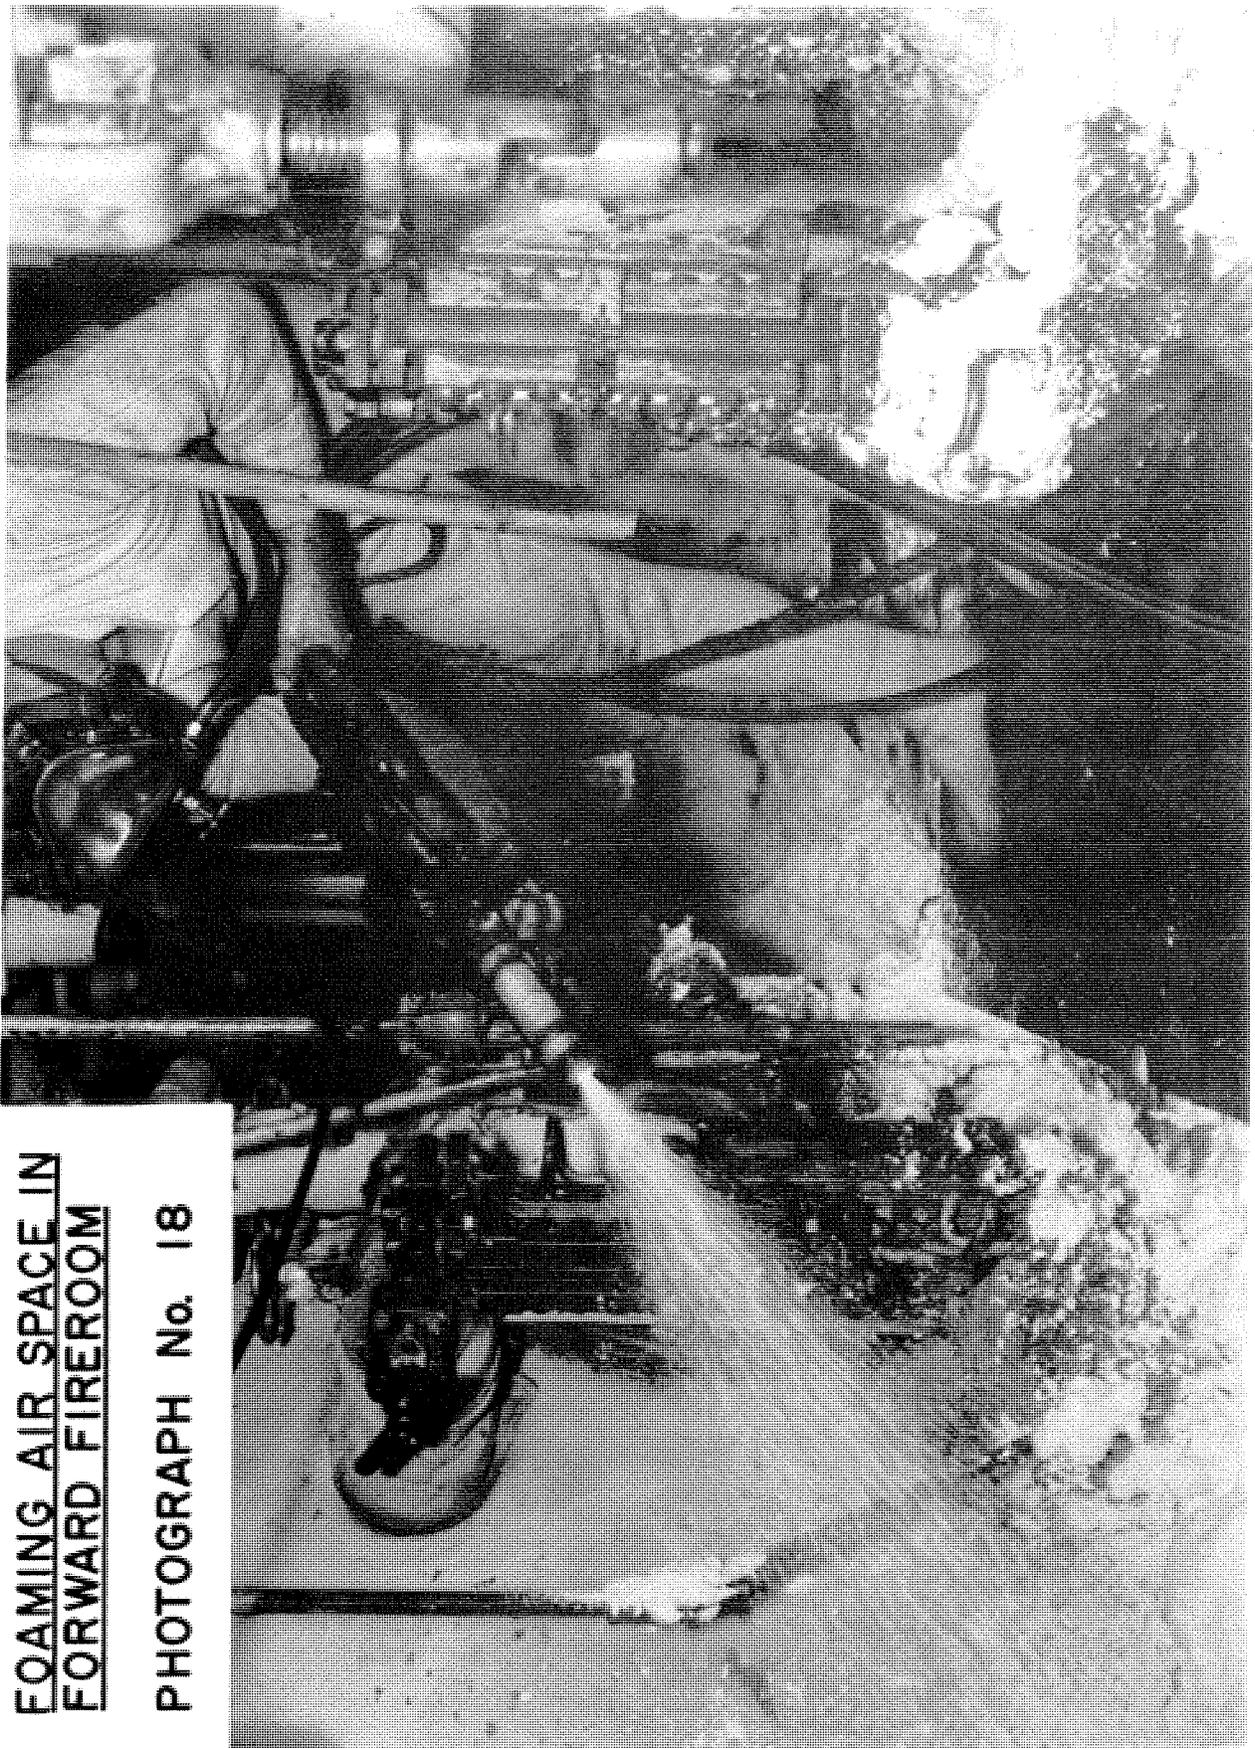
PHOTOGRAPH No. 18

NOTE: In Photograph 18, page 72, note a diver from USS GREENLET (ASR 10) building up a layer of foam in the upper level of the forward fireroom of FRANK KNOX. (It was necessary to foam above the waterline prior to proceeding with the underwater portions.) The diver is standing on plywood that had been laid on a layer of foam about two feet thick. Note the gun with two separate supply hoses carrying the resin and catalyst. The materials are mixed together in the small mixing chamber beyond the trigger. A barrel of appropriate length was added to the mixing chamber for foaming underwater.

FOAMING AIR SPACE IN  
FORWARD FIREROOM

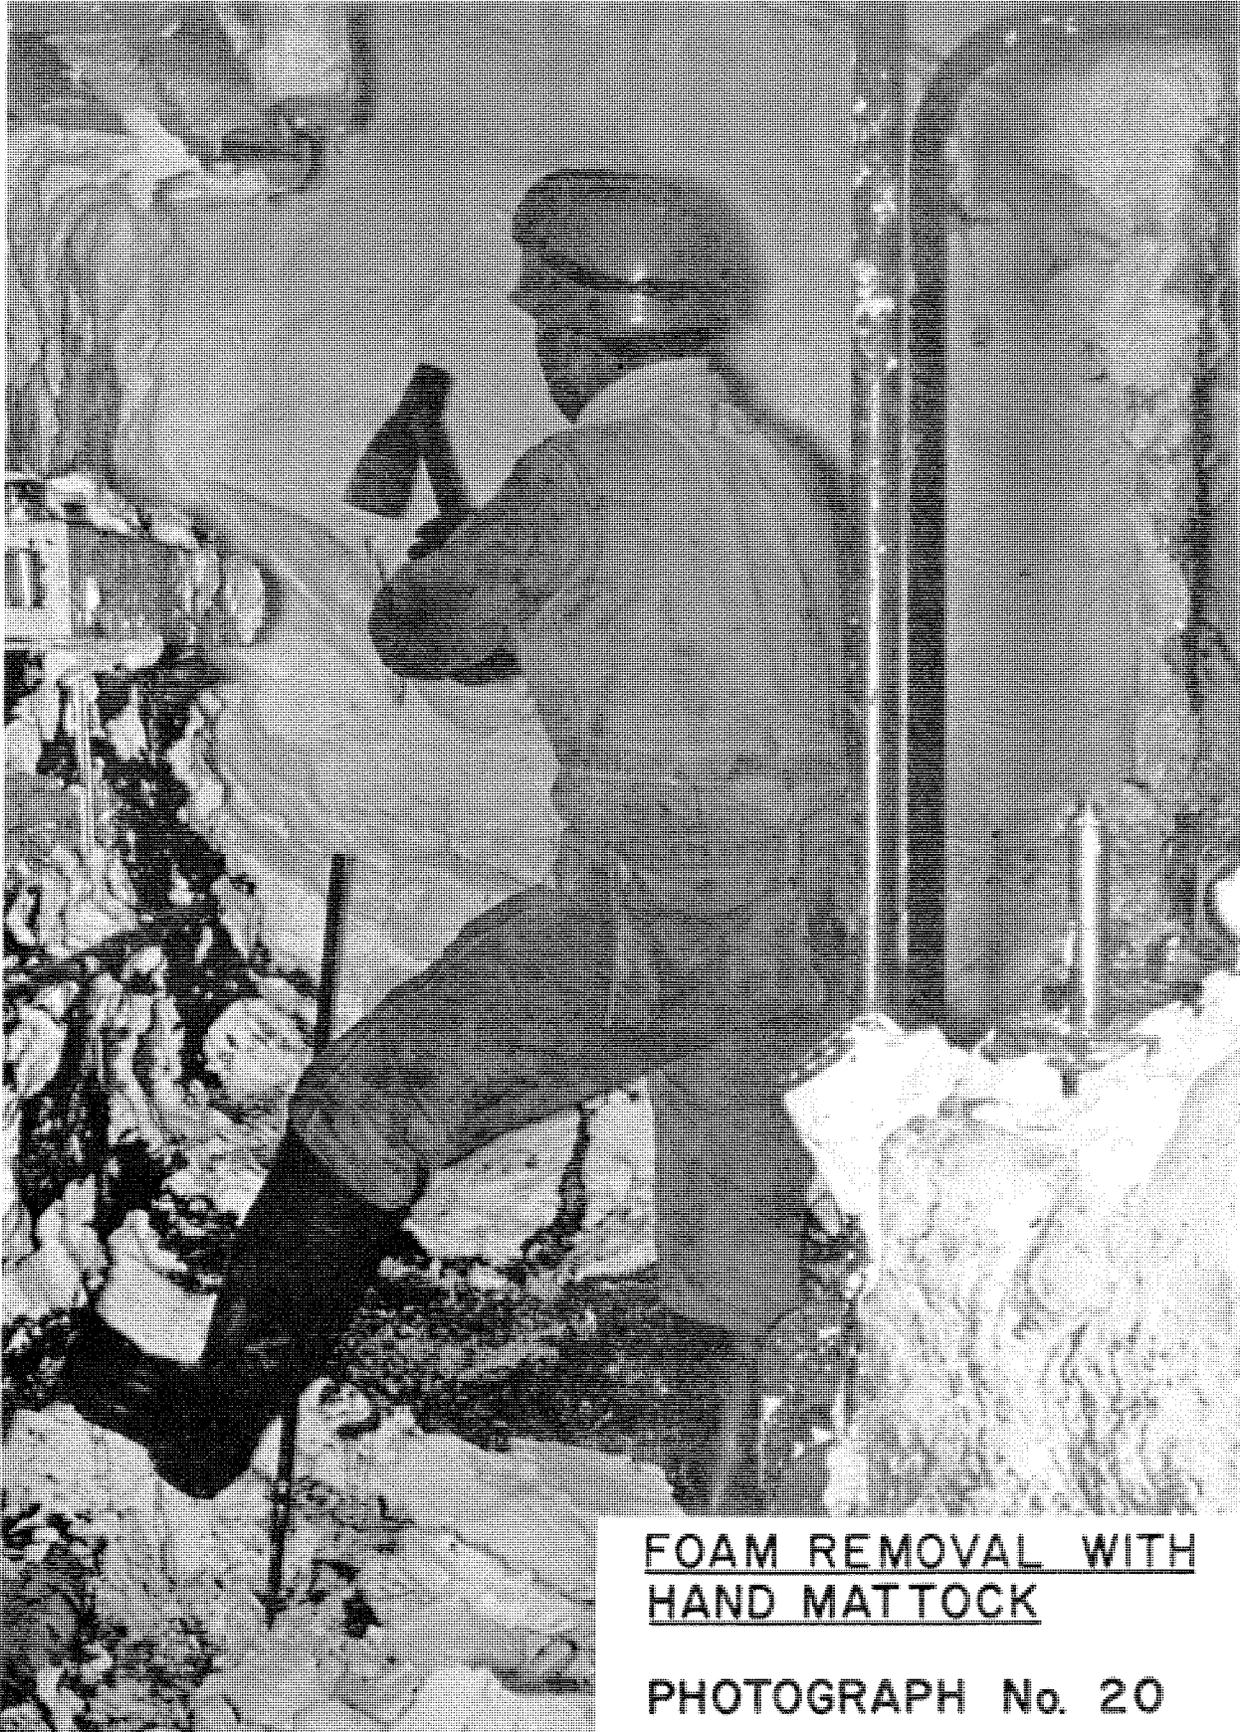
PHOTOGRAPH No. 20

FOAM REMOVAL WITH  
HAND MATTOCK

Power and hand tools, low and high-pressure water systems, and small hand tools, such as paint scrapers and edgers were used to breakup the foam; hacksaws were successful, but slow. Dry foam (such as was located in the above waterline space of B-1 and B-2) had a density of 0.04, and was most difficult to remove. Where operationally possible, and where there was the least risk to the ship's equipment, lightweight hand mattocks were used. (In Photograph 20, page 76, a worker uses a hand mattock to remove foam from the forward starboard corner of the forward engineroom, upper level.)

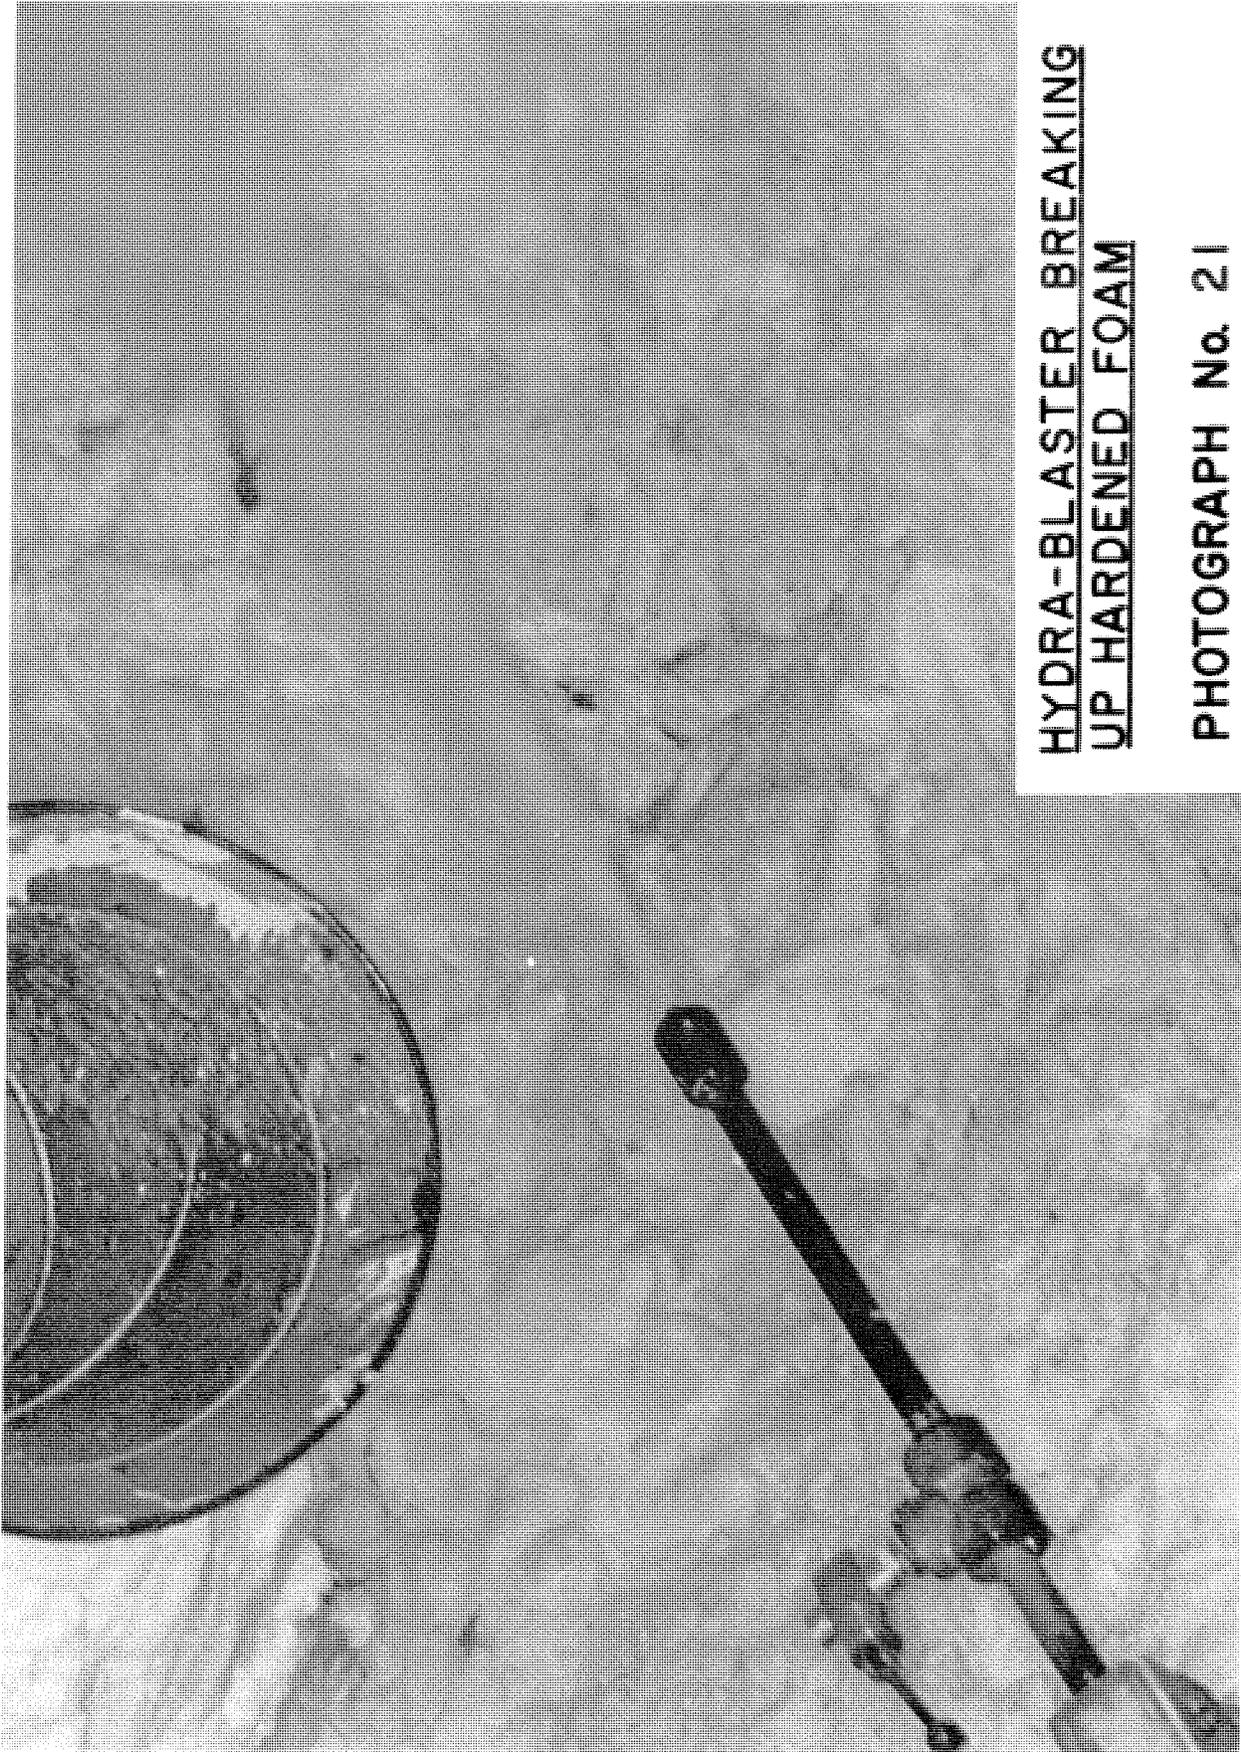
PHOTOGRAPH No. 21

HYDRA-BLASTER BREAKING  
UP HARDENED FOAM

A high-pressure water blasting system was also utilized, but extra precaution was necessary to avoid danger, to the operator and assisting personnel, that might result from the high-pressure water jetting. The Hydra-Blaster was a Model WBG-263 unit, manufactured by the American Power Stage Company, and was operational in the 3000 to 5000 psi range (see Photograph 21, page 77). It was later estimated that the Hydra-Blaster was equivalent to the use of five men in removing foam mechanically.

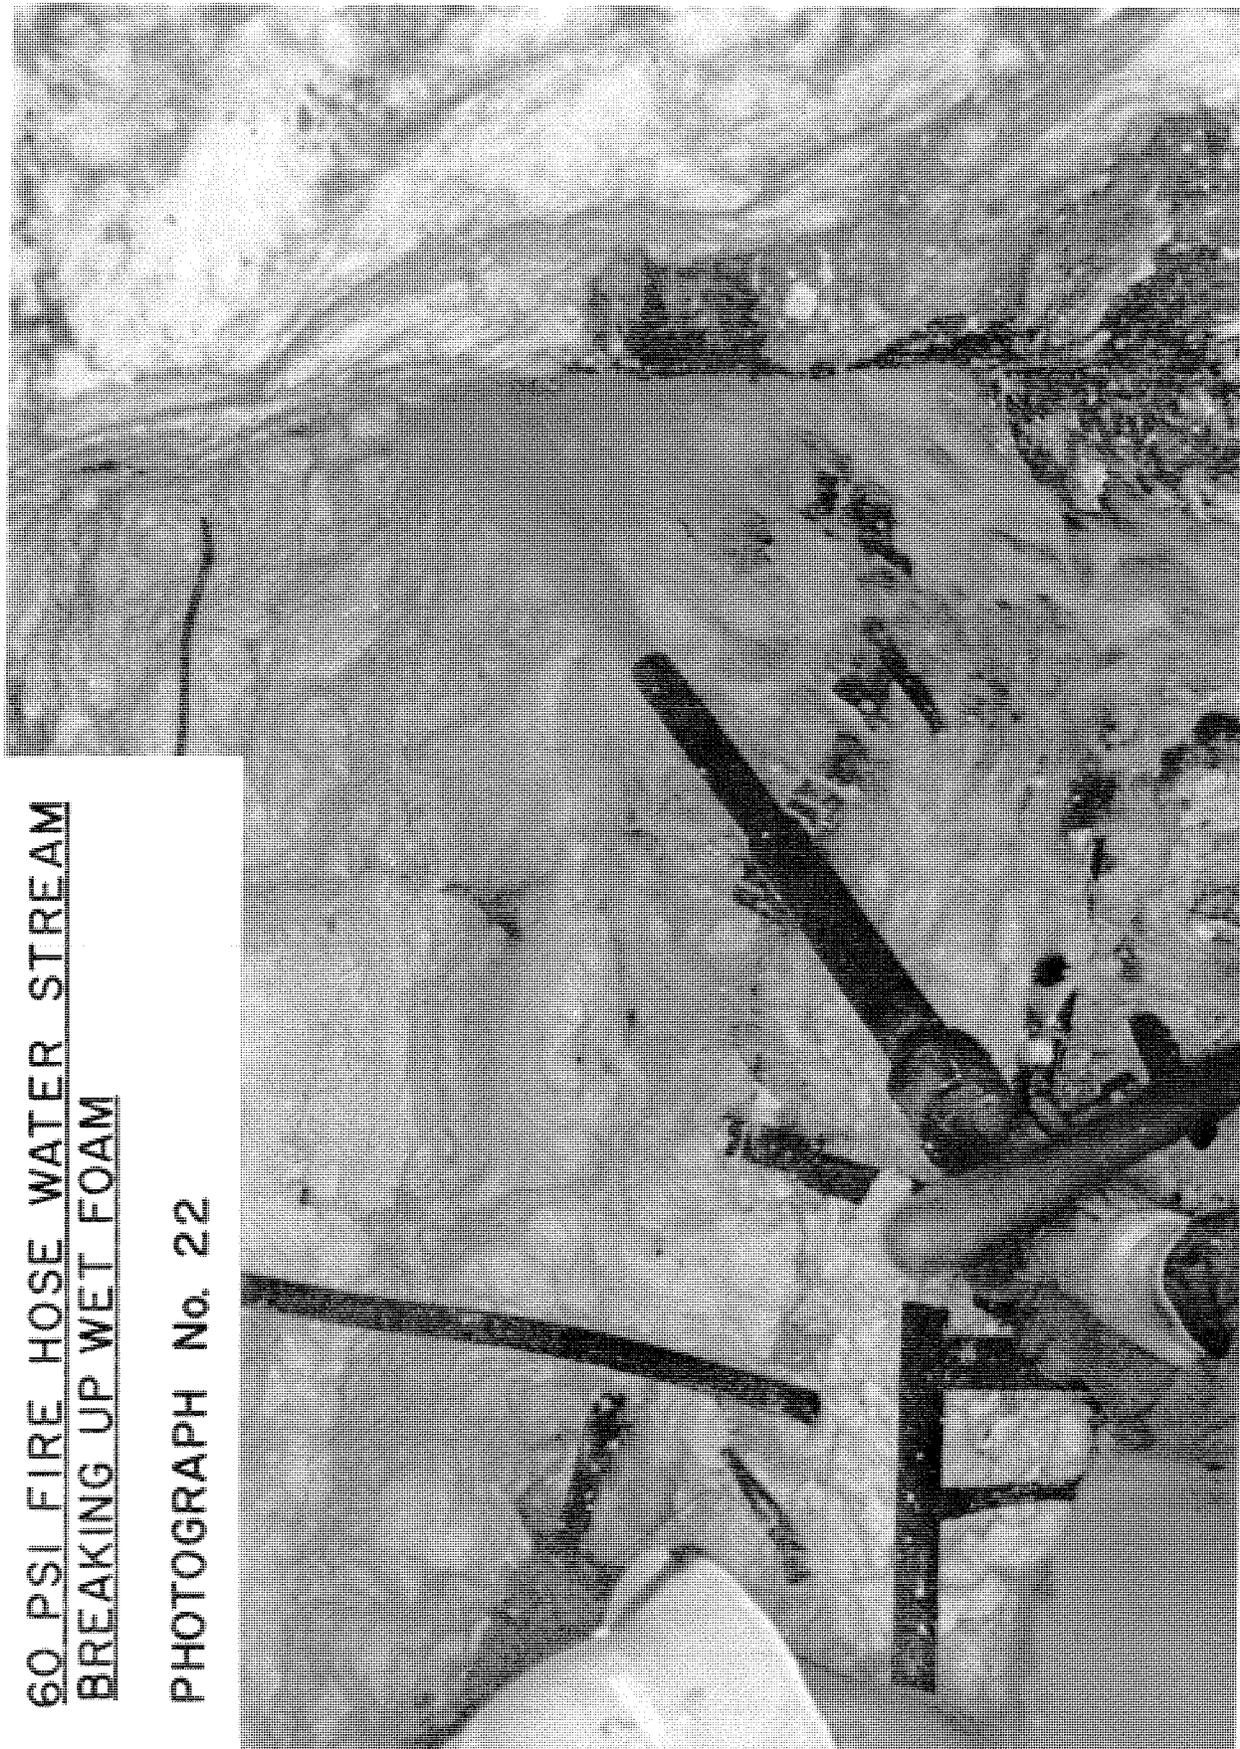
PHOTOGRAPH No. 22

No apparent damage was done to the ship or its equipment during this operation. Some of the foam near the bottom of the ship was wetter than the foam at the top and was easily removed with fire hose water jets of 60 psi (see Photograph 22, page 80).

60 PSI FIRE HOSE WATER STREAM  
BREAKING UP WET FOAM

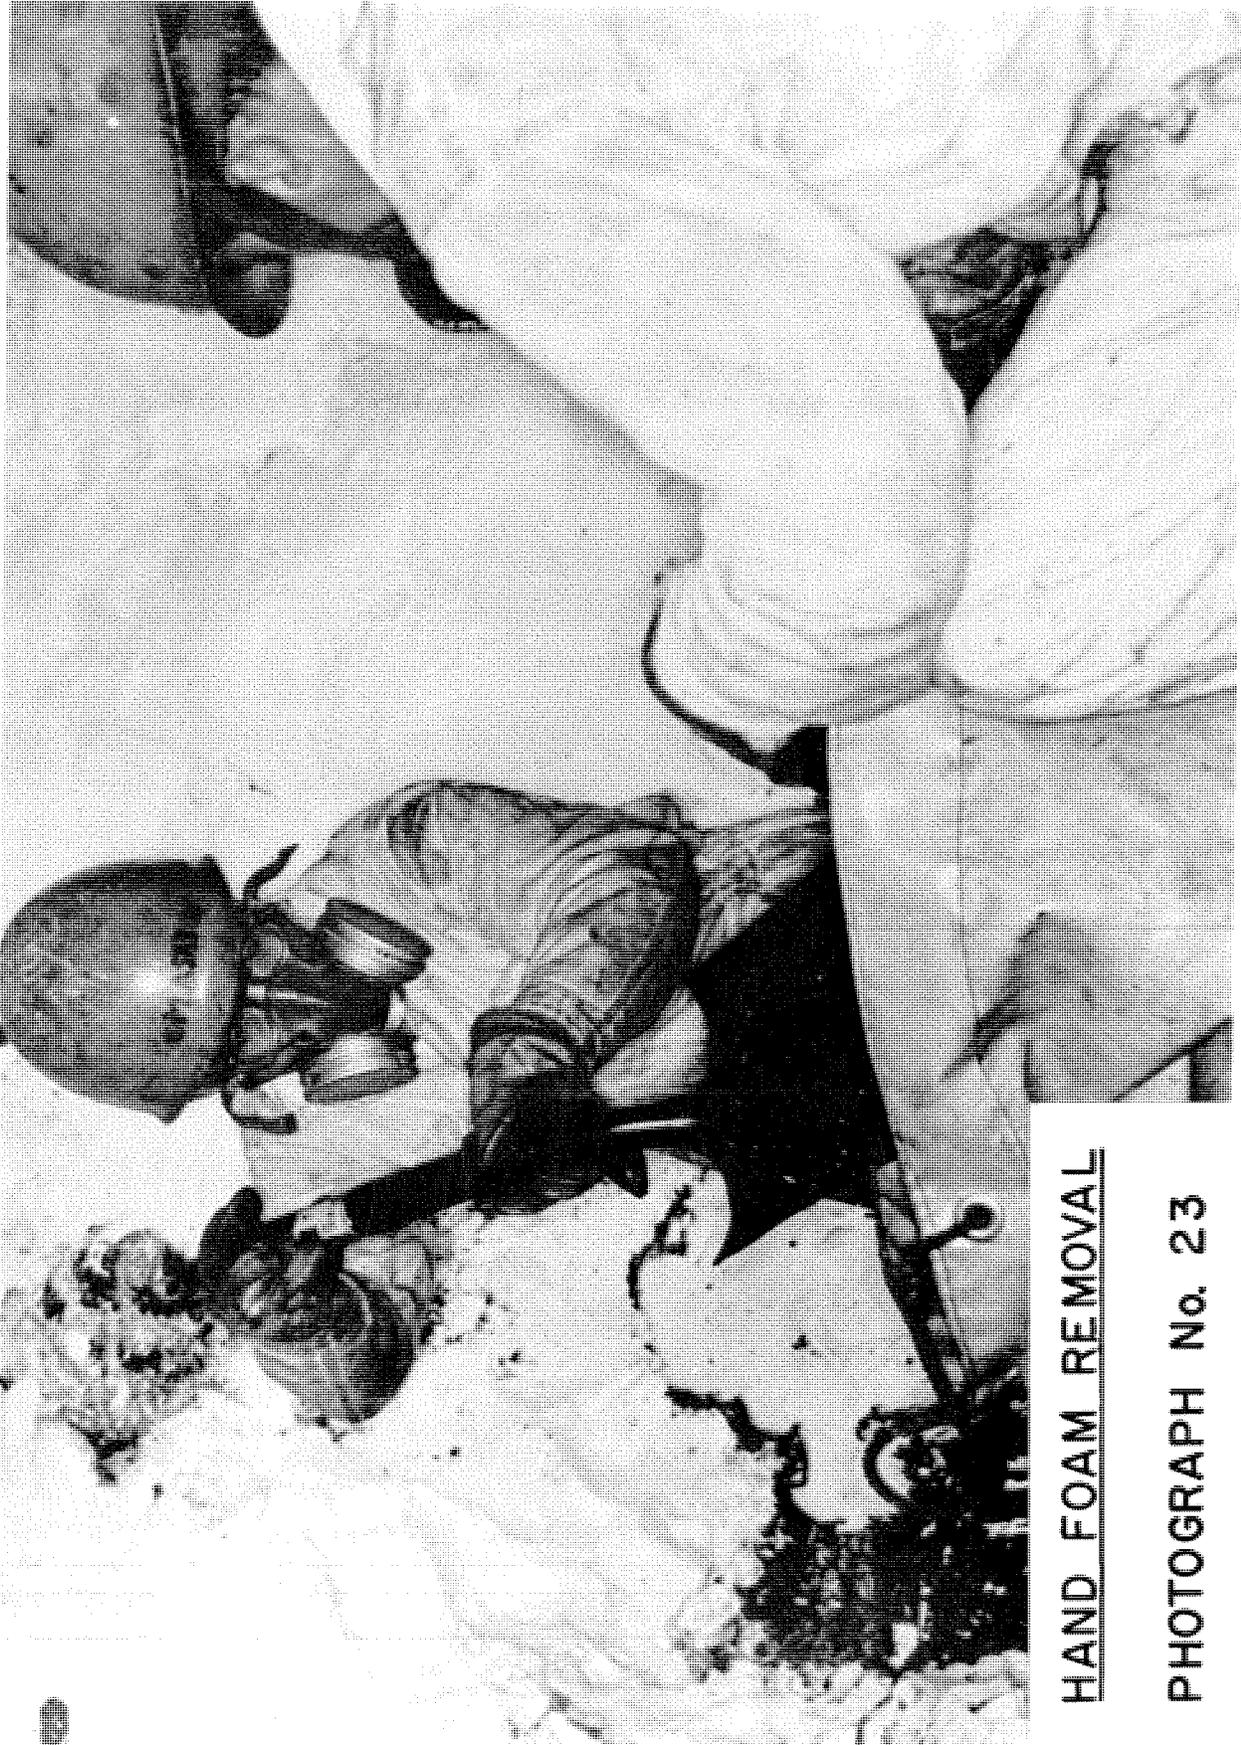
PHOTOGRAPH No. 23

HAND FOAM REMOVAL

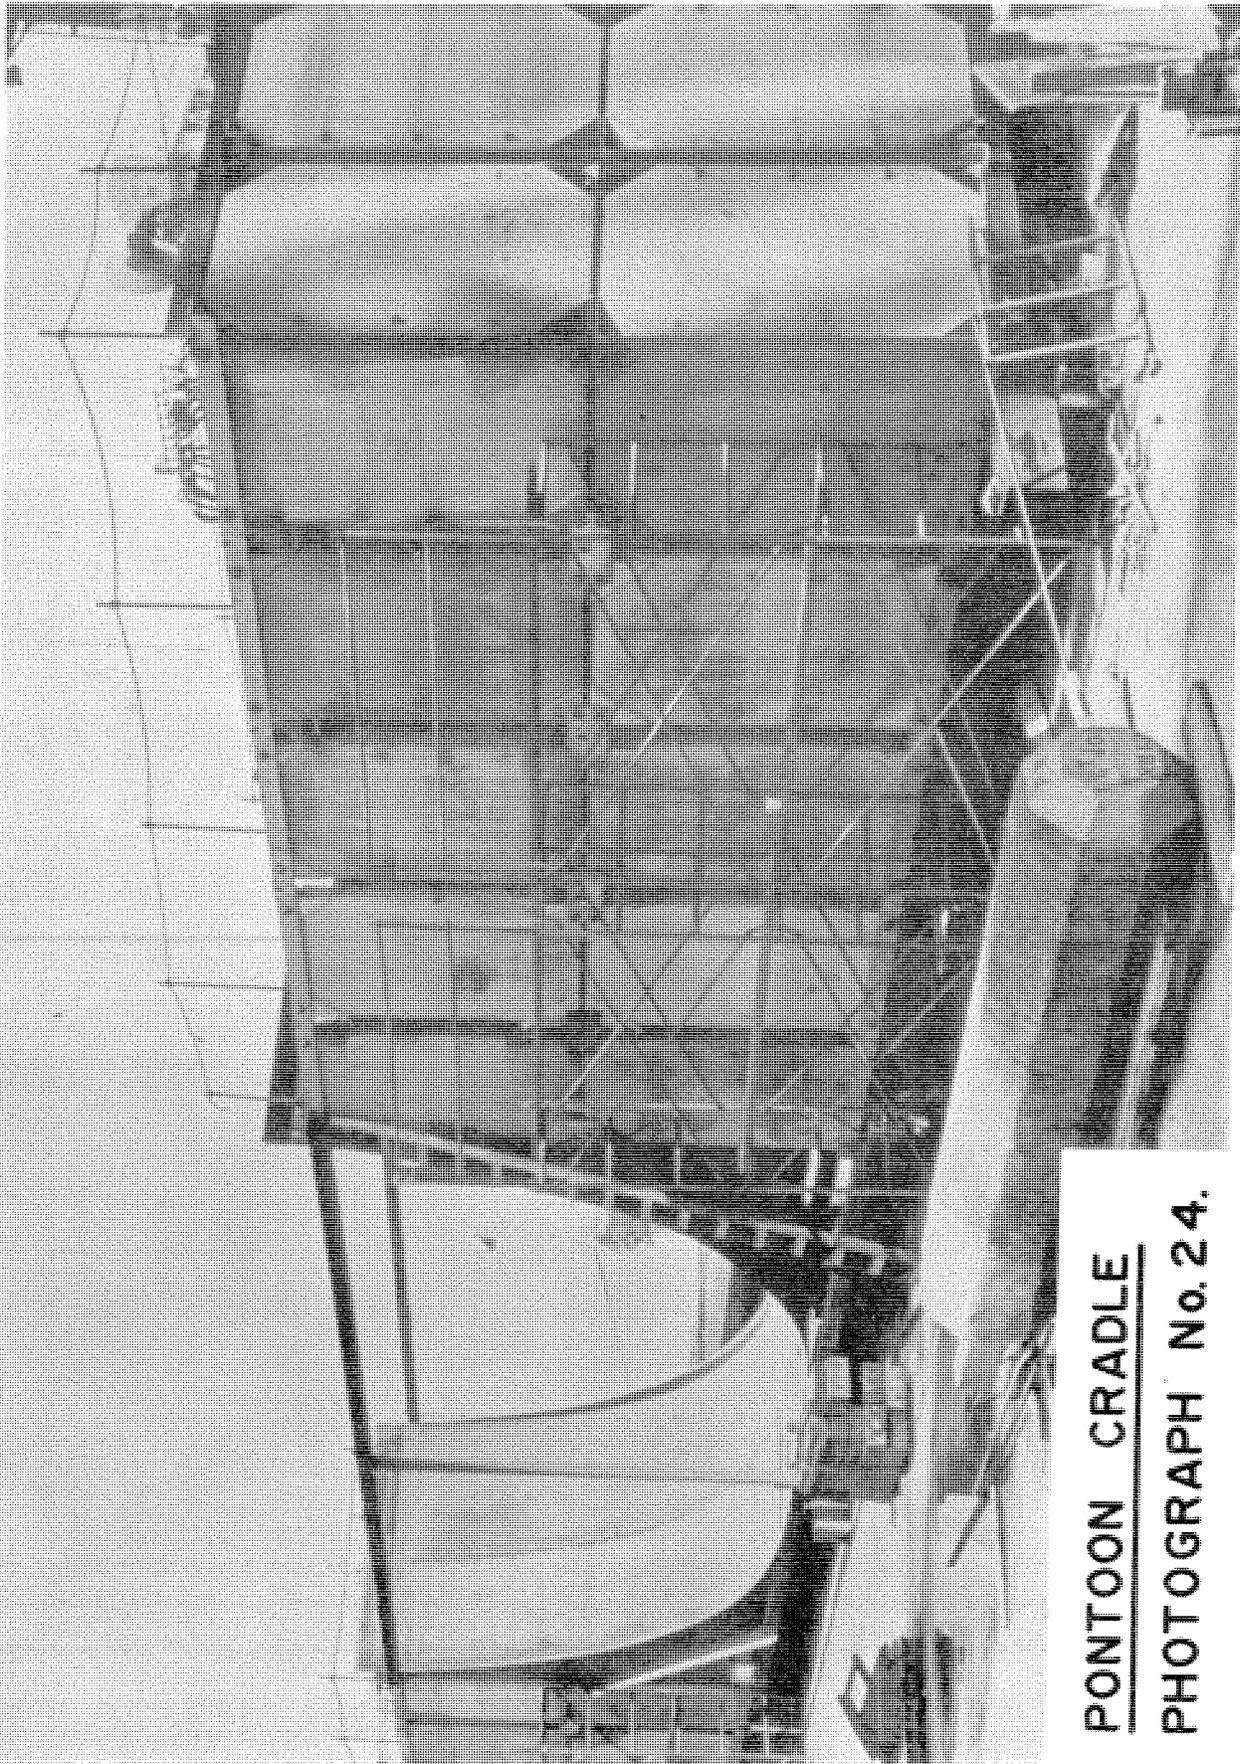
1. Pontoon cradle. A large cradle fabricated from BUDOCKS pontoon cells was designed and built. This cradle was designed to be lifted to the scene in an LSD. It was to have been slid under the stern of FRANK KNOX to the mid-ships area where it would have provided 540 net tons of lift (see Photograph 24 page 85).

**PONTOON CRADLE**  
**PHOTOGRAPH No. 24.**
