FACEPLATE

The Official Magazine for the Divers and Salvors of the United States Navy

Fall 1983
Volume 14, No. 3

34-Ton Propeller Changed on USS ENTERPRISE

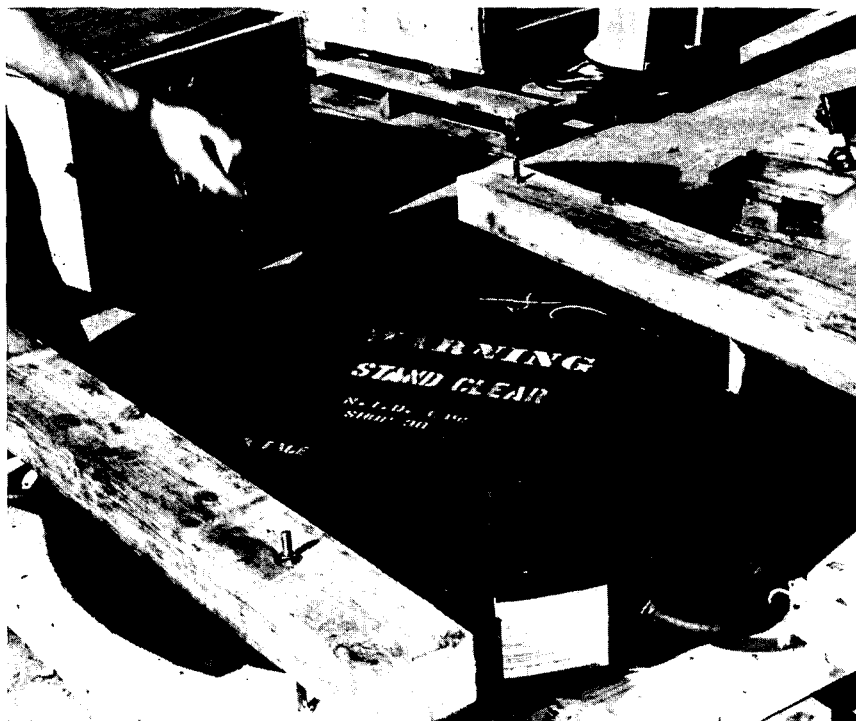
Divers uncrate the pilgrim nut backing plate.

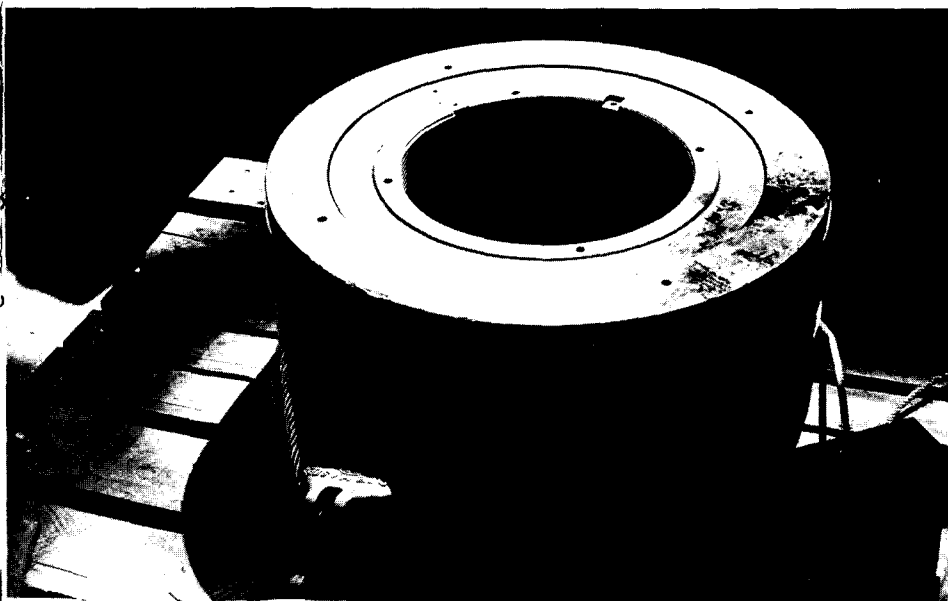
New Propeller Installed

The impact from the grounding had reduced the distance across the propeller blade tips from 21 to 17 feet.

The installation of the new propeller was relatively straightforward. After arrival and visual inspection, the 34-ton, 21-foot replacement propeller was lifted from the flatbed truck and placed on the pier, using the 100-ton floating crane. A lifting eye had been installed in the propeller hub. This would allow the dive team to rotate the propeller 90° on its axis before lowering it into the water alongside the barge. (This was accomplished by utilizing the 50-ton chain hoist.)
