U.S. NAVY SHIP SALVAGE MANUAL

VOLUME II

SUBMARINE SALVAGE

OFFICE OF THE SUPERVISOR OF SALVAGE, U. S. NAVY
NAVAL SHIP SYSTEMS COMMAND
WASHINGTON, D. C.
1970

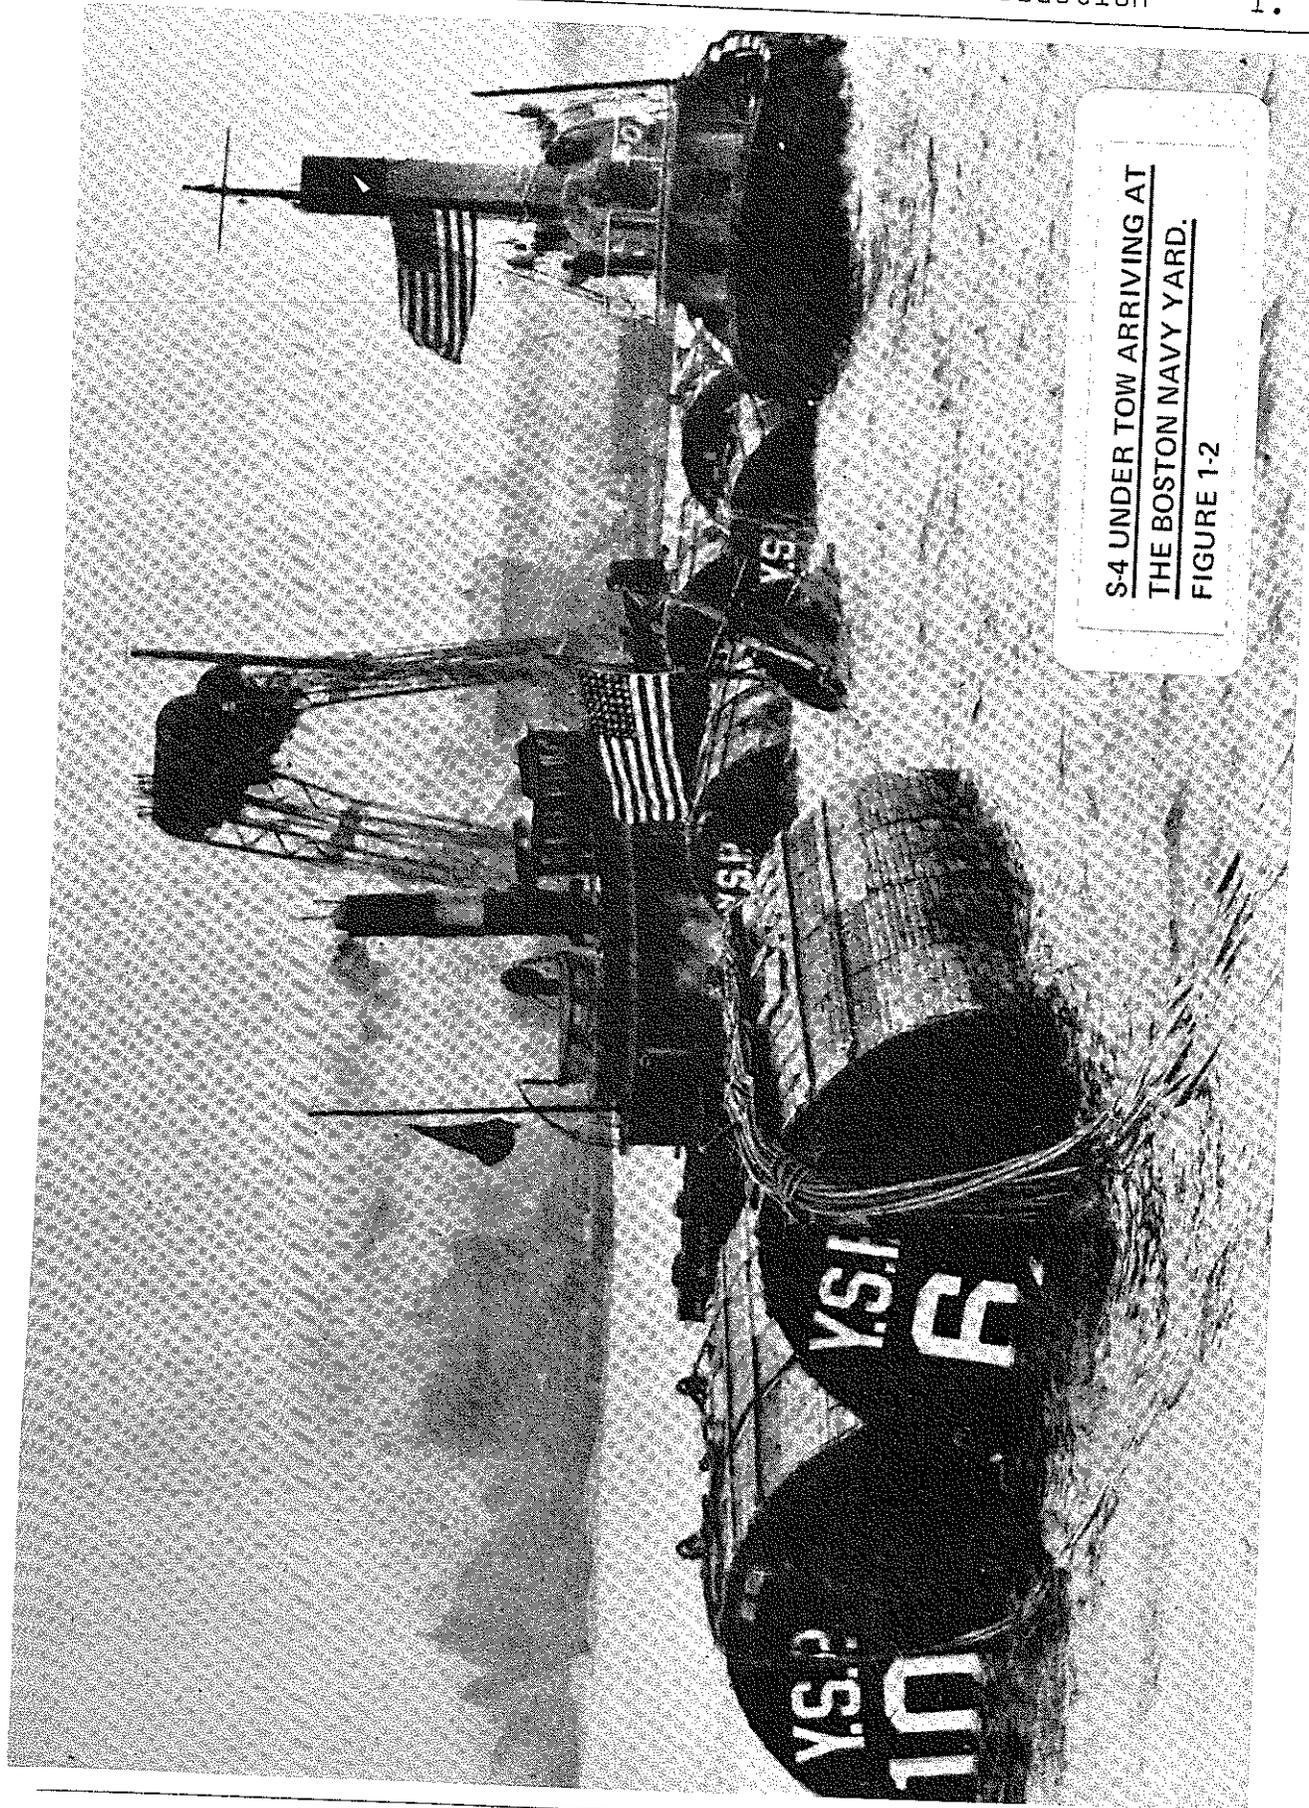
S-4 UNDER TOW ARRIVING AT
THE BOSTON NAVY YARD.
FIGURE 1-2

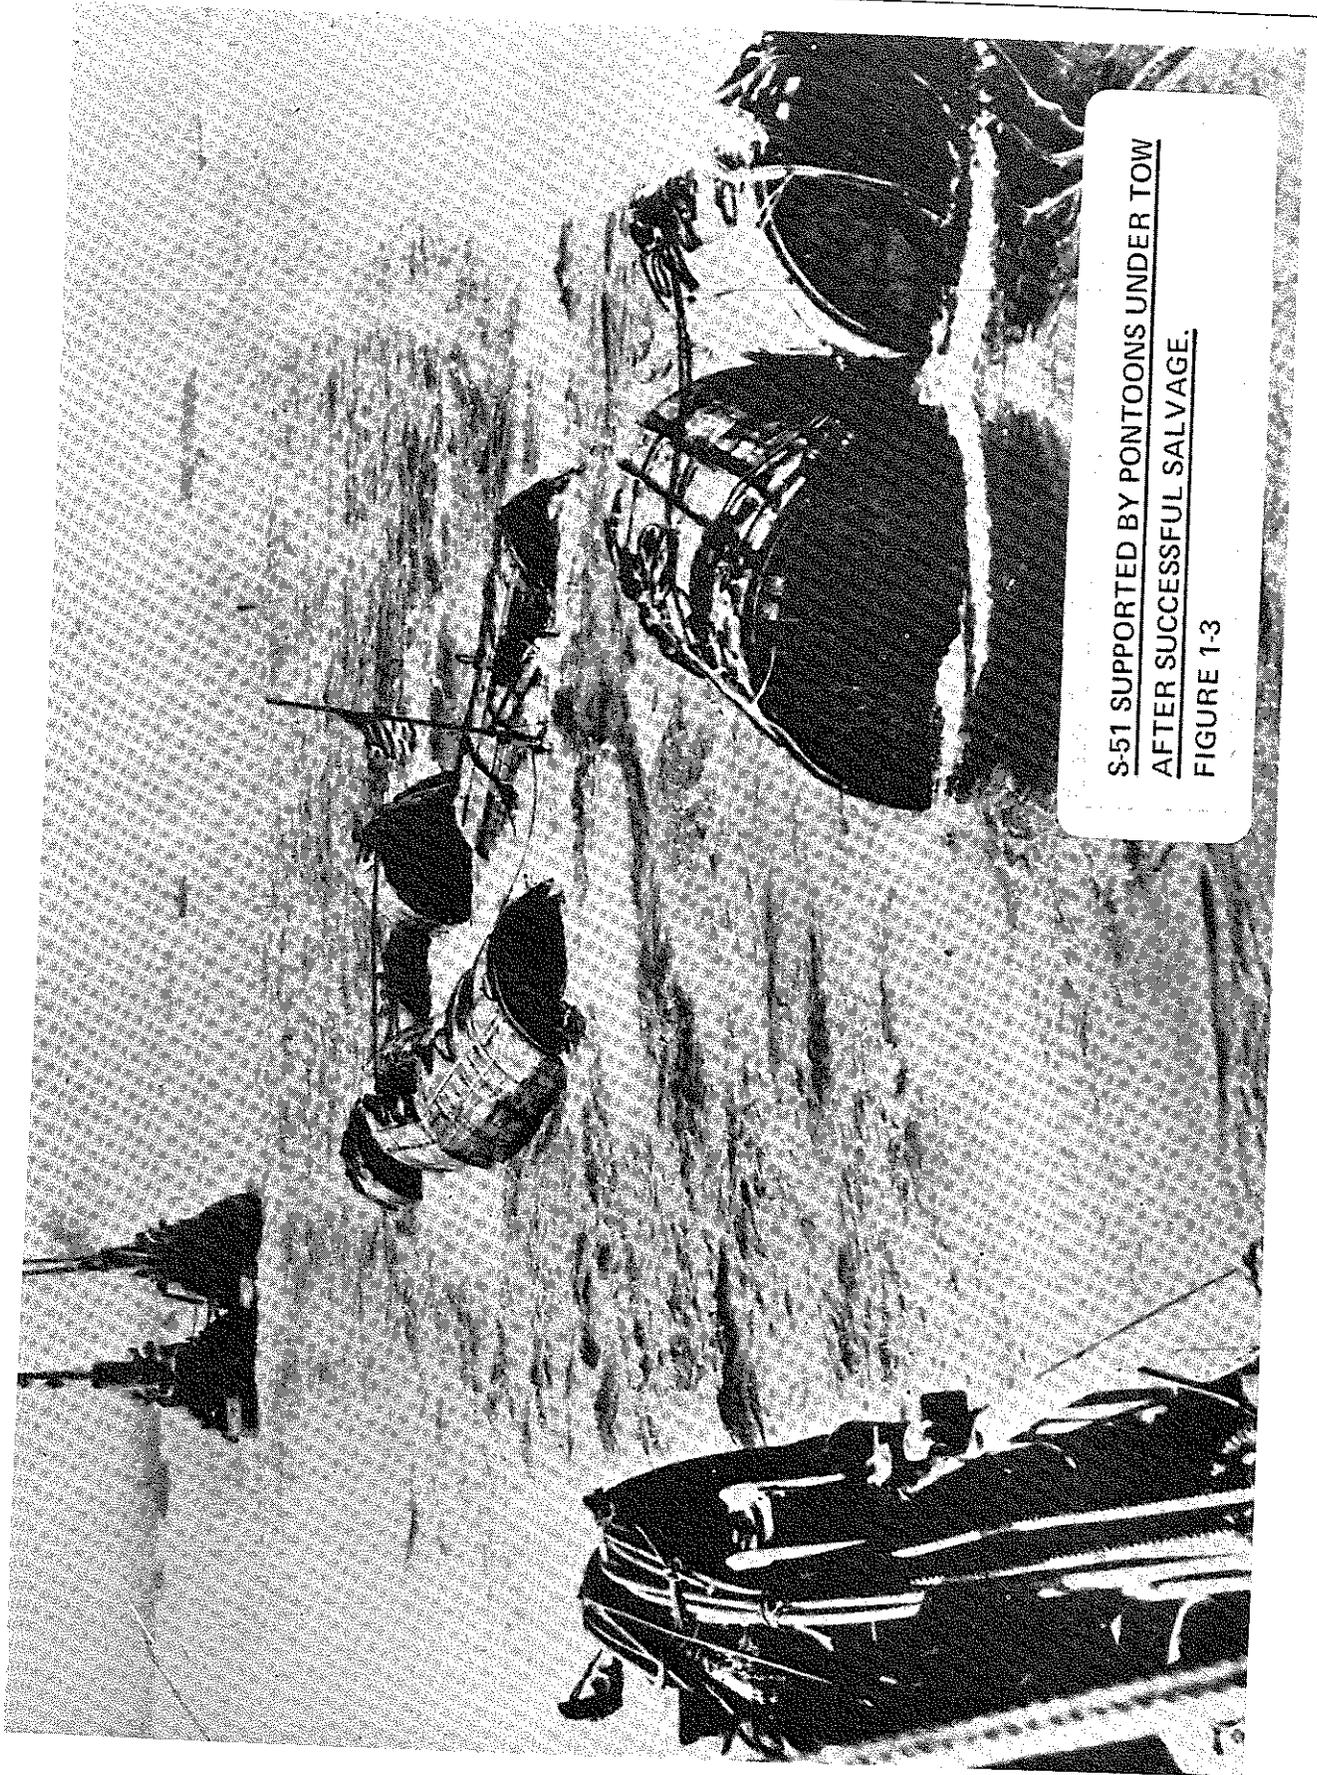
S-51 SUPPORTED BY PONTOONS UNDER TOW
AFTER SUCCESSFUL SALVAGE.
FIGURE 1-3

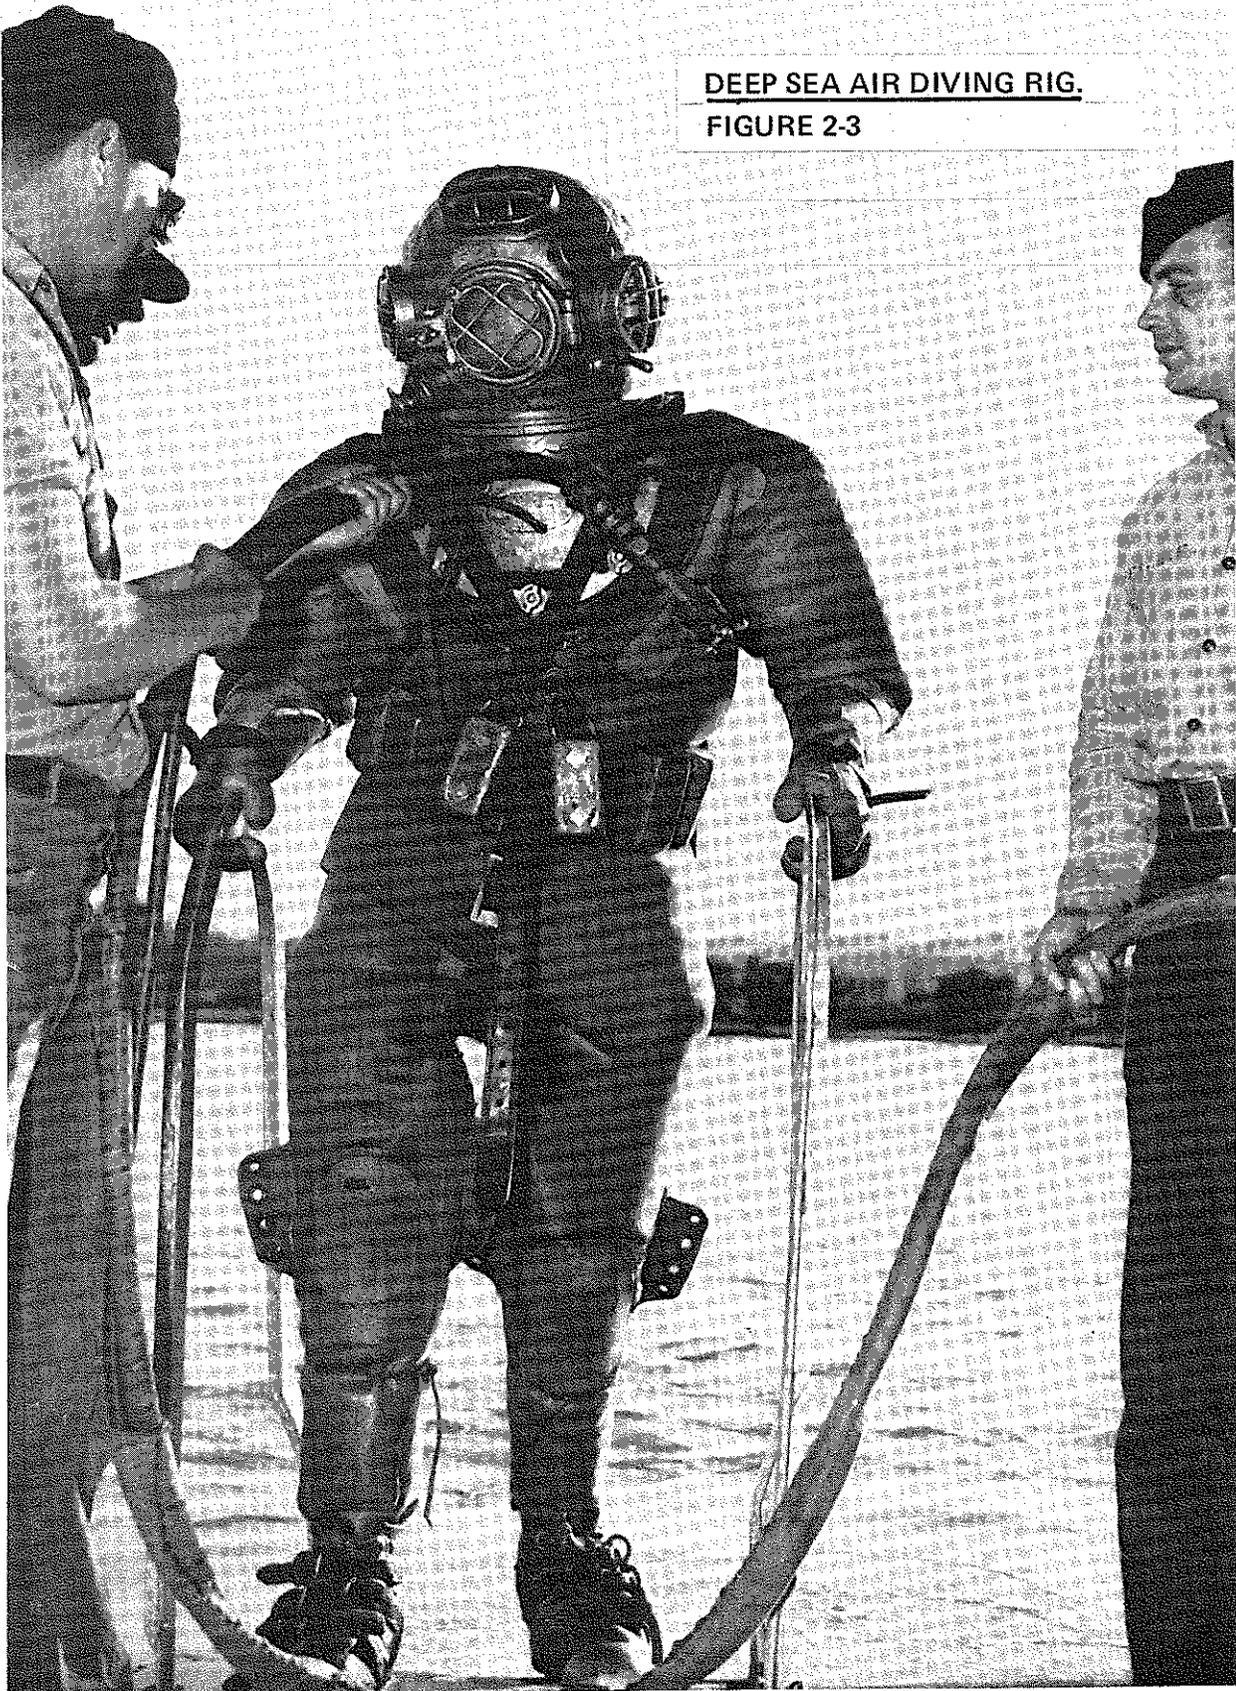
FIGURE 2-3

DEEP SEA AIR DIVING RIG.

The deep-sea diving outfit consists of a watertight canvas suit, helmet, weighted shoes, and weight belt (Figure 2-3). The diver breathes compressed air or a mixed gas supplied by the salvage or diving ship through an air hose. This has, for many years, been the primary diving method for performing heavy work underwater. The diver is in communication with the Salvage Officer, on the surface, and can thus report observations or receive instructions.

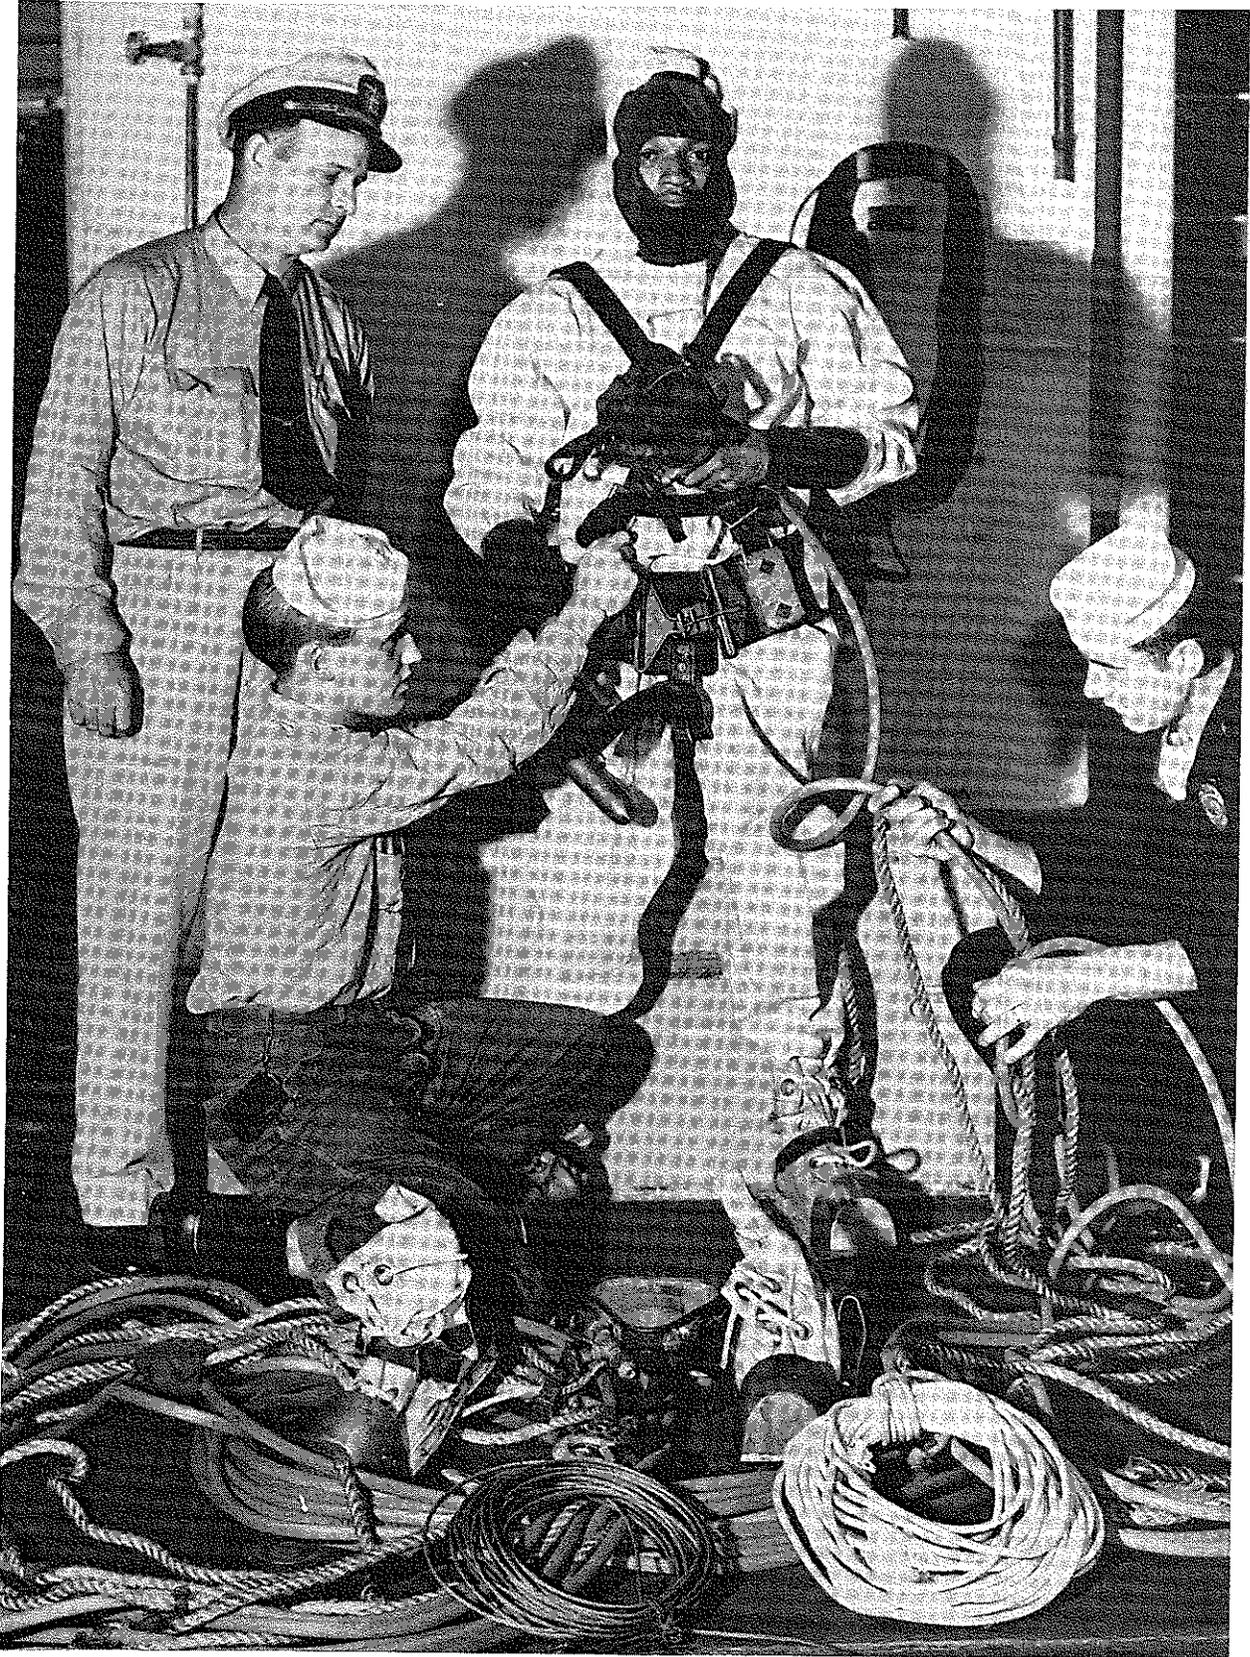
LIGHTWEIGHT AIR DIVING RIG.
FIGURE 2-4

The lightweight, surface-supplied diving apparatus is also made up in a heavy canvas suit (Figure 2-4). The air is breathed through a full-face mask strapped to the head of the diver. In the lightweight rig, the diver is freer in his movements, but seldom has voice telephone communications with the surface; a definite handicap in salvage operations. A surface-supplied diver, whether in deep-sea dress, or in a lightweight rig, is especially vulnerable to fouling his air hose and lifeline on projections of the wreck. The diver must constantly be aware of his position, and where his air-line might become entangled.

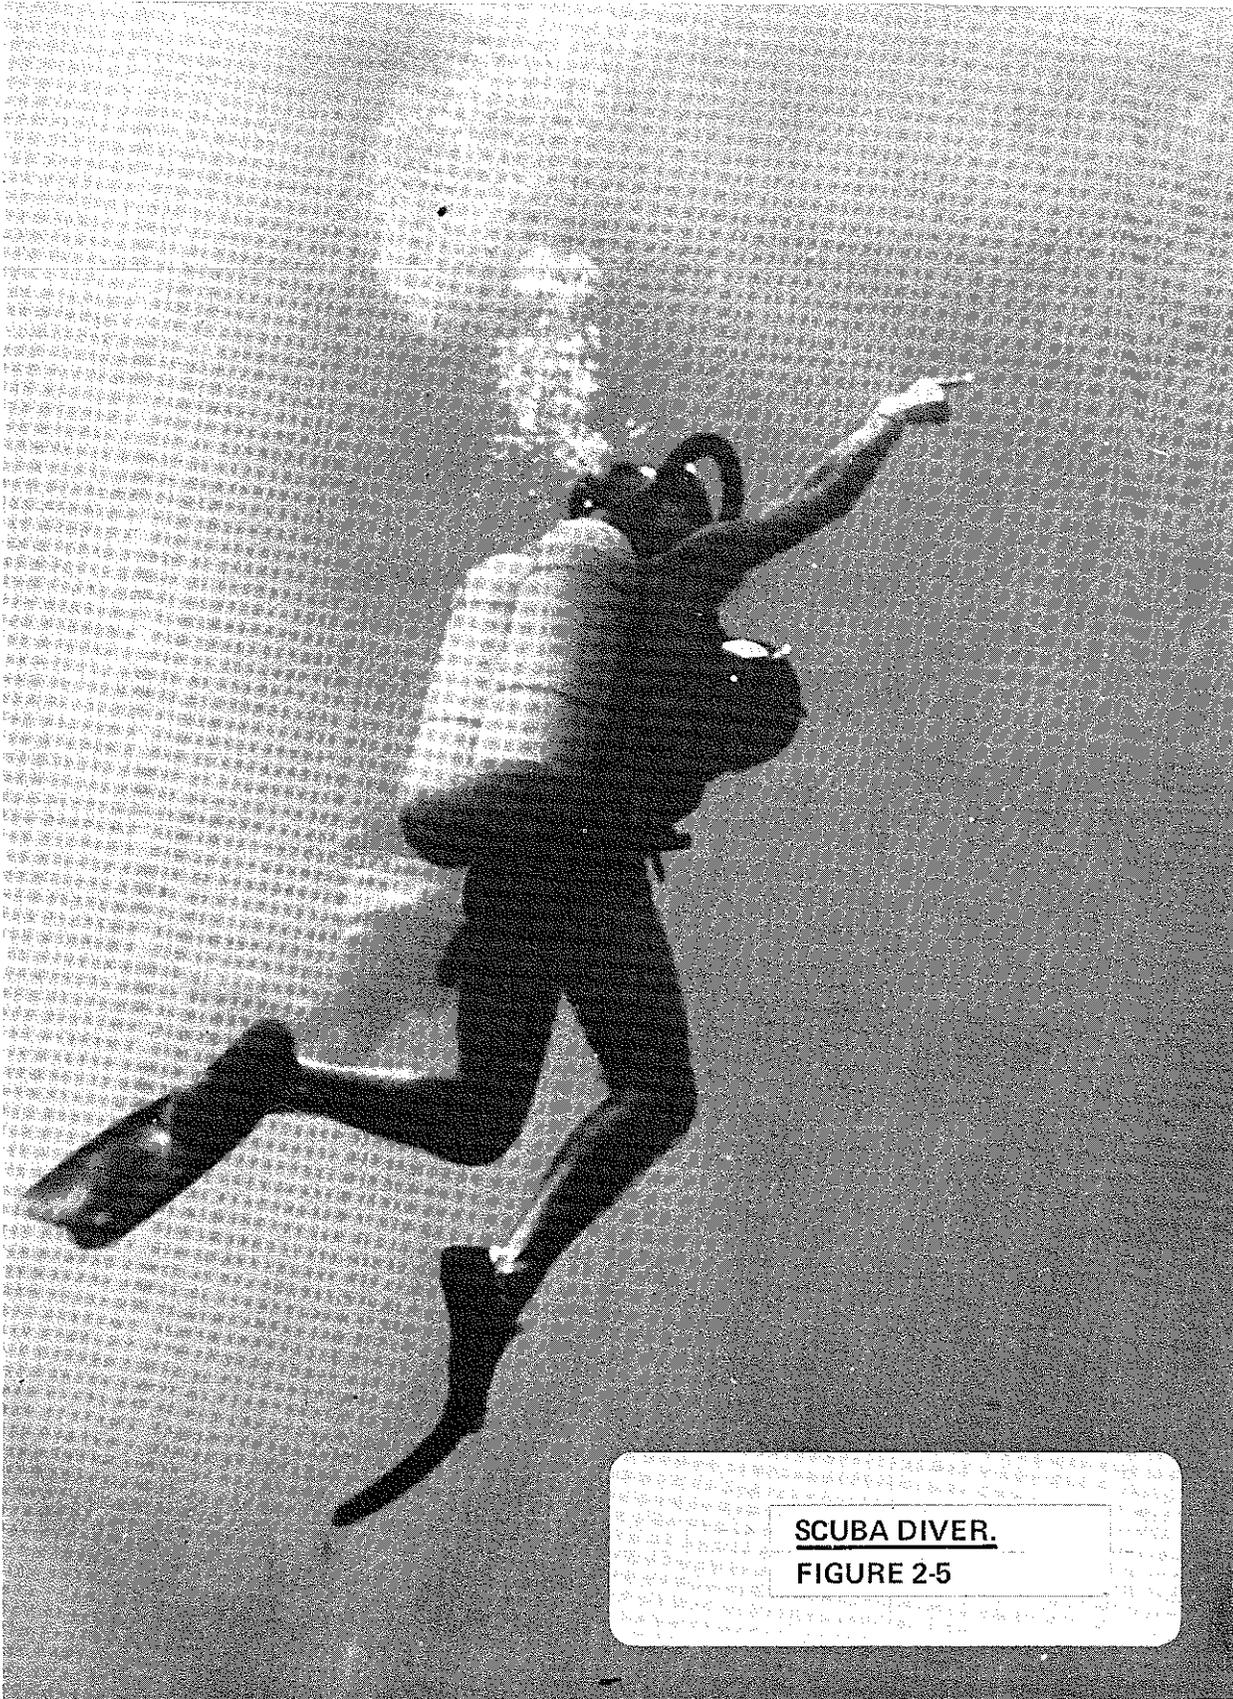
SCUBA DIVER.
FIGURE 2-5

The demand type (open circuit) breathing apparatus is the simplest type and the one most frequently used. The diver carries large cylinders of compressed air on his back and breathes through a mouthpiece (Figures 2-5 and 2-6).

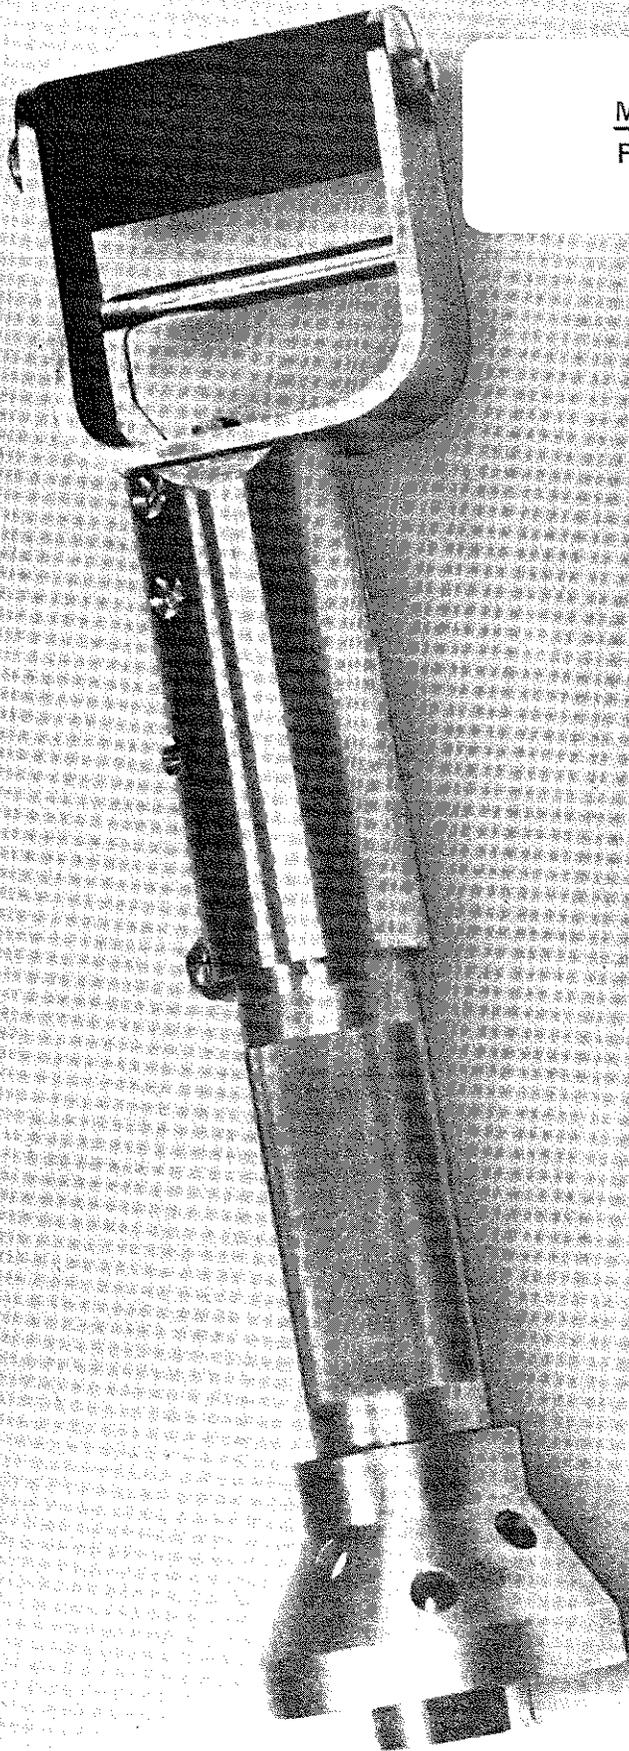
MODEL D DRIVER.
FIGURE 2-20

3. The Mine Safety Appliance Co. Model D driver (Figures 2-20 and 2-21) is designed for use in depths up to 1000 feet and employs larger, solid or hollow stud components.

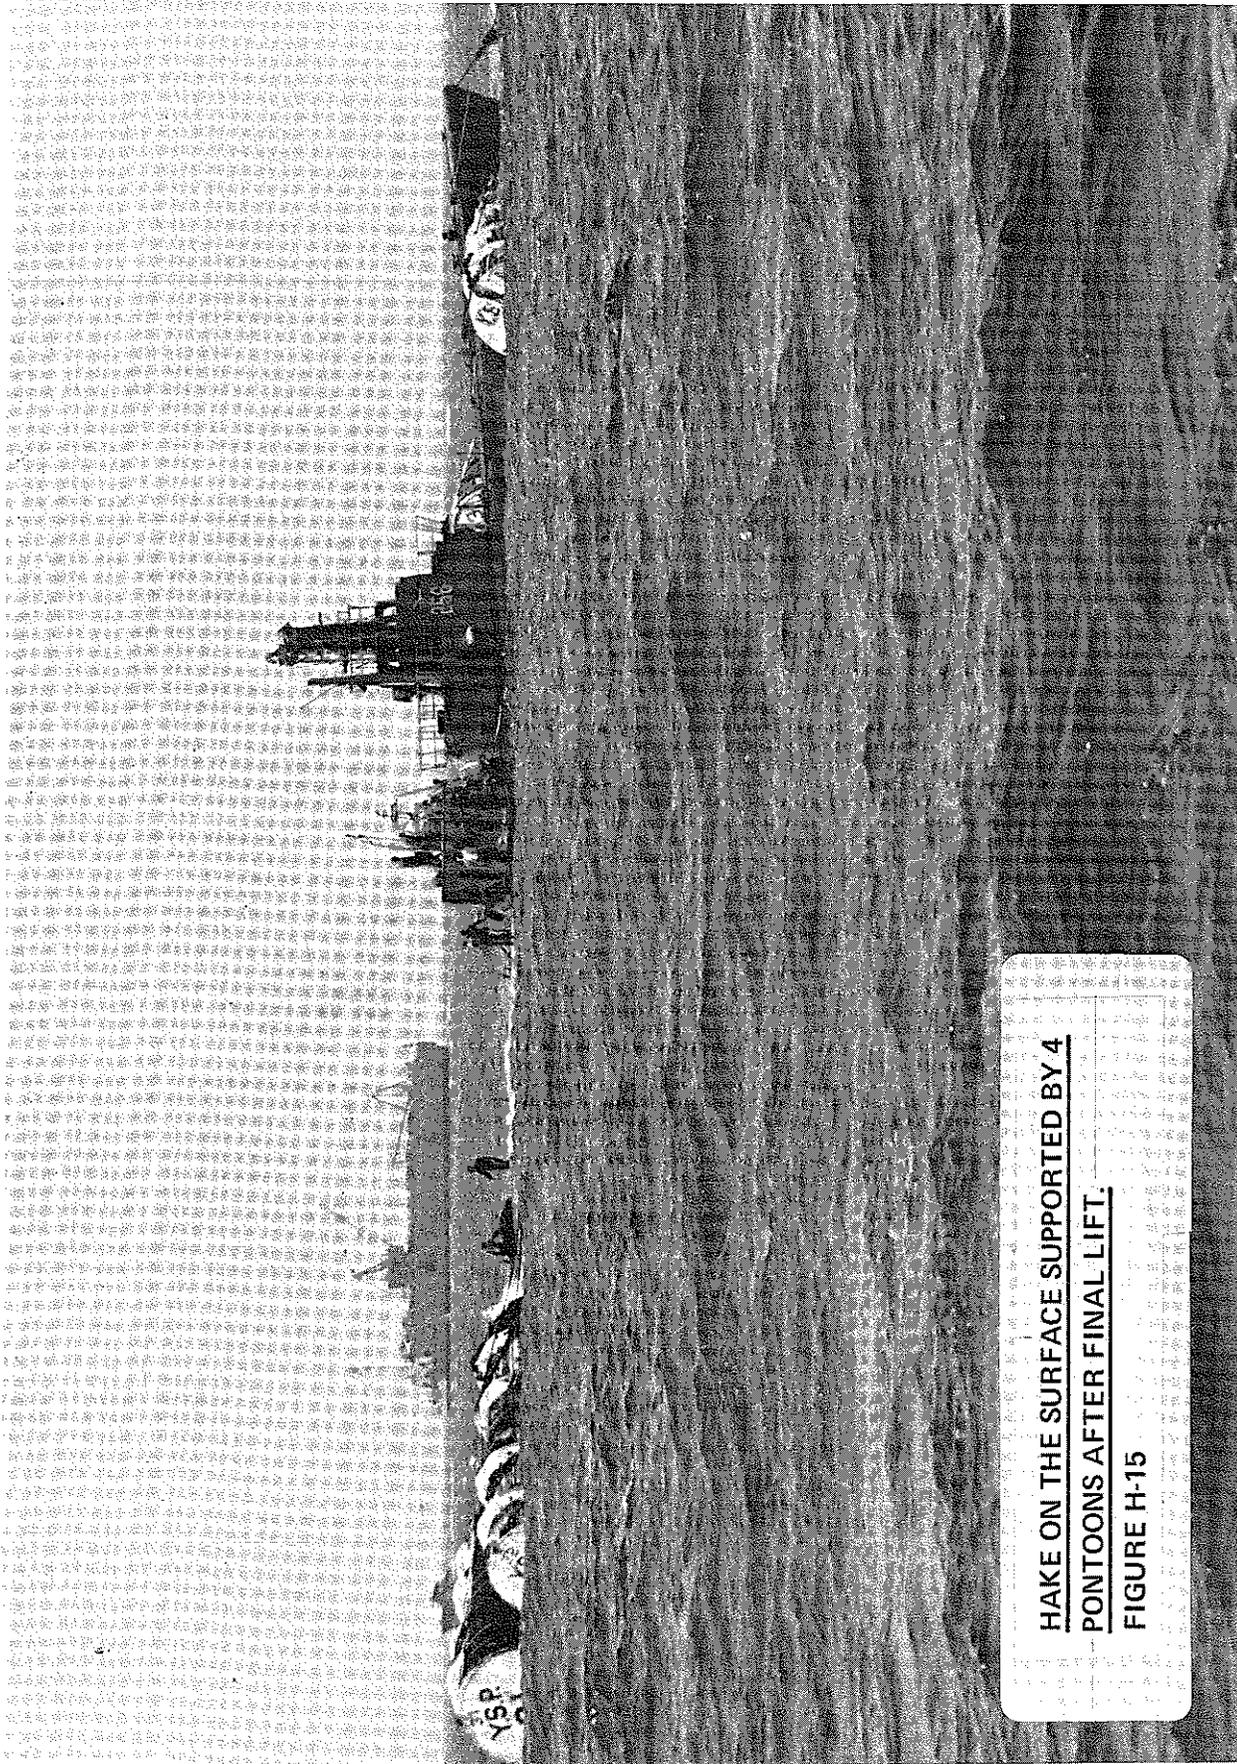
**HAKE ON THE SURFACE SUPPORTED BY 4
PONTOONS AFTER FINAL LIFT.
FIGURE H-15**

In passing and connecting the pontoon blow hoses, a damaged blow valve was discovered on the forward starboard pontoon; the valve was repaired and all was ready for blowing by noon. With the compressors on board the YC on the line, blowing commenced shortly thereafter; the submarine's bow surfaced with a 15 degree up angle by 1330. Blow of the after pontoons was commenced causing the submarine to surface twenty minutes later. All pontoons were moderately loaded and ex-HAKE was stable on the surface.

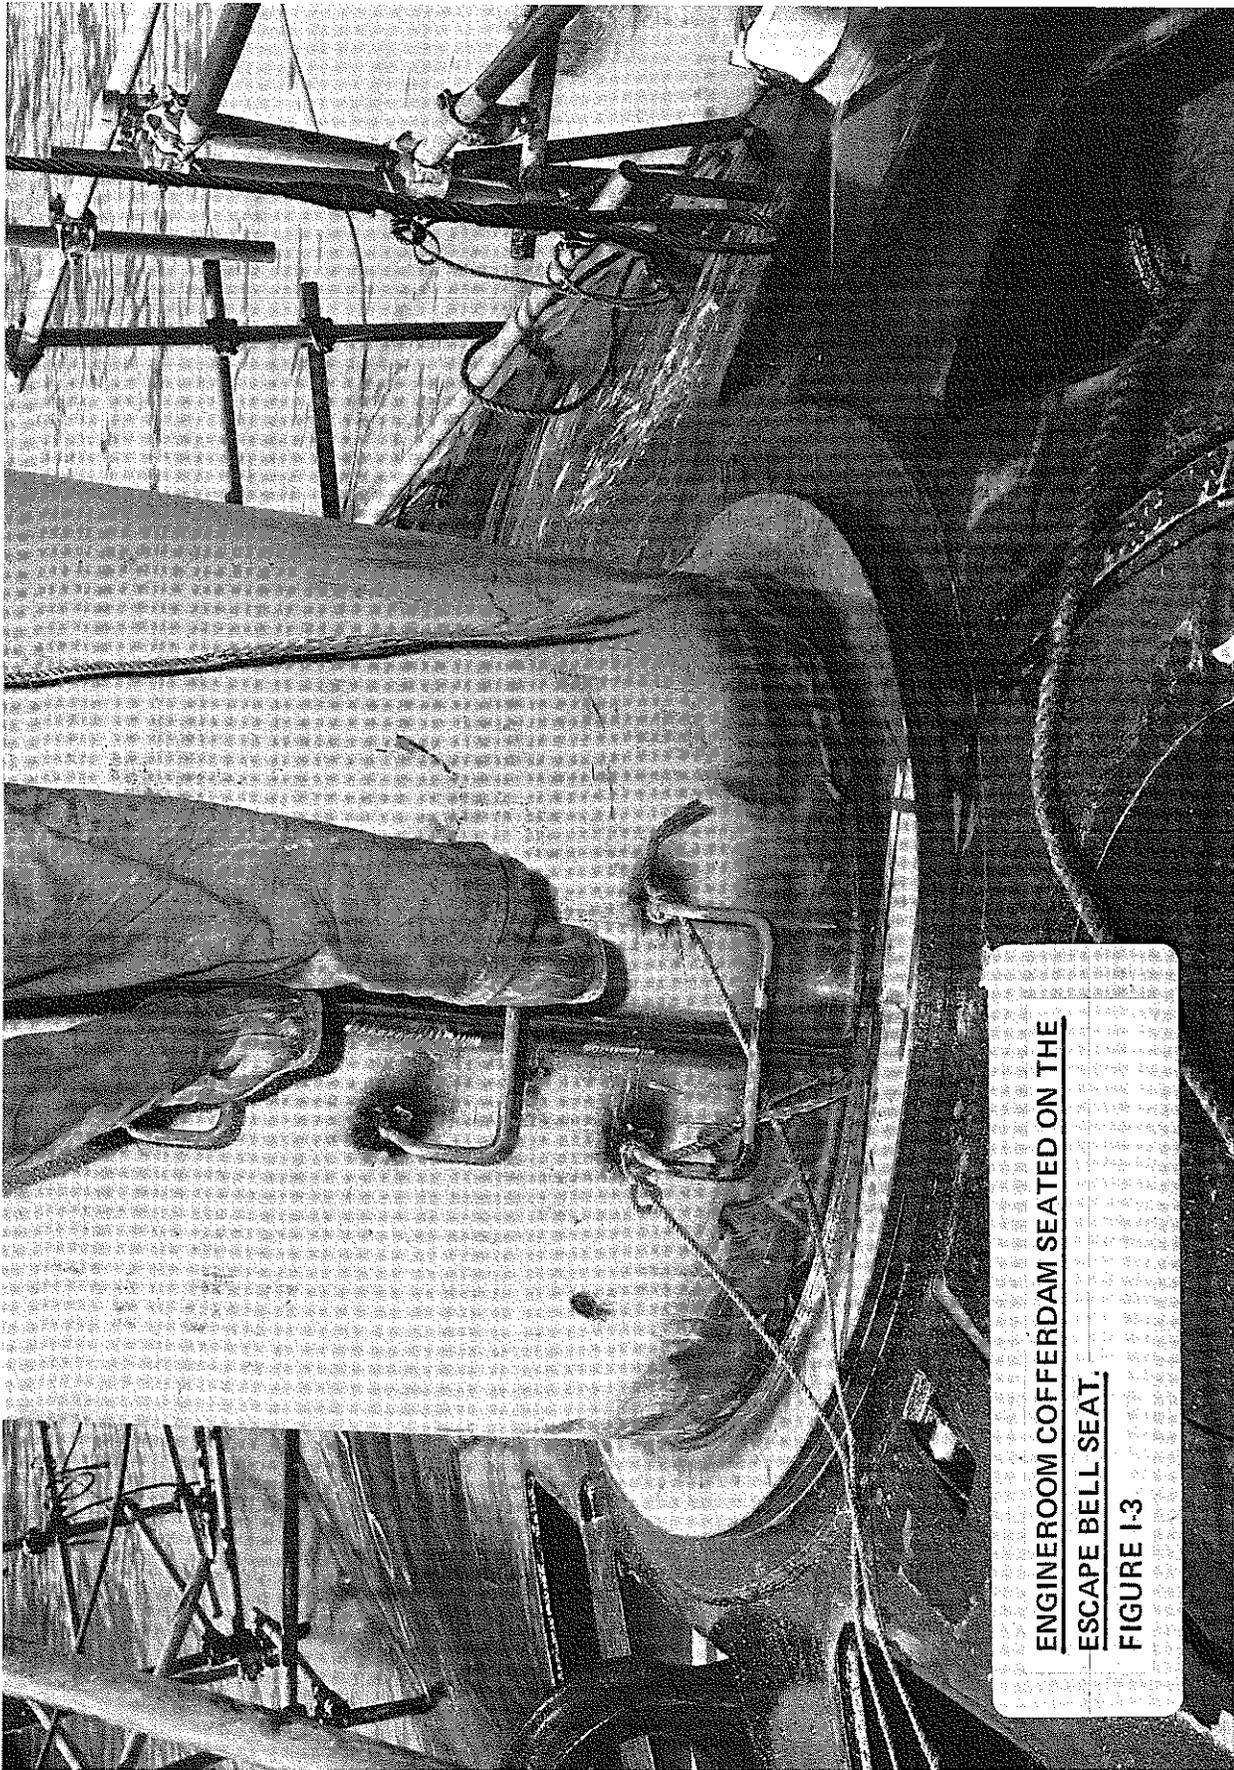
ENGINE ROOM COFFERDAM SEATED ON THE
ESCAPE BELL SEAT.
FIGURE I-3

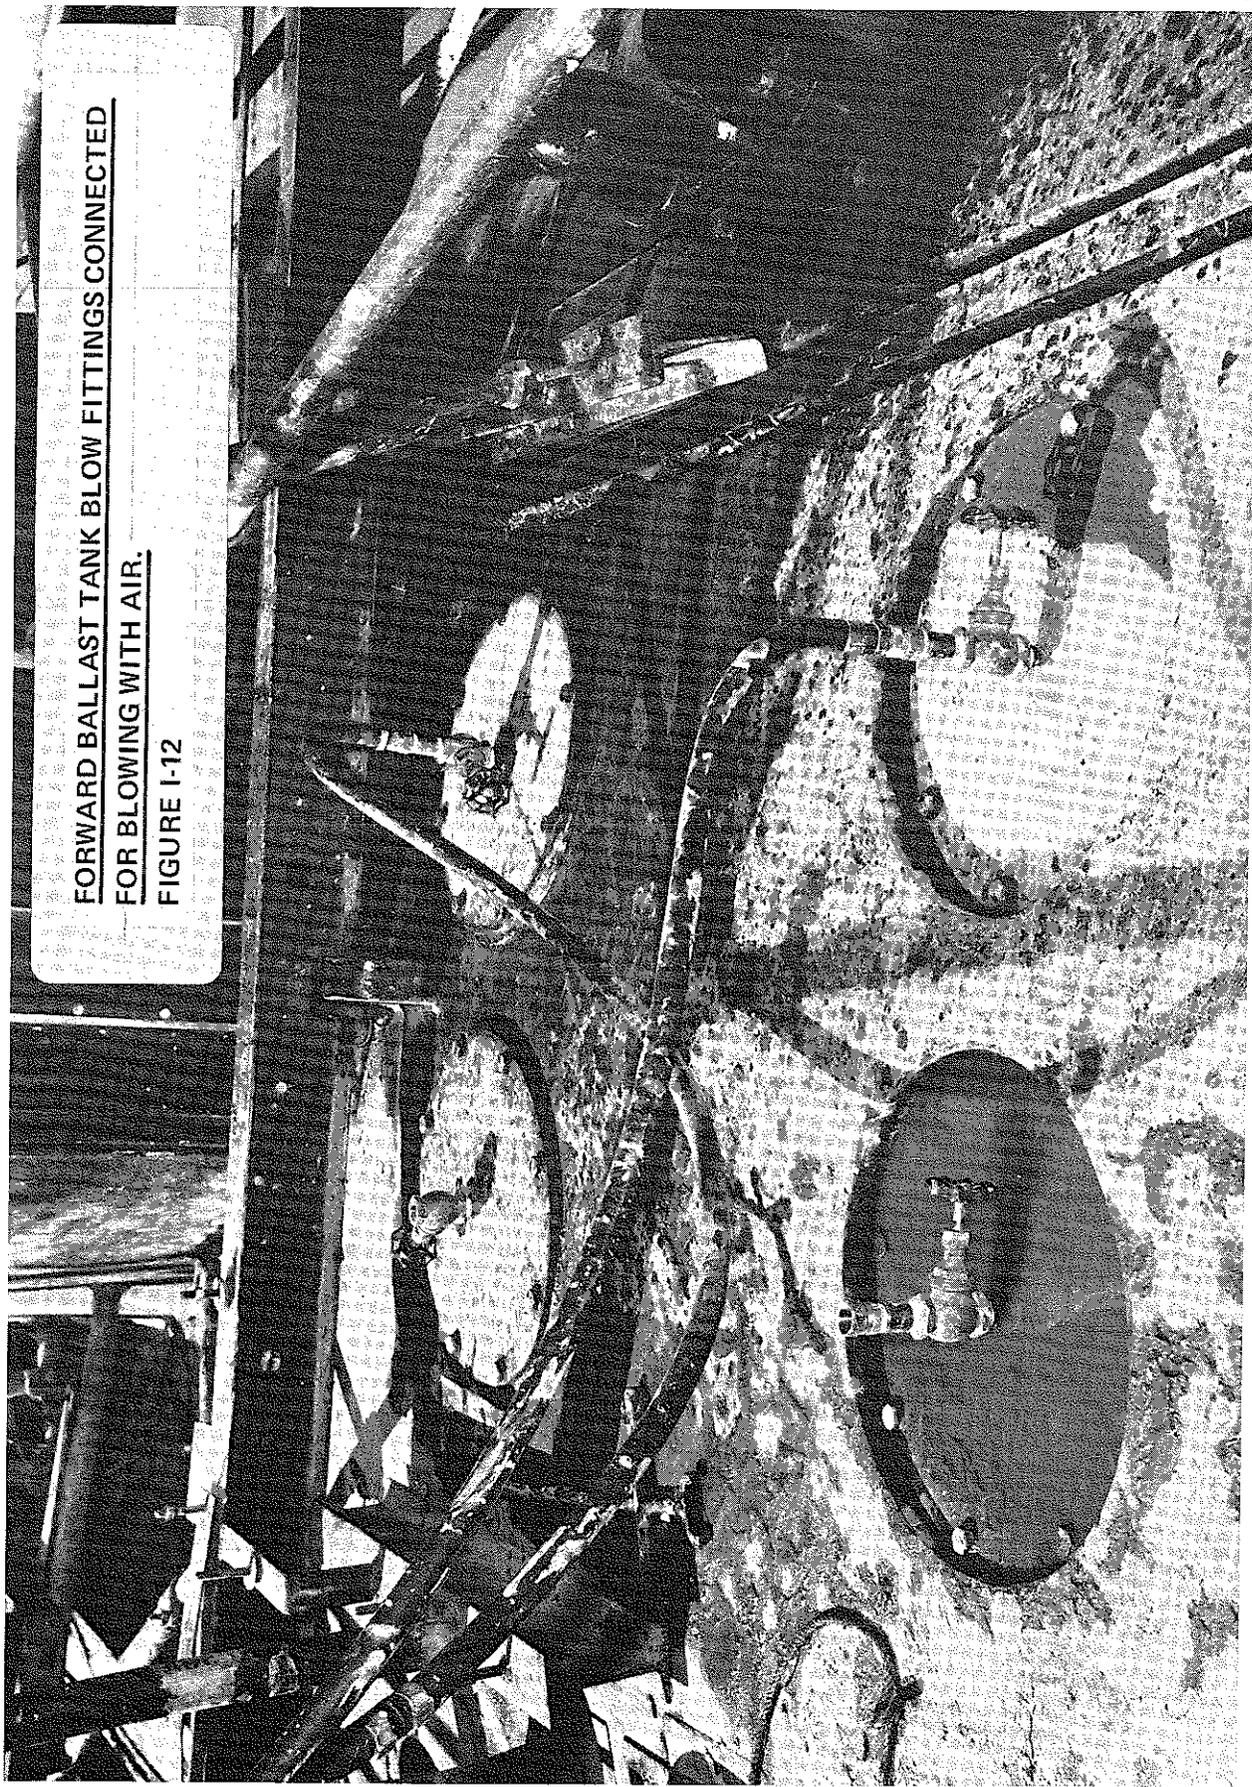
FORWARD BALLAST TANK BLOW FITTINGS CONNECTED
FOR BLOWING WITH AIR.
FIGURE I-12

On 17 May all patching was completed. Cofferdams were installed on the after access hatch and on the patch for the reactor compartment. Blow fittings were installed on main ballast tanks forward, and a fitting to pump the sonar dome underwater was installed. At 0500 the forward two spaces were pressurized and water expulsion commenced. This blow continued until 1240, when it was decided to shift to pumping. These spaces were vented, and at 1825 the conning tower access hatch was opened. Salvage crews entered the submarine and found the water level forced down to about three feet below the upper level. Prior to the entry of personnel into the submarine, careful checks were made for chlorine and hydrogen gas; none was found.
