EX-USS SHADWELL Disposal – Wreck in Place

In February of 2017, following a request for Salvage from the Naval Research Lab (NRL), OPNAV tasked SUPSALV to support Naval Research Laboratory (NRL) with the removal and disposal of EX-USS SHADWELL (LSD-15) which was moored on Little Sand Island, in Mobile, AL.

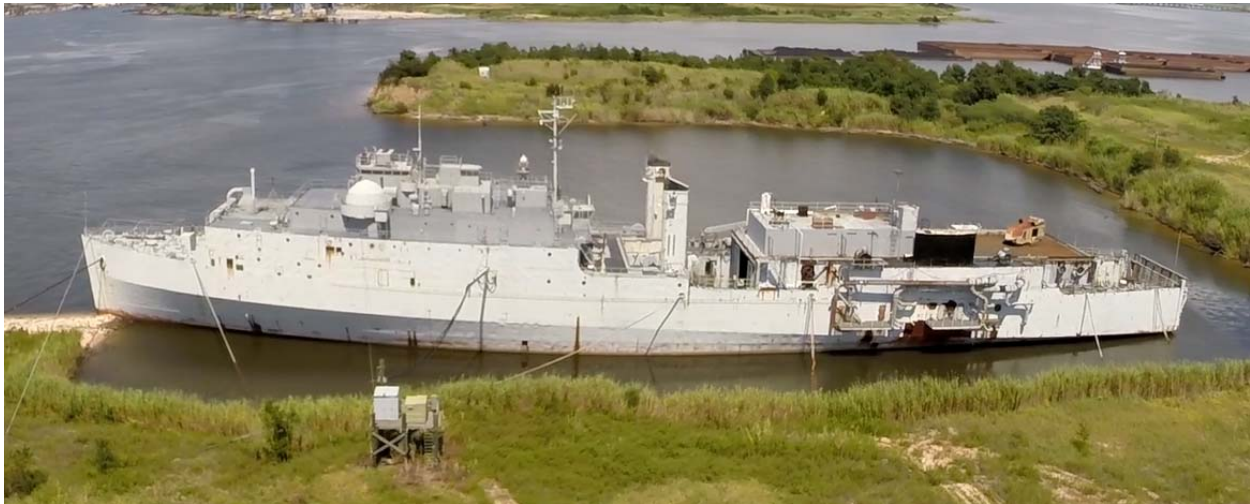
EX-USS SHADWELL in her mooring on Little Sand Island where NRL used her as a full scale R&D platform for conducting firefighting tests.

The most recent survey determined that she was grounded along 60% of her length and the extreme degradation of her structural members and shell plating raised the potential for catastrophic failure during a tow to a ship breaking facility to unacceptable levels. To avoid significant dredging operations to free her and to avoid a high risk tow through the heart of the Mobile's navigation channel, the determination was made to conduct the disposal of the ship in place.

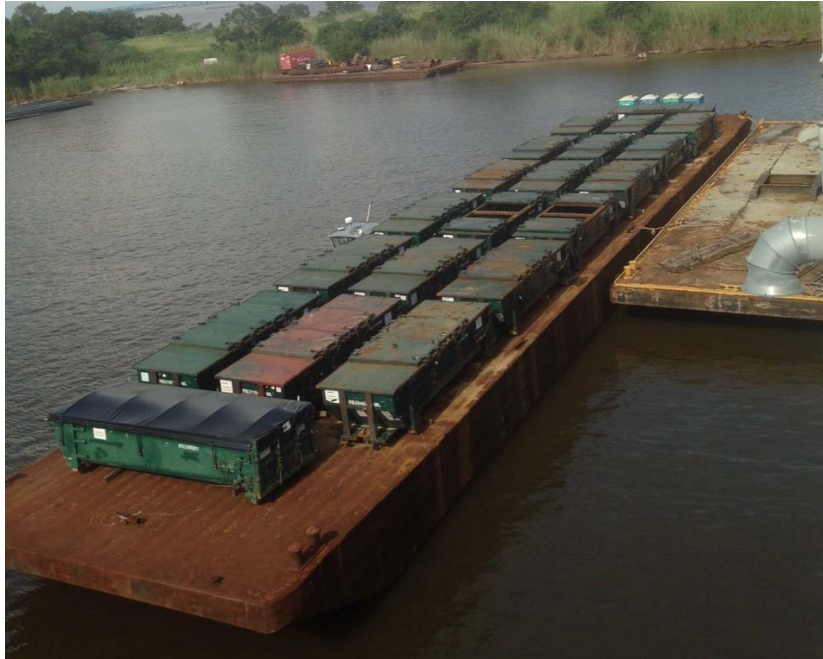
Trash Barge alongside EX-SHADWELL equipment with multiple dumpsters for each type of waste. (10 July 2017)

To safely scrap and dispose of SHADWELL, meeting all environmentally regulations, a dismantling plan was prepared. The initial step was to remove the fittings, furnishings and trash from all spaces and decks. A trash barge was brought along side for processing, sorting and transferring waste streams coming off SHADWELL. Pictured below is the trash barge with individual dumpsters for each kind of waste. Trash removal was essentially completed by 18 July with more than 95% of the identified loose material removed.

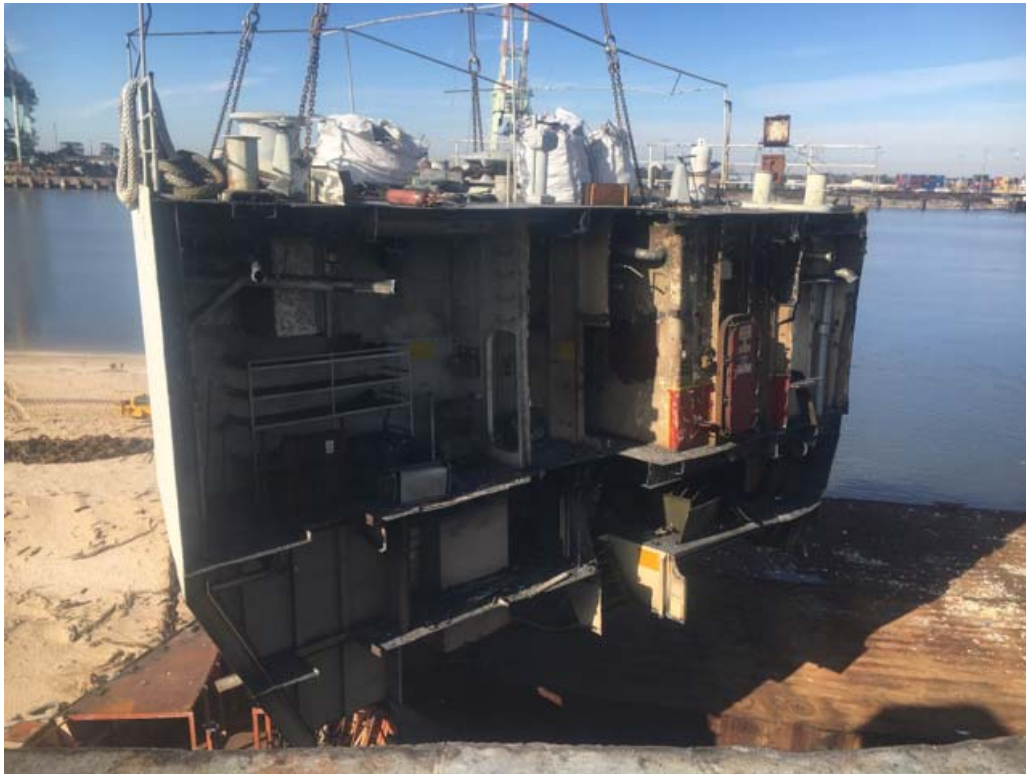
Bow section being lifted from SHADWELL's hull on 7 January. Note mooring line on left and anchor capstan center.

EX-SHADWELL disposal continued throughout the months of December and January. Working with DONJON, LCDR Eric Brege, the SUPSALV project manager developed an overall cut plan to remove the structure in a controlled, methodical way. To allow the ship to be pulled onto the beach more easily, significant trim was induced by removing significant portions of structure at the bow and working aft.

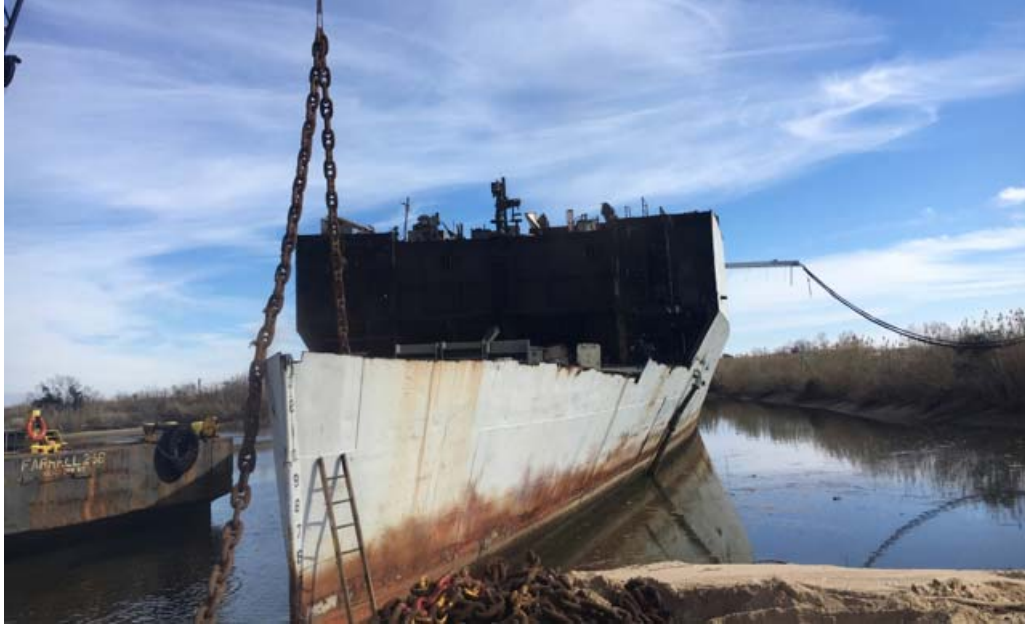
EX-SHADWELL's anchor chains are removed from the chain locker after 1st and 2nd Decks have been removed from the bow.

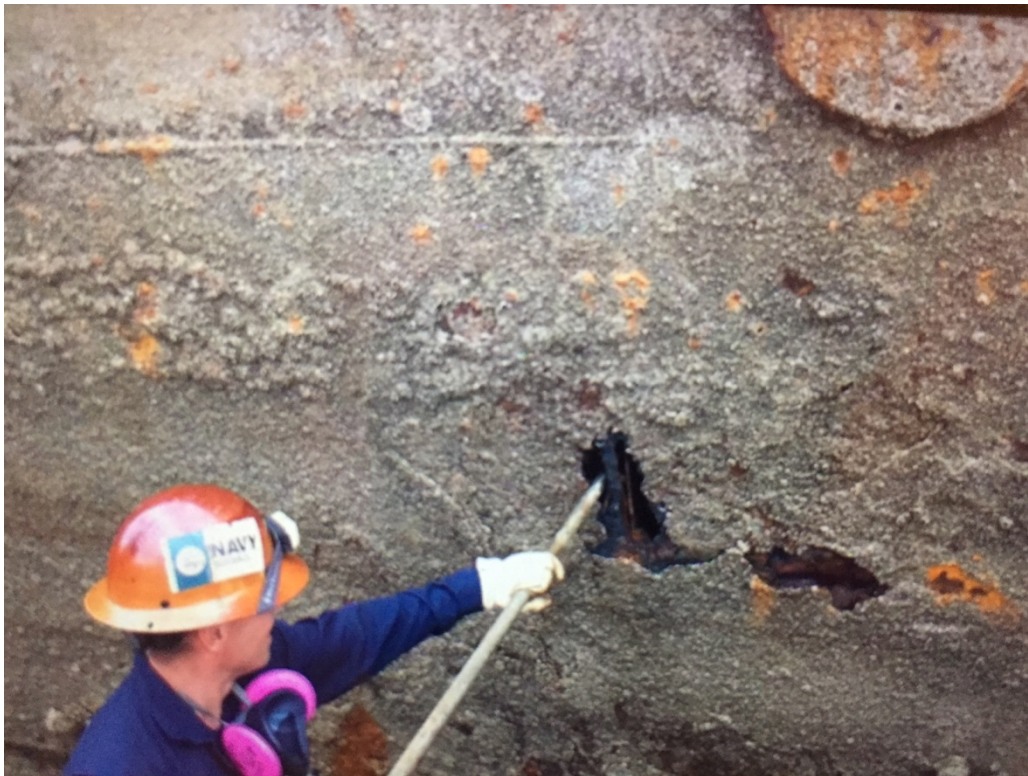
EX-SHADWELL's hull is easily pierced with just a metal rod, showing the severity of hull degradation

As portions of the ship normally below the waterline were exposed, the wrecking in place option was validated as numerous holes in the shell plating were exposed. In fact, the hull was weak enough around the engine rooms and boiler rooms that a broom handle was able to easily pierce the hull. Had SHADWELL been dredged out and brought into the channel for towing, the lack of structural watertight integrity along with her holed hull could easily have led to catastrophic failure within the shipping channel.

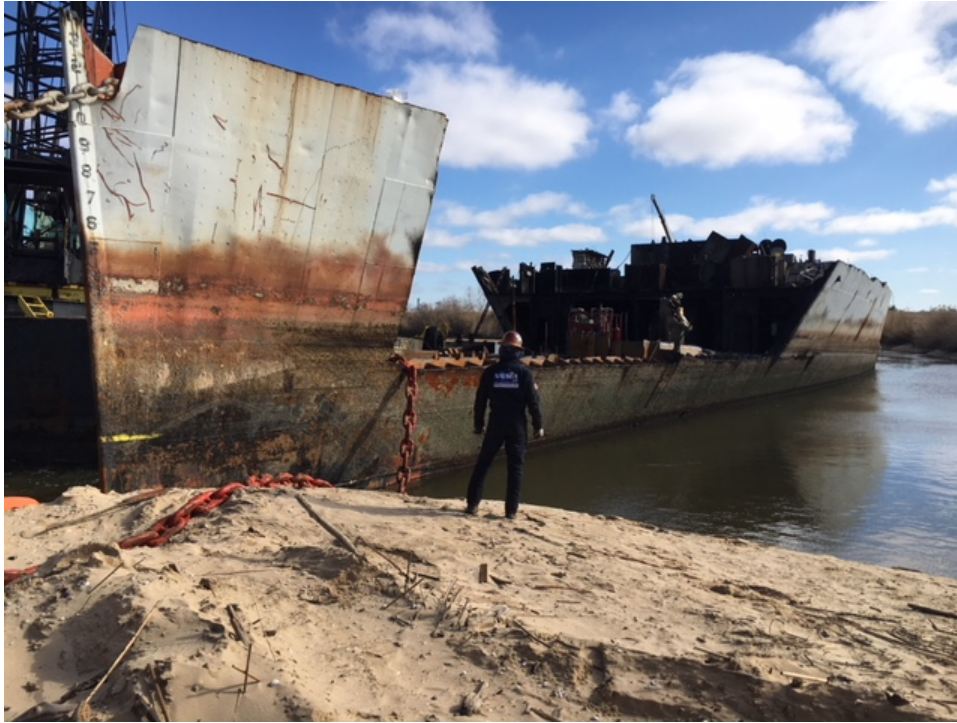
13 January 2018 - LCDR Brege observes the forward sections of the ship cut down to just above the waterline as the ship is being prepped for pulling onto the beach with the 300T chain puller.

After bow sections above the waterline were removed, the ship was rotated perpendicular to the beach and pulled up onto the beach. In the image below, the bow remains attached to the hull but has been pulled to the beach and chains are in place for the 300-Ton chain puller to slide the hull forward across the sand.

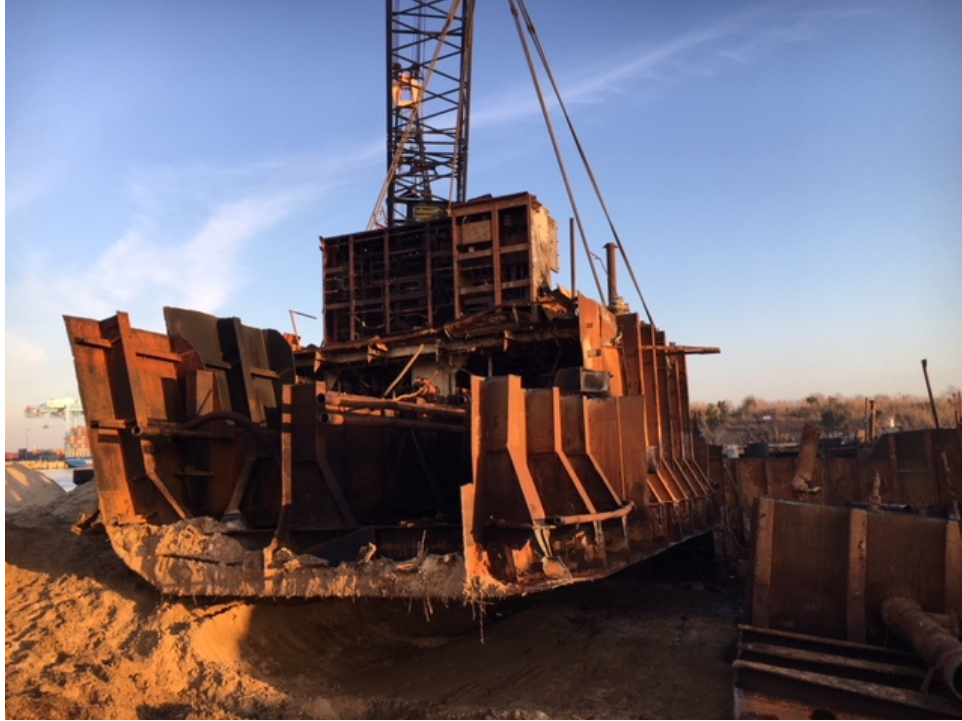
6 February image of the starboard side of Auxiliary Machinery Room being lifted free of the beach.

The project team continued to move steel rapidly as the project nears completion. Each hull section, weighing between 35 and 110 LT each, is lifted onto a barge for transport to a steel scrapyards. By the first of February, over 3,200 Long Tons of hull had been removed. The ship disposal continued as planned in the final 3 weeks and the last section of the hull was lifted onto the scrap barge on 19 February. Following the removal of the ship, all equipment was removed from the island, a SONAR survey was conducted to locate any items within the cove requiring removal, and post project soil samples were taken for analysis in the same locations as the pre-project samples.
