## **SUPSALV Supports Critical Piping Systems Repairs on USS INDEPENDENCE (LCS 2)**

20 January 2015

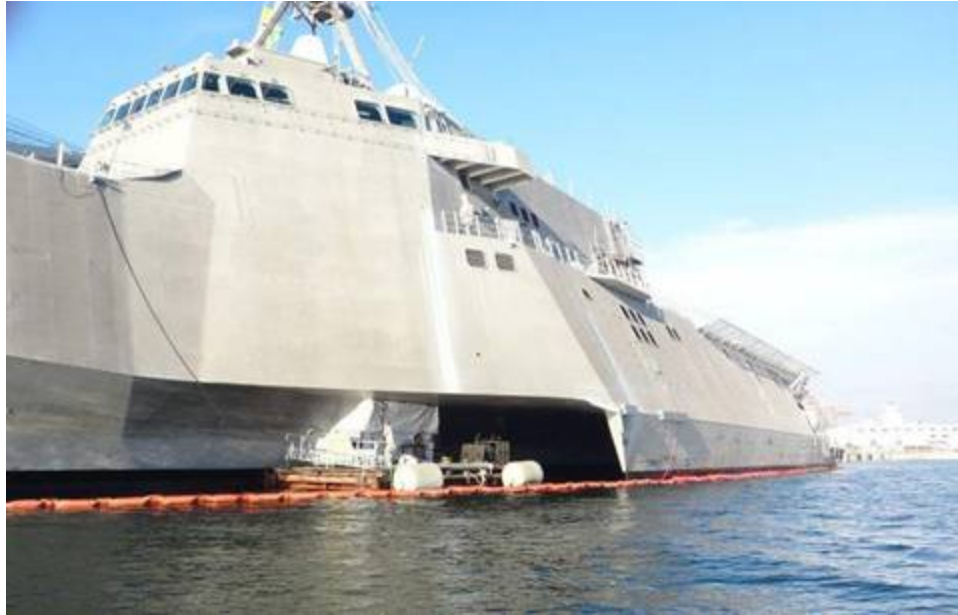
USS INDEPENDENCE (LCS 2) pier side with welding barge positioned for Hull Mounting Plate installation.

To support this repair which would have normally required dry-docking, NAVSEA 00C designed an open top cofferdam system to be installed on the hull of the ship that would allow pumping the water out - thus isolating that section of the hull from the sea. To further reduce the cost of this repair, 00C modified an existing cofferdam body. Engineers used computer modeling software to design a mating flange that would fit to the ship's unique hull and provide a watertight seal.

To hold the cofferdam in place, six Hull Mounting Plates (HMPs) for removable padeyes were designed and then welded to the ship's aluminum hull, both port and starboard, in the vicinity of the overboard discharge piping hull opening. The HMP's can remain on the hull for future use.

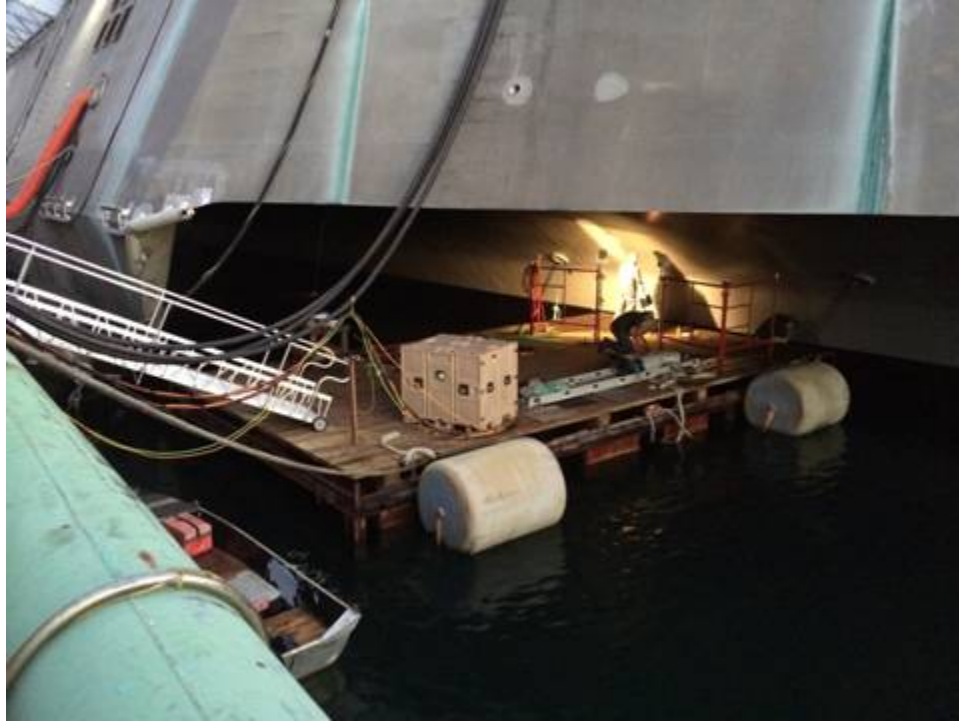
Welders installing a Hull Mounting Plate on the starboard side of the INDEPENDENCE hull.

Heineman reported that, "In preparation for future LCS class repairs, NAVSEA qualified Phoenix's welding team on aluminum welding –topside and hyperbaric- which allowed this repair to take place."

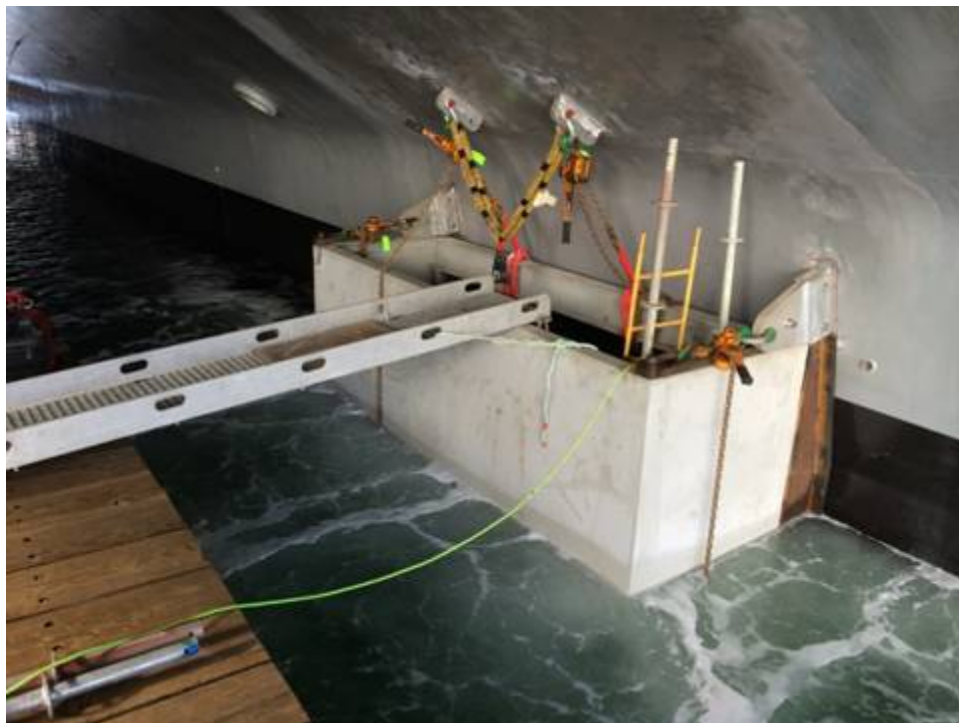
Cofferdam fastened securely to the ship and dewatered allowing repairs to skin valves to take place

In order to perform the required repairs, a water tight boundary was needed outside the skin of the ship to allow the internal repair team to remove and replace degraded 10 inch diameter seawater discharge piping up to the hull penetration.

After HMPs had been welded, and welds certified, the cofferdam was deployed, sealed, and dewatered. With the cofferdam in place, the local contractor removed and replaced the degraded piping section. Because the cofferdam provided the only barrier to the sea, a dive team was on station 24 hours a day for seven days during the entire repair process ensuring the cofferdam maintained its seal protecting the ship and the workers inside.
