SUPSALV Performs Stern Tube Bearing Replacement on USS GEORGE H. W. BUSH (CVN 77) in Norfolk, VA.

4 January 2013

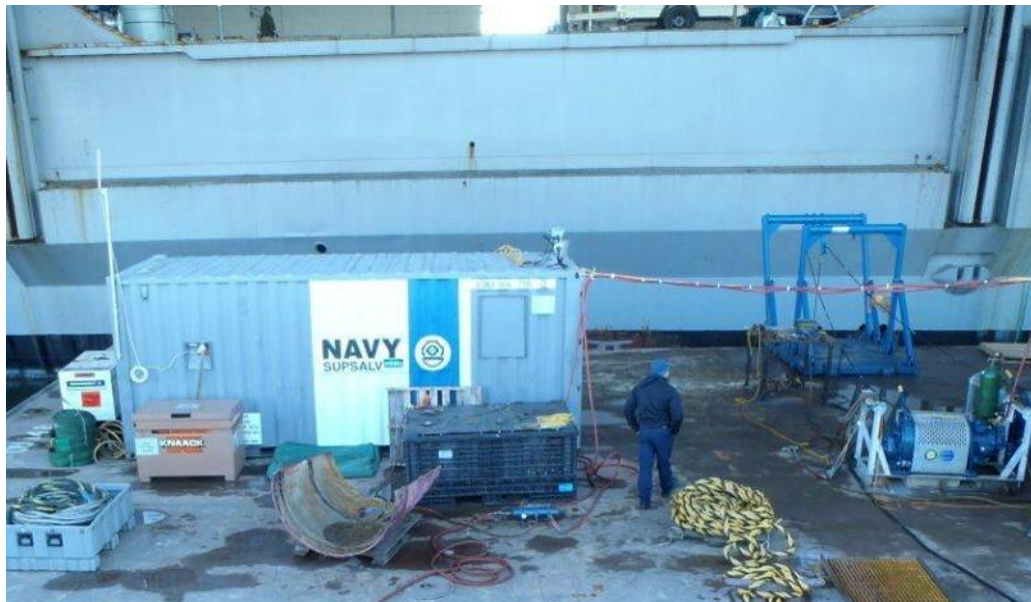
Diving and rigging barge used to conduct stern tube bearing replacement. Note A-Frame handling system with hydraulic winch system (tugger) on the right side of the picture. SUPSALV van on left provides critical gear like bearing removal platform, hydraulic jacks, and A-Frame and winch system to support this repair procedure. In front of the van is the stern tube fairwater which covers the bearing. It has been removed to the barge for refurbishment.

NAVSEA 00C representative and divers from Phoenix International, SUPSALV's Diving Services contractor, arrived on scene on 5 December and positioned the rigging barge with its A-Frame handling system astern for managing the heavy loads associated with this task. An image of the diving and rigging barge is shown below. Note the A-Frame handling system and hydraulic tuggers which were installed on the barge to aid the divers in handling heavy equipment in the water and under the ship.

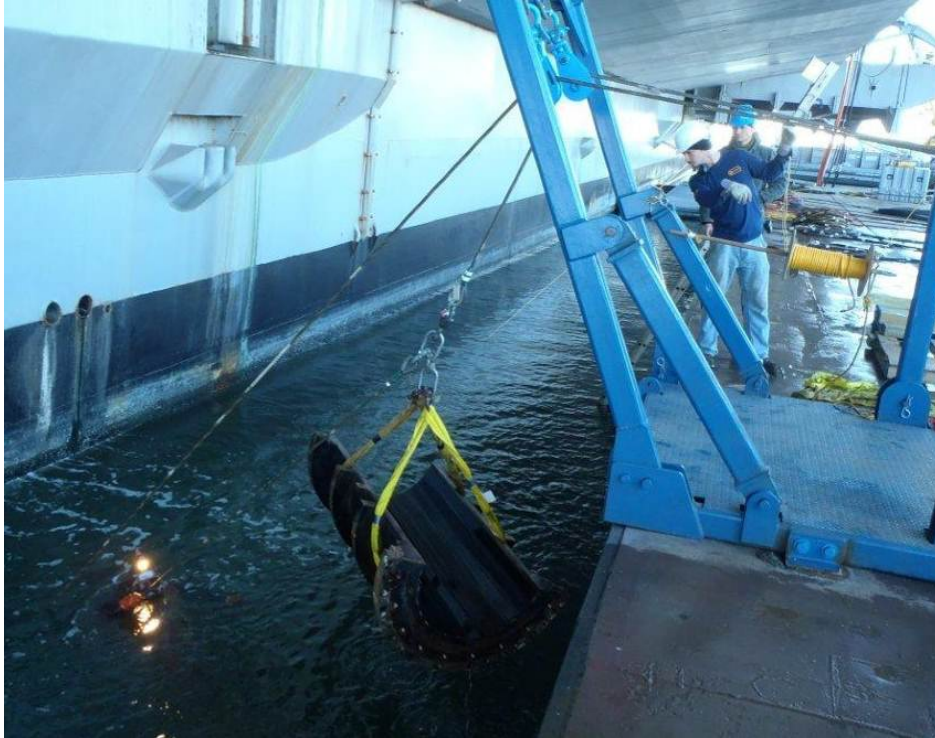
With a Phoenix diver watching from the water, the repair crew pulls one-half of the stern tube bearing clear from the water at the starboard side of the USS GEORGE H. W. BUSH using A-Frames (blue structure) and hydraulic tuggers (not visible).

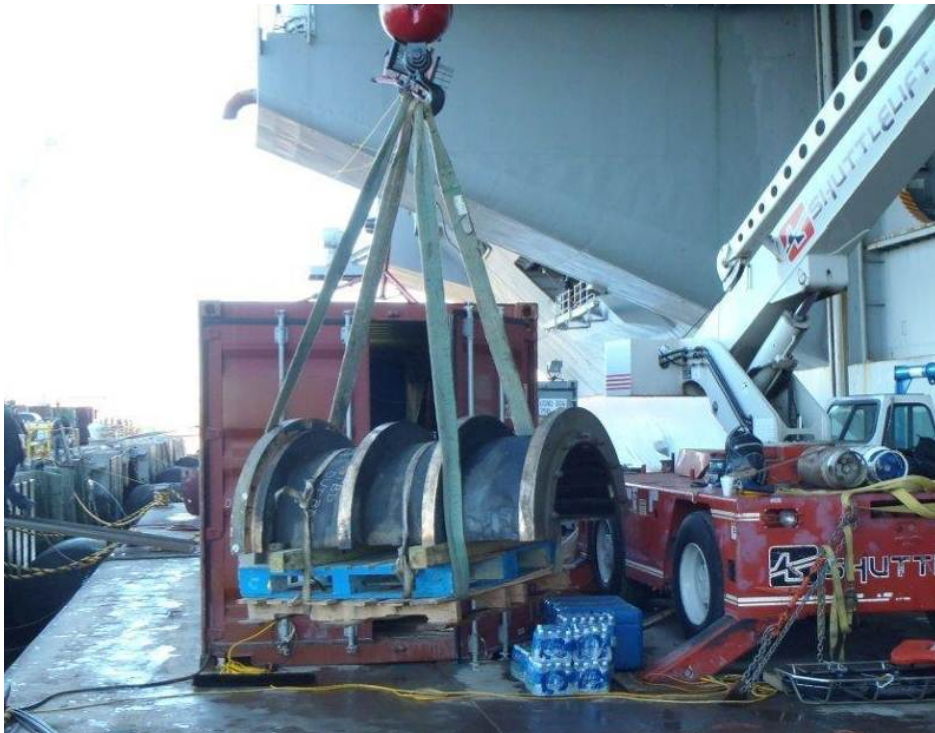
A portable crane is used to move bottom bearing shell from the dive and rigging barge to the pier.

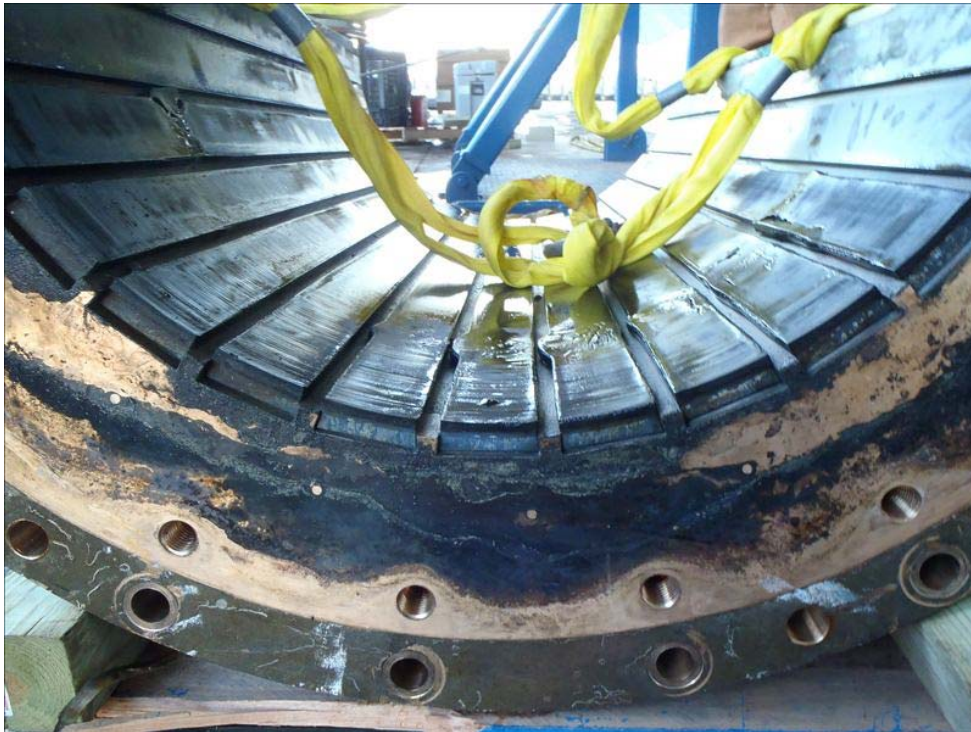
To jack out the bottom half of the bearing, the shaft had to be lifted. A bearing removal platform, which is an I-beam assembly constructed to hold the bearing halves safely while being jacked out, and a set of powerful hydraulic jacks were used. After 8000 psi was applied to the jacks, the shaft lifted approximately 1/8" easing the load off the lower half of the bearing. Then, on 13 December, jack-out bolts were used to slide the bearing half onto the bearing removal platform from where it was removed and placed on the barge. Damage to the bearing stave surface is evident in the following picture.

Damaged staves are visible on the bottom half of the stern tube bearing. This bearing is resting on the dive and rigging barge prior to being transferred to NNSY's bearing shop.

On December 14th, the top half of the bearing was jacked back into the bearing shell to ensure positive control during rotation. It was then rotated to the bottom position and jacked out and removed. Both halves were sent to NNSY bearing shop for cleaning, restaving, dressing, and measuring. SUPSALV received both bearings back from the repair shop in ready for issue (RFI) status on 17 December. Re-installation began immediately and the bearing replacement and fairwater reassemble tasks were completed on 27 December, 2012 returning the ship to service.
